St Paul's Church

Newport

Structural Condition
Survey

Job Number: 12373

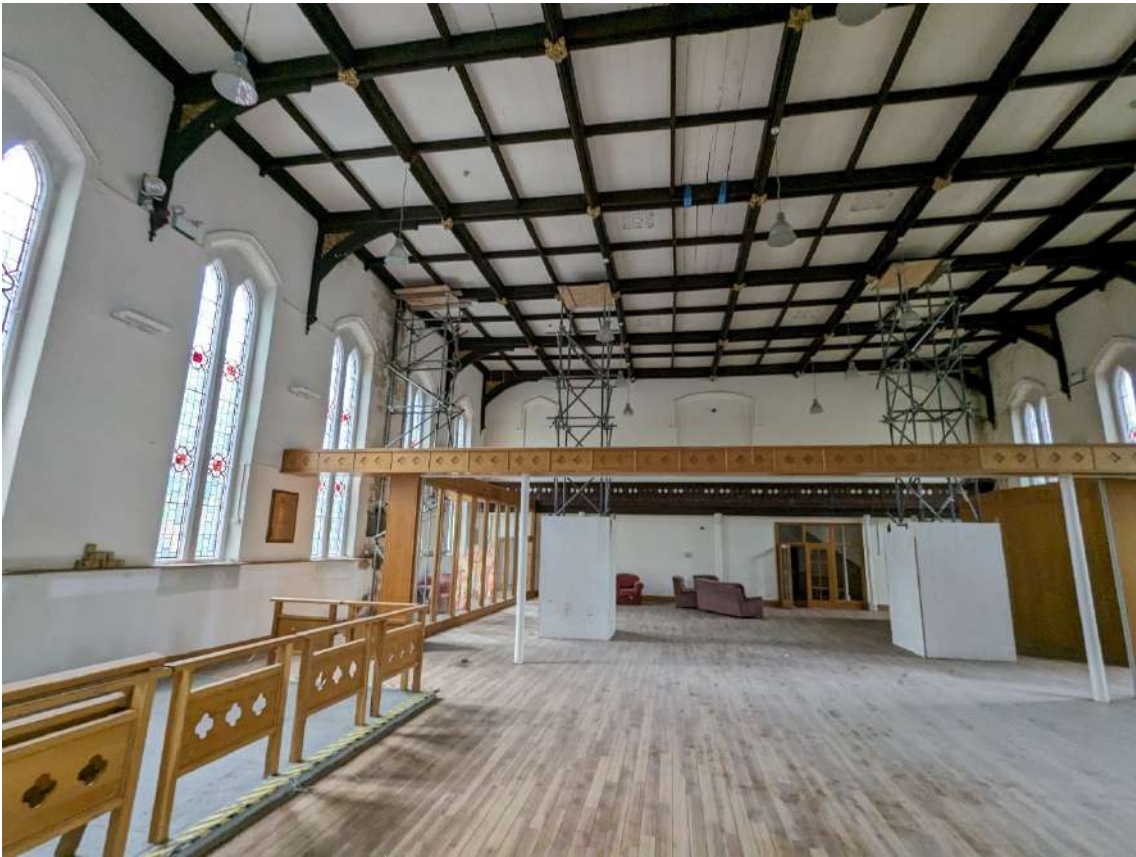
- 2.2.1 The scaffold towers in place to provide propping to truss 4 appeared to be in sound condition structurally based only on a visual inspection from floor level, however there appeared to be some issues with the propping closest to the bearing of the truss.

- 2.2.2 Two of the three scaffold towers were arranged with scaffold boards running perpendicular to the truss, with plywood over. However the propping at the bearing has been arranged with the scaffold boards running parallel to the truss, meaning that the plywood over appears to be spanning between the boards, picking up the load of the truss over.

- 2.2.3 The arrangement described above should be reviewed on site by the scaffolding contractor and remedied.

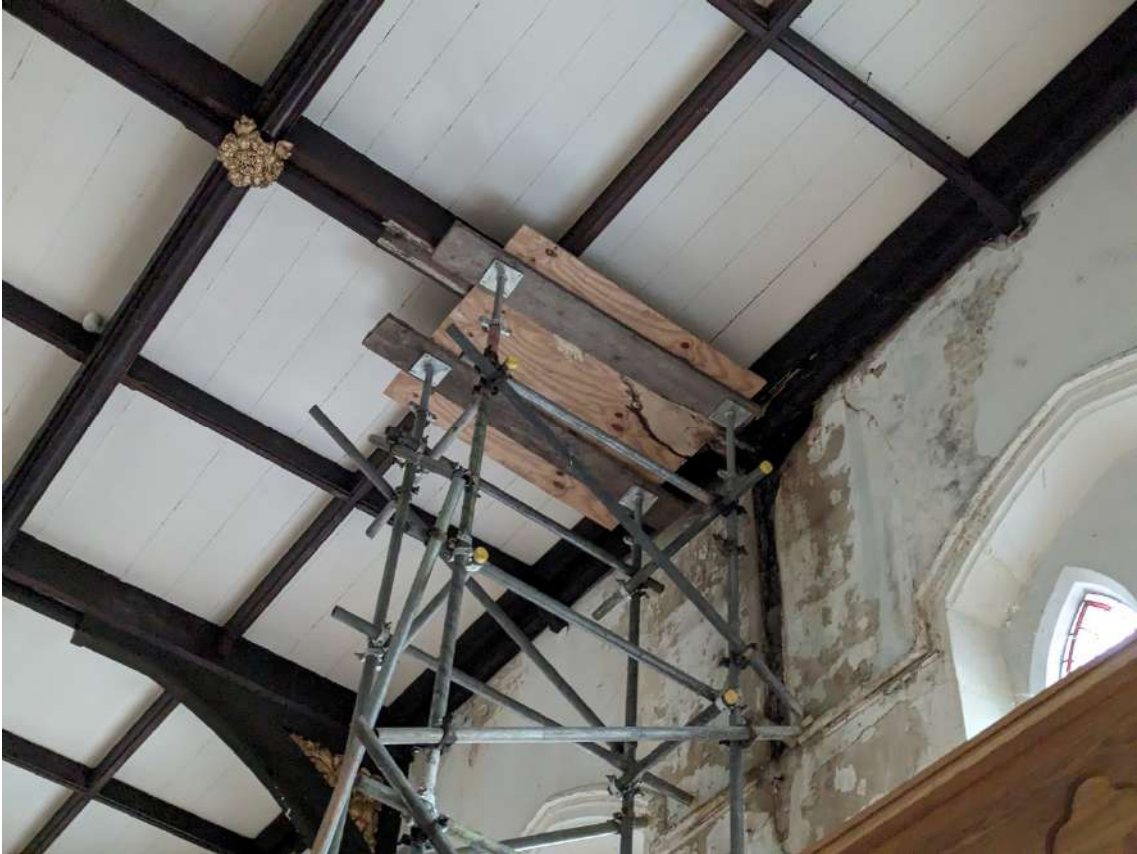
- 2.2.4 The plywood supporting the bearing of Truss 4 shows signs of water damage, which may have lead do decay of the plywood. Though more importantly this evidences the fact that water is still penetrating the structure at this point and is likely causing the condition of the bearing of truss 4 to worsen even further.

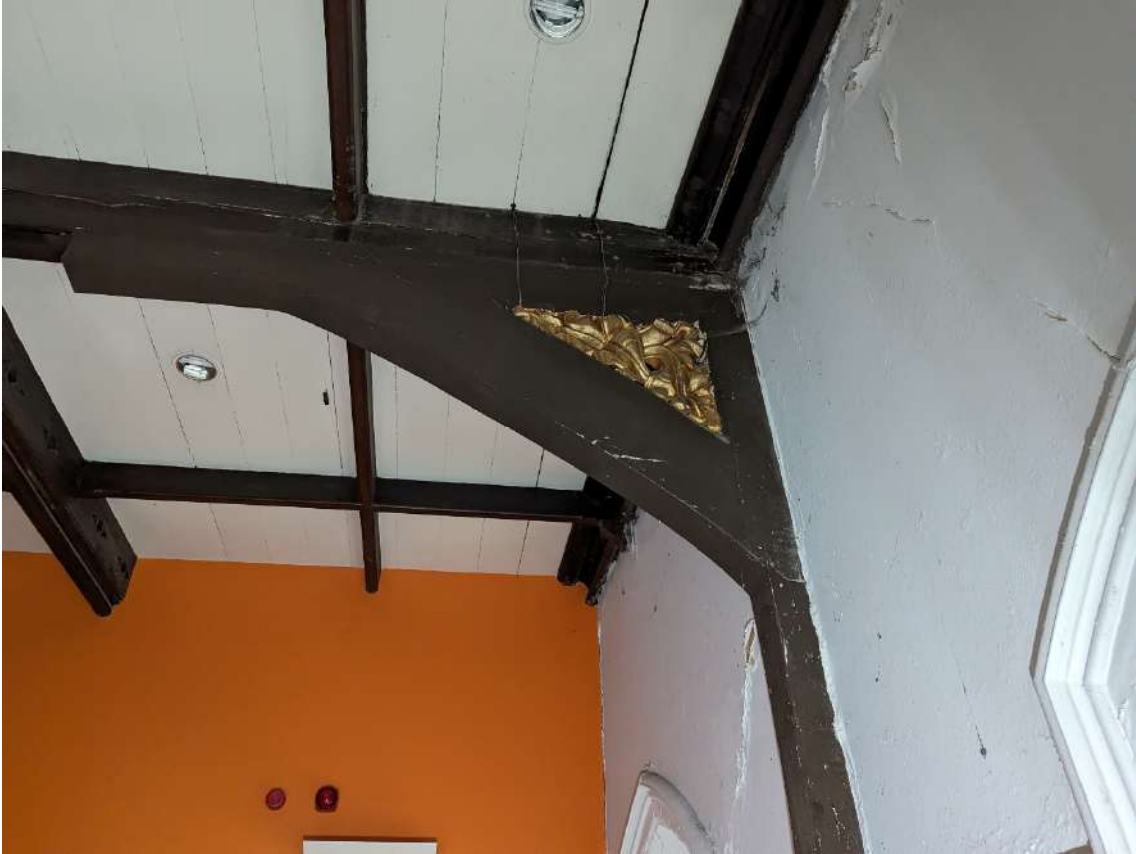
- 2.3.1 The South Bearing of Truss 1 was inspected from first floor level only, which provided for a closer visual inspection, but no probing could be carried out.
- 2.3.2 The signs of decay and crushing of the bearing noted previously were still present however the condition did not appear to be significantly worsened since the previous reports.

- 2.3.3 As has been previously noted, a repair should be carried out to this truss end, utilising steel plates either in a face plate or fitch plate configuration in addition to replacement of the decayed timber with like for like sized timbers.

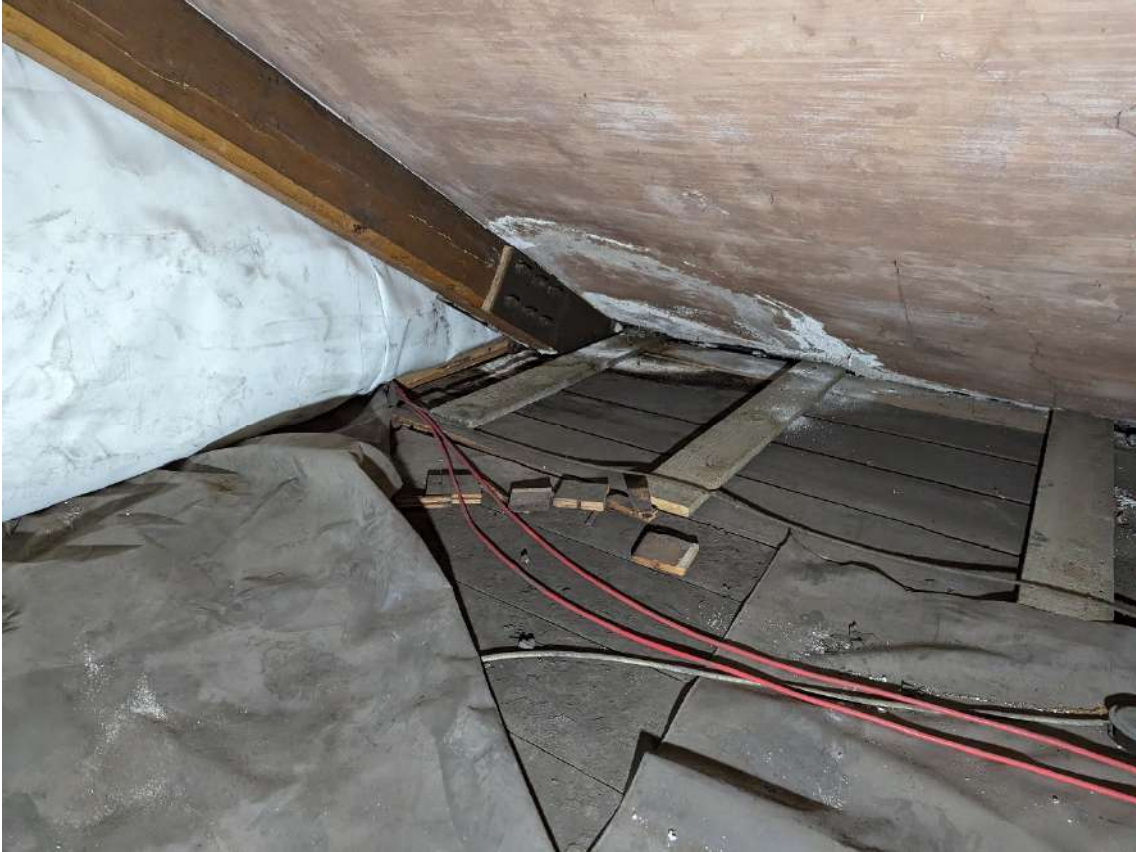
- 2.4.1 From within the lower attic space, it was possible to review the principle trusses, however the combination of the historic pitched ceiling and the newer flat ceiling meant that detailed inspection of the truss bearings and rafter ends was not possible.
- 2.4.2 It was generally noted from within the roof space that whilst there were numerous signs of historic water ingress which aligned with the previous reports, the roof structure visible did not appear to be actively damp. This may be in part due to the relatively dry weather in the lead up to the inspection.

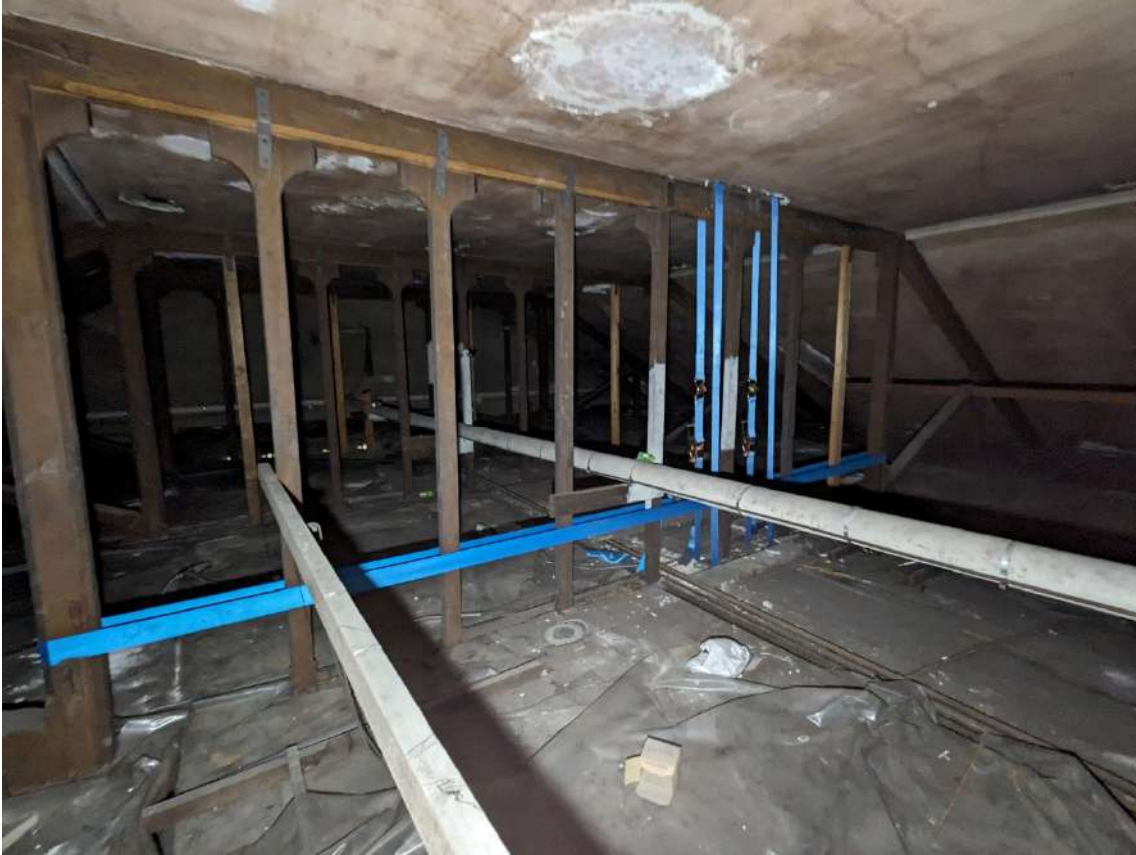
- 2.4.5 Three sets of ratchet straps have been used to arrest the movement in truss 5 caused by the failing joint in the bottom chord previously recorded. The ratchet straps appear to be performing adequately, however they do not represent a permanent solution and a permanent repair should be carried out.

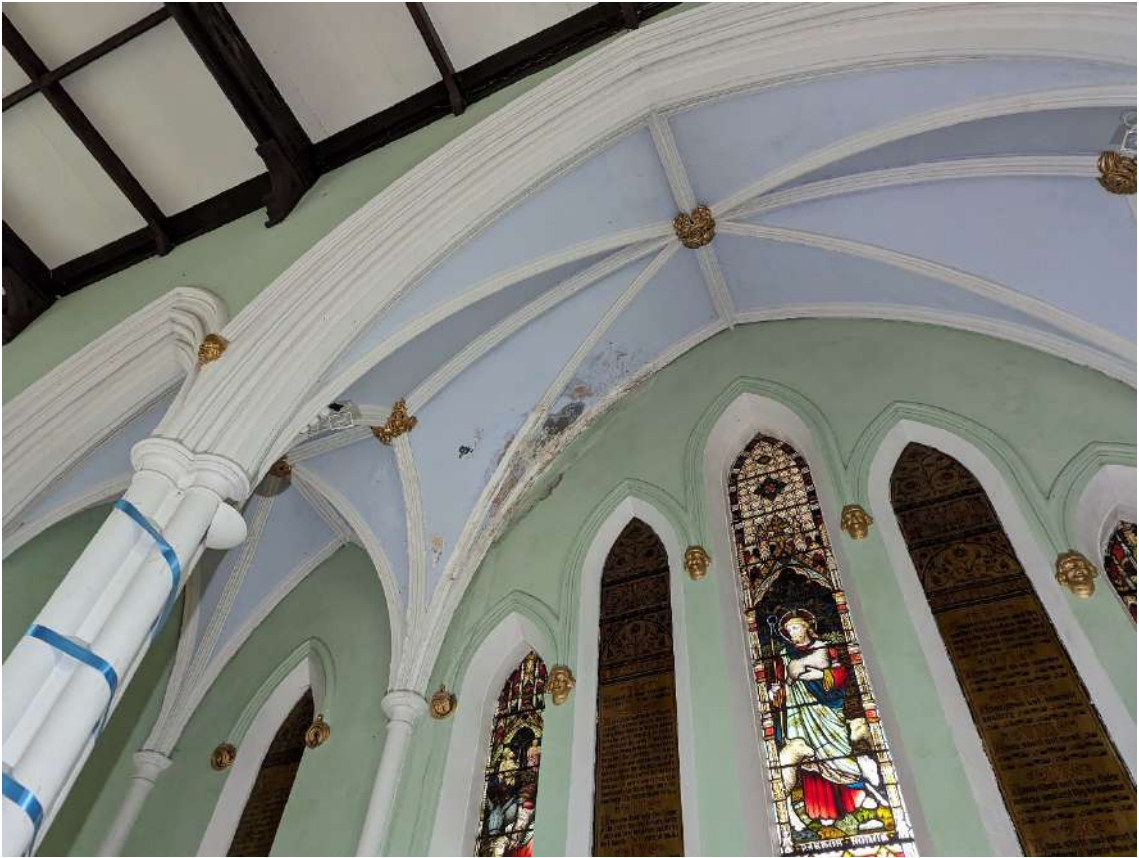
- 2.5.1 It was noted from within the ground floor hall that there was notable water ingress to the arched roof over the Apse. This area of the roof was not visible from the attic space. This should be further investigated in order to identify the condition of the structure over as well as identifying the route of the water ingress.

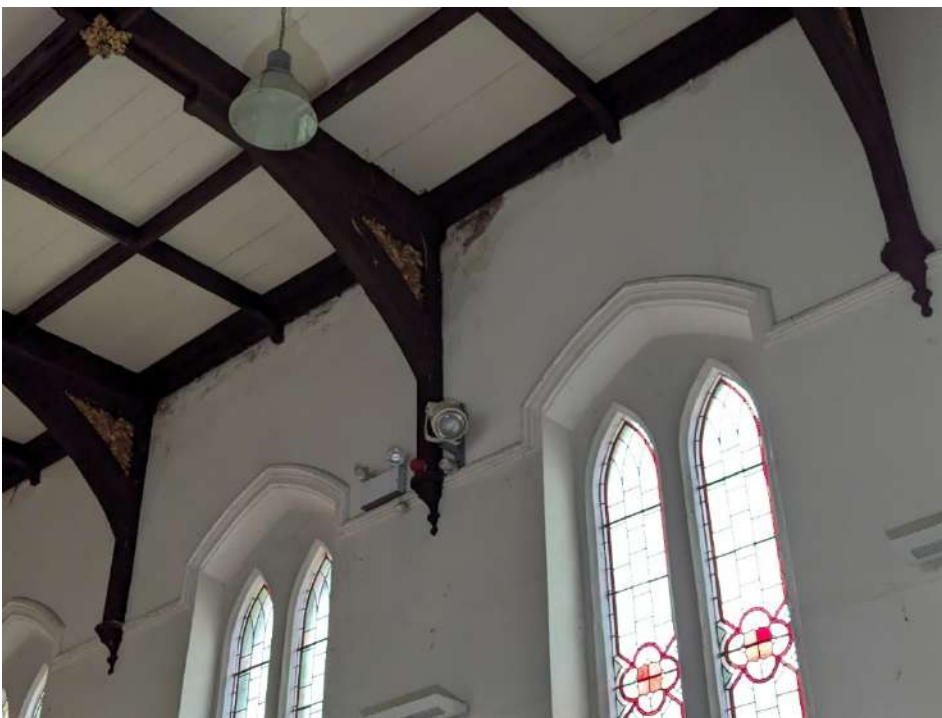
- 2.5.2 Other than the bearings of Truss 1 and 4, the South wall showed little signs internally of damp, however the North wall showed signs for damp along much of its length suggesting that the parapet gutter is likely to have failures along its length.
