**Coc Y North Barn, Coc Y North Lane, Rhiwderin**

**Structural Inspection Report**

## **Steve Morgan Associates**

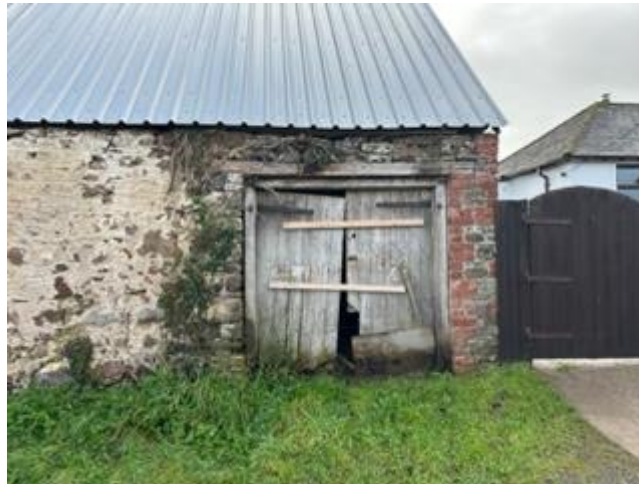
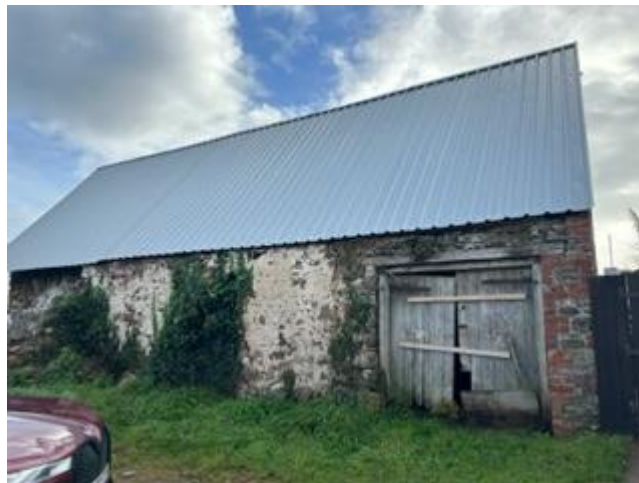
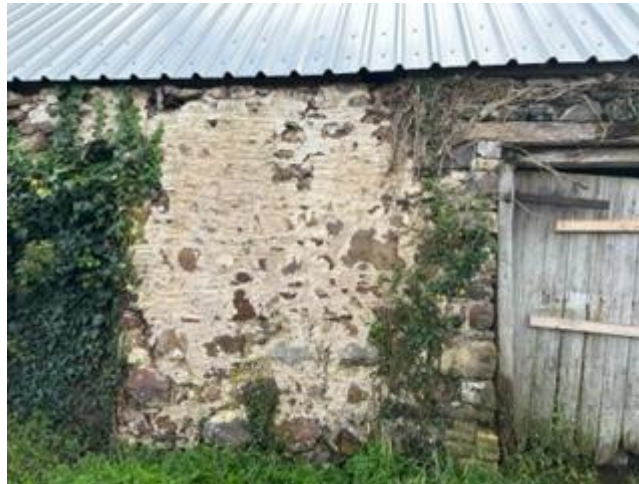
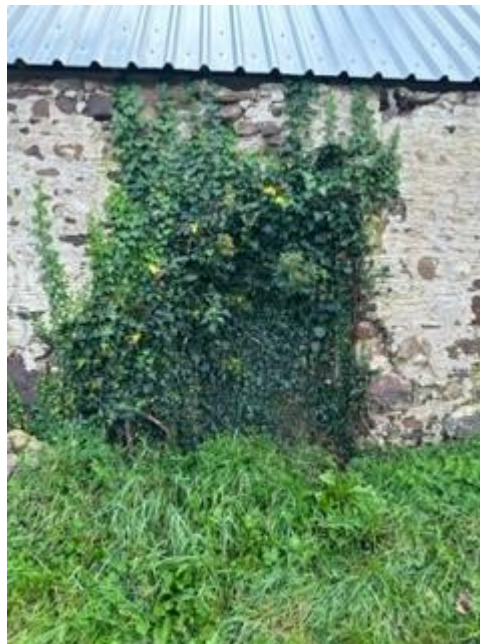
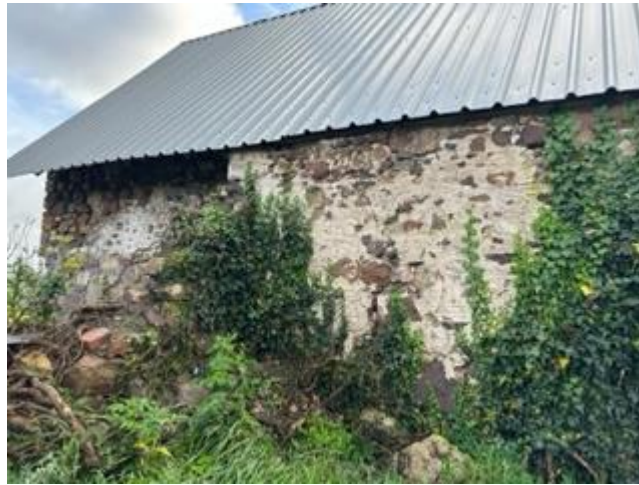
The front elevation contains a double door opening to the left of the elevation. To the right-hand side of the elevation there is evidence of historic repair to the door reveal with brickwork added. The lintel over the opening is timber and is likely to require replacement.

The elevation is partially concealed by vegetation. The vegetation should be treated and removed with any damage to the masonry made good.

There is a small return in the elevation to the left-hand side. It is possible that this may have been due to an historic addition to the original barn. The wall adjacent to the return and adjacent to the left-hand gable has a large crack running from eaves level down to the base of the wall. The crack will require stitching. It would also be prudent to inspect the foundations at the base of the wall at this location as the ground levels appear to have reduced, possible due to erosion/localised settlement of the external ground.

Figure 1  
Front (Coc Y North Road) elevation 1 of 5

Figure 2  
Front (Coc Y North Road) elevation 2 of 5

Figure 3  
Front (Coc Y North Road) elevation 3 of 5

Figure 4  
Front (Coc Y North Road) elevation 4 of 5

Figure 5  
Front (Coc Y North Road) elevation 5 of 5

- (xii) It is probable that some rebuilding/repair/resetting of masonry at eaves level will be required.
- (xiii) The crack to the front elevation should be repaired. This can be carried out once the cause of the movement to the front elevation/left hand gable corner has been established. The repair can comprise resetting of masonry across the crack or, potentially, a proprietary crack stitching system.

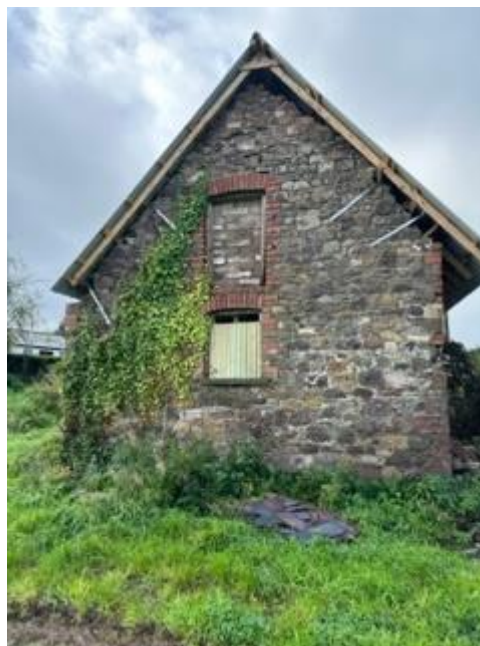
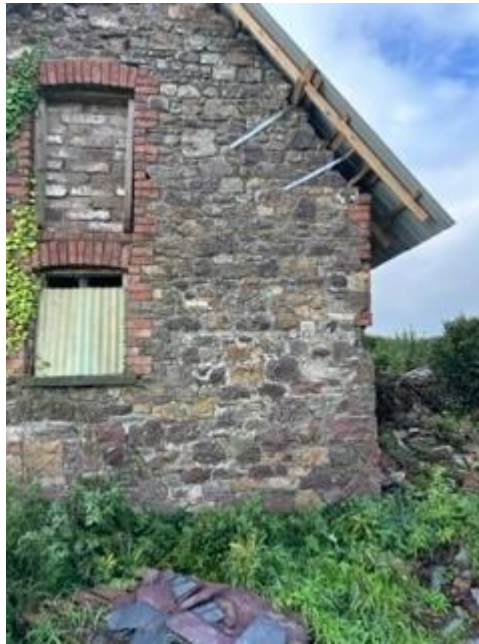
The left-hand gable is of random masonry as the front elevation. There are two window openings in the elevations, one at ground and one at first floor level. The first-floor opening has been blocked up. The windows have brickwork features to the perimeter. It is possible that the first-floor opening was a door opening.

The elevation contains the steel straps used to secure the roof structure. It is anticipated that these will be removed in the proposed scheme and an alternative solution proposed for the strapping.

This elevation again contains a large area of vegetation which should be treated and removed.

Figure 6  
Left hand gable end elevation.

Figure 7  
Close up of Figure 6

- (x) All vegetation should be treated and removed. Some repair to the bed joints can be anticipated once the vegetation is removed. The extent of the repointing can only be assessed when the vegetation has been removed.

- (xi) The current strapping detail is considered aesthetically unacceptable. The roof design should consider internal straps concealed on any inner skin to the conversion.

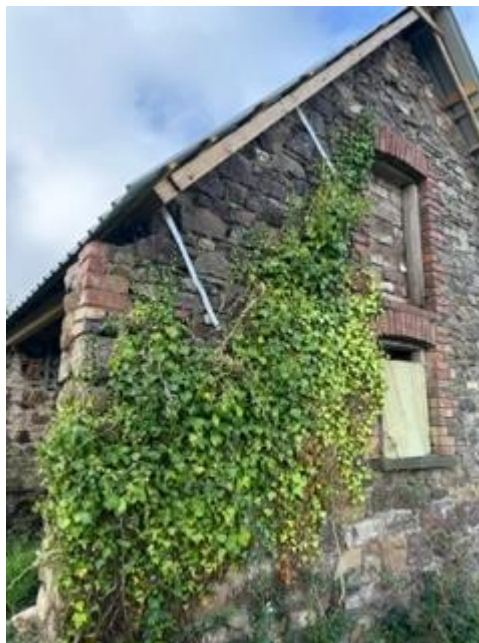
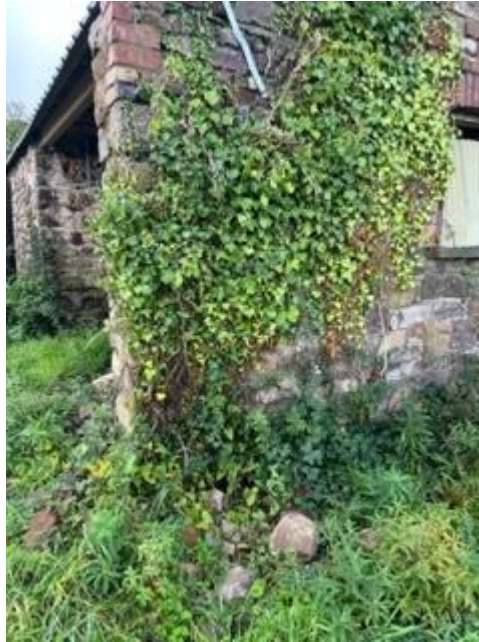
The left-hand side of the gable has suffered some deterioration with loose and damaged masonry at the return with the rear elevation.

Figure 8  
Left hand side of gable end.

Figure 9  
Close up of low-level masonry deterioration

- (iii) It will be necessary to carefully expose the base of the wall to the left-hand gable before the extent of remedial measures can be fully assessed. The ground levels may also need to be built up locally to prevent further deterioration of the wall in this location.

- (viii) Some minor masonry repairs will be required internally where voids were noted to the main wall.
- (ix) Minor rebuilding of the masonry will be required to the rear elevation double doors and to the gable end/rear elevation junction.

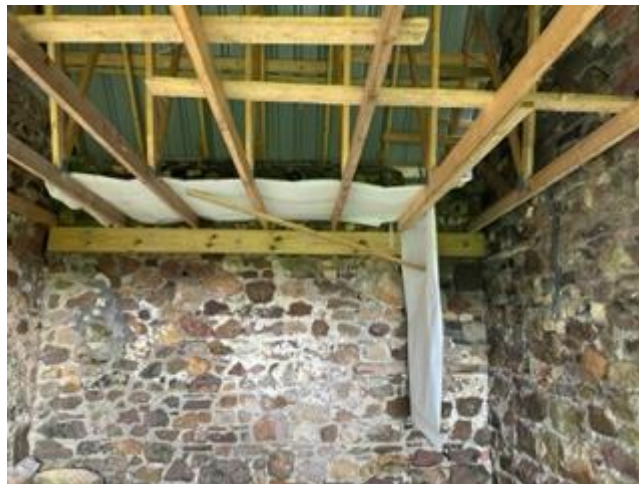
The area is open plan with the soffit of the roof trusses exposed. There is evidence of separation between the front elevation and gable walls, however this appears historic. It should be noted that the separation occurs at the location where the external ground levels appear to have eroded.

Figure 10  
Internal elevation left hand room (from Coc Y North Road)

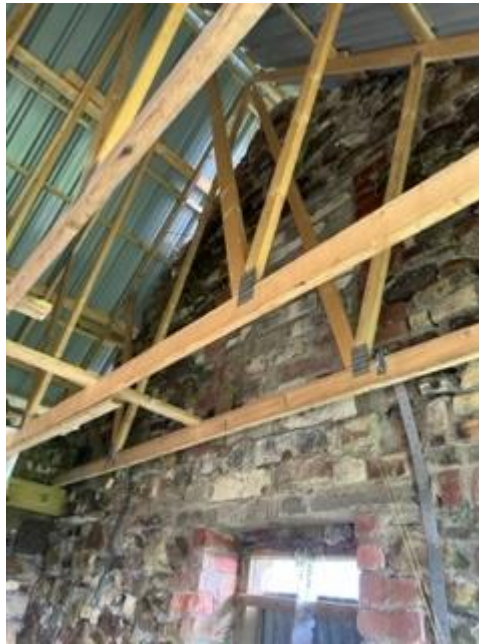
The original roof has been replaced with timber trusses and a steel cladding finish. It is anticipated that the roof will be replaced in the proposed scheme.

Figure 11  
Internal trussed roof

- (i) It is anticipated that the existing roof finish will be replaced in the proposed scheme. It is anticipated that the trusses have been designed to accommodate a standard tiled/slate roof finish. The strapping arrangement to the roof will need to be considered and amended with the current arrangement being unsightly.

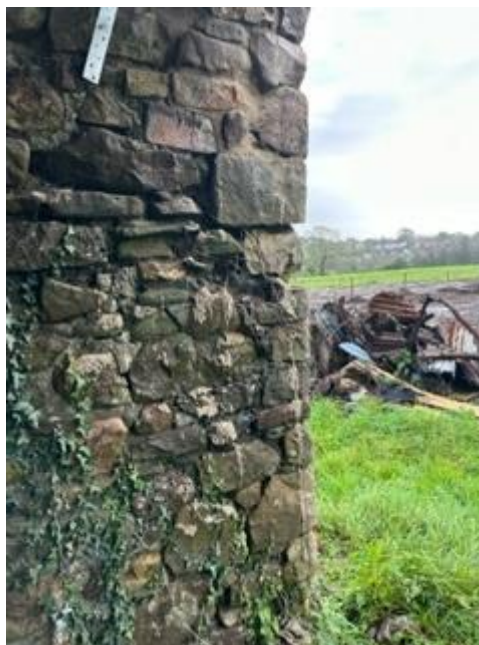
Figure 12  
Deterioration to gable end - internally

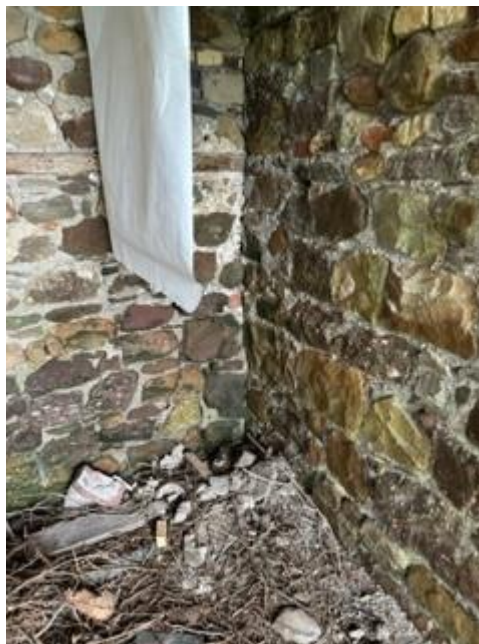
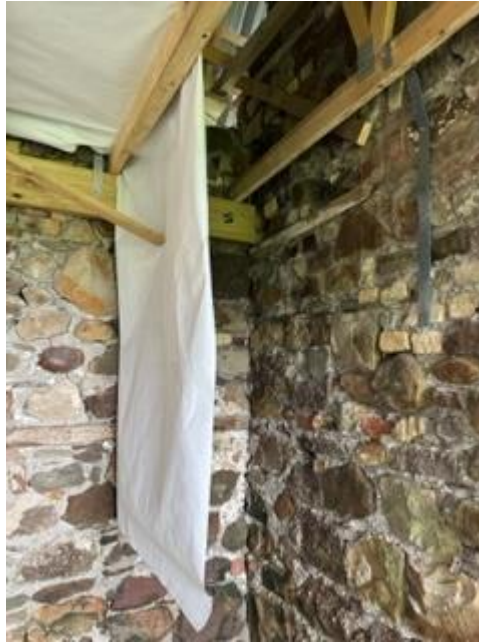
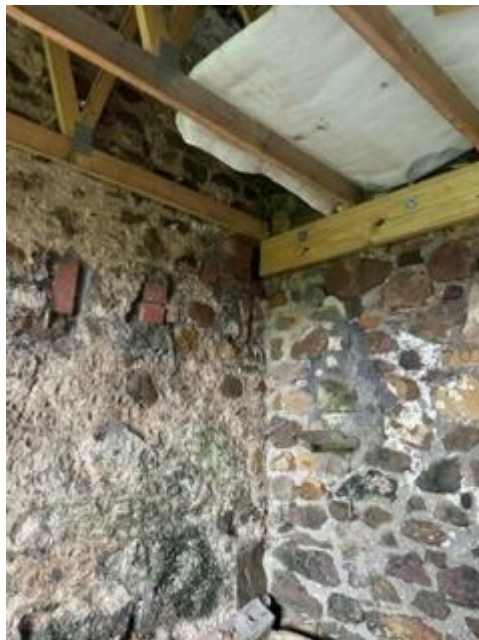
Figure 14  
Cracking at junction of gable end and LH gable end elevation

Figure 15  
As Figure 14

Figure 16  
As Figure 14

- (vii) The internal cracks at the junction of the front elevation wall and gable end wall should be trapped/tied in. The repair can comprise galvanised straps at close centres.

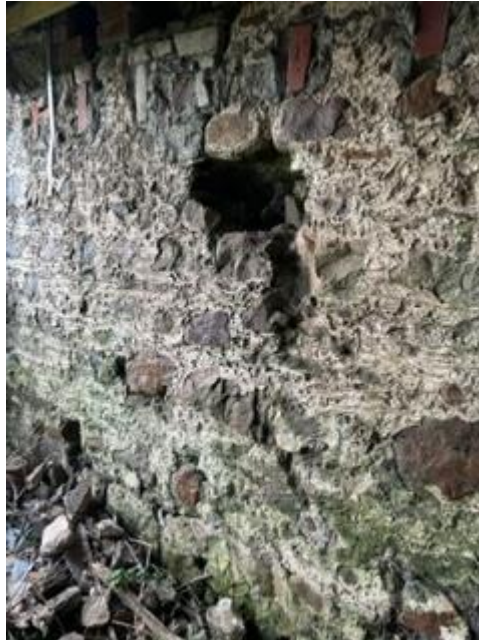
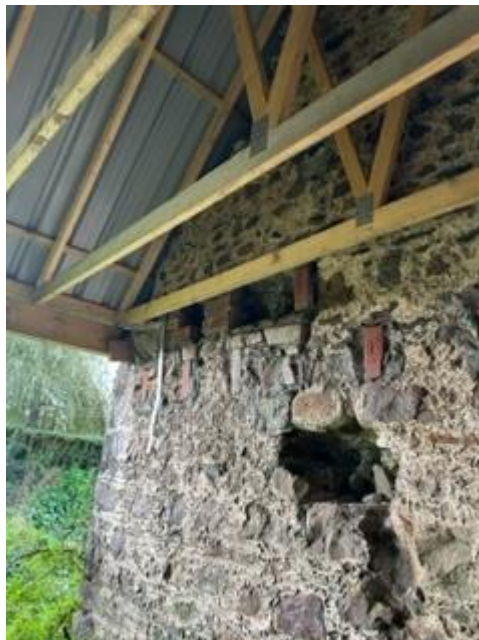
There is evidence of minor damage to the internal wall. Some repair/rebuilding will be required locally.

Figure 17  
Internal deterioration to internal wall

Figure 18  
As Figure 17

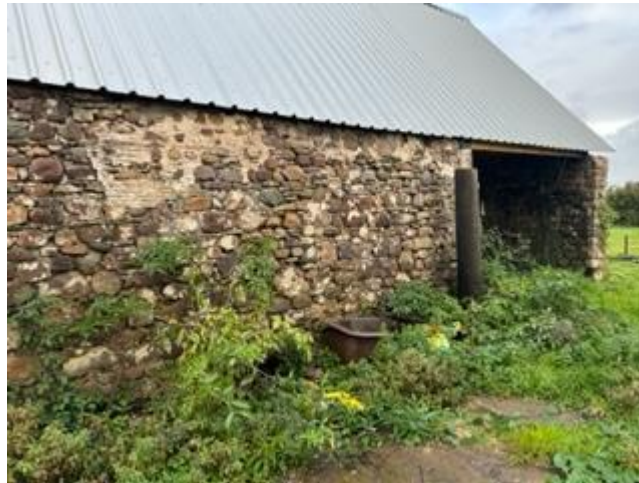
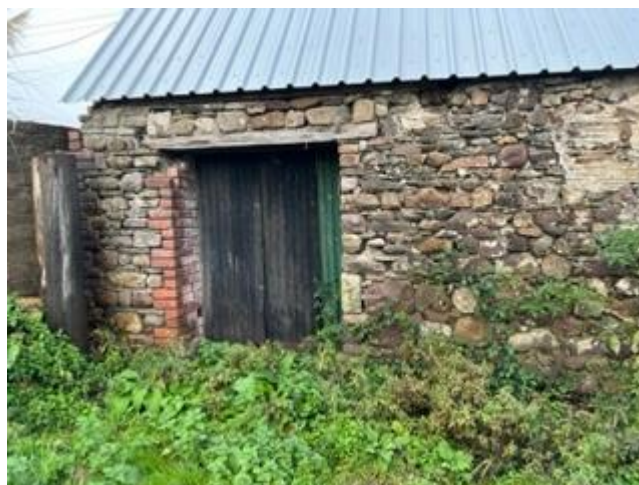
The rear elevation contains a large opening to the right of the elevation which extends up to the gable end. A further double door opening is located to the left of the elevation. The lintel over the left-hand opening has deflected significantly and will need to be replaced. There is also some deterioration of the masonry to the left of this opening and some minor repair/rebuilding can be anticipated.

The masonry to the rear elevation is painted with the finish having deteriorated.

Figure 19  
Rear elevation

Figure 20  
As Figure 19

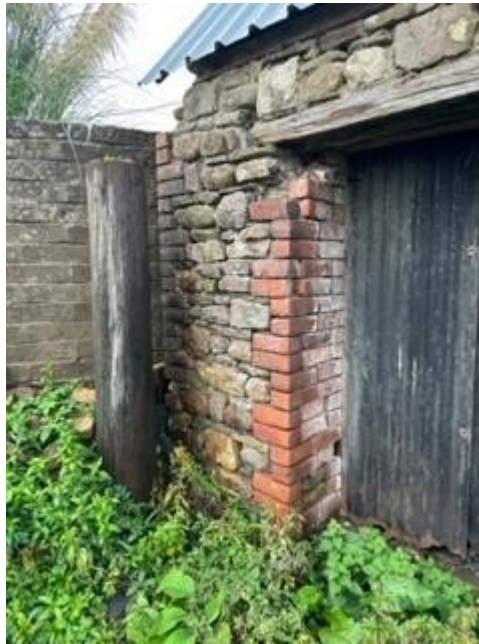
Figure 21  
Brickwork reveals to structural opening.

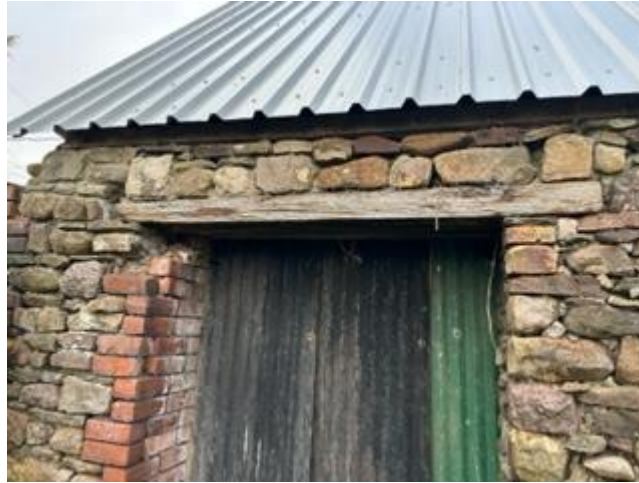
Figure 23  
Lintel to structural opening.

- (v) All lintels are likely to require replacement but, as a minimum, they will need to be checked when fully exposed.
- (vi) It would be prudent to carry out a more detailed inspection of the room to the right-hand side of the barn with no access available at the time of the inspection.

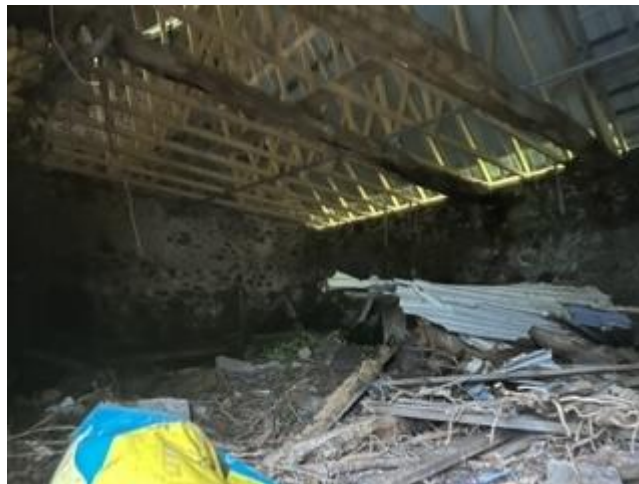
Figure 24  
Trussed roof to right hand room.

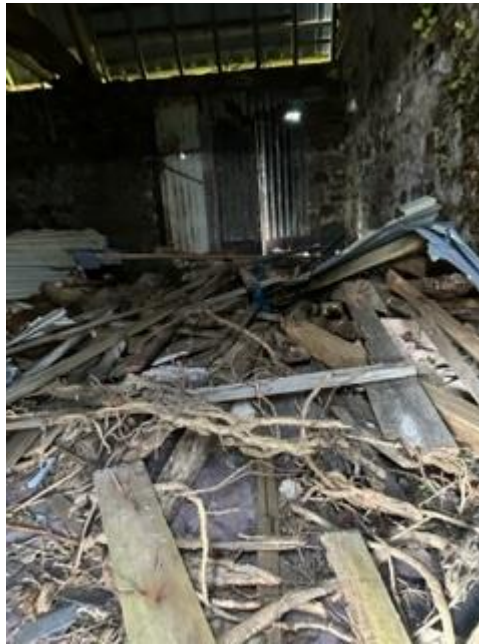
The roof finish is as the adjacent room. There is significant debris within the room which will need to be removed to enable a more detailed inspection. There was no obvious evidence of deterioration of the perimeter walls.

Figure 25  
Debris to right hand room.
