St Paul's Church Newport

Structural Appraisal of Existing Roof Structure Updated May 2015

Project Number: 6882

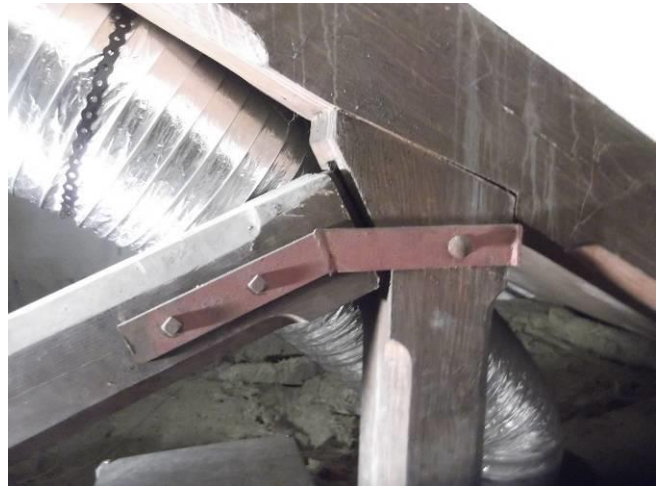
- 3.3. General problems with the roof trusses include the pull out of the bracing member at the connections of the element to the vertical truss members.
- 3.4. The pull out of the connections has occurred as they appear to have been originally designed for compression load only. This is evident from the detailing of the connection, namely a mortise and tenon connection without pegs. The omission of pegs from the connection means that when tension is applied the tenon pulls out of the socket, as has been recorded for the majority of the trusses.

- 4.4. Remedial works to these connections would consist of simply strapping the bottom end of the brace member to the adjacent vertical post of the truss in a manner similar to the existing repairs. This should prevent future pull out of these connections, improving the overall robustness of the trusses.

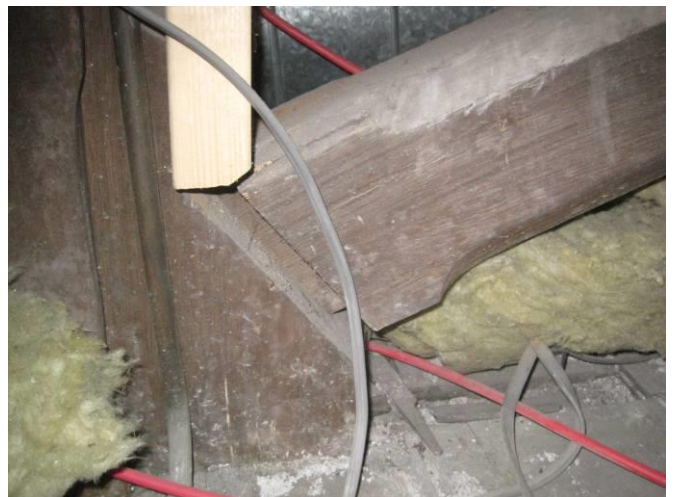
- 3.5. This pull out has occurred historically and is not clear with the level of survey carried out if it is ongoing (due to creep). Remedial work has been carried out previously with the strapping of the connections at the head of the braced member. The strapping has not been replicated at the base of the braced member. By not strapping the base the repair is ineffective as it will not prevent further pull out occurring, it will only mean that the pull out occurs in the base connection only

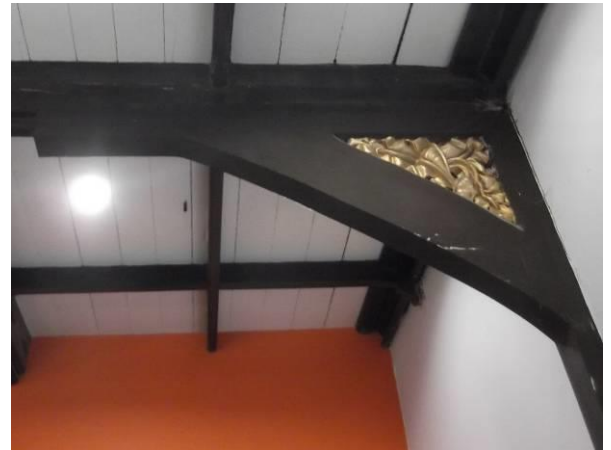
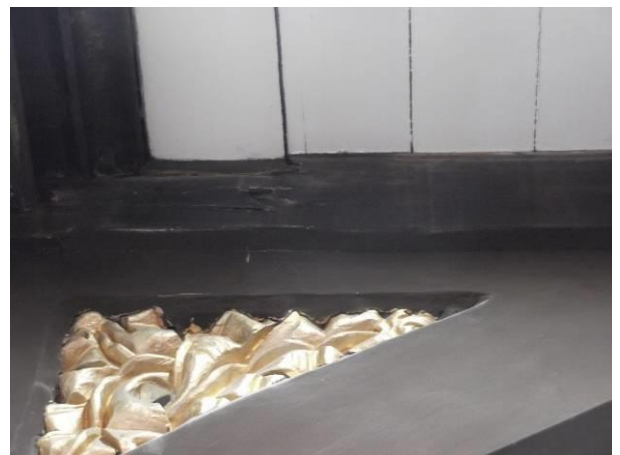
- 3.7. Truss 1 south bearing: due to its location in the first floor offices this truss bearing is easier to appraise from below than those in the main church space. The bottom chord of the truss shows significant distress at the bearing and a significant distance away from the wall (not accurately measured but in the order of 1.5m). The member is warping at the sides at the bearing, and large cracks are visible in the timber. The bearing does show some compression, due to the use of the floor space directly below the truss it was not possible to carry out a survey to determine how much compression of the decayed timber has occurred. The bracket in this location was strapped back to the wall due to the condition of the timbers.

- 4.9. Each truss end repair detail is likely to be different due to the extent of the decay, though the approach will be the same. Truss 1 from visual indication will require the largest connection due to the length of deterioration along the bottom chord.

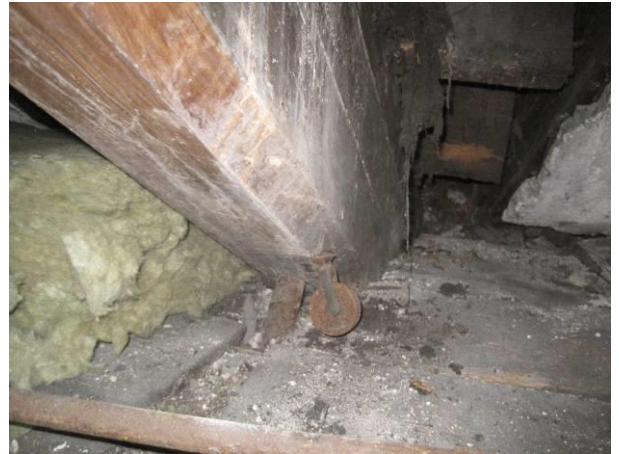
- 3.8. Truss 1 bearings when inspected from within the attic space have a further connection in the form of the valley member supporting the west gable roofs. Limited access was available to inspect these members. From what was seen this member at the south bearing is also showing signs of decay due to water ingress, the north bearing appeared sound. The truss bearing is in a similar state as the valley bearing.

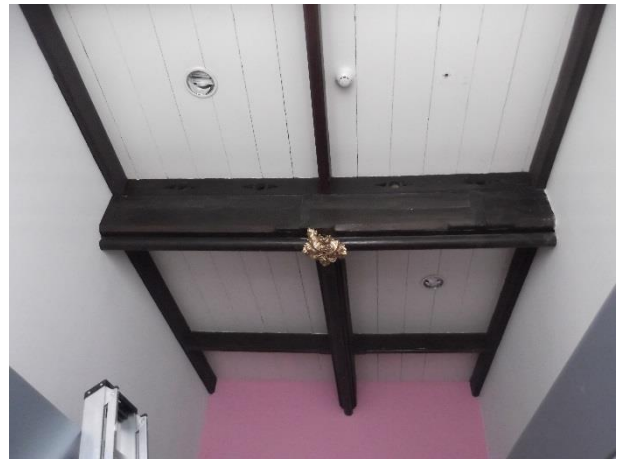
- 3.9. Truss 1 has partitioned office space along its length, unlike the rest of the trusses it is harder to appraise the truss as a whole. The truss appears to sag towards the centre of the bottom chord. The attic space bearing on truss 1 has been turned into a service zone for the occupied space beneath. This puts further additional loading on the truss compared to the remainder and therefore increased sagging on this truss would be expected.

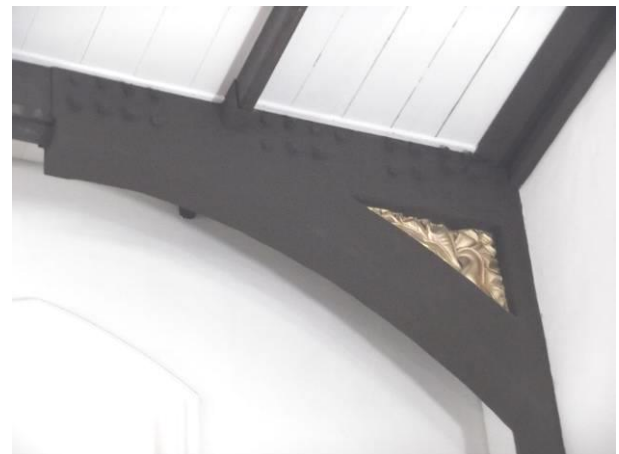
- 3.10. Localised repairs to truss bearings have been carried out on the north ends of Truss 2 and Truss 6. The repairs consist of a pair of steel plates connecting the bottom truss member to the truss rafter. Truss 2's repair has included the removal of the existing bottom chord bearing and replacement with new timber. From visual inspection of this repair, the connection and bearing appear to be in good condition.

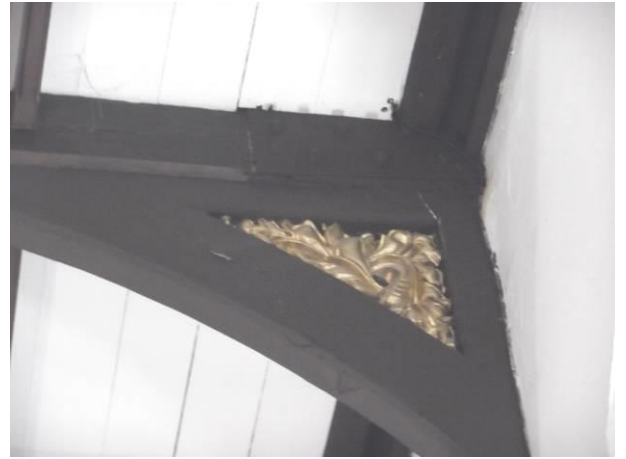
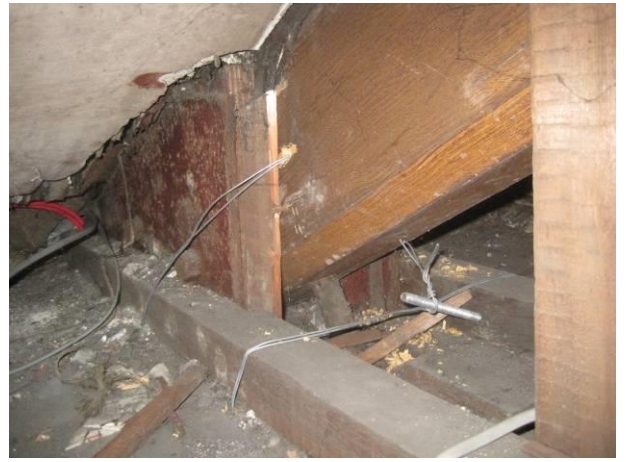
- 3.11. Truss 6's repair is of a similar nature, however the bearing timber of the bottom chord has not been replaced. Where the plates are bolted into the bottom chord the timber appears to be distressed and shows signs of degradation – large cracks in the timber and softening of the top of the timber. Further repair work will be required for this connection.

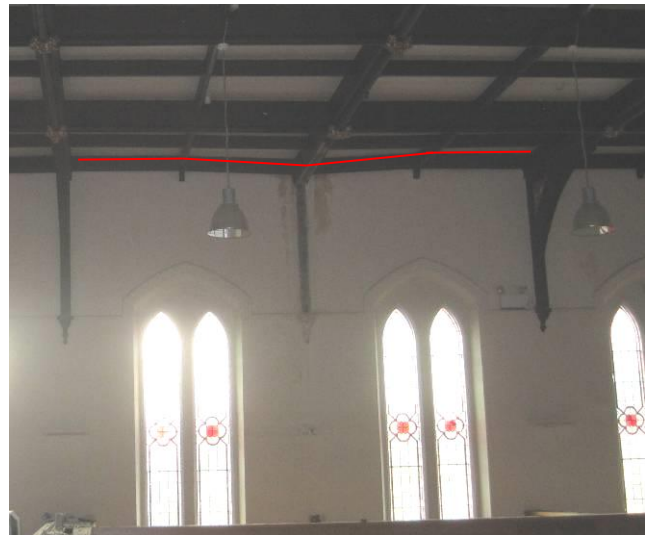
- 3.12. Truss 4 south bearing – localised sagging at the bearing connection has occurred, string line measuring of the ceiling from within the attic space has recorded a 60mm drop at the bearing relative to the trusses on either side. This has been confirmed by recording the levels of the ceiling from ground floor using a distometer.

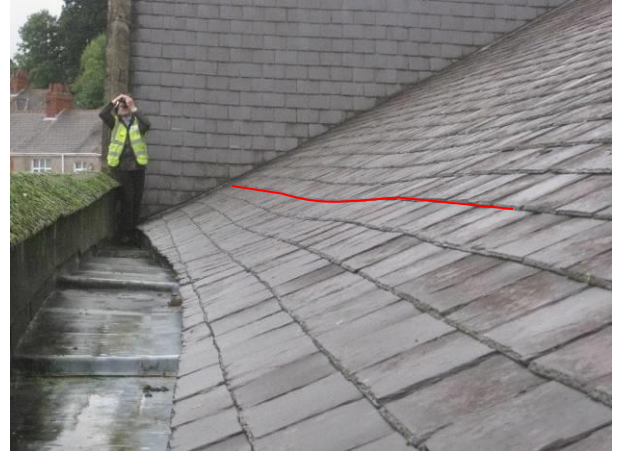
- 3.13. External inspection of the roof from the gutter shows a visible depression in the roof line, at the approximate location of the truss 4 on the south side only.

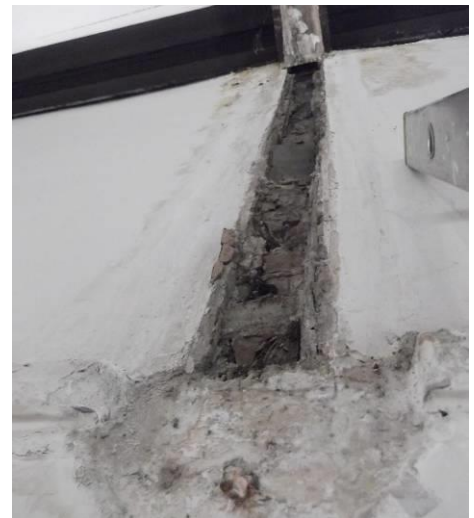
- 3.16. This degradation of the timber is likely to have occurred due to water ingress from the roof gutter. The eaves of the main church space have a gutter located between the parapet and the roof slope. From the building geometry it is likely that the gutter sits both in the line of the wall thickness, and above the bearings of the roof trusses. Without removing external finishes from along the gutter line this cannot be confirmed.

- 4.10. Further to repairing the timber bearings, repair or replacement of the gutters and eaves waterproofing will be required to prevent further water ingress causing future issues with the repaired timbers. Improvement to the eaves details, and possibly the rainwater goods (downpipes) may be required to address risks posed by overtopping of the gutters if the capacity of the downpipes is exceeded.

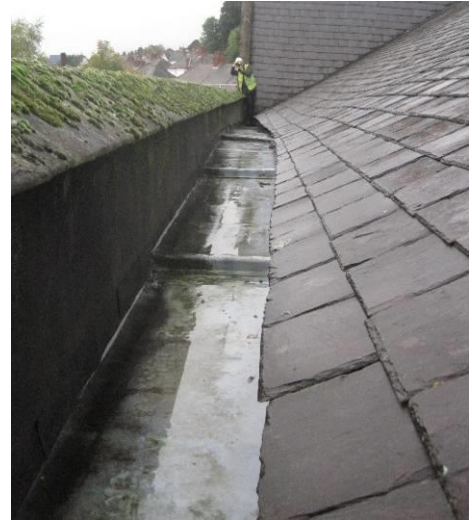
3.19. External inspection of the gutter shows that the high point is centred on the middle of the length of the main church space. The gutter then falls away in steps towards the gable ends. It would appear in the location of truss 4 the gutter is also pitched inwards towards the centre of the building. This would encourage water ingress if the internal gutter upstand is not high enough. It is not possible to determine however if the gutter was initially pitched causing water ingress or if the pitch was generated by the movement of the truss bearing.

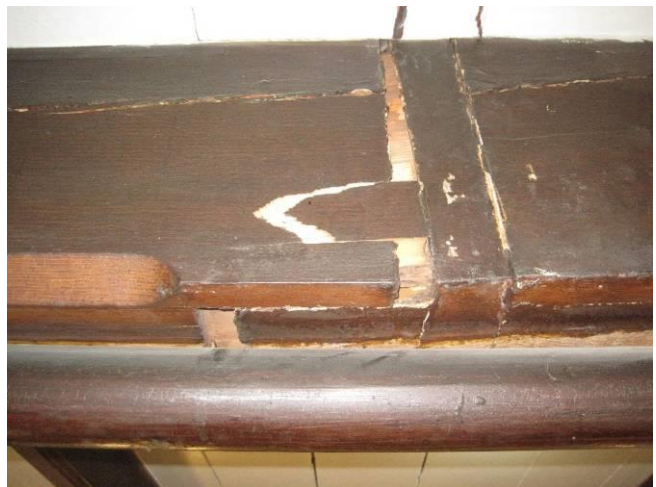
3.27. A large crack was found within the connection located in the centre of the bottom truss chord. From visual inspection below the ceiling and from above one half of the half lap connection has failed in tension. This has produced the crack and a small rotation in the bracket. The connection is likely to still be working due to the loading on the connection being taken up entirely by the iron connection and the remaining timber section (approx. $\frac{1}{2}$ the size of the timber chord).

3.28. Emergency remedial work was carried out on this connection strapping the truss between the central primary vertical timbers, and strapping the timbers each side of the crack vertically to the upper horizontal truss member. The details of this are included at the end of this section.

- 4.17. The repair will need to restore the formation of the half lap joint so that the load is shared between the two half timbers at the point. At present the whole load appears to be taken by one of the two half timbers. A form of steel strap/tie repair will be required, by-passing the existing damaged connection and transferring load directly between the two parts of the bottom chord, either side of the half lap section.

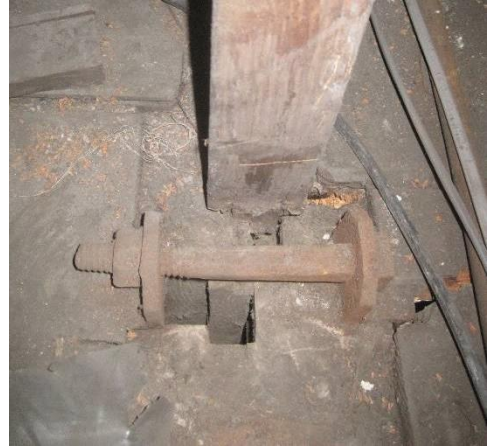
The truss 5 bearings appear to be ok as seen from the attic space, which indicates that the failure in the bottom chord is not connected to other structural issues.

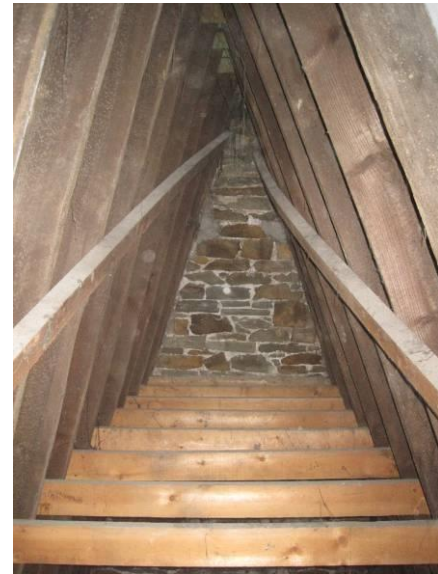
3.29. West End Gables – the roofs of both the north and south gables show significant bowing in the plane of the roof slope. The bow is evident in each of the common rafters, becoming more significant towards the centre of the roof length (between the masonry gable wall and the apex of the main roof body). The previous remedial work in this area was presumably carried out to limit further bowing of the roof members.

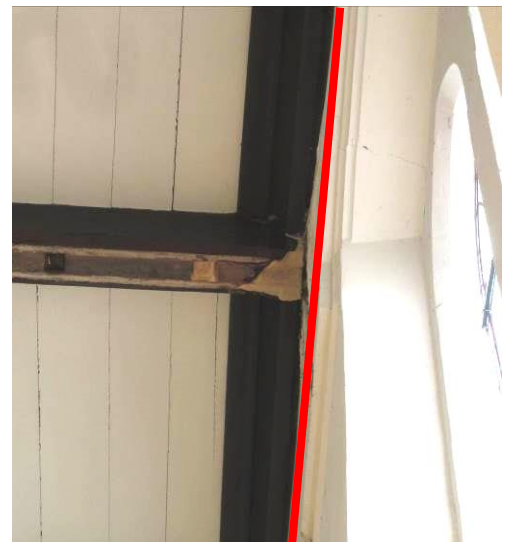
Viewed from below, there also appears fairly clear evidence that Truss 4 is pulling away from the wall.

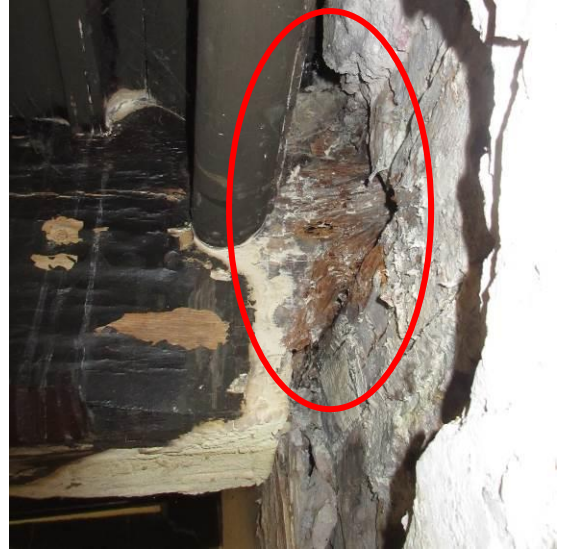
The timber wall plate on which it bears is also severely degraded and has crushed significantly locally under the truss bearing end.

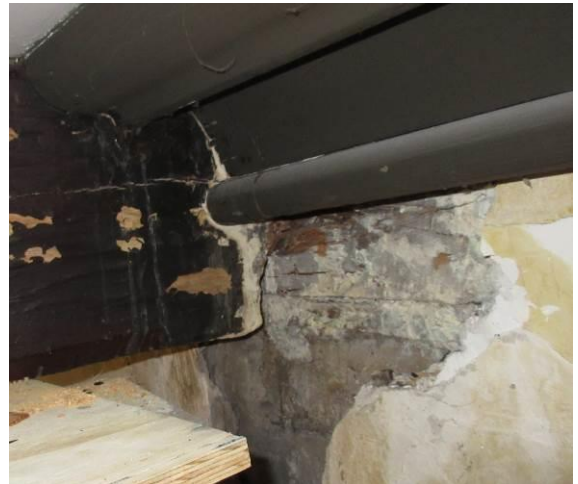
However, when the tie beam was drilled to assess its integrity away from the face of the wall, it was found to be reasonably sound 200mm from the wall, and apparently undamaged 340mm from the face of the wall.

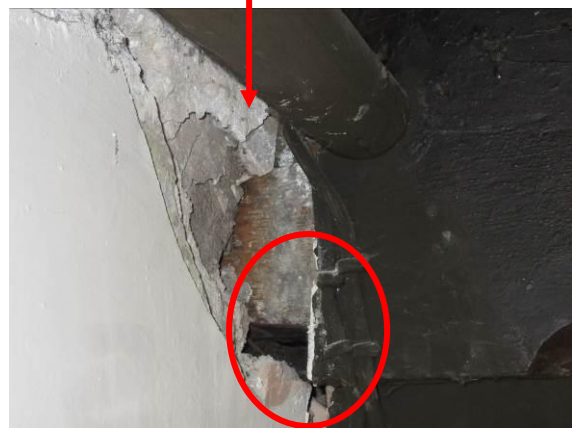
A small notch in the bottom chord is visible where it bears on the wall.

The timber is in reasonable condition.

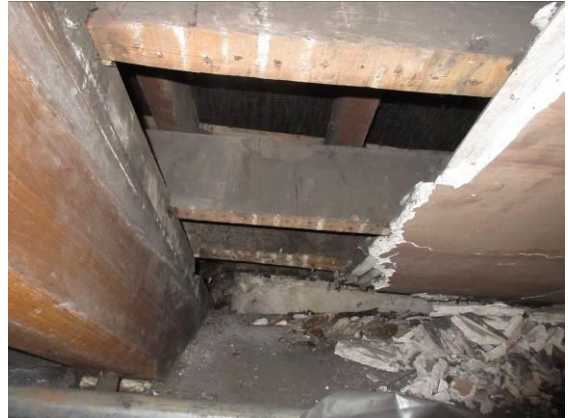
It is clear that the tie beam once extended a significant distance onto the wall head. A bearing length of approximately 570mm was recorded, but all of this timber is now totally degraded.

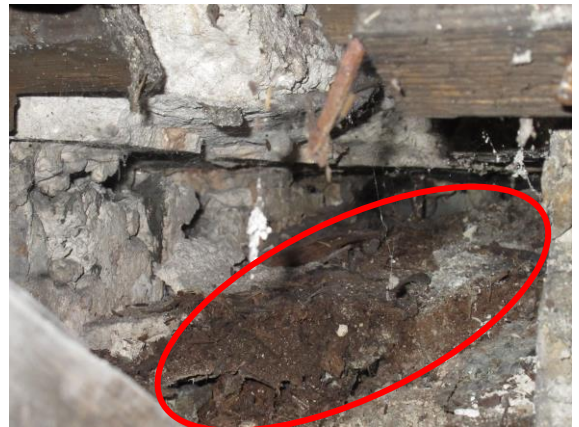
There is a purlin towards the bottom of the roof slope, which has separated from its bearing on the top chord of the truss. The purlin is continuous over the truss, probably spliced at trusses 3 and 5 on either side.

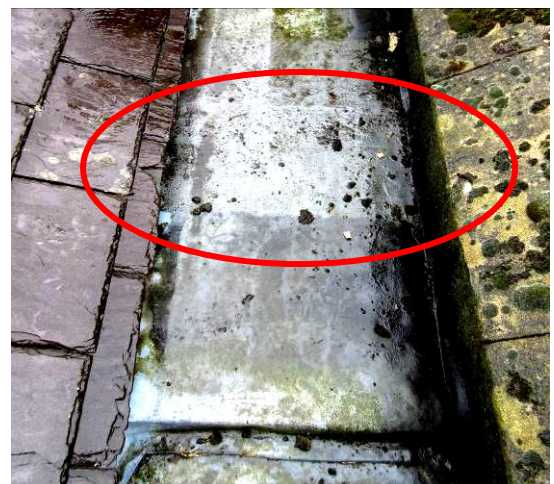
There is evidence of a proprietary 'painted' repair to a split in the lead of the gutter immediately above the bearing end of truss 4. It is not known when this repair was undertaken, and for how long the split was present prior to it being repaired.

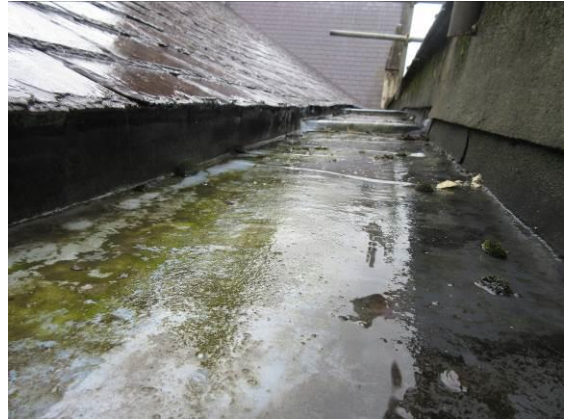
At the outlet at the west end (adjacent to the bearing end of Truss 1) the gutter is holding water and the lead detailing at the junction with the valley gutter appears untidy.
