TW2590 / 23 – 24th May 2023

DAMP / TIMBER INSPECTION REPORT

TREDEGAR CHAMBERS
BRIDGE STREET
NEWPORT
NP20 4AQ

Surveyed by Terry White C.S.R.T. C.S.S.W.
Independent Damp Remedial Surveyor

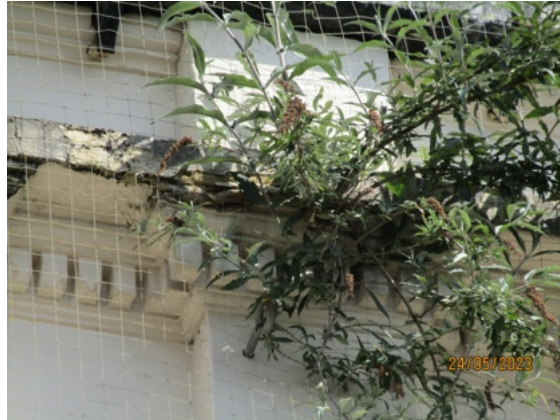
Localised vegetation growth and internal dampness (indicative of gaps / cracks and perished mortar joints etc.) were evident.

You should instruct a specialist contractor (familiar with listed buildings) to inspect decorative façades /parapet walls, cornices, ledges and other features to the front elevation so that you can budget an appropriate contingency sum for remedial works / repair / re-pointing etc.

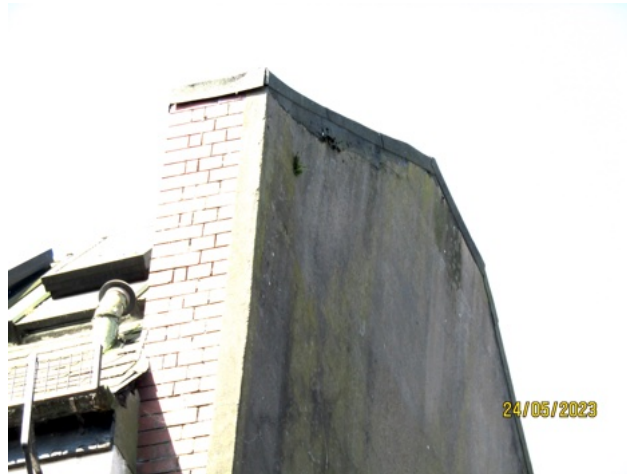
The render the main rear wall could not be inspected in detail but crazing / deterioration was visible.

The external render should be more thoroughly inspected at all levels for evidence of cracking and / or significant hollowness. Any cracked or hollow areas should be repaired or renewed as appropriate.

“Patch-repairs” are acceptable if the areas of deterioration are not too large however, the render is likely to be at a stage where it needs replacing.

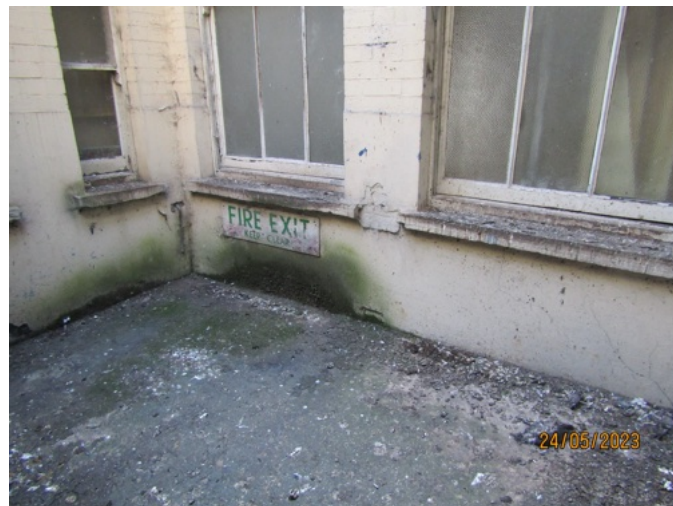
The render within the rear courtyard is in direct contact with the path, which will increase the risk of ground moisture “bridging” any existing damp proof course / internal dampness.

The render appears to be of cement specification, which can impede the natural evaporation of moisture from the masonry in solid masonry constructed buildings. See Conflicts on Pg.4.

Render should stop approx. 150mm from the ground and the bottom edge finished in a “bell mouth” or “bell cast” detail (the masonry below the bell cast should be left exposed) to prevent ground moisture from rising into the render / walls.

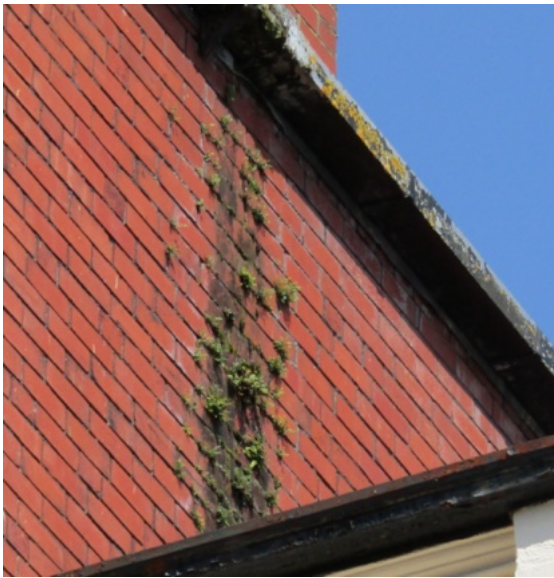
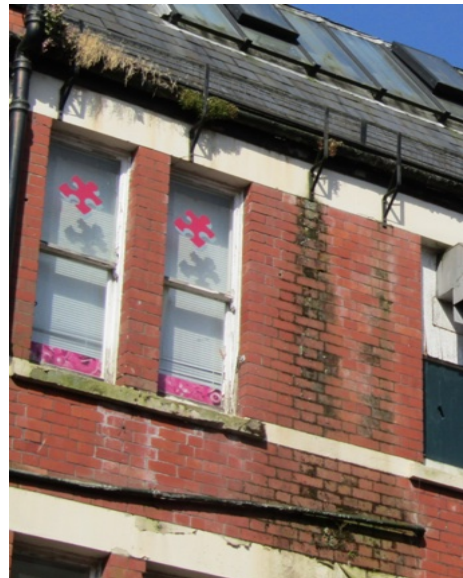
Where visible, the brickwork and mortar (“pointing”) appeared in reasonable condition however, staining / vegetation growth was apparent where gutters have failed. This will have caused the corresponding mortar joints to perish.

Vegetation should be removed, the masonry cleaned, and perished / damaged mortar joints repointed.

The mortar joints and masonry should be more thoroughly inspected by a specialist contractor and, as stated by your surveyor, the Bath stone detailing throughout the property is in need of thorough inspection and specialist repair.

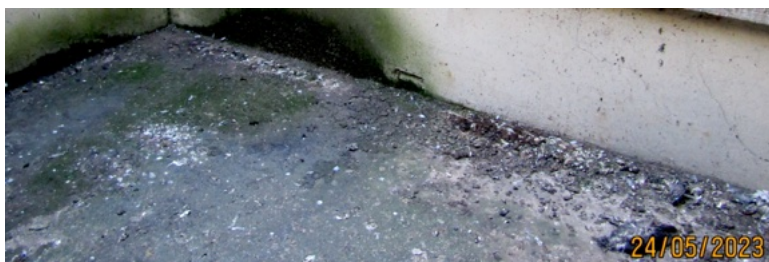
There are abutting paths to the courtyard and rear walls. Abutting paths (especially concrete) will restrict drainage of groundwater and encourage moisture to penetrate the base of the walls.

Good building practice recommends that, where practical, external ground levels are at least 150mm below internal floor level.

It is recommended that any paths / soil levels higher than this be reduced and decking cut back from abutting the wall. It is acceptable to create a channel or gully at the base of the wall and not necessary to carry-out extensive excavation works.

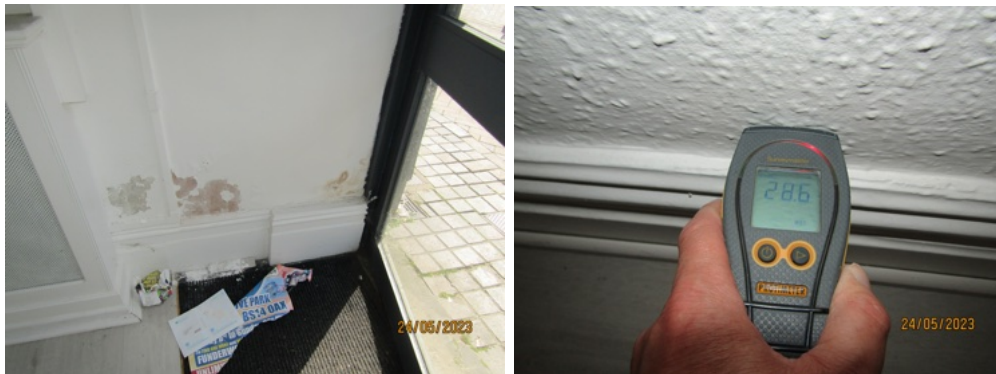
If moisture rises or penetrates from the ground into a wall, it carries with it soluble salts which may be deposited in the wall fabric and plaster, as the moisture evaporates these salts, in particular chlorides and nitrates, are hygroscopic; meaning that they are capable of attracting and absorbing moisture from the atmosphere when the relative humidity is high. This means that the accumulation of salt may exacerbate dampness and wall plaster / decoration deterioration.

Much of the dampness on (or adjacent to) external walls will be being caused or exacerbated due to external defects and therefore it is usually sensible to have all recommended external remedial works carried out in the first instance (see External Recommendations). It is always sensible to ensure that there are no plumbing / drainage defects that could be causing /contributing to dampness levels.

It is recommended that, once the existing plaster has been removed, the masonry be left exposed for a period of time before re-plastering in order to allow any residual / trapped dampness the opportunity to evaporate before the new plaster is applied. Dehumidifiers / blow heater could be used to accelerate the drying out process.

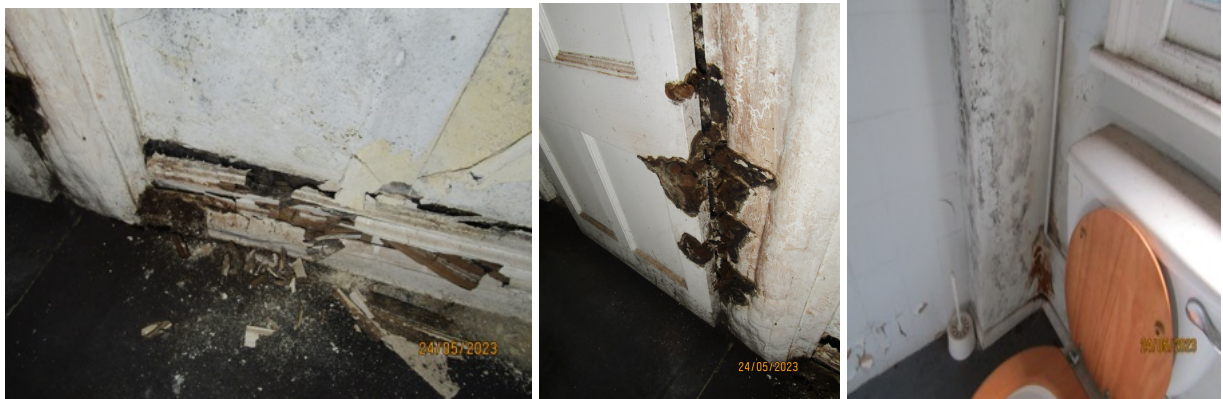
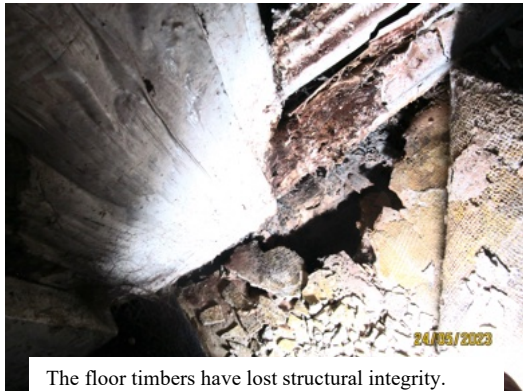
Significant damage due to a Dry Rot outbreak has occurred to timbers adjacent to the rear wall at Ground floor level and the corresponding First Floor Level timbers, spreading into the kitchen and W.C. areas). The floor / ceiling timbers in these areas have lost structural integrity and therefore the areas should be avoided until repair works / treatments can be undertaken.

The first step after discovering fungal decay is to try to ascertain how and where the water is entering. In this instance, moisture ingress associated with leaking rainwater goods, roof covering defects, failed flashings (between roofs and parapet walls), chimney stacks and internal plumbing defects (leaks) are responsible.

Any decayed timber should be removed (ensuring that remaining sections and masonry are adequately supported). All removed timber should be replaced with new (preferably pre-treated) timber.

Timbers and areas affected by Dry rot (*Serpula lacrymans*) must be additionally treated in accordance with the Property Care Association Cod of Practice – see fungal attack (wet rot & dry rot) on Pg. 18.

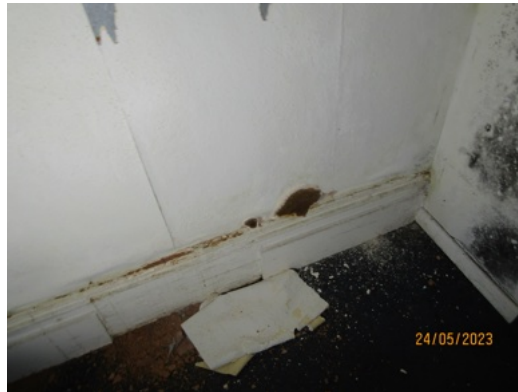
The floor timbers have lost structural integrity.
