IN RESPECT OF:-

**TREDEGAR CHAMBERS
BRIDGE STREET
NEWPORT
NP20 4QA**

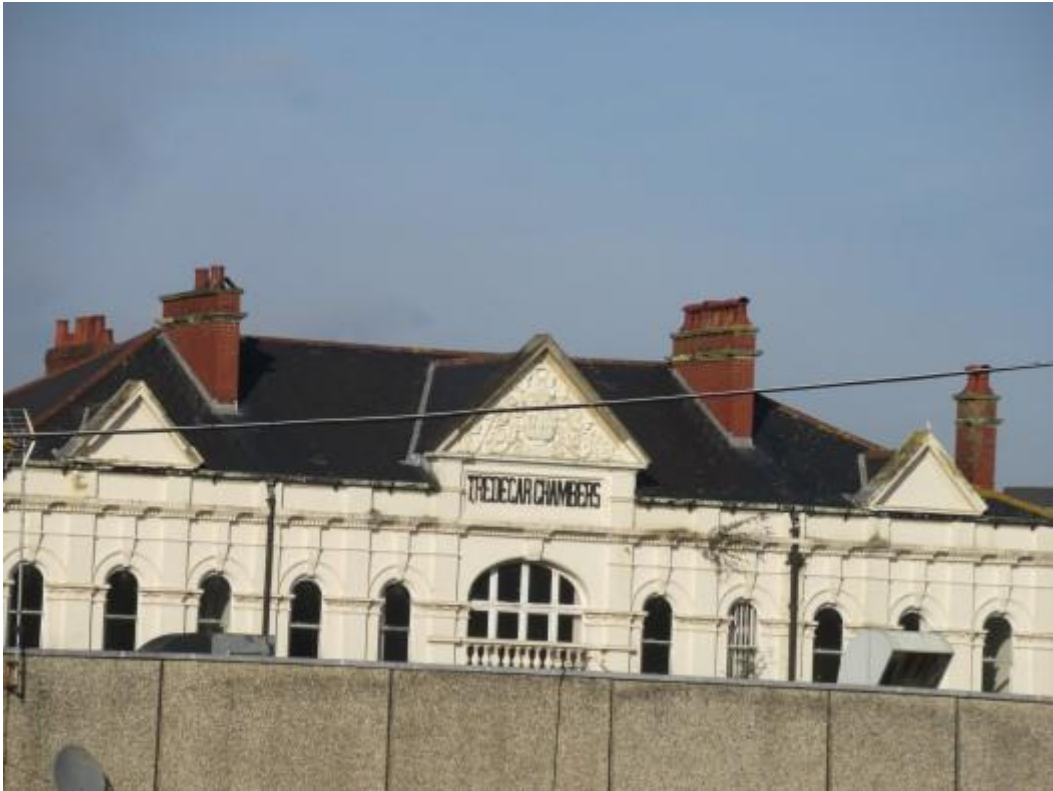
Roof slopes where extending to the front of the property. The photograph shows three feature gable roofs with lead valley details formed between the gable roofs and front main roof slopes.

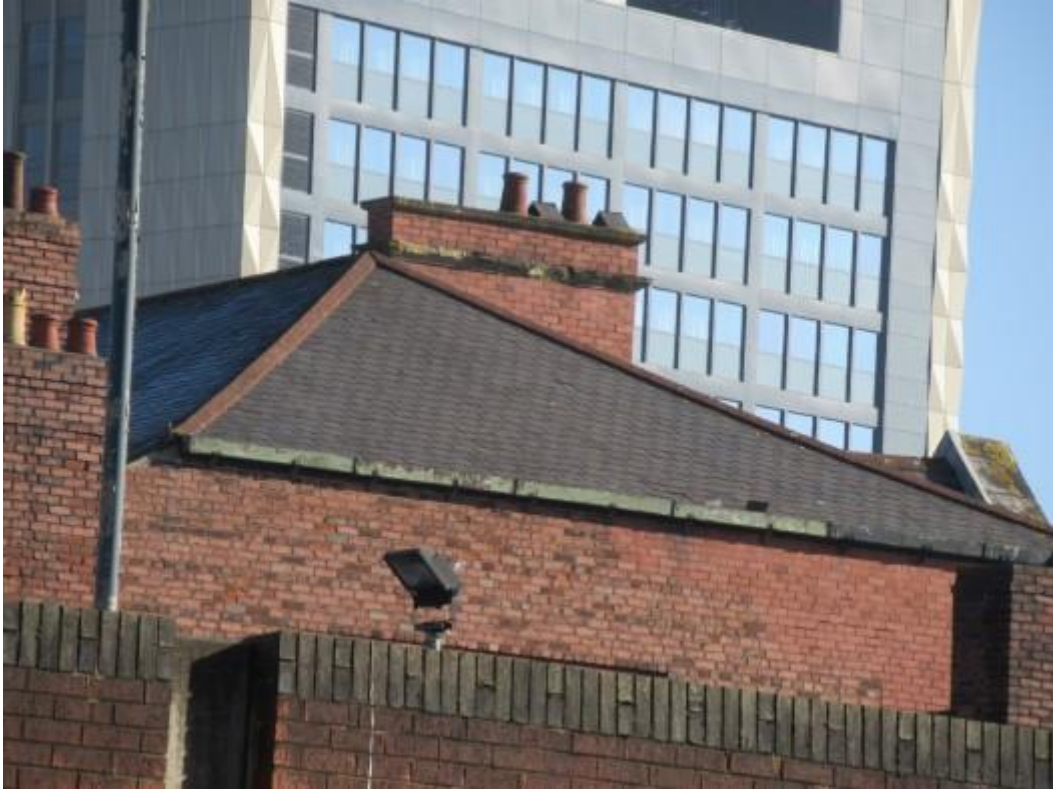
Left hand side roof slope to the property as viewed from neighbouring grounds. The photograph shows the general condition of the slate roof coverings. The concrete ridge and hip tiles are also noted. Several cracked and failed slates to the side roof slope are noted. Routine maintenance works are required.

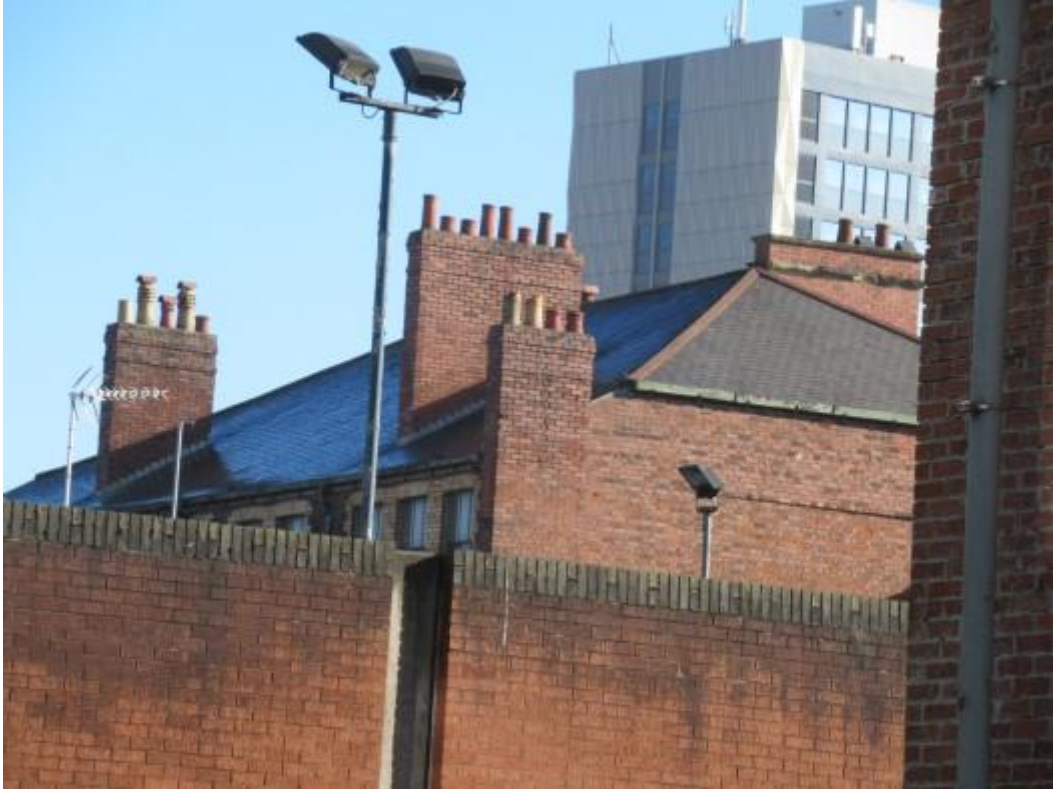
Further illustration of the left hand side and rear roof slopes. The photograph shows the rear main roof area. There are several cracked and displaced slates.

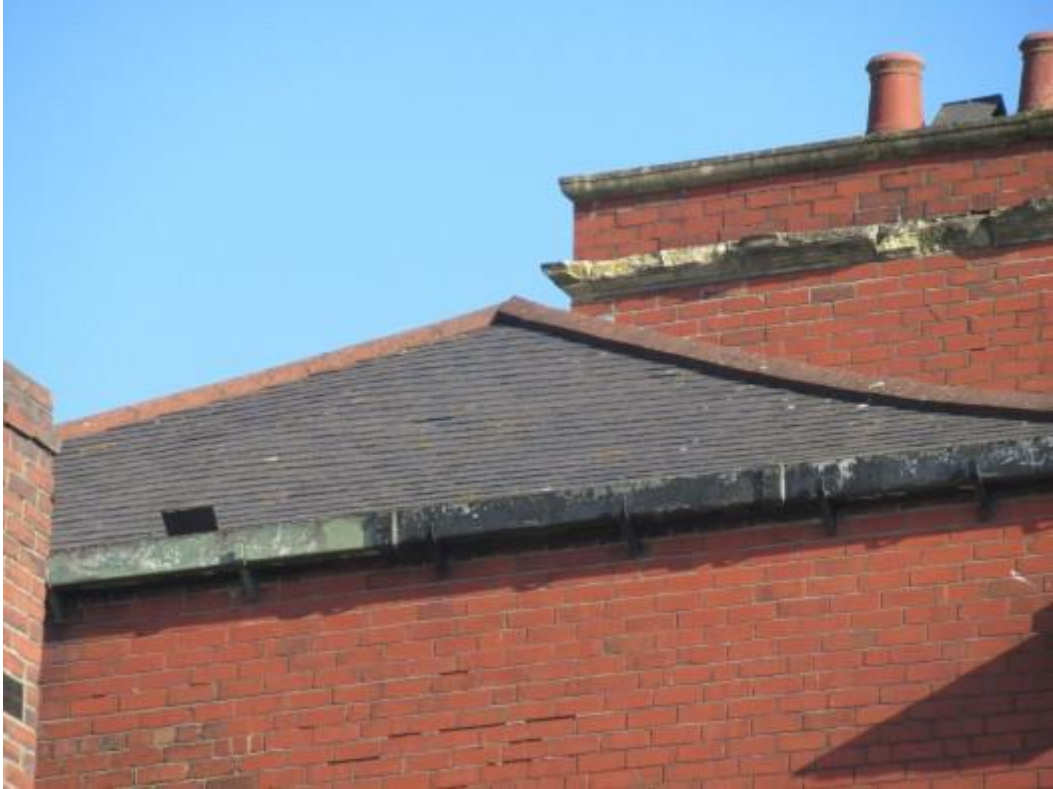
Further illustration of the left hand side roof slope with failed slates noted.

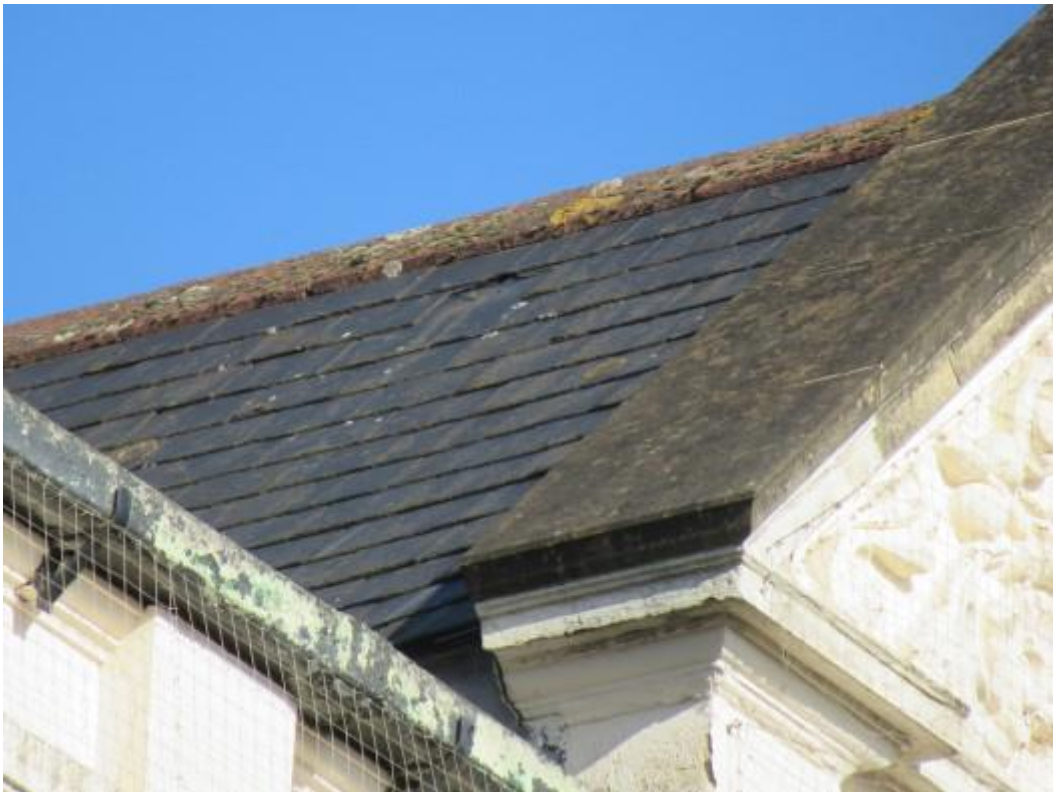
Failed slate to the front elevation of the property where extending to the front principal gable.

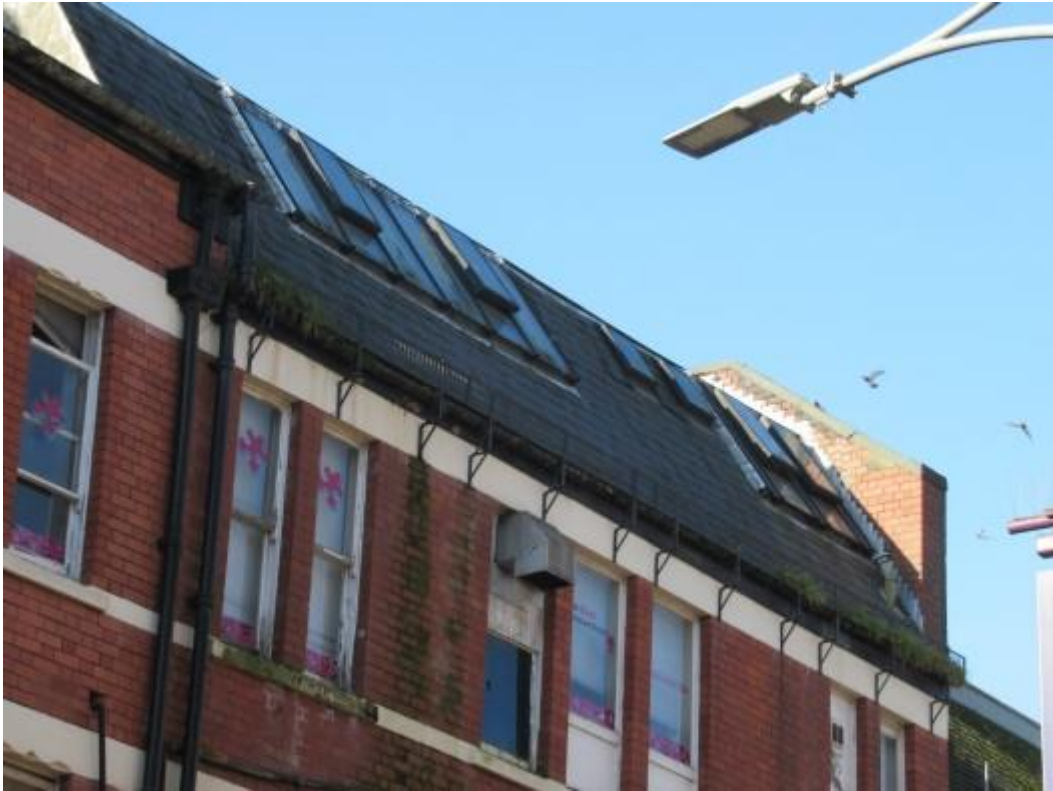
Right hand side mansard roof area. The photograph shows various roof lights to have been installed in past years. The photograph also shows the rear parapet wall and lead flashing detail. Works will be required in relation to the parapet wall and flashing where water ingress has occurred.

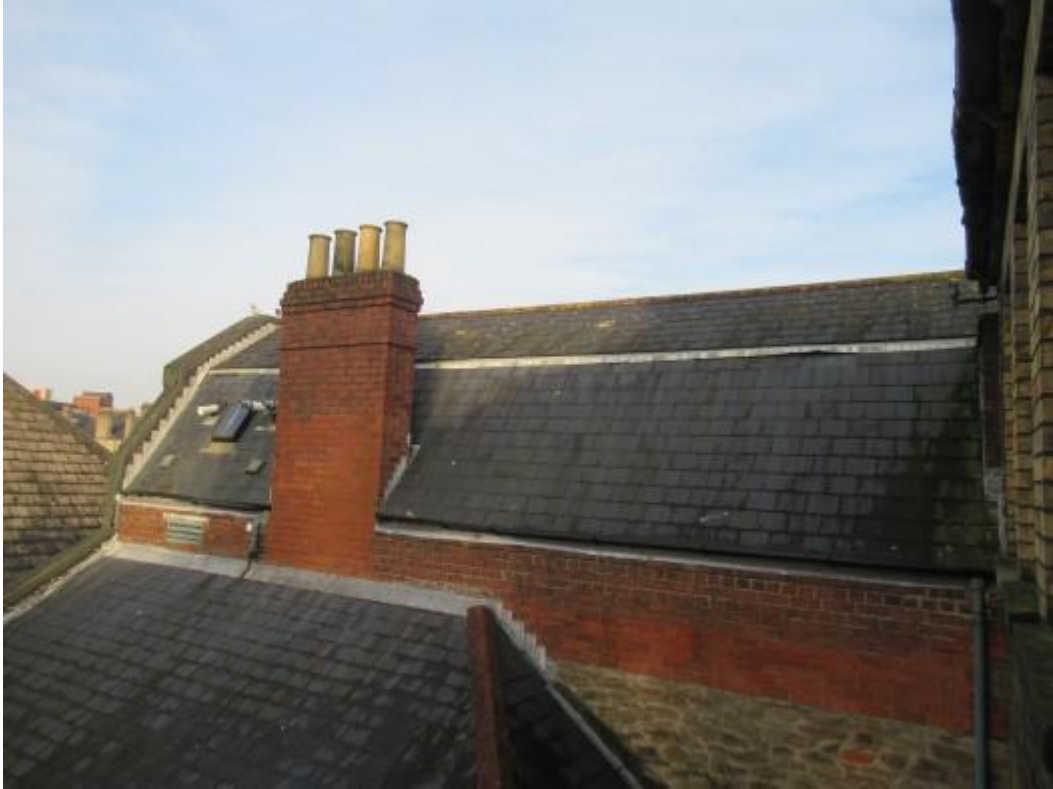
Left hand side of the rear mansard roof. The photograph shows the lead flashing detail between the lower and upper section level of the mansard. There is lifting of the leadwork. Several loose/failed slates are also noted. The photograph also shows lead flashing details between the roof and adjoining walls. There is significant water ingress in the area of the flashing details.

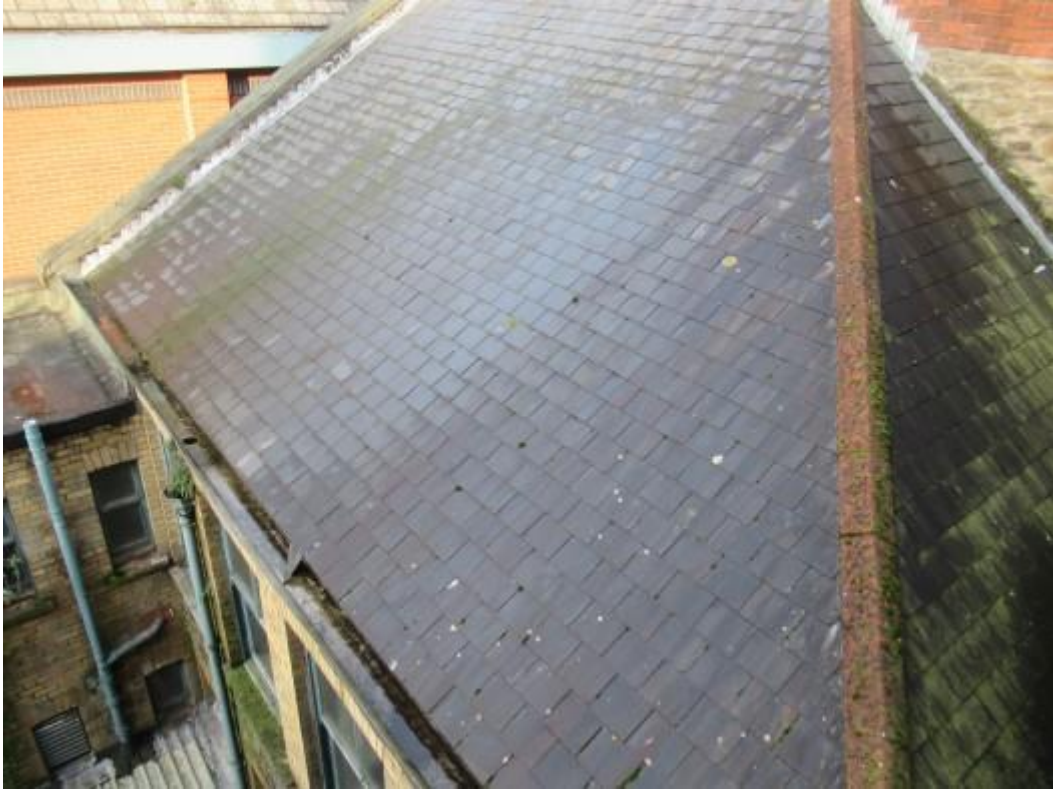
Lower level roof where extending towards the rear right hand side of the property. The photograph shows isolated failed slates. The photograph also shows the rear parapet wall and flashing detail. There is significant water ingress to this area. Further upgrading of the flashing and parapet wall detail and copings will be required to prevent ongoing problems of water ingress.

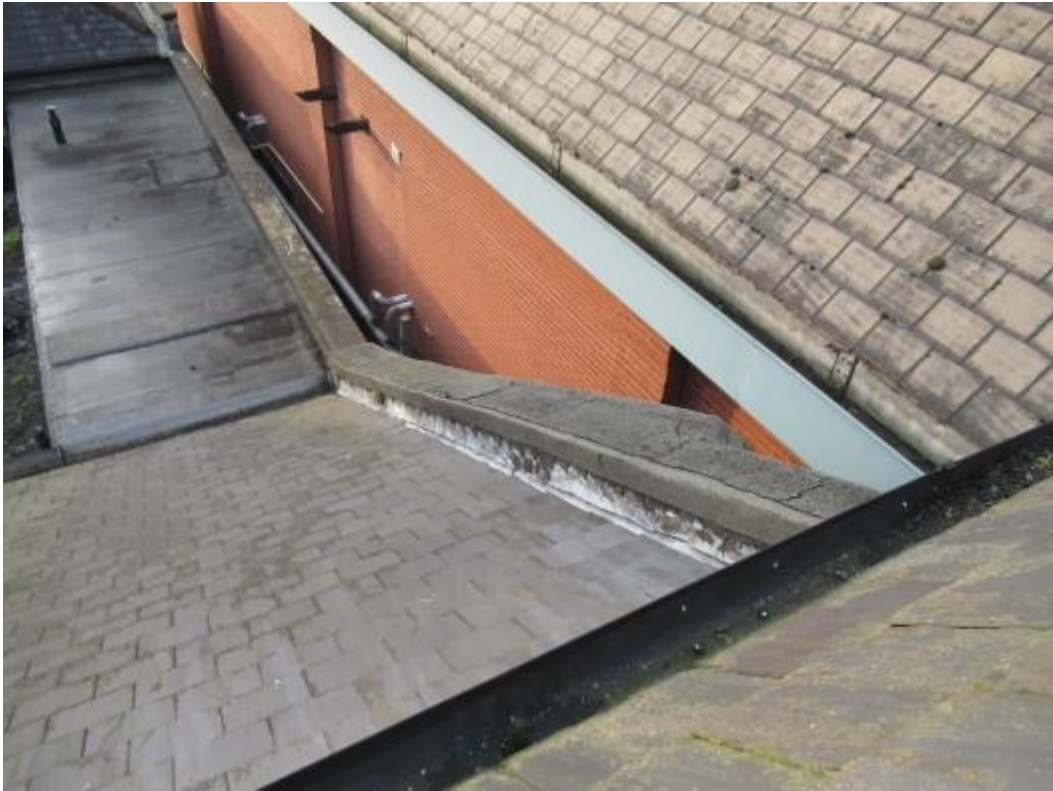
Further illustration of the flashing detail where extending to the rear. The photograph shows the flashing to have been attended to and resealed in bitumen in past years. This has been poorly completed. The photograph also shows a bitumen felt capping to the parapet. This is ineffective and has not prevented water ingress occurring. The parapet and flashing detail will require removal and upgrading.

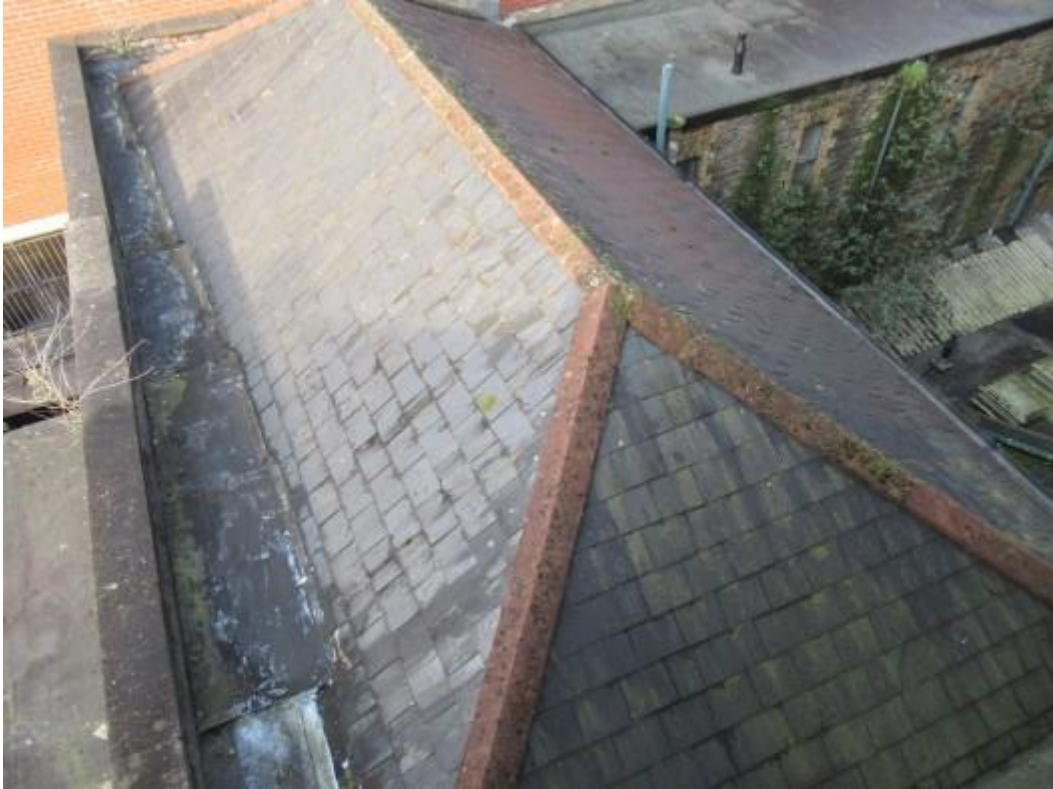
Lower level roof where extending towards the rear left hand side of the property. The photograph shows the roof to be of a hipped style with concrete ridge and hip tiles provided. There are isolated cracked/displaced slates. The photograph also shows a perimeter parapet gutter detail. The parapet gutter has been sealed in bitumen in past years.

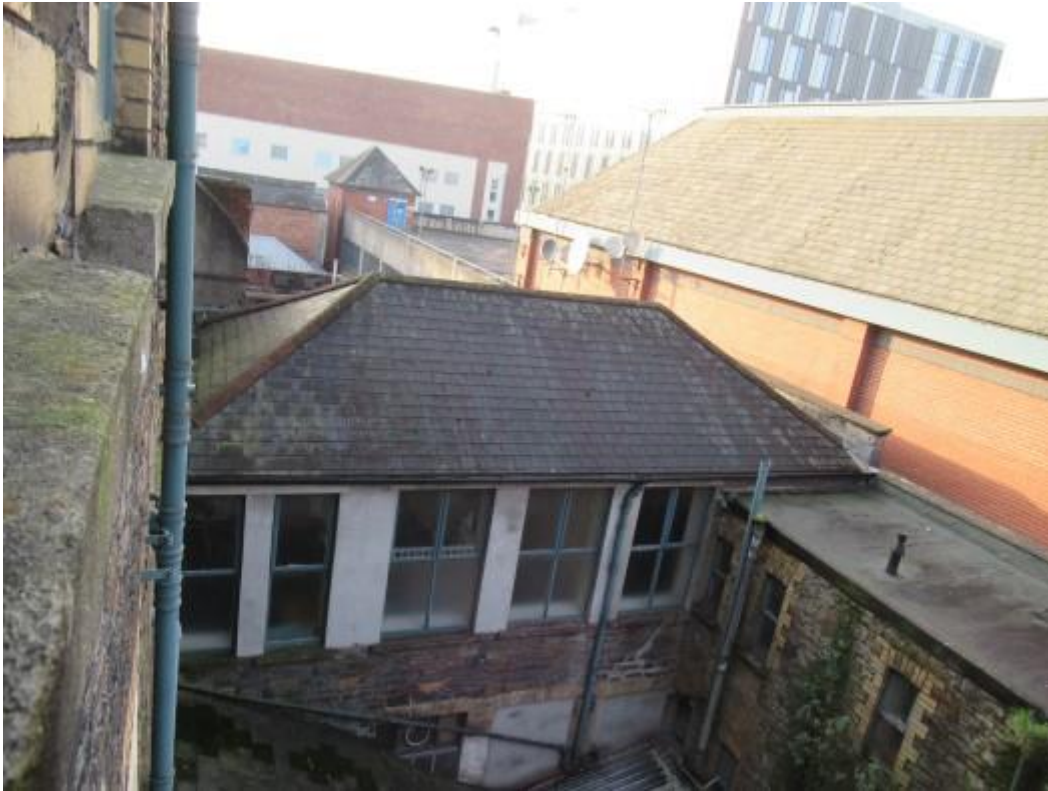
Further illustration of the rear left hand side lower level roof area. The hipped style of the roof is noted.

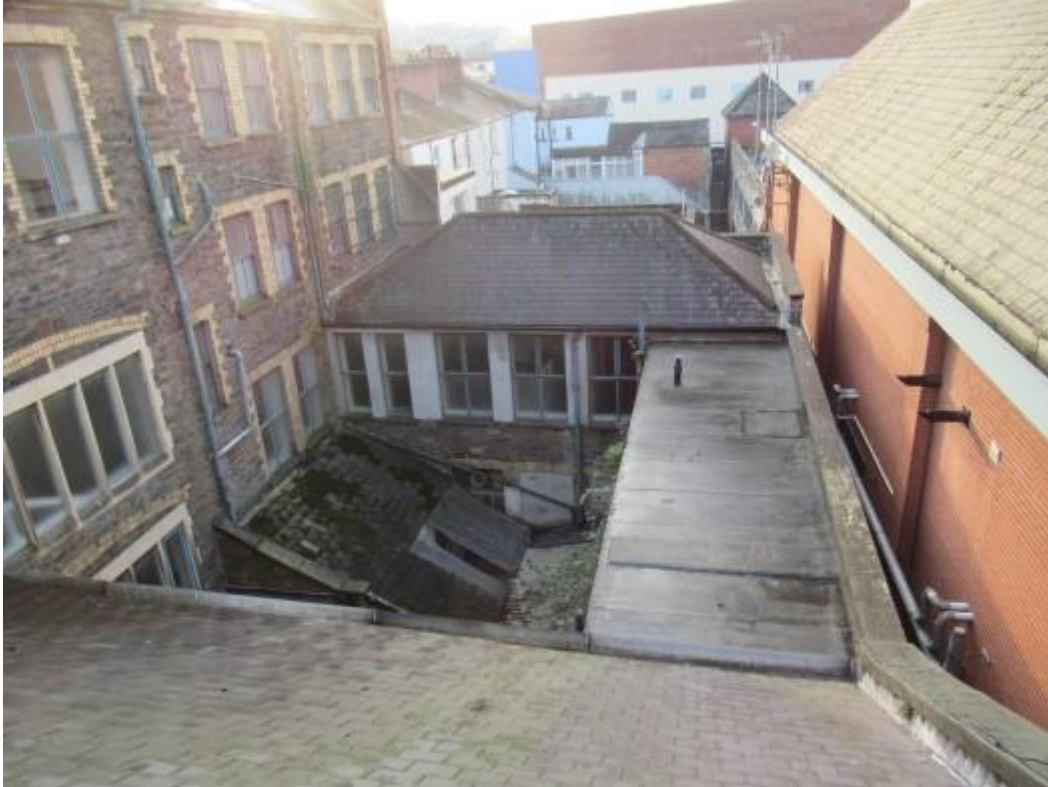
Further illustration of roofs to the rear. To the right of the photograph the flat roof with bitumen felt covering is noted. This has reached the end of its useful life. Internally, there is water ingress to this area. The existing roof should be stripped and renewed.

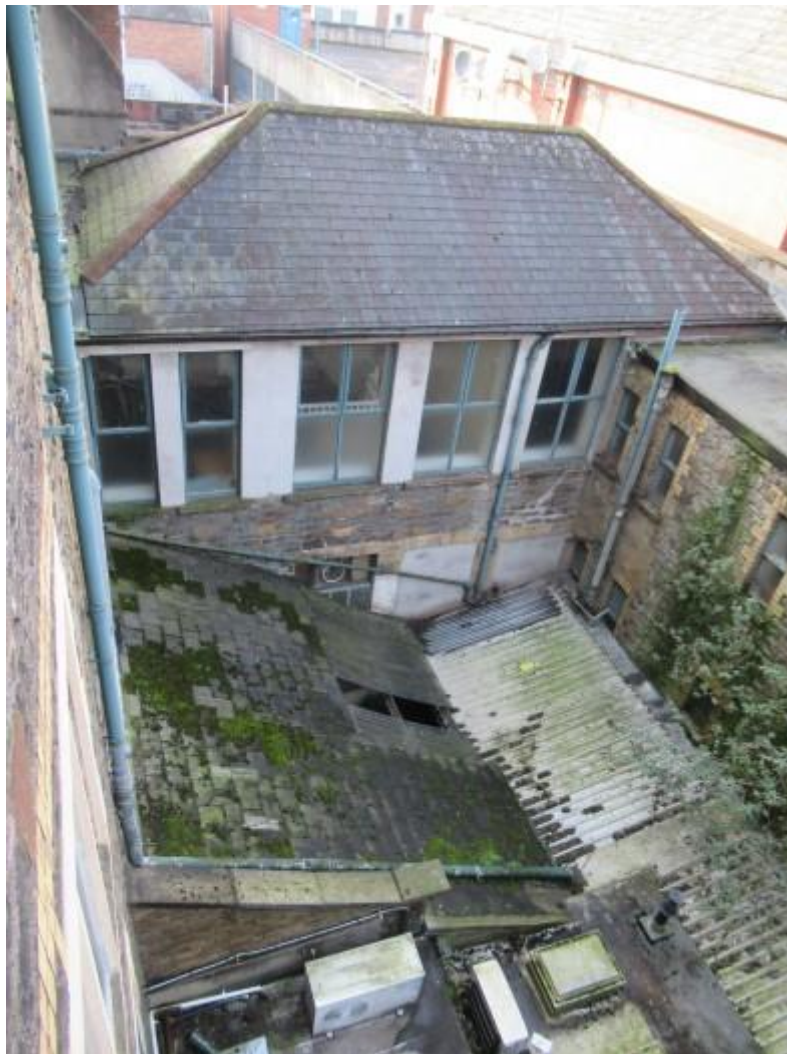
Lower level single-storey roofs to the rear courtyard area. The photograph shows a lower level slate roof area and various shallow pitched corrugated roof areas. We would recommend these areas are stripped and new coverings provided.

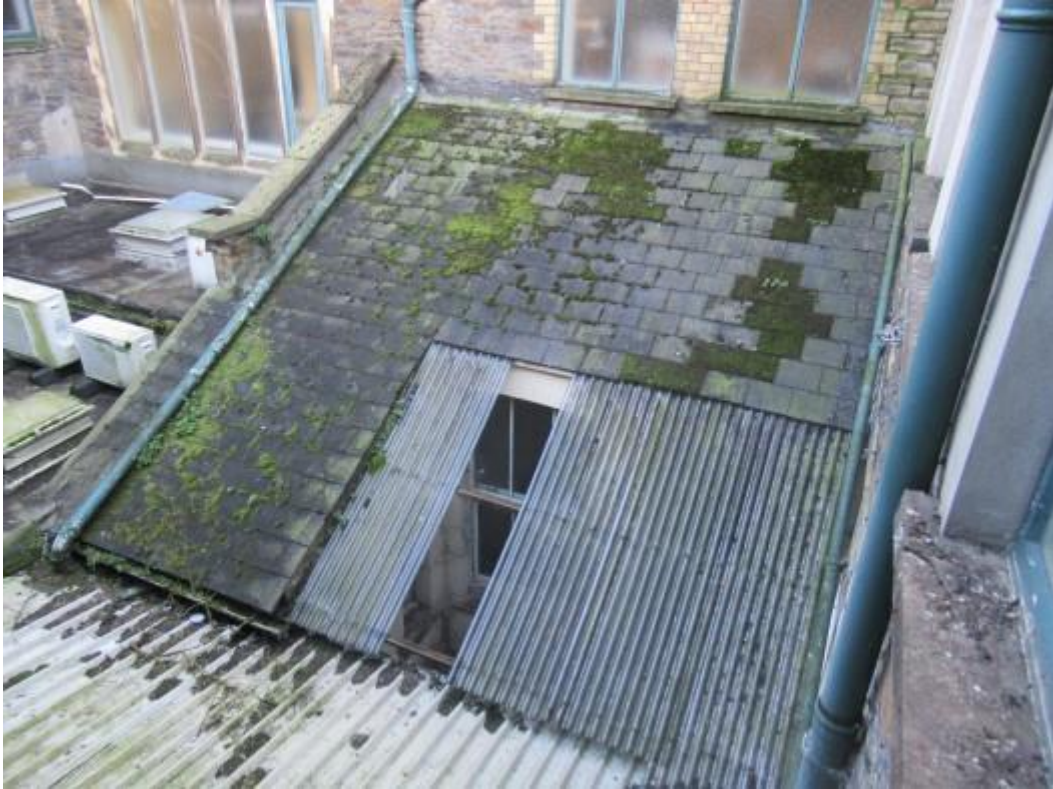
Further illustration of lower level slate roof and corrugated roof areas. The. Internally, there is evidence of water ingress to the roof which has caused damage to the internal finishes. This is, in part, associated with poor flashing details. We recommend the existing roof area is stripped and renewed.

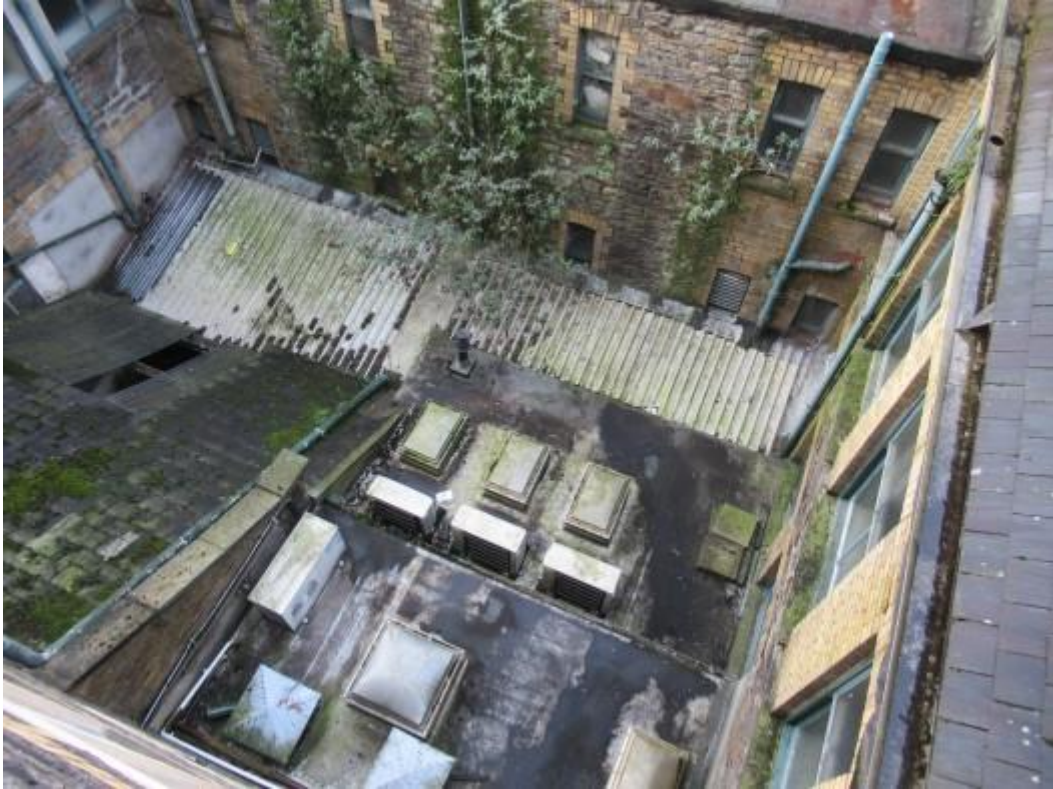
Further illustration of roofs to the rear courtyard area. The photograph shows the corrugated roof area and flat roof area. There are various roof lights and air conditioning plant to the flat roof areas. For budget purposes we would recommend that allowance is made for the stripping of the existing flat roof areas and their full upgrading. This will also enable works in relation to dry rot affecting the timbers as detailed elsewhere within this report.

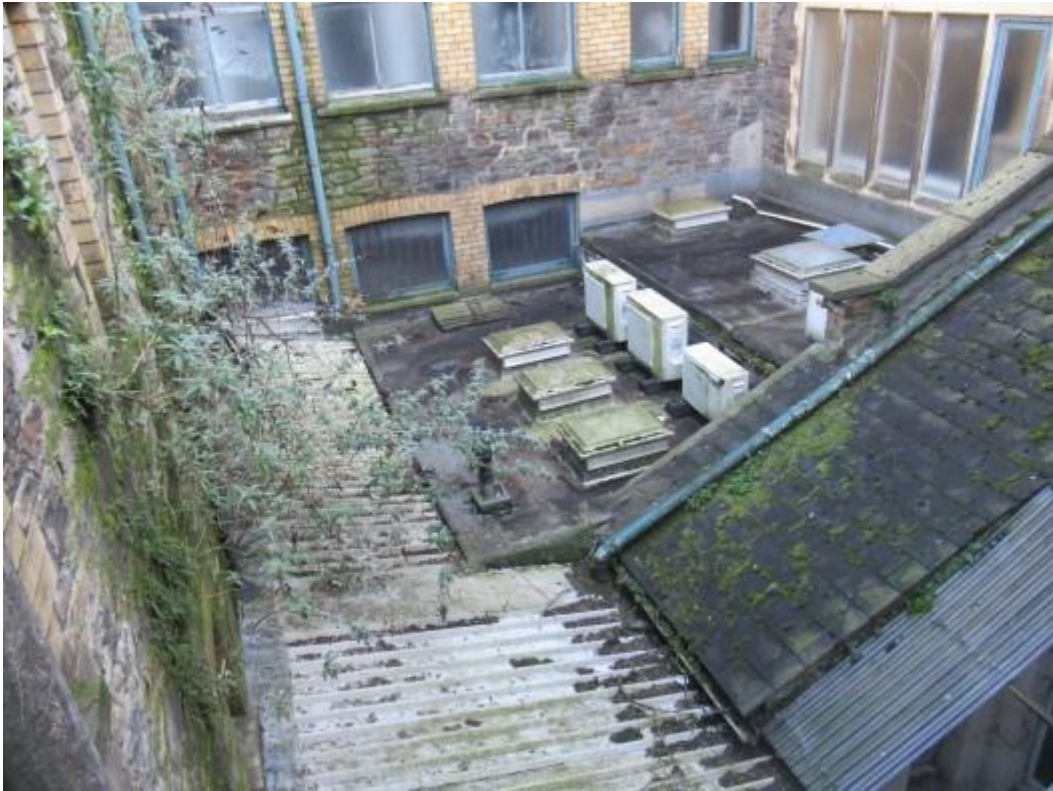
Further illustration of roofs to the rear with the lower level flat roof area noted.

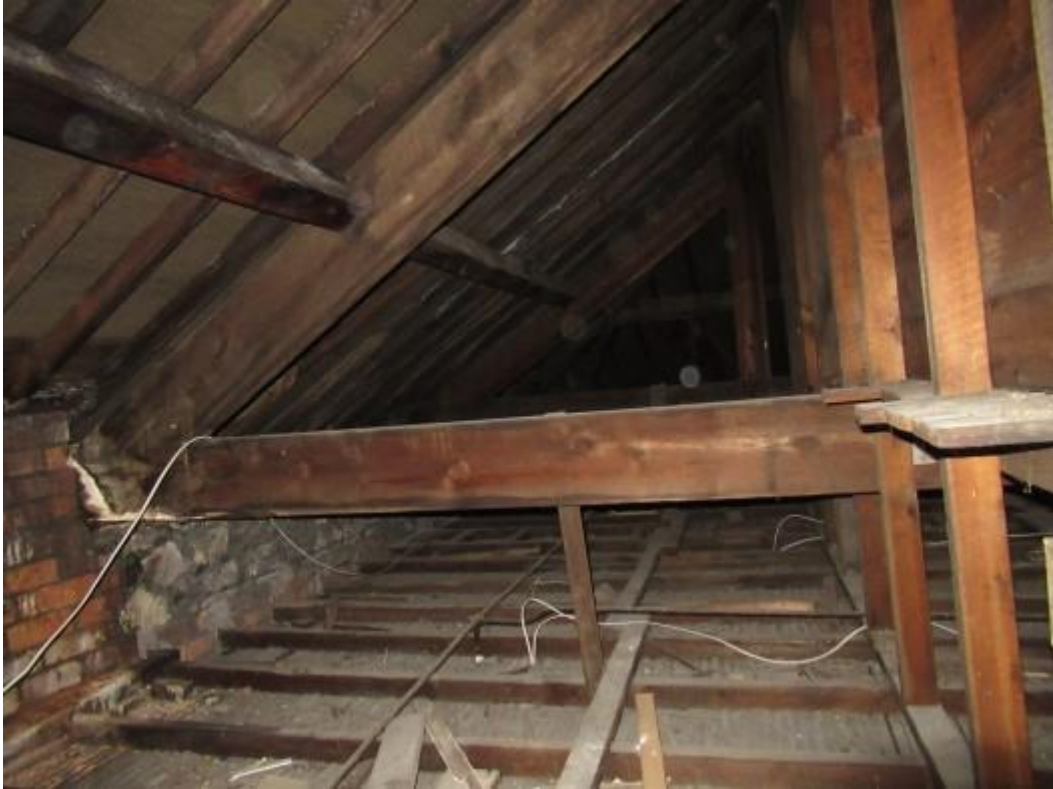
Roof void where extending to the right hand side of the property. The left hand side roof slope extends to the right hand side elevation where facing Cambrian Road. The photograph shows staining of timbers. There is more significant staining and rot within timbers was noted where built into the external walling adjacent to the chimney stack. The rotten timbers will require cutting out and upgrading as necessary. We anticipate this will involve replacement of the lower section of timbers to the principal truss.

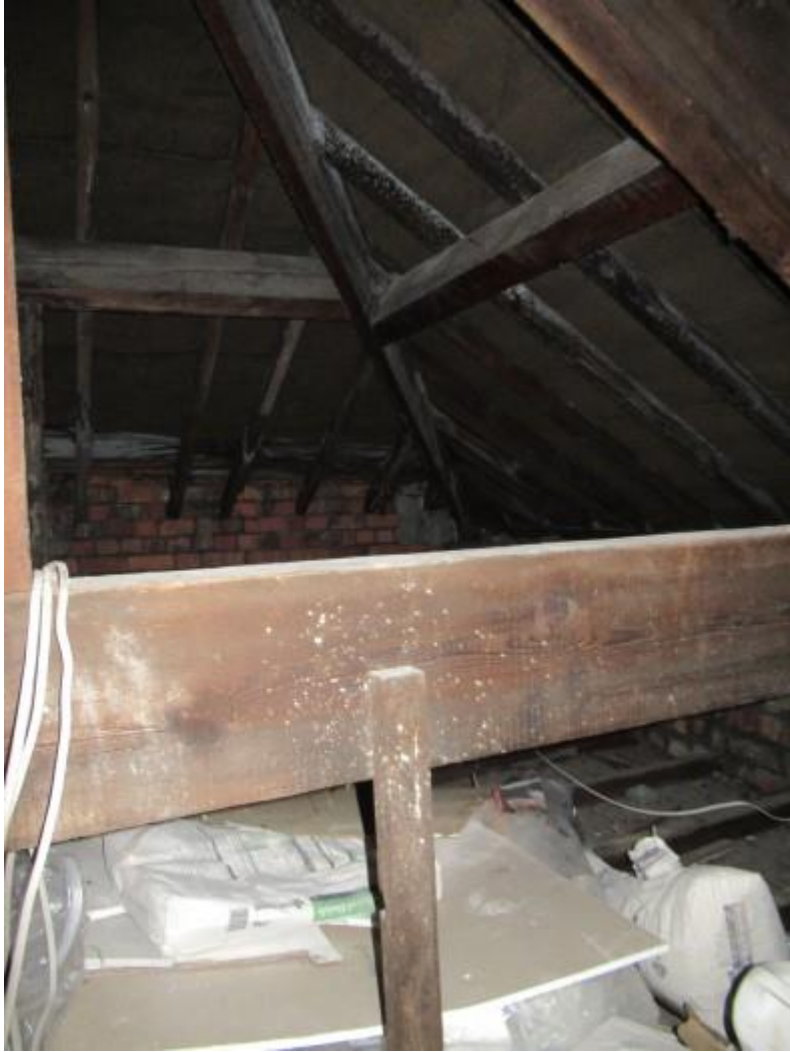
Further illustration of roof timbers to the right hand side lower level roof area. The photograph shows condensation staining to the underside of the timbers consistent with inadequate ventilation.

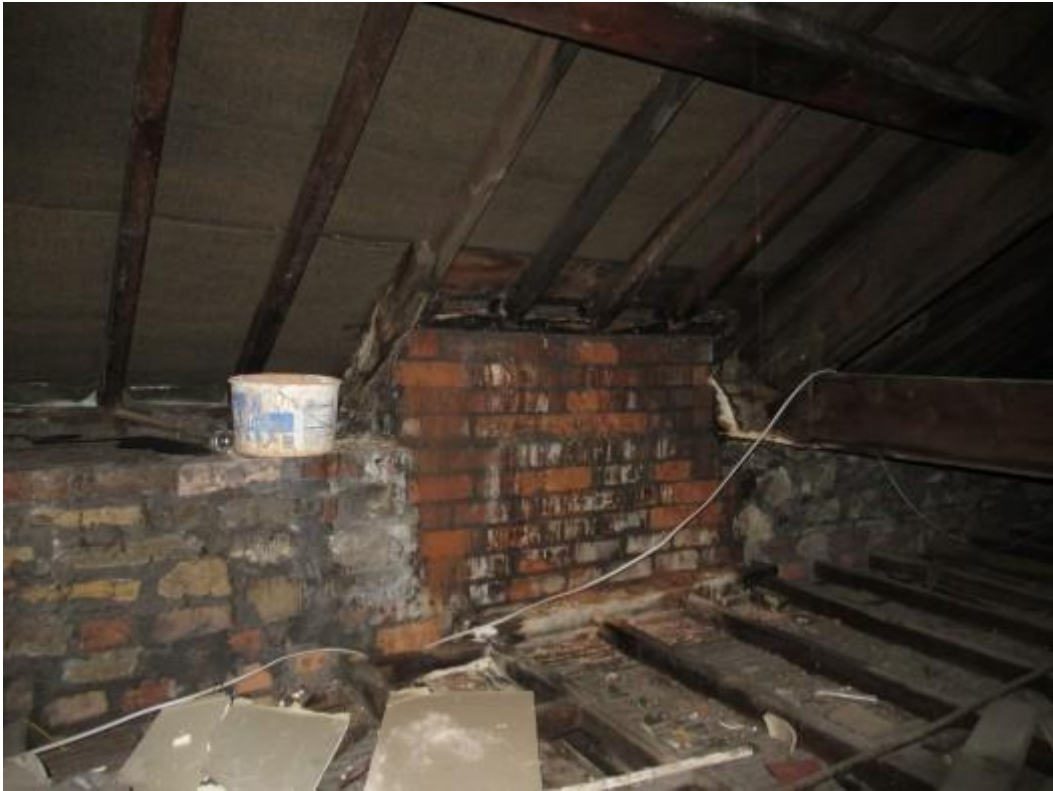
Further illustration of timbers to the right hand side of the roof with more extensive rotten timbers around the side chimney stack noted.

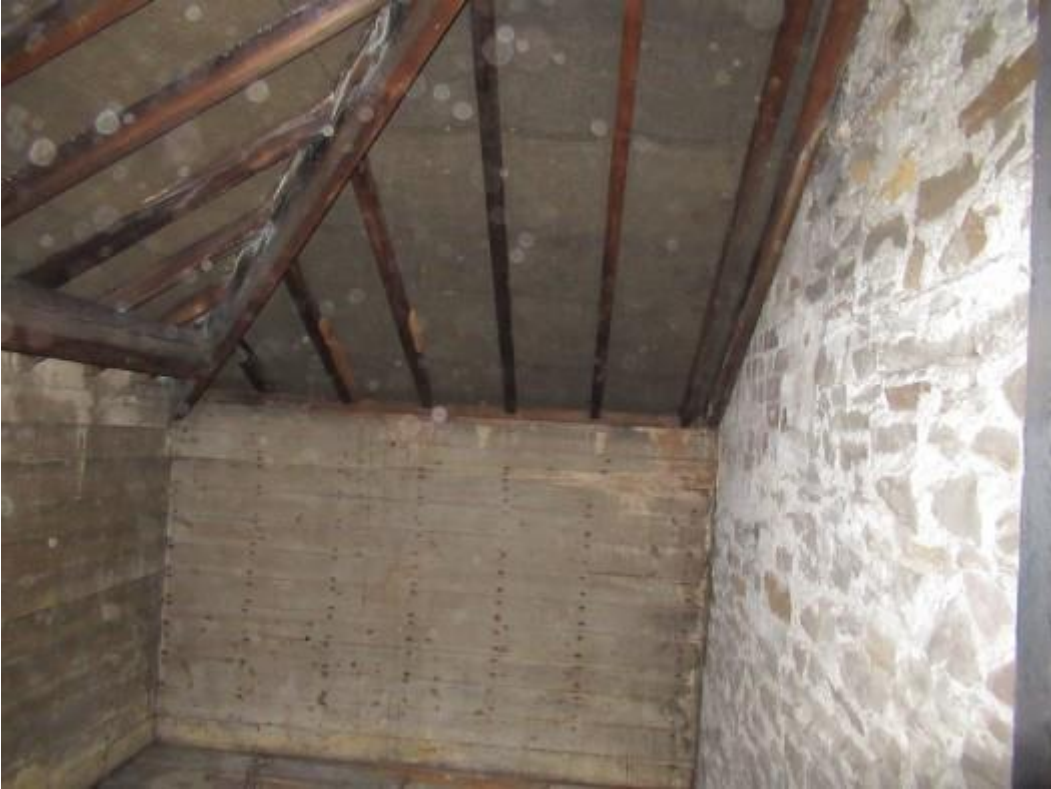
Further illustration of timbers to the right hand side of the roof. The photograph shows the principal hip rafter towards the front right hand corner of the roof. Staining of the timbers indicative of condensation is evident.

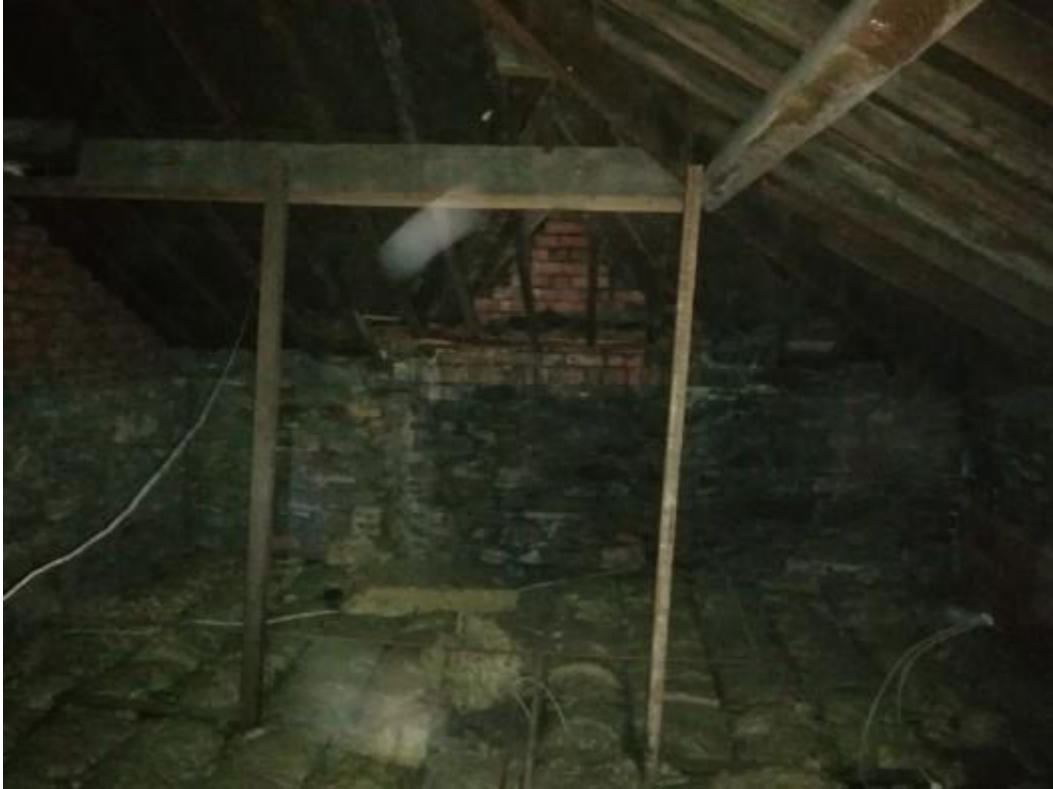
Left hand side roof void to the property. The photograph shows the roof void as viewed towards the front gable. To the right of the photograph the left hand side roof slope is noted. The photograph shows damp staining of timbers to the front. This is consistent with water ingress in the area of the parapets. The rotten timbers will require cutting out and replacing as necessary.

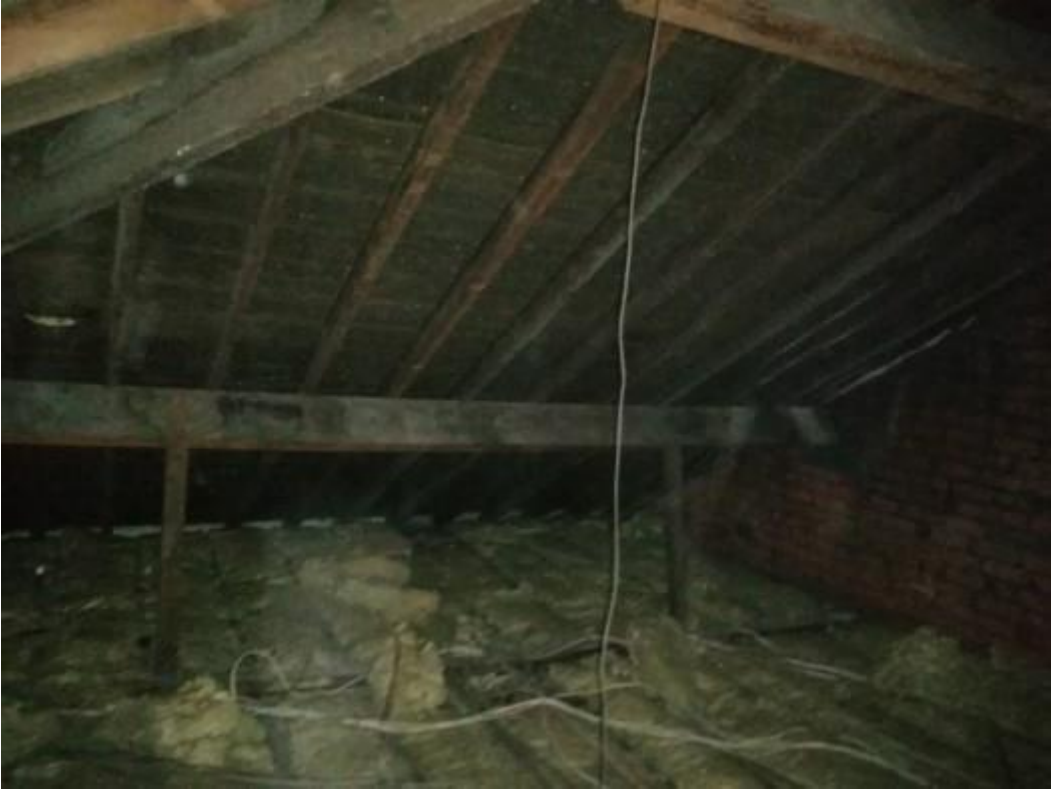
**Further illustration of the left hand side roof slope as viewed towards the rear.
The photograph shows the timber purlins providing support of the rafters.**

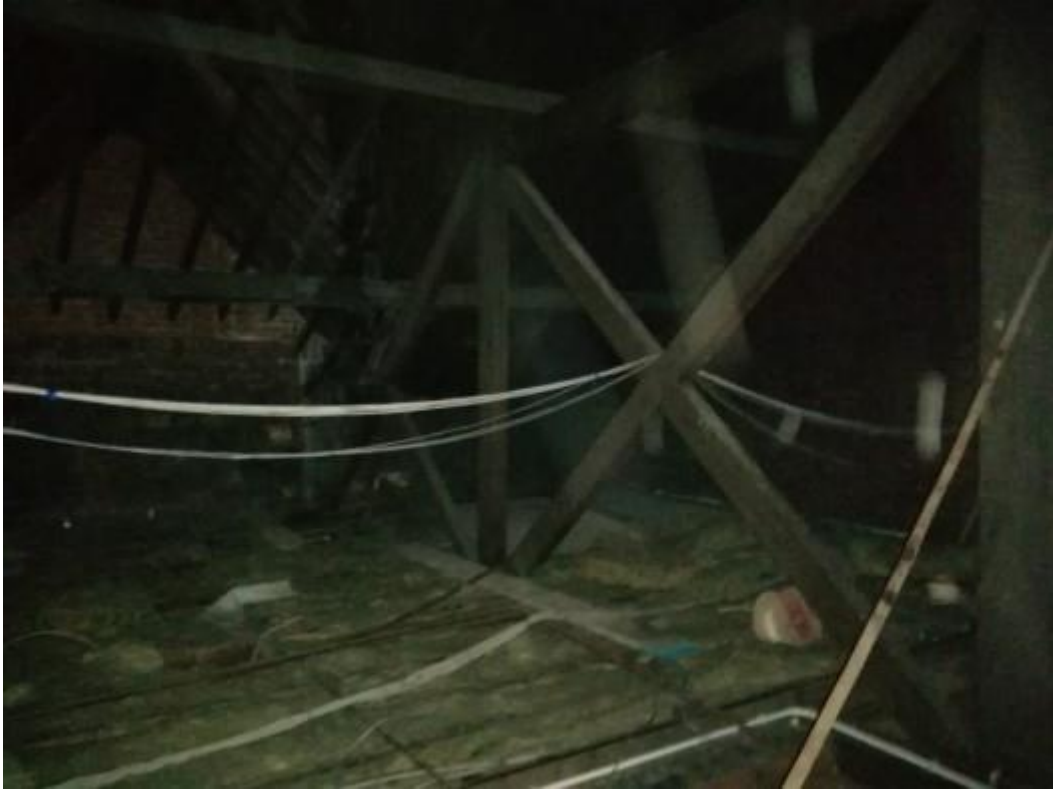
Central roof void. The photograph shows principal trusses providing support of the rafters. The photograph shows the roof as viewed towards the front of the property with the front central gable wall noted.

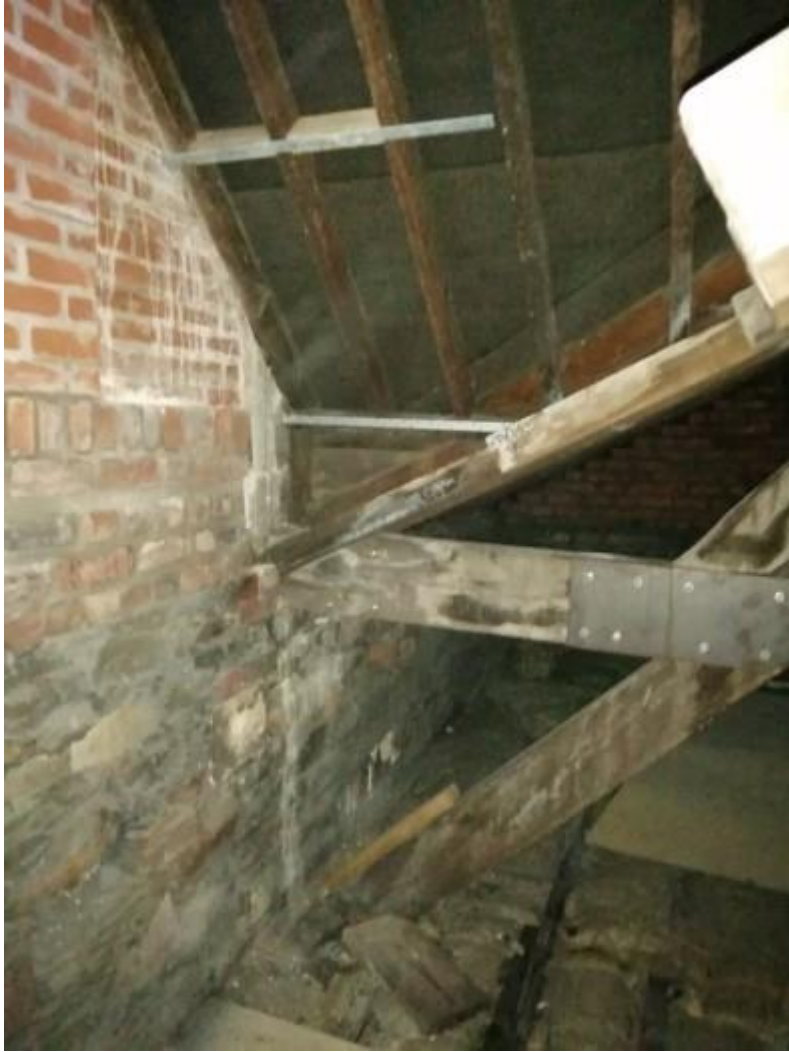
Further illustration of timbers where extending to the front gable. The photograph shows substantial repair to have been carried out to the timbers in past years to include additional steel plates bolted alongside the original timbers to provide additional support. The photograph also shows evidence of rebuilding of the front gable to include additional lateral support straps to the gable.

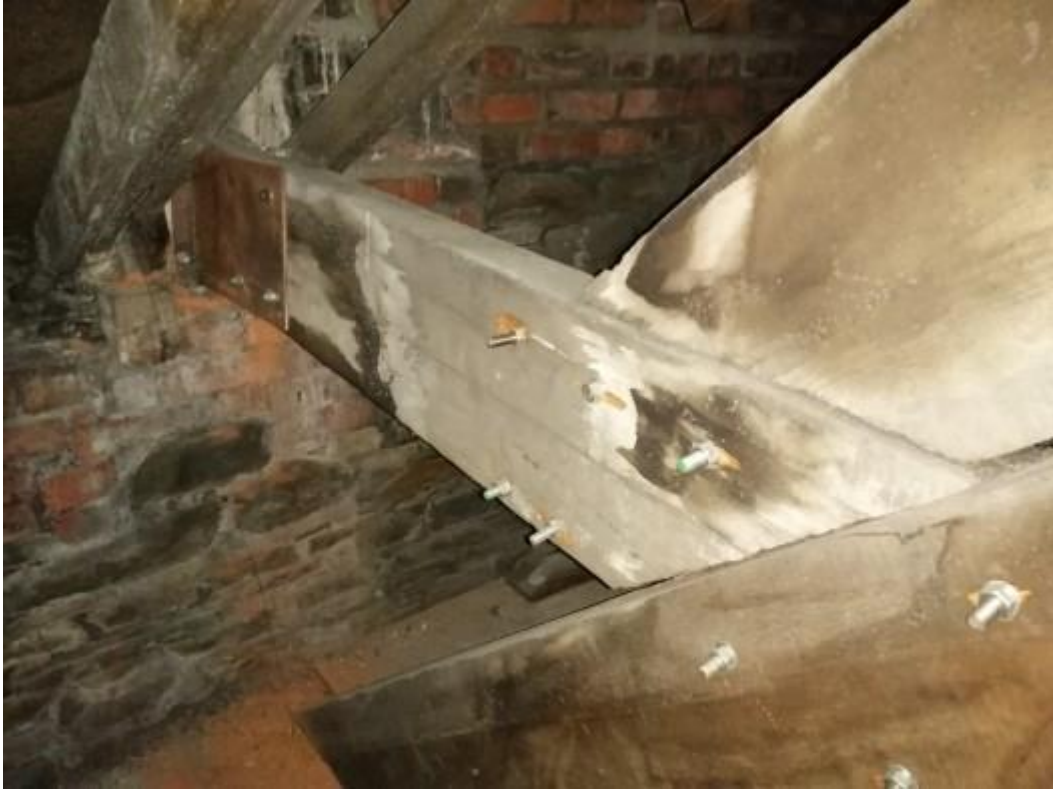
Further illustration of past repair where extending towards the front gable with additional steel plates provided.
