IN RESPECT OF:-

**TREDEGAR CHAMBERS
BRIDGE STREET
NEWPORT
NP20 4QA**

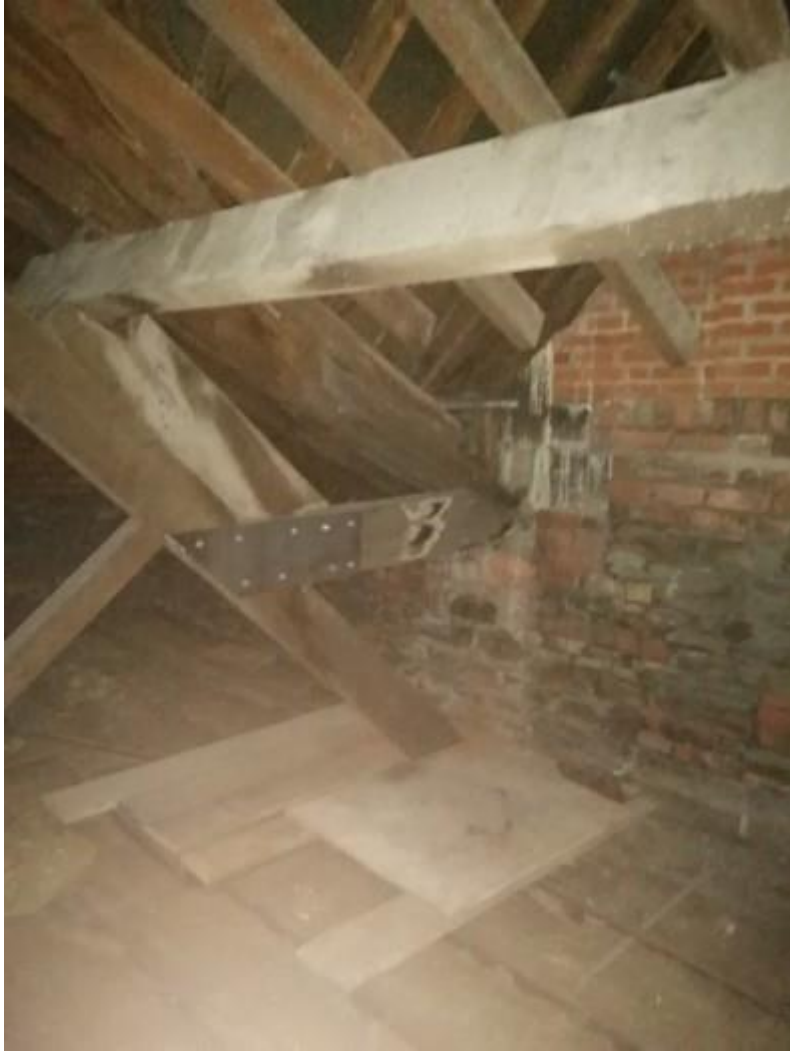
Further illustration of past repair towards the central roof area where extending towards the front gable.

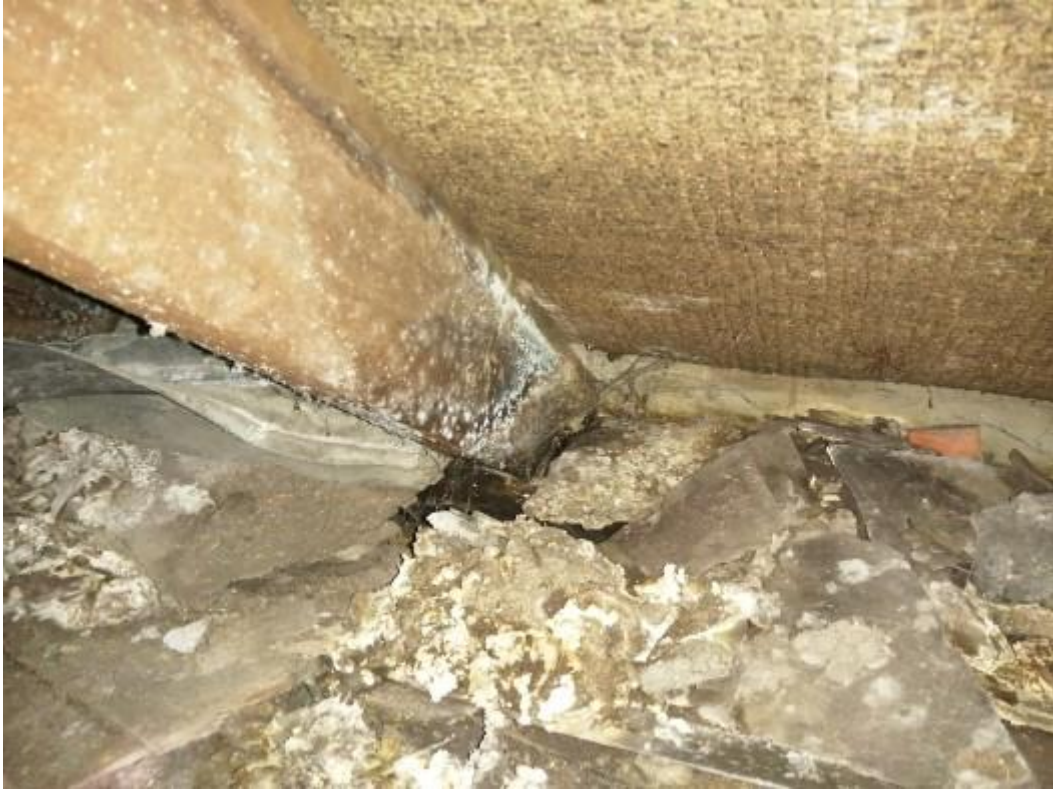
Typical rotten rafter foot and wall plate where extending towards the front of the property. There are further areas of rot affecting timbers to the perimeter of the property. The areas of rot will require cutting out and replacing as necessary. This will necessitate partial stripping of the roof coverings.

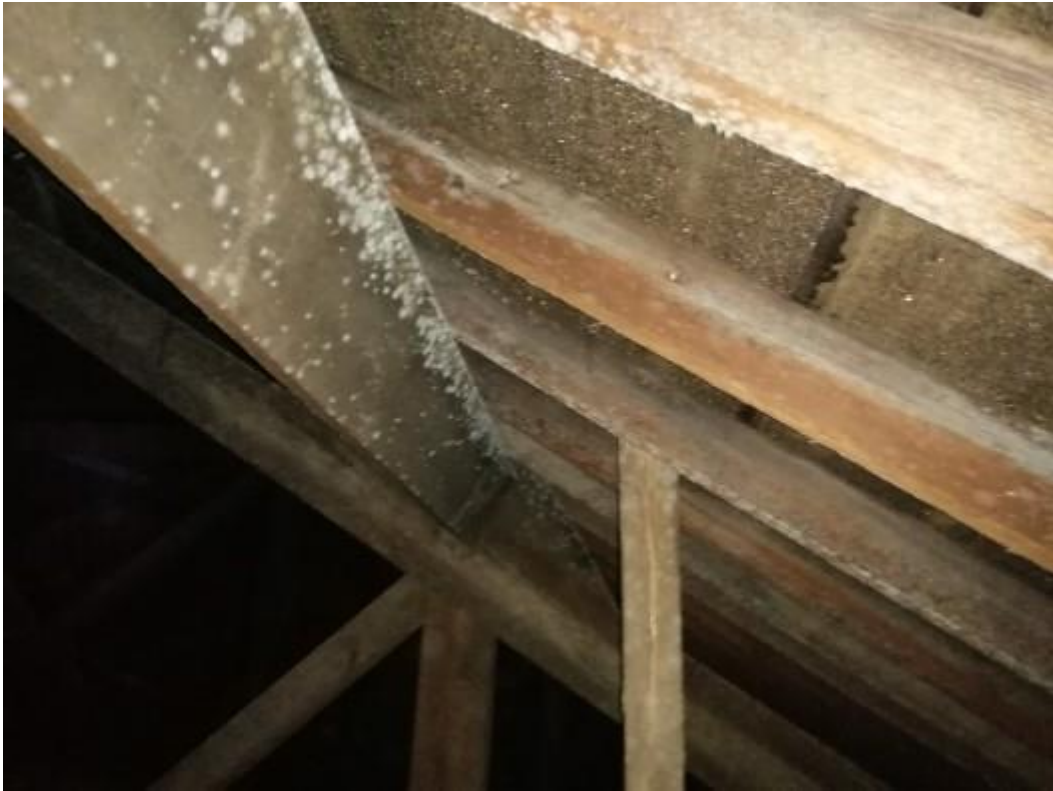
Typical moisture to underside of sarking felt and condensation to roof timbers.

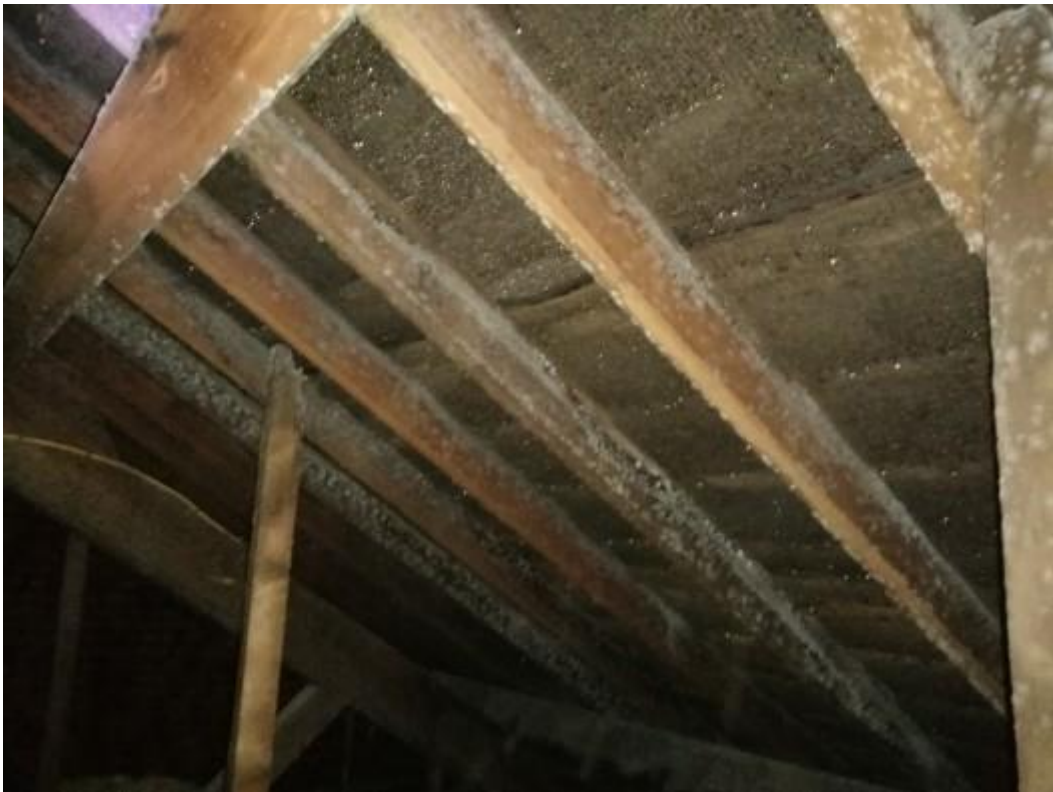
Further illustration of moisture to underside of sarking felt and condensation to timbers.

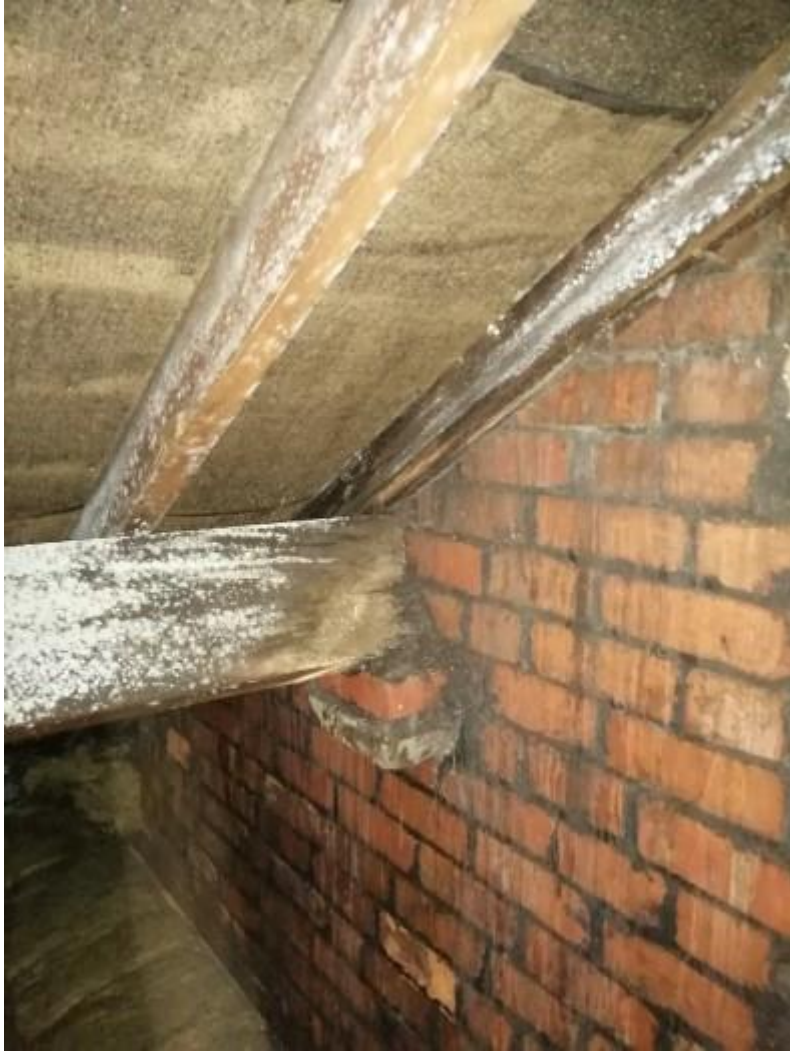
Further illustration of condensation to underside of roof timbers to the central roof area.

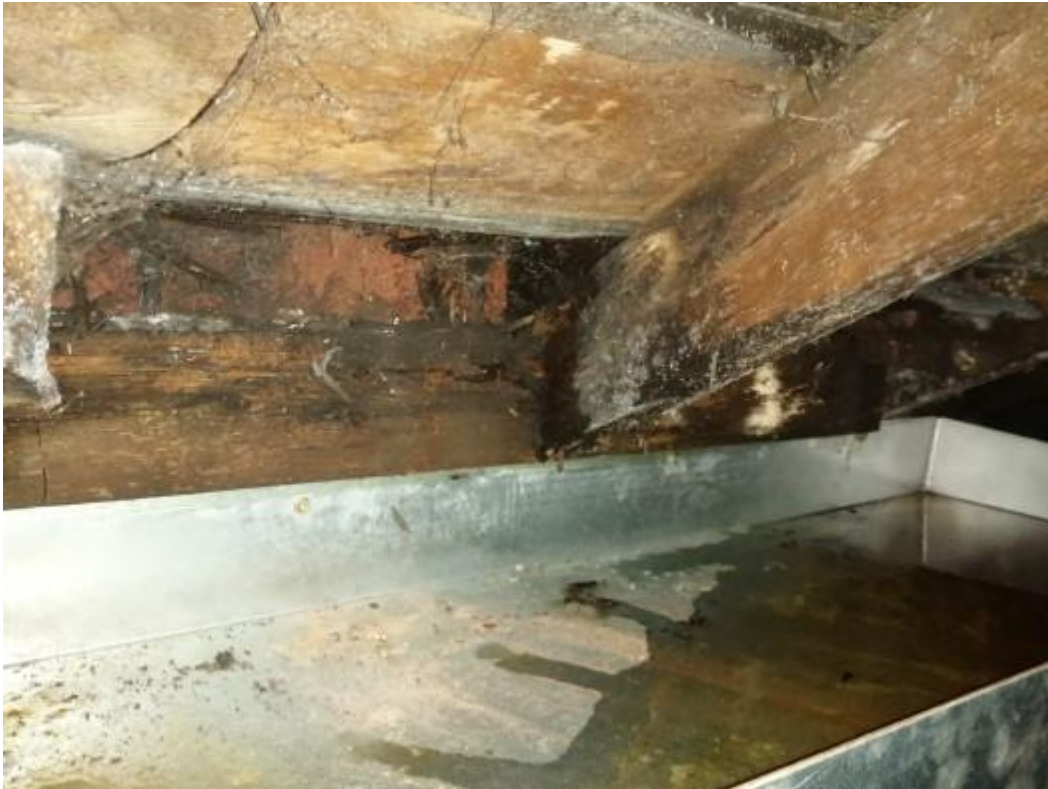
Further illustration of the tray detail. The photograph shows the rot and deterioration of timbers adjacent to the chimney stack. The timbers will require cutting out and replacing as necessary.

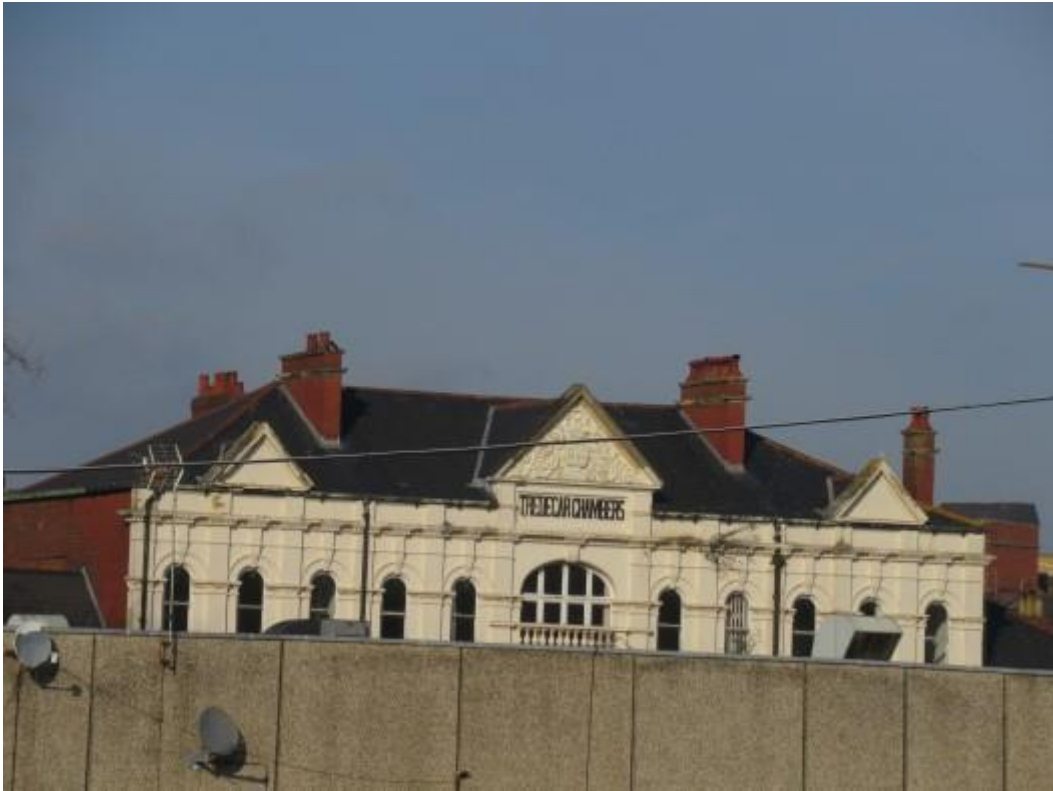
Chimney stacks to the front of the property. The photograph shows the stone detailing. There is spalling and damage of the stonework. Specialist repair in respect of the stonework will be required.

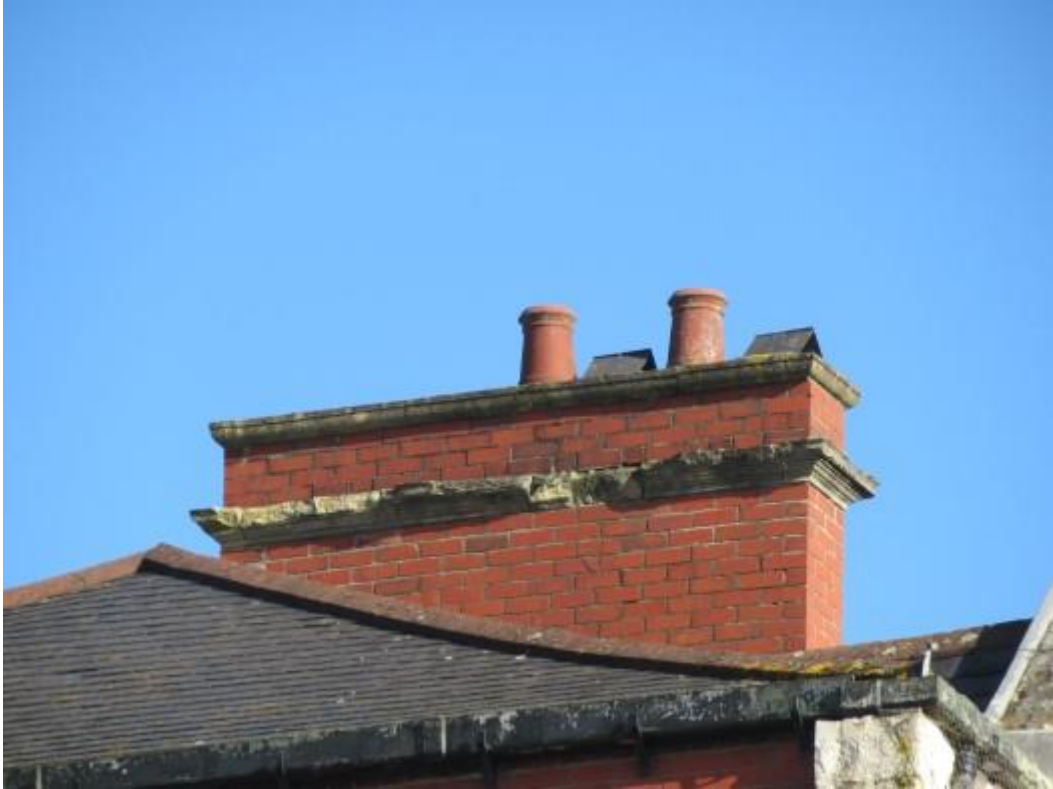
Upper section of the chimney stack to the left hand side of the main roof. The photograph shows the surface spalling and damage of the stonework. Specialist repair will be required. The photograph also shows two retained chimney pots with slate cappings also noted to redundant flues. Further chimney pots, where extending to the rear, have been removed. Upgrading of the flue outlets should be carried out as necessary.

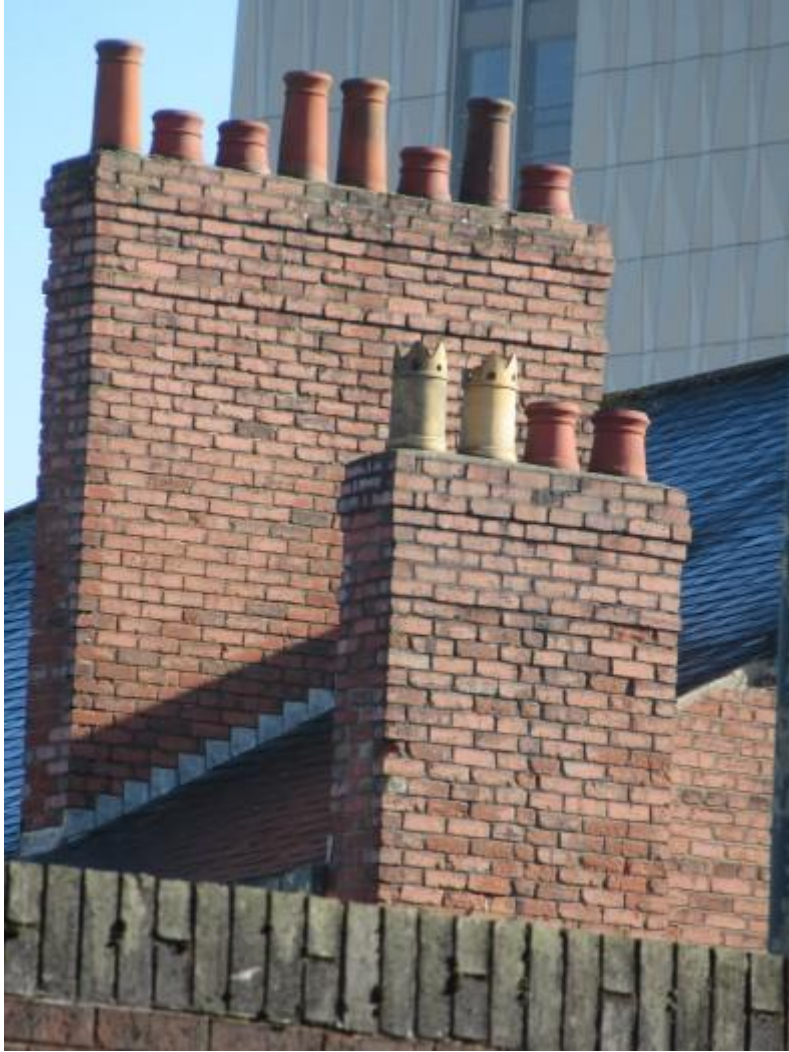
Chimney stacks to the left hand side and rear of the main roof. The photograph shows areas of loose pointing and surface weathering of brickwork. The photograph also shows clay chimney pots. Lead flashings, where visible for inspection, are also noted. Whilst no substantial works are deemed necessary remedial works are recommended to cut out and replace spalled and damaged bricks and to attend to areas of loose pointing as necessary. Ventilated cappings to the redundant flues should also be provided.

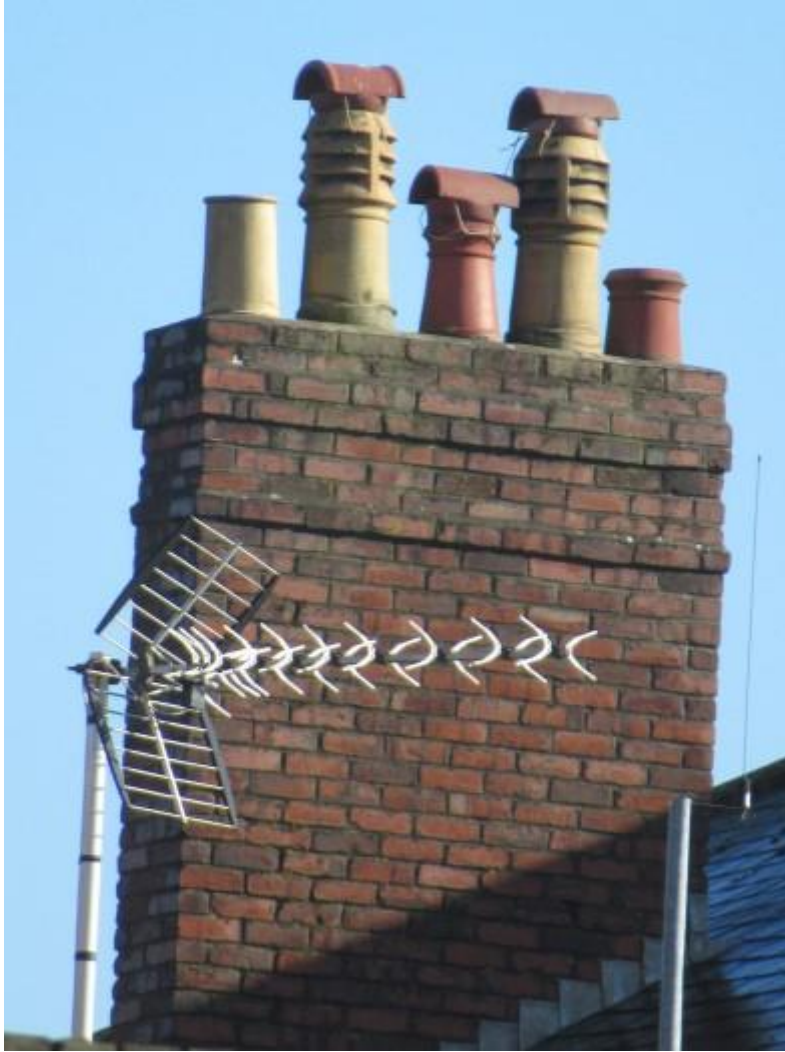
Further illustration of chimney stack to the rear. The stack has been attended to and repaired in past years to a satisfactory standard. No significant damage was noted. There are ventilated cappings fitted to the central chimney pots. Further ventilated cappings should be fitted as necessary.

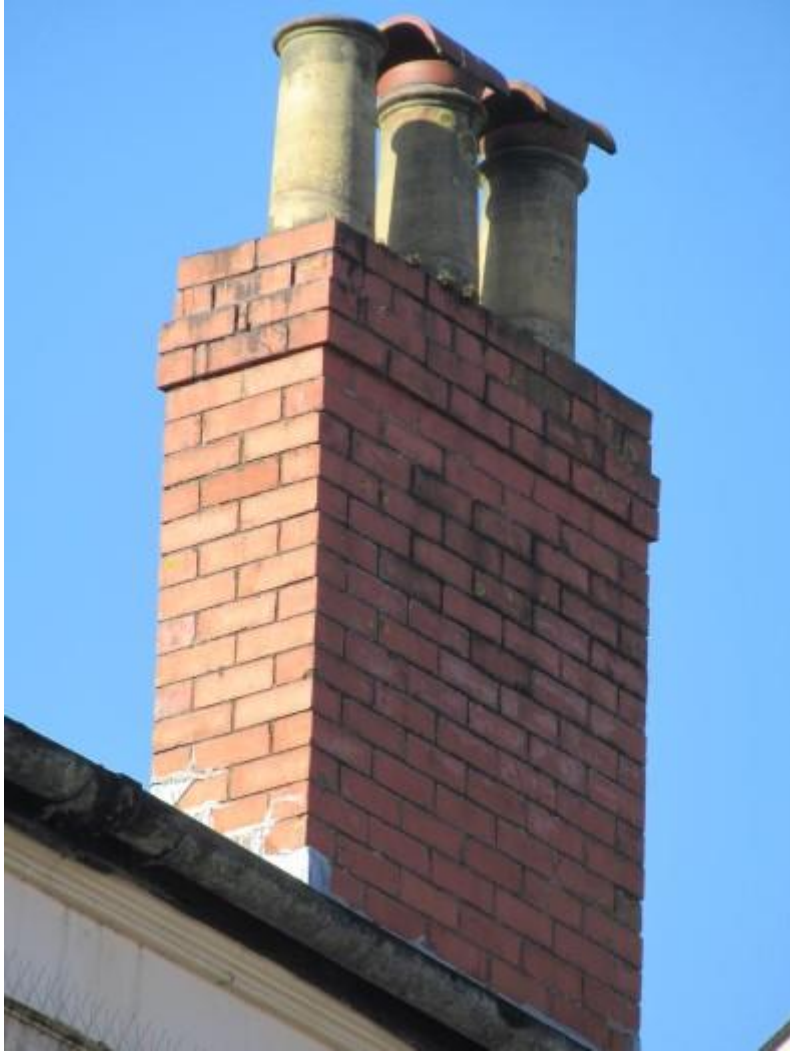
Chimney stack to the right hand side of the property. There is significant water ingress at the base of the chimney stacks to the right hand side of the property.

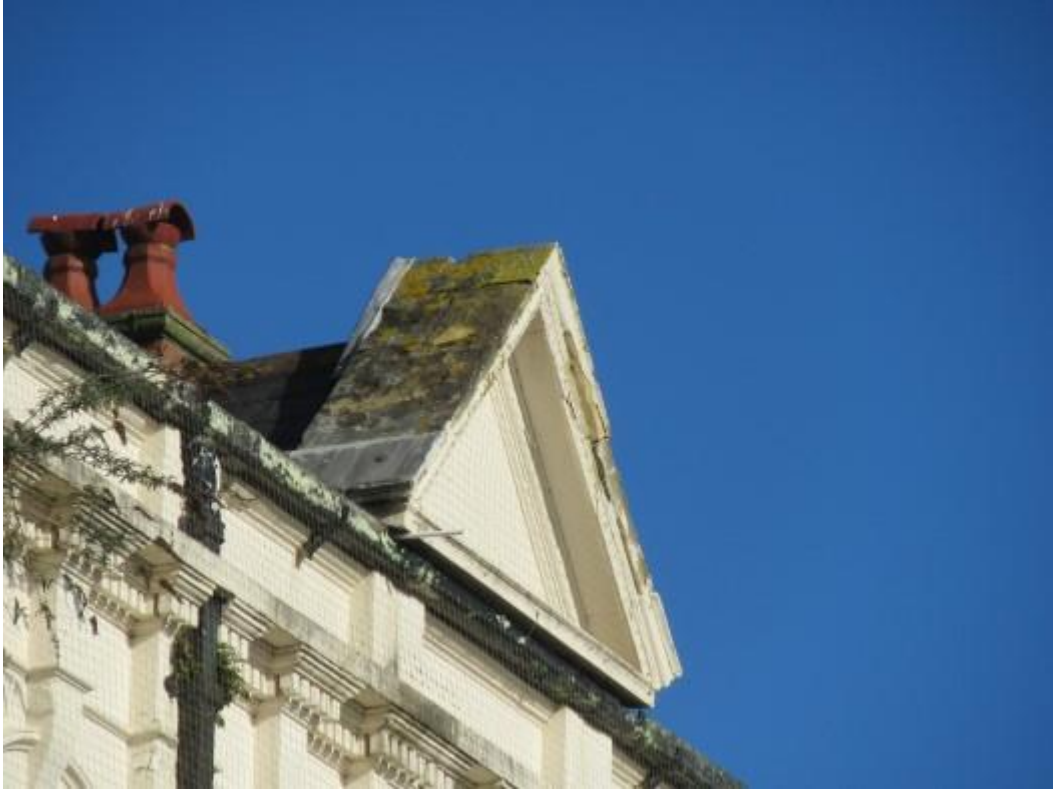
Guttering where extending to the front of the property. The photograph shows an outlet from the guttering to a cast iron downpipe. The photograph shows the general deterioration of the gutter with age. The guttering is in basic order. Allowance should be made for complete replacement of the gutters and downpipes throughout the property.

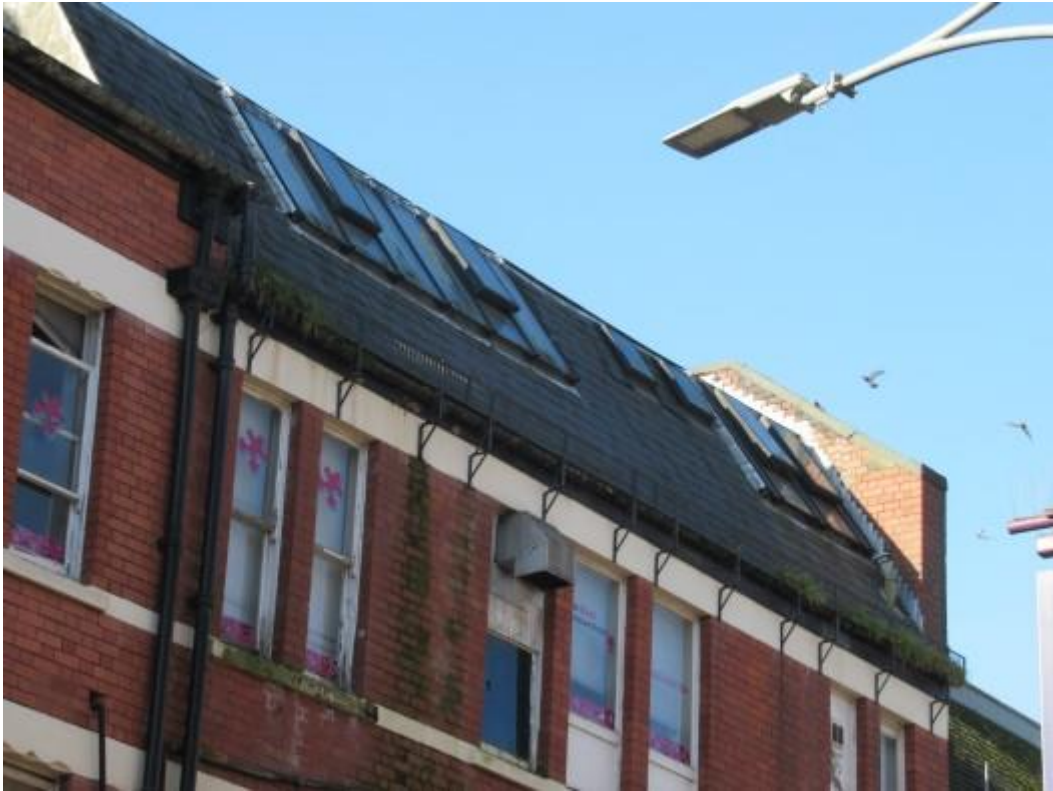
Guttering to the right hand side of the property. The photograph shows extensive vegetation and leakage. This is contributing to internal damp.

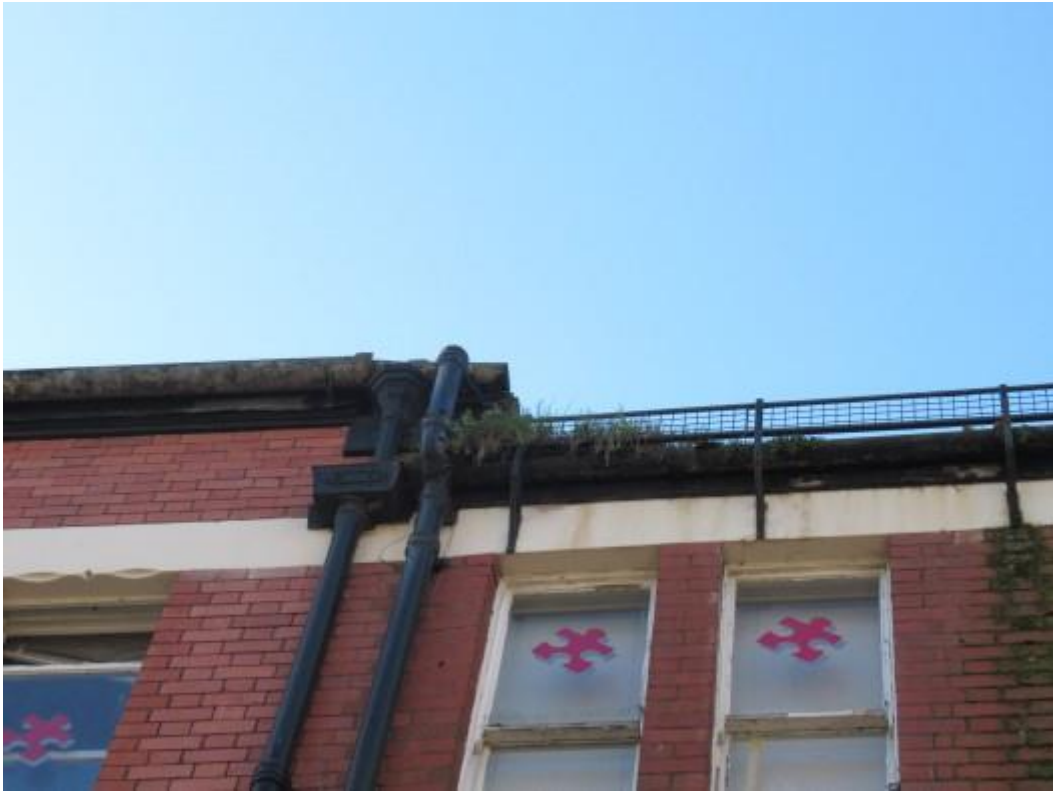
Further illustration of typical blockage and vegetation within the guttering.

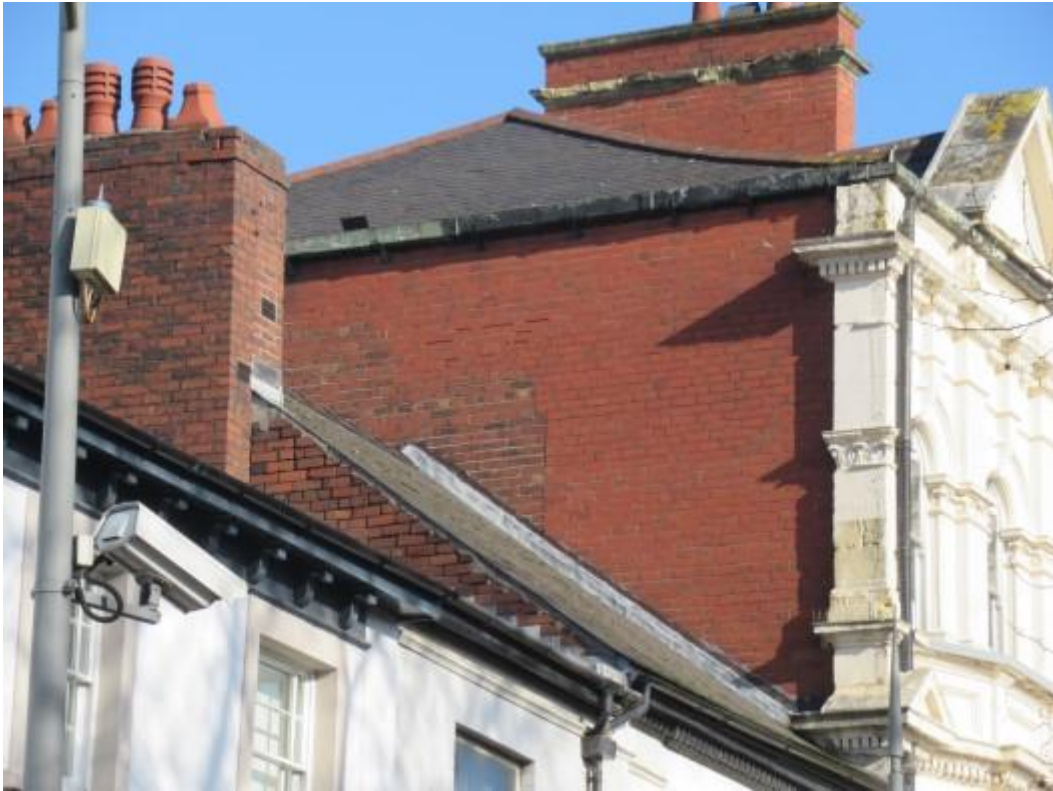
Brickwork and pointing to the left hand side of the property where extending above the roof of the left hand side neighbouring property. The photograph does show evidence of past re-pointing albeit there are further areas of loose pointing. Minor areas of re-pointing work are required. The photograph also shows the stonework where extending to the front of the property with surface weathering, spalling and damage noted. Specialist repair in respect of the stonework to the front and right hand side of the property will be required.

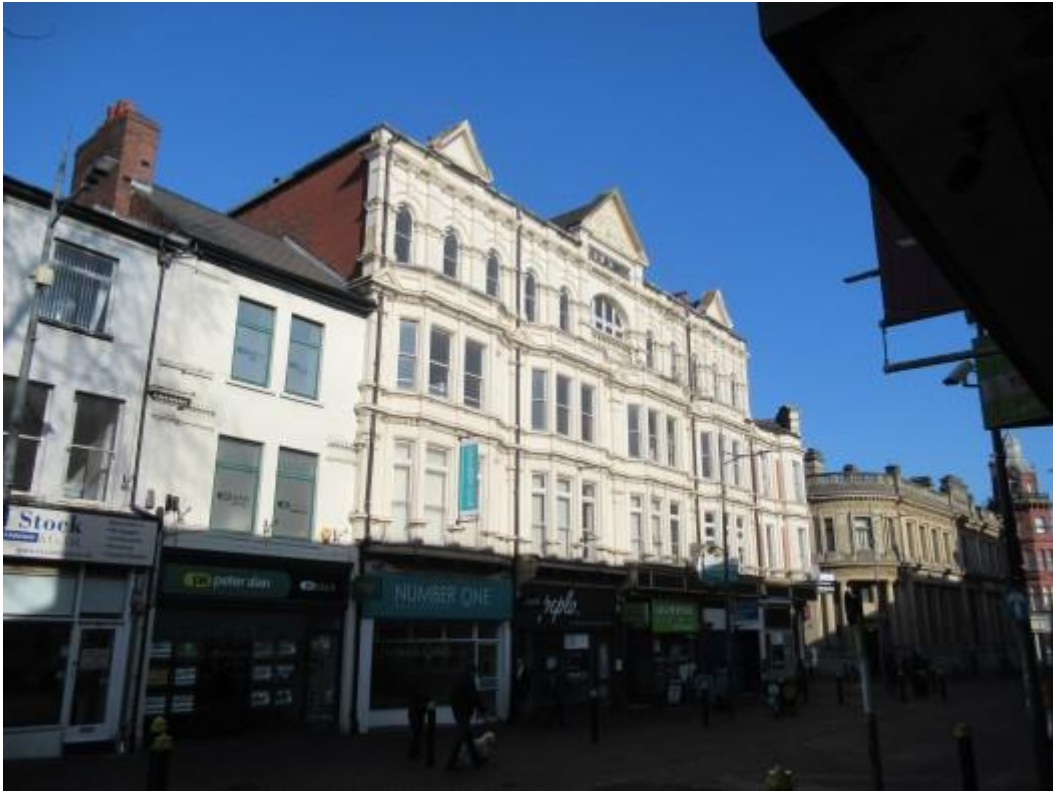
Further illustration of the front elevation. The photograph shows the render and stone detailing to the main elevation. The photograph also shows the bay windows where extending to the first and second floors with small flat roof areas above.

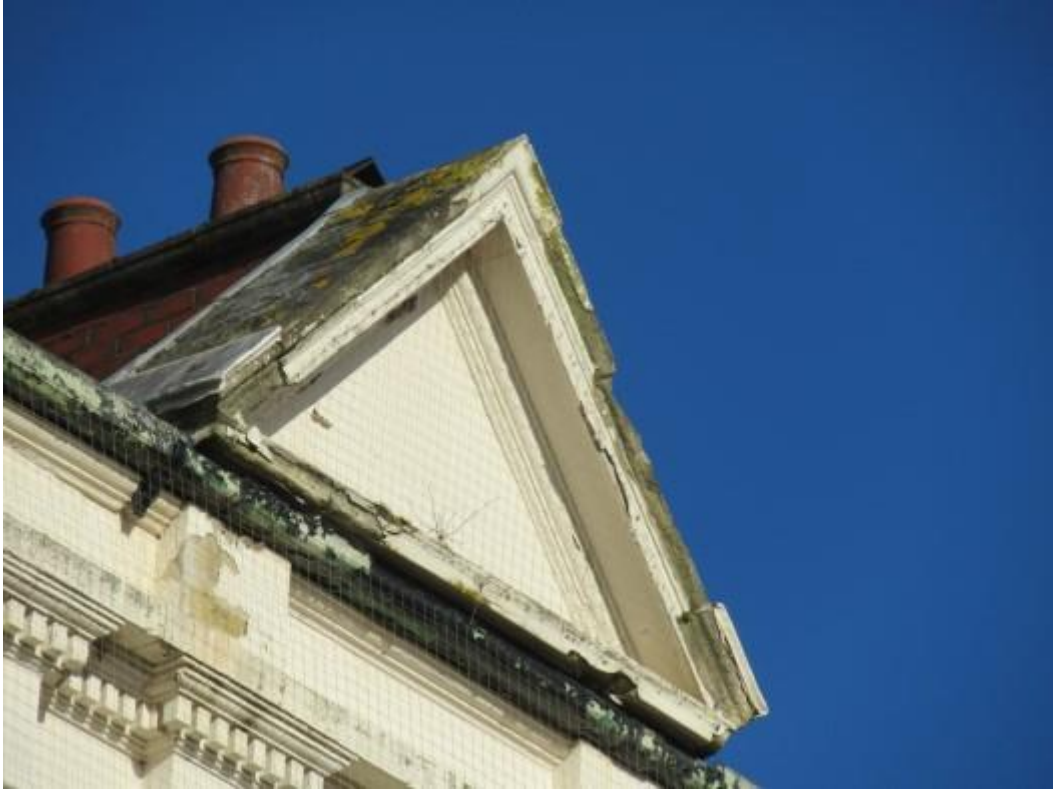
Typical spalling and damage of stone detailing to the front left hand gable. Whilst past repair has been carried out, to include attention to the leadwork, further works are required. This will include further works in relation to the leadwork to prevent problems of water ingress occurring.

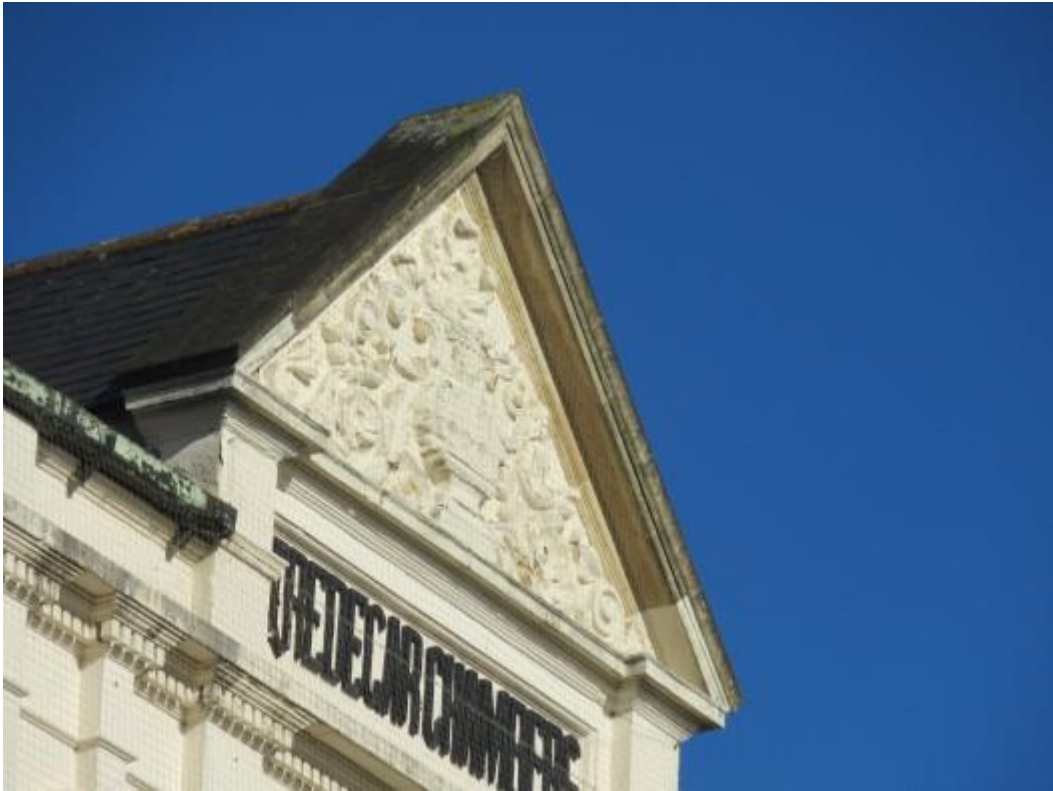
Central gable to the front of the property. As noted, this area has been rebuilt internally in past years with new brickwork noted. Externally, the coping details have also been attended to and upgraded and stonework repaired. Further repair will be required.

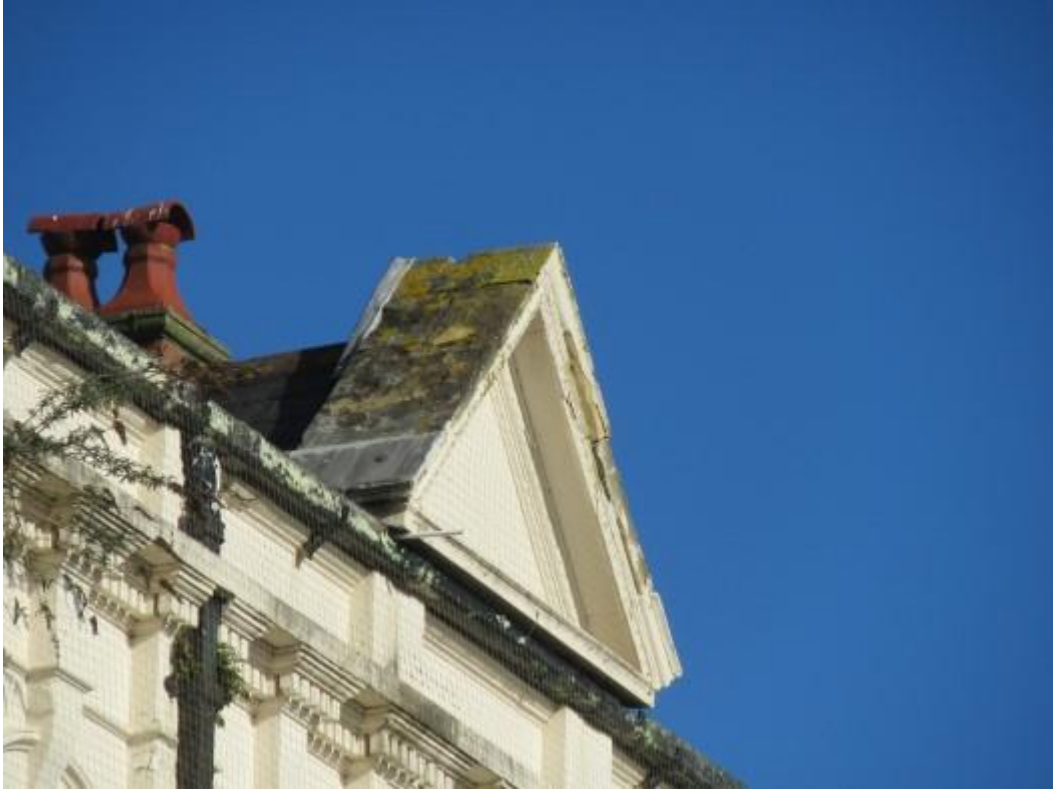
**Right hand side gable with spalling, damage and general deterioration evident.
Repair and upgrading works are required.**

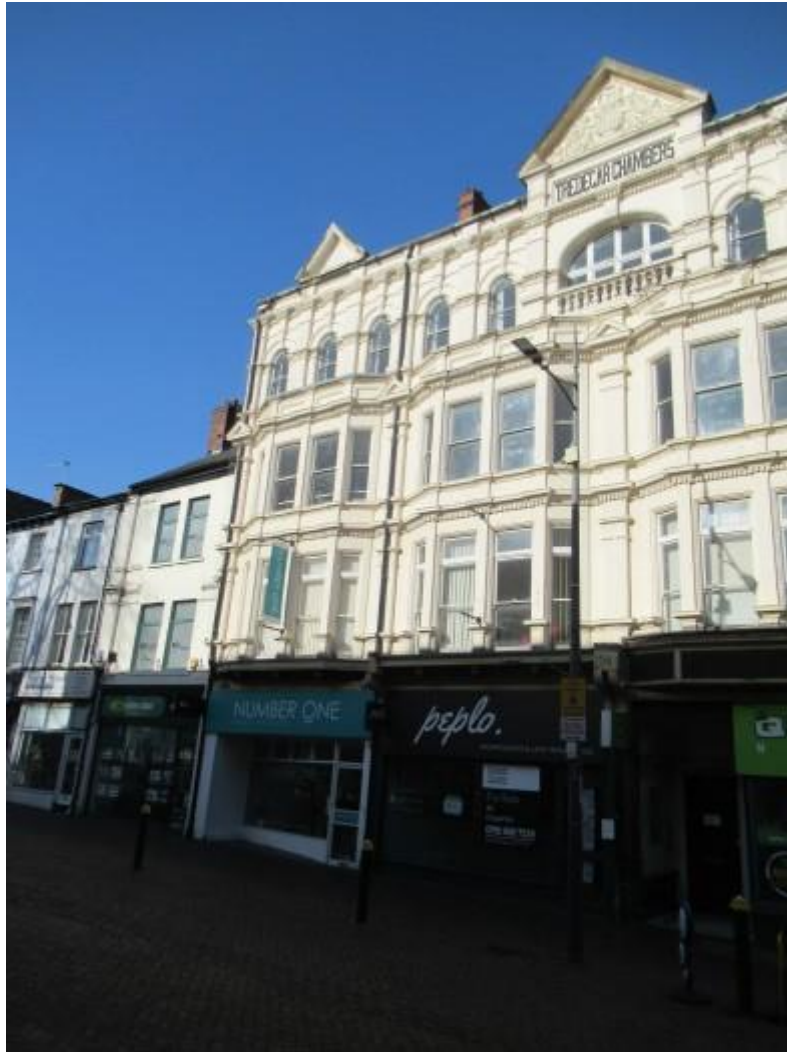
Further illustration of the front elevation. The photograph shows the general condition of the ground floor shop fronts and render and stone walling finishes where extending above.

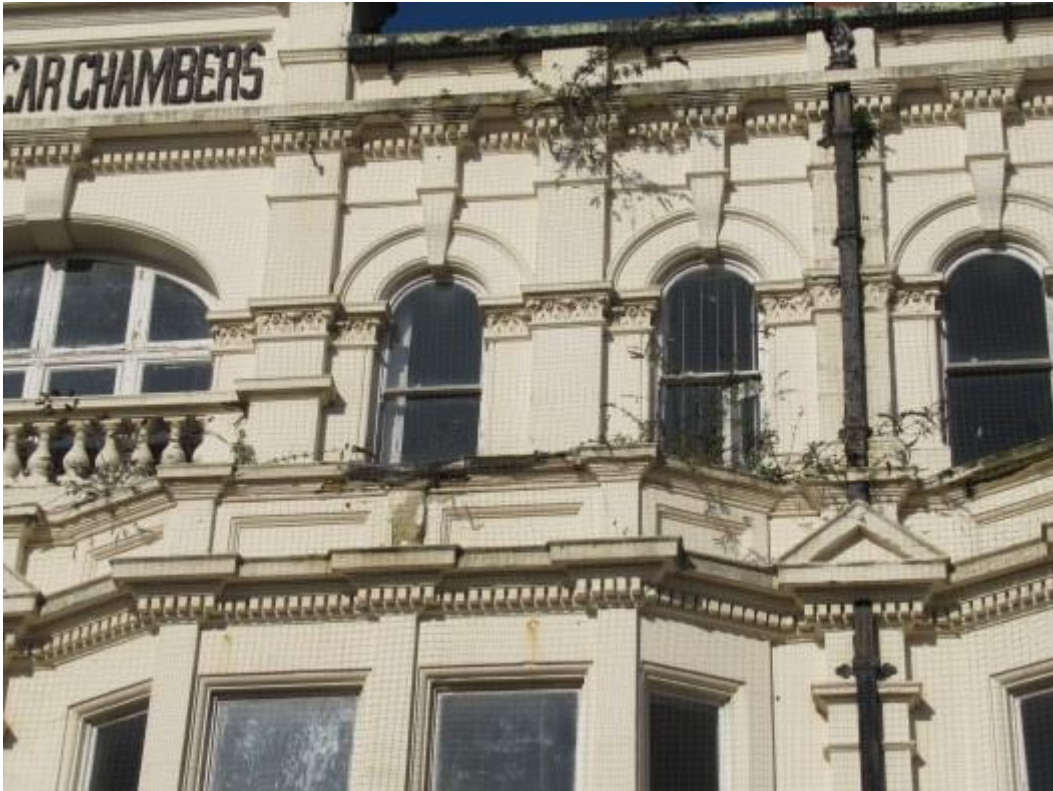
Damage of stonework to the front of the property. The photograph shows spalling and damage of the stonework to the lower area parapet walls extending over the bay windows. There is water ingress to these areas. Repair and upgrading works are required.

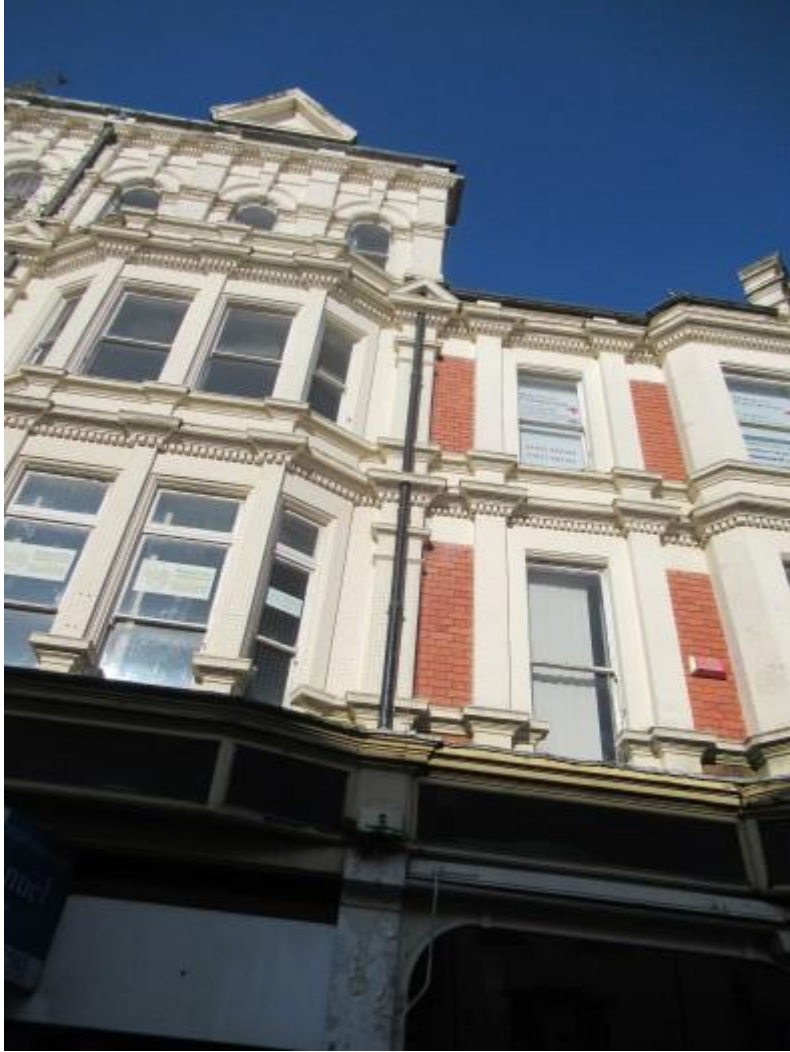
Walling where extending to the right hand side of the front elevation. The photograph shows brickwork to the lower section of walling and further Bath stone detailing.

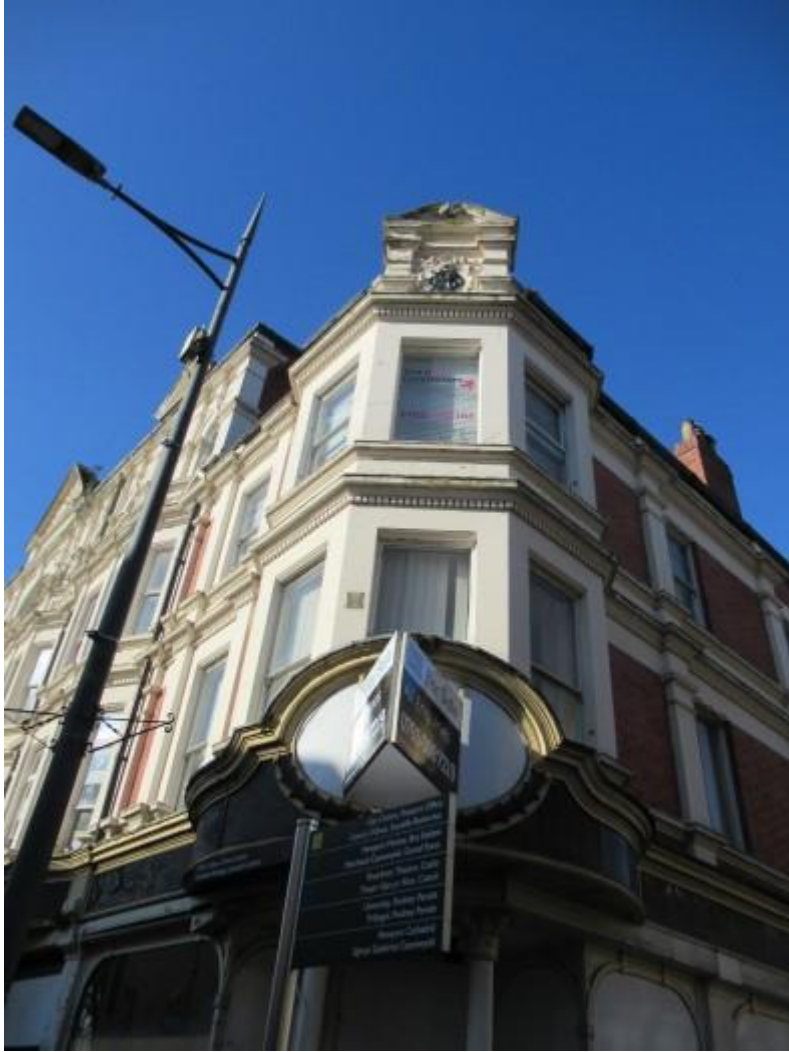
Walling to the front right hand corner of the property with brickwork and stone detailing noted. Areas of surface spalling and weathering are noted particularly to the stonework at high level. Specialist repairs will be required.

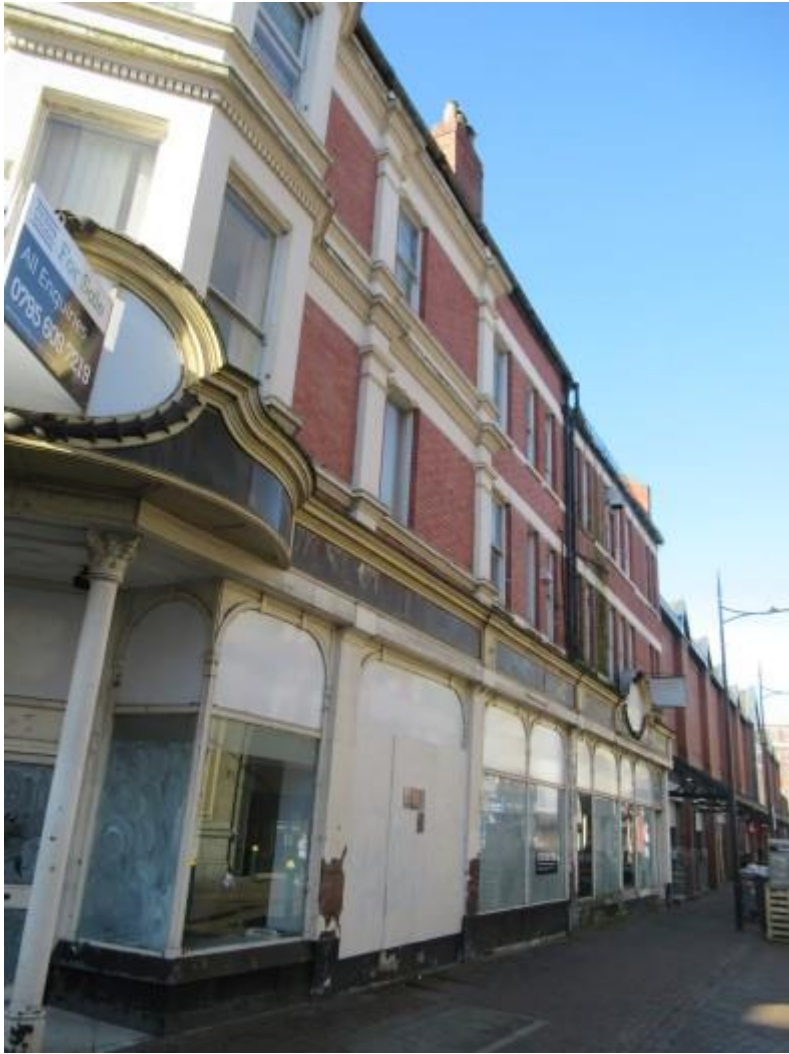
Right hand side elevation. The photograph shows the shop front area to the ground floor and brickwork and stone detailing above.

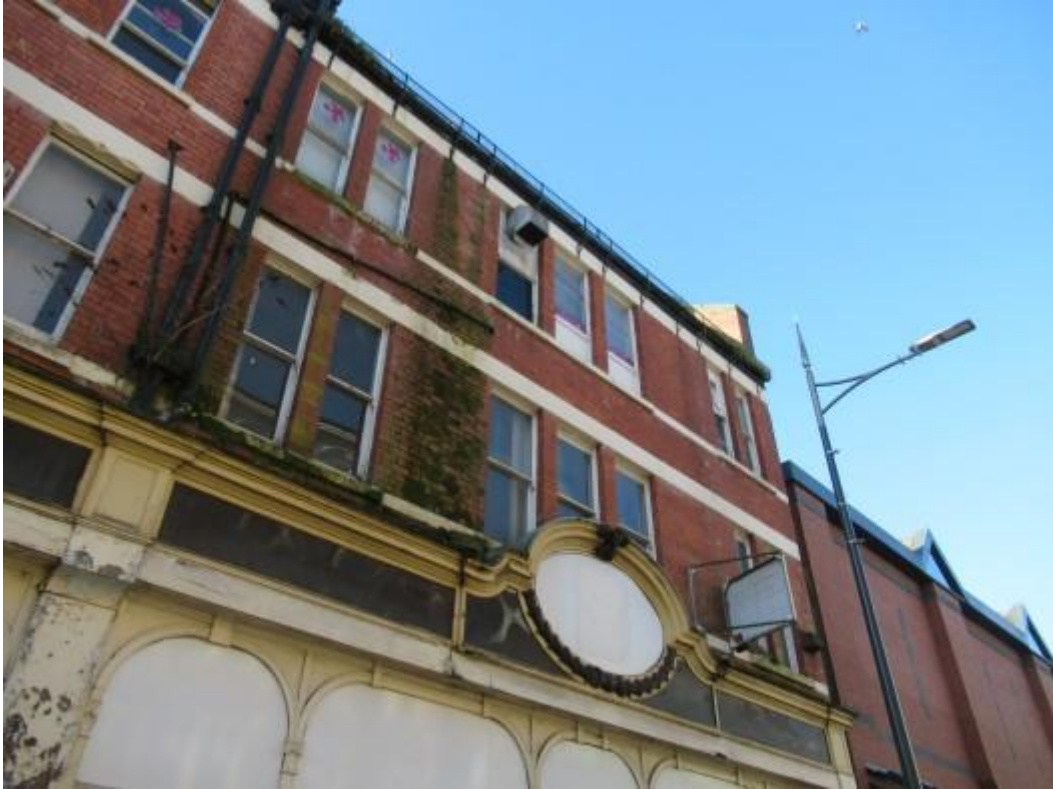
Further illustration of the right hand side elevation. The photograph shows deterioration of the brickwork consistent with leakage of rainwater goods. General staining and localised damage to the stone detailing is also noted.

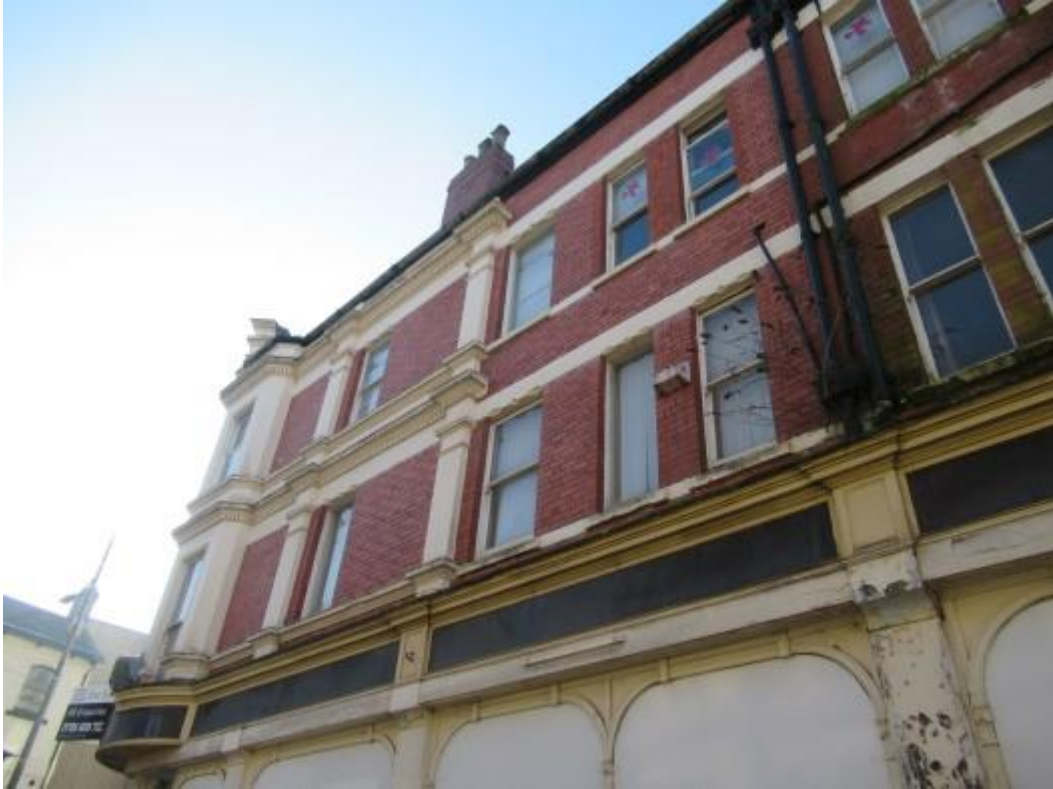
Further illustration of first and second floor walling to the right hand side of the property.
