IN RESPECT OF:-

**TREDEGAR CHAMBERS
BRIDGE STREET
NEWPORT
NP20 4QA**

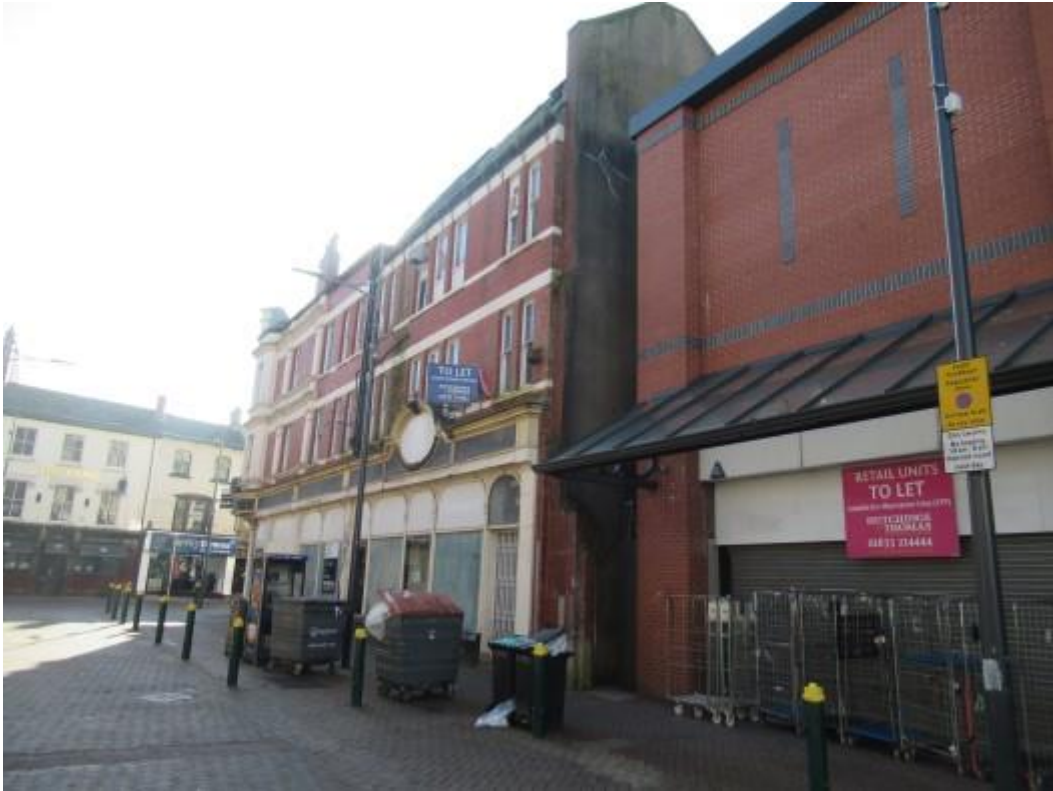
Right hand side elevation as viewed from the rear. The photograph shows the render finishing where extending to the rear wall. This area of walling is not fully accessible.

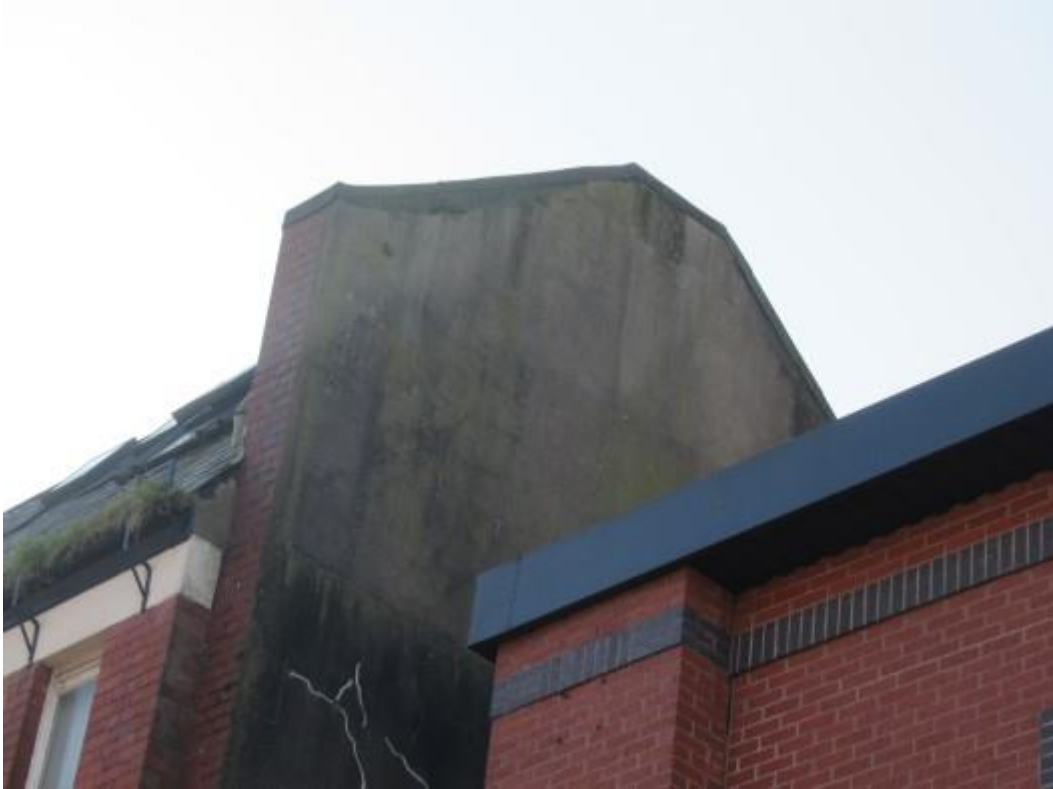
Further illustration of rendering with areas of cracking and crazing noted. Areas of past repair are noted with cracks having been filled. This does not provide a satisfactory long term repair solution and further upgrading work is recommended.

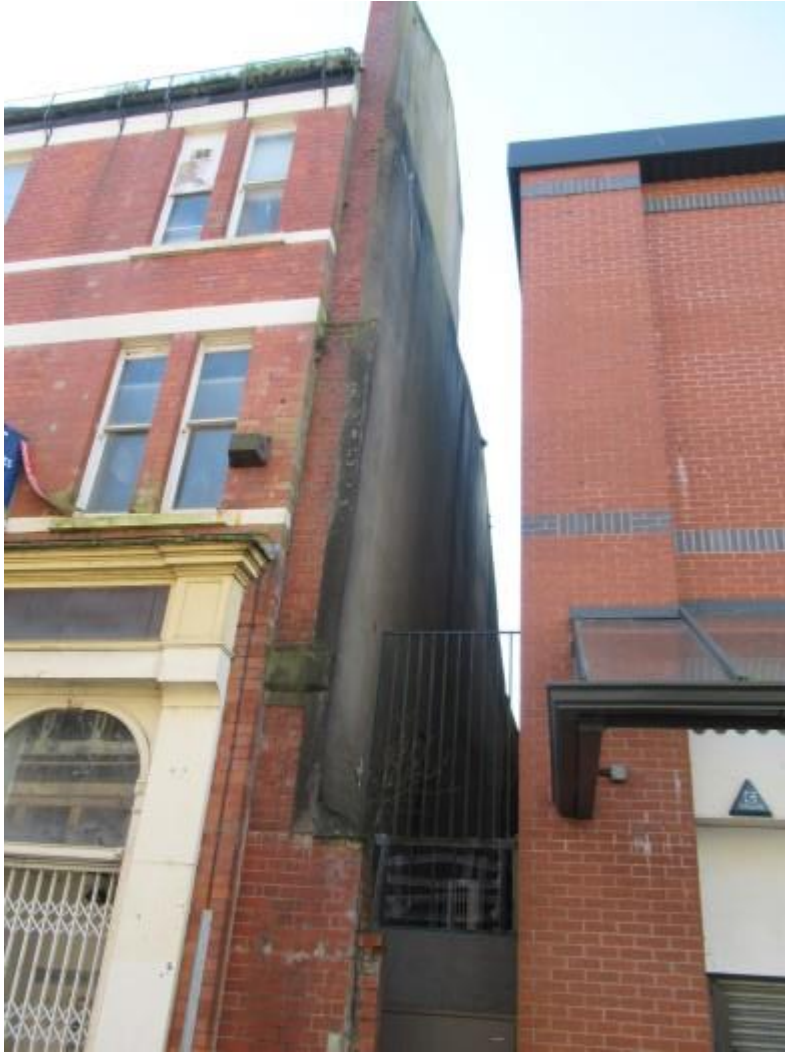
Further illustration of rendering.

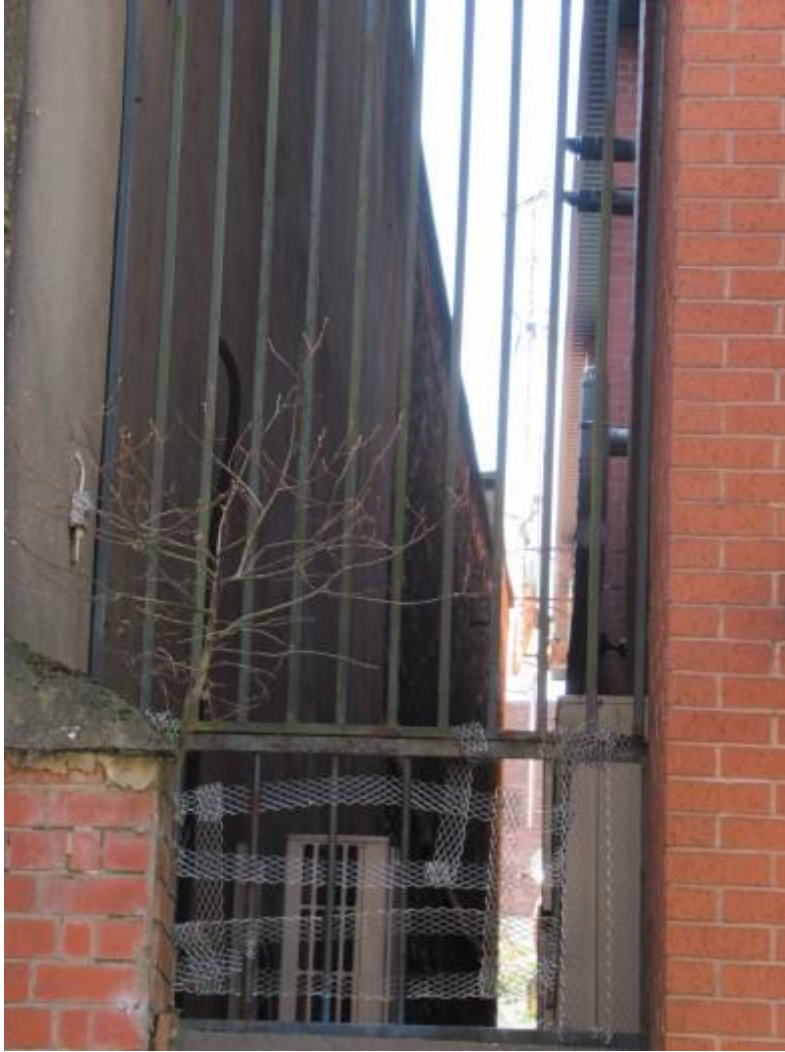
Further illustration of walling as viewed towards the rear. The photograph shows the render finishes and older stonework. The pointing to the stonework is of an older black ash mortar. The pointing has deteriorated with age. Allowance should be made for either re-pointing or rendering work.

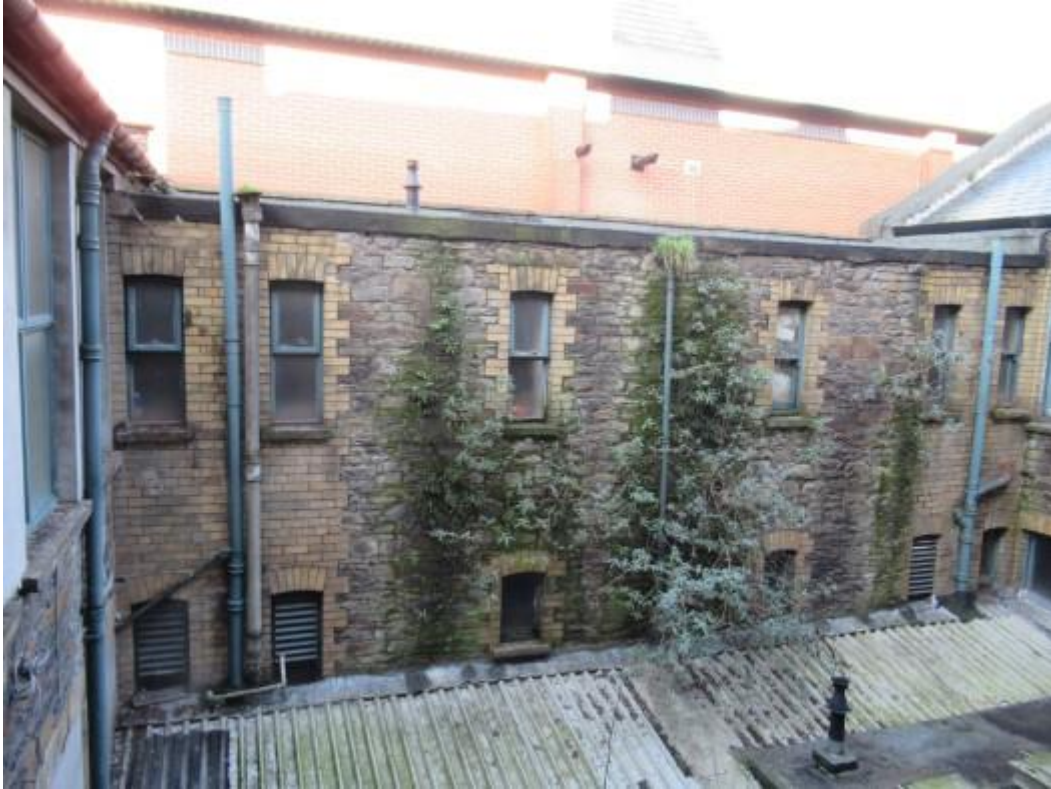
Typical condition of walling to the rear where facing the central courtyard area.

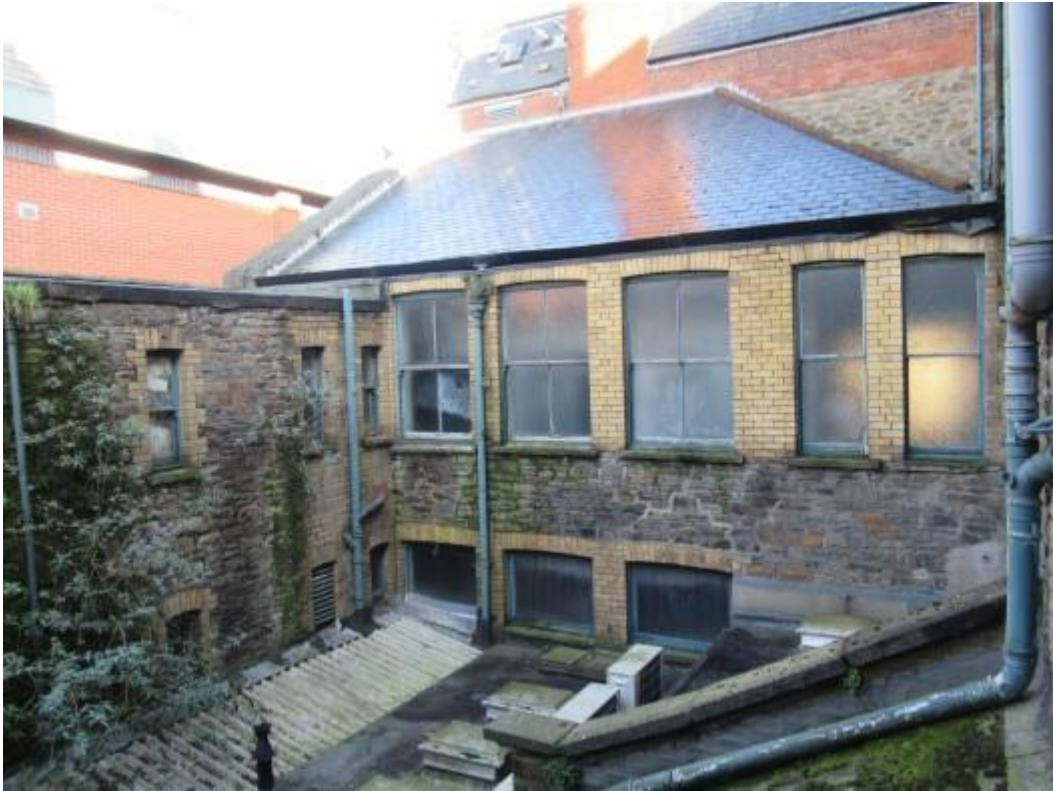
Further illustration of walling to the rear. Past re-pointing work has been carried out. The photograph shows the areas of brickwork detailing. No significant damage was noted.

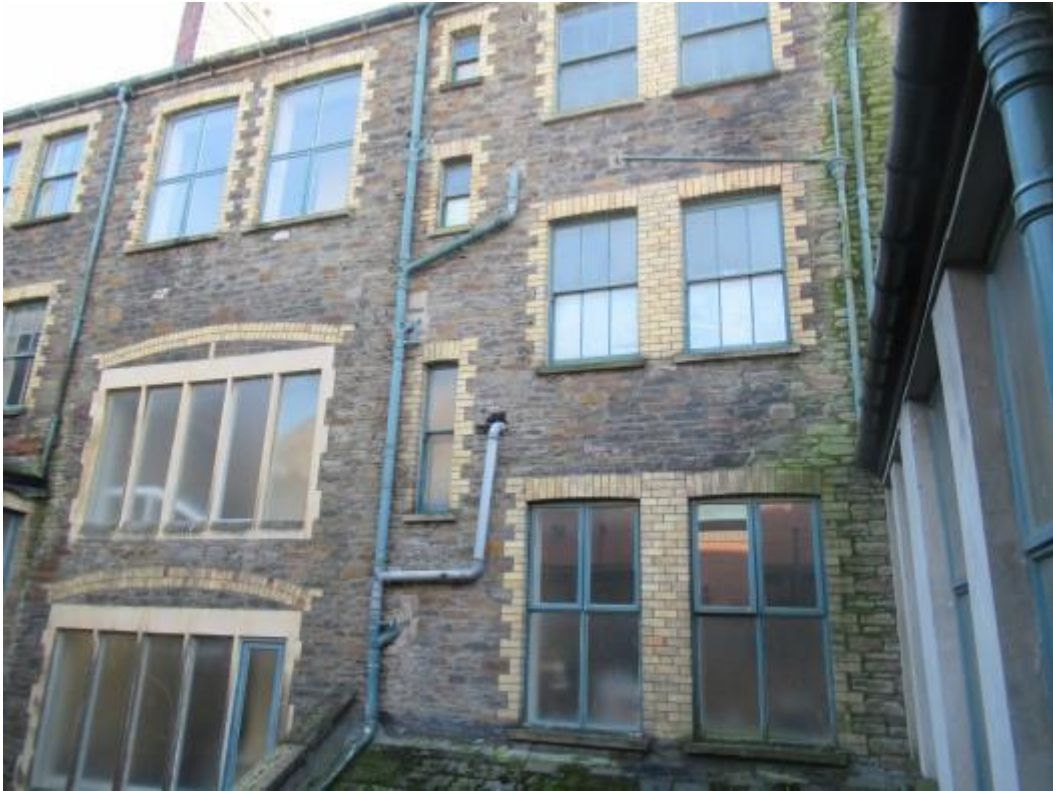
Walling to the rear of the main building. The photograph shows localised damage of the walling around the soil pipe outlets. This will require attending to as necessary. The photograph also shows staining of the walling consistent with leakage of rainwater goods. Internally, there are areas of corresponding water ingress to these areas.

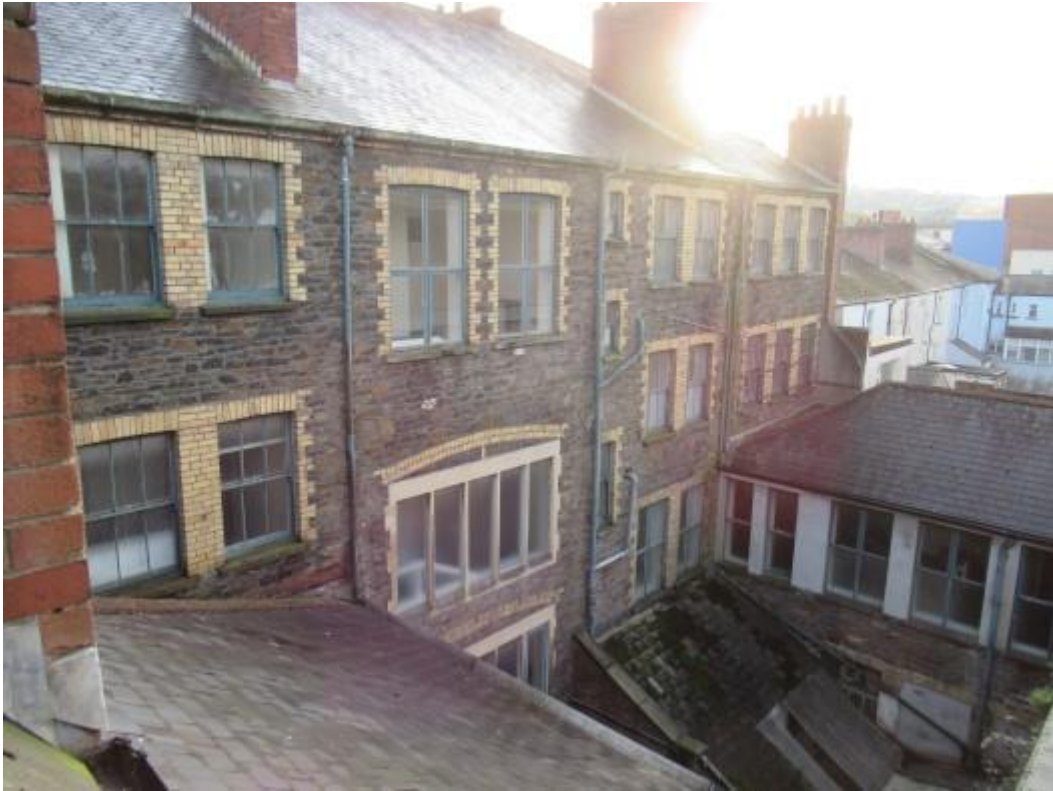
Further illustration of walling to the rear of the main building.

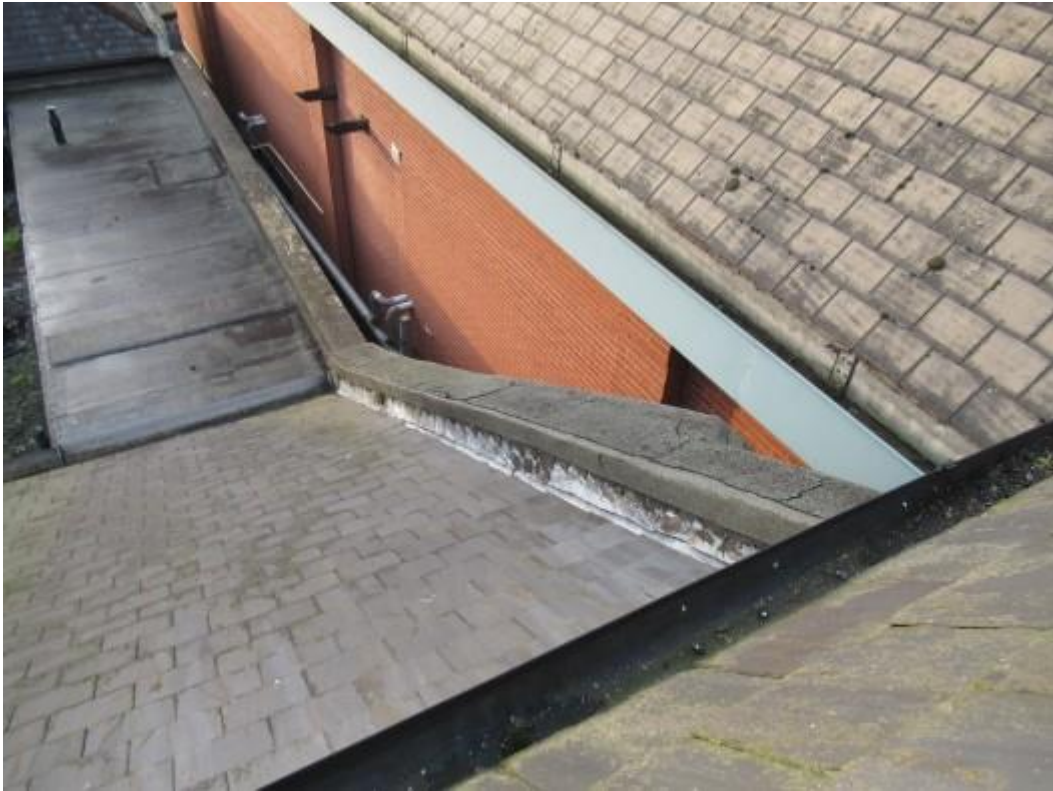
Bitumen felt covering to the parapet coping to the rear.

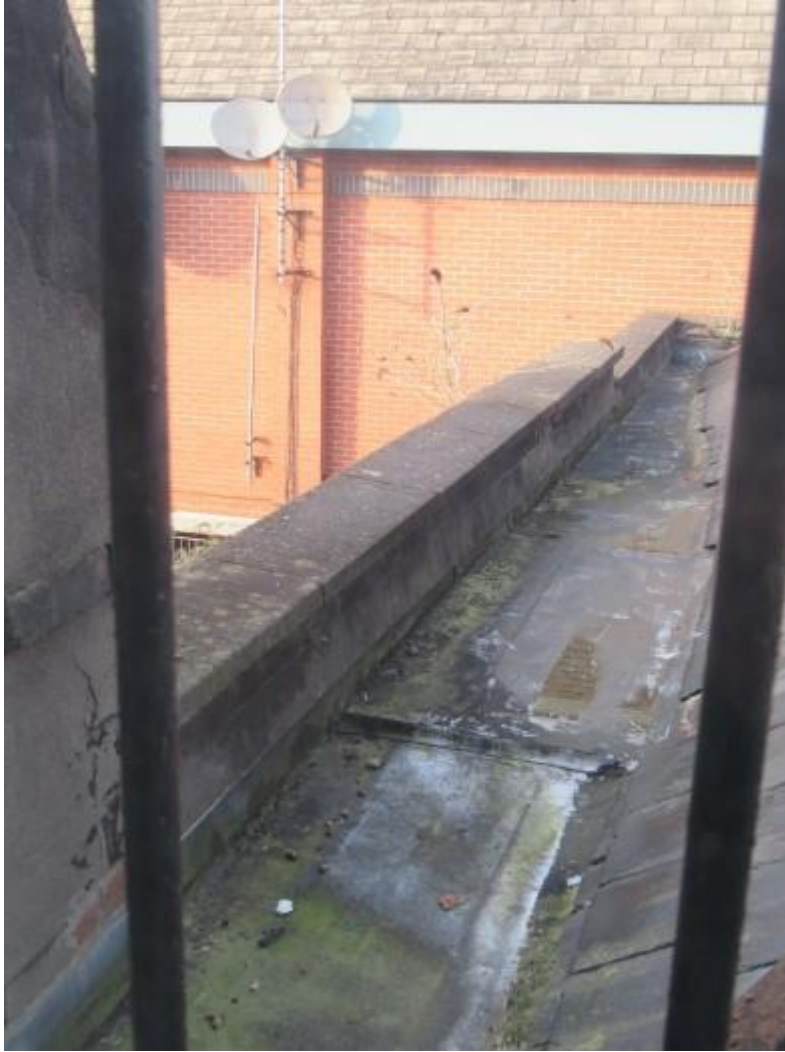
Low level parapet wall to the left hand side of the rear section of the property. The photograph shows the leadwork to the gutter detail and general condition of the coping and render finishes. There is localised deterioration with age. Repair will be required. The photograph also shows deterioration of the parapet to the rear wall.

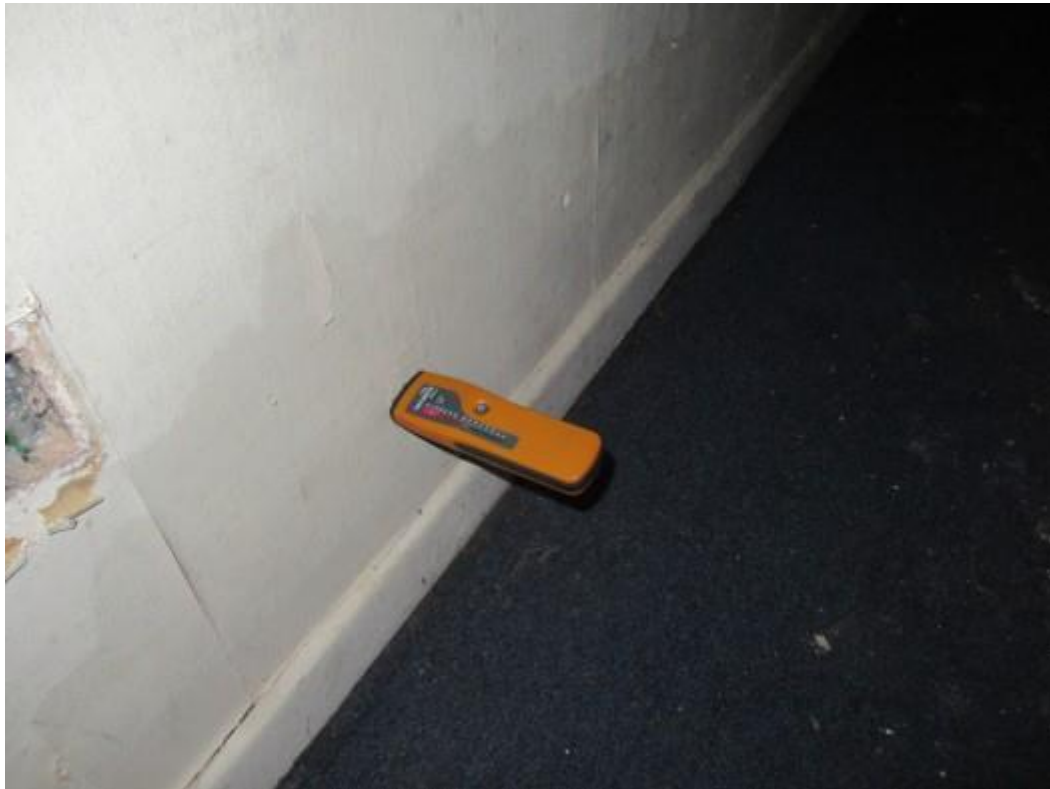
Visible damp to internal wall to ground floor. The photograph shows a high moisture meter reading. Further areas of similar damp were recorded. Remedial damp-proofing work will be required as necessary.

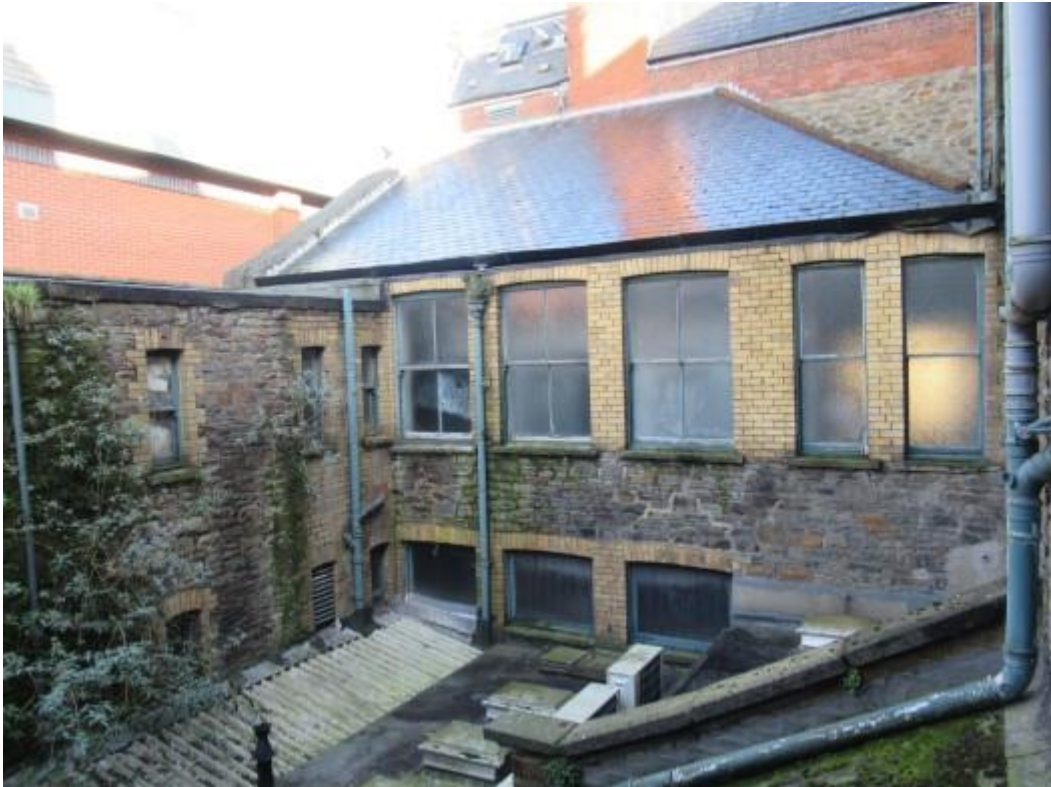
Typical condition of windows where facing the rear courtyard area. The photograph shows older box sash windows. The windows have deteriorated with age. The box sash windows throughout the property will require overhauling and refurbishing as necessary.

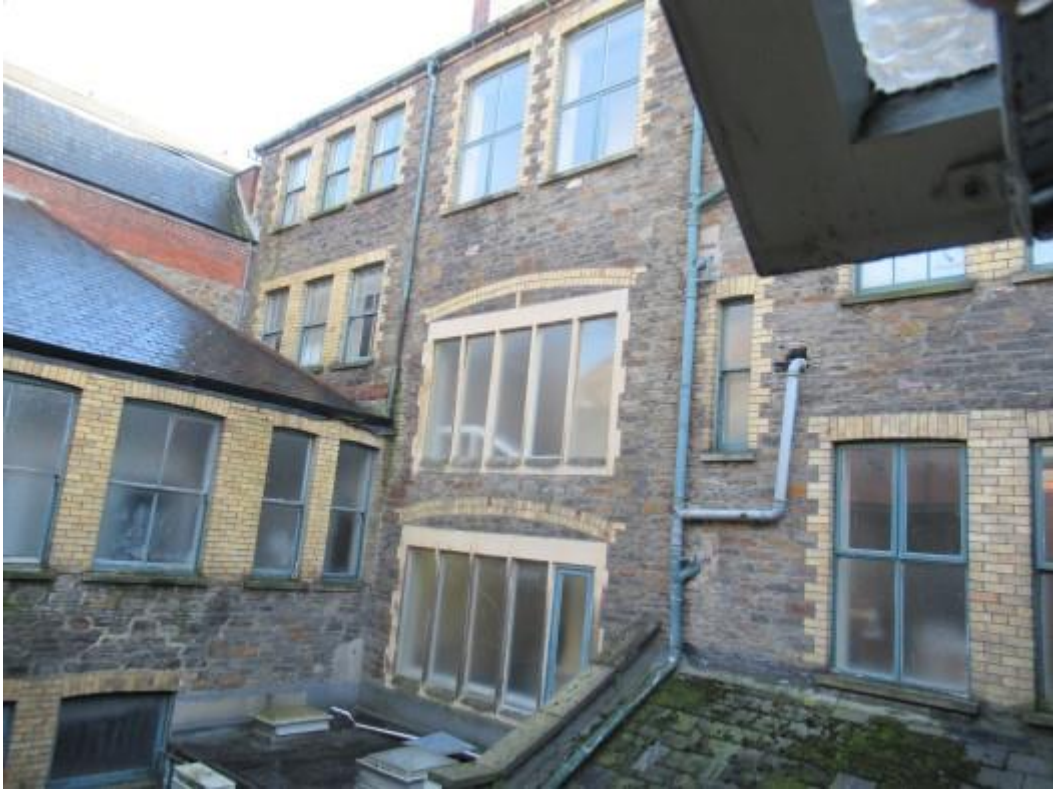
Windows to the rear of the main building. The windows comprise a mixture of box sash and softwood timber casement units. The windows will require overhauling and refurbishing as necessary.

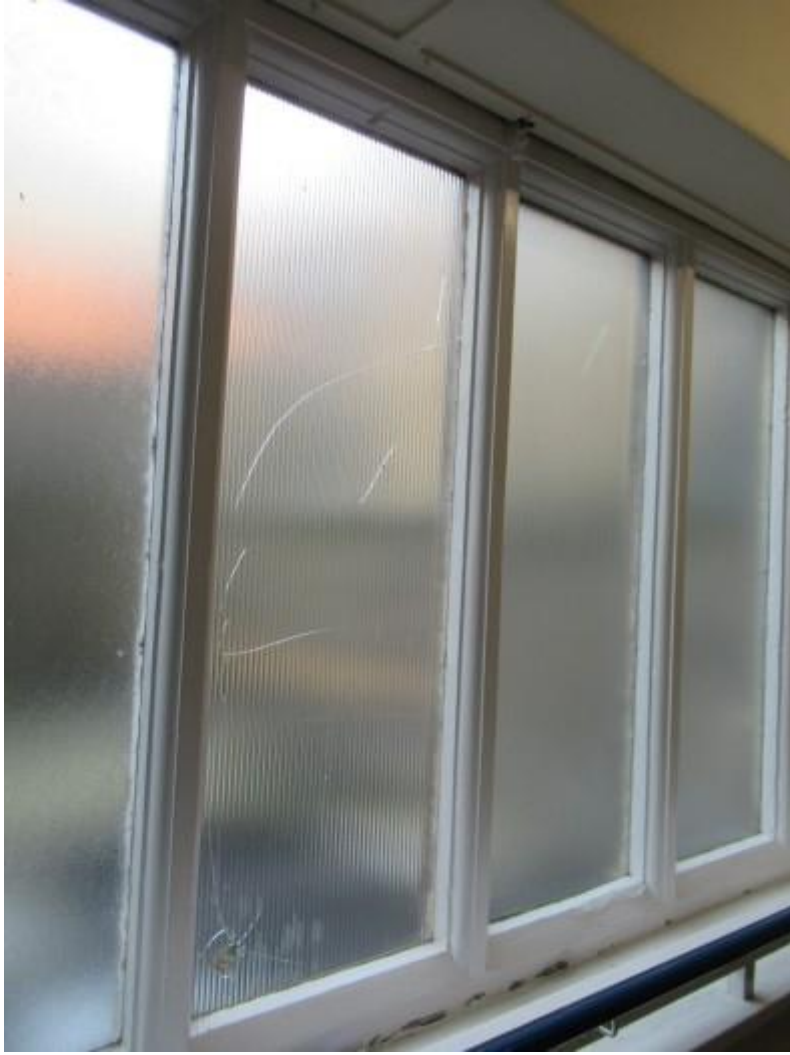
Timber framed window/glazed screen to the rear of the stair/landing area to the main building. The photograph shows cracked glazing. Sections of cracked glazing throughout the property will require upgrading as necessary.

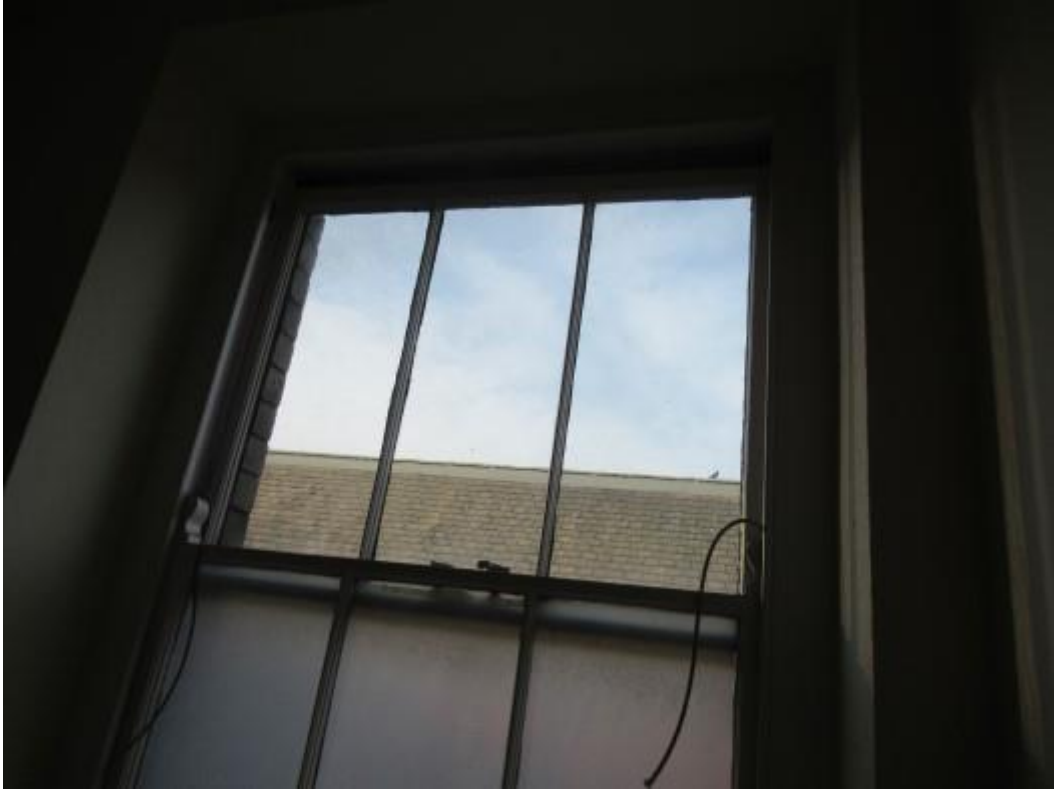
Typical failed sash cords to box sash window.

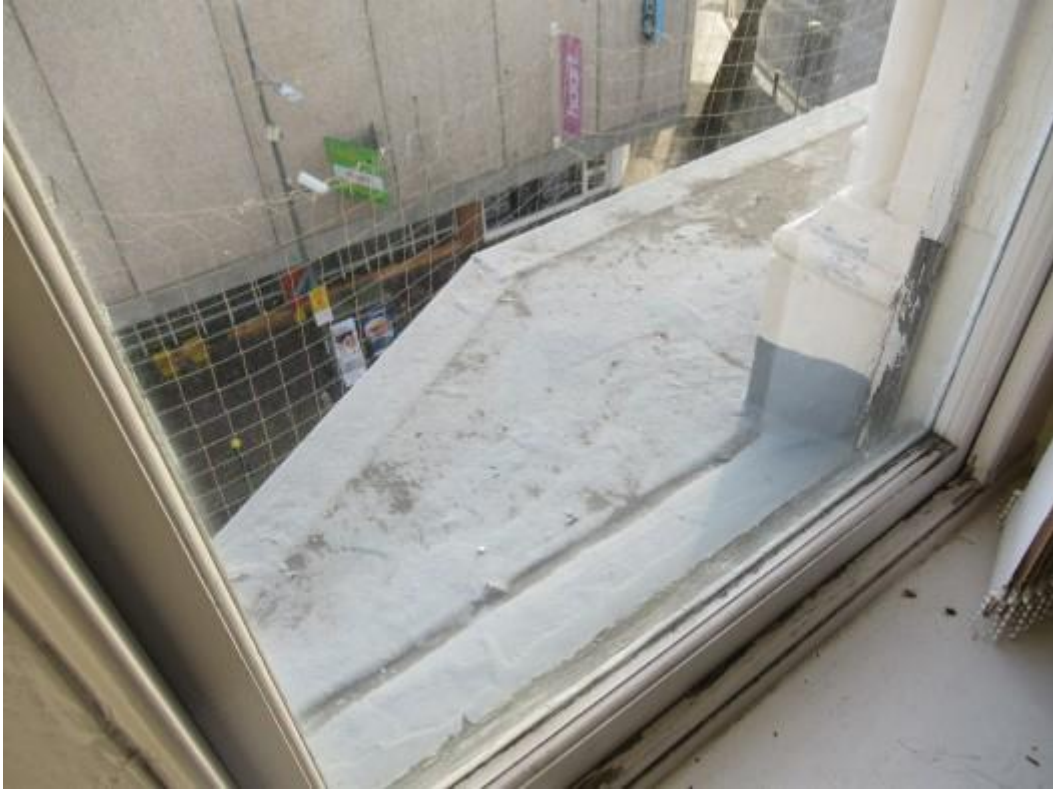
Typical detailing between box sash window and bay window where extending to the left hand side of the front elevation. Whilst past upgrading work has been carried out there are on-going issues of water ingress. The detailing between the roof and window is in poor order and is contributing to rot and decay affecting timbers. Upgrading work will be required as necessary. Similar works will be required to the bay window details to the front of the property.

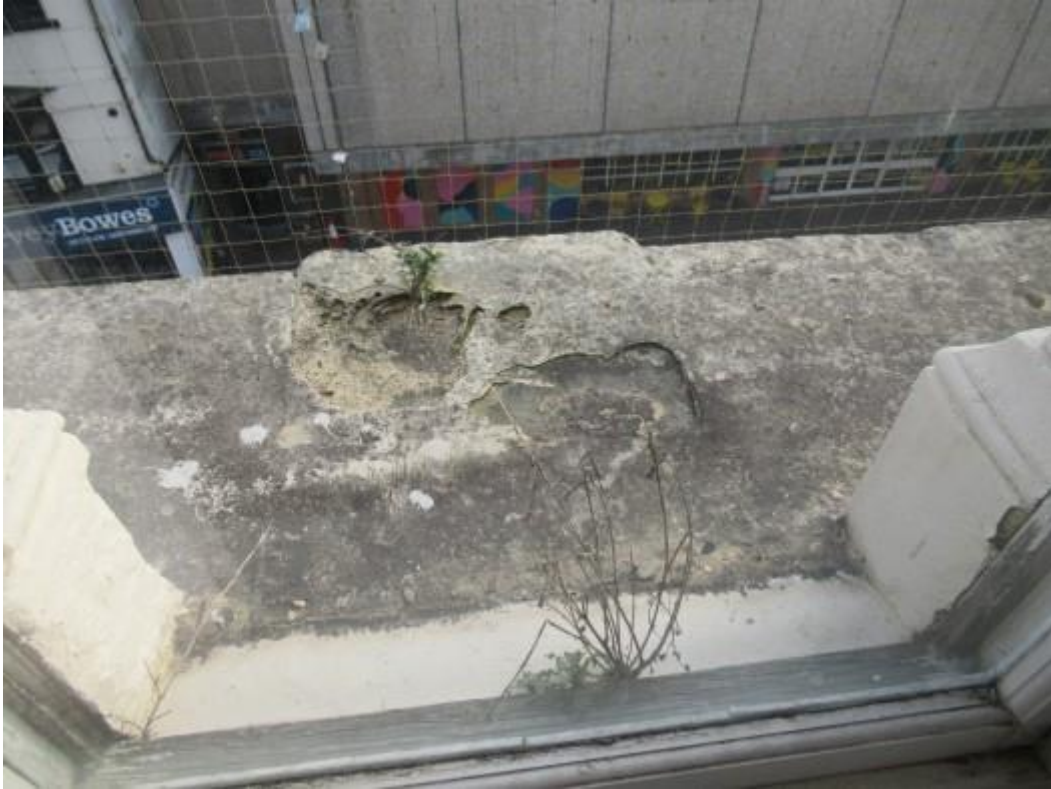
Further illustration of typical detail between stonework/bay window open box sash window. The photograph shows deterioration of the stonework. The stonework is in need of repair. The photograph also shows deterioration of the timbers at the base of the framework. Repair and upgrading work will be required.

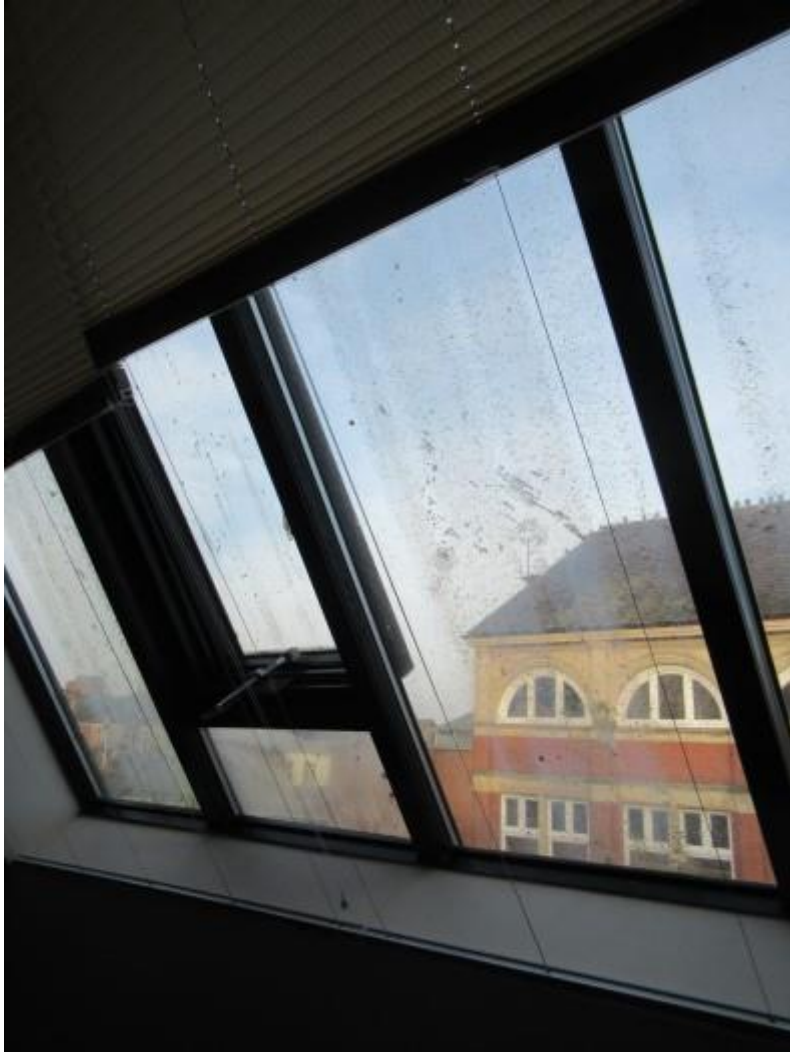
Internal view of roof lights to the right hand side elevation of the property. The photograph shows general staining and discolouration together with failed glazing. Interstitial condensation within double-glazing was noted.

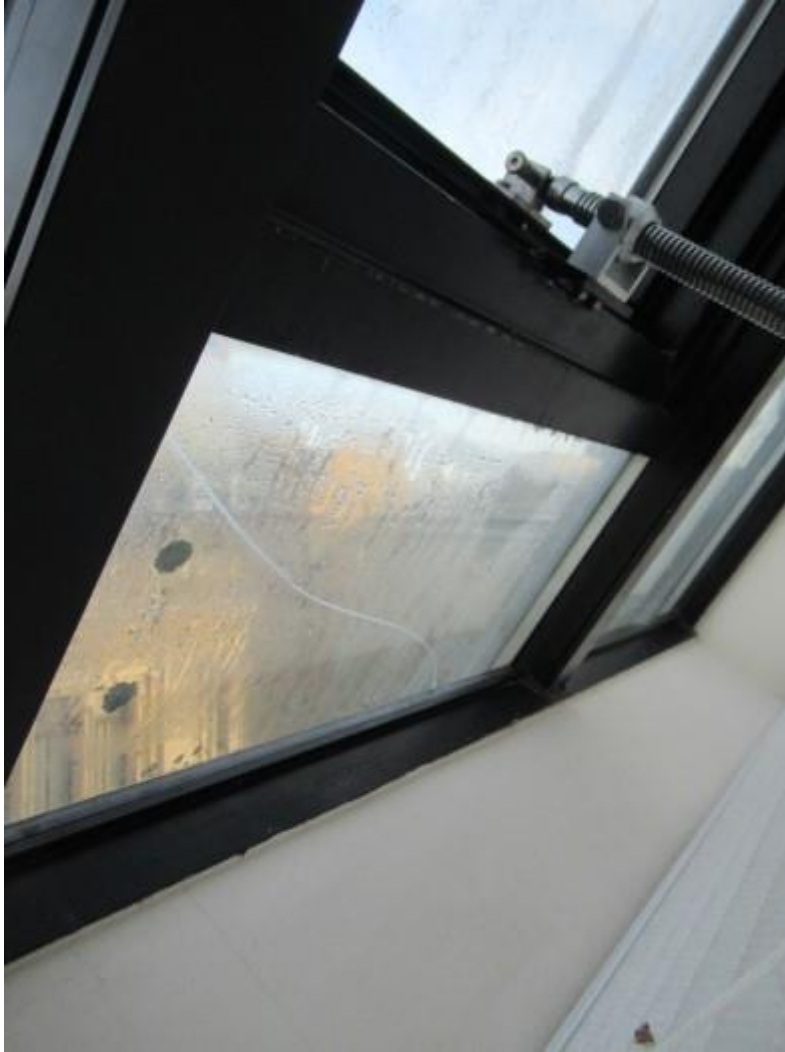
Further illustration of glazing to roof light with cracked glazing and condensation noted.

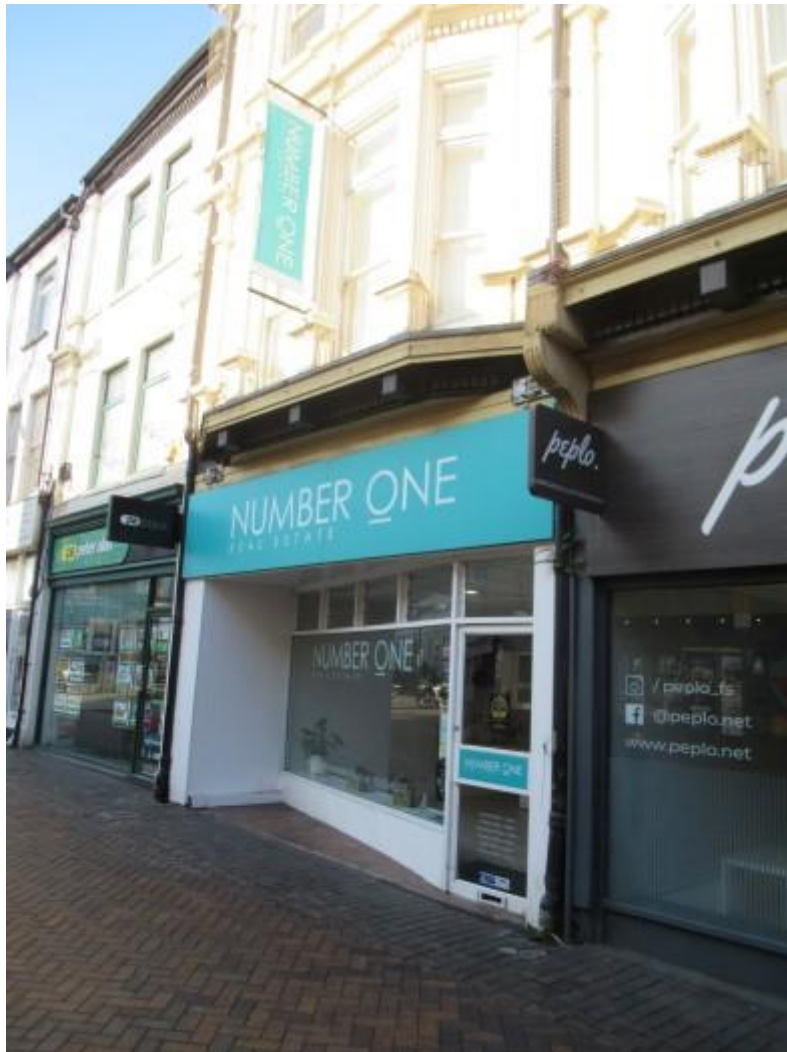
Shop front to ground floor left hand side retail unit. The unit is currently tenanted.

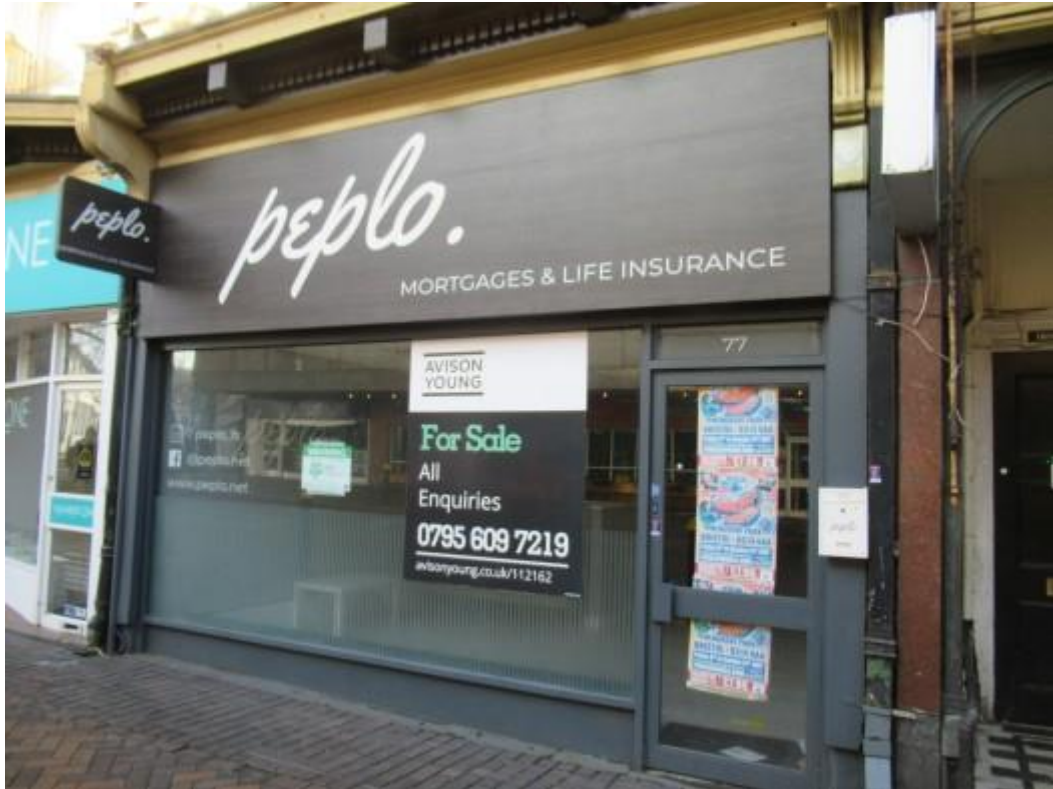
Shop front to No. 77. The photograph also shows the fascia detailing where extending above the shop fronts. There are areas of rot and decay affecting the timbers above. Repair and upgrading work will be required as necessary.

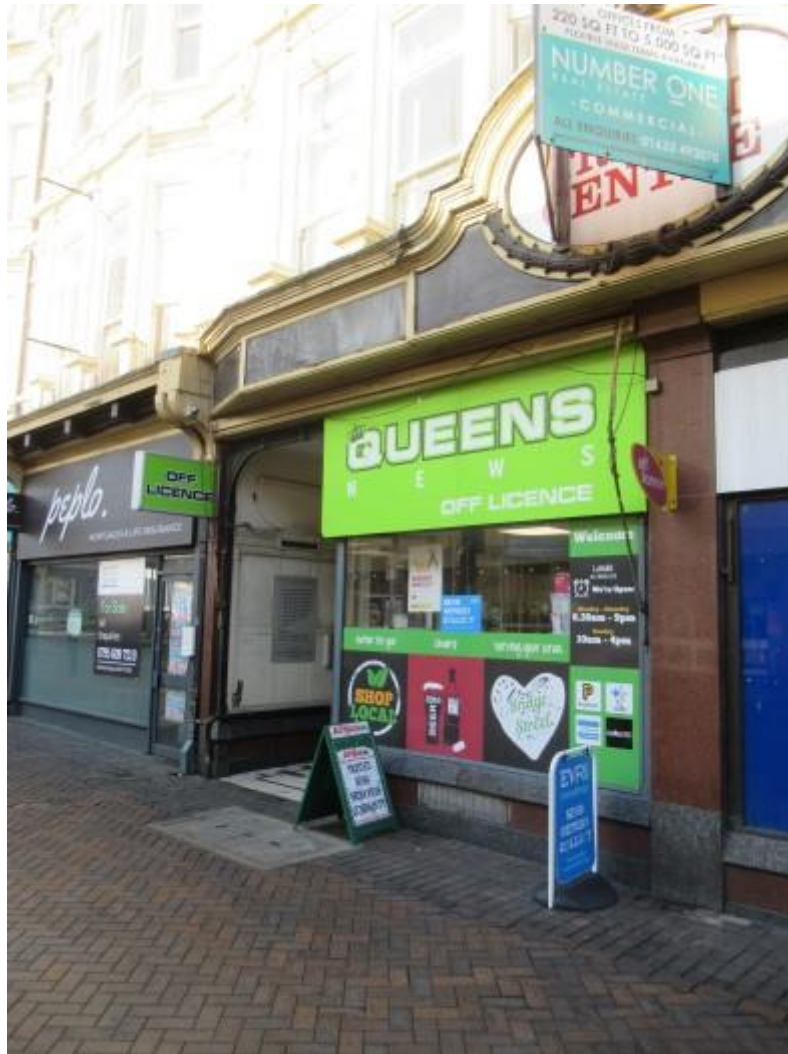
Further illustration of ground floor shop front area.

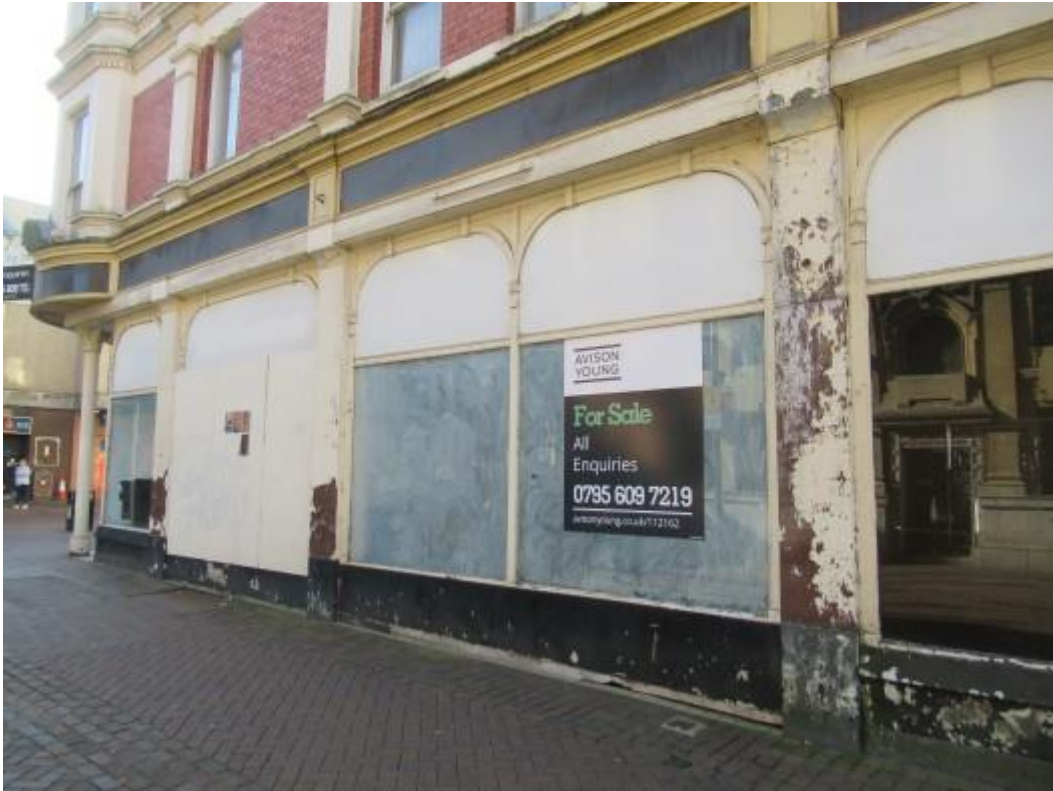
Shop fronts to the right hand side of the property. There is general deterioration of the shop fronts to this area. Overhauling and refurbishment of the existing shop fronts or alternatively removal and upgrading work will be required.

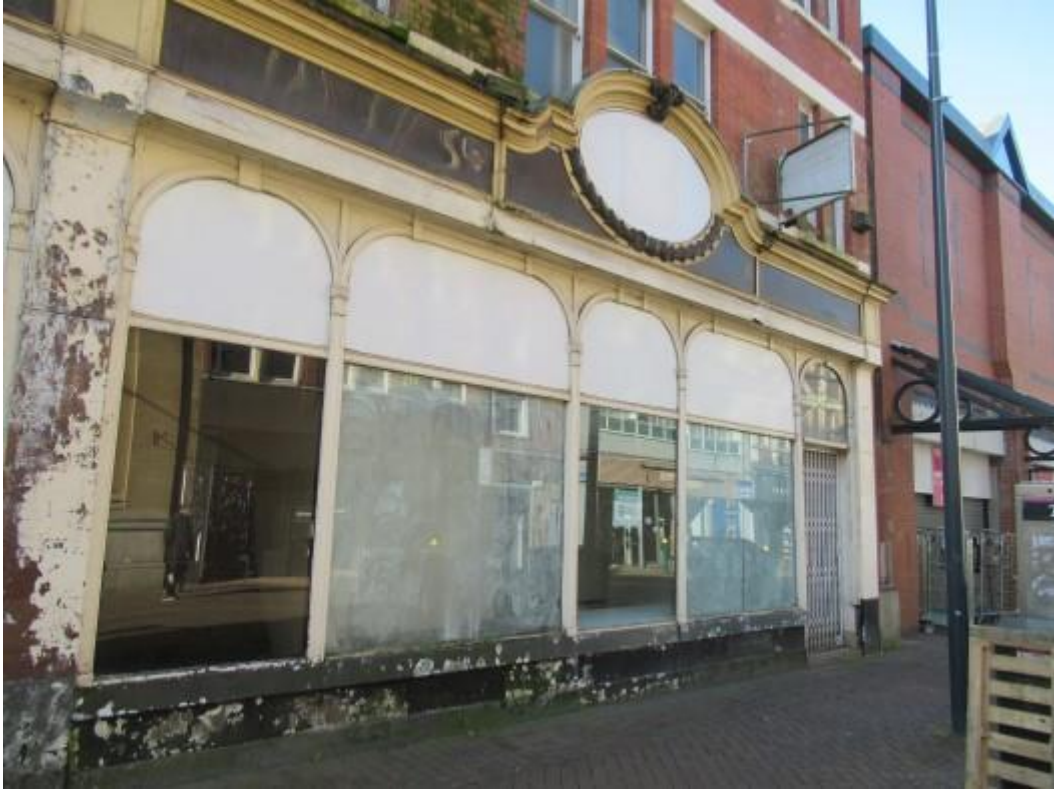
Further illustration of shop fronts where extending to the right hand side of the property.

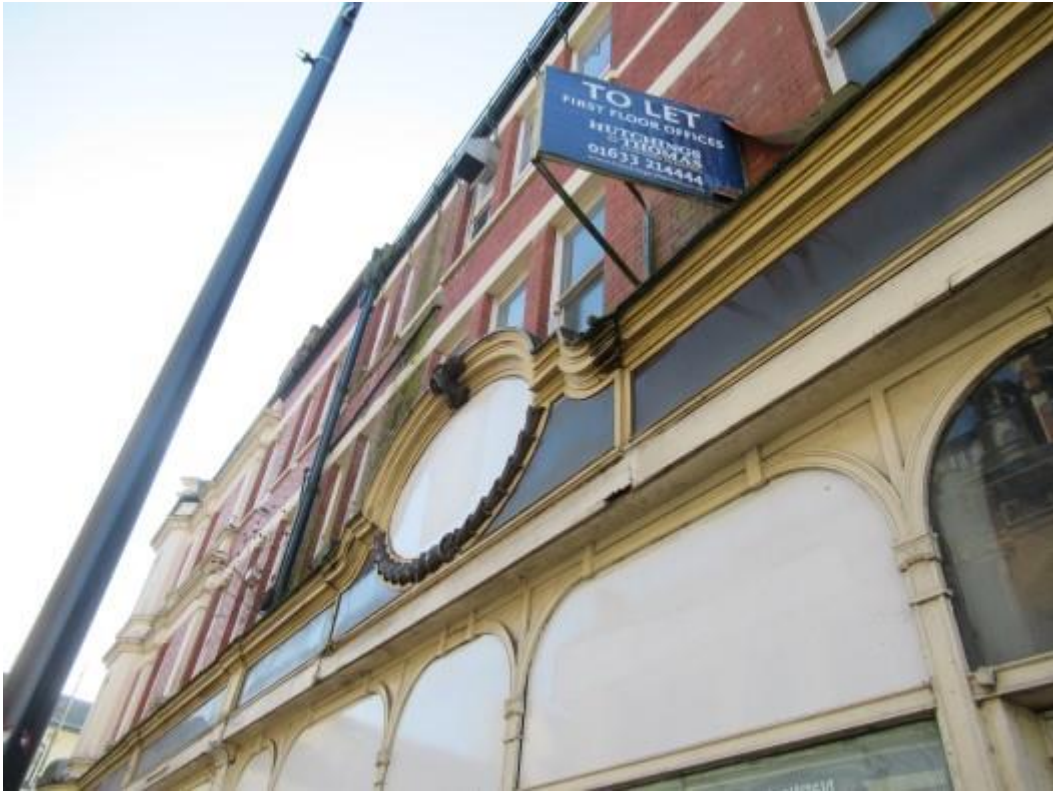
Shop front fascia signage to the right hand side of the property. There are areas of rot and general decay affecting timbers. Overhauling and refurbishment will be required as necessary.

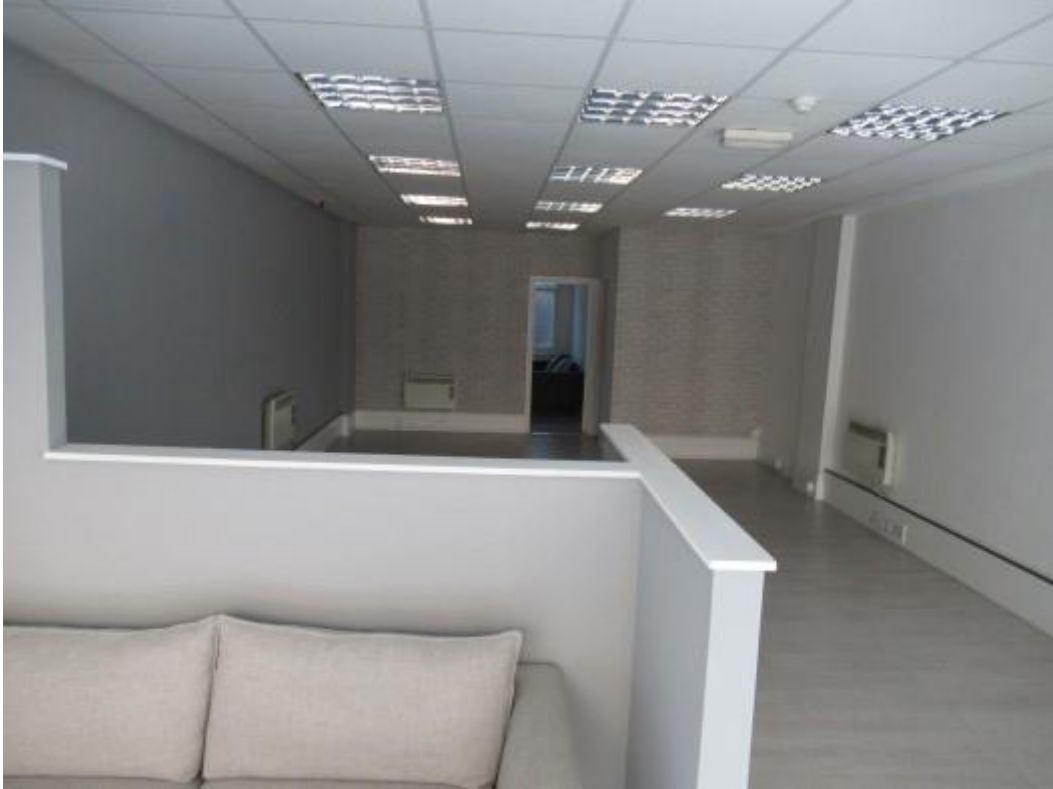
Internal finishes to the ground floor unit, No. 77. The photograph shows the general condition of the internal wall finishes and suspended ceiling. Whilst the ceiling is in satisfactory order there is inadequate fire protection above the ceiling to comply with current standards.
