IN RESPECT OF:-

**TREDEGAR CHAMBERS
BRIDGE STREET
NEWPORT
NP20 4QA**

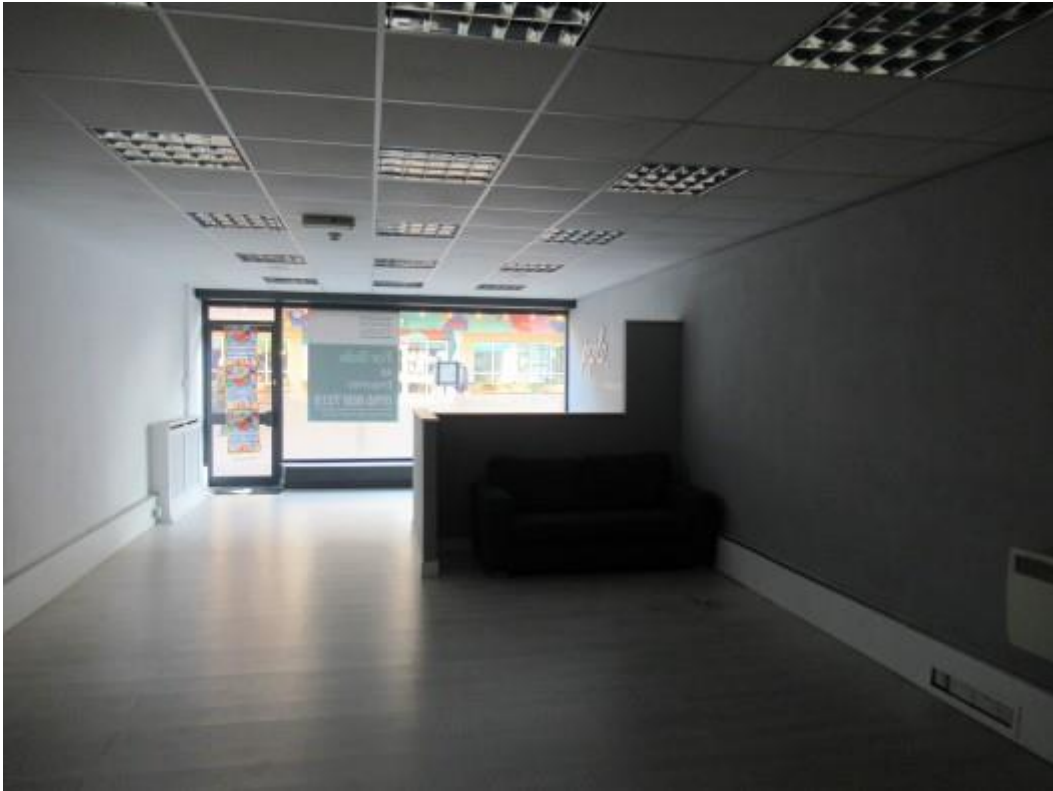
Further illustration of ground floor unit, No. 77.

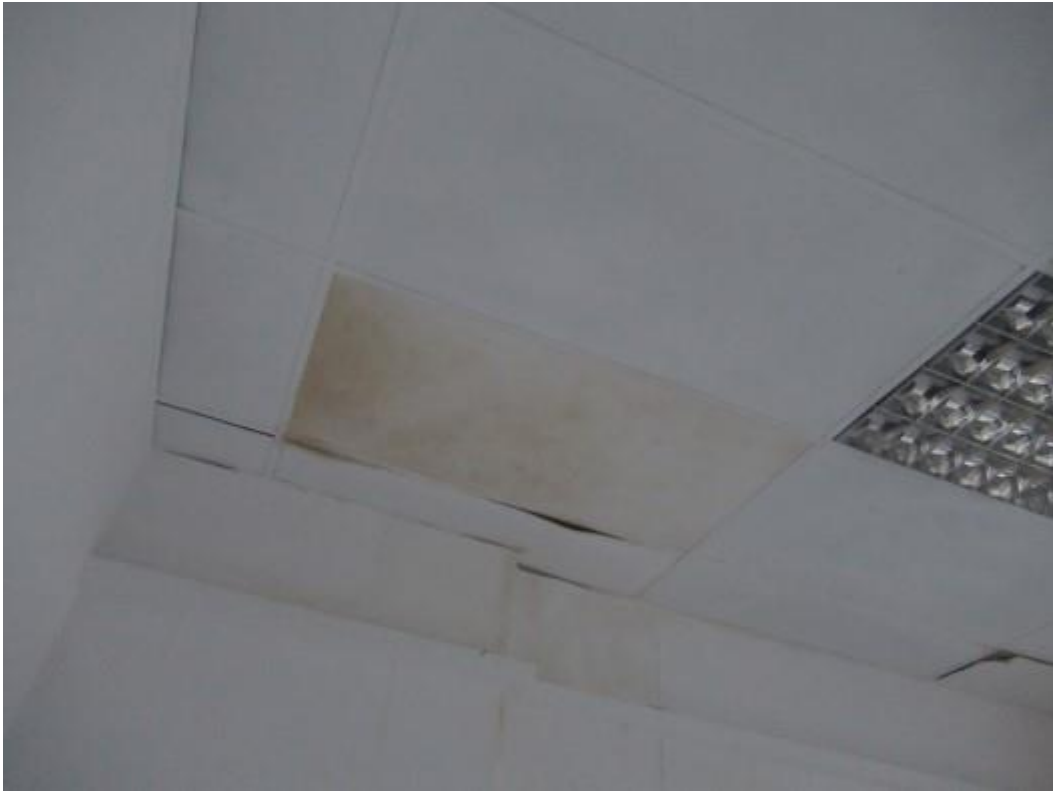
Damaged ceiling tiles to No. 77. This is below the pitched roof where extending to the single-storey section to the rear. There is significant water ingress to this area. Upgrading of the roof above will be required as previously detailed.

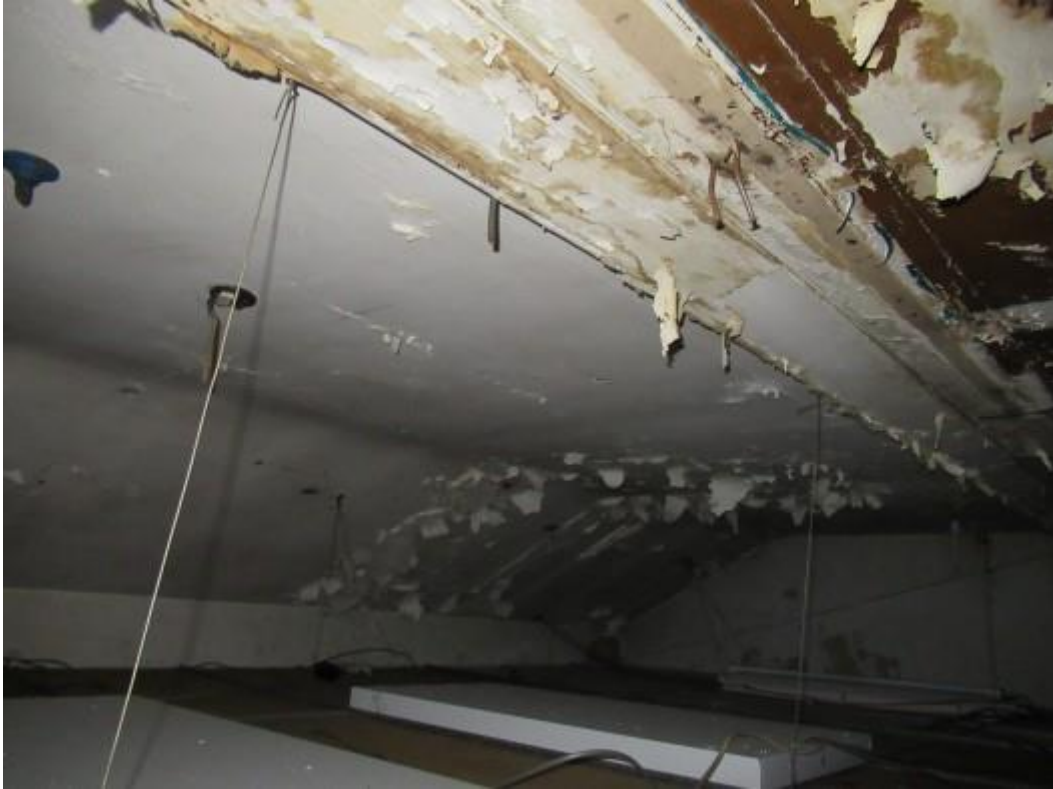
**View above the suspended ceiling. An older lath and plaster ceiling is noted.
This has deteriorated with age.**

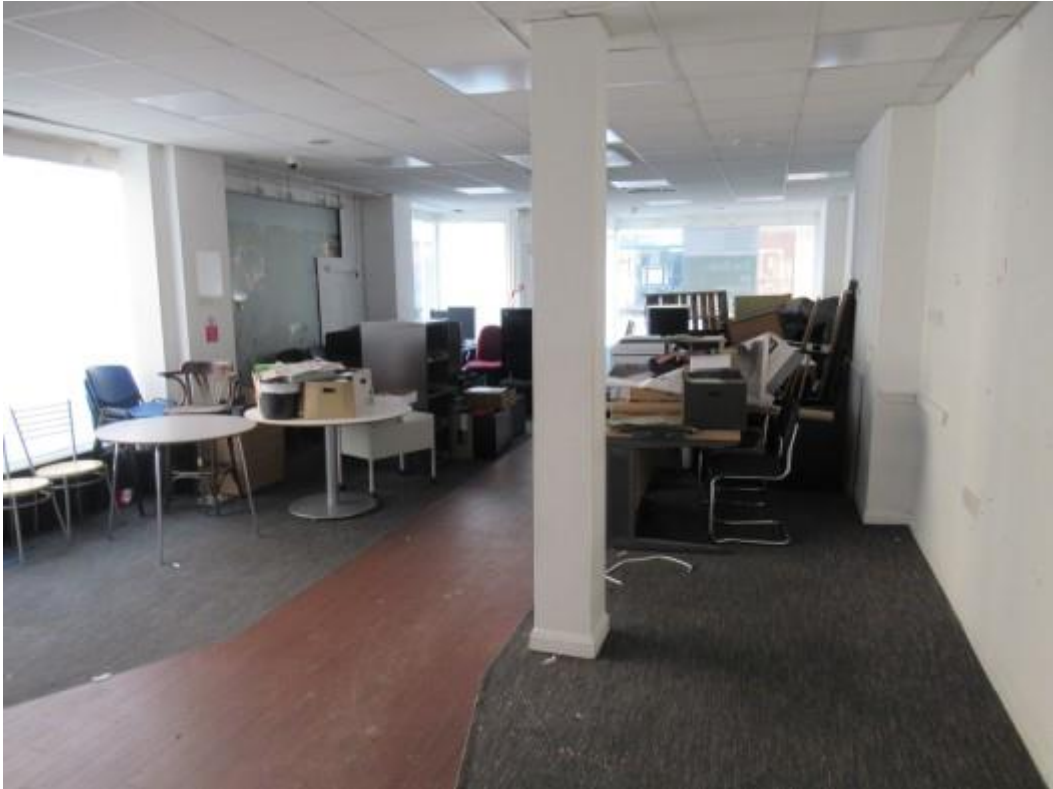
**Ground floor right hand side retail/office unit. The unit is in need of upgrading
and refurbishment.**

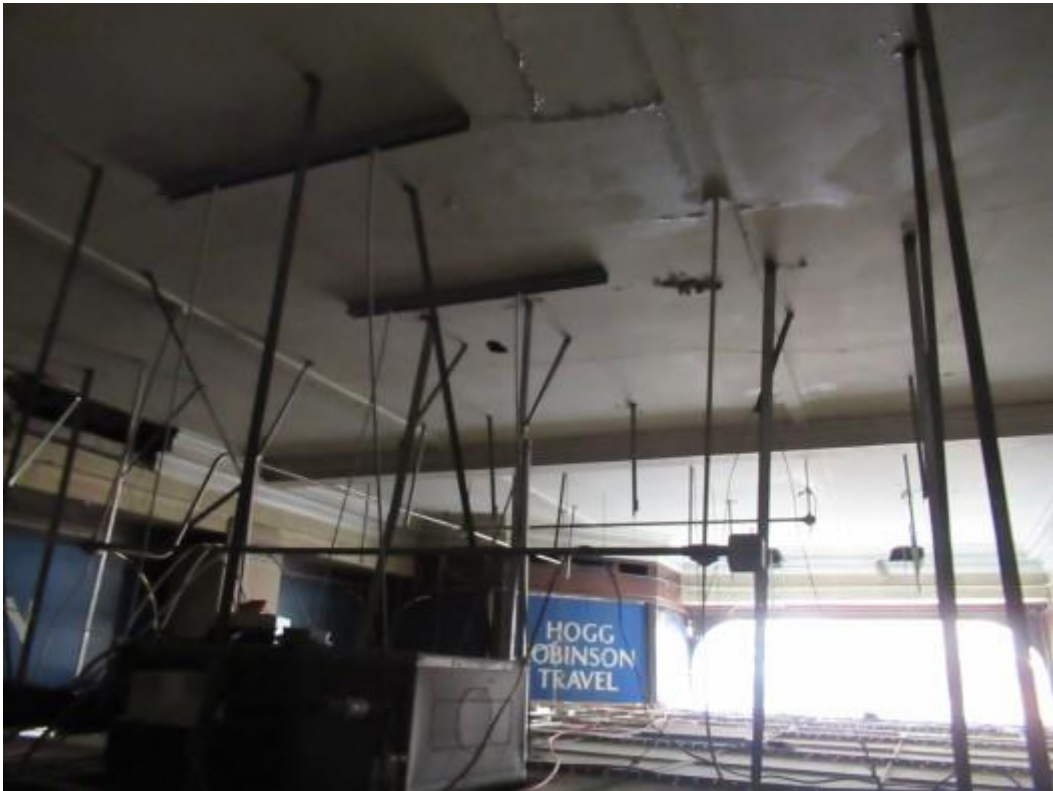
View above the right hand side unit. An original lath and plaster ceiling is retained above. The ceiling is damaged. There is inadequate fire protection between the ground and first floors and upgrading works will be required.

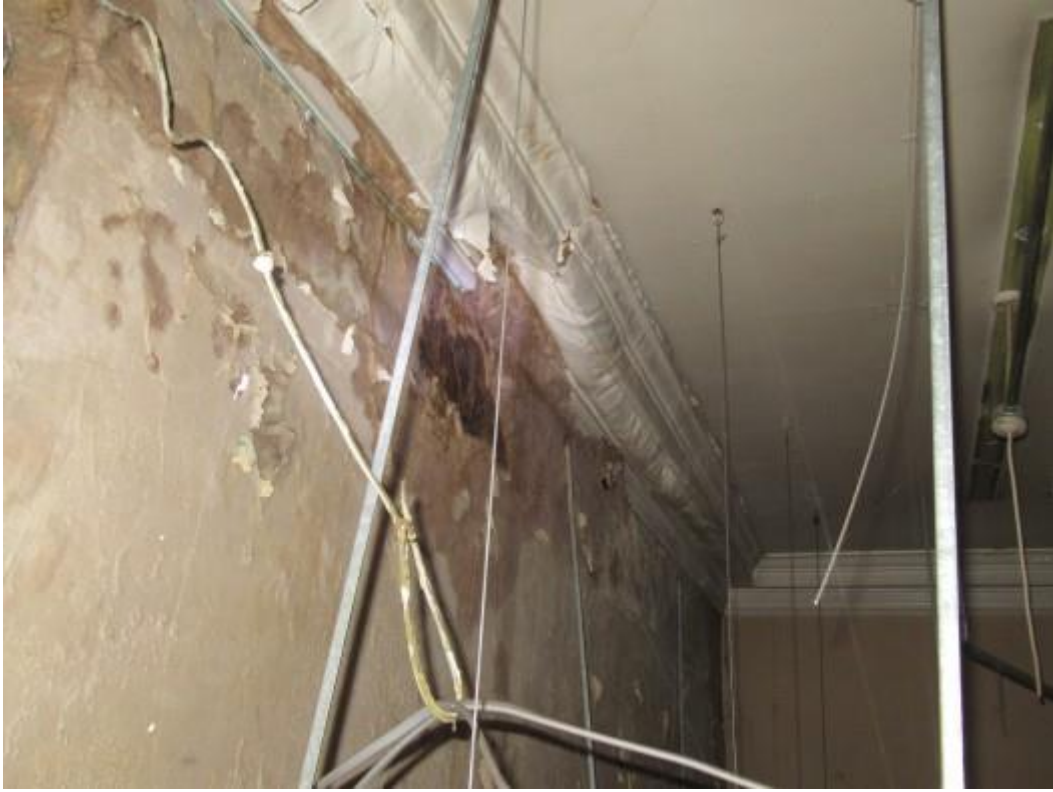
View above the ceiling to the kitchen area to the right hand side unit. There is extensive dry rot to this area. Substantial replacement of timbers and specialist treatment work will be required.

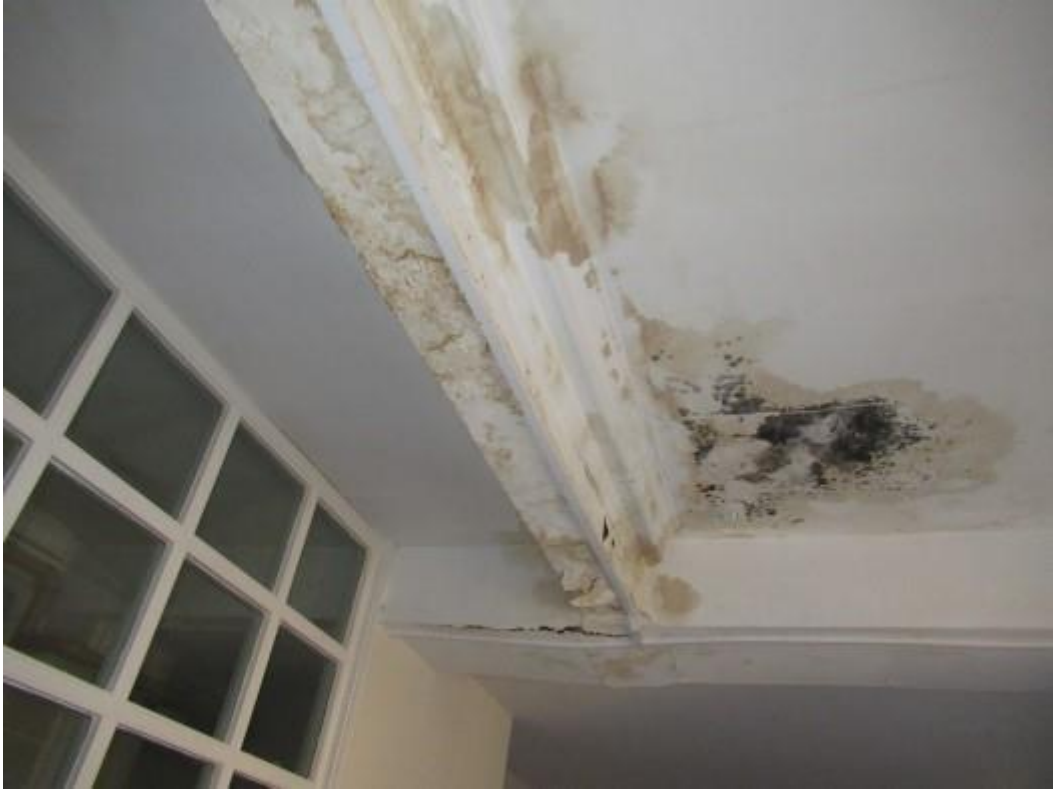
Damp affected and damaged ceiling finishes to upper floor accommodation to the right hand side of the property. There is a risk that timbers, where concealed to this area, have been affected by further areas of rot and decay. Further investigation in relation to the timbers will be required in conjunction with upgrading of the ceilings. We anticipate replacement of timbers being required.

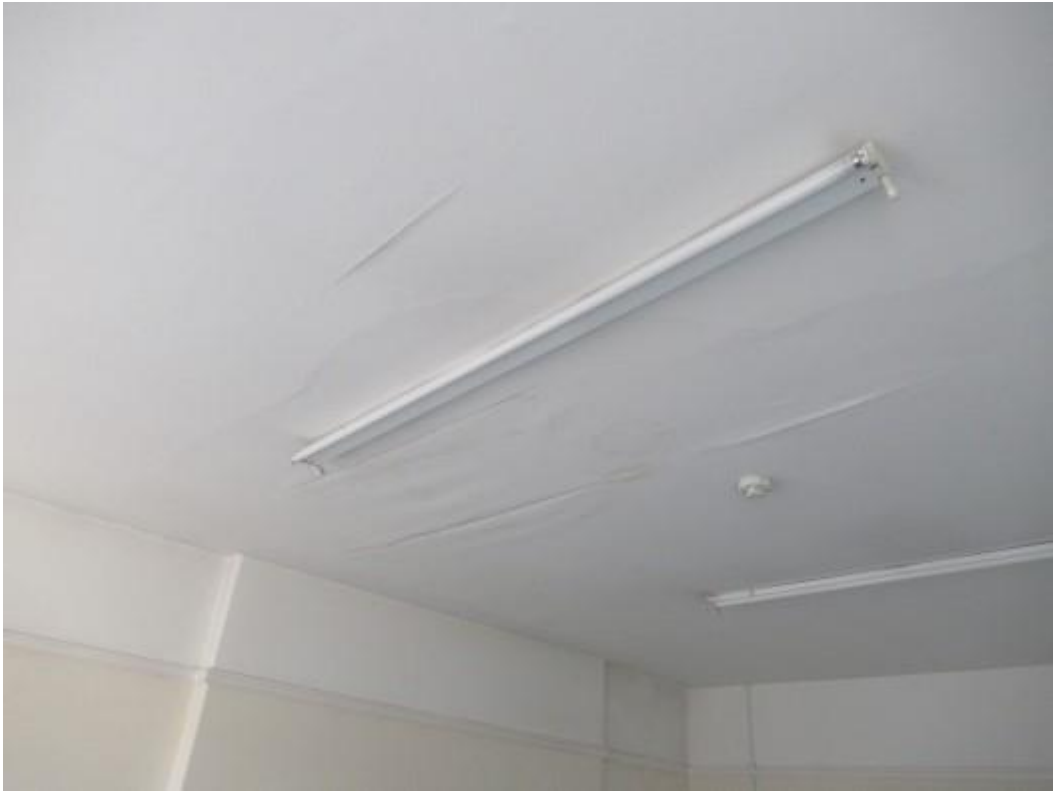
Typical cracking and deterioration of ceiling to upper floor accommodation.

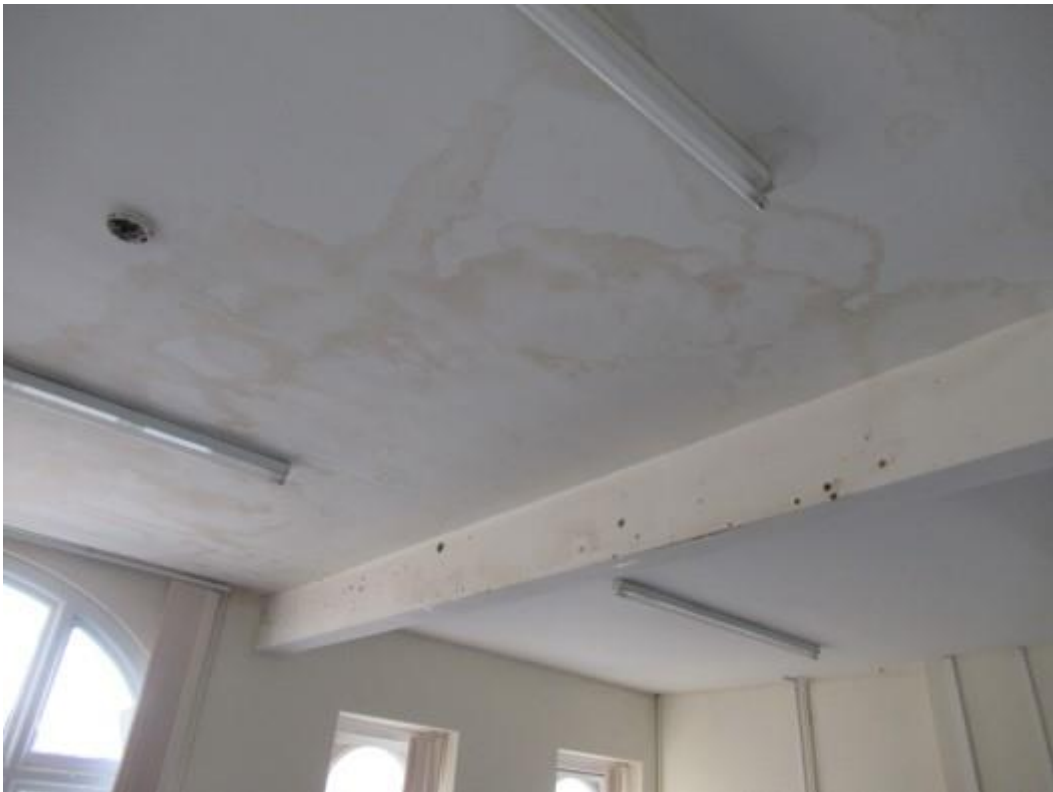
Further illustration of staining and damage to ceiling to upper floor accommodation. This is noted to the front section of the property where facing the front gable. Replacement work will be required.

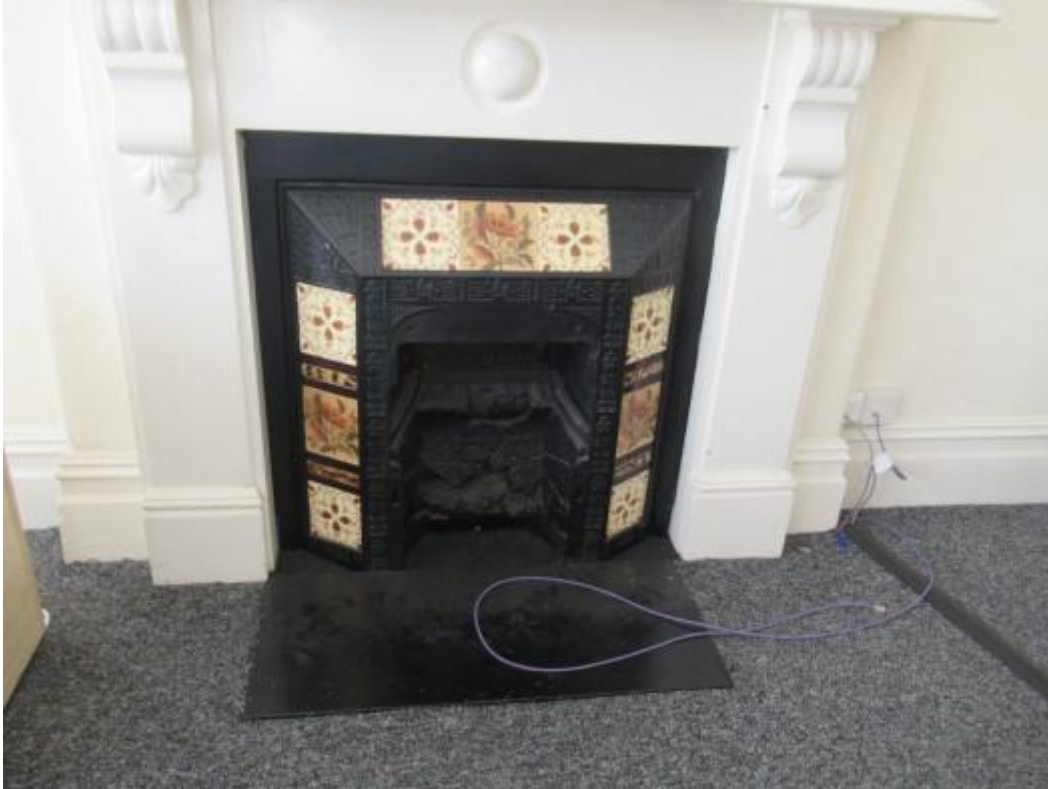
Typical condition of fireplace retained to the first floor accommodation. The fire grate is damaged and incomplete. The fire surround and hearth are in reasonable order. There are similar fireplaces retained within the property albeit the majority of the fireplaces have been removed and fireplace openings blocked up.

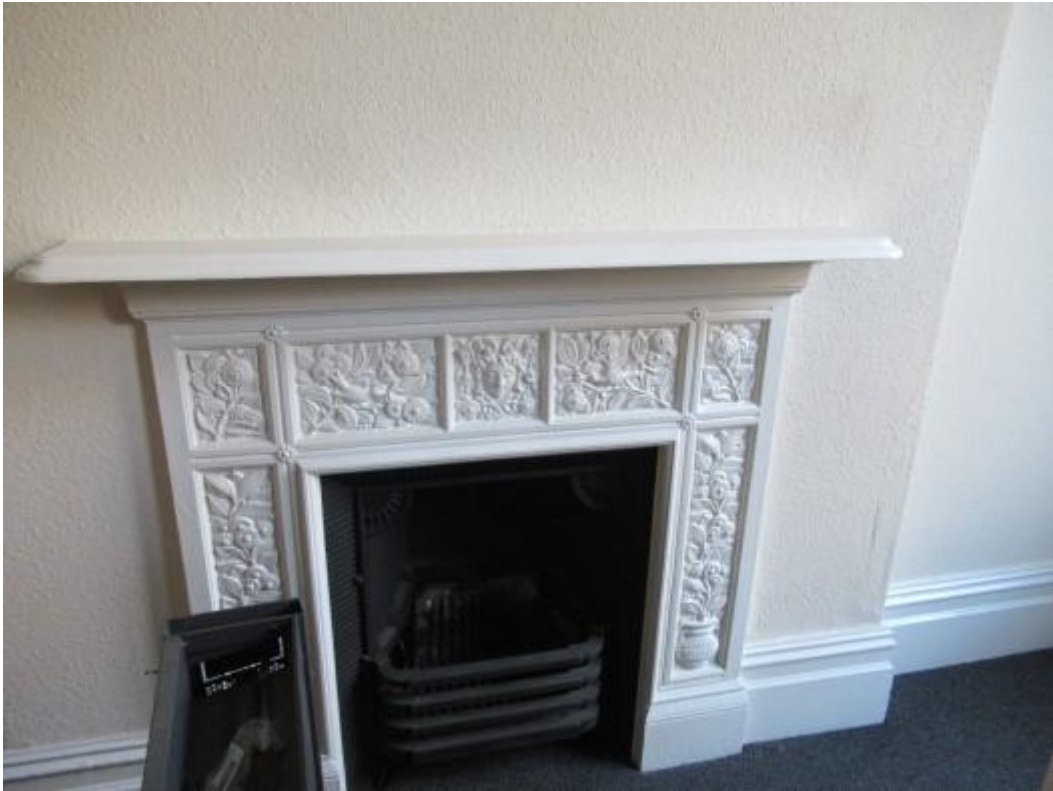
Further illustration of typical cast iron fire grate retained within the property.

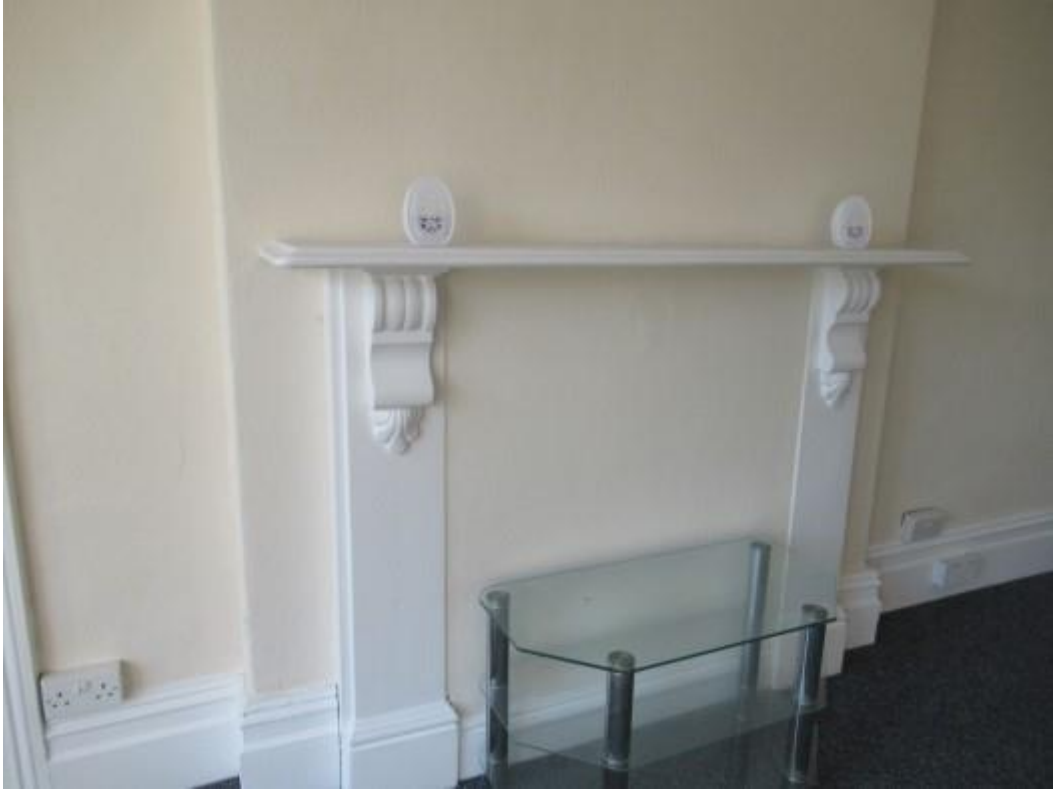
Fire surround retained to upper floor accommodation. The fire grate has been removed and the opening blocked up. The redundant flue is unvented. The majority of the redundant flues throughout the property are unvented. Upgrading of ventilation is recommended to reduce the risk of condensation problems occurring.

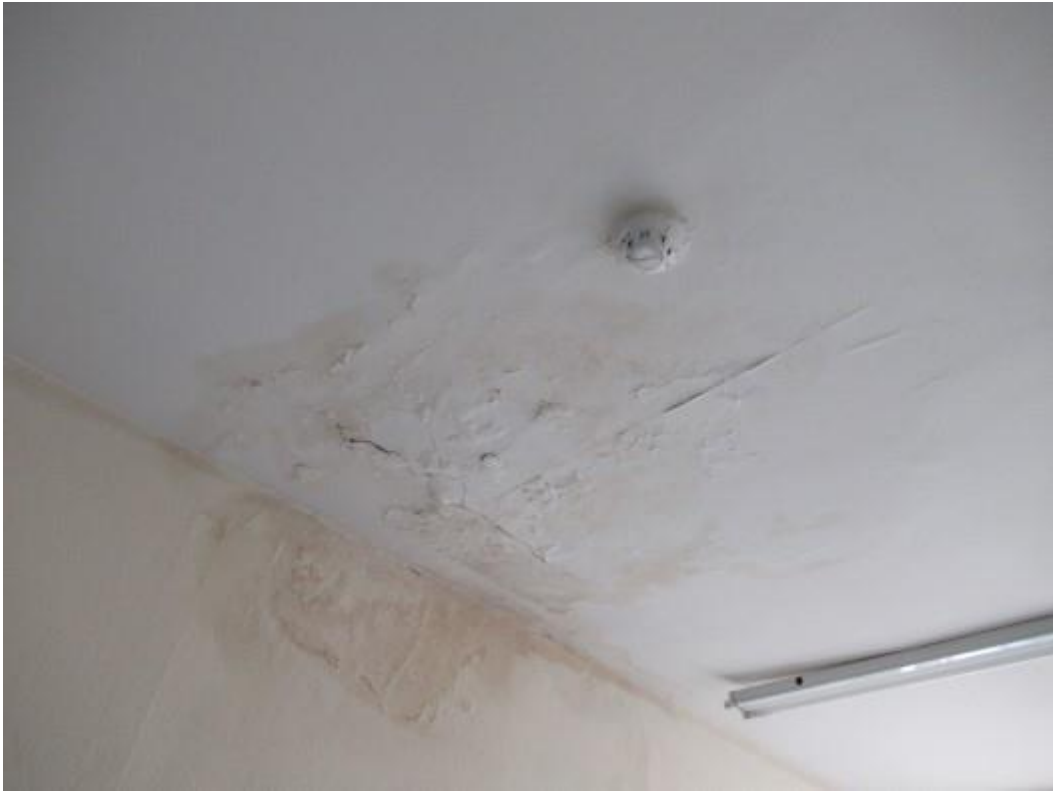
Typical damp staining to upper floor accommodation consistent with water ingress at the base of the chimney stack. This has caused damage to the wall and ceiling finishes.

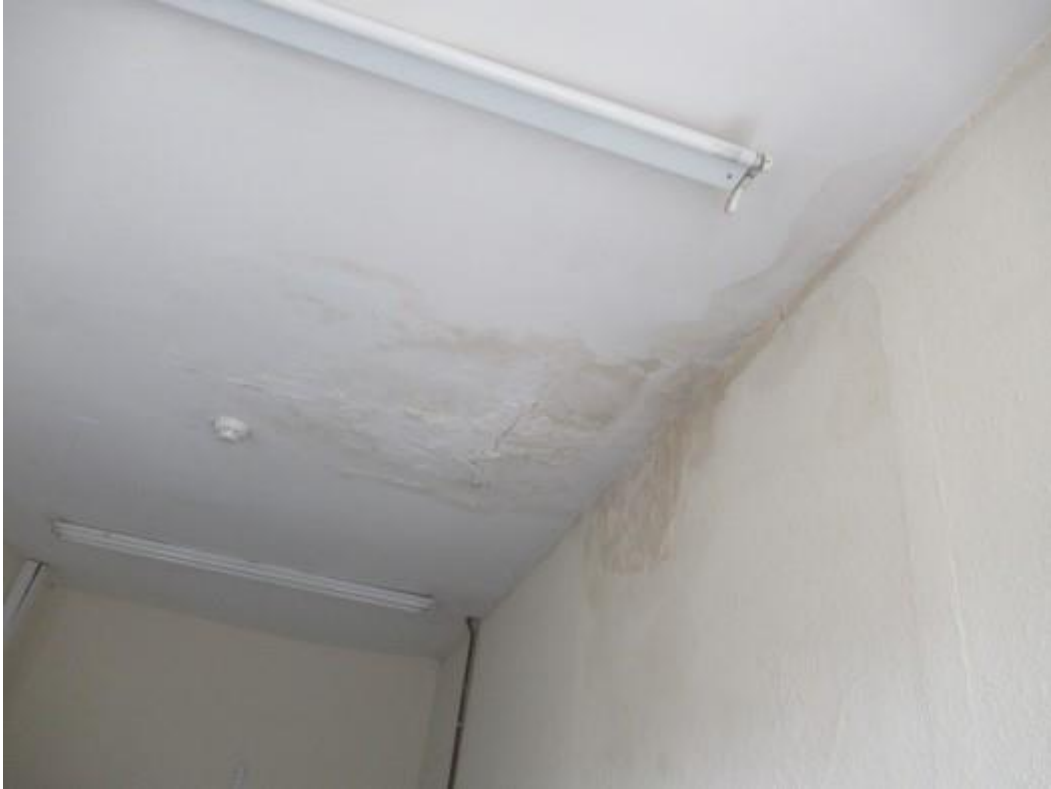
Further illustration of damage to wall and ceiling finishes consistent with water ingress at the base of a chimney stack. There are further areas of damp staining at the base of chimney stacks to chimney breasts throughout the property.

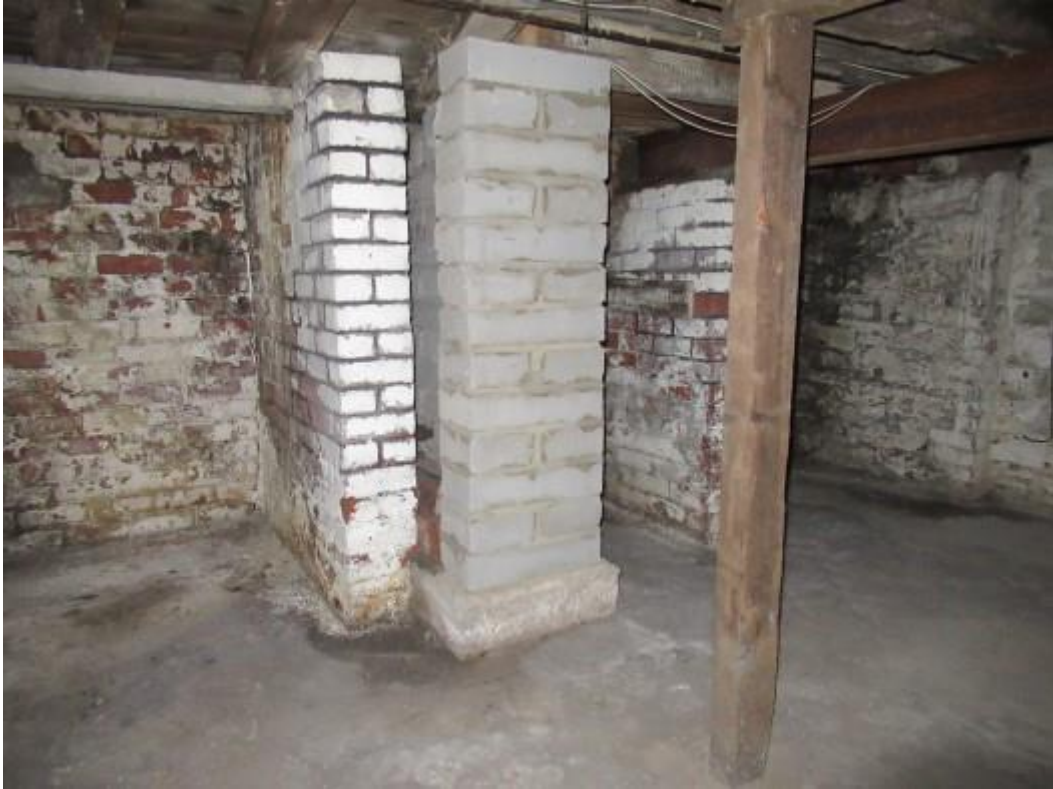
Basement area where below the ground floor right hand unit. The photograph shows evidence of past repair and strengthening to the underside of the floor to include steel and concrete beams providing intermediate support of the floor timbers. The photograph also shows a concrete block pillar providing intermediate support.

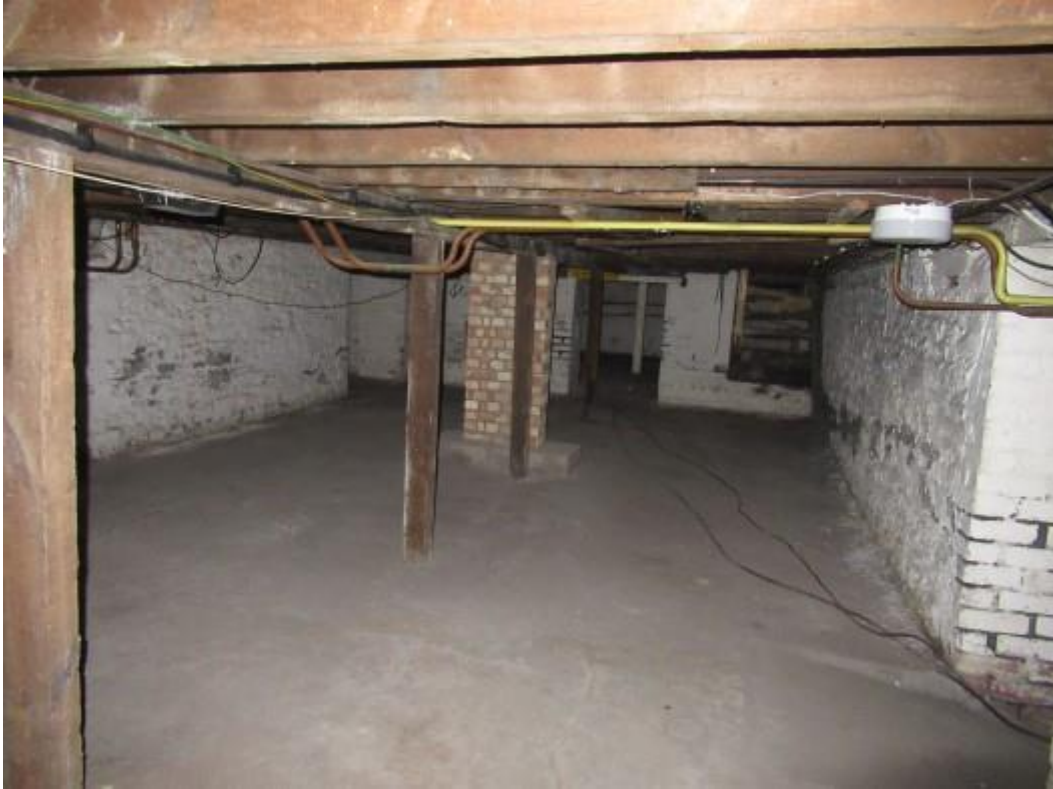
Further illustration of typical condition of underside of ground floor as viewed from the basement area. The photograph shows various intermediate supports to the flooring including brickwork pillars and timber struts to the underside of timber beams.

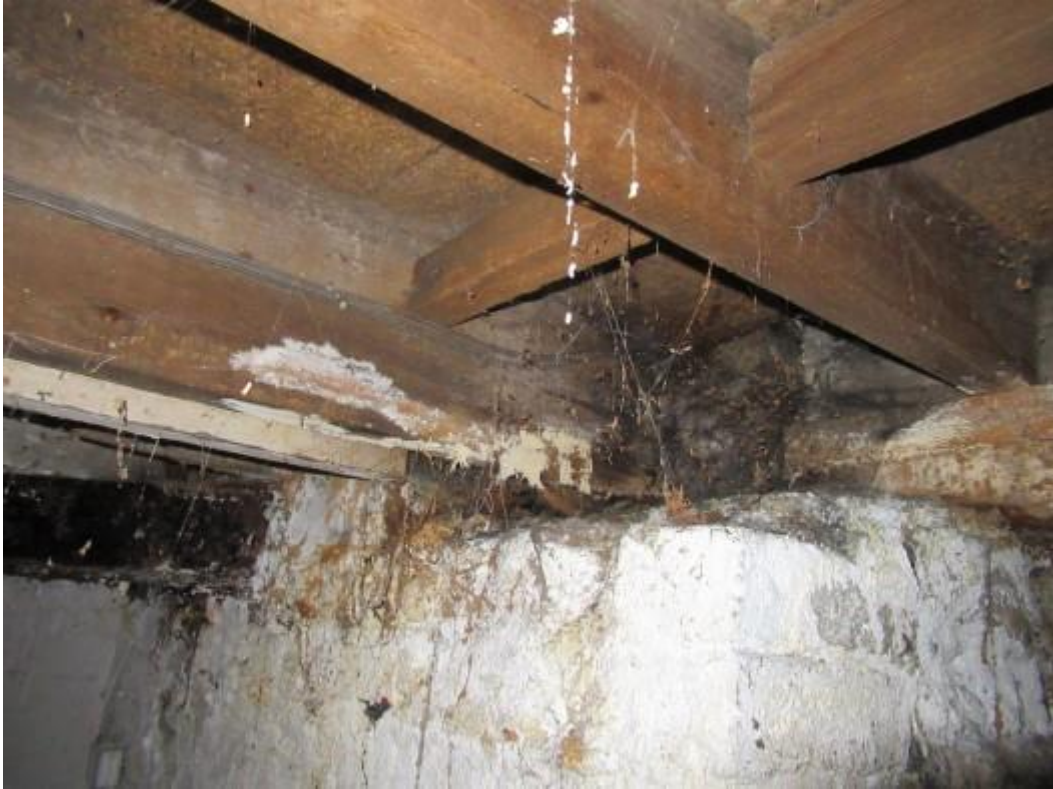
Further illustration of underside of timbers to the ground floor. Whilst past repair has been carried out there are further areas of rot and decay affecting timbers where built into the front wall. Further works to cut out and replace rotten timbers will be required. There is also evidence of active wood boring insect infestation.

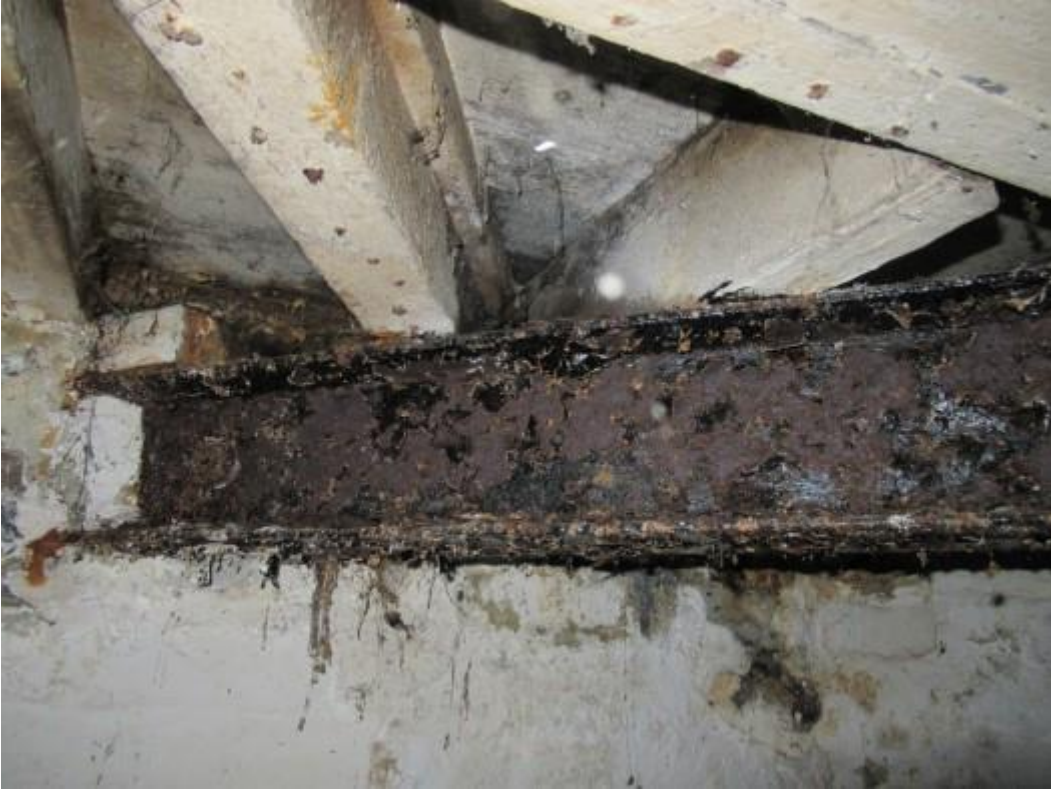
Typical past repair undertaken with steel beam noted. The beam has corroded.

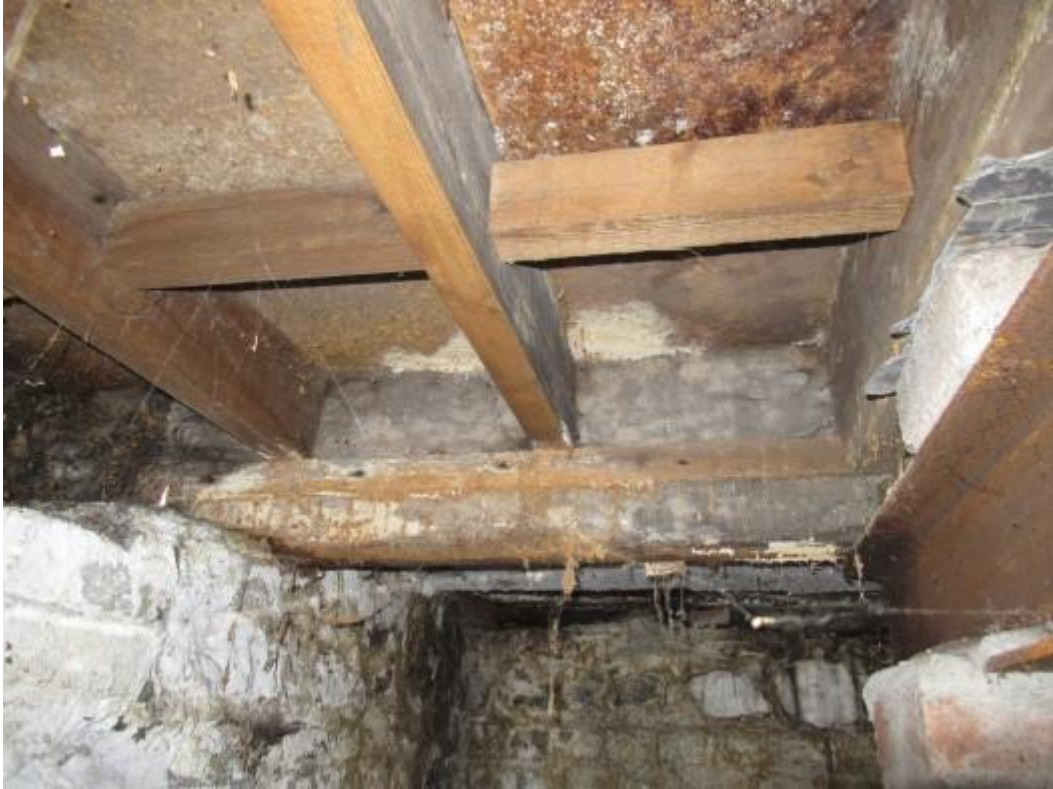
Further illustration of typical rot and wood boring insect infestation to underside of timbers to the ground floor. Rotten timbers will require cutting out and replacing.

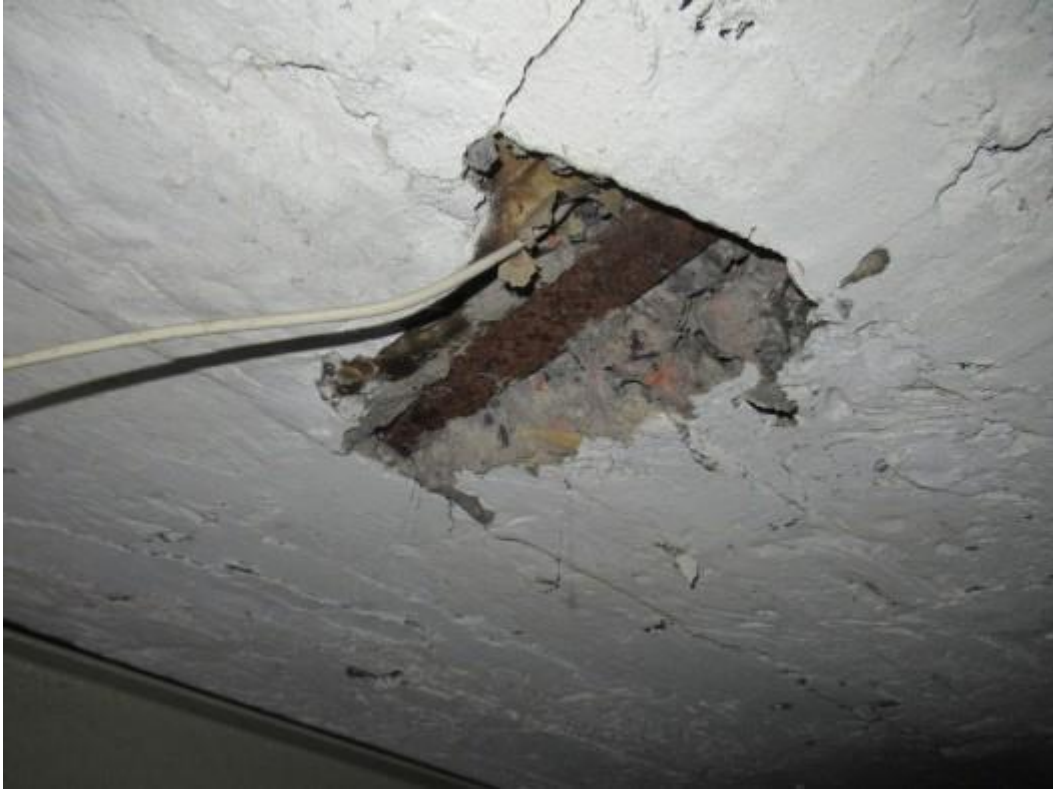
Typical condition of underside of reinforced concrete floor to the ground floor. The photograph shows spalling and damage of the concrete. This has exposed steelwork above with corrosion evident.

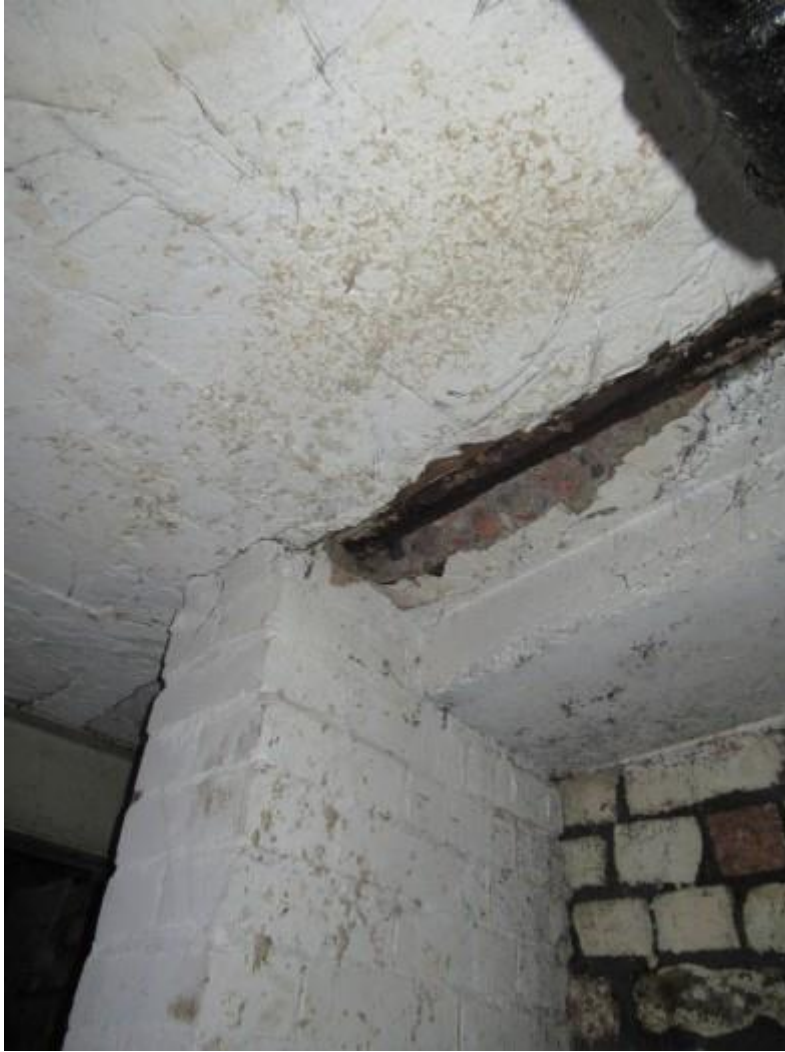
Further illustration of typical spalling and damage to underside of suspended concrete floor with corrosion noted.

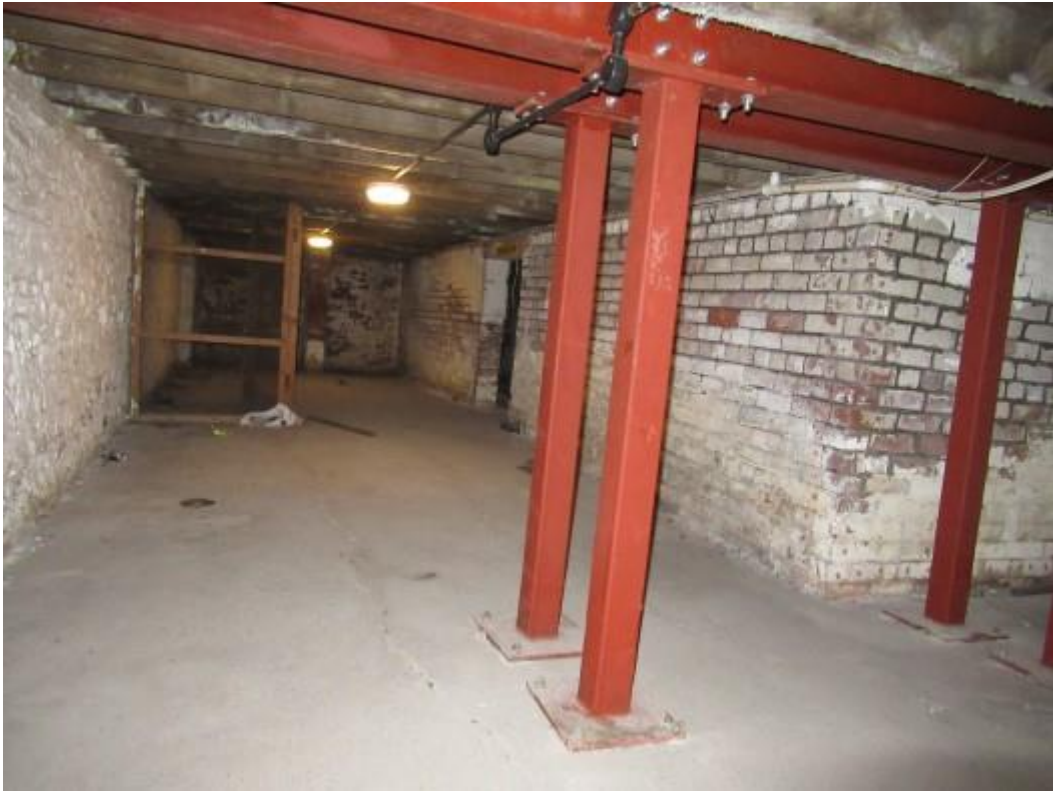
Further illustration of basement area with more recently installed steel framework noted. This provides support to the underside of the stair area.

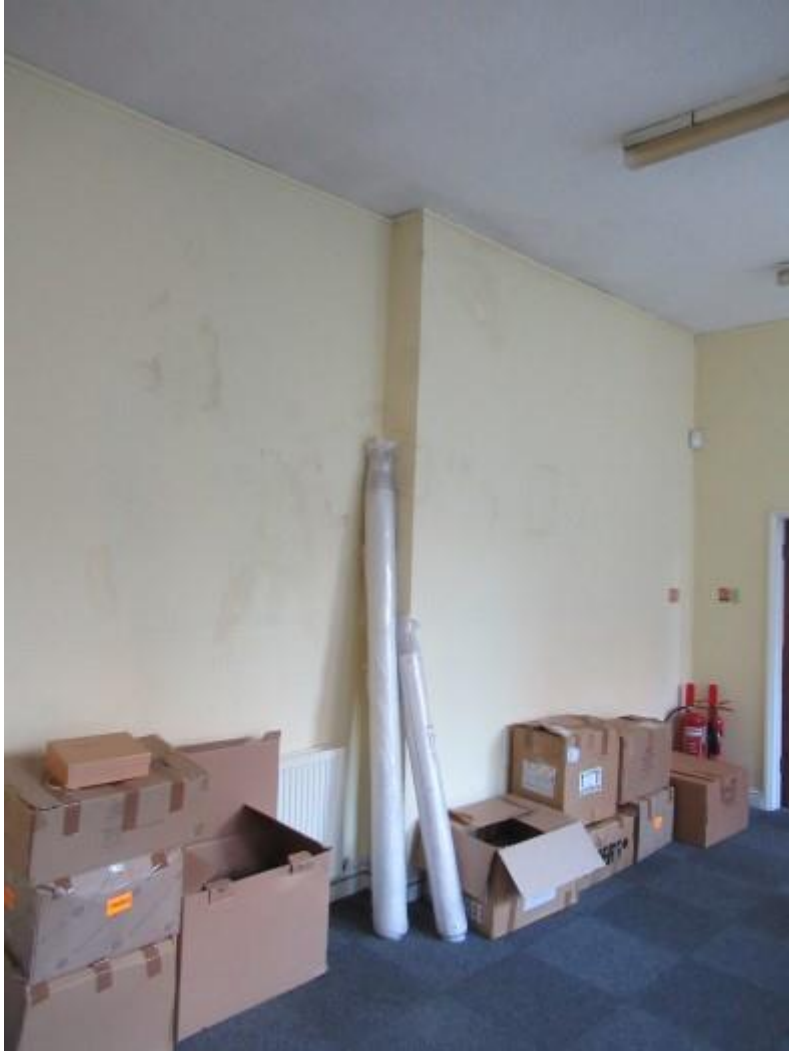
First floor accommodation to the left hand side of the property. The photograph shows damp staining of the side wall. This is below the parapet gutter detail formed between the left hand side lower level roof area and lead guttering.

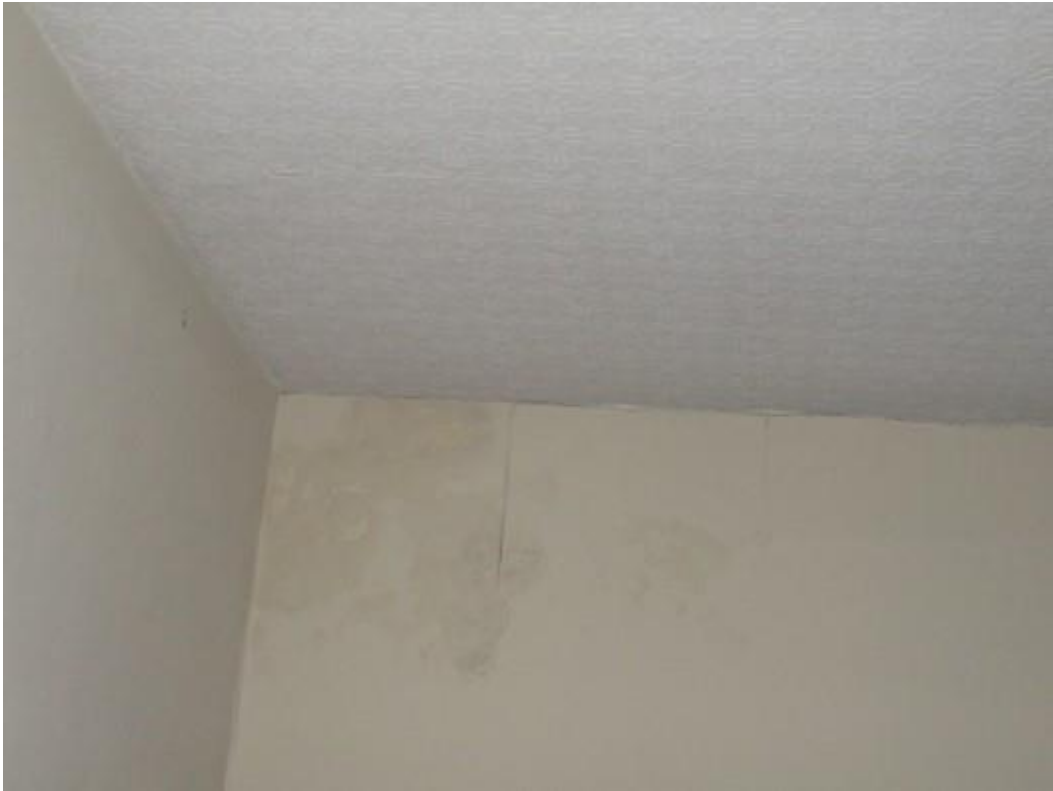
Damp affected and damaged plaster finishes to the kitchen accommodation to the rear of the first floor left hand side unit. This is below the flat roof area above.

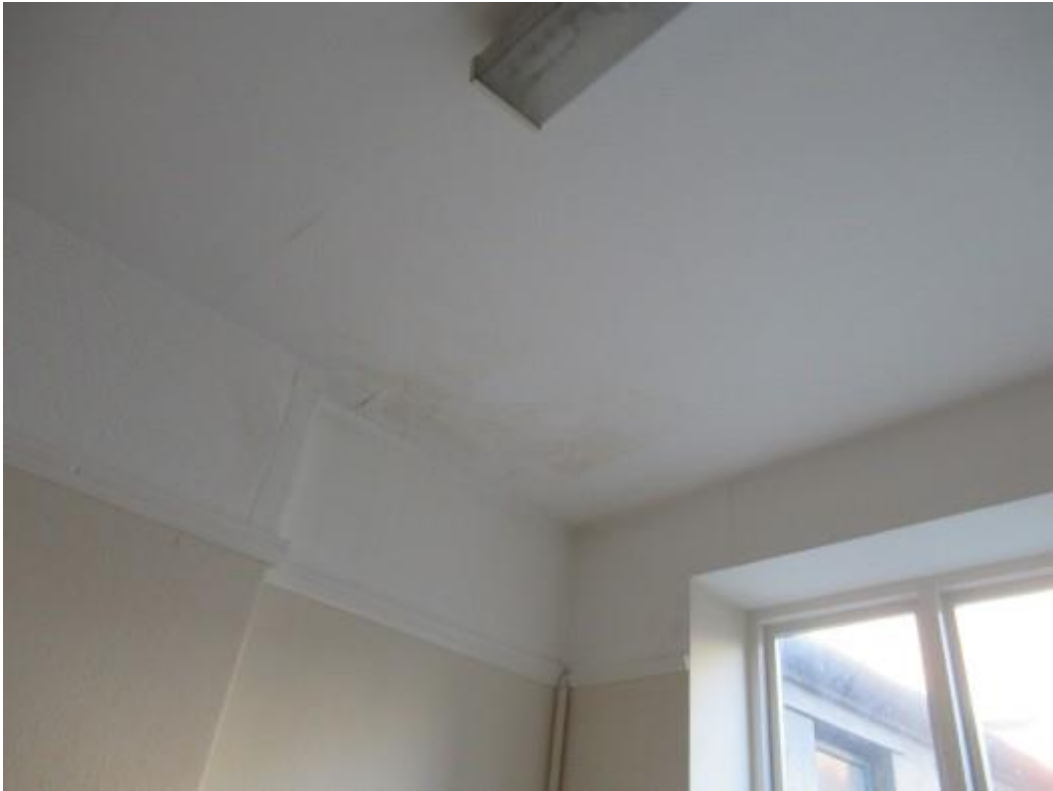
Damp affected and damaged wall and ceiling finishes to the first floor. This is consistent with leaking and overflowing rainwater goods externally.

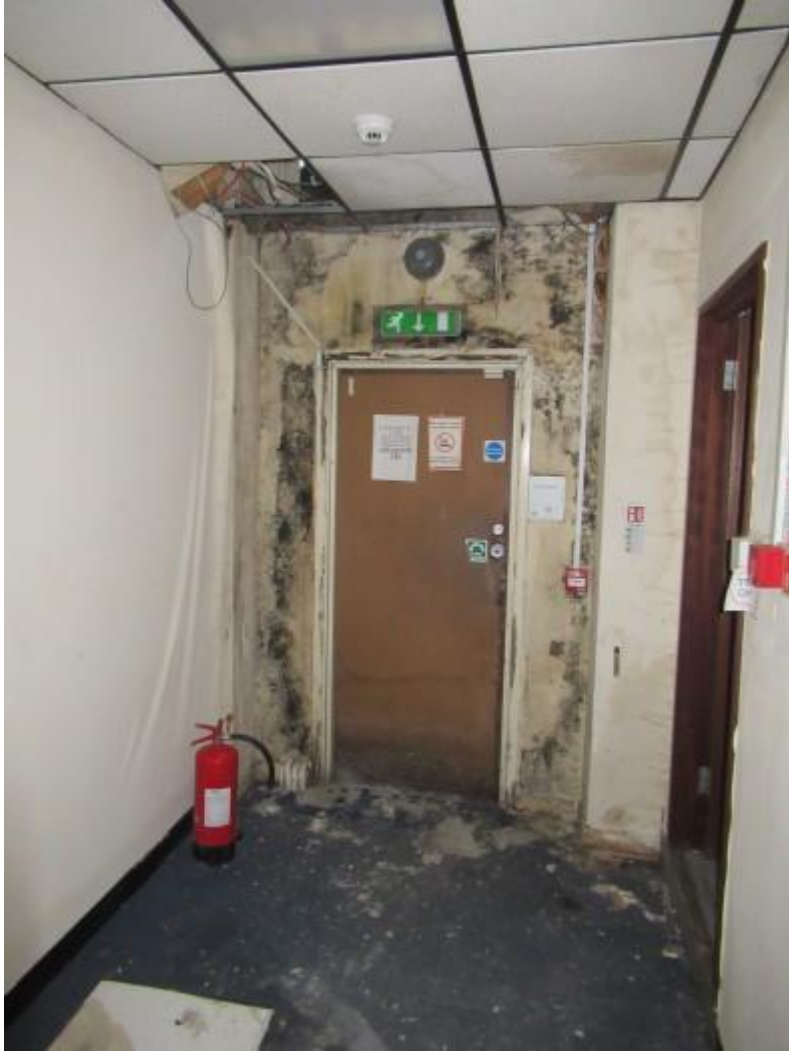
Typical water ingress around fire exit door to the left hand side of the ground floor right hand unit. There is significant water ingress to this area. This has contributed to dry rot within the property. All areas of damp affected and damaged finishes will require hacking off and re-plastering as necessary.
