IN RESPECT OF:-

**TREDEGAR CHAMBERS
BRIDGE STREET
NEWPORT
NP20 4QA**

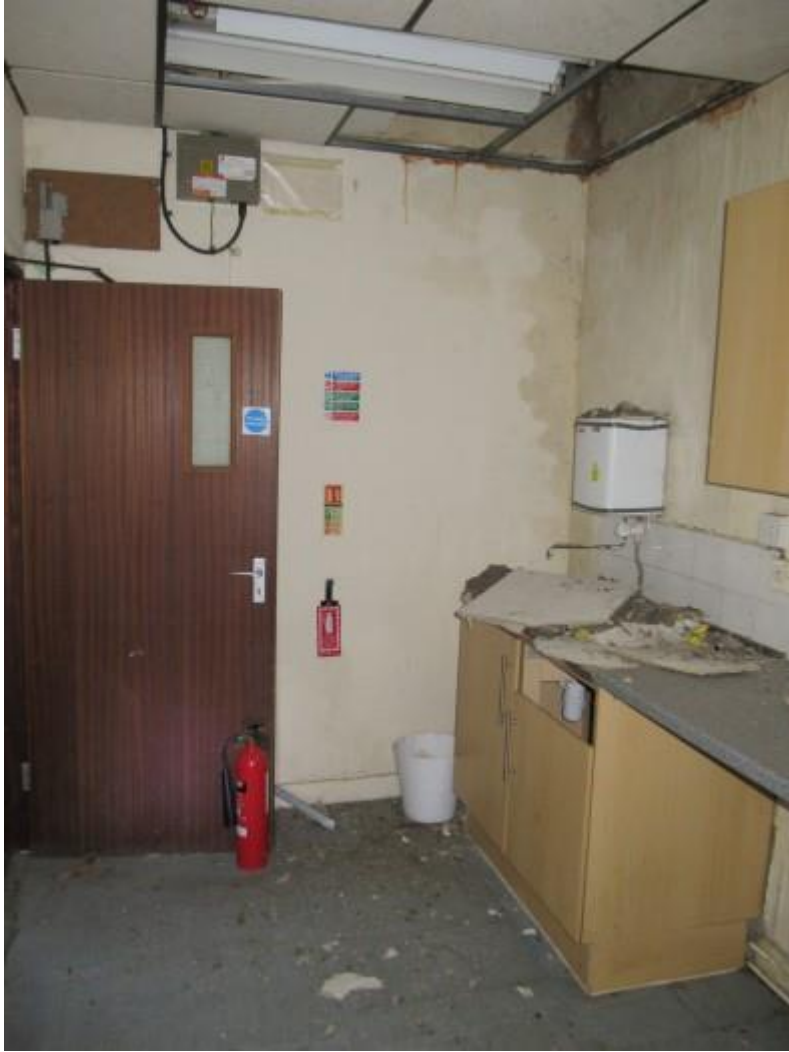
Kitchen area serving the ground floor right hand side unit with water ingress noted. There is significant dry rot to this area. The water ingress is consistent with deterioration of flashings and roof coverings above.

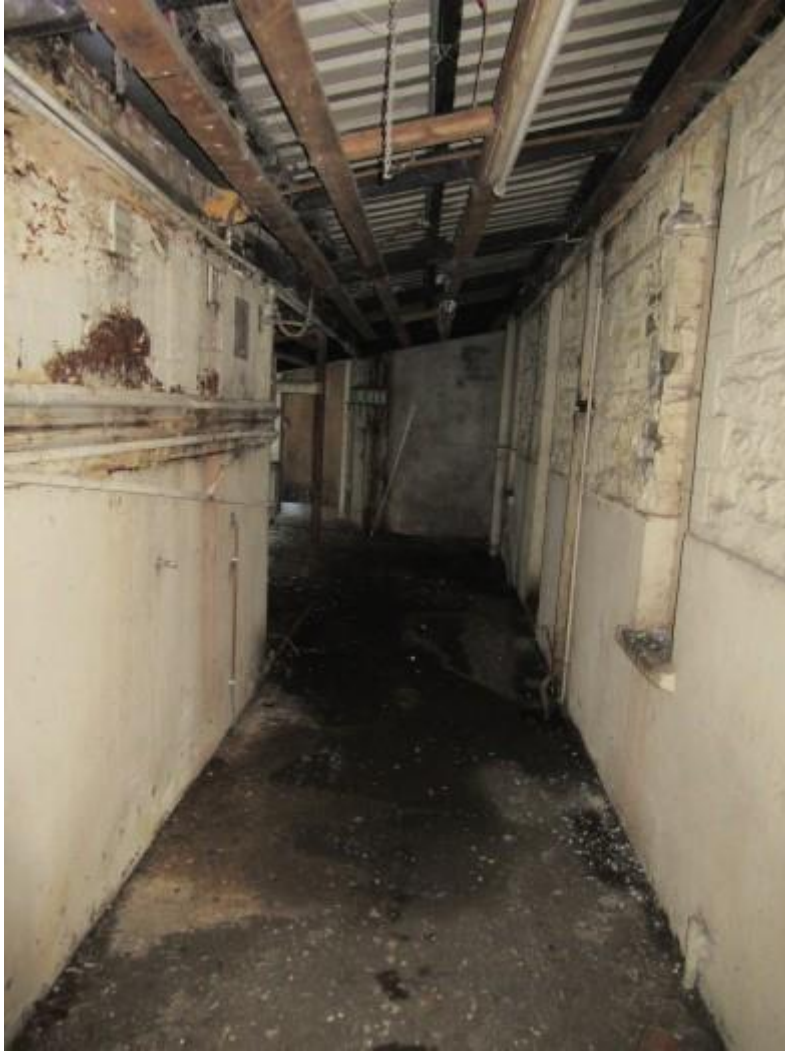
Covered area to the rear courtyard. There is significant water ingress to the area consistent with the poor condition of roof coverings and rainwater goods. Removal and upgrading of the roof coverings will be required.

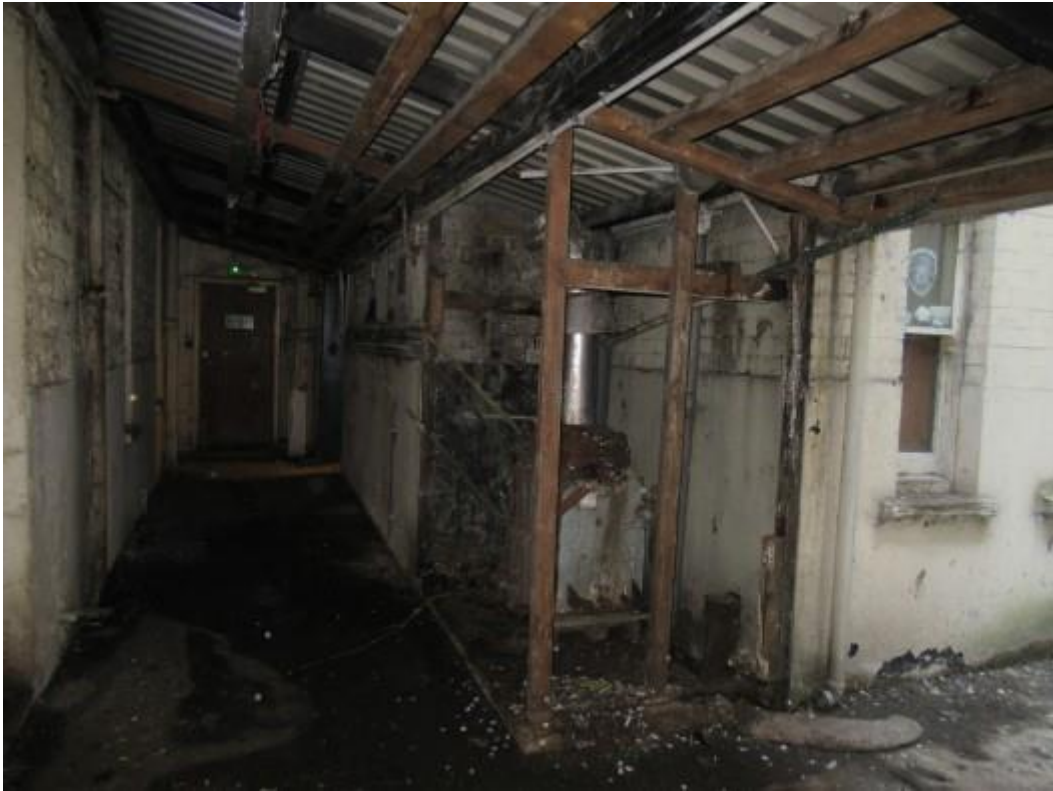
Further illustration of the covered area to the rear with water ingress noted.

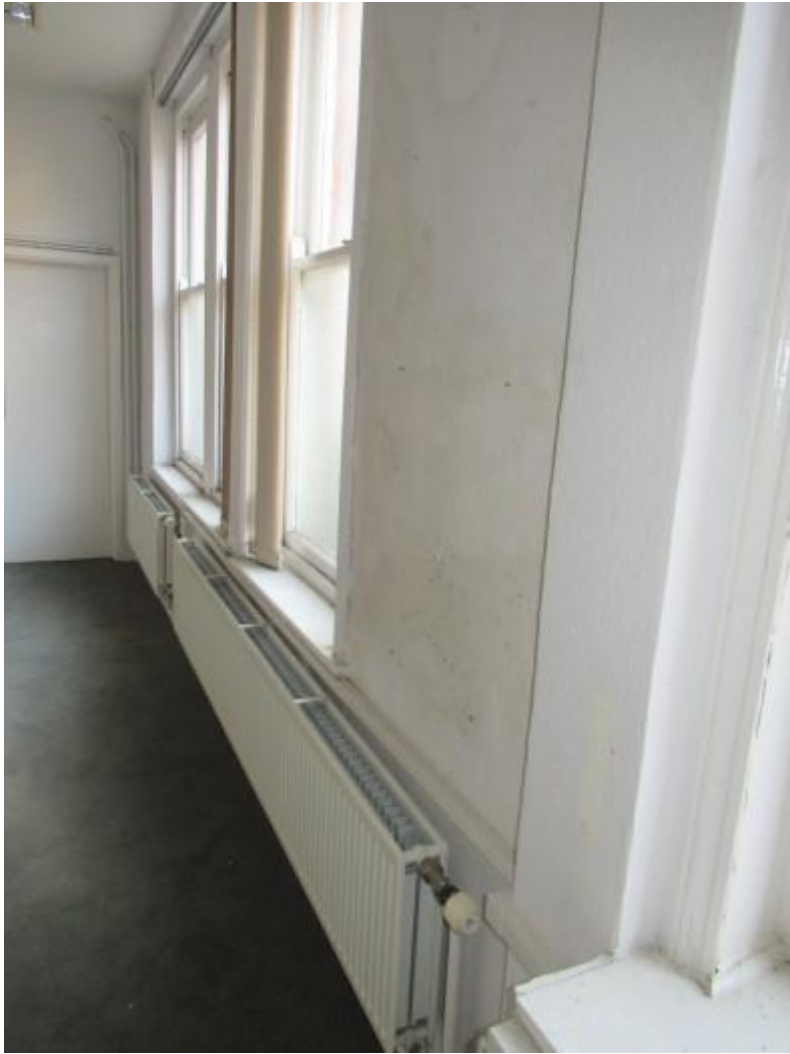
Typical damp affected and damaged plaster finishes consistent with water ingress.

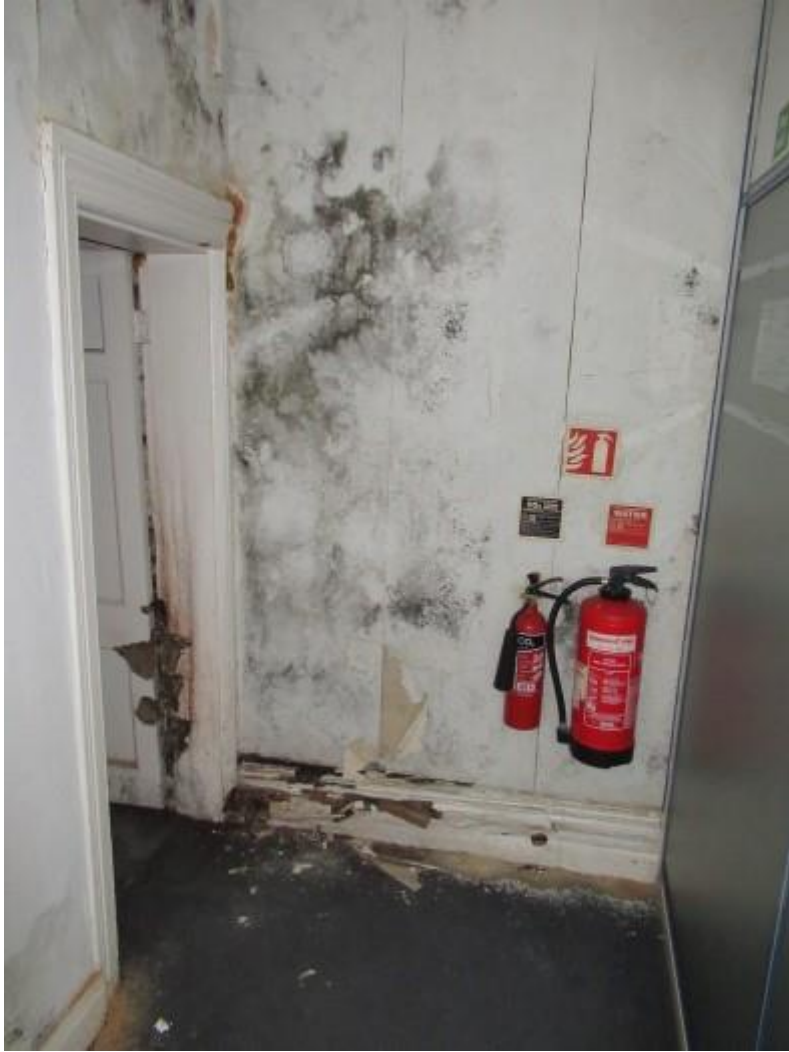
Damp affected and damaged plaster finishes to the rear of the first floor. The photograph also shows significant dry rot.

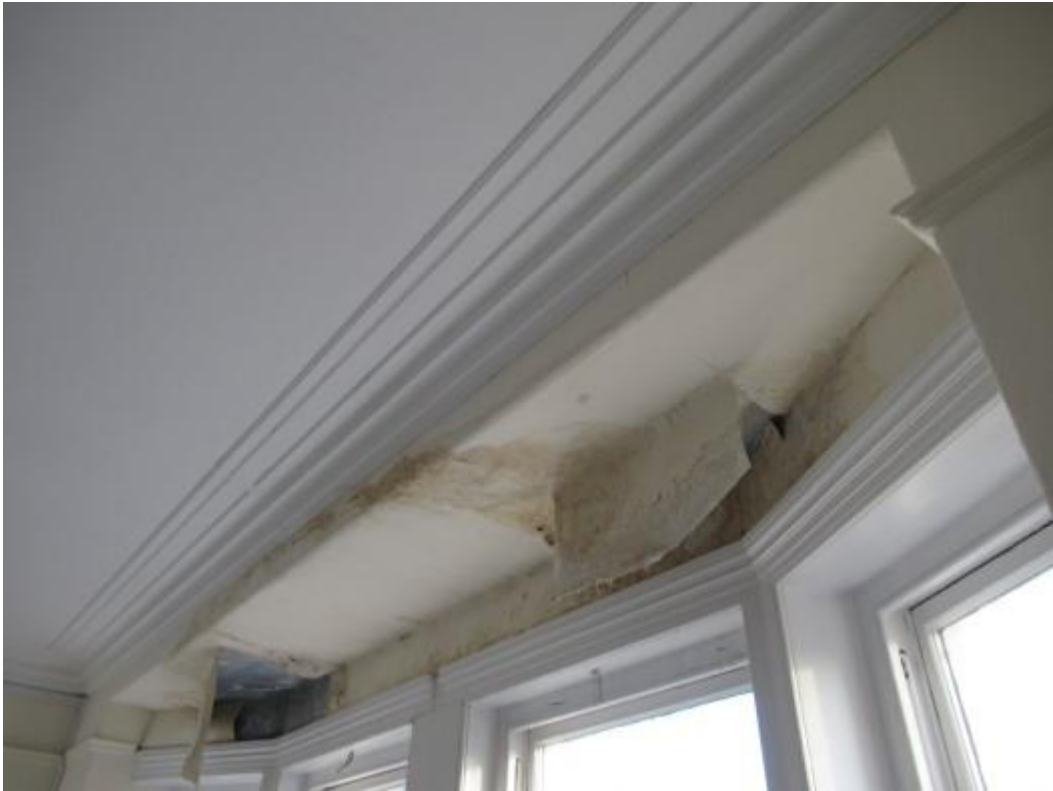
Damaged ceiling and water ingress to bay window area to the first floor to the front of the property. There is similar damp staining and damage to finishes to the bay windows throughout the property.

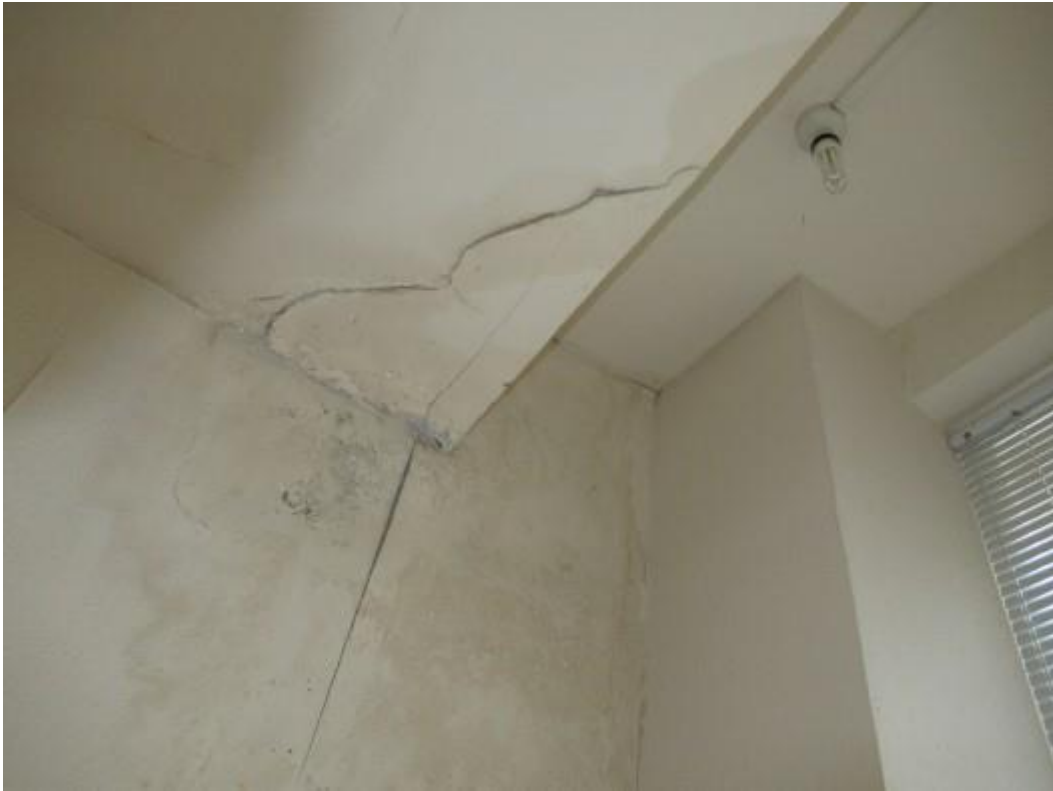
Further illustration of typical damp affected and damaged plaster finishes to the upper floor accommodation consistent with water ingress.

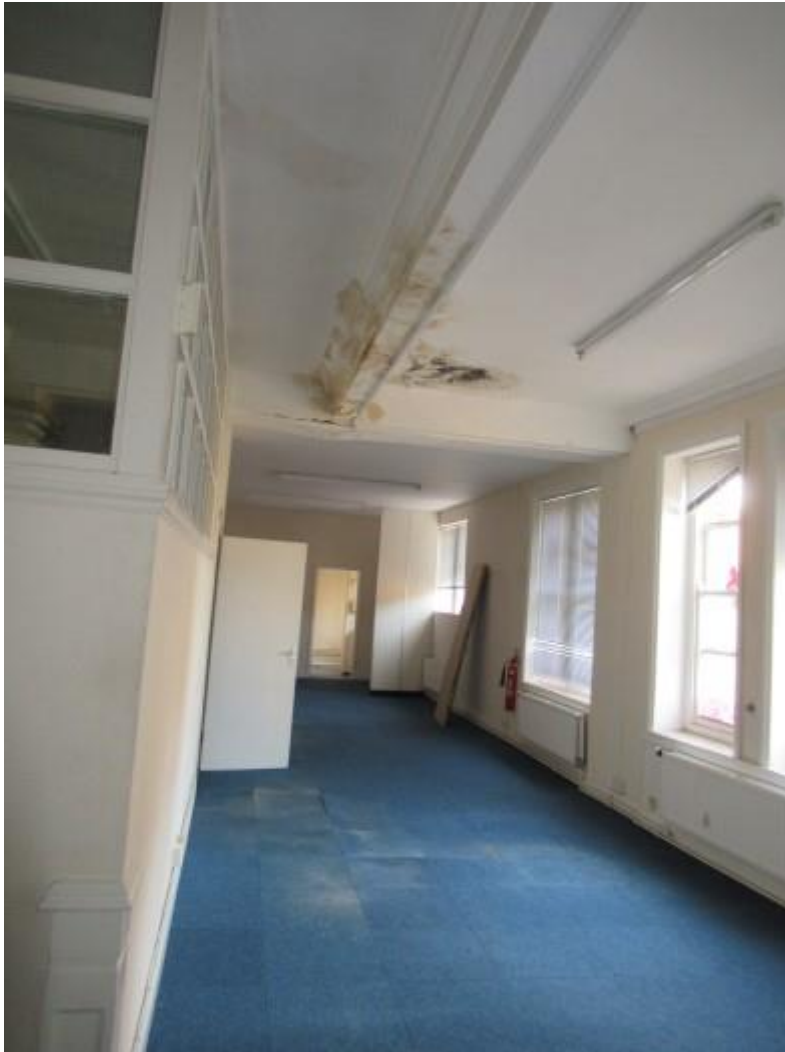
Right hand side office accommodation. The photograph shows damp staining consistent with water ingress. As detailed, there is a risk that the water ingress to this area has caused rot and decay of timbers. On removal of the damp affected and damaged plasterwork a further assessment of timbers will be required and upgrading work carried out as necessary.

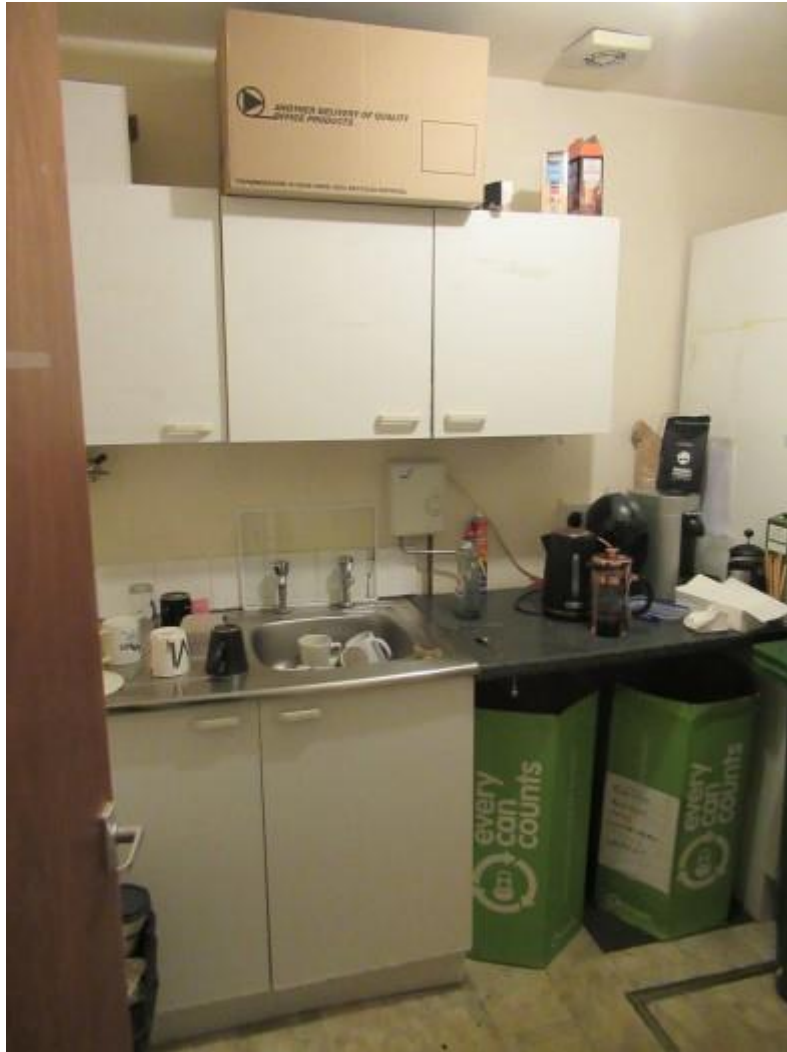
Typical condition of kitchen units to ground floor unit, No. 76.

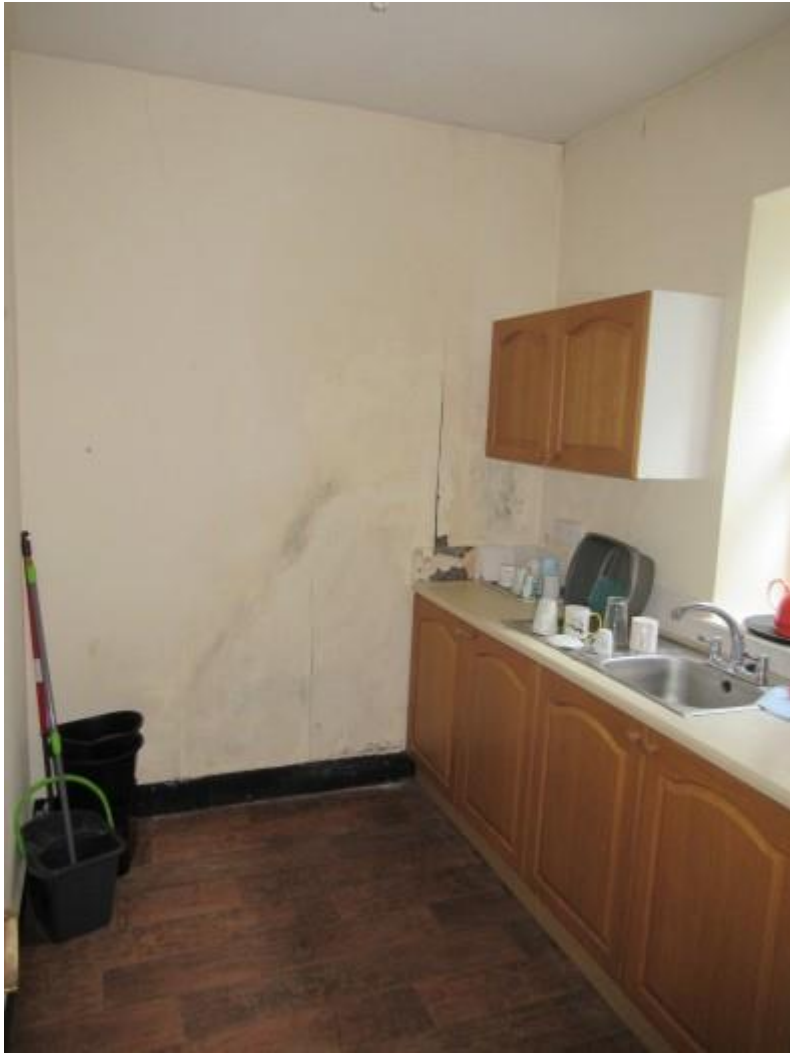
Kitchen accommodation to the first floor to the rear of No. 76.

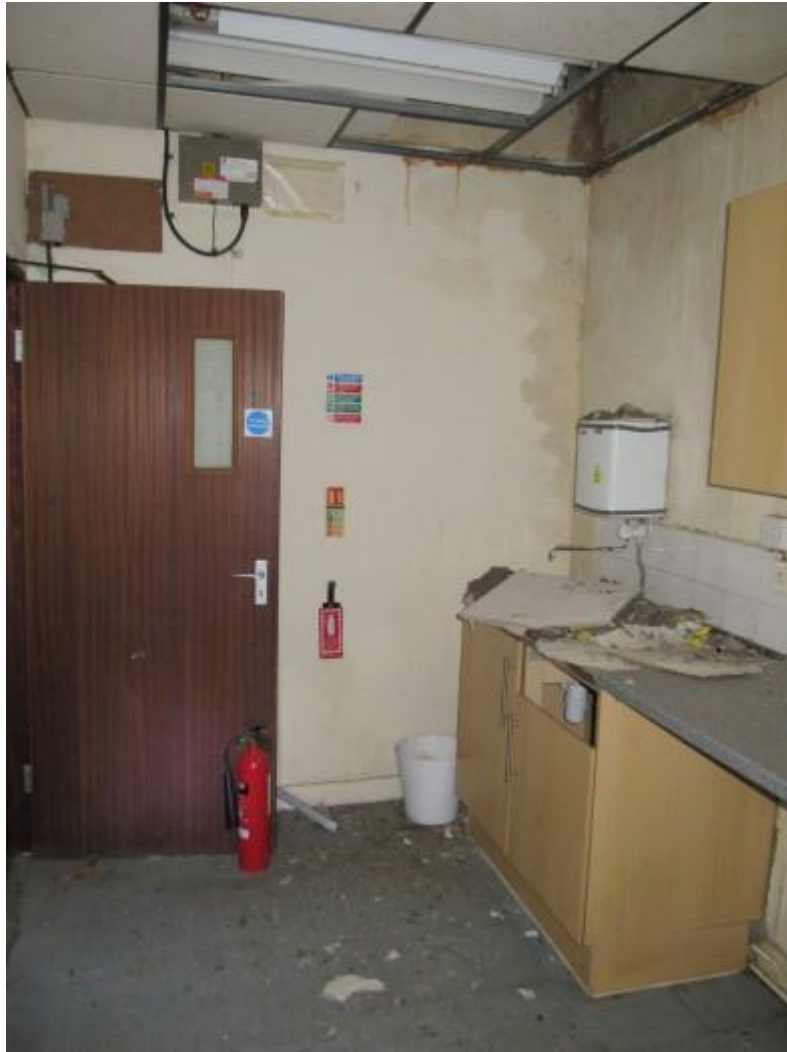
Poor condition of the kitchen units to the rear of the ground floor right hand side unit.

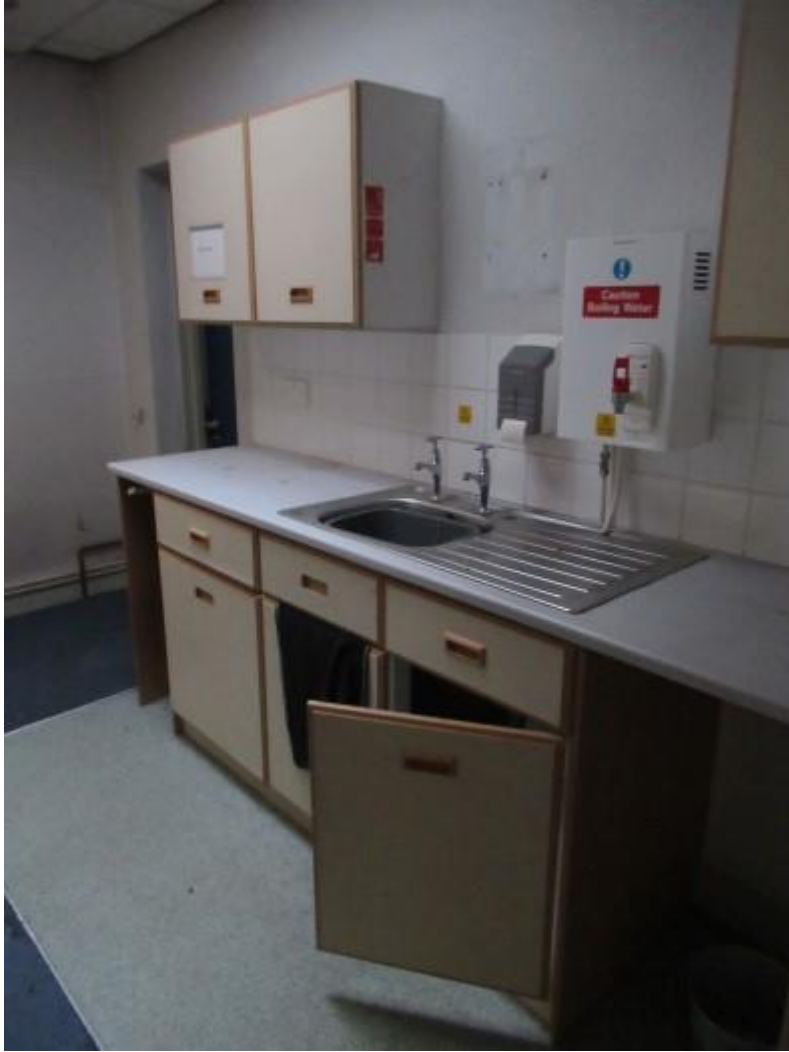
Kitchen units to the ground floor unit. Whilst the units are functional the area is affected by dry rot and decay. We anticipate the existing units will require stripping out and upgrading in conjunction with treatment in relation to rot.

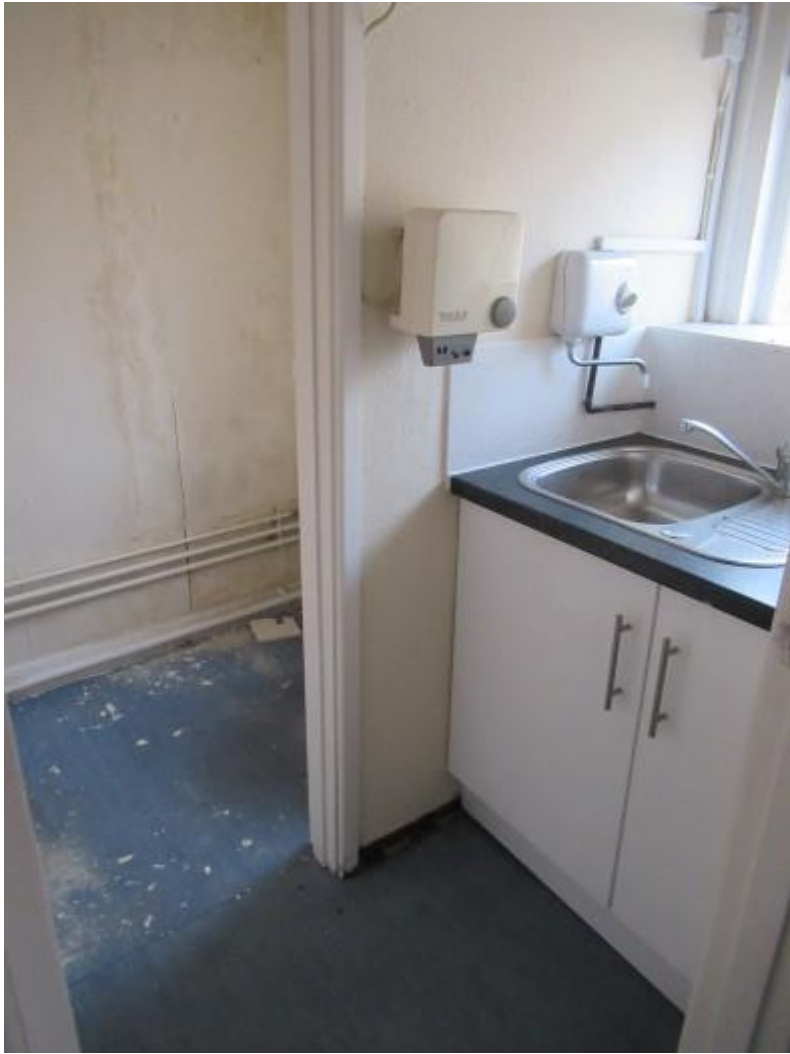
Typical condition of sink unit to first floor accommodation.

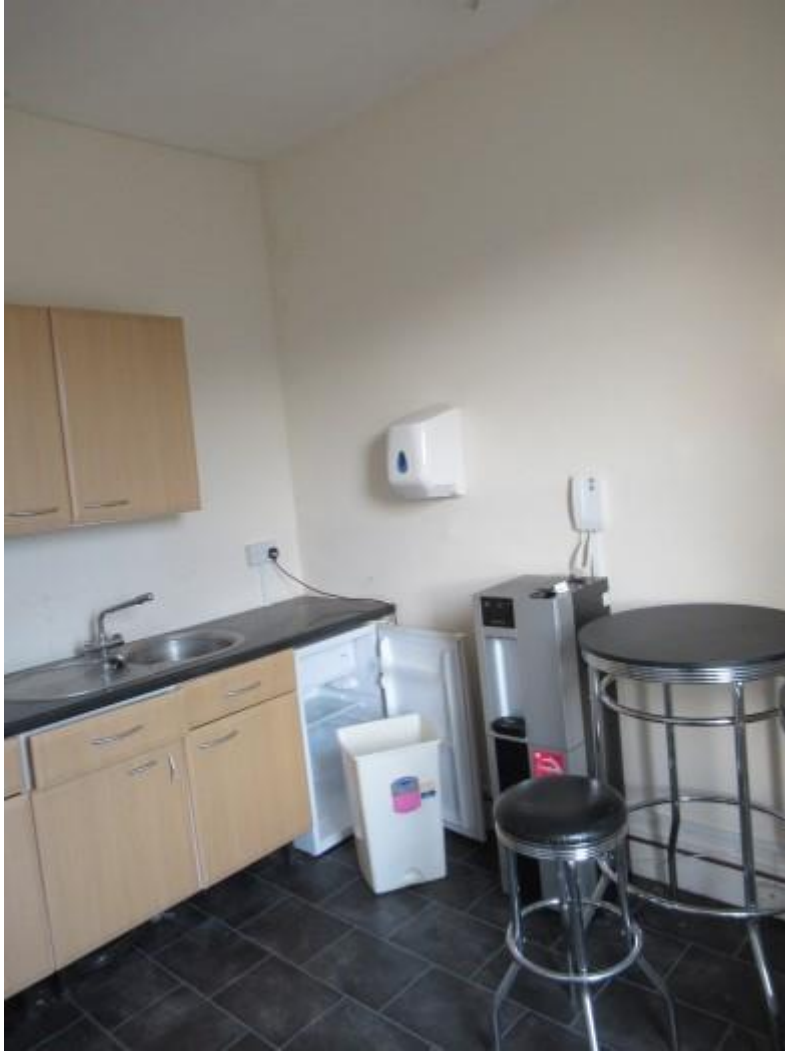
Further illustration of typical condition of current kitchen accommodation to upper floor accommodation. In conjunction with upgrading of the property upgrading of the kitchen units to the property will be required as necessary.

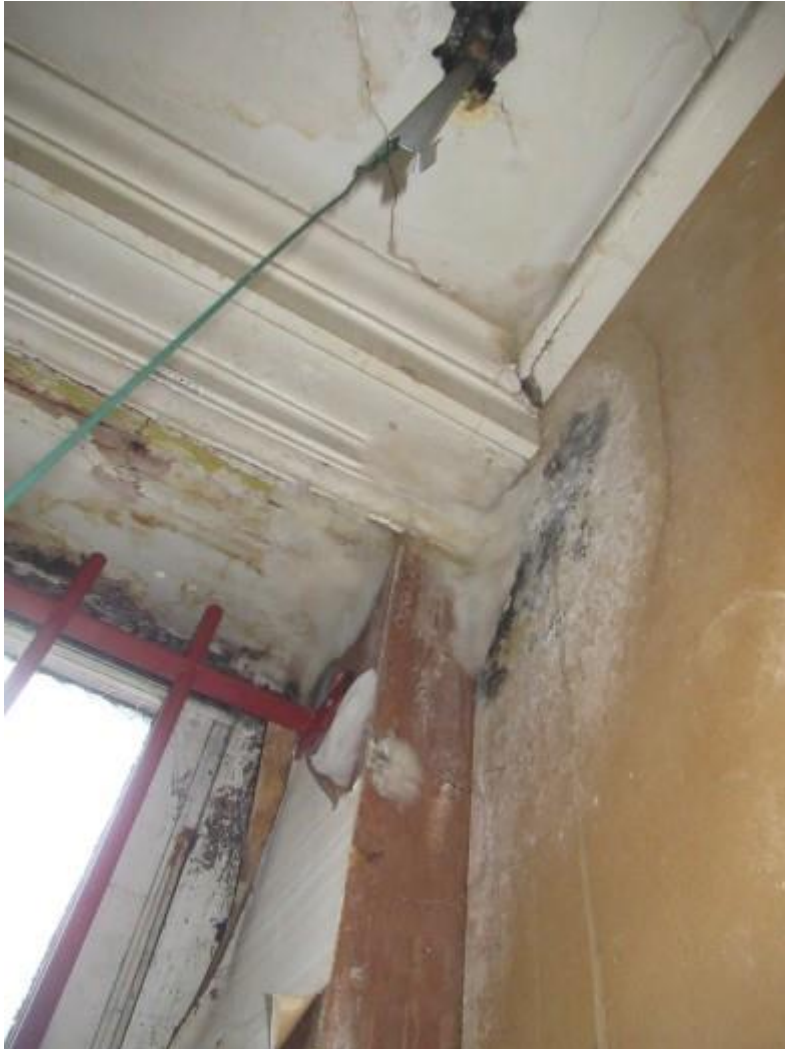
Dry rot and fungal growth above the suspended ceiling to the left hand side store room to the ground floor right hand side unit.

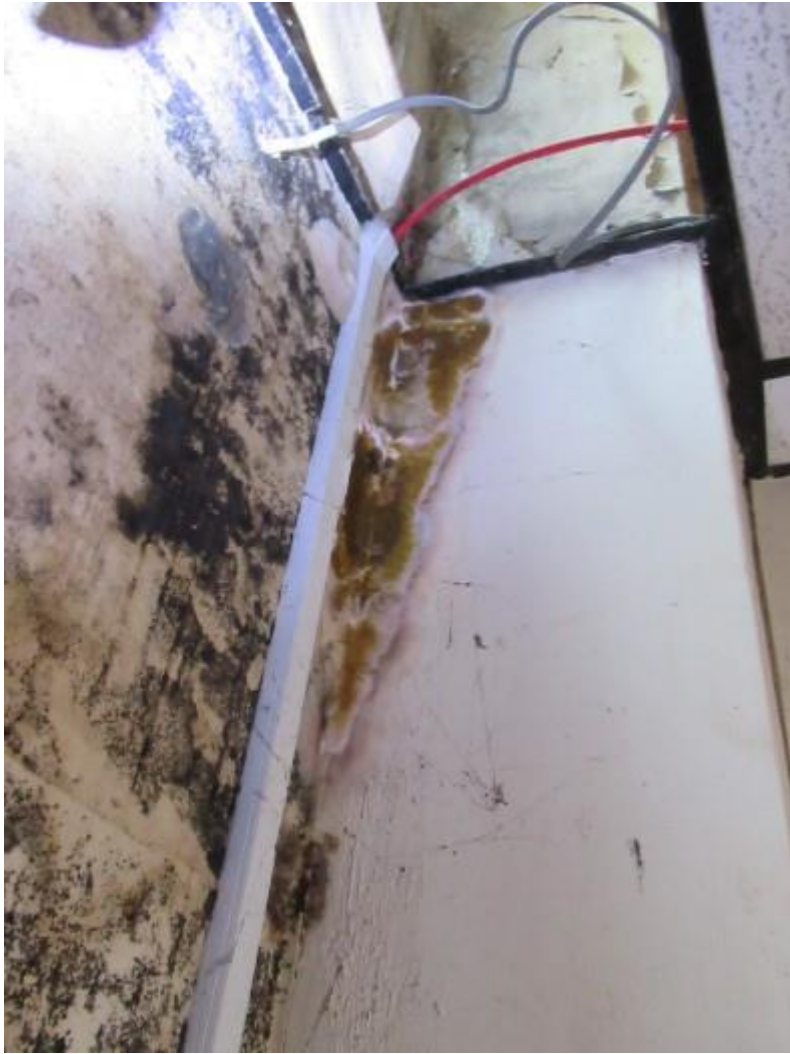
Further illustration of dry rot fungus to the rear.

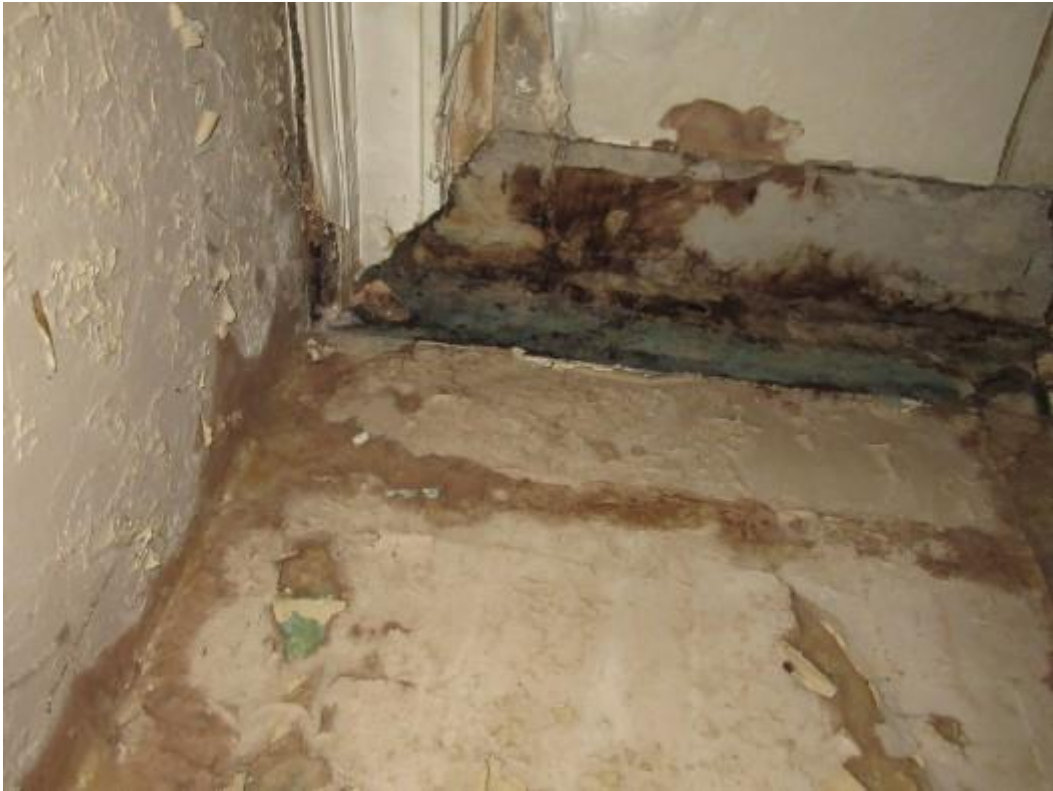
Dry rot above ceilings to the rear kitchen. There is further significant dry rot within the timbers where extending above this area.

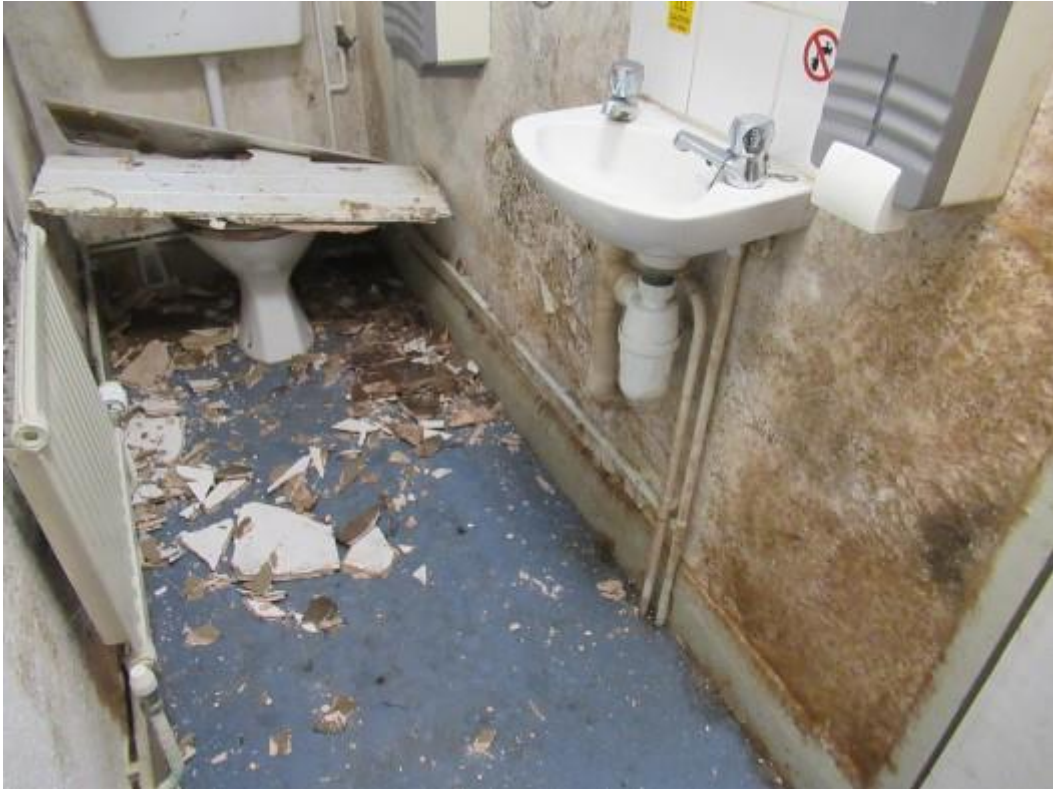
Rot within timbers to the WC accommodation to the rear.

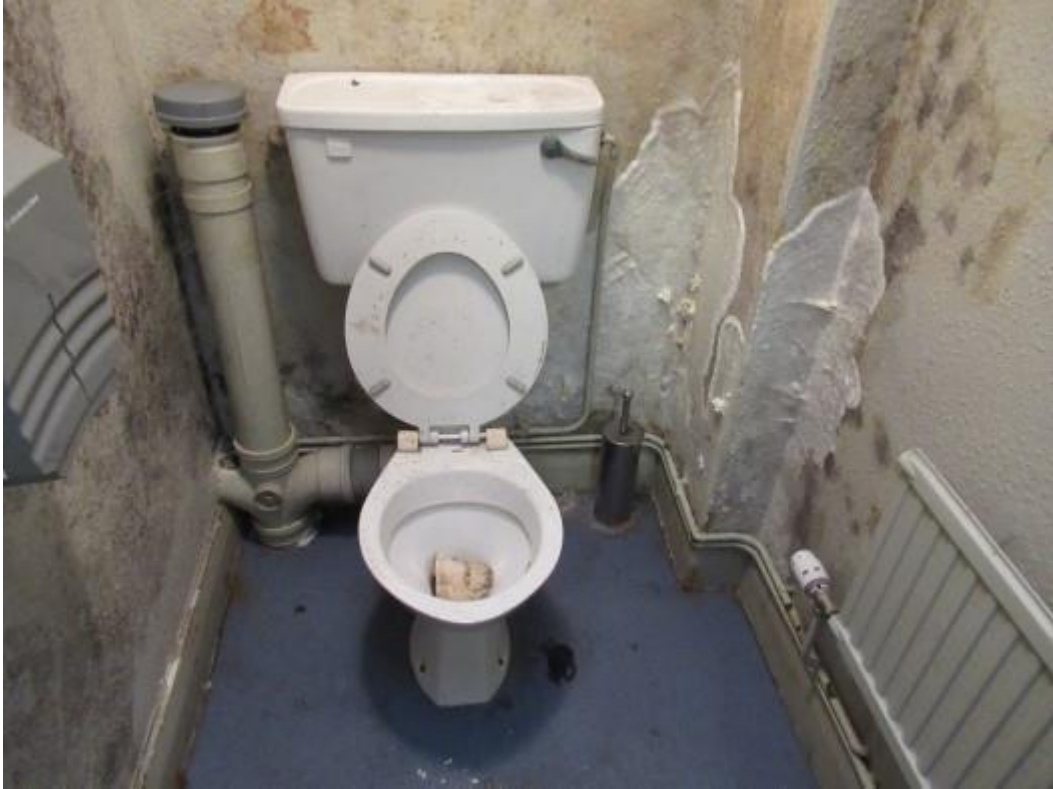
Further illustration of rot within ground floor WC accommodation.

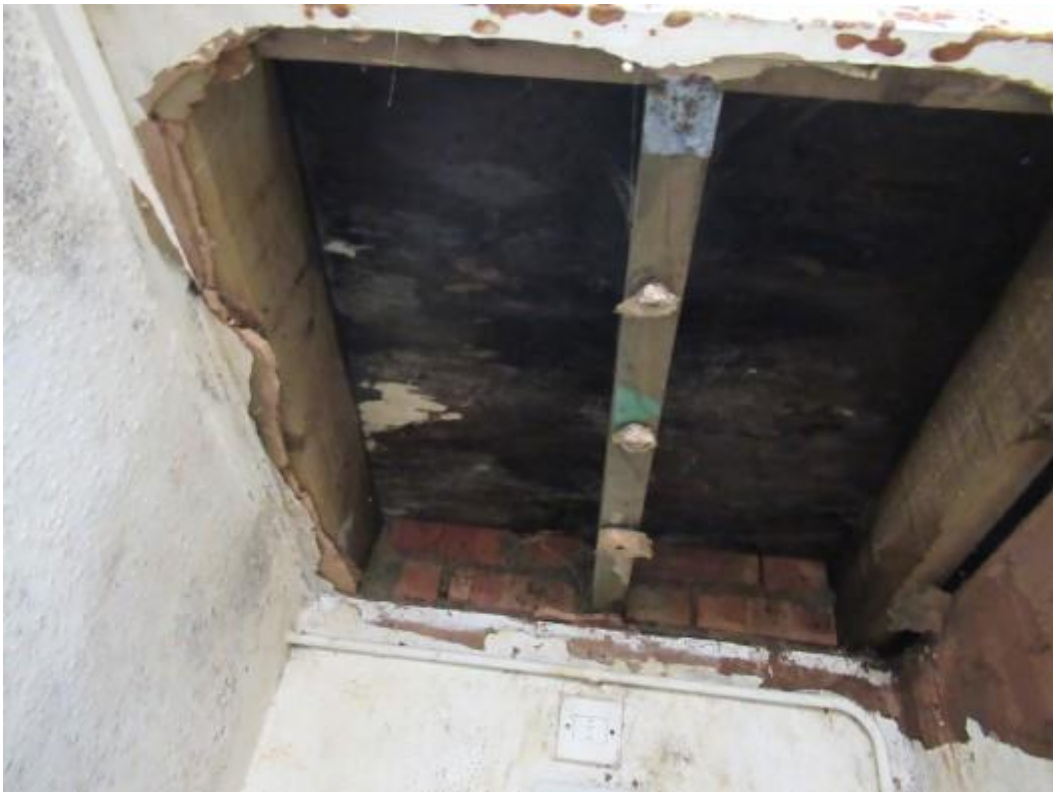
Underside of the flat roof above the WC accommodation. There are areas of rot and decay affecting timbers consistent with water ingress.

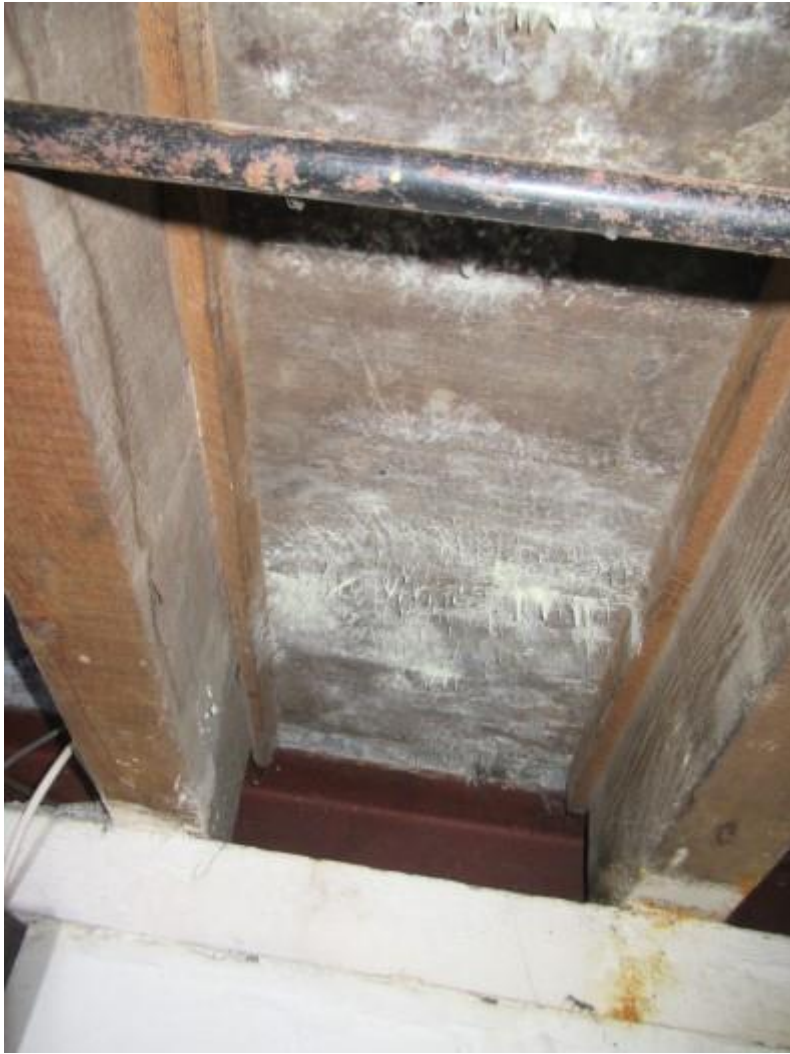
Fungal growth to the underside of timbers to the basement area.

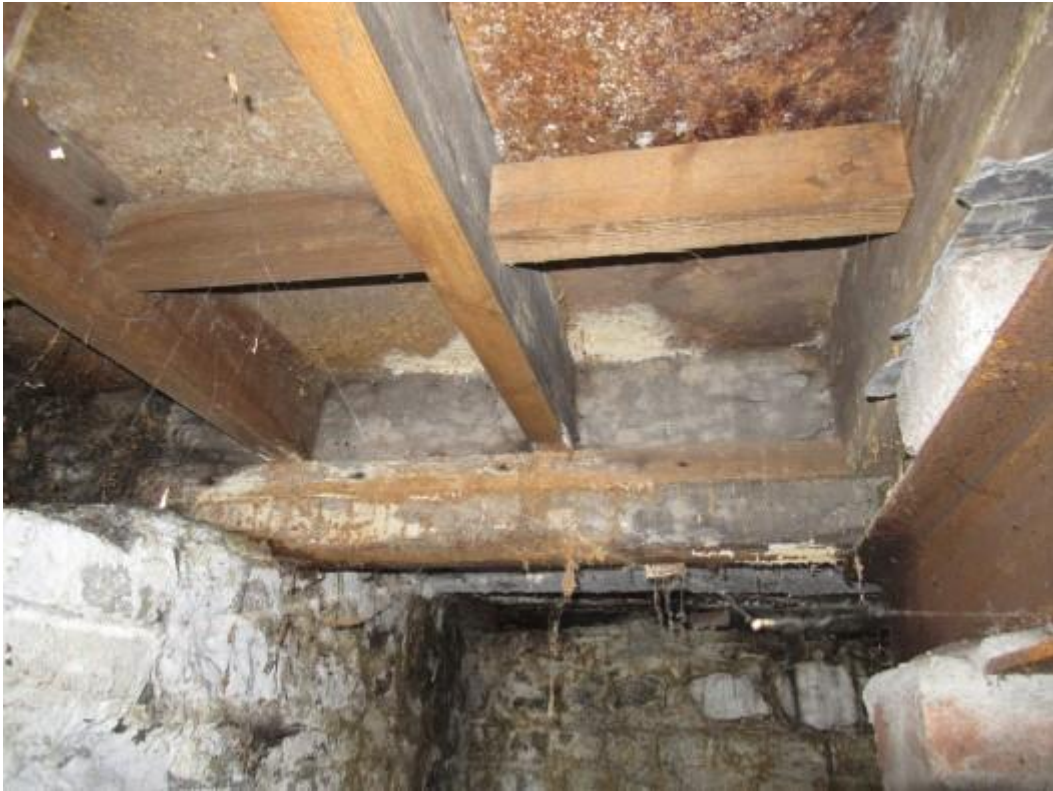
Further illustration of underside of timbers to the basement area with active wood boring insect infestation and fungal growth to timbers noted.

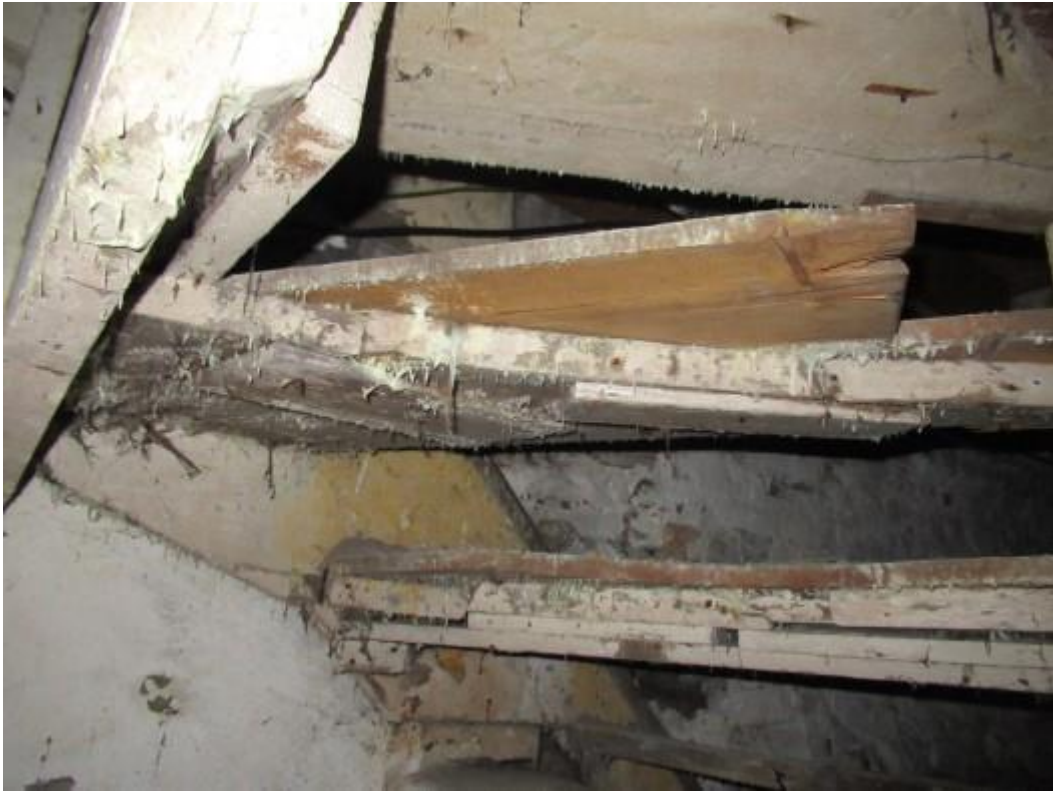
Fungal growth to underside of redundant timbers to the basement area. The timbers to this area will require removal. Timber treatment work will also be necessary.

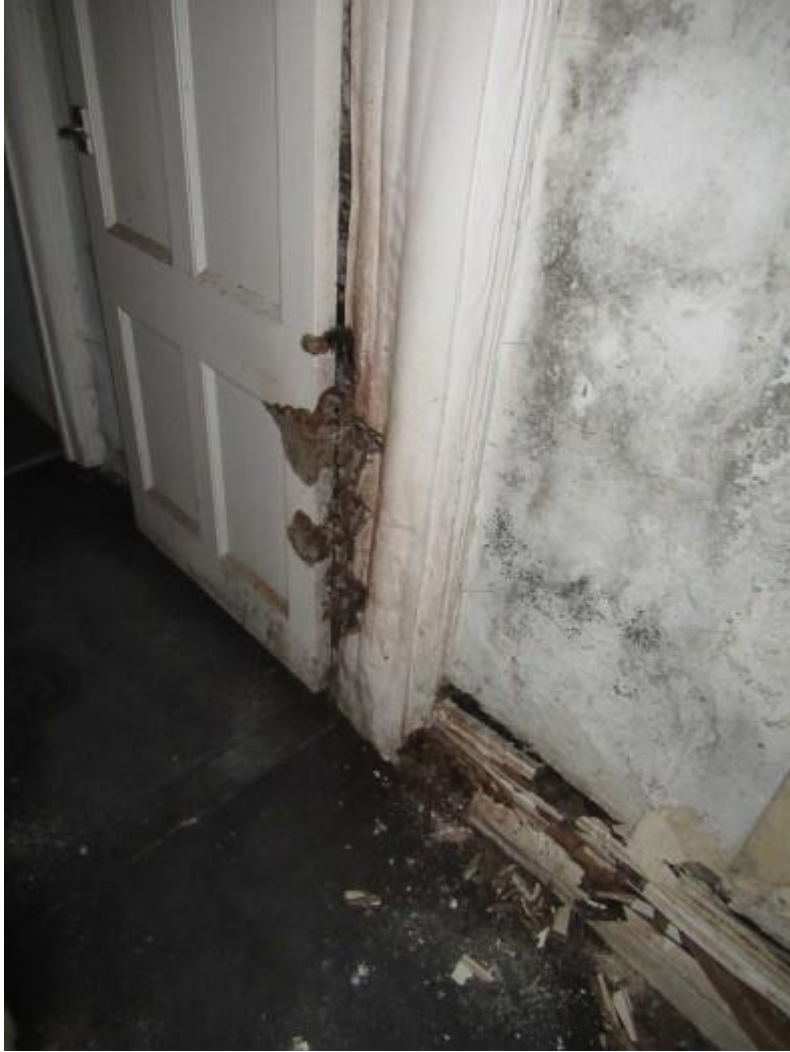
Dry rot within timbers to the first floor to the rear. This corresponds with the rot noted above the kitchen area below.

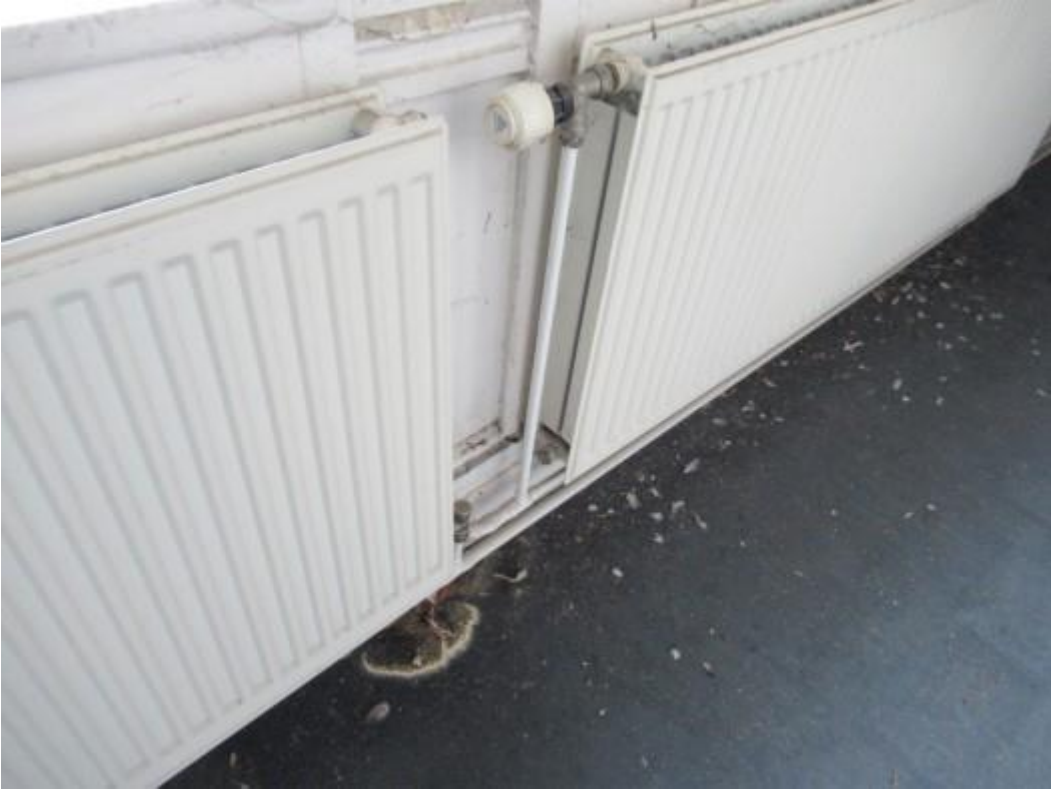
Left hand side access corridor to the rear of the first floor right hand side of the property. The photograph shows rot within the flooring. This corresponds with the rot noted above the suspended ceilings to the store room to the ground floor.

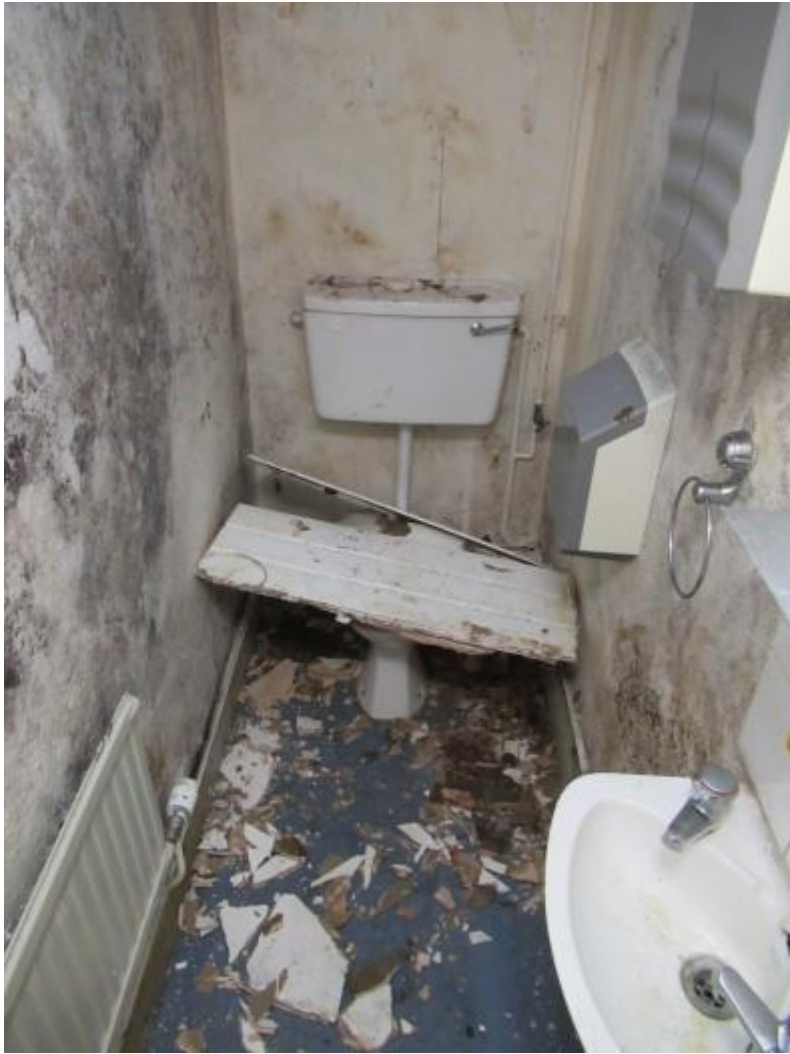
Poor condition of sanitary fittings to the rear of No. 80.
