IN RESPECT OF:-

**TREDEGAR CHAMBERS
BRIDGE STREET
NEWPORT
NP20 4QA**

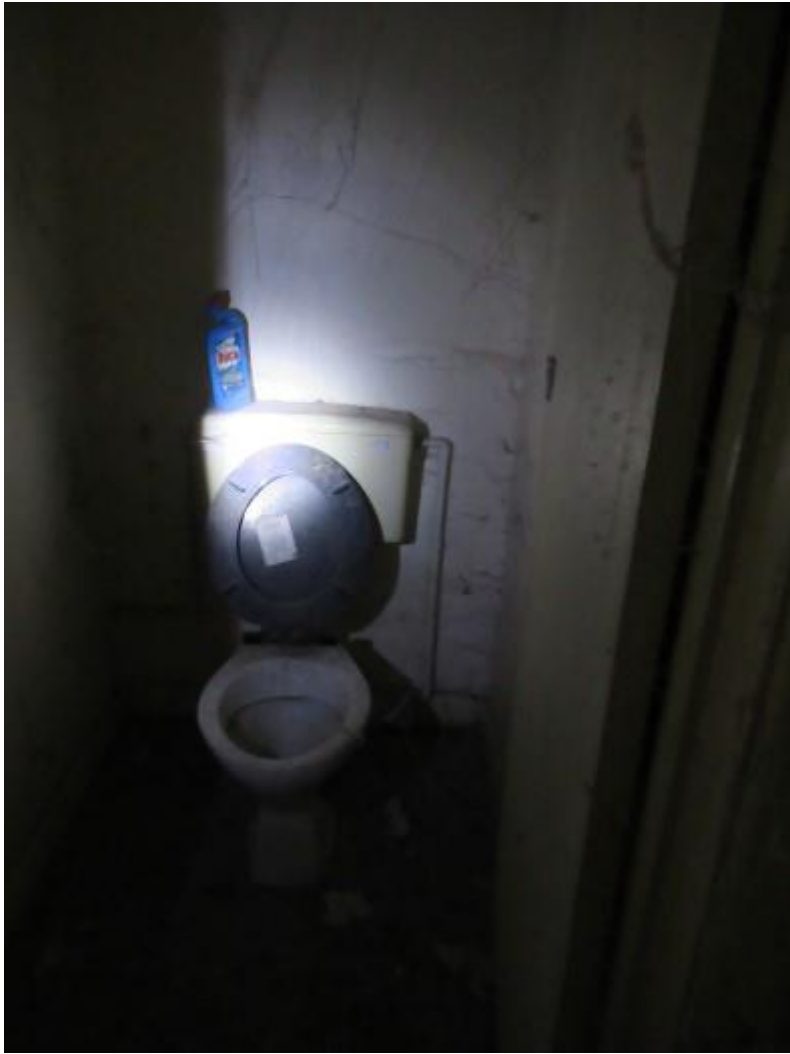
Poor condition of sanitary accommodation where accessed from the covered courtyard area. Depending on the proposed use to this area upgrading of the sanitary fittings will be required.

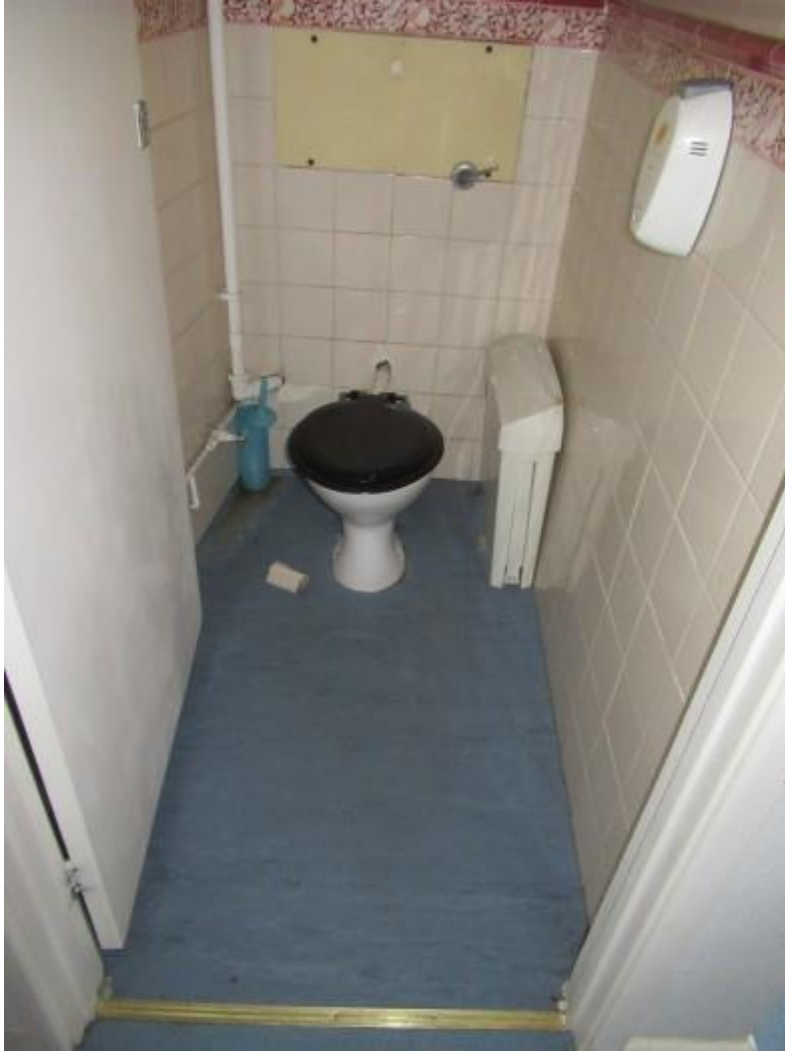
Typical condition of sanitary accommodation to the first floor.
