**Regency Chambers, Bridge Street, Newport  
Structural Assessment Report**

## **Steve Morgan Associates**

Doc ref: 125REG rev 1

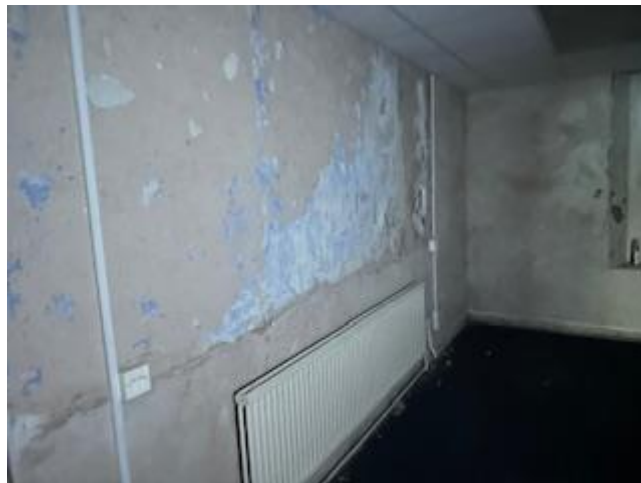
Figure 1  
Basement wall for proposed removal (1)

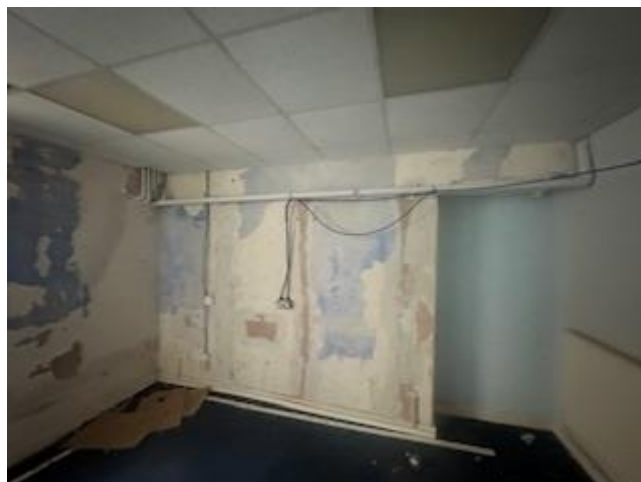
Figure 2  
Basement wall for proposed removal (2)

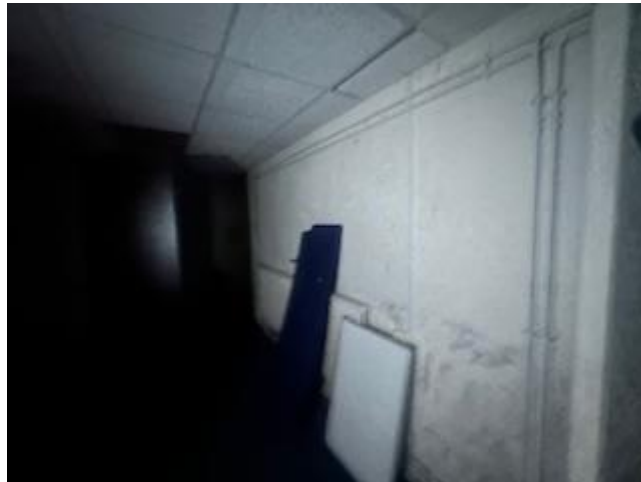
Figure 3  
Basement wall for proposed removal (3)

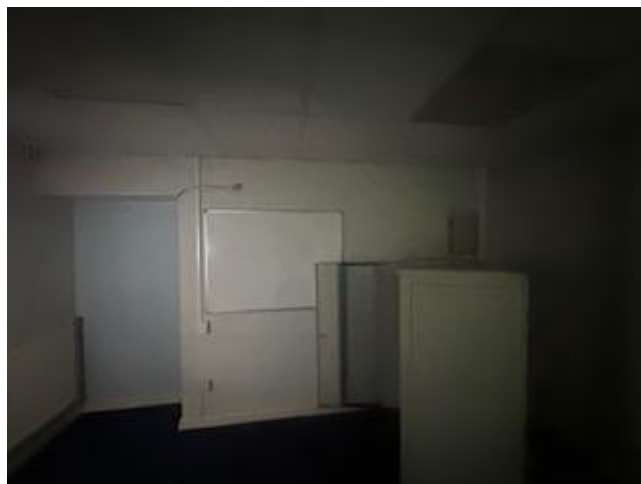
Figure 4  
Basement wall for proposed removal (4)

The proposal is to remove internal walls within the basement to accommodate the flat layout. The walls, based on the initial assessment, appear to be loadbearing. This will be established prior to any demolition works.

The walls to the basement appear to be in excess of 250mm thick and generally solid. As the walls generally continue through the full height of the building, the loads will need to be calculated. Based on initial calculations, it is considered that 203x203 steel column sections will generally be adequate to support the proposed loads.

The walls will be replaced with steel beams located on concrete padstones. A temporary works design will be undertaken for the use of the contractor prior to the removal of the walls. The temporary works design will set out both the method and layout of the temporary propping. All design will be approved by the Local authority under a Building Regulations application. The temporary works is likely to be a combination of needles and propping.

The removal of the walls is considered to be a standard building operation if undertaken by a competent building contractor. All beams will be fire protected. The proposed structural openings are of nominal size and no specialist propping is considered necessary. Due to the headroom within the basement, it is considered that beams not exceeding 200-250mm in depth will be utilised.

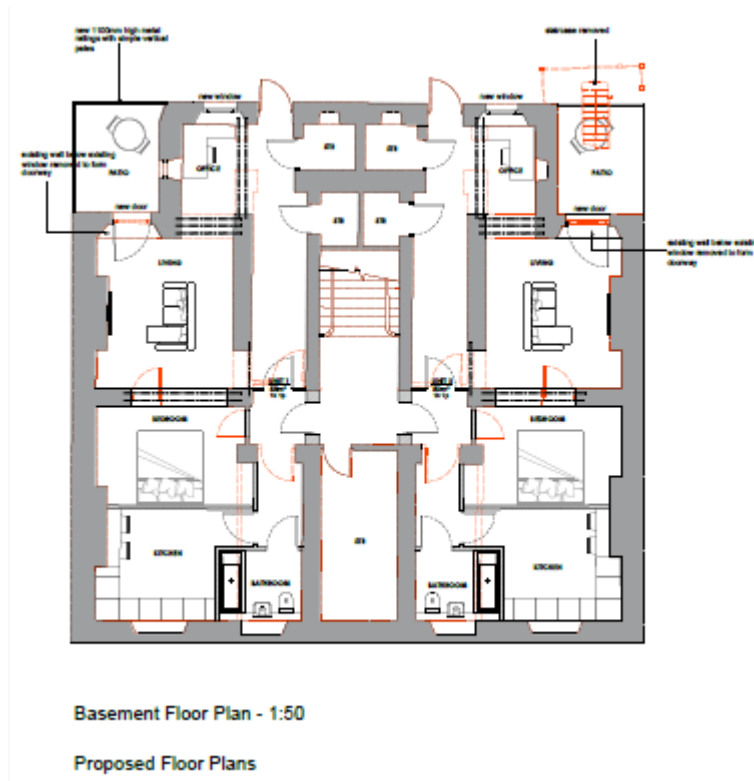
Figure 5  
Proposals

It is considered that the proposed structural works indicated in Figure 5 are achievable provided the correct temporary works are installed. Initial indications would suggest the use of 203x203 column sections will have the capacity to support the wall loads.
