# Tree Technical Note

**Client:** Ty Green Ltd

**Site Address:** Land at Penyworlod Farm, Penhow, Caldicot, NP26 3AJ

**Date:** 24.05.23

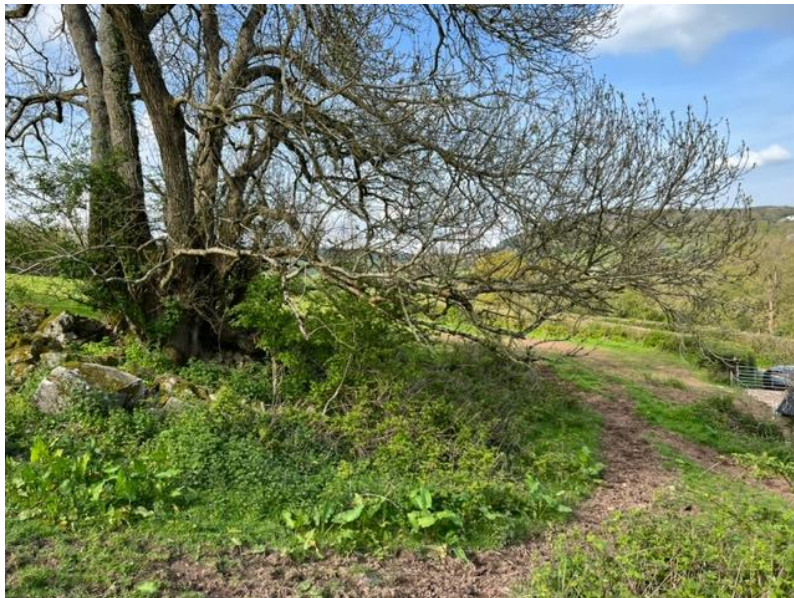
In the image above the horse track around T1 is visible in the foreground. Tree protection fences on this track will keep rooting areas safe from development activity. The tree should be reduced in size to improve site safety.

1. Make T1 safe by re pollarding or crown reduction of 6-8m at suitable lateral branches but retain the tree for historical and wildlife value.
2. Ensure T2 remains as a field tree as it stands now with some minor crown cleaning work if required.
3. Erect suitable tree temporary tree protection fencing for each tree to provide the CEZ area around T1 and T2 as shown on the TCP-TPP a4 plan.

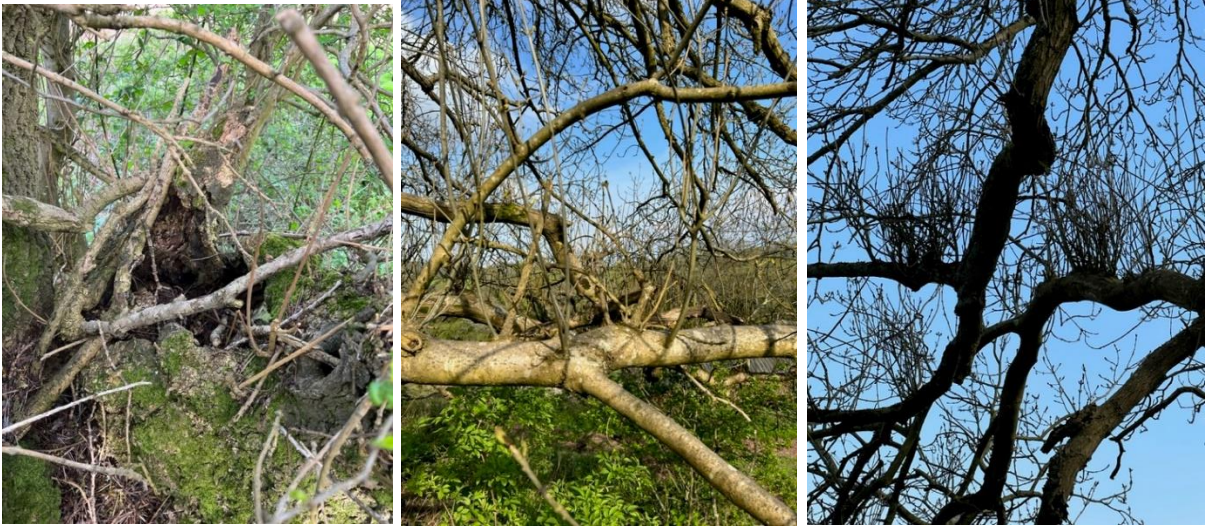
T1. Closest to the barn is a veteran ash pollard which has become outgrown. This means that a long time ago all main scaffold limbs were removed from the tree back to the main low stump. Some of these original pruning wounds have now decayed and have left the main low stump hollow in places with cavities within the tree trunk/stem. Being a veteran and important for ecological purposes, the tree is an A/2/3 category tree under BS5837. The tree does have *Hymenoschyphus fraxineus* infection. I can tell this by the reaction shoots that are throughout the crown. These are small pencil like shoots that stand mostly vertical on all limbs. I could also see various areas of dead buds/twigs within the crown. The tree will need to be in full leaf for a final categorization for ash die back but my gut feeling is the tree will be well into stage 2 or maybe even stage three. Stage four is a tree that is pretty much dead.

The client wants to keep the tree so knowing the true physiological condition will be important when in full leaf for long term safety reasons. Infected mature ash trees are known to drop large limbs as they become more brittle as the physiological decline progresses to stage 2+. We should not forget that this tree's structure is already compromised through decay within the main stem/s. My feeling is the tree should be reduced in size significantly by around 6-8m at suitable lateral branches, or potentially back to where the main scaffold limbs develop from the main low stem as a full re pollard. If this were to happen, it'd remove leverage and remove a lot of risk to the existing barn and potential work area of the proposed. The tree will then continue to provide epicormic regrowth shoots as long as it is able to do so. This could be many years and even eventually lead to another crown forming if the tree physiological reserve copes with the hard pruning which is required for safety. This pruning process is what the tree has been through before.

The above images show infection reaction shoots in response to the Hymenoscyphus infection T1 has.

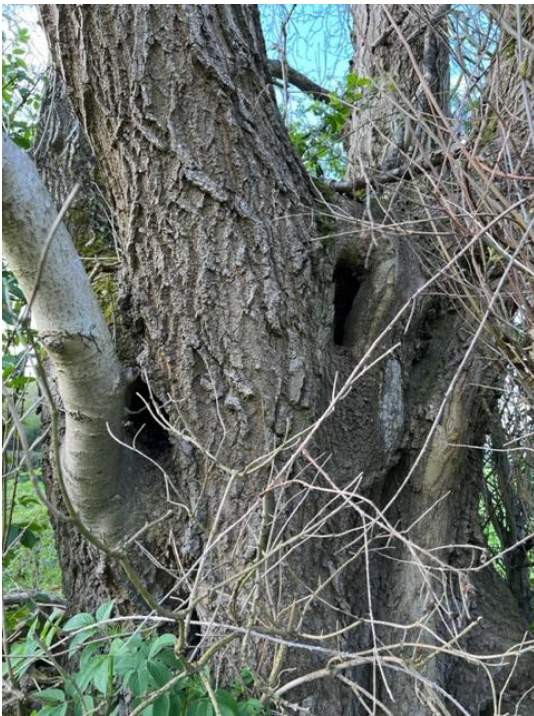
This image left shows the various decayed pruning wounds that extend back into the hollow stem. Great for wildlife but not good for structural support of weak limbs near buildings.
