ARBORICULTURAL REPORT

Health and Condition Survey

**140 Caerleon Road
Newport
NP19 7GS**

Date: July 2024

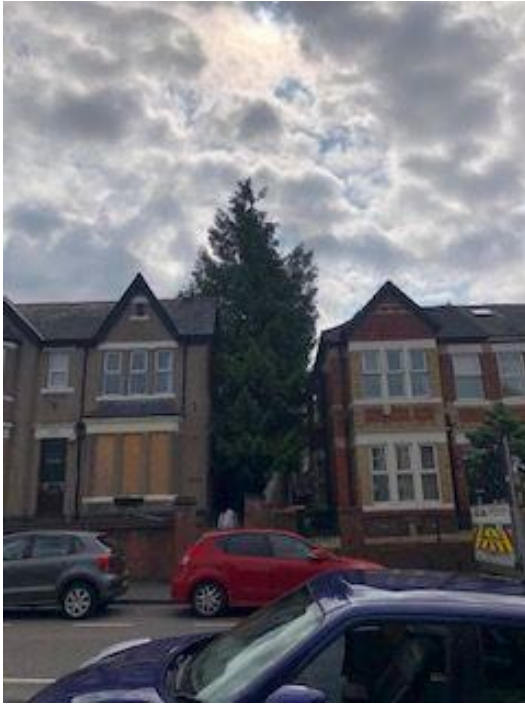
IMAGE 1: Tree T1

This property is currently disused and can be accessed from the Caerleon or Morden roads. The single tree that is on the site is shown in IMAGE 1. The tree is located on the southern side of the main building and at its nearest point the main stem is 1.88 metres from the building.

This tree has a single stem and due to its height and location it is clearly visible from the public highway and the neighbouring properties. The southern side of the crown overhangs the neighbouring property by approximately three metres and a number of its branches are in contact with the walls and roof of the adjacent buildings.

After taking into consideration all the relevant factors such as the tree's form, its exposure, condition and the surrounding targets, in my professional opinion the risk of the tree's roots, stem or branches failing is in the medium category.

| Tree stem ID | Species | Age | Ht | Crown spread | DBH | Pc | Sc | Observations / Recommended works | Cat | Risk |
|---|--|---|---|---|---|---|---|--|---|---|
| T1 | Western Red Cedar (<i>Thuja plicata</i>) | EM | 14.0 | N - S 7.3 E -W 7.8 | 50 | F | G | Due to its increasing size and growth this tree is not suitable for this location and should be removed. | 2 | M |

1. To prevent further structural damage this tree should be removed to within 50cms of the existing ground level.
2. All recommended tree work should be completed within the recommended time period in Table 1 and in accordance with BS3998:2010 Tree Work - Recommendations and current good practice.
3. Prior to any tree pruning or removal the structure of the tree should be checked for roosting, nesting or hibernating species such as bats and birds. (Refer to the biodiversity section below).

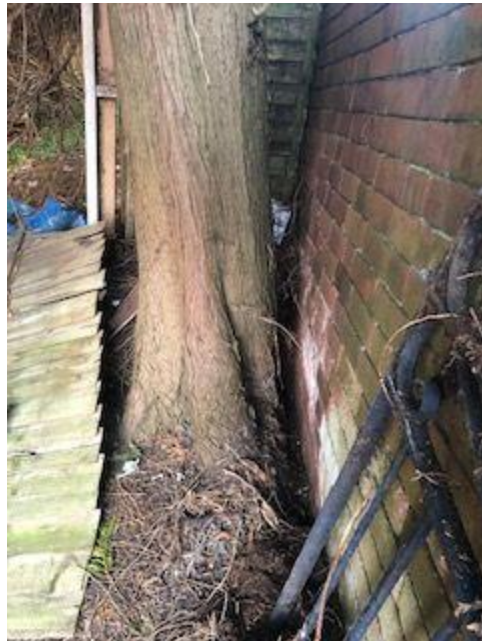
IMAGE 2: Main stem and boundary wall

There is a brick boundary wall on the southern boundary which has a vertical misalignment with a lean to the south and failed joints at numerous locations.

Due to the debris and decomposing leaf litter around the rooting area of the tree only the base of the main stem is visible. The base of the stem is directly adjacent to the brick boundary wall that divides 138 and 140 Caerleon Road - IMAGE 2. The tree may not be the main cause of the damage to the wall but it is a significant contributing factor. As the main stem and roots continue to grow the pressure and structural damage to the wall will increase in severity.
