## Tree Condition Inspection

62 Field Park Road

Dated: April 2023

Reported by Mr. Vaughan. Lewis. L4 Dip Arb. M.ARBORA  
Approved by Mr. S J Ambler Cert.Arb.(RFS), Tec.Arbor.A., Dip.Arb.(RFS), F.ARBORA.  
of

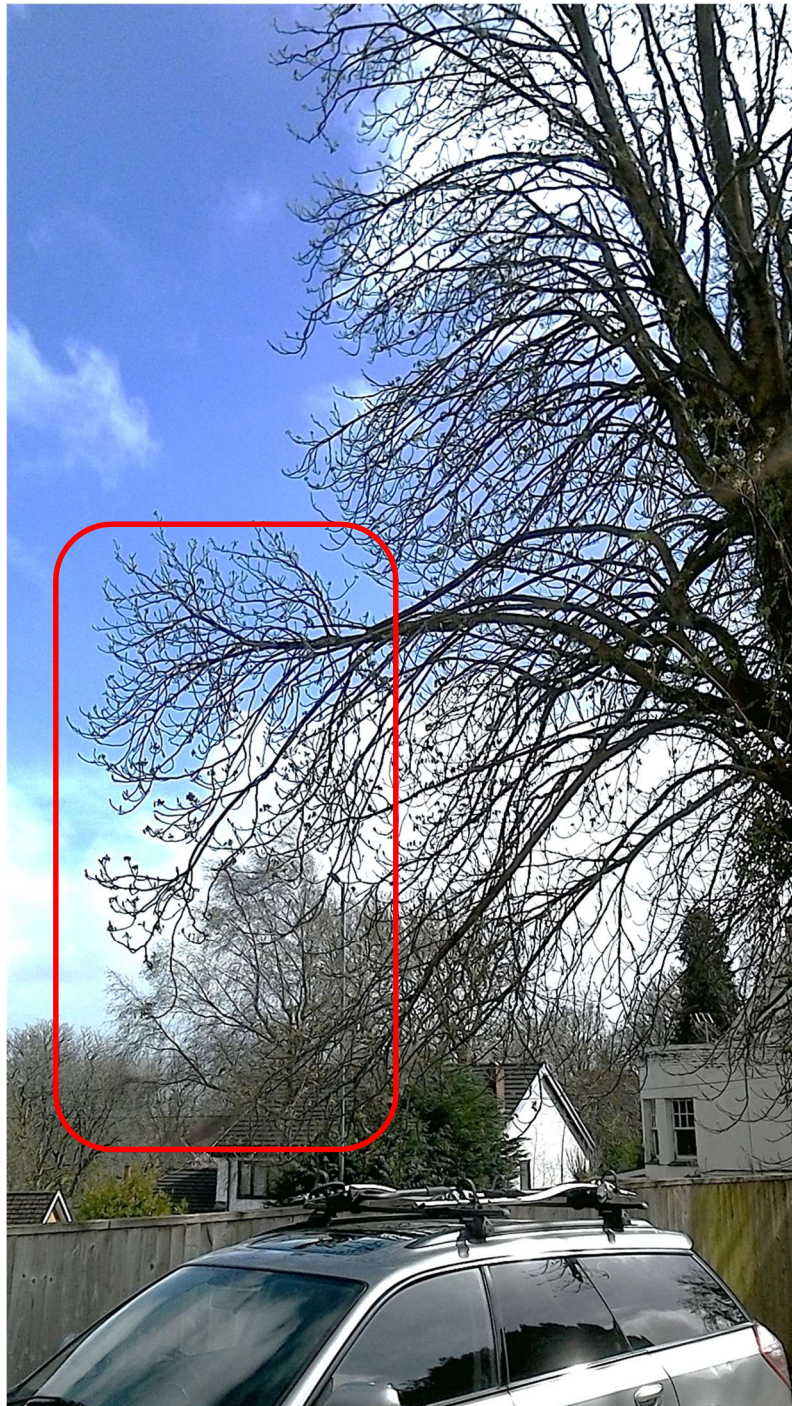
**Photograph 1.** Tree 2 - The lateral and descending branches to the east overhang the neighbouring property. The limbs formed at 6-8-m AGL extend beyond the main crown by some 3-m.

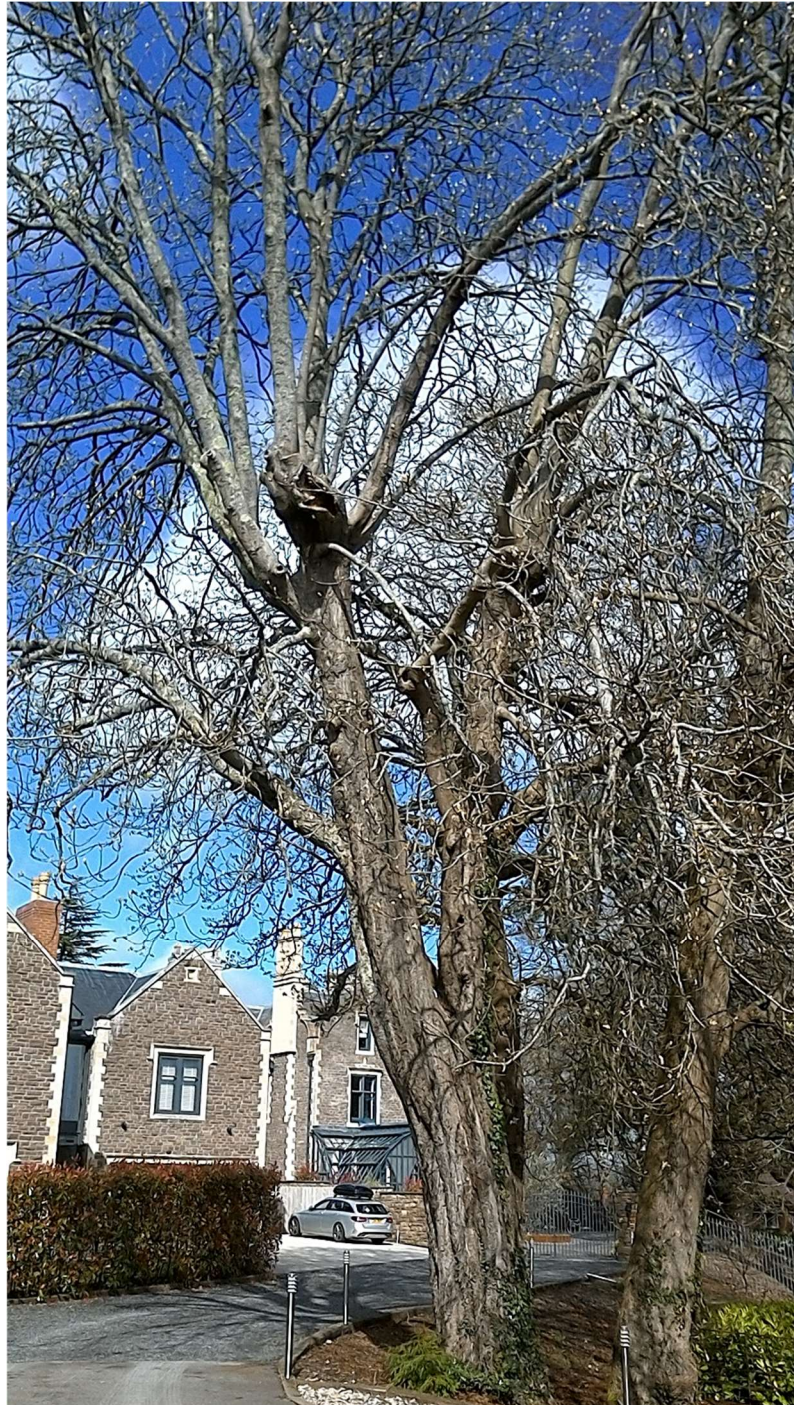
| Tree N.o | Tree Tag | Tree Species | Stem (mm) | Crown Spread | Tree Height (m) | Age Class | Remarks | Recommendations | Target | Bat Habitat | Priority | Photo Ref |
|---|---|---|---|---|---|---|---|---|---|---|---|---|
| 6 | 1088 | Horse chestnut<br>( <i>Aesculus hippocastanum</i> ) | 1040 | L | 32m | M | <p>This tree is a lapsed, high pollard formed at 8-10-m AGL.</p> <p>The cream coloured, flat fungal fruiting body of <i>Rigidoporus ulmarius</i> was identified between the buttresses to the north-east during the 2007 survey, but has not been observed since. However, it still appears to be associated with minor localised decay when assessed with a rudimentary resonance test, using a sounding hammer. <i>R. ulmarius</i> results in a brown rot, typically associated with a wound site. Here, it is located on the structurally significant, tension side of the tree with an asymmetric crown pre-disposed to the south and west.</p> <p>Several black exudates were noted on the stem up to 2-m above ground level, likely to be associated with the commonly occurring Bleeding canker of horse chestnut (<i>Pseudomonas syringae</i> pv. <i>aesculi</i>).</p> <p>Although the tree was inspected out of leaf during the last two condition surveys, a discussion with the resident would suggest the crown also has the commonly occurring Guignardia leaf blotch (<i>Guignardia aesculi</i>). A rather disfiguring condition that turns the leaves a patchy brown, sometimes curling along their length and can result in premature leaf abscission. Typically this occurs in the lower portion of the crown. Although this reduces the ability of the tree to photosynthesis, there is no evidence</p> | <p>Given that this tree is likely to have low vitality a single pollard operation is not advised. Therefore:-</p> <p>Undertake a two phased pollard operation, initially by 6-m, and then 3 years later at 1.5-m above the previous knuckles, and retaining the lower branching.</p> <p>Qualified climber to undertake a bat, and nesting bird inspection prior to works occurring.</p> <p>Remove deadwood.</p> <p>Place on a 10-year, pollarding cycle, subject to growth rates and size, to be assessed by a qualified arborist prior to any intervention.</p> | High | Med | 2 | 2 |

| Tree N.o | Tree Tag | Tree Species | Stem (mm) | Crown Spread | Tree Height (m) | Age Class | Remarks | Recommendations | Target | Bat Habitat | Priority | Photo Ref |
|---|---|---|---|---|---|---|---|---|---|---|---|---|
| | | | | | | | <p>of serious long-term consequences. Also Horse chestnut leaf minor (<i>Cameraria ohridella</i>) is typically present (unconfirmed).</p> <p>The tree forks at 4-m AGL to form a dominant south-west stem, and sub-ordinate east stem is formed under tension, but with a broad deep rib on the tension side and a slightly less prominent column of reaction wood to the south-east, in response to torsional wind loading.</p> <p>There is a decay cavity at 4-m to the north, measuring 300-mm diameter x 300-mm deep (estimated), with an ascending pocket of decay. A small downward facing cavity also occurs to the south at 4.5-m AGL potentially coalescing, although there is no obvious indication when undertaking a rudimentary resonance test with a sounding hammer, off a ladder. The cavity opening has been widened by squirrels, but still has bat potential.</p> <p>There is an upward facing cavity in the pollard knuckle on the inner side of the east stem.</p> <p>A dead peg with decay cavity is noted at 9-m AGL to the southwest, measuring an estimated 1000-mm x 300-mm x 100-mm.</p> | Monitor annually. | | | | |

**Photograph 2.** Tree 6 - There is a decay cavity at 4-m to the north, an ascending pocket of decay. A small downward facing cavity also occurs to the south at 4.5-m AGL potentially coalescing. There is an upward facing cavity in the pollard knuckle on the inner side of the east stem.

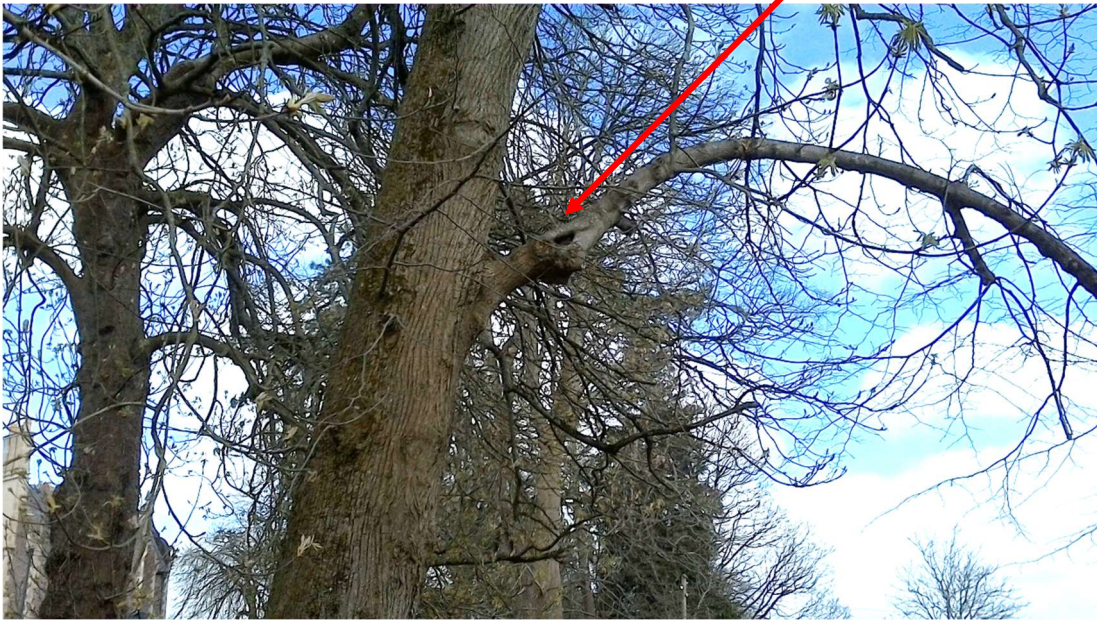
| Tree N.o | Tree Tag | Tree Species | Stem (mm) | Crown Spread | Tree Height (m) | Age Class | Remarks | Recommendations | Target | Bat Habitat | Priority | Photo Ref |
|---|---|---|---|---|---|---|---|---|---|---|---|---|
| 7 | 1694 | Crimean lime<br>( <i>Tilia x euchlora</i> ) | 730 | L | 22.2 | M | This tree forks at 8-m AGL to form a bifurcated stem, with a subordinate east stem and dominant west stem. It has recently undergone a crown reduction (circa 2018). A small decay cavity occurs on the tension side of the lower arching limb, over the Court House driveway. There is notable reaction wood suggesting significant decay.<br><br>Located in management company land. | Remove lower limb over the Court House drive. | High | Low | 3 | 3 |

**Photograph 3.** Tree 7 - A small decay cavity occurs on the tension side of the lower arching limb, over the Court House driveway. There is notable reaction wood suggesting significant decay.

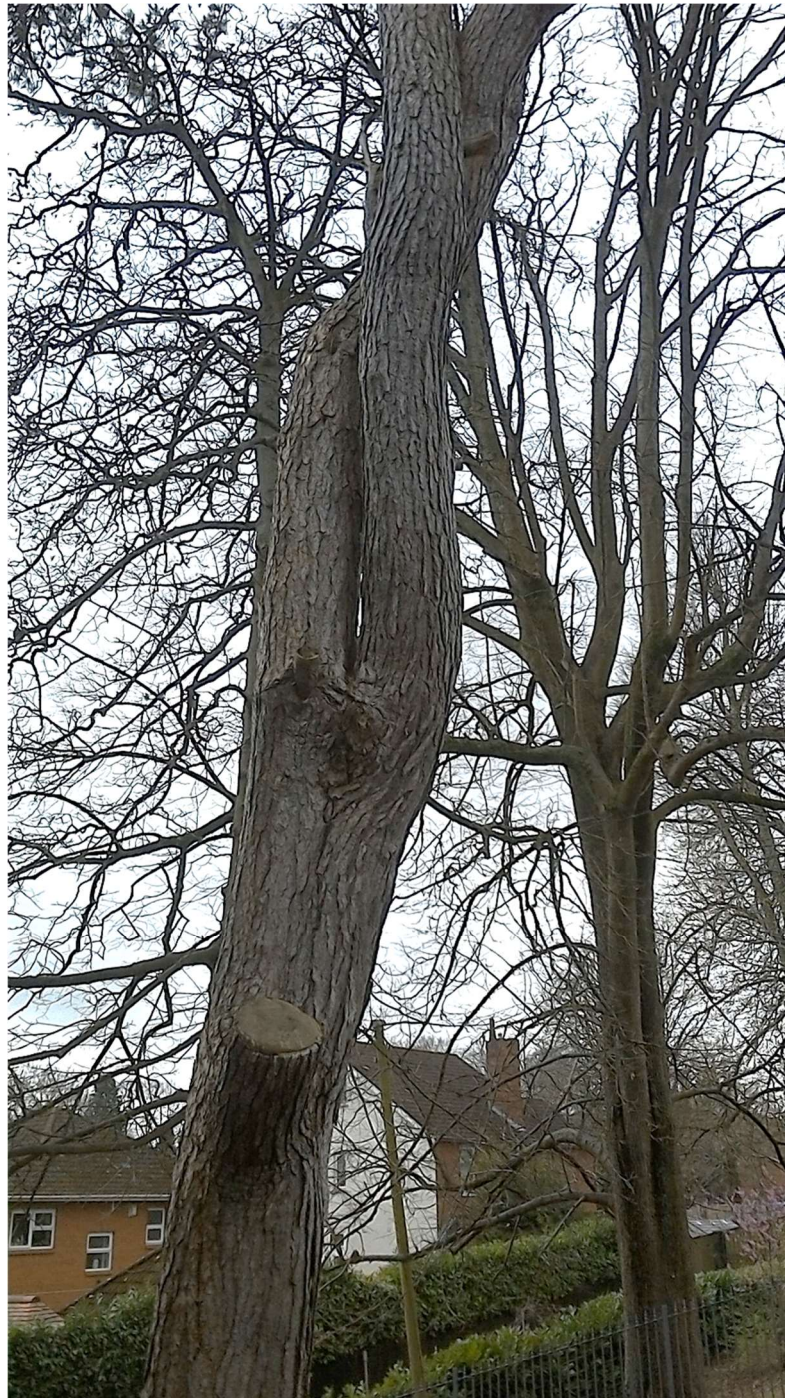
| Tree N.o | Tree Tag | Tree Species | Stem (mm) | Crown Spread | Tree Height (m) | Age Class | Remarks | Recommendations | Target | Bat Habitat | Priority | Photo Ref |
|---|---|---|---|---|---|---|---|---|---|---|---|---|
| 12 | 1686 | Corsican pine<br>( <i>Pinus nigra</i> ssp.<br><i>laricio</i> ) | 910 | L | 27.3 | M | <p>There is a pocket of basal decay developing to the north, identified with a rudimentary resonance test, using a sounding hammer, measuring approximately 200-mm long x 200-mm high.</p> <p>Due to wind-loading there is a broadening of the base to the south.</p> <p>As typical for the species, there are acute changes of angles within the branches forming the upper crown, and thereby creating notch stresses.</p> <p>A lower limb has been removed at 3-m AGL to the north, resulting in a large diameter stub.</p> <p>The tree forks at 6-m AGL under tension due to the east stem crossing the west stem, with each forming opposite sections of the crown from where they derived on the trunk. The stems make contact at 9-m AGL, with discernible reaction wood forming to create a 'cushion', in accordance with the 'axiom of uniform stress'.</p> <p>The only rib formation is to the north, where an old branch stub acts as a wedge within the fork union. There is notable broadening at the base of the south stem under loading from the prevailing south-westerly wind.</p> <p>There is minor branch tip dieback noted within the crown.</p> | <p>Remove deadwood &gt; 50mm diameter.</p> <p>Redress stub to branch collar.</p> <p>Monitor tree basal decay, crown health and lateral bark crack annually</p> | High | Low | 4 | 4 |

| Tree N.o | Tree Tag | Tree Species | Stem (mm) | Crown Spread | Tree Height (m) | Age Class | Remarks | Recommendations | Target | Bat Habitat | Priority | Photo Ref |
|---|---|---|---|---|---|---|---|---|---|---|---|---|
| | | | | | | | A lateral bark crack is noted on the tension side of the east stem, to the side of a branch stub.<br><br>Located within garden of the main house. | | | | | |

**Photograph 4.** Tree 12 - The tree forks at 6-m AGL under tension due to the east stem crossing the west stem. The stems make contact at 9-m AGL , with discernible reaction wood forming to create a 'cushion' .

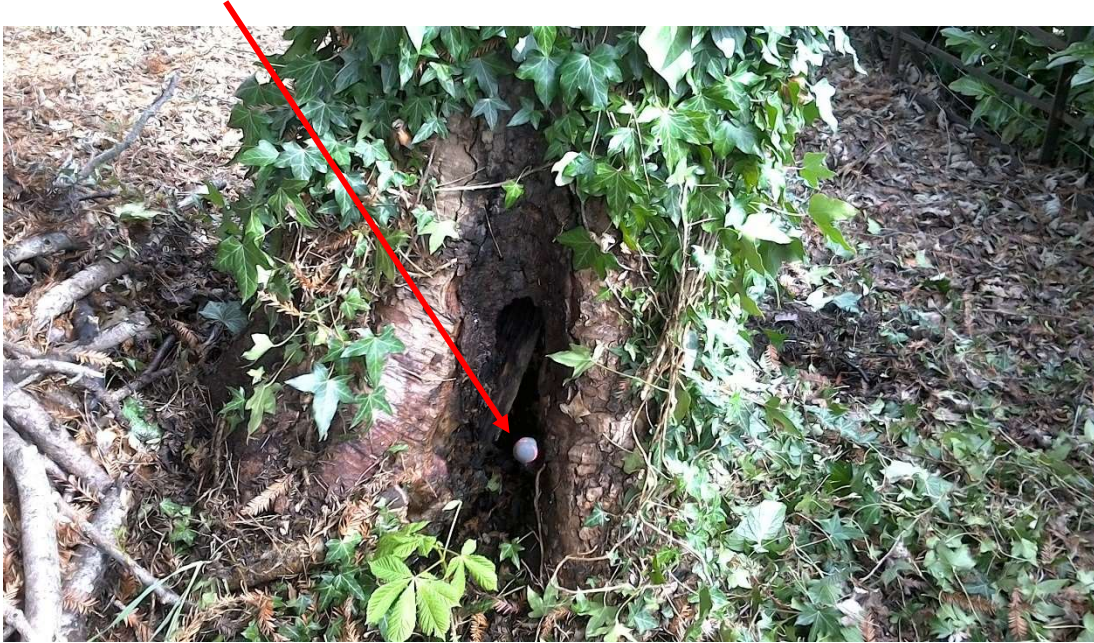
| Tree N.o | Tree Tag | Tree Species | Stem (mm) | Crown Spread | Tree Height (m) | Age Class | Remarks | Recommendations | Target | Bat Habitat | Priority | Photo Ref |
|---|---|---|---|---|---|---|---|---|---|---|---|---|
| 15 | 1681 | Sycamore ( <i>Acer pseudoplatanus</i> ) | 590 | EM/M | 19.5 | EM | There is a basal decay wound to the south measuring 200-mm x 150-mm.<br>Using a metal probe the decay extends centrally to a depth of 400-mm (previously this decay was measured at 250-mm depth in 2017).<br>There is, however, significant buttress development occurring in reaction to this decay, to either side of the cavity, but with decay now progressing into these buttresses.<br>Due to the dominant presence of tree 14, the deep, crown is asymmetric and predisposed to the east over the Court House drive. | Remove deadwood.<br><br>Undertake decay detection testing to map the extent of decay and ascertain its structural integrity.<br>OR<br>Consider coppicing this tree in order to release the Coastal redwood. The sycamore will rejuvenate, by producing shoots from the | Med | Low | 3 | 5 & 6 |

**Photograph 5.** Tree 15 - There is a basal decay wound to the south. A metal probe extends to a depth of 400-mm (previously this decay was measured at 250-mm depth in 2017).

| Tree N.o | Tree Tag | Tree Species | Stem (mm) | Crown Spread | Tree Height (m) | Age Class | Remarks | Recommendations | Target | Bat Habitat | Priority | Photo Ref |
|---|---|---|---|---|---|---|---|---|---|---|---|---|
| | | | | | | | <p>Small and medium diameter deadwood occurs in the crown, and is primarily related to competition shading by the Coastal redwood (T14), and squirrel related browsing damage.</p> <p>Located within garden of main house.</p> | cut stool, to form a multi-stemmed tree, overtime. | | | | |

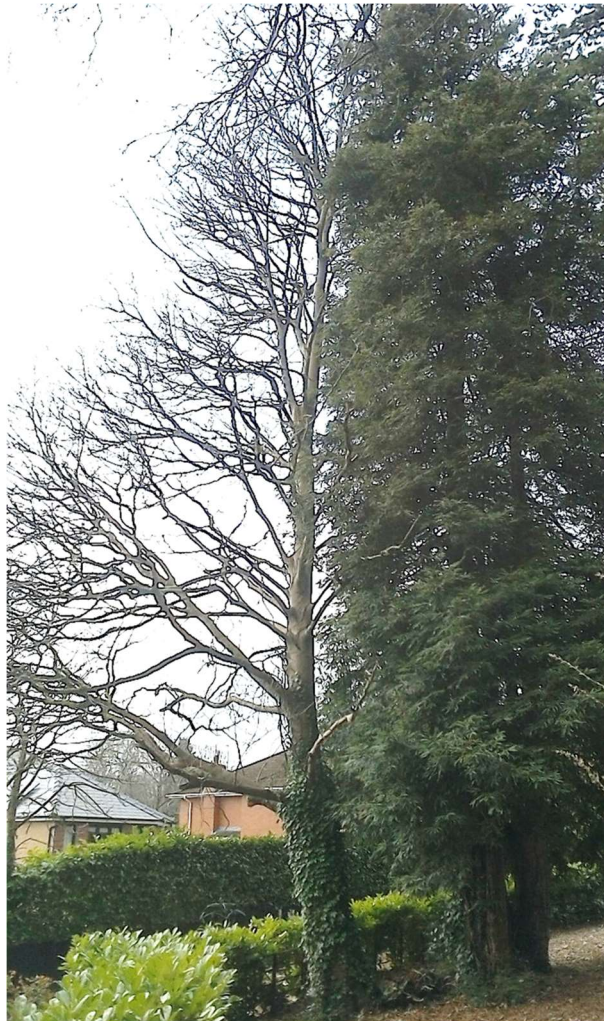
**Photograph 6.** Tree 5 (left). Asymmetric crown predisposed to the drive of the Court House, with the dominant Coastal redwood (T14 - right).

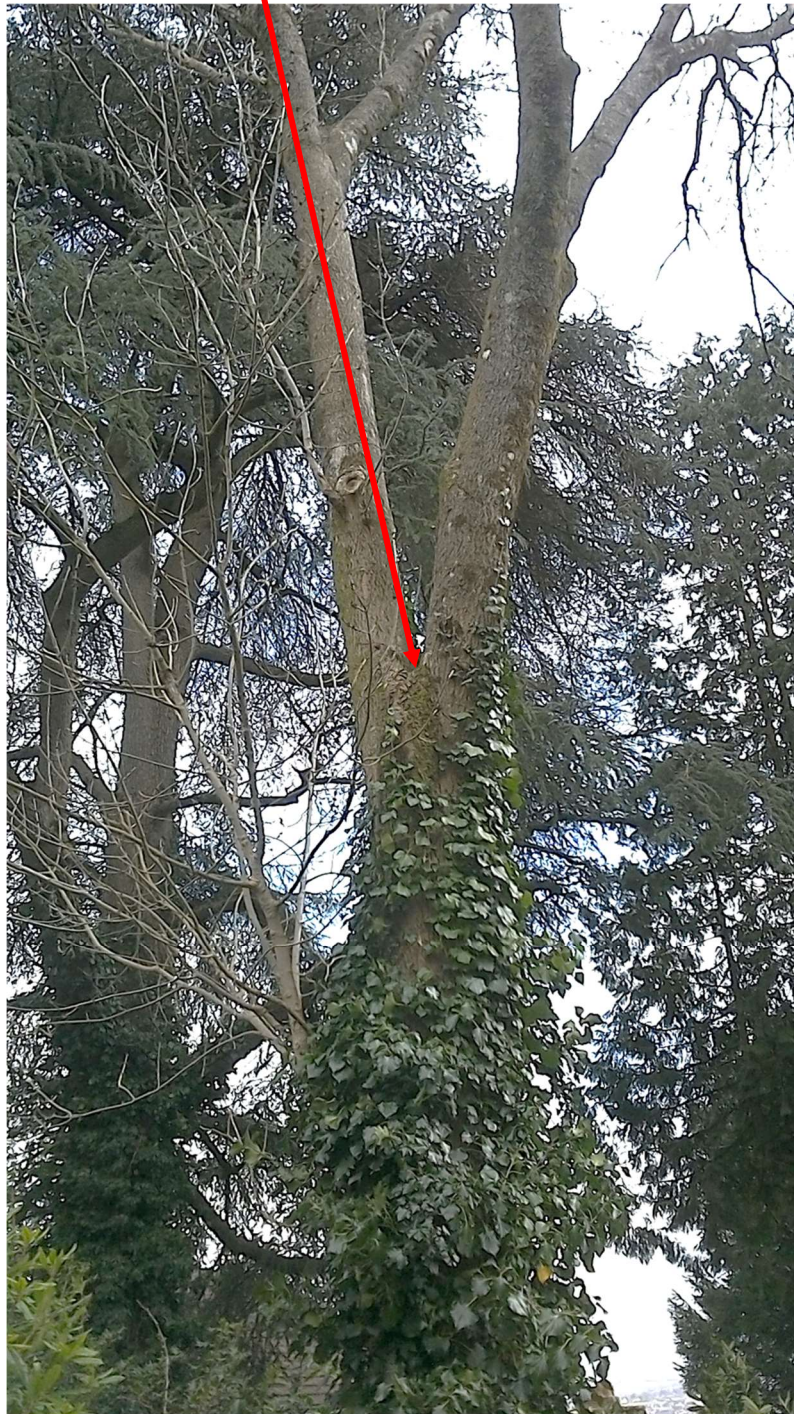
**Photograph 7.** Tree 3 – Structurally weak, main fork formed under compression, with the crown displaying the early symptoms of Ash dieback disease .

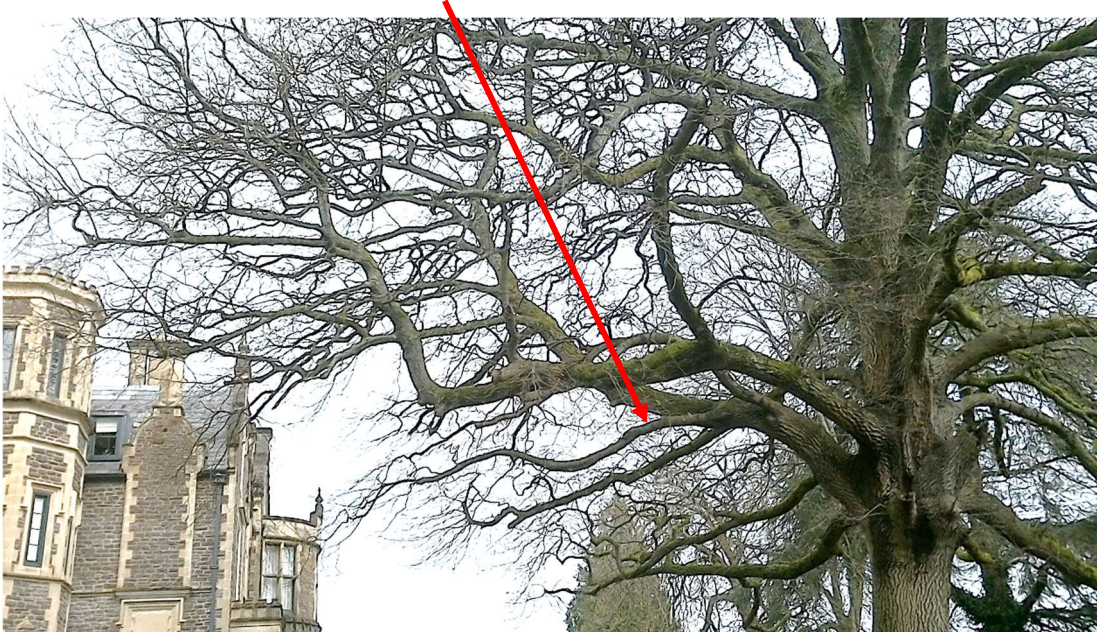
| Tree N.o | Tree Tag | Tree Species | Stem (mm) | Crown Spread | Tree Height (m) | Age Class | Remarks | Recommendations | Target | Bat Habitat | Priority | Photo Ref |
|---|---|---|---|---|---|---|---|---|---|---|---|---|
| 20 | 1678 | Turkey oak<br>( <i>Quercus cerris</i> ) | 1270 | VL | 30 | M | <p>This is a magnificent specimen tree of impressive size and spread.</p> <p>There is a decay cavity on the underside of the west primary lateral branch, at 6-m above ground level, under which cars park and turn.</p> <p>There are several pruning pegs, with a large fractured and torn peg at 10-m above ground level, to the southeast following failure of a lateral limb. Subsequently the large diameter south limb no longer benefits from the dampening effect that this neighbouring limb would have offered.</p> <p>The massive, heavily end loaded, lateral limb growing towards the Court House has notable reaction wood at the fork union, with the parent stem.</p> | <p>Remove the lateral primary branch with decay cavity, at 6-m AGL to the west, back to the main limb.</p> <p>Remove minor deadwood to southeast over the Court House.</p> <p>Undertake climbing inspection to assess the structural integrity on the tension (upper) side of the massive lateral limbs.</p> <p>Subject to findings:-</p> <p>Reduce the south and west lateral limbs over the</p> | High | Low | 2 | 8 & 9 |

**Photograph 8.** Tree 20 – decay cavity on primary branch over parking area/ turning circle.

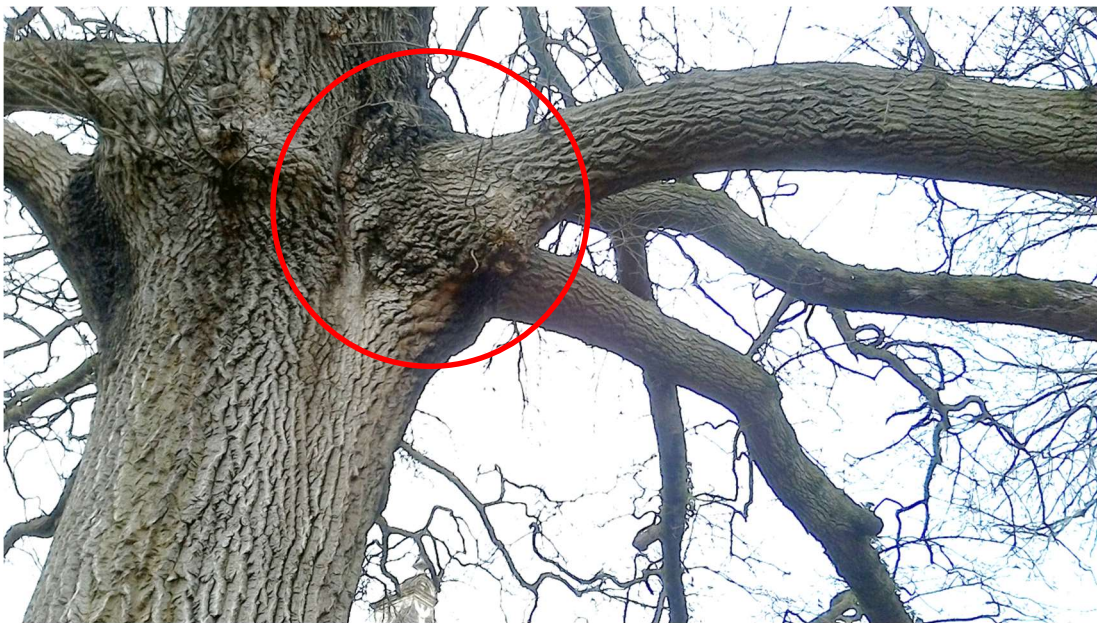
**Photograph 9.** Tree 20 – Reaction wood at fork union of north-east lateral limb that extends over the Court House grounds.

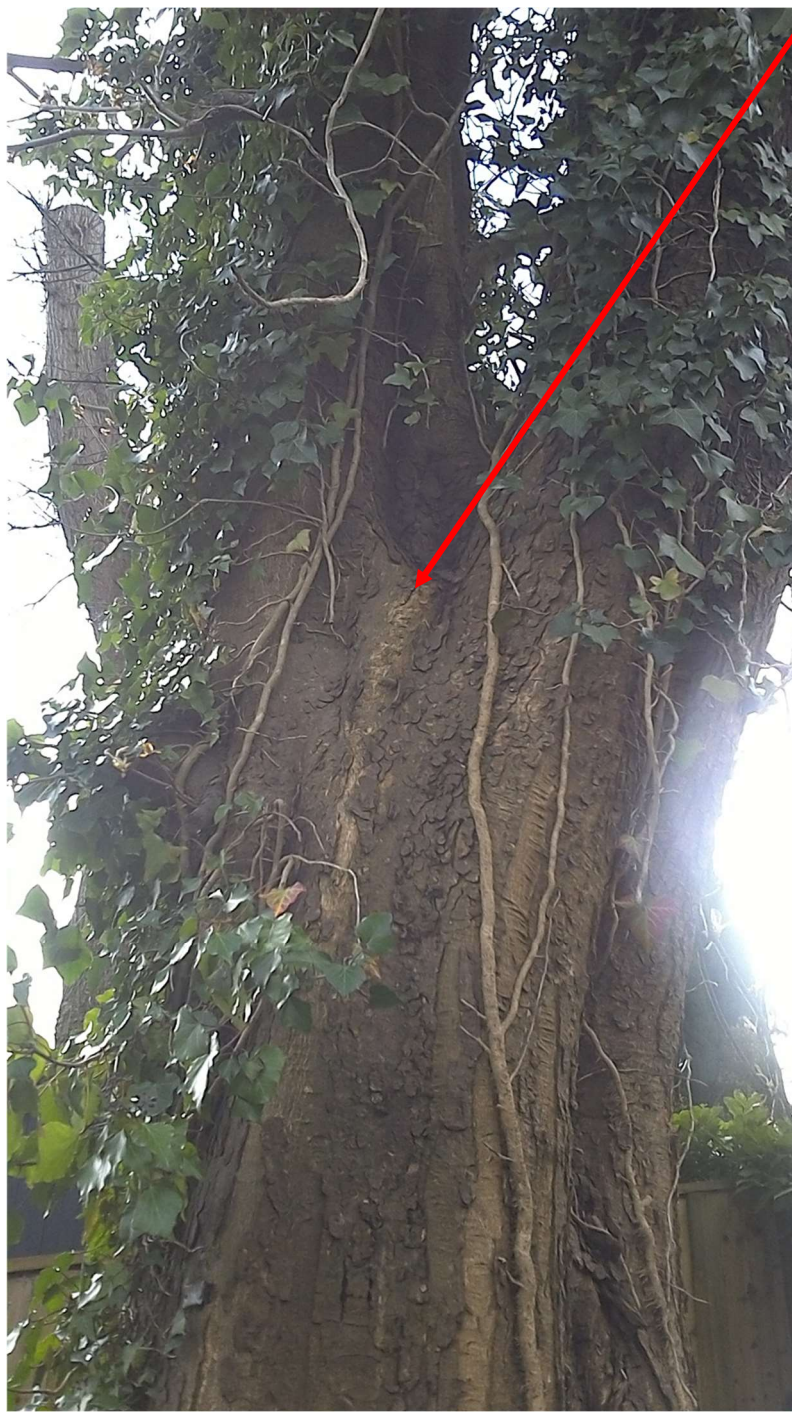
| Tree N.o | Tree Tag | Tree Species | Stem (mm) | Crown Spread | Tree Height (m) | Age Class | Remarks | Recommendations | Target | Bat Habitat | Priority | Photo Ref |
|---|---|---|---|---|---|---|---|---|---|---|---|---|
| 21 | 1696 | Horse chestnut<br>( <i>Aesculus hippocastanum</i> ) | 850 | L | 22 | M | <p>There is a decay wound noted on the northwest buttress considered insignificant at this time.</p> <p>The tree forks at 3-m AGL to form two co-dominant stems, with the eastern stem, soon forking again.</p> <p>This tree has a slightly compressive main fork union formed at 3-m AGL, with narrow columns of slightly pronounced reaction wood, forming ribs. These ribs have recently formed, following the removal of one neighbouring tree (T22 circa 2016) and the pollarding of another (T23 – circa 2022). For the same reason the tree has an asymmetric crown predisposed to the north, although young branch growth is now forming on the south side in response to new light levels, as the competition has been removed. There is also notable, branch extension growth to the north.</p> | <p>Reduce north crown by 2-m distally in an attempt to aid rebalancing of the crown.</p> <p>Sever ivy so the fork remains visible for tree condition inspections.</p> <p>Monitor compression fork.</p> <p>Monitor decay wound.</p> | High | Low | 3 | 10 & 11 |

Photograph 10. Tree 21- Slightly compressive main fork union, with elongated, shallow rib formation.

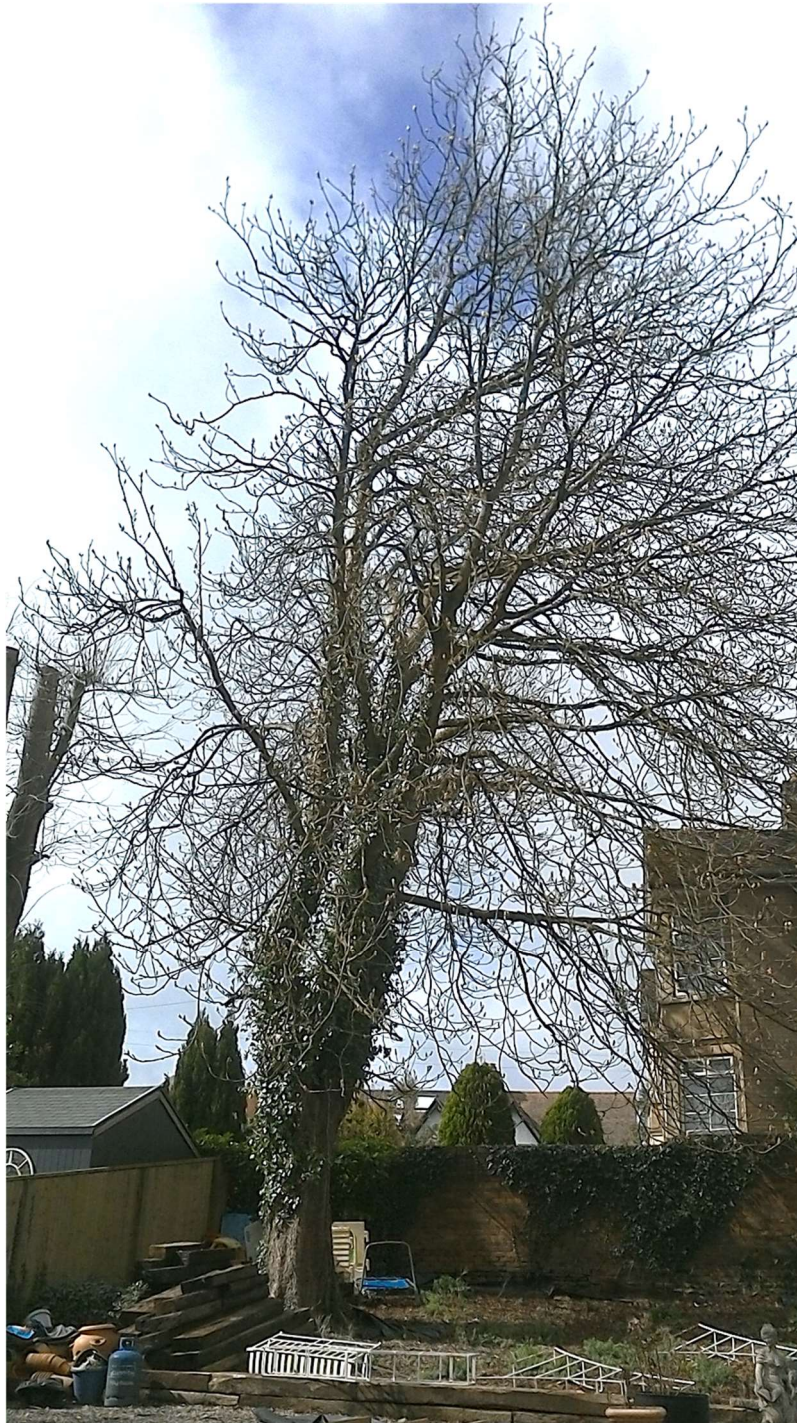
**Photograph 11.** Tree 21 – Asymmetric crown predisposed to the north (house). Formally this tree was part of a group of three, and has since lost the protection of its neighbouring trees.
