Subject - Tree 104 Caerleon Campus

Date May 2026

| Technical Advice Note | | | |
| <b>Subject</b> | Construction of retaining wall replacement and its effect on Tree T104. | <b>cc</b> | Newport City Council Planning Department |

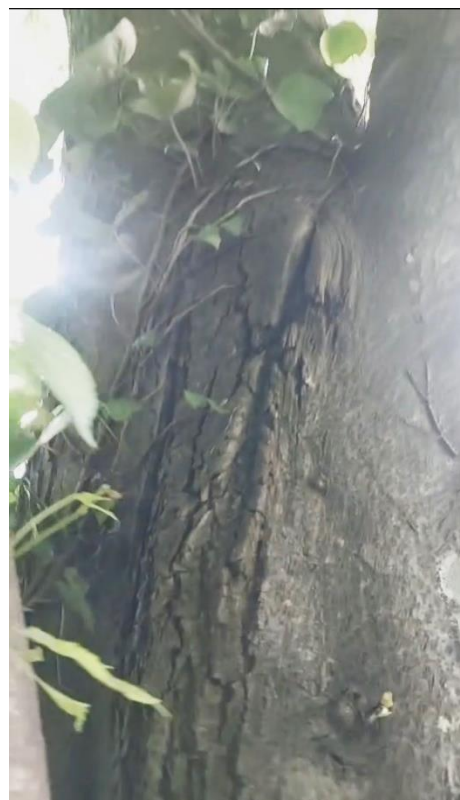
| Structural Condition | Poor (compressive defect) |

Single stemmed with several low lateral branch formations. A compression defect is noted at 1.7 metres above ground level as the recent photograph to the right shows (taken 7<sup>th</sup> May 2026).

I therefore recommend that T104 be felled and removed to ground level, with stump and principal root material removed by grinding as required to facilitate the engineering works and replacement wall construction.

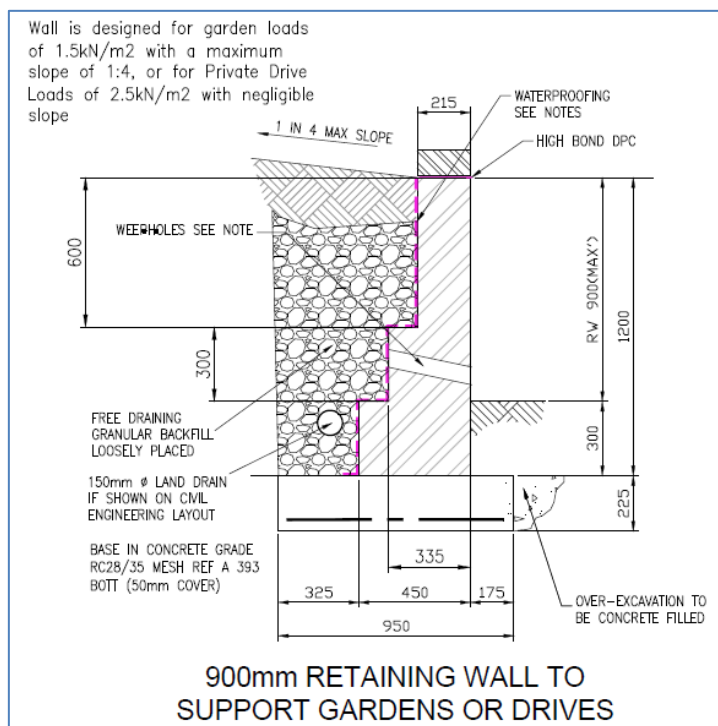
The replacement wall detail is shown on drawing RW08 Rev C1 by Betts Associates, an extract of which is reproduced below.

Although the wall is to be rebuilt broadly on the line of the original structure, the replacement detail is wider and requires excavation into the immediate rooting zone for the concrete fill. In practical terms, retention of T104 would therefore depend upon undertaking significant works within an already constrained and compromised Root Protection Area.

Demolition of the failed wall and associated reconstruction would unavoidably risk severance of roots, disruption of the soil profile and localised compaction from plant, operatives and materials. Where major roots have developed along the wall interface, damage is particularly likely during breaking out, excavation and removal of existing structures. Such disturbance is contrary to the normal objective of keeping the Root Protection Area undisturbed where a tree is to be successfully retained.

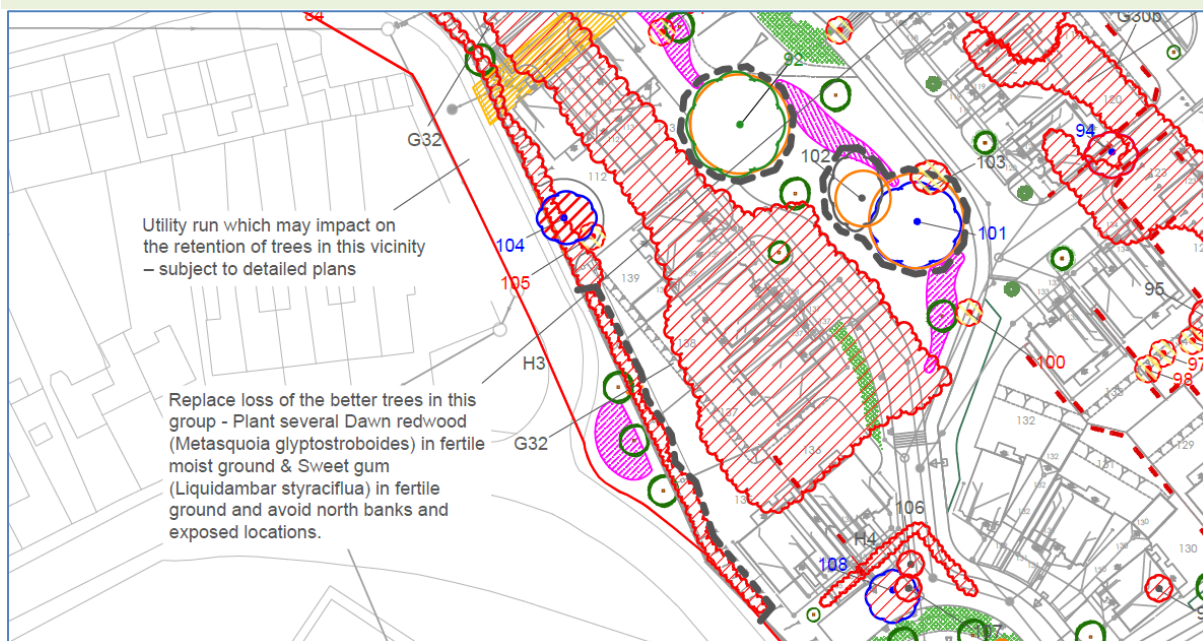
#### TREE LOCATION PLAN T104

T104, a Common Lime (*Tilia x europaea*), stands at the western edge of the development parcel adjacent to the public highway and immediately west of Plot 112. It is positioned approximately 1.5 metres from the existing retaining wall, placing the stem and principal rooting area in direct relationship with the wall reconstruction works.

The available rooting environment is materially restricted. Although the calculated Root Protection Area for a stem diameter of 475 mm is approximately 5.7 metres radius, equating to about 102 square metres under BS 5837 methodology, the tree appears to have access to only about 55 square metres of effective rooting space due to the retaining wall, gas substation, concrete slab, kerbing, hard surfacing and associated underground apparatus. This represents a substantial pre-existing constraint on both root development and long-term anchorage.

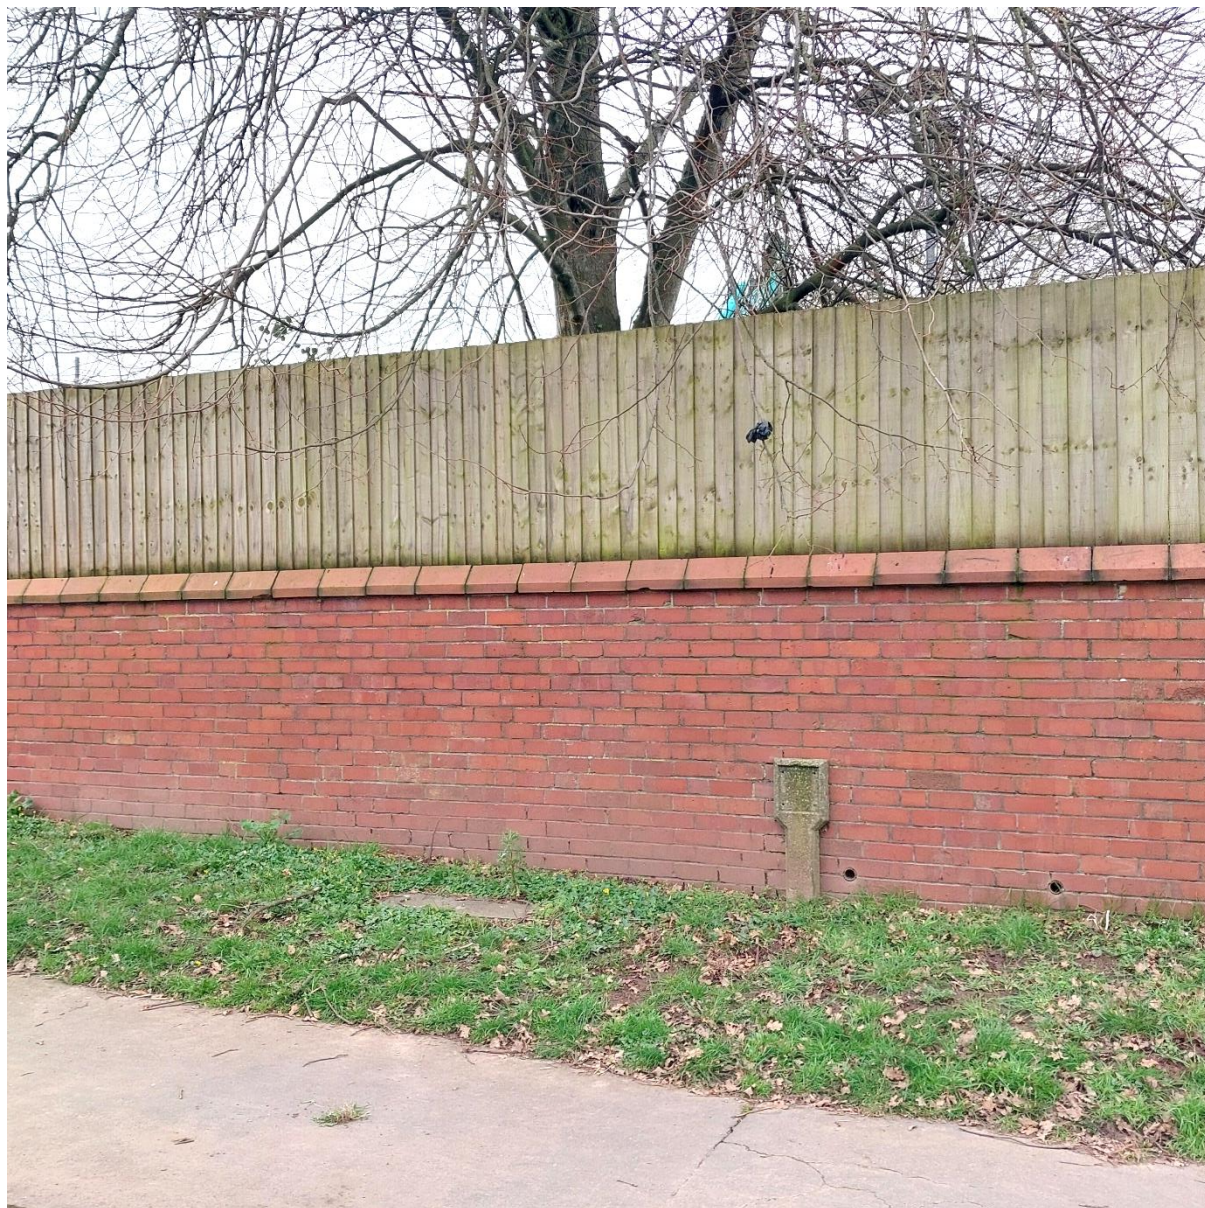
Asymmetric root-plate compromised by the retaining wall and concrete slab and nearby hard surfaces and services.

Photograph 1 – Tree T104 showing proximity to wall and evidence of underground services

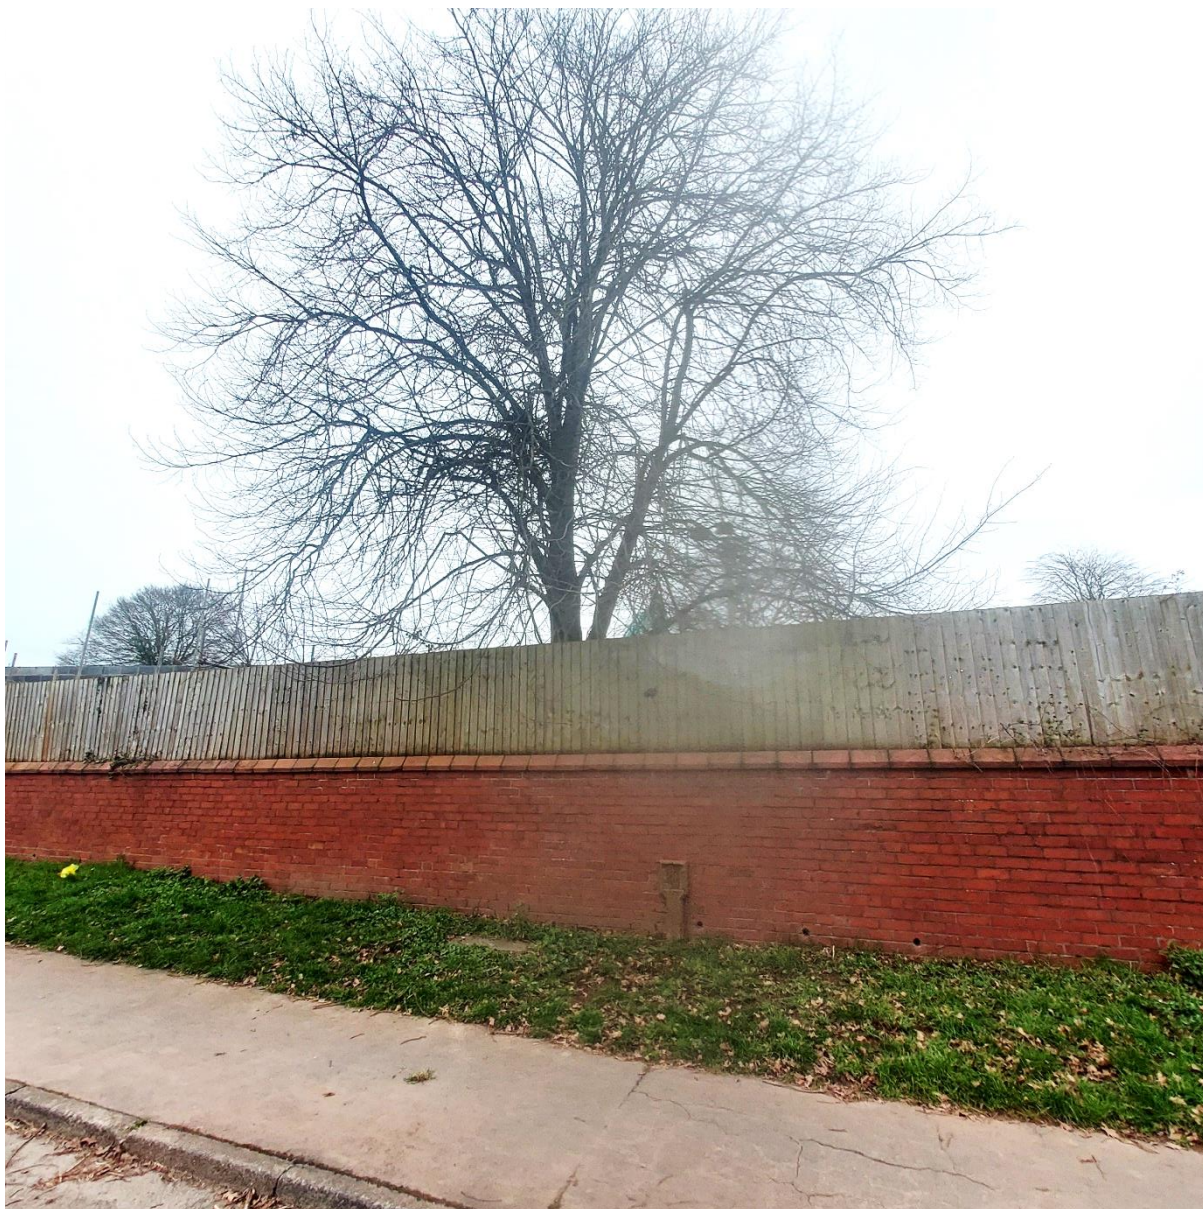
Photograph 2 – Tree T104 viewed from a distance.

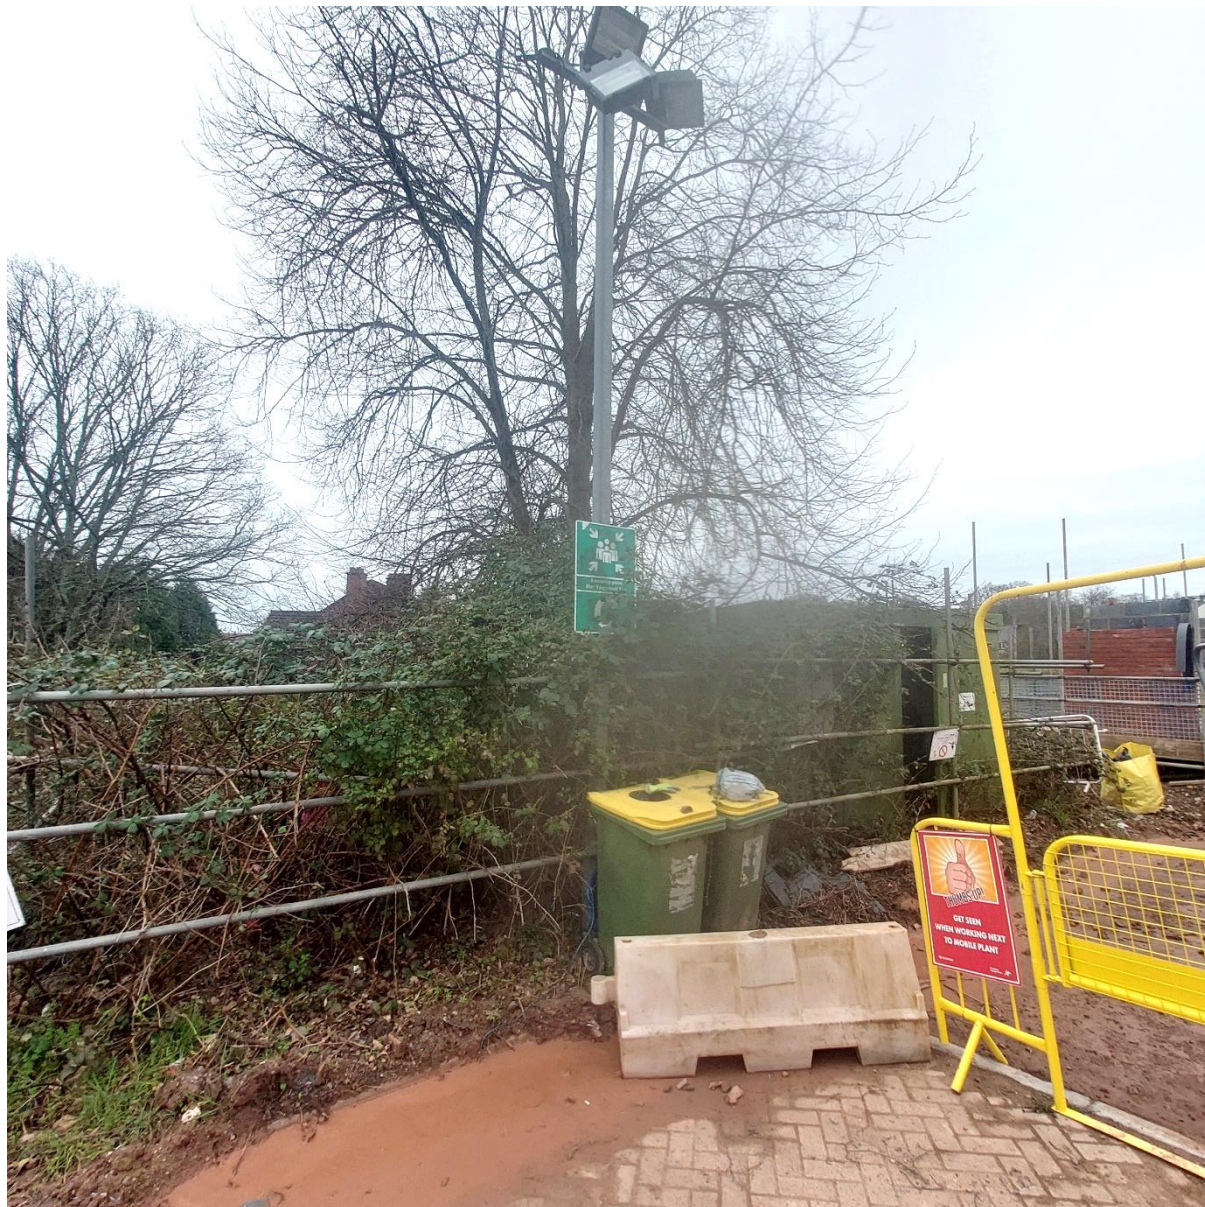
Photograph 3 – showing existing hard surface, lighting column and gas substation.

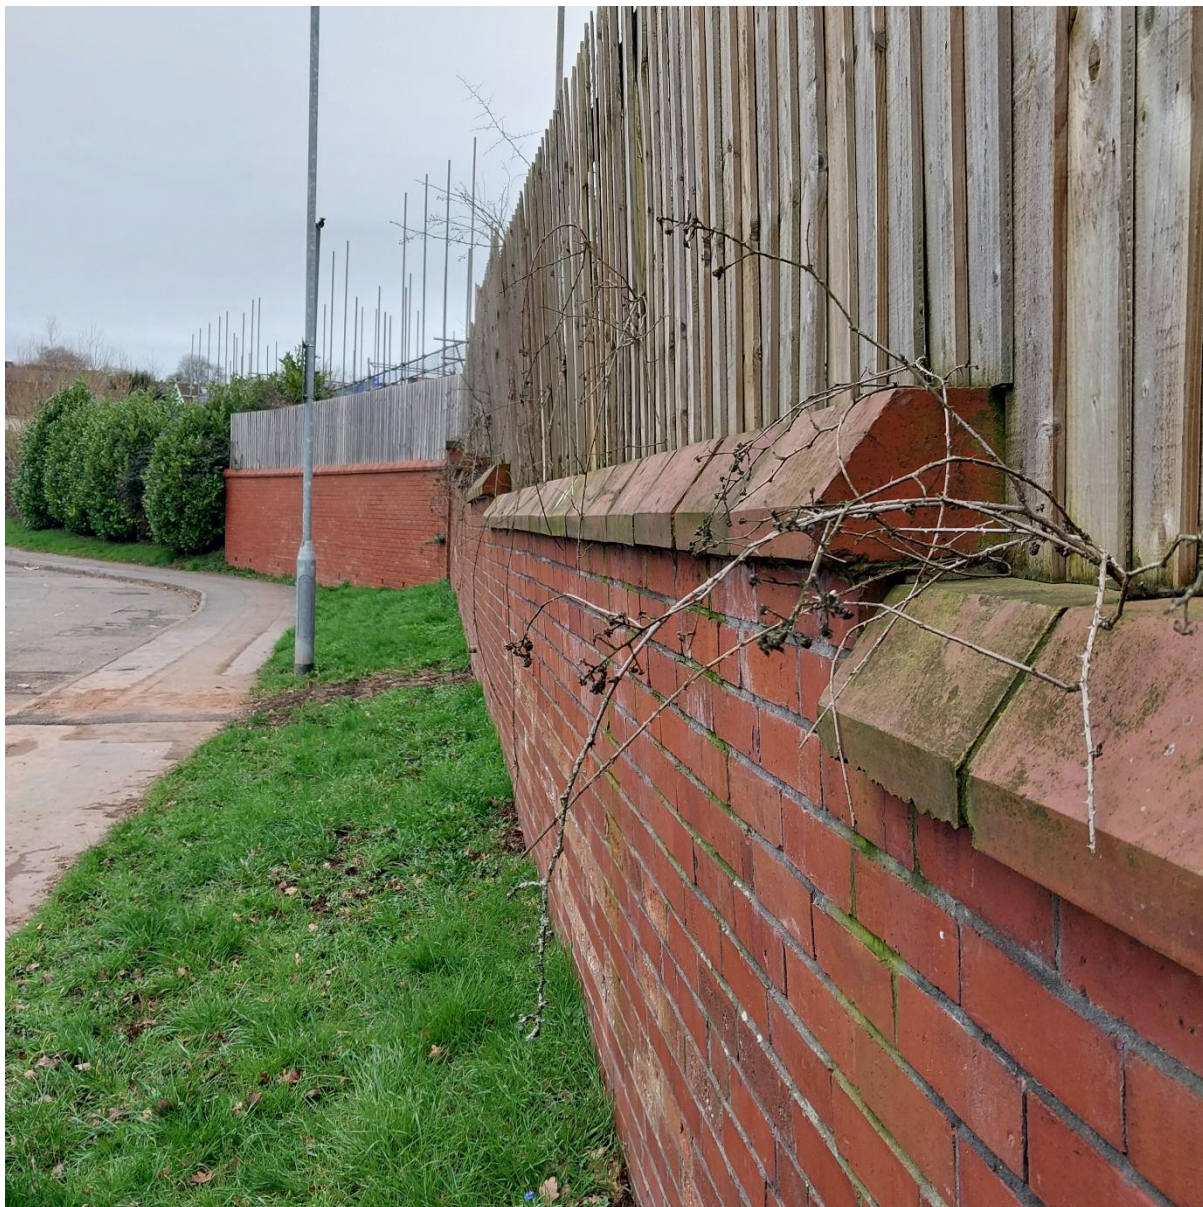
The existing retaining wall is formed in engineering brick and, from the information provided, has been condemned by the structural engineer due to progressive failure, visible cracking and measurable displacement from vertical. In arboricultural terms, this is highly material because the wall forms part of the current physical containment to the tree's already asymmetric rooting environment and provides some support.

Photograph 4 – view of wall to be replaced looking northwards

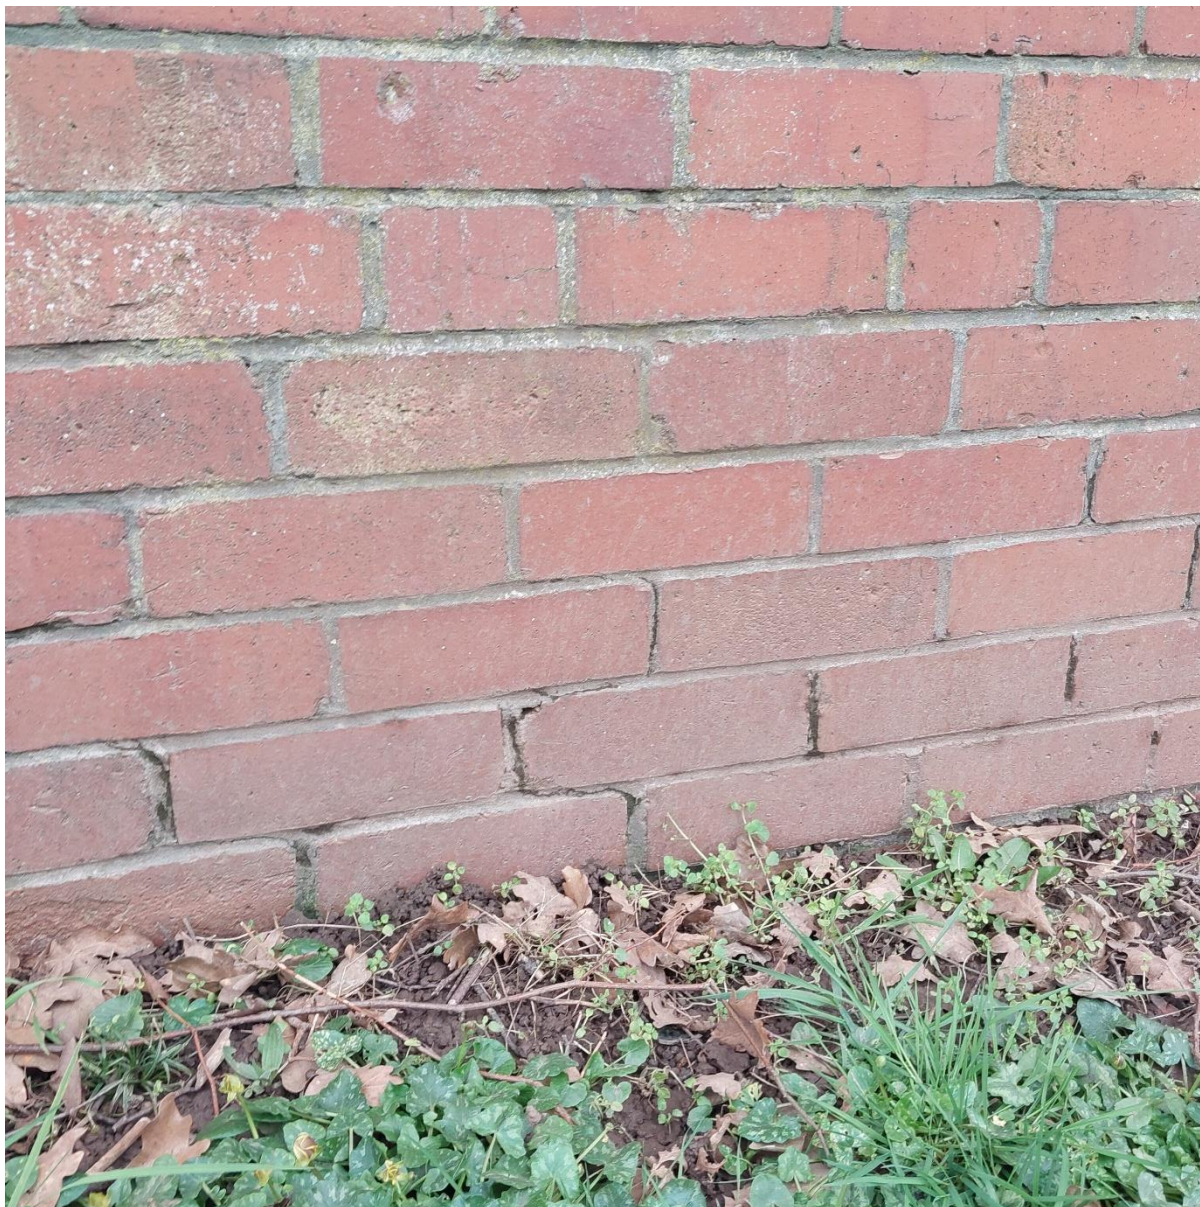
Picture 5 – cracks evident in the wall

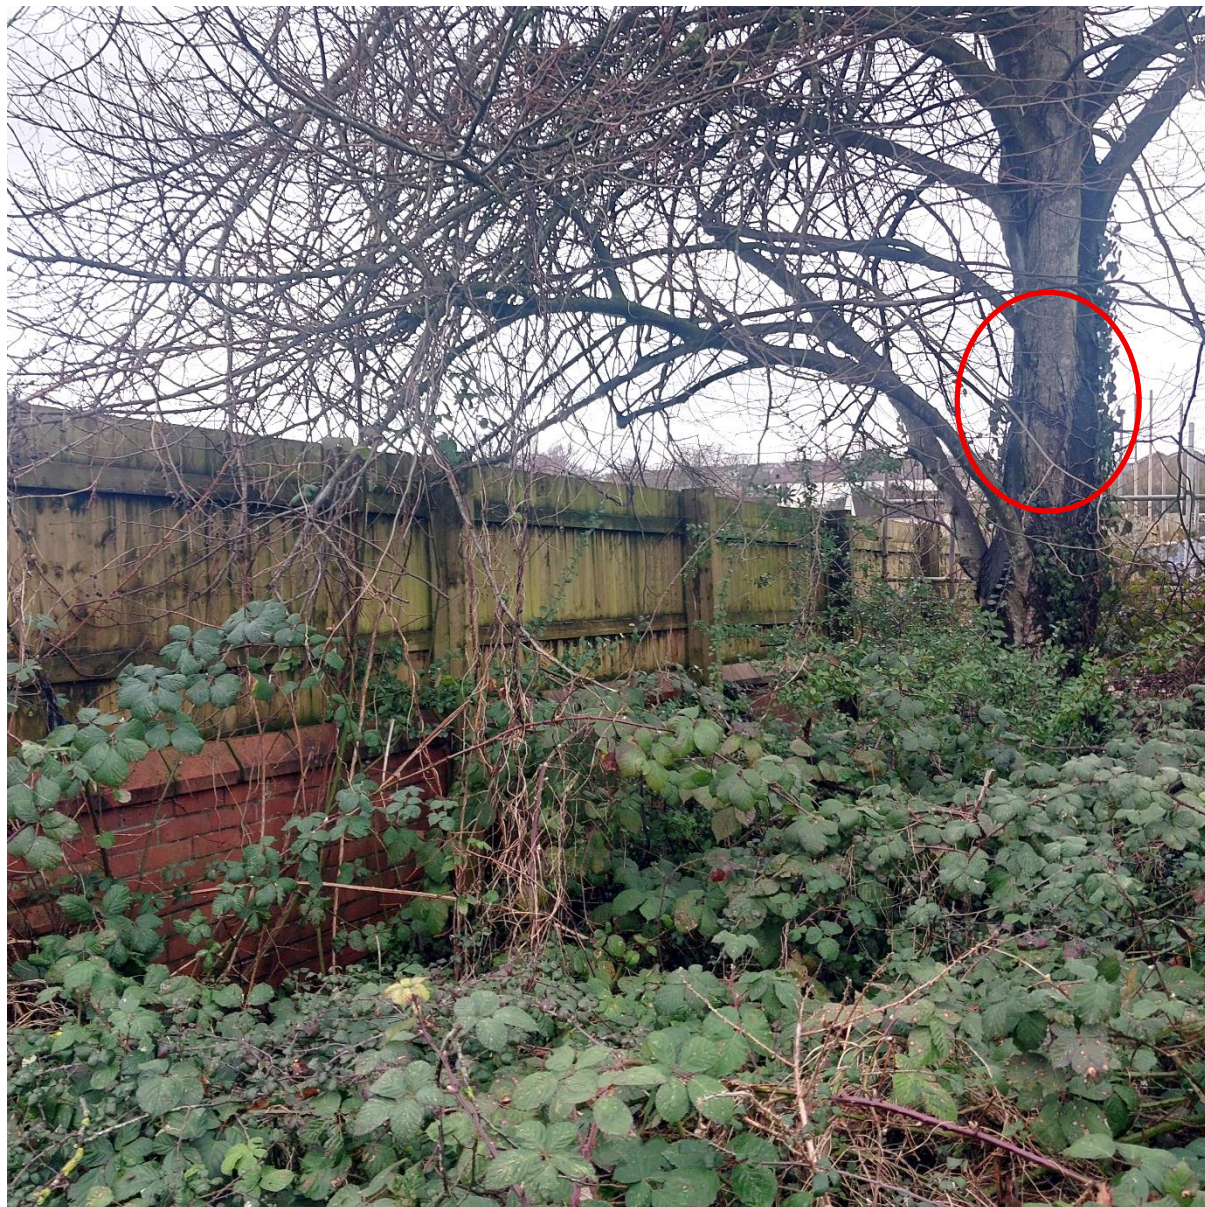
Picture 6 – relationship of tree and boundary wall. red circle overlays the compression defect.
