**Imported Fill  
Validation Report**  
Proposed Residential  
Development  
Herbert Road  
Newport

Keepmoat

**October 2016**

**Report No. 12032/VR1**

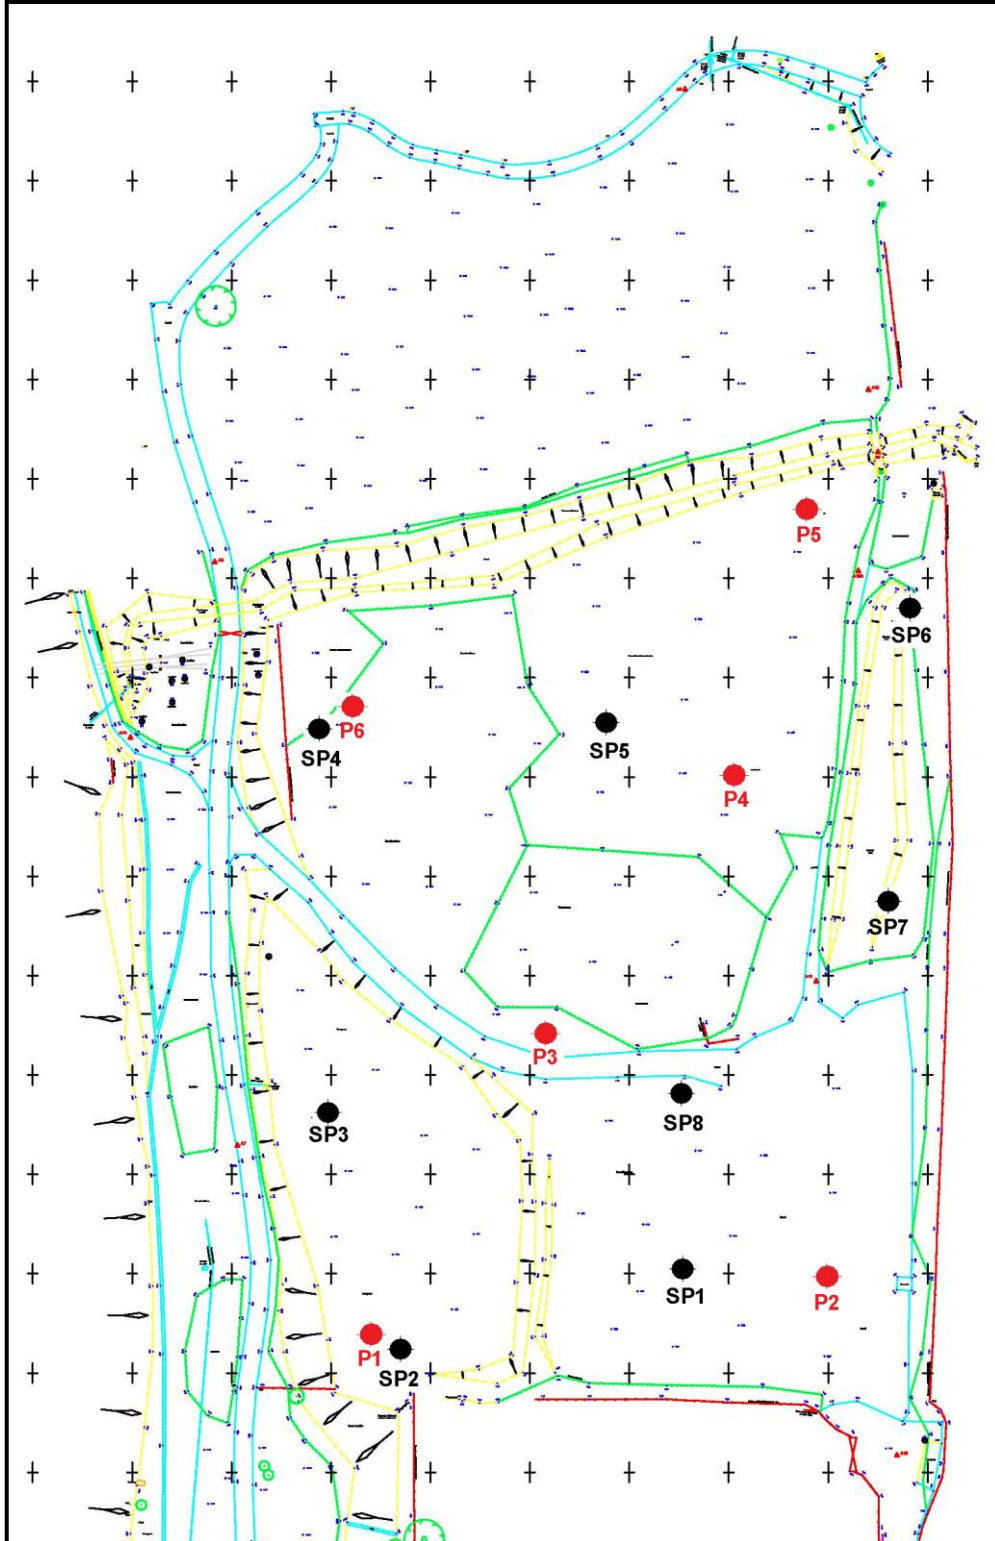
**Figure 6.1: Piezometer (P1 – P6) and Settlement Pin (SP1 – SP8) Locations**

During July 2015 six vibrating wire piezometers and eight settlement monitoring pins were installed across the site.

During earthworks half of the monitoring points were lost or damaged resulting in the loss of data comparable to baseline conditions. Monitoring Pins 2, 3, 4 and 6 were lost. Monitoring Pins 1, 5, 7 and 8 remain intact.

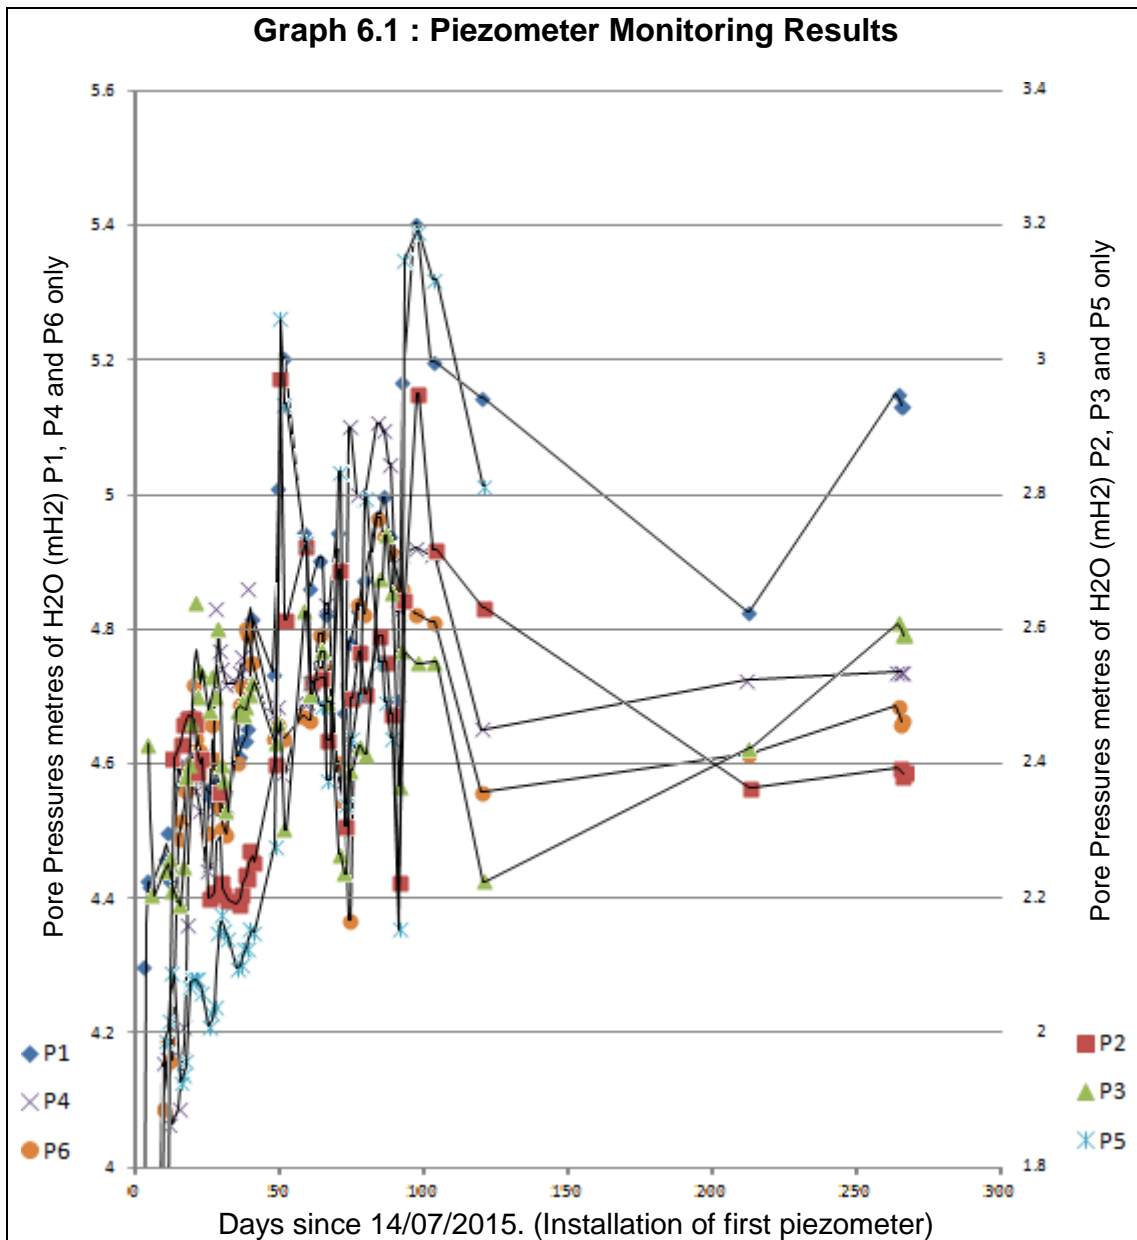
During full time supervision the increasing pore water pressures observed from the piezometers appeared to correlate with the placement of fill. As evidenced by jumps in pore water pressure over the day. Peak pore water pressure dissipated initially quickly but the rate of dissipation reduced resulting in jumps of pore water pressure.

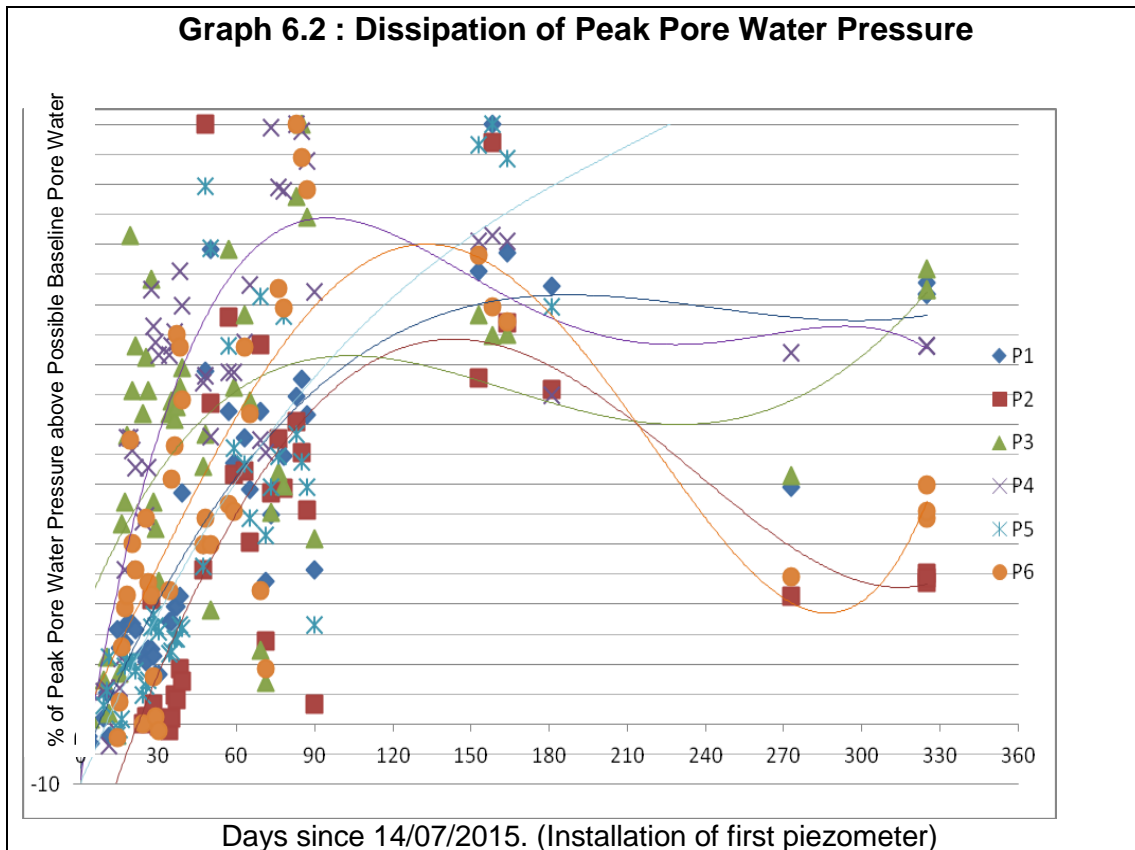
During settlement pore water pressure dissipates as water is squeezed out of consolidating material. The graph below shows the generation of peak pore water pressure generated by the placement of fill typically between 3 and 5 months after the commencement of the earthworks.

Pore water pressure has been observed to be dissipating, evidence of consolidation and settlement. However the monitoring of pore water pressure dissipation has been disrupted by unsupervised filling events subsequent to the termination of full time supervision.

Pore water pressure dissipation of a single filling event should produce a single curve. Unsupervised filling events are likely to explain for the polymodal lines of best fit of pore water dissipation suggesting that following the initial placement of the assessed stockpile further material has been placed on site. Gaps in monitoring at 4 months and 8 months after the commencement of the earthworks have lead to some uncertainty over likely pore water pressures beneath the site at those times.

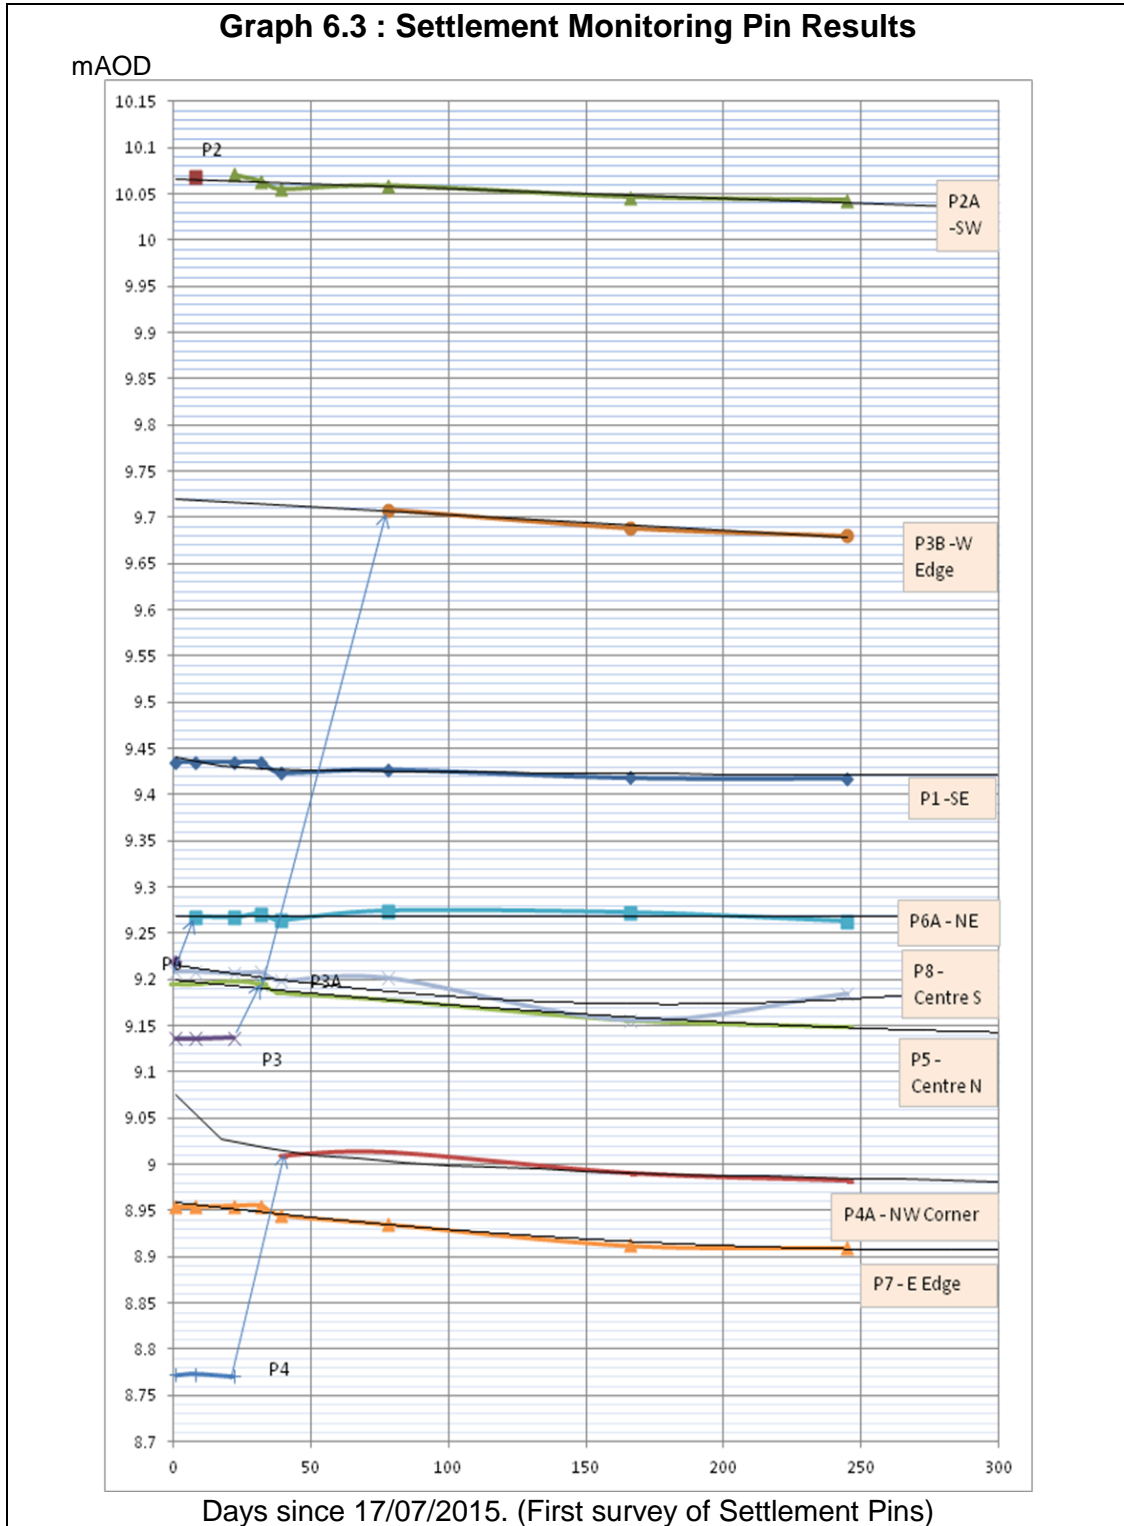
The graph below shows all of the surveyed monitoring pins on an arithmetic time scale. When a monitoring pin was damaged or destroyed an effort was made to replace the pin. When a monitoring pin was damaged / destroyed it was given a sequential alphabetical designation.

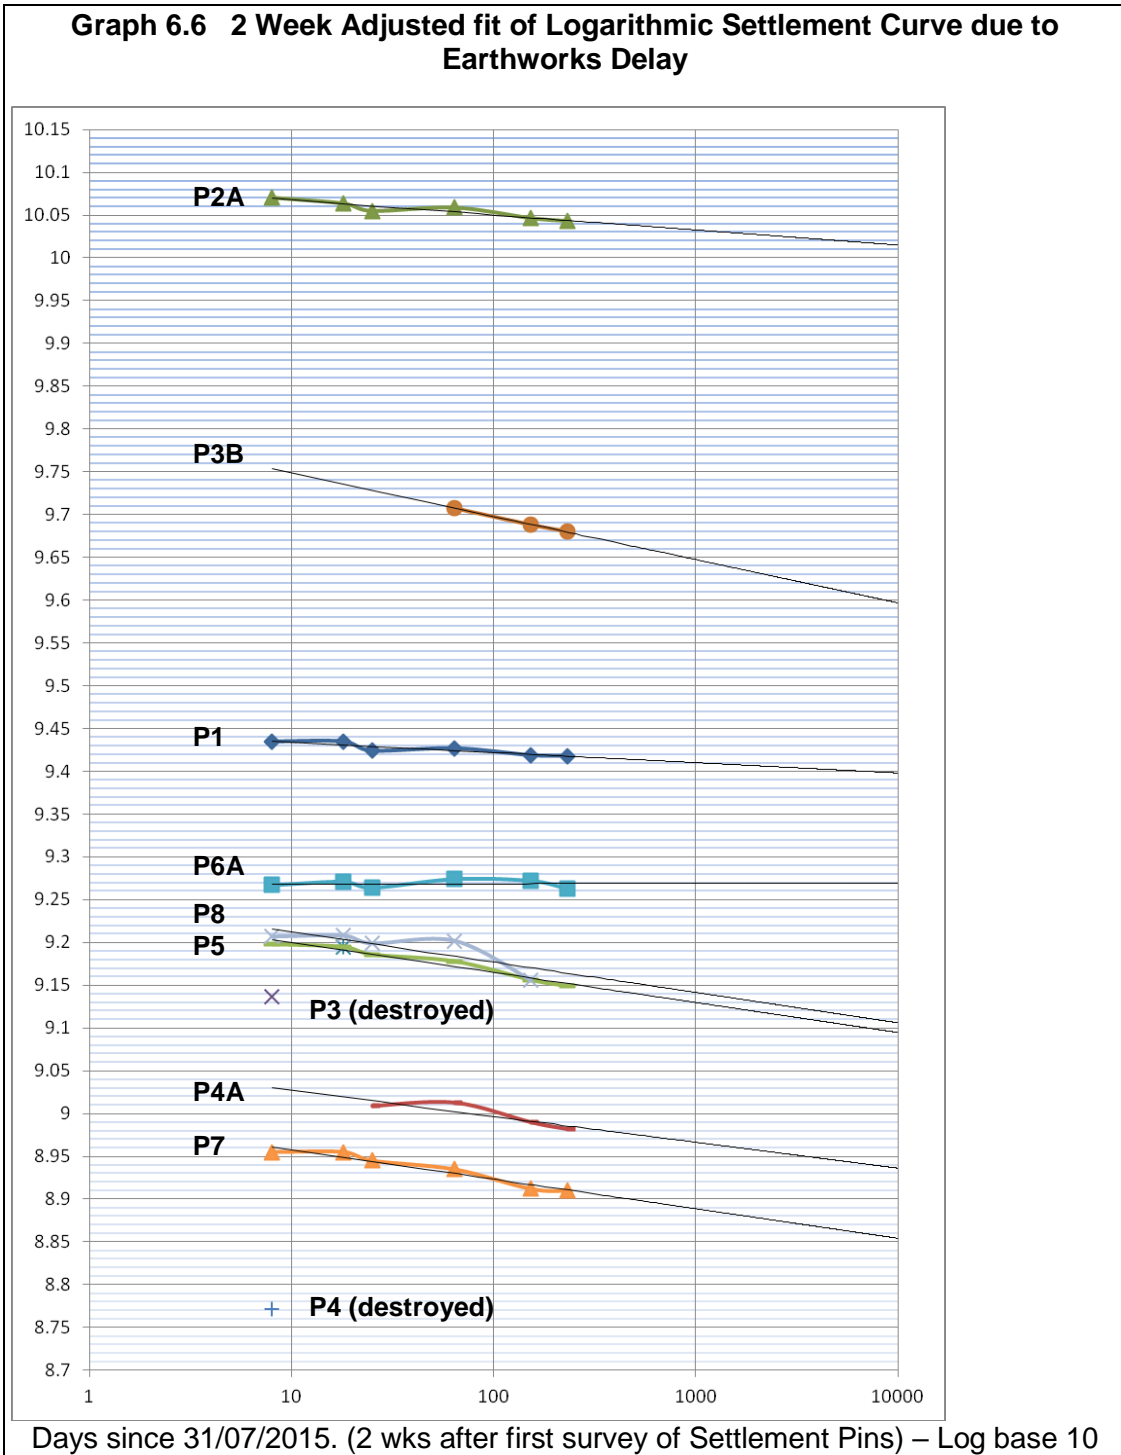
Data for Monitoring Pins 5, 7 and 8 do not appear to fit a logarithmic settlement curve as no settlement was observed within the first two weeks. This suggests that the start date may be out. Therefore Graph 3.6 shows settlement on a logarithmic scale starting on 31/7/2015, two weeks after the commencement of the earthworks. Settlement at Monitoring Pins 5 and 7 appear to be a closer fit as a result.
