**IMPORTED FILL
VALIDATION REPORT**

Proposed Residential Development
Herbert Road
Newport

Prepared for:
Keepmoat

Report No. 12032/VR1

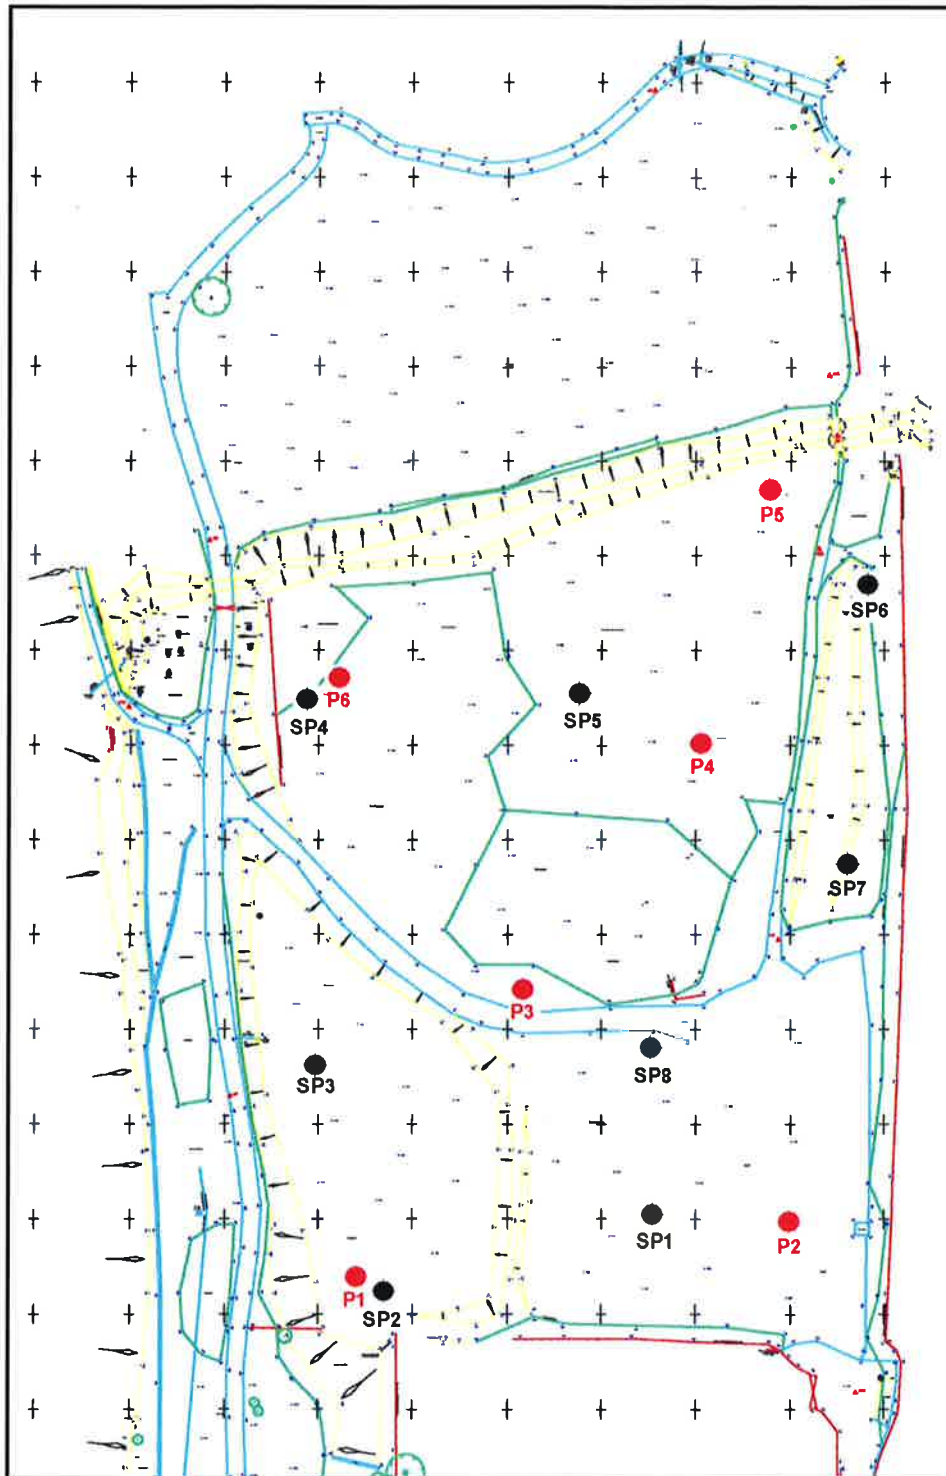
Figure 5.1: Piezometer (P1 – P6) and Settlement Pin (SP1 – SP8) Locations

During earthworks half of the monitoring points were lost or damaged resulting in the loss of data comparable to baseline conditions. Monitoring Pins 2, 3, 4 and 6 were lost. Monitoring Pins 1, 5, 7 and 8 remain intact.

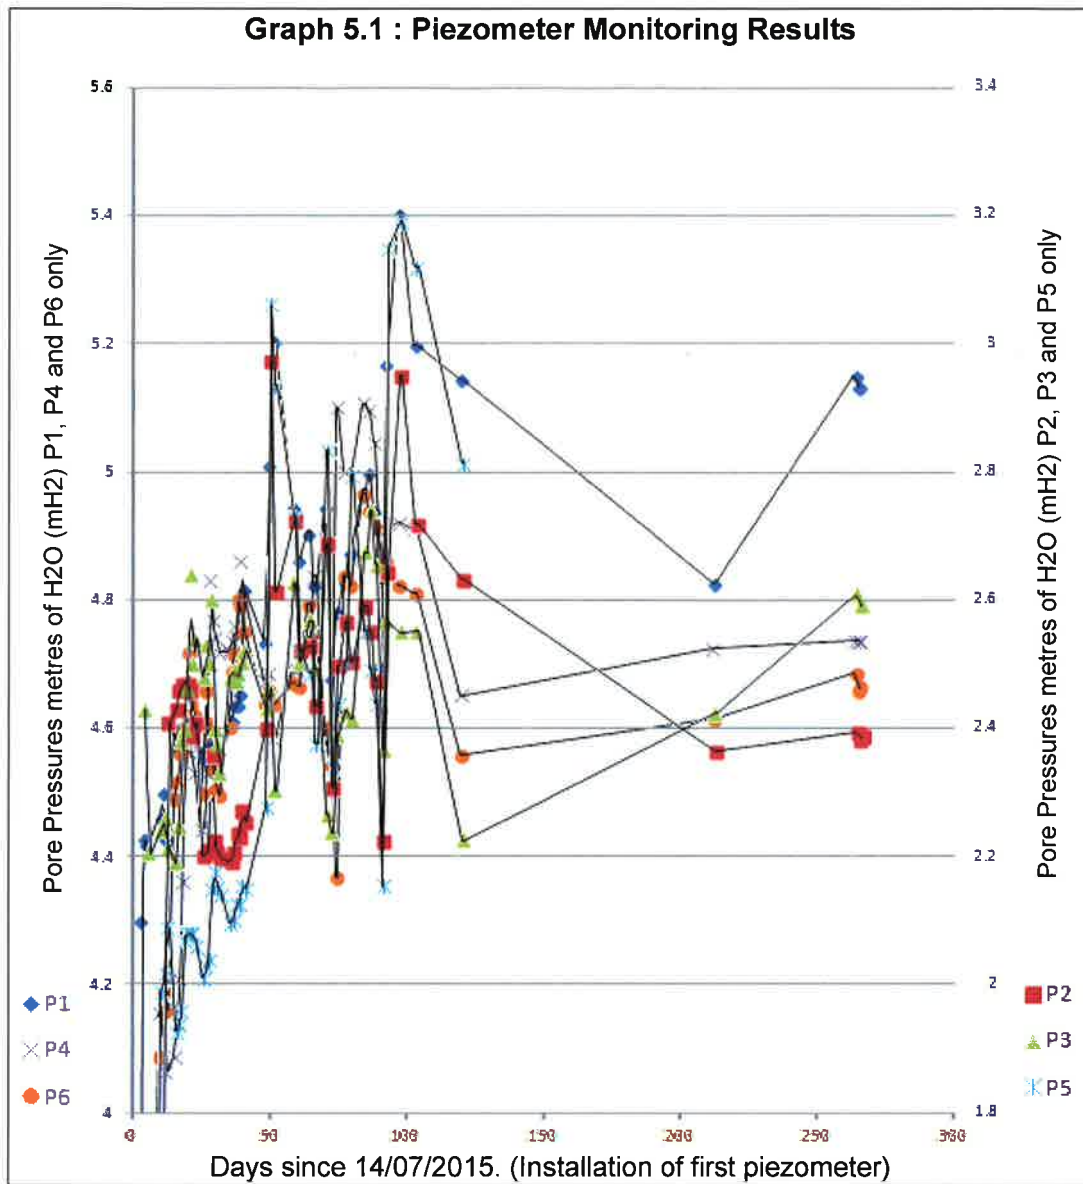
During full time supervision the increasing pore water pressures observed from the piezometers appeared to correlate with the placement of fill. As evidenced by jumps in pore water pressure over the day. Peak pore water pressure dissipated initially quickly but the rate of dissipation reduced resulting in jumps of pore water pressure.

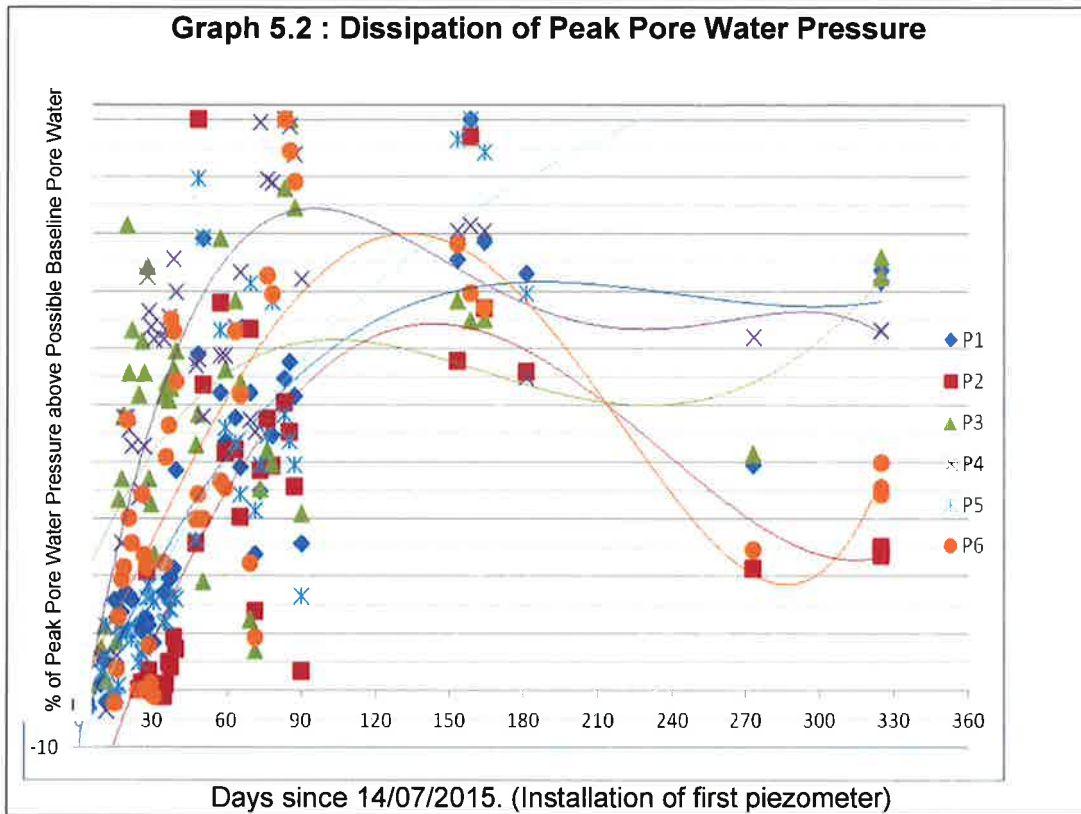
Pore water pressure has been observed to be dissipating, evidence of consolidation and settlement. However the monitoring of pore water pressure dissipation has been disrupted by unsupervised filling events subsequent to the termination of full time supervision.

Pore water pressure dissipation of a single filling event should produce a single curve. Unsupervised filling events are likely to explain for the polymodal lines of best fit of pore water dissipation suggesting that following the initial placement of the assessed stockpile further material has been placed on site. Gaps in monitoring at 4 months and 8 months after the commencement of the earthworks have lead to some uncertainty over likely pore water pressures beneath the site at those times.

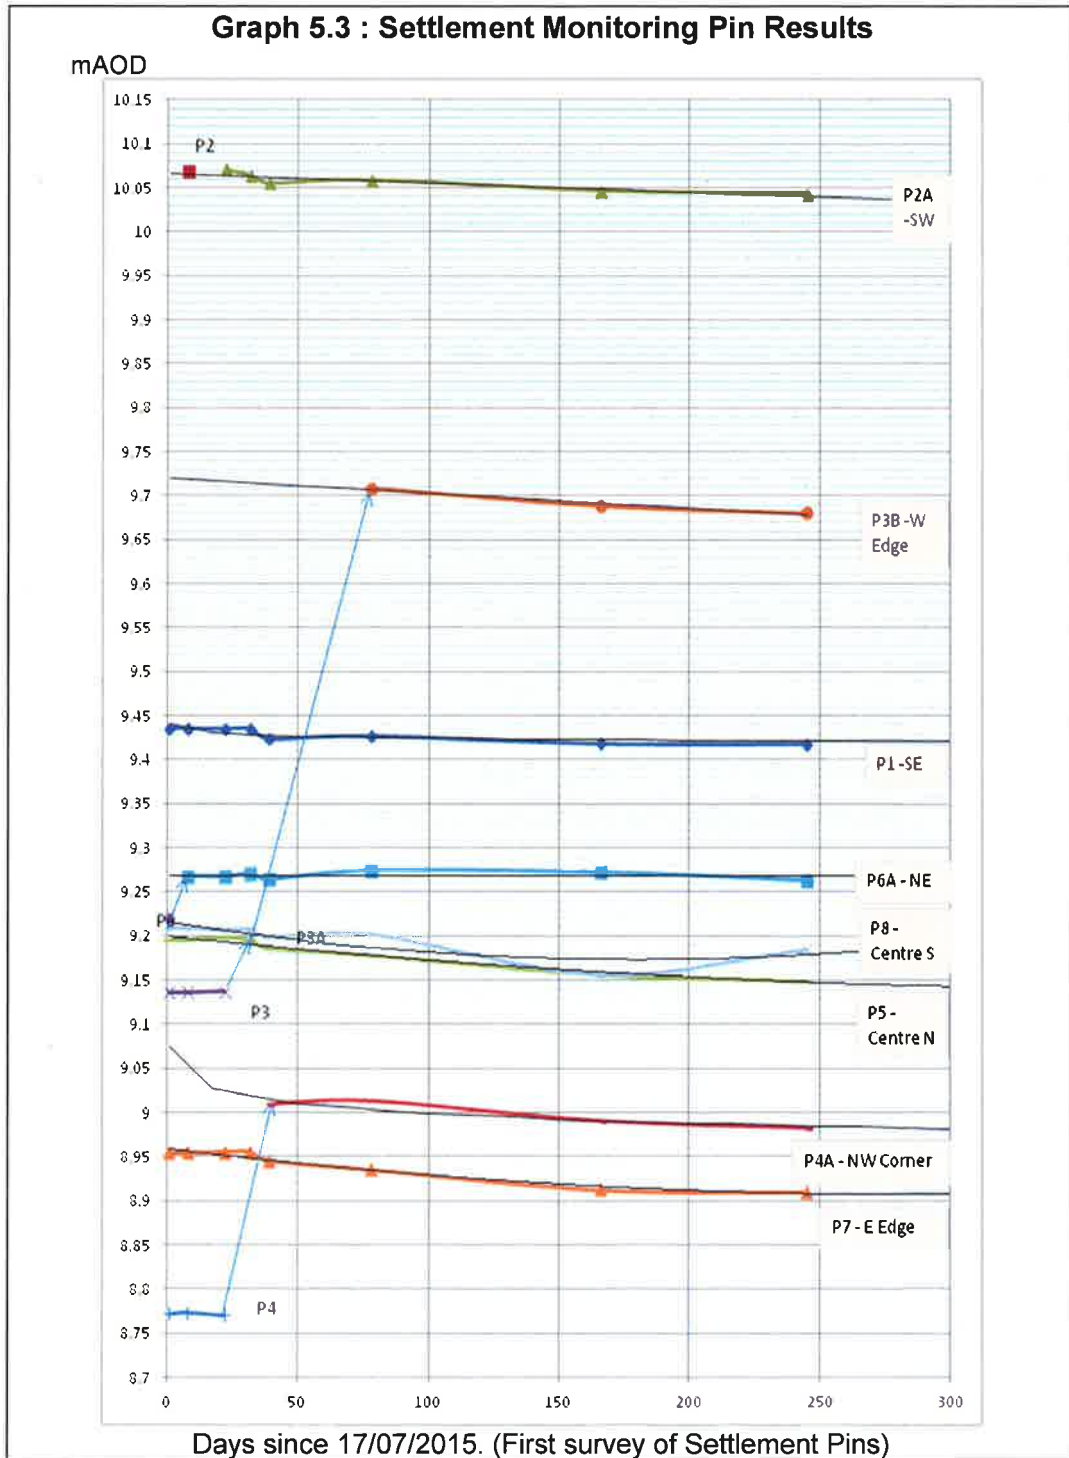
The graph below shows all of the surveyed monitoring pins on an arithmetic time scale. When a monitoring pin was damaged or destroyed an effort was made to replace the pin. When a monitoring pin was damaged / destroyed it was given a sequential alphabetical designation.

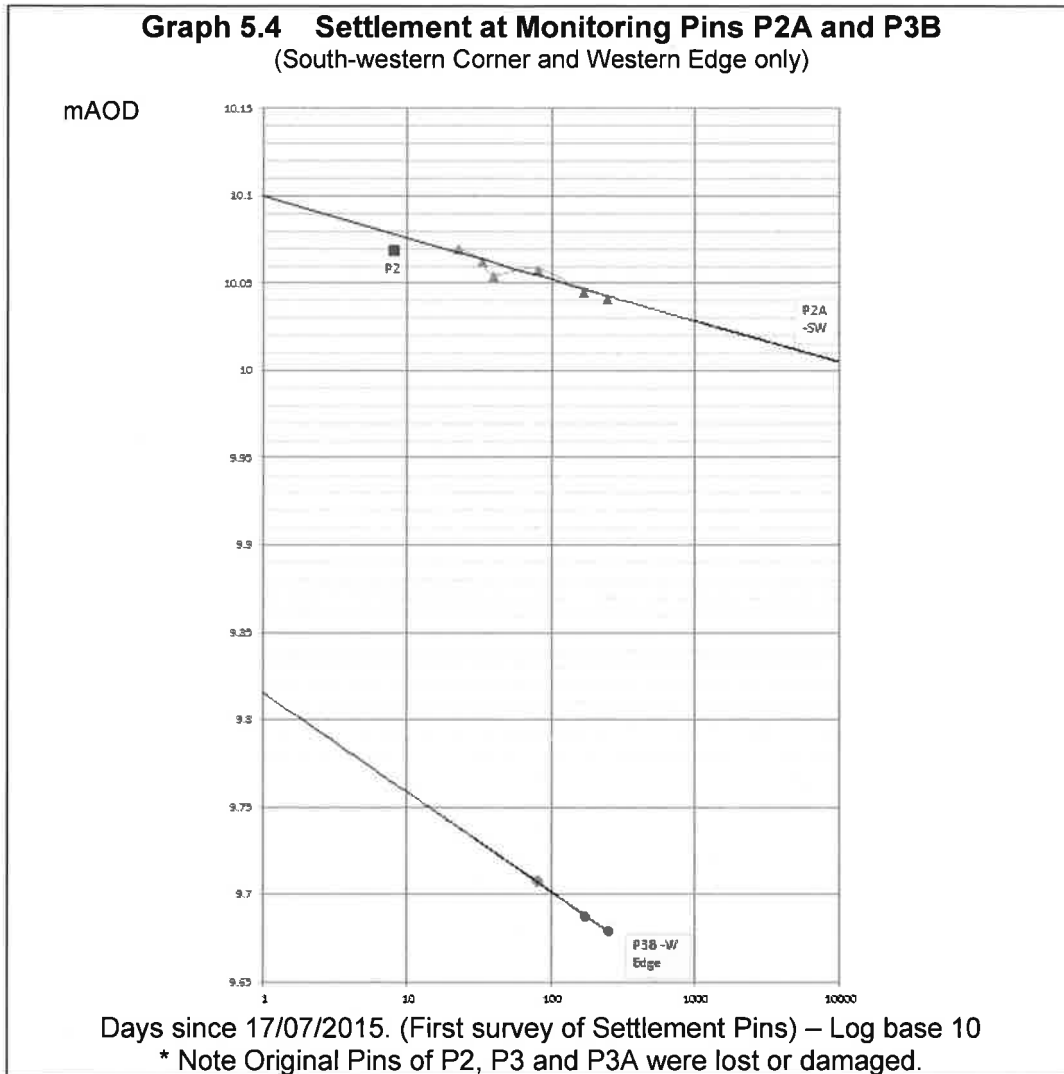
Monitoring Pin 2

Unfortunately baseline conditions for Monitoring Pin 2 (located within the south-western corner of the site) were lost as the pin was destroyed following the placement of fill. Monitoring Pin 2A however recorded ~28mm of settlement over 7 months. Whilst the initial readings may be lost it may be possible to conjecture future settlement from the data obtained.

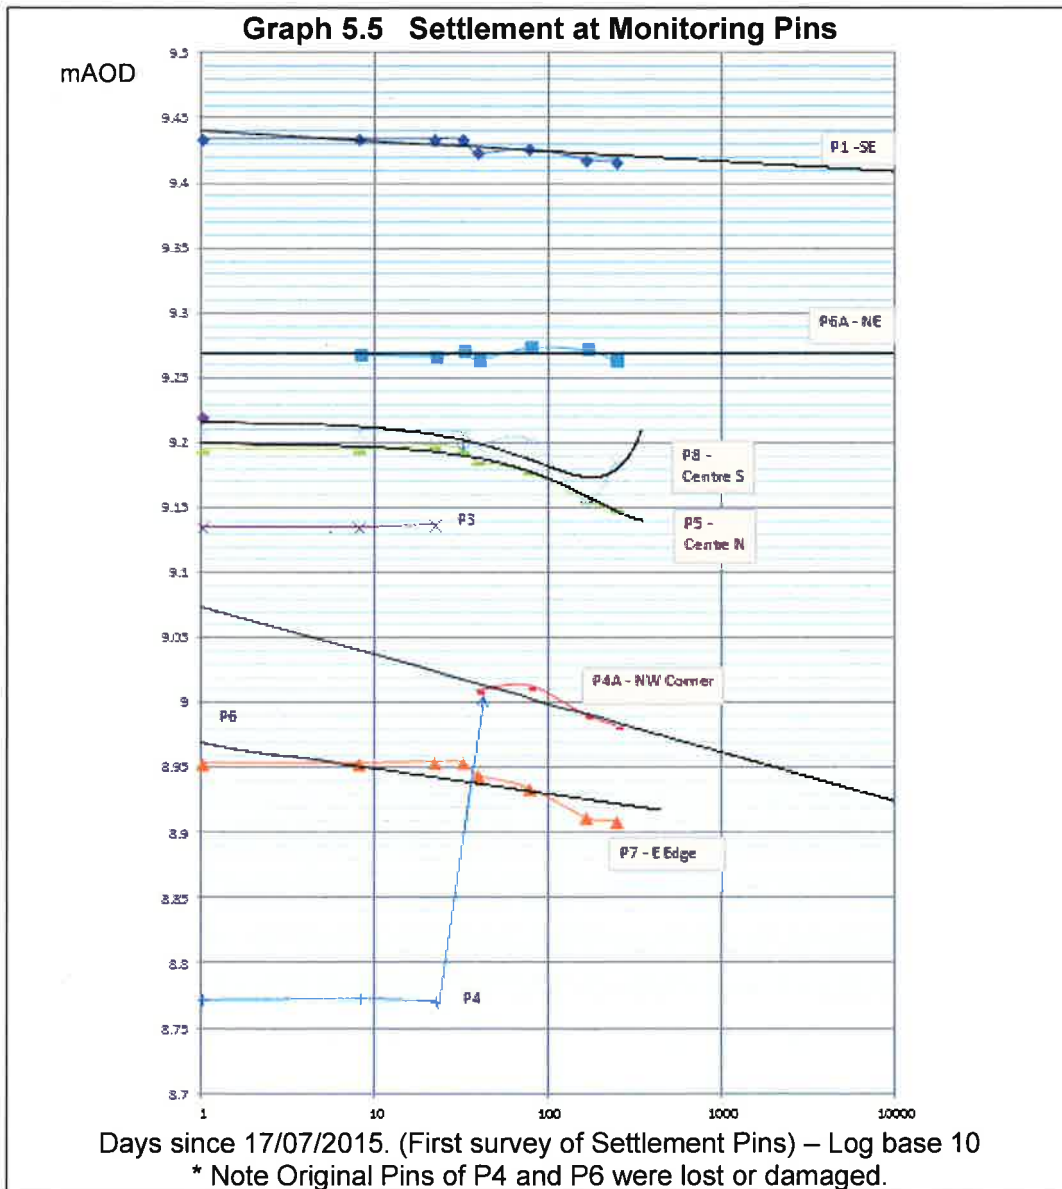
Monitoring Pin 3

Unfortunately baseline conditions for Monitoring Pin 3 (located on the western edge of the site) were lost as the pin was destroyed following the placement of fill. Monitoring Pin 3A was similarly lost. It is considered that any attempt to assess future settlement from Monitoring Pin 3B would be open to too much error and inaccuracy to predict. It is however noted that having measured ~30mm settlement in 5 months that future settlement at this location may be greater than at Monitoring Pin 2A.

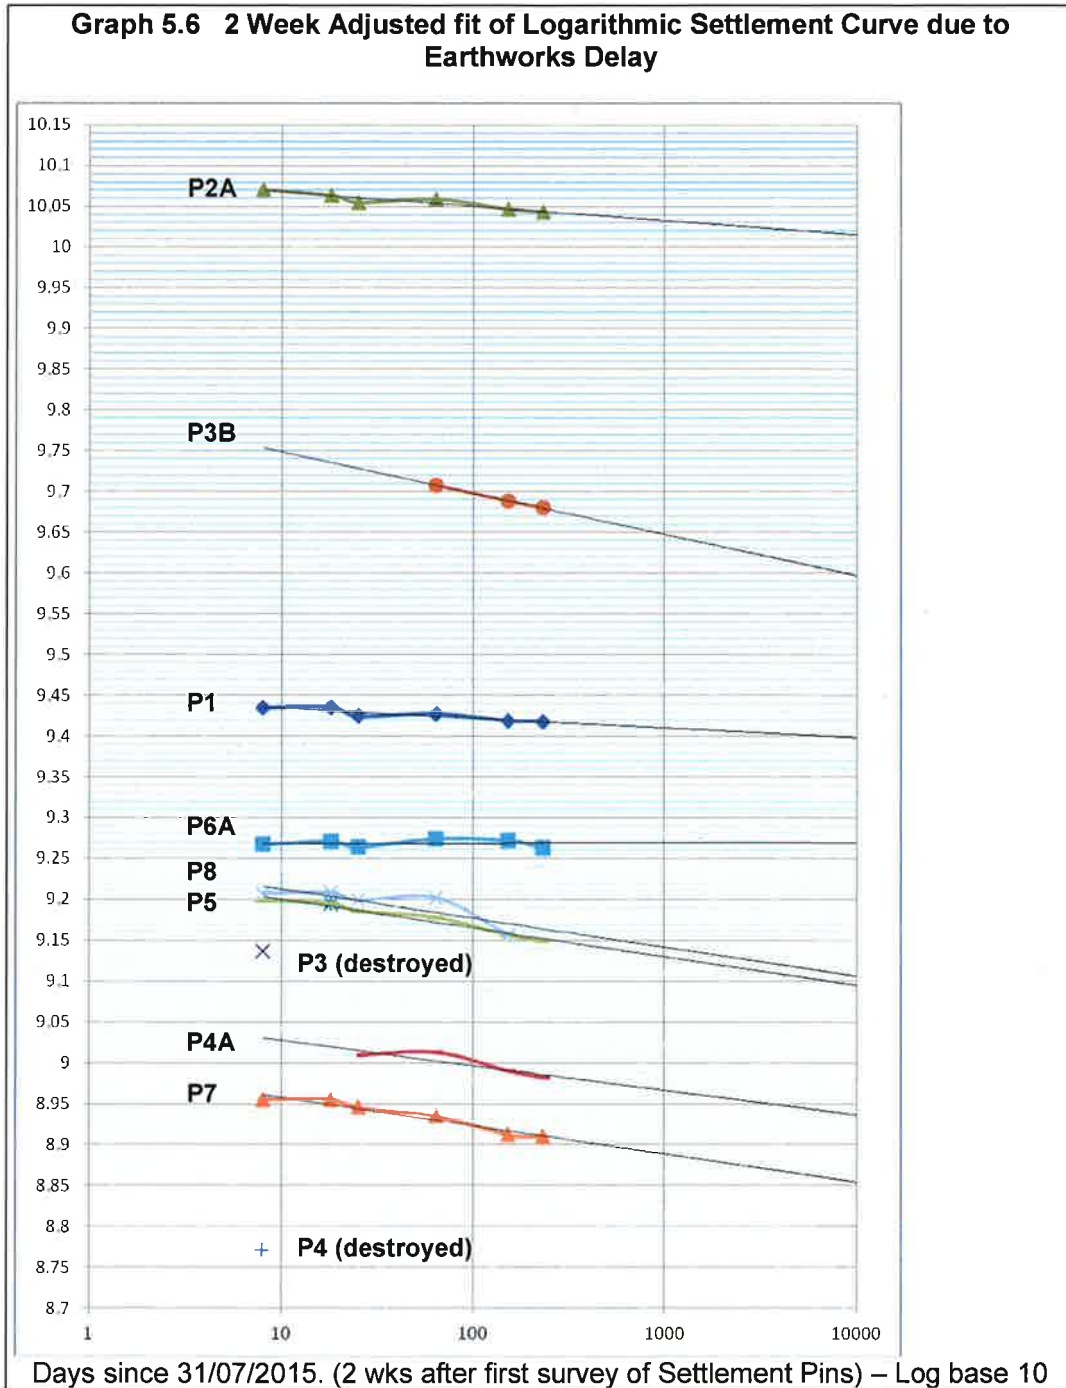
Data for Monitoring Pins 5, 7 and 8 do not appear to fit a logarithmic settlement curve as no settlement was observed within the first two weeks. This suggests that the start date may be out. Therefore Graph 3.6 shows settlement on a logarithmic scale starting on 31/7/2015, two weeks after the commencement of the earthworks. Settlement at Monitoring Pins 5 and 7 appear to be a closer fit as a result.
