**HISTORIC BUILDING ANALYSIS & RECORDING  
LEVEL II**

**9 High Street, Caerleon, Newport**

**Planning Application 26/0208 and associated Listed Building Consent Application**

**Grade II Listed Building Cadw Ref: 2968**

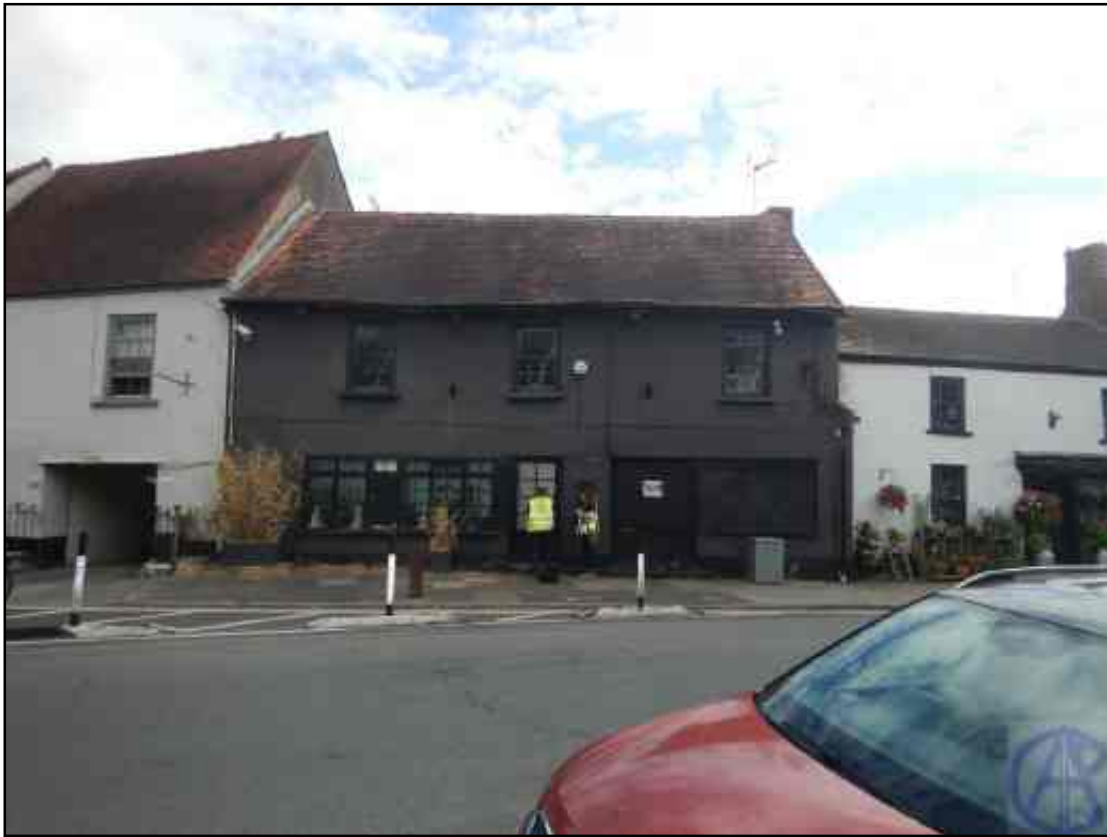
Photo ID: DSCN4372

General view of the principal south-west elevation from High Street.

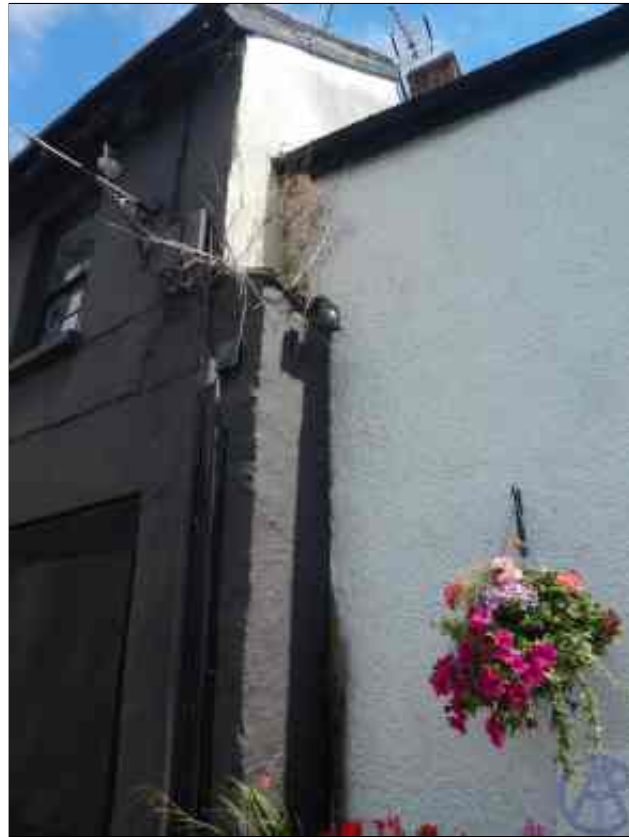
Photo ID: DSCN4383

Junction between No. 9 and the adjoining property at the southern end of the principal elevation.

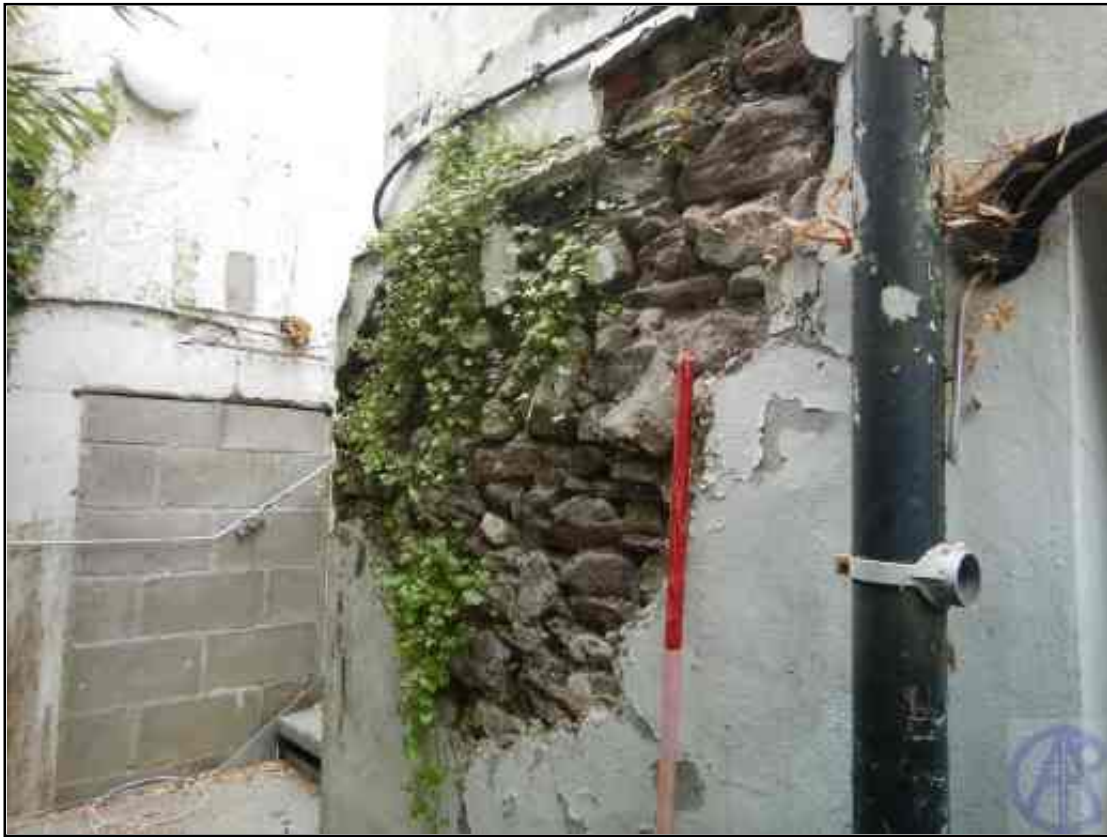
Photo ID: DSCN4496

An area of failed render exposes the ground-floor wall fabric, which comprises irregular rubble masonry with occasional brick inclusions **PL08**. The reduced thickness of the wall above may indicate that the first floor was added or rebuilt in a lighter material, possibly brick, although the surviving render prevented this from being confirmed externally.

Exposed rubble masonry within an area of failed render on the rear range.

| DSCN4496 | External | SW | External corridor from fire escape to eastern car park area. External wall behind Room 2 at ground-floor level. Missing render exposes random coursed stone construction beneath. | 20/07/2026 | AP | 10/08/2026 | AP | <b>PL08</b> |

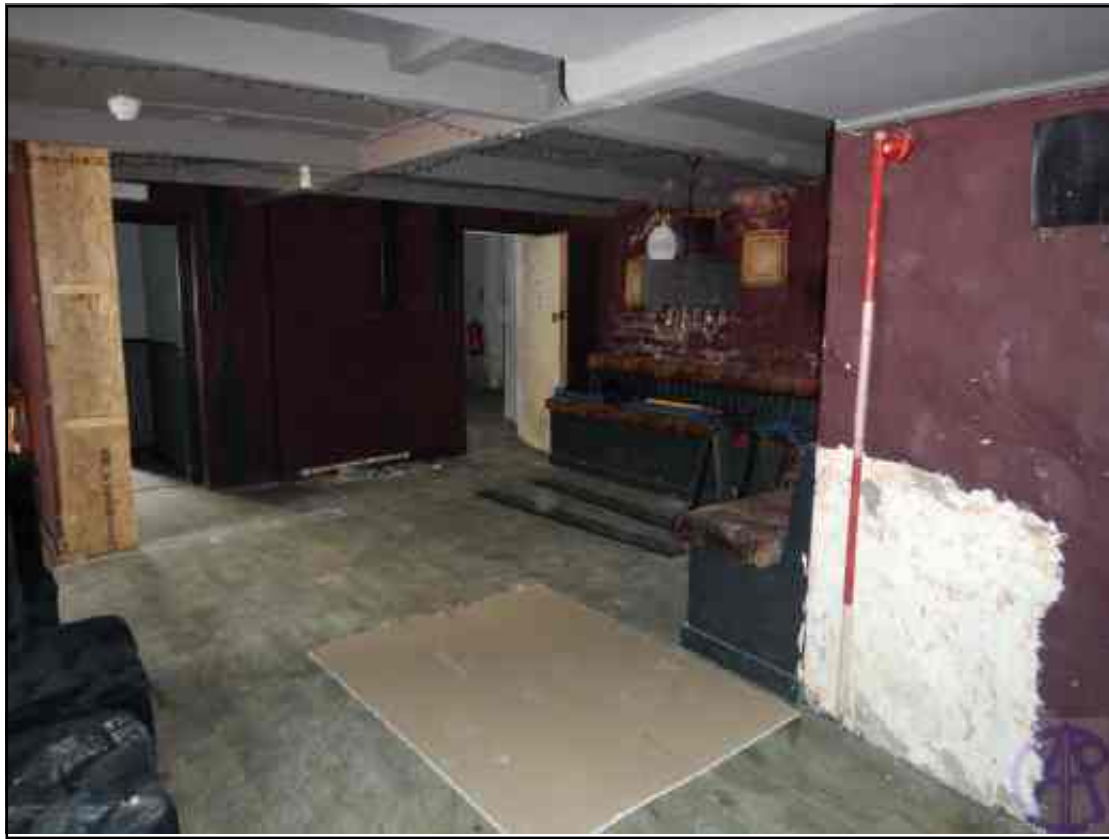
Photo ID: DSCN4403

The north-eastern end of Room 2 is shown in **PL18**, with access openings leading into Rooms 3 and 4. The intervening wall retains the heavily rendered, dark-red finish found elsewhere in the room and is partly concealed by fixed perimeter seating and decorative panelling. The ceiling includes an exposed section of rolled-steel joist, together with painted timber beams and nogged joists. Its level and exposed construction contrast with the boxed ceiling structure in Room 1 and suggest that the ceiling within Room 1 may have been lowered or otherwise concealed during later alterations.

North-eastern end of Room 2, with openings leading into Rooms 3 and 4.

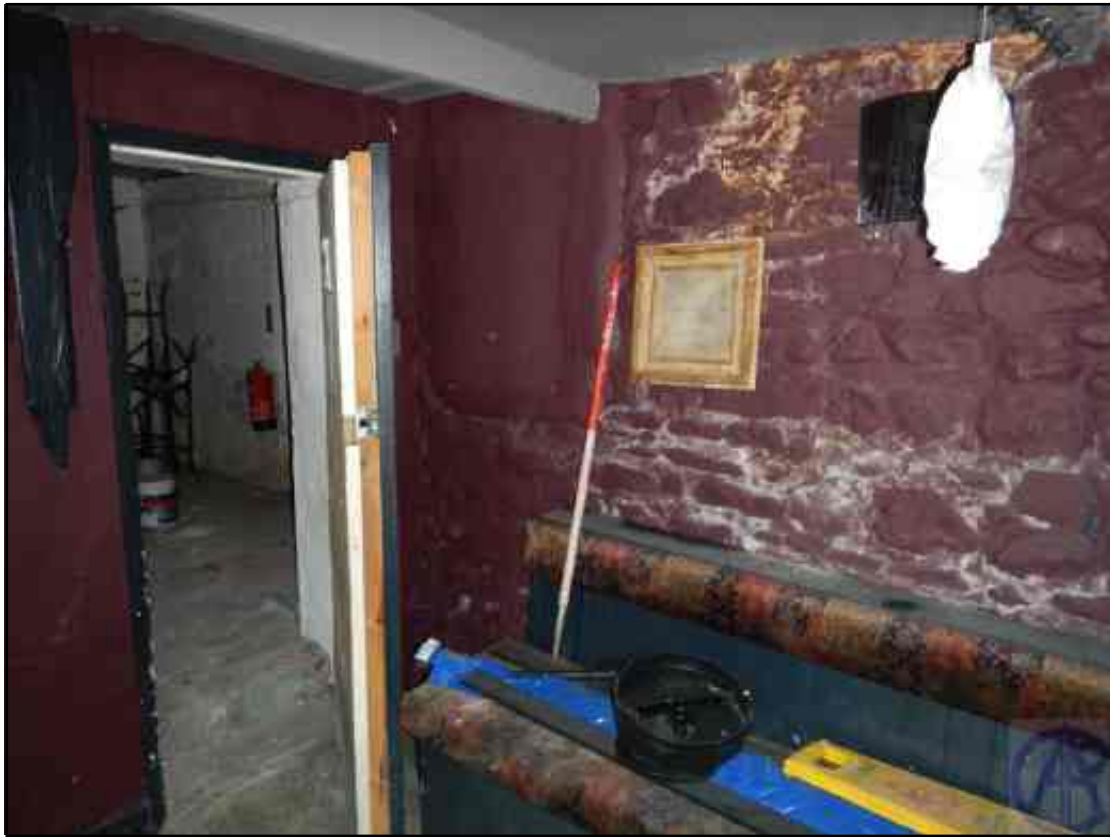
Photo ID: DSCN4407

Rendered area corresponding with a possible blocked window in Room 2.

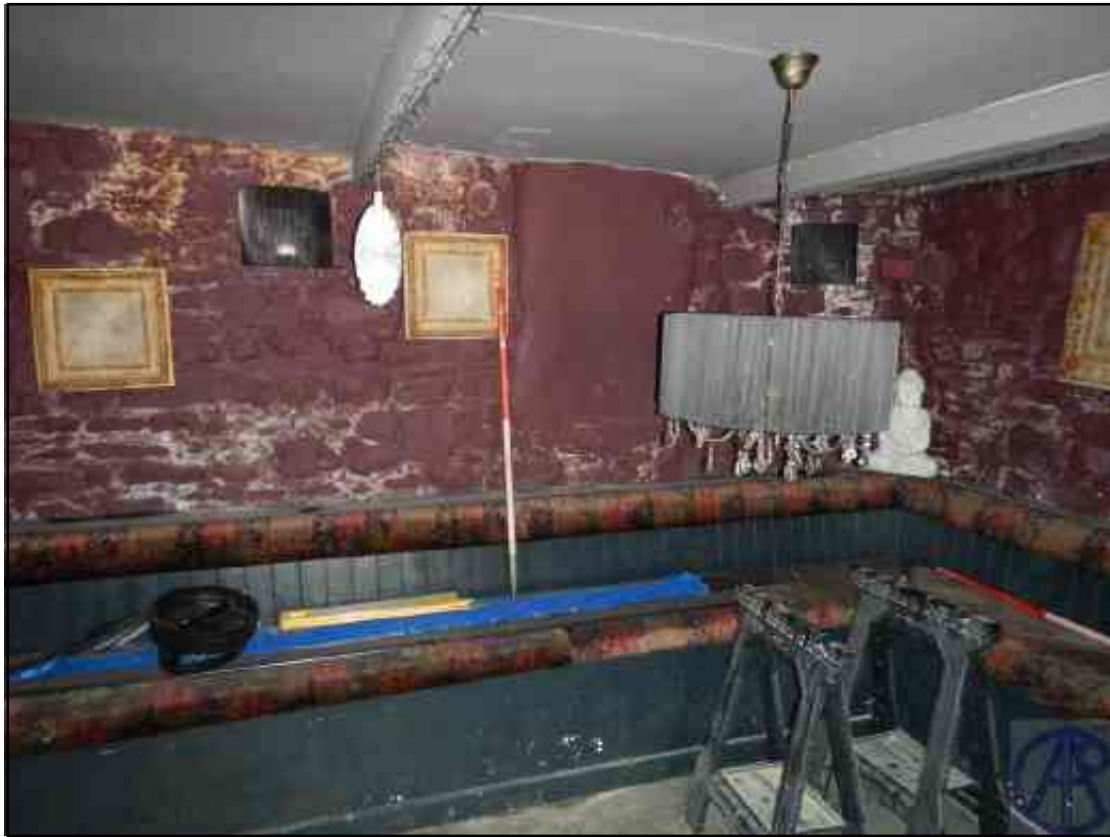
Photo ID: DSCN4406

Second rendered area corresponding with a possible blocked window in Room 2.

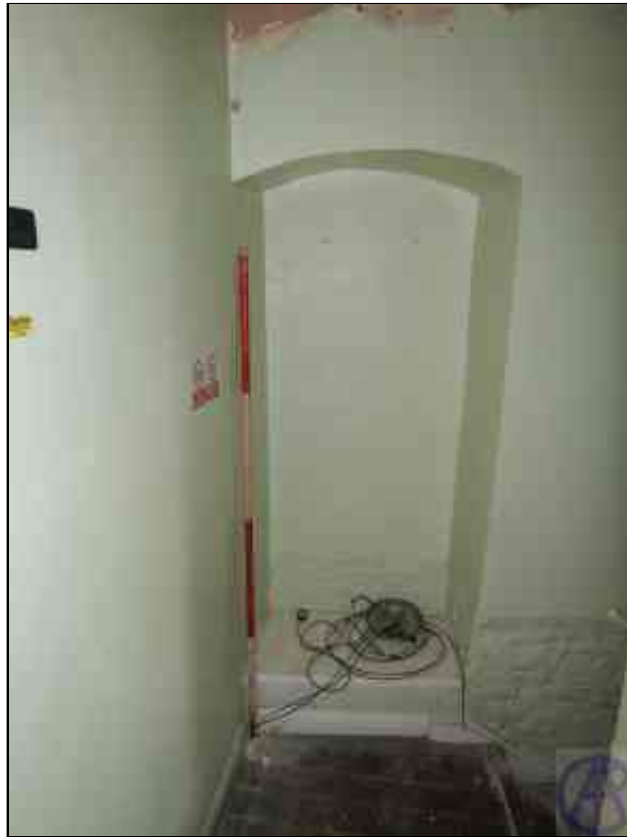
Photo ID: DSCN4446

Blocked opening within the south-eastern party wall at first-floor level.

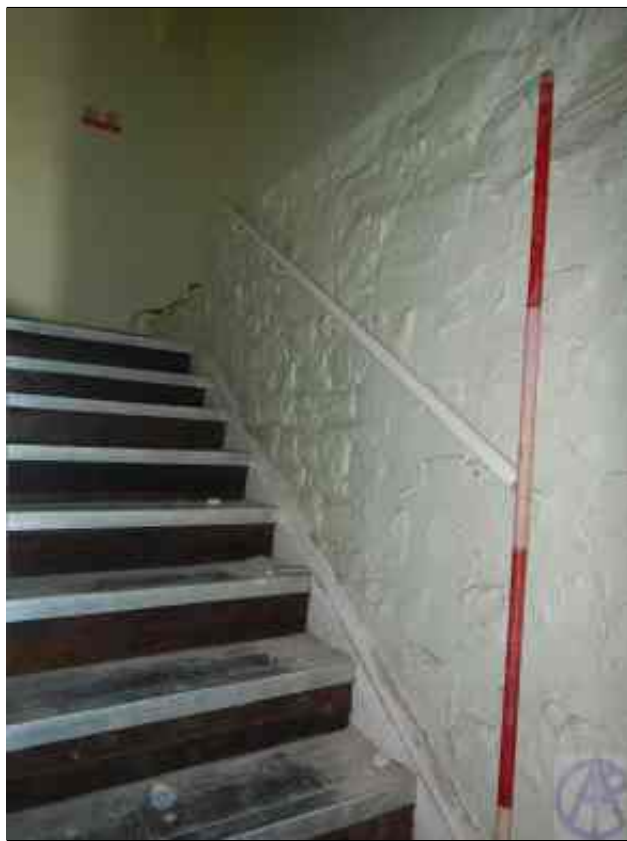
Photo ID: DSCN4444

With the exception of the south-eastern party wall, the walls enclosing the staircase and first-floor landing appear predominantly to be of modern stud construction. The party wall rising from the ground floor is formed from painted rubble masonry. At approximately mid-stair level, however, it incorporates a rendered area finished to resemble the surrounding rubble construction **PL31**. This section, when tapped, was found to be hollow, indicating that it conceals an opening or recess. No diagnostic jambs, lintel or other structural details remained visible, and it was therefore not possible to determine whether the feature represents a blocked doorway, an alcove or another former opening.

Hollow rendered feature within the rubble party wall beside staircase 6.

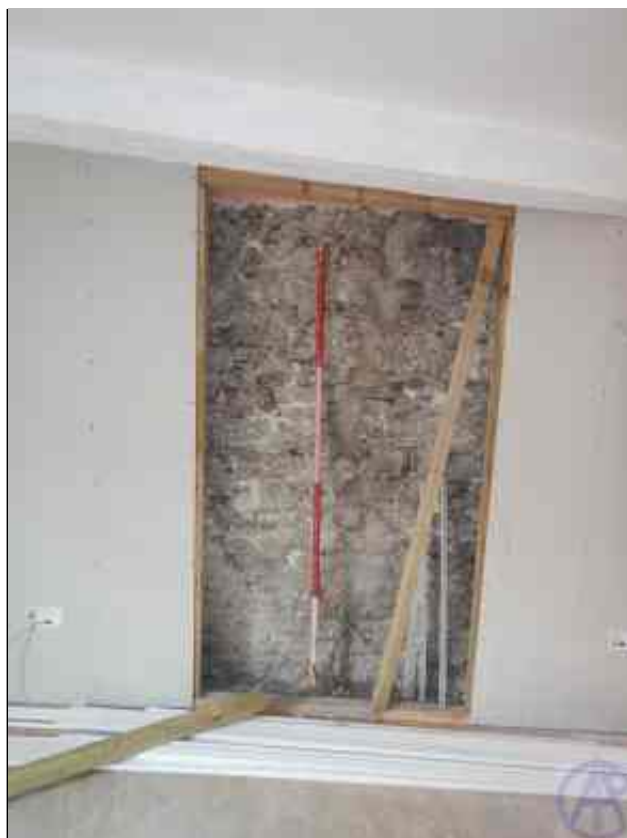
Photo ID: DSCN4463

Limited evidence for the earlier fabric is visible at the north-western gable, where a section of plasterboard has been removed. This exposes rubble-stone masonry bonded in lime mortar, with areas of later cementitious repair **PL35**.

Rubble-stone masonry exposed behind plasterboard at the north-western gable of Room 7.

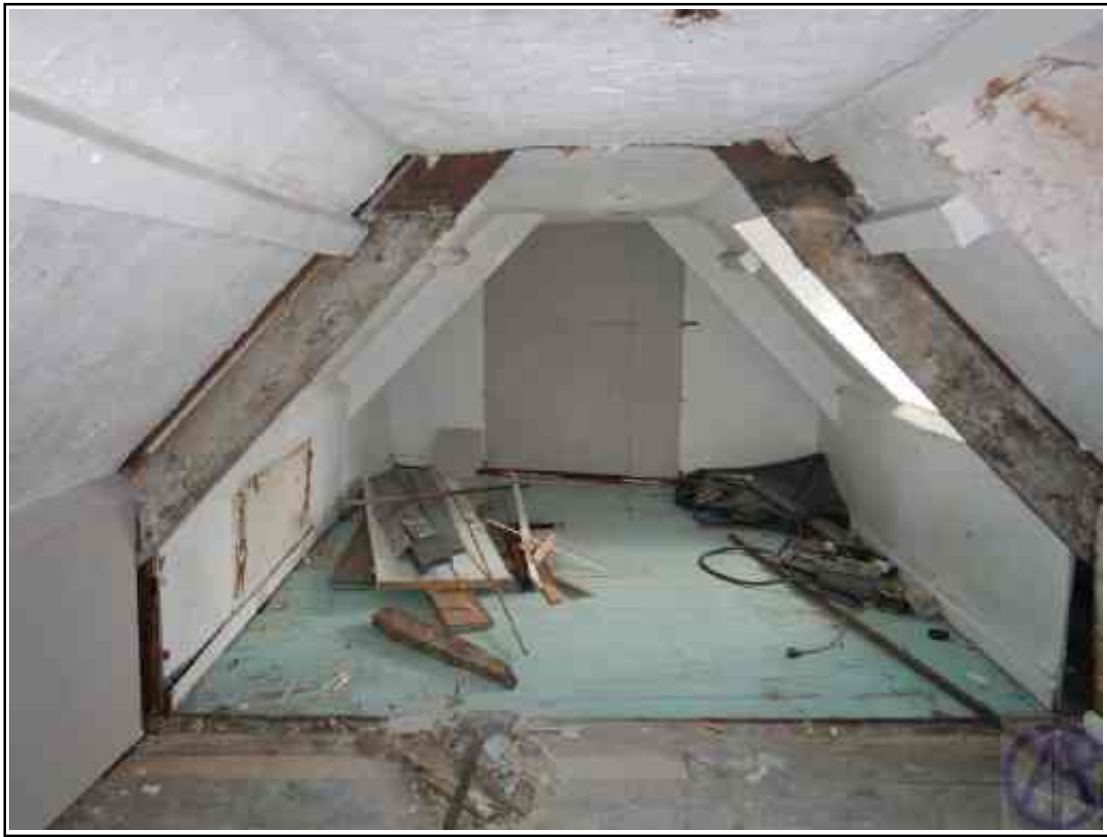
Photo ID: DSCN4510

Room 11 viewed towards the north-west, showing the floorboards and exposed roof trusses.

| DSCN4510 | Second floor | NW | Room 11 – Second-floor room. Room 11 occupies the majority of the second floor. The floor is formed of timber planks. The eastern wall features two dormer windows. The room is relatively bare, with the roof trusses and purlins exposed. The northern extent of the room follows the same unusual diagonal alignment observed on the two floors below. In this instance, the stonework has been obscured behind a large section of plywood. The room has been plastered and painted, with the ceiling appearing to feature an Artex finish. Panelling has been fitted to the lower sections of the walls, although some holes expose the lath and plaster beneath. | 20/07/2026 | AP | 10/08/2026 | AP | <b>PL38</b> |

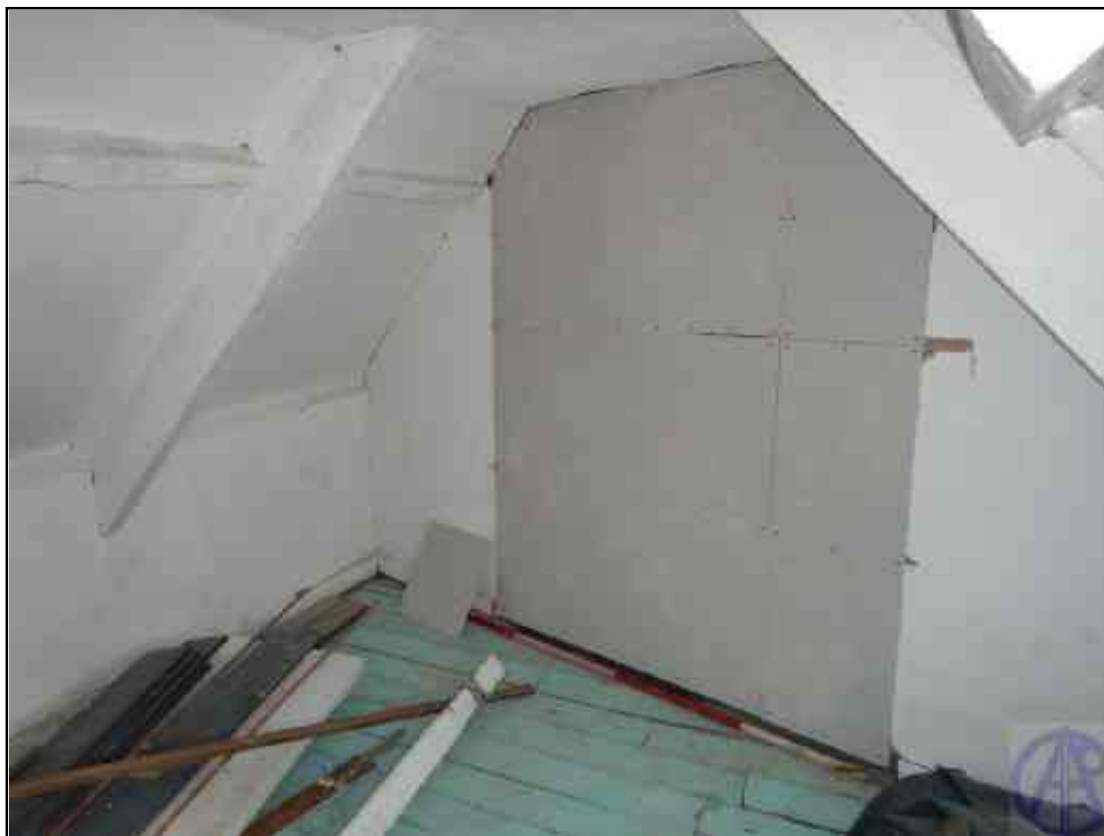
Photo ID: DSCN4511

Angled north-western gable of Room 11 and the differing alignment of the floorboards.

| DSCN4511 | Second floor | N | Room 11 – Second-floor room. The northern extent of the room follows the same unusual diagonal alignment observed on the two floors below. In this instance, the stonework has been obscured behind a large section of plywood. | 20/07/2026 | AP | 10/08/2026 | AP | <b>PL39</b> |

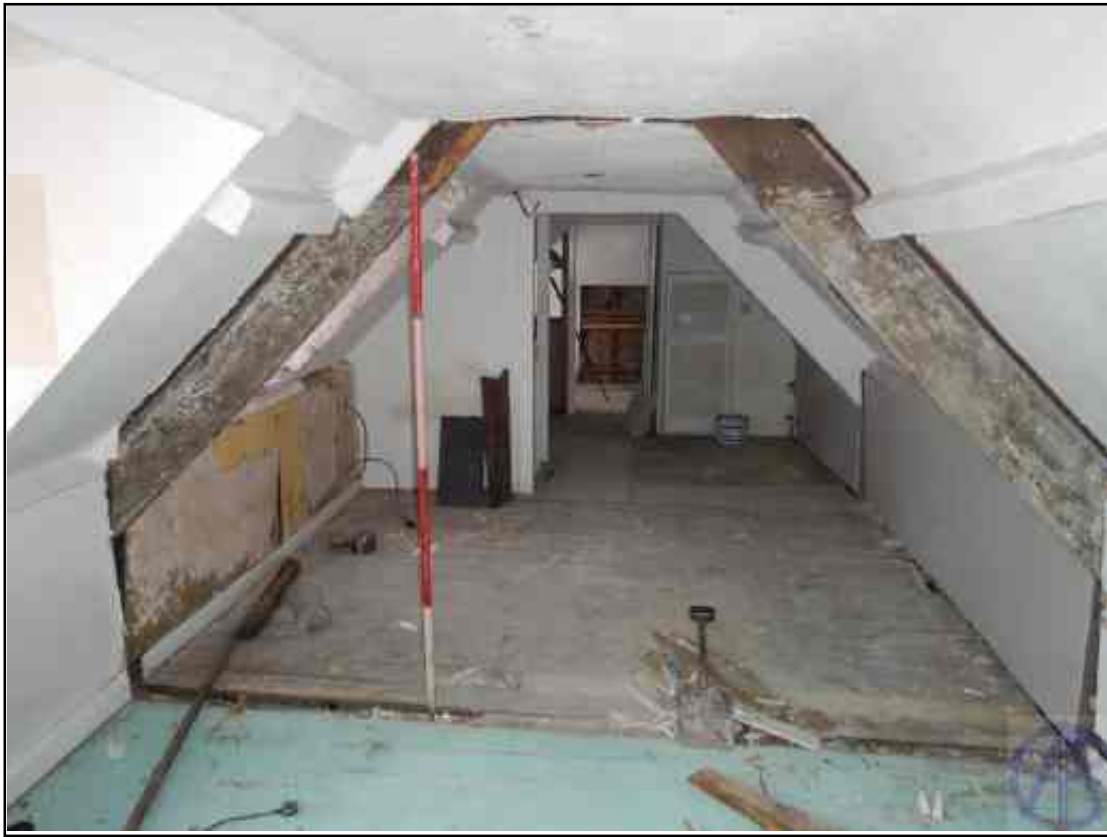
Photo ID: DSCN4512

Viewed towards the south-west, the space was occupied by the stairwell to the left and the small Room 12 against the south-western gable wall **PL40**. A view from within Room 12 confirmed that its internal divisions were again of modern studwork construction, while the boarded floor incorporated several later repairs.

Room 11 viewed towards the south-east,  
showing the stairwell and Room 12.

| DSCN4512 | Second floor | SE | Room 11 – Second-floor room. Room 11 occupies the majority of the second floor. The floor is formed of timber planks. The eastern wall features two dormer windows. The room is relatively bare, with the roof trusses and purlins exposed. The northern extent of the room follows the same unusual diagonal alignment observed on the two floors below. In this instance, the stonework has been obscured behind a large section of plywood. The room has been plastered and painted, with the ceiling appearing to feature an Artex finish. Panelling has been fitted to the lower sections of the walls, although some holes expose the lath and plaster beneath. | 20/07/2026 | AP | 10/08/2026 | AP | <b>PL40</b> |

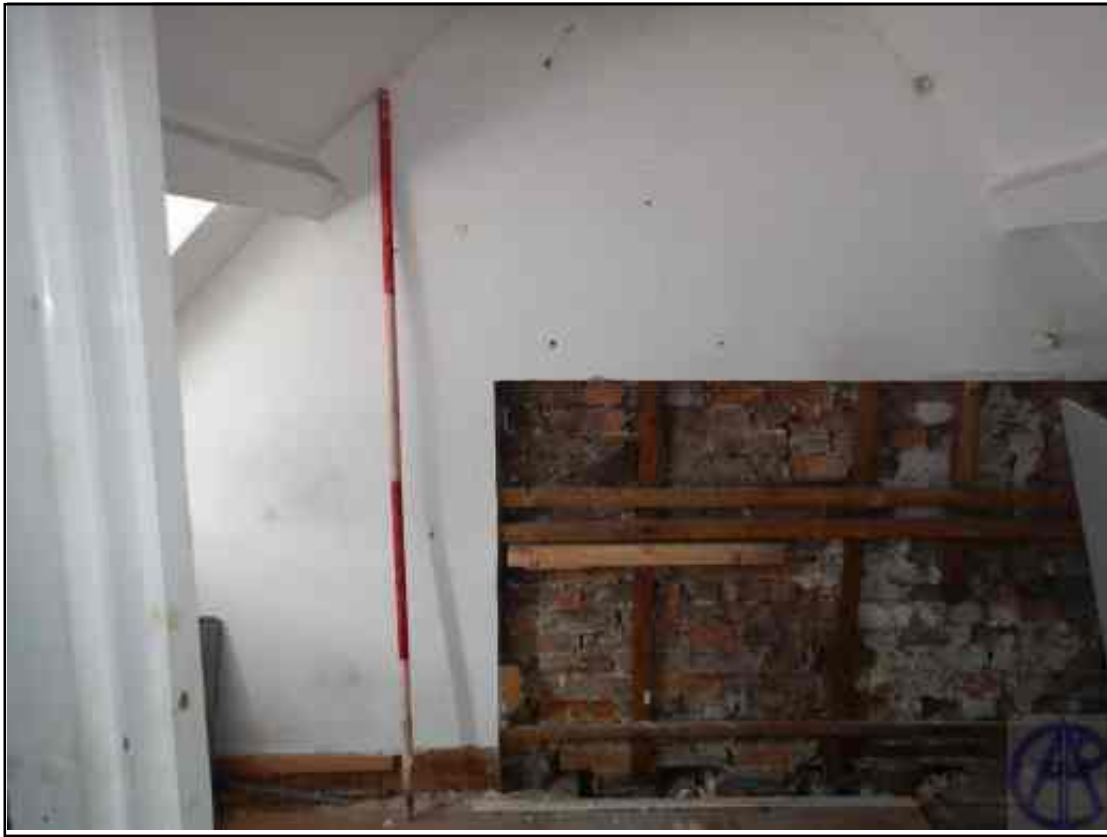
Photo ID: DSCN4520

Handmade brickwork exposed behind cladding at the south-eastern gable/party wall.
