## SUPPORTING INFORMATION

PHOTOGRAPHY DOCUMENTING INVESTIGATIVE WORKS TO EXISTING FLOOR / CEILING AND JOIST POSITION

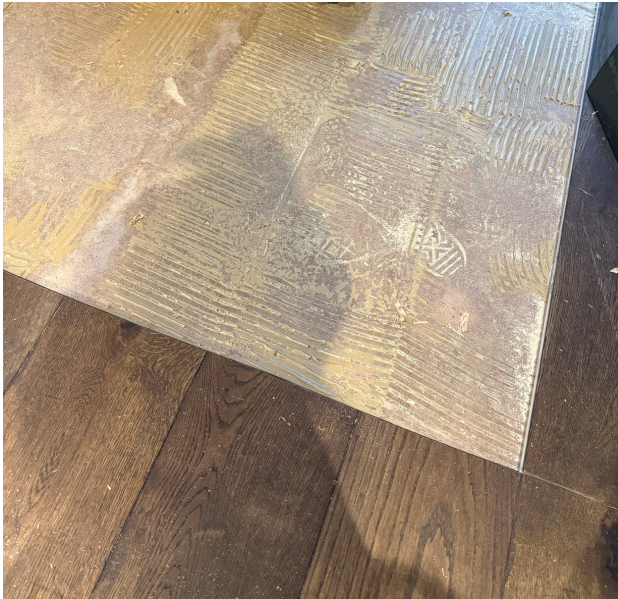
### EXISTING FLOOR FINISH:

35MM ENGINEERED TIMBER BOARDS  
GLUED TO CHIPBOARD, SITTING ON MDF BOARDS.

ENGINEERED TIMBER PLANKS HAVE BEEN RETAINED  
FOR RE-USE IN ORDER TO MAKE AREA GOOD POST  
DUCTWORK INSTALLATION.

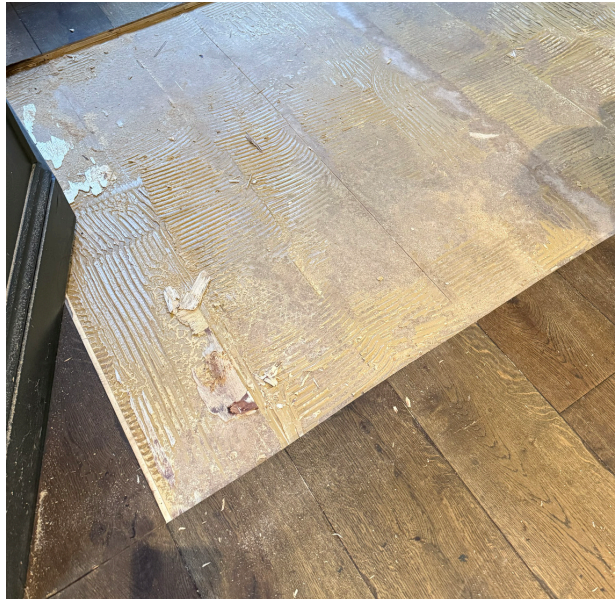
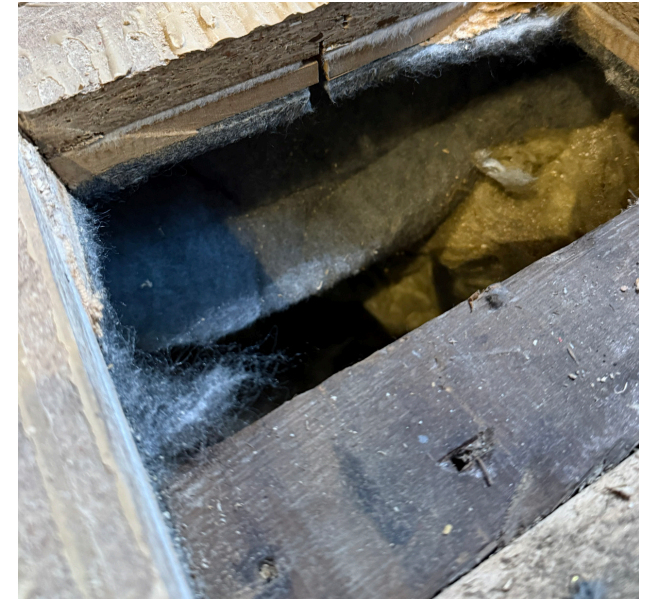
### EXISTING FLOOR FINISH:

BENEATH MDF BOARDS SIT ACOUSTIC INSULATION  
BLANKET, FOLLOWED BY A VOID FILLED IN PART  
WITH INSULATION.

JOISTS EXPOSED.

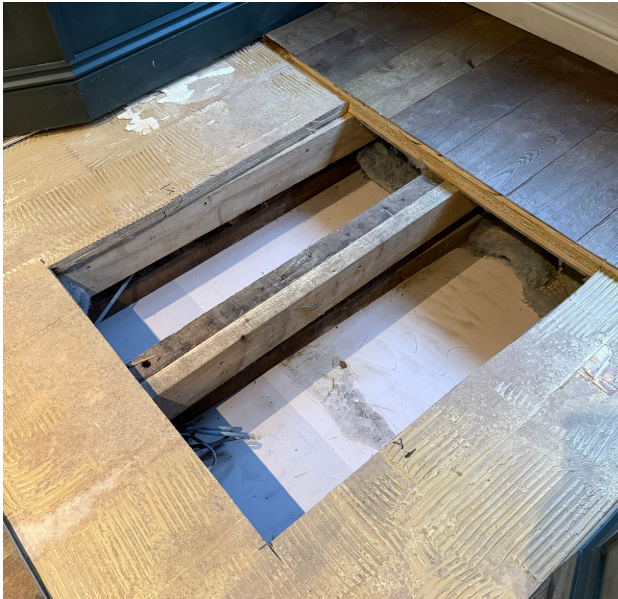
### EXISTING CEILING FINISH BELOW:

PLASTERBOARD.  
(NO LATH & PLASTER PRESENT)

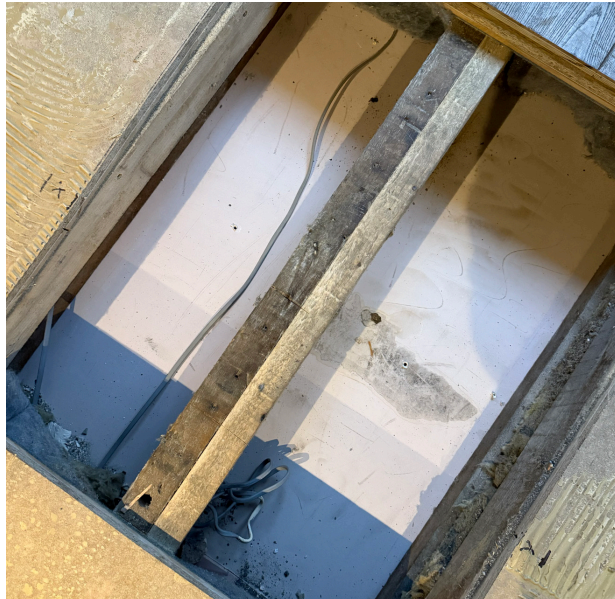
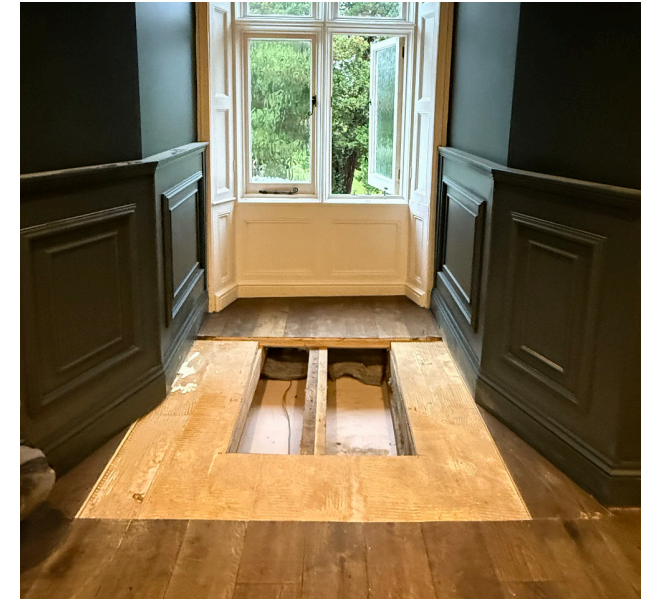
### JOISTS LOCATION

VOID WILL NOT REQUIRE ANY STRUCTURAL CHANGES.  
DUCTWORK TO BE SPLIT IN TWO SECTIONS TO PASS BETWEEN EXISTING JOISTS, AND RE-CONNECTED TO A HEADER DUCT.

DUCTWORK WILL BE BESPOKE MANUFACTURED AND SIZED TO SUIT THE DISTANCE BETWEEN THE EXISTING JOISTS, TO AVOID ANY CUTTING OR TRIMMING.

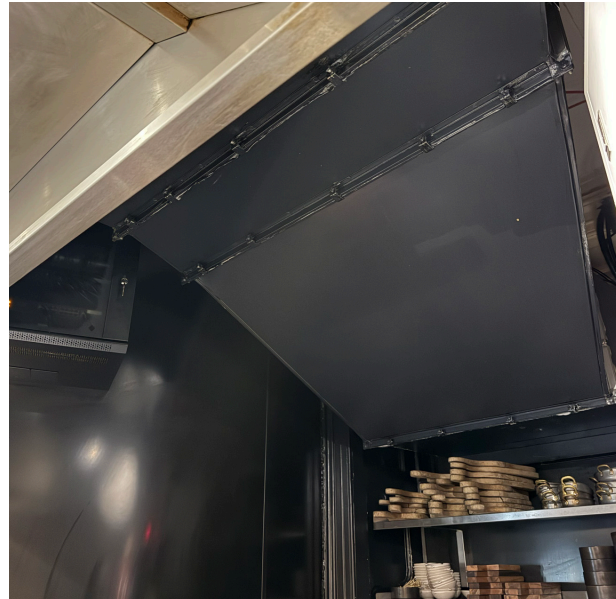
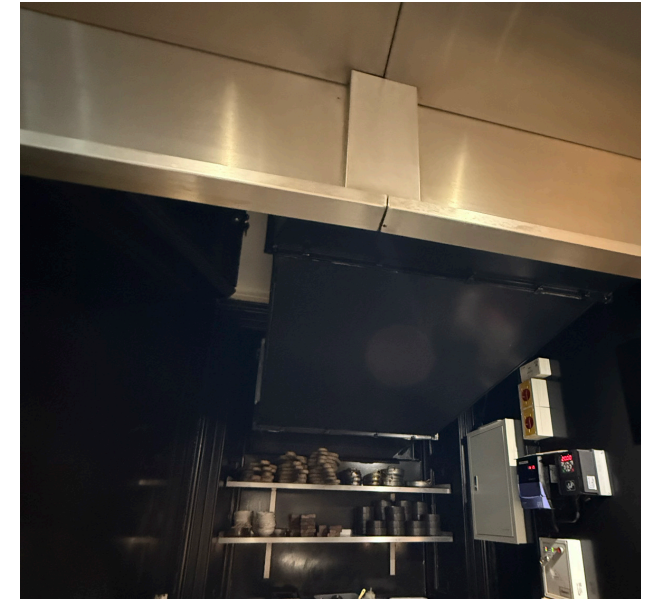
**EXISTING DUCTWORK POSITION  
IN KITCHEN AREA BELOW**

EXISTING DUCTWORK EXITS VIA EXISTING WINDOW  
APERTURE.

EXISTING WINDOW WAS REMOVED IN PART AND  
HAS BEEN RETAINED, TO BE RE-INSTALLED AND  
MADE GOOD AS PART OF PROPOSED WORKS.
