## Arboricultural Tree Report

A site visit was carried out on the 05/06/24 at National Trust, Tredegar House, Newport. Two trees were inspected that are in proximity to an existing children's playground. This playground is planned to be removed and replaced. This report will focus on the two trees these works will affect. Both have had metal numerical tags installed on their stems. These are referenced in this document for ease of ongoing management.

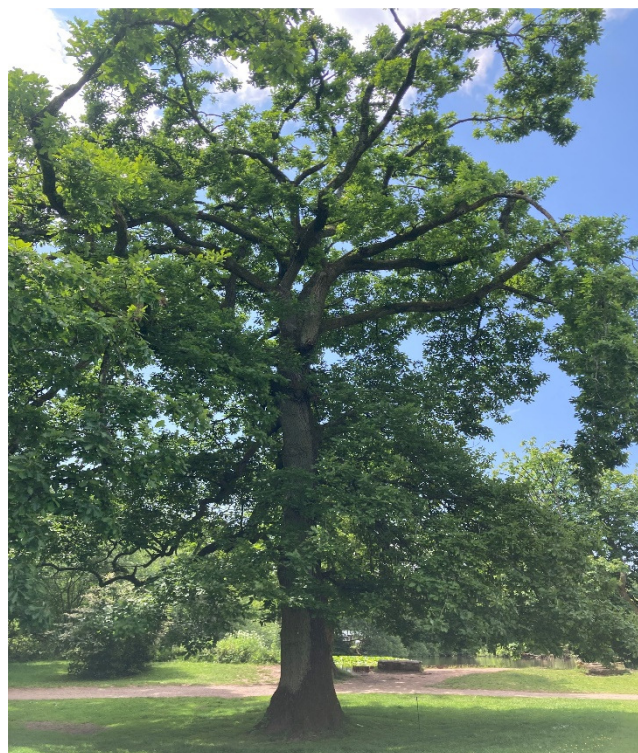
(Fig 2)

Tree tag – 2370

Genus/Species – *Quercus petraea* (Sessile Oak)

Target – NT Very High usage Zone. This means tree is on an annual inspection regime. Proximity to main footpath and overhanging children's playground.

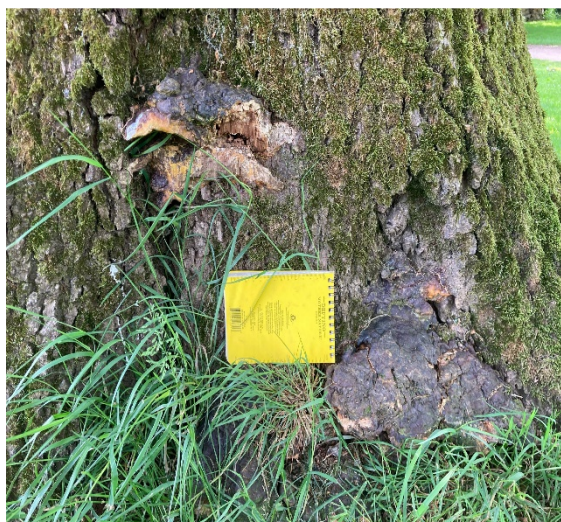
(Fig 3)

Base of tree on Northwest facing side, evidence of multiple old *Ganoderma* sp. fruiting bodies. No signs of fresh fruiting bodies at time of inspection. Whilst it is difficult to identify which species definitively when the fruiting body is this deteriorated, the pore surface has a strong contrasting pale and dark layer which is quite distinctive of *Ganoderma resinaceum*. The effects of this fungi when advanced can cause uprooting or stem breakage. Whilst it is established the tree has responded vigorously with adaptive growth at it's root flares (See fig 3 below).

When tapping around areas surrounding the fruiting bodies evidence of hollow developing. Surrounding buttresses are well established and normal for species, compensating for dysfunction in base. On the East facing side hollow is evident. When probed 30cm of penetration was evident before sound wood was found. Butress flares around this defect are well formed. (See fig 4 below). Proximity to children's playground on North and West facing sides. 6m from base of tree to concrete pad and perimeter fence of playground. Well within drip line of crown.

Reduce crown on South and East facing sides to rebalance crown in line with previous tree works. This will also reduce the load over the dysfunction at the base caused by the Ganoderma fungi.

Any ground works carried out in the area near base of the tree must avoid damaging roots further by encroaching into the remaining 6m gap that currently exists. As this play area predates BS 5837 (2012) guidance. The area around the tree which has been constructed on is very close. With a diameter of 99cm the recommended exclusion zone to significant works near the base would be 12m. Currently only 6m exists. Any future works in this area must not encroach any closer and ideally widen this gap as much as is practically possible to allow the tree to recover.

Once construction of new play area is complete, a tree circle with a woody mulch to a depth of 75mm around whole tree ideally to drip line but this can be reduced if not practical in that area. This will help to condition and reduce compaction around the tree by improving the soil structure.

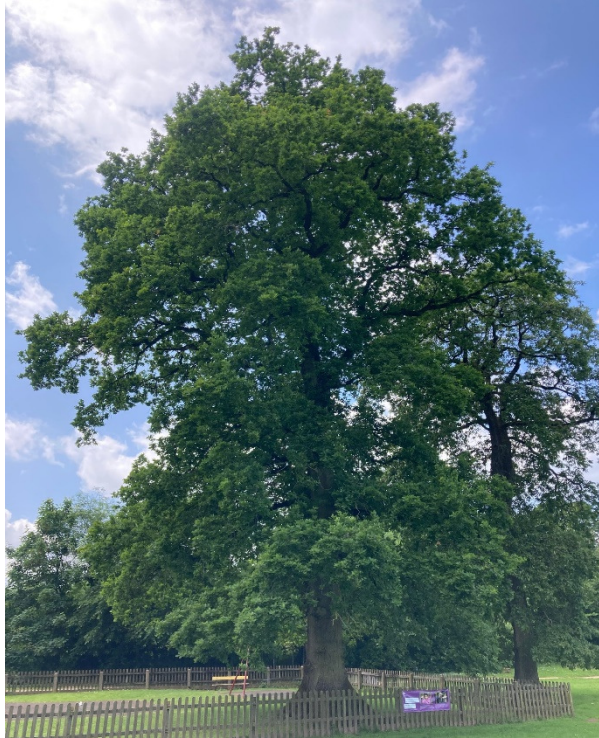
(Fig 5)

Tag – 2371

Genus/Species – *Quercus robur* (Pedunculate Oak)

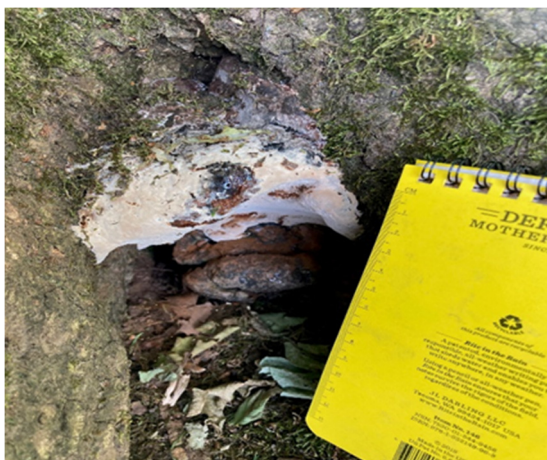
(Fig 6)

Root flare is well established in all directions. Small fruiting body of *Ganoderma* sp. at base on Northwest facing side (See Fig 6 below). Unable to accurately identify at time of inspection due to immature fruiting body. The buttress formations around this area of dysfunction are solid when tapped and normal for species. Wooden fence runs alongside of tree at 1m approx. Playground swings and concrete pad are approximately 5m from base of tree (See fig 7 below).

Recommend reinspecting in Autumn to see if fruiting body has matured to aid correct identification.
