## **ARBORICULTURAL REPORT**

**Location :** 16 Clytha Park Road, Newport NP20 4NA

**Date of inspection :** 9th June 2026

**Consultant / Surveyor :** Nick Thomas Dip.Arb, Cert.Arb.RFS

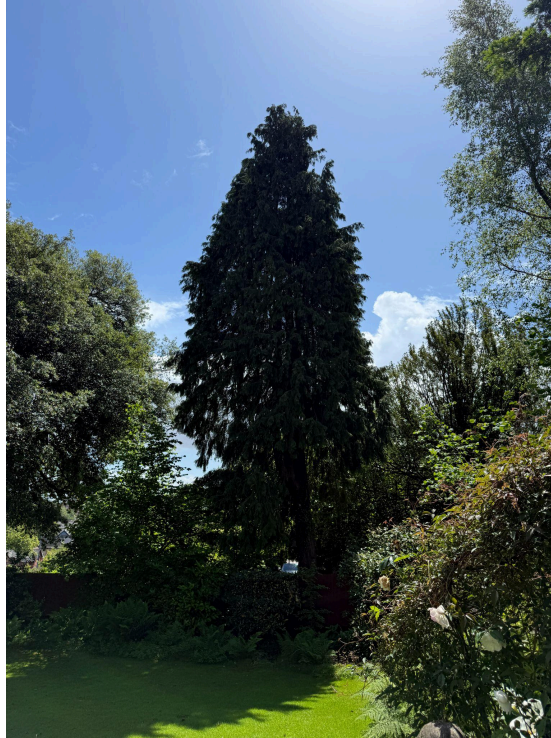
This tree has been previously topped at 10 metres above ground level. This has resulted in contorted regrowth which has developed into a number of vertical stems. From ground level decay is visible at the location of the original top pruning cut. There is some small diameter deadwood in the inner crown.

The tree's vigour and annual extension growth is average for the species therefore its physiological condition has been classified as fair. Due to its form its structural condition is poor. As the tree continues to increase in height there is a corresponding increase in the risk of branch or stem fractures during periods of high winds.

**IMAGE 1 : Tree 357 from the garden of the property.**

To reduce the risk of future branch or stem failures the height of the tree should be reduced by 5 metres.

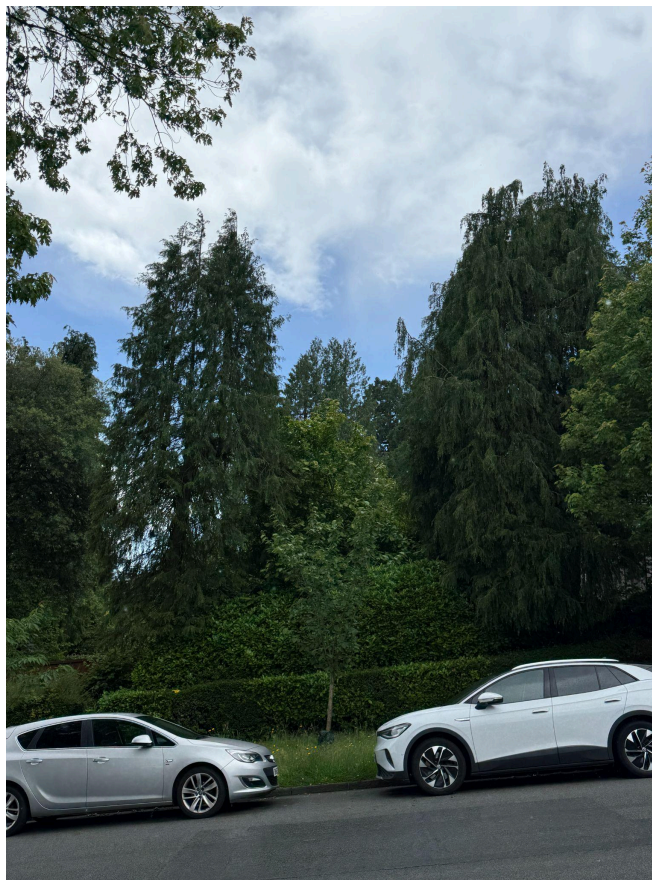
This tree has been previously topped at 8.5 metres above ground level with probable decay in a number of the original pruning cuts. This has resulted in contorted regrowth

which has developed into a number of vertical stems. There is some small diameter deadwood in the inner crown.

The tree's vigour and annual extension growth is average for the species therefore its physiological condition has been classified as fair. Due to its form its structural condition is poor. As the tree continues to increase in height there is a corresponding increase in the risk of branch or stem fractures during periods of high winds.

This tree has been previously topped at 9 metres above ground level with decay in a number of the original pruning cuts. This has resulted in contorted regrowth which has developed into a number of vertical stems. There is some small diameter deadwood in the inner crown. The main stem forks into two at 1.5 metres above ground level and the northern stem forks at 3 metres above ground level. Both forks have included bark.

There is a collapsing small diameter branch on the north east side of the crown at 8 metres above ground level.

**IMAGE 2 : Tree 358(lhs) and tree 359(rhs)**

To reduce the risk of future branch or stem failures the height of the tree should be reduced by 3.5 metres.

To reduce the risk of future branch or stem failures the height of the tree should be reduced by 4.5 metres and the collapsing branch should be reduced by 1.5 metres.

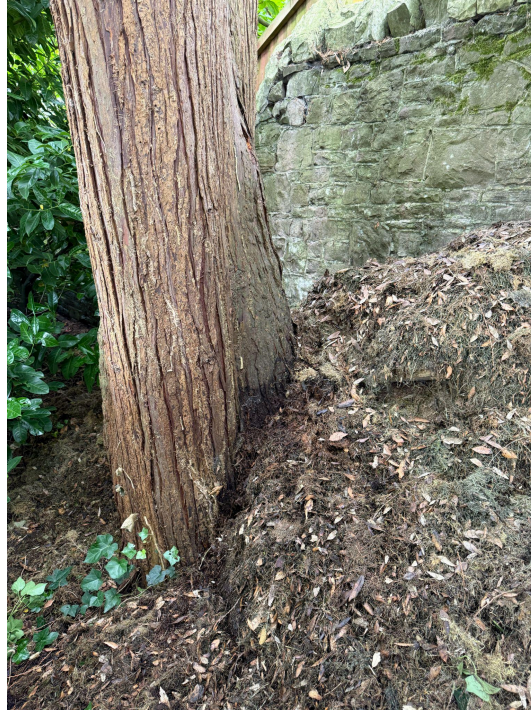
There was a mound of decomposing grass clipping around the base of the tree which were in contact with the main stem. To prevent the decay of the bark and main stem these clippings have now been removed.

**IMAGE 3** : Prior to their removal the grass clippings around the base of tree 359.

The bark area affected by the grass clippings should be monitored annually for any necrosis or decay.
