## Single site survey

**Client:** St Thomas' Church

**Address:** 3 Church Row, Redwick, Caldicot NP26 3DE

**Location description:** Tree located to the "Cider Press" building in the village centre

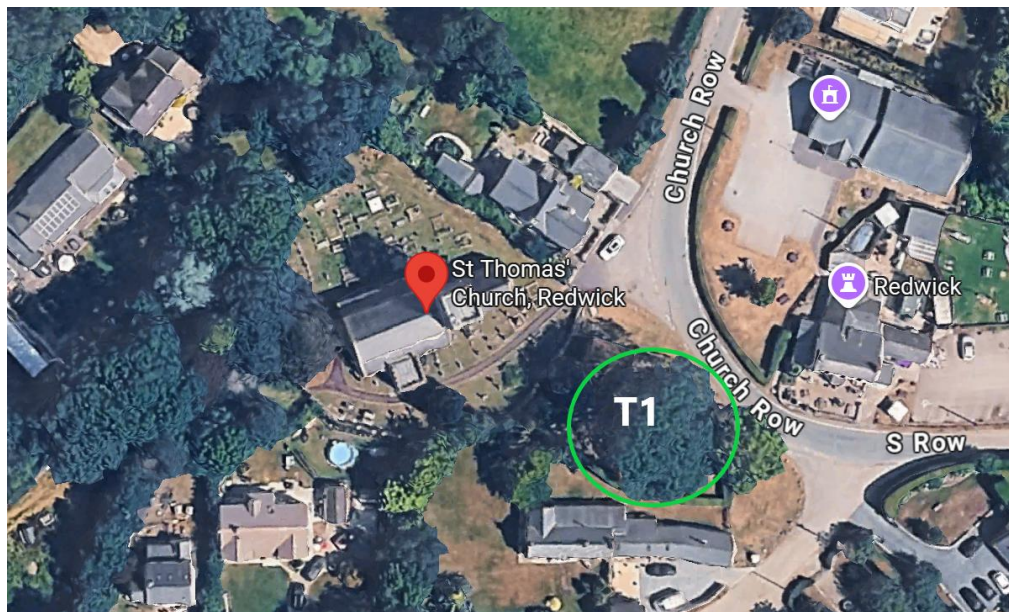
- Mature open crown ash tree
- Height 26m
- Spreads average 11m
- Stem diameter 950mm
- Fair physiological condition
- Characteristic structural condition
- High target area

- Semi-mature low stem epicormic shoots.
- Stem epicormic shoots show no Hymenoscyphus fraxineus infection.
- Open stem cavity wound at historical limb removal wound 2.2m to west of stem.
- Further occluded limb removal wound at 5m west side of stem.
- Potential for the stem to be hollow between the two points noted above.
- Dead wood throughout crown averaging 80mm diameter.
- Some dead wood as a result of natural cladoptosis but other sections most likely due to Hymenoscyphus fraxineus infection.
- Outer crown Hymenoscyphus fraxineus infection appears stabilised.
- Wide and spreading crown.

- Buildings within the vicinity of the tree are likely to alter aerodynamic loads and potentially affect the spreading limbs that may have become more brittle due to *Hymenoscyphus fraxineus* (stabilised) infection and current 2026 drought.
- Evidence of historical storm damage.
- Recent drought stress failed 90mm diameter branch from north crown.

This mature ash tree in the village centre is an impressive tree. It has formed a main focal point in the village centre for many years. *Hymenoscyphus fraxineus* has been a factor in the tree's recent life but there is evidence to suggest that the decline of foliage tips has halted. There are historical stem/limb removal wounds that do indicate there may be some degree of hollowing within the stem but hollow mature trees are a reasonably normal occurrence. Overall, the risks from the tree are the obvious chances of falling dead wood to the area below the tree's crown or the potential of elongated limbs to suffer breakage due to climatic conditions or disease. The recent 90mm diameter limb failure is highly likely to have been down to drought and the limb being a north crown limb (north facing limbs can often have phototropic form and extended length with the branch looking for light).

1. Remove semi mature stem epicormic shoots using natural target pruning.
2. Remove dead wood from crown greater than 15-20mm diameter.
3. Prune out storm damage stubs.
4. Lift low crown foliage to a uniform 4m height.
5. Consider crown reduction of crown (2-3m) to reduce limb breakage potential.
6. All pruning work to be in accordance with BS3998 2010.
7. Review tree's condition in summer 2029.
