**Arboricultural Mitigation  
and  
Tree Recovery Scheme  
for  
Oak Tree T3,  
24 Parkend,  
Langstone,  
Newport**

*Inspected by:-  
Julian Wilkes BSc.For, MSc.Land Man, MIC.For, TechArborA  
Treescene Ltd  
4 Old School House  
School Lane  
Gwaelod-Y-Garth  
Cardiff  
CF15 9HN  
Tel No. 029 20599300*

*8<sup>th</sup> October, 2026*

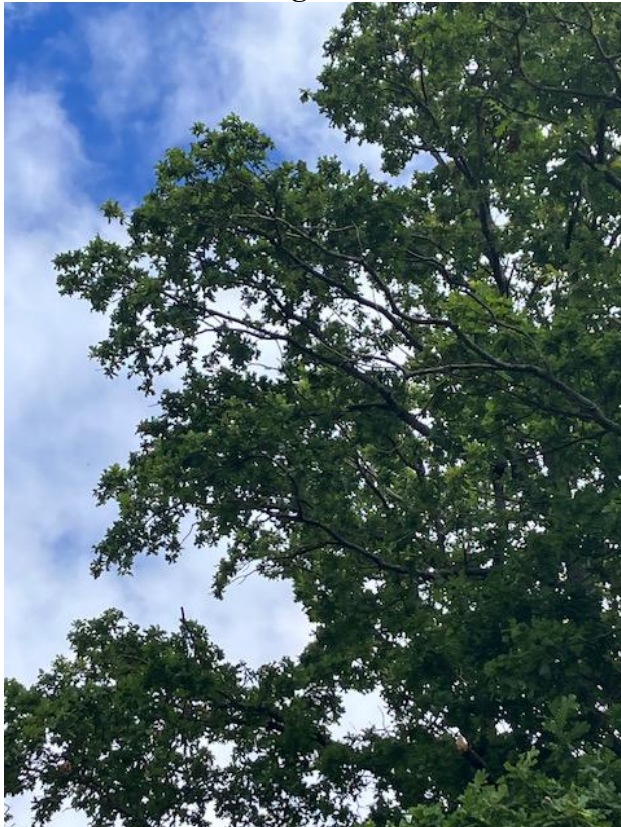
**Image 0521**

- a) A triple-stemmed tree of good form and reasonable vigour.
- b) Evidence of historical excavation on southern side of RPA (see attached image 0523).
- c) No evidence of any significant defects, cavities or fungal infection at base.
- d) Some evidence of slight thinning and dieback of foliage in outer crown (see attached images 0521 and 0524).
- e) Some minor accumulation of dead wood on southern side of crown (see attached image 0522).

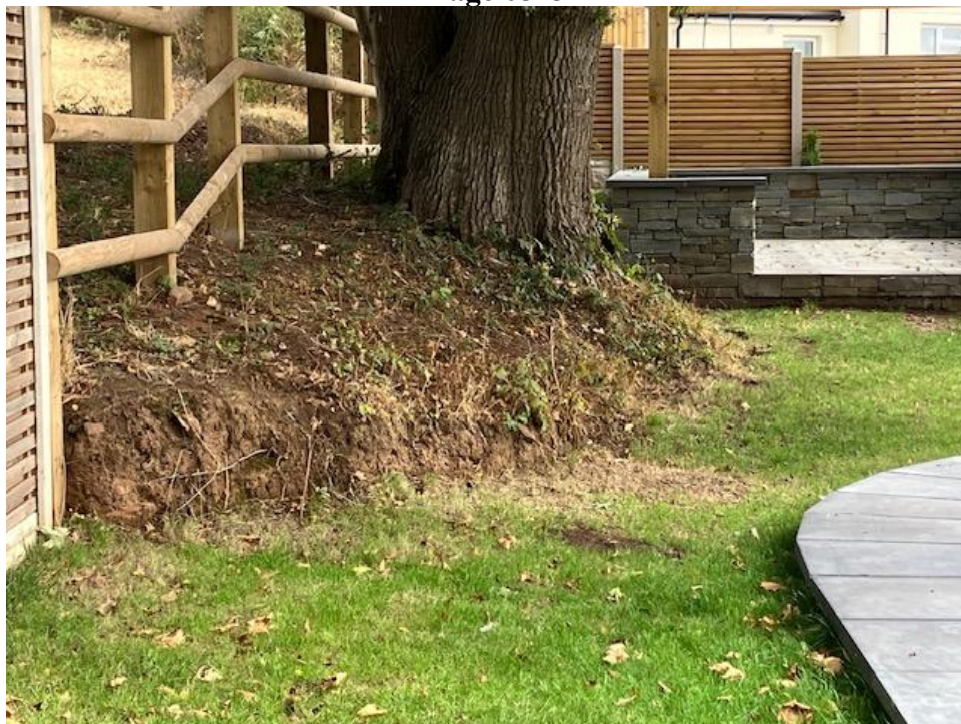
**Image 0523**

There did not appear to be any decline in condition between May and September, in spite of the challenging climatic conditions for tree health during those three months, and therefore it is concluded that the tree has not been significantly adversely impacted upon by the excavation works in relation to the installation of the retaining wall.

The tree protection measures detailed in the AMS/TPP should be installed prior to the commencement of any construction activity on site.
