## STRUCTURAL REPORT

The Old Cowshed  
Bowdens Lane  
Newport  
NP26 3AA

**RE: Structural Inspection of The Old Cowshed, Bowdens Lane, Penhow, Newport. NP26 3AA**

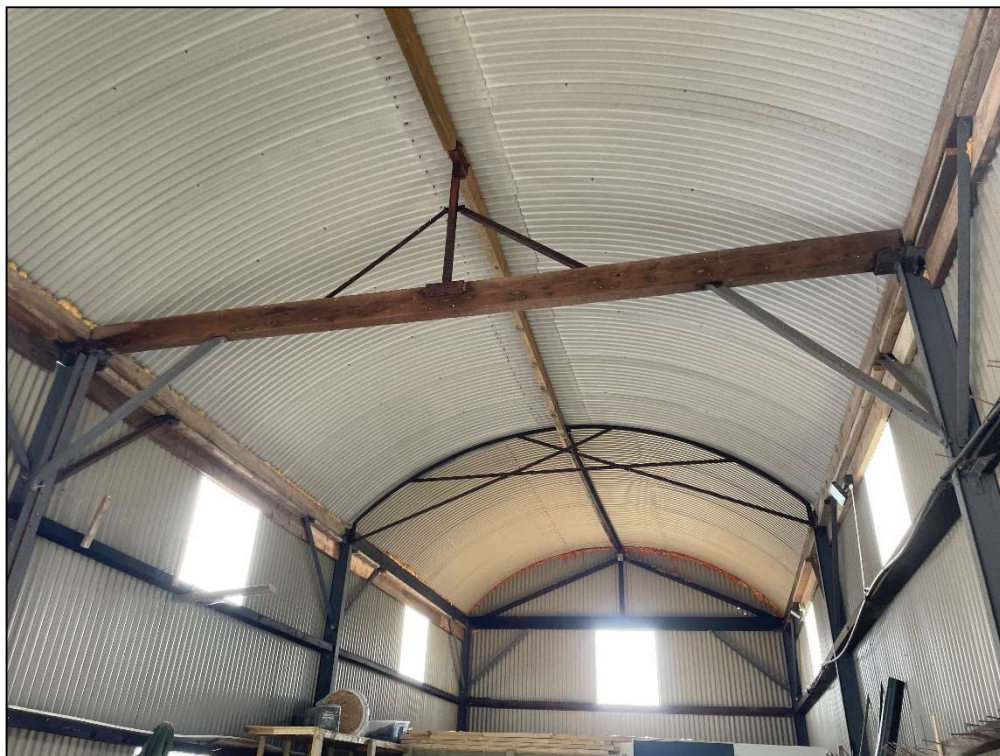
Photograph 1

The property is a Dutch barn, which consists of steel stanchions supporting steel trusses, which supports corrugated sheeting as roof finishing and a timber ridge. The trusses are a variation of a scissor truss and king post truss (**photograph 1**).

The steel stanchions and trusses appeared to be in good structural condition, without any signs of corrosion or excessive deflection.

The timber side rails appear to be sagging slightly, although expected for an agricultural building of this age.

We consider that the floor slab and main stanchions are adequate with minor strengthening works to support the increased loading of extra purlins and composite sheeting. However, we would suggest that for the thermal improvement of the building, infill timber panels will be required in between the existing stanchions, which would result in the main stanchions becoming somewhat redundant to provide lateral support to the frame.

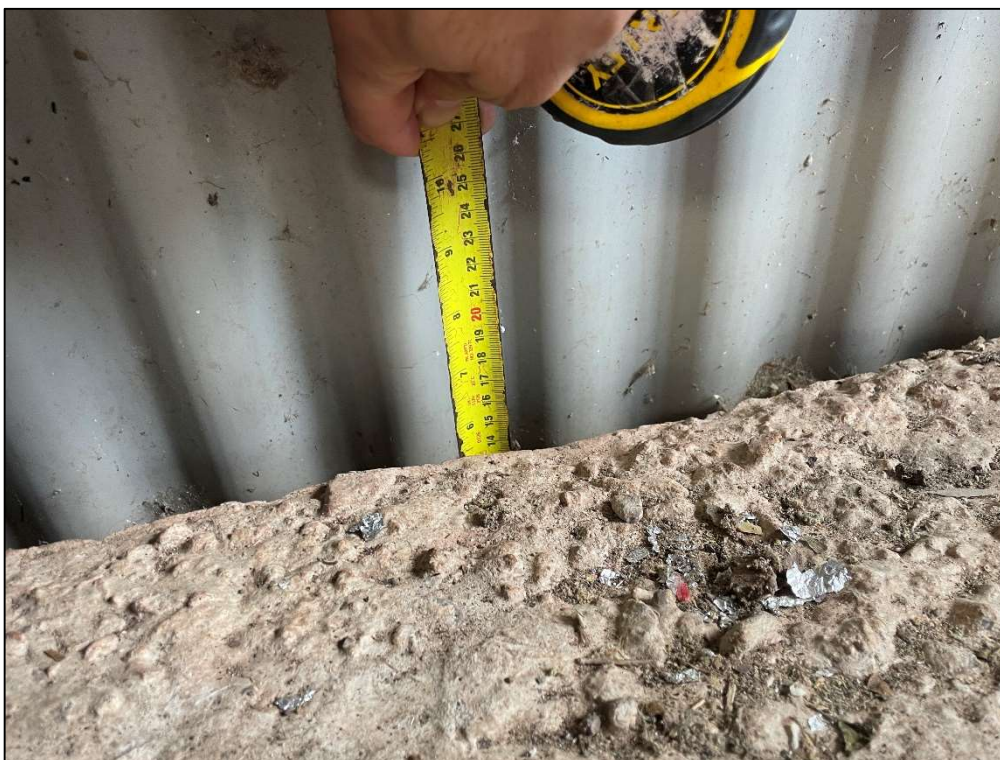
Photograph 2

The ground floor slab was found to be a 125mm thick concrete slab (**photograph 2**).

The ground floor slab is adequate for habitable use.
