**CONCRETE STRUCTURE ASSESSMENT REPORT  
NEWPORT CENTRAL LIBRARY  
NEWPORT**

**Date: 20<sup>TH</sup> JULY 2016**  
**Ref: BH.DB/16027.01.D001**

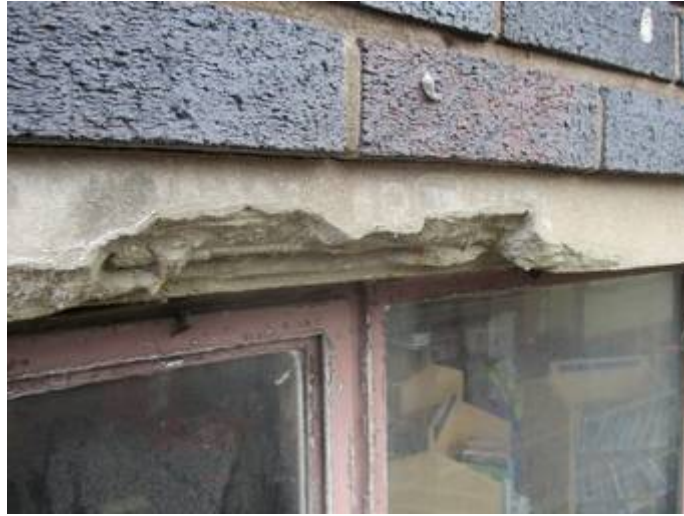
4 – View of a typical spalled edge beam/nib.

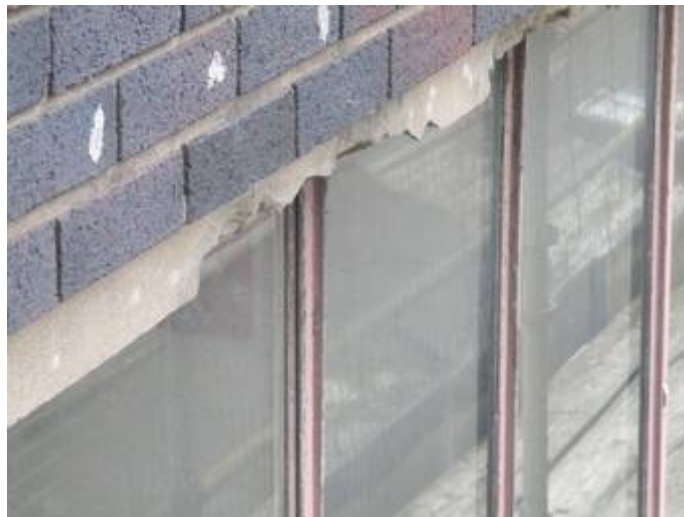
5 – As above.

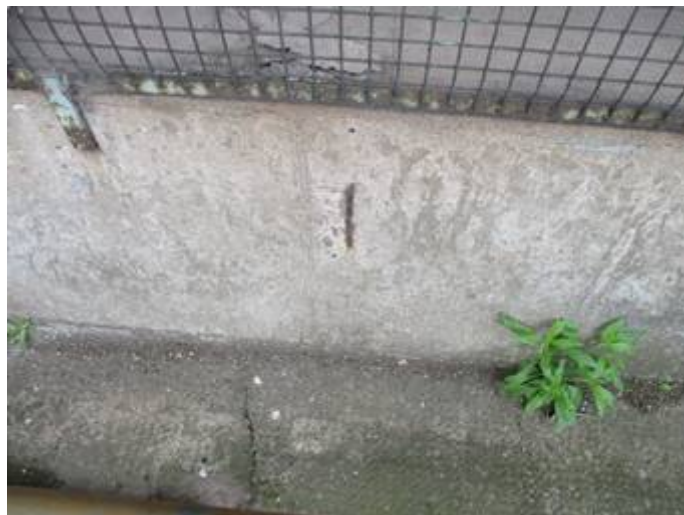
6 – A low level external spall.

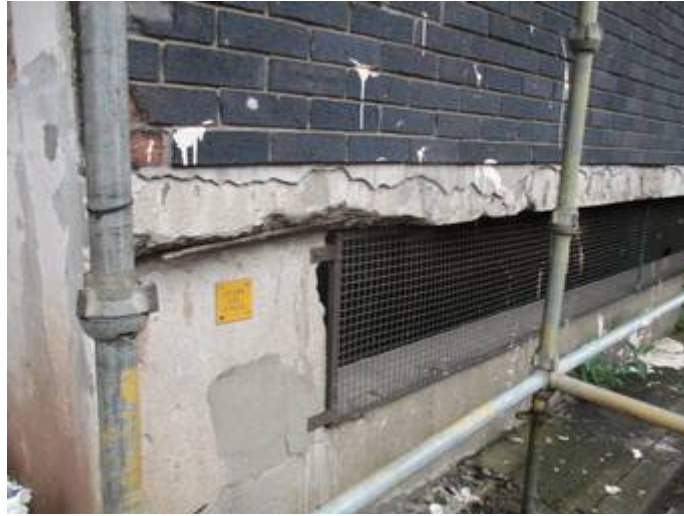
7 – A spalled edge beam/nib.

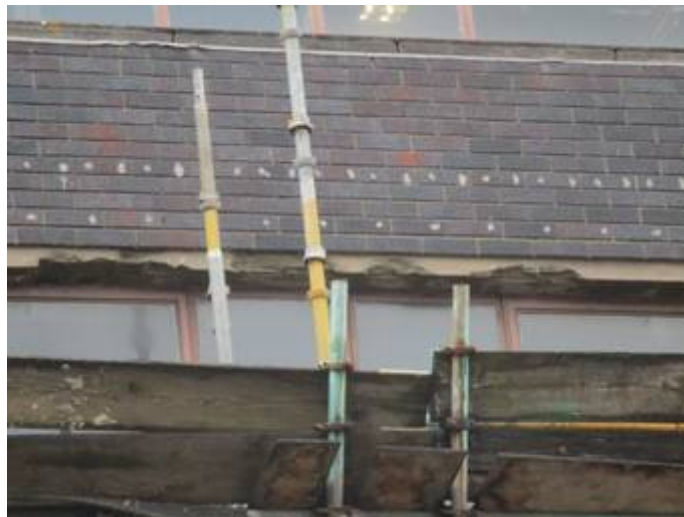
8 – As above.

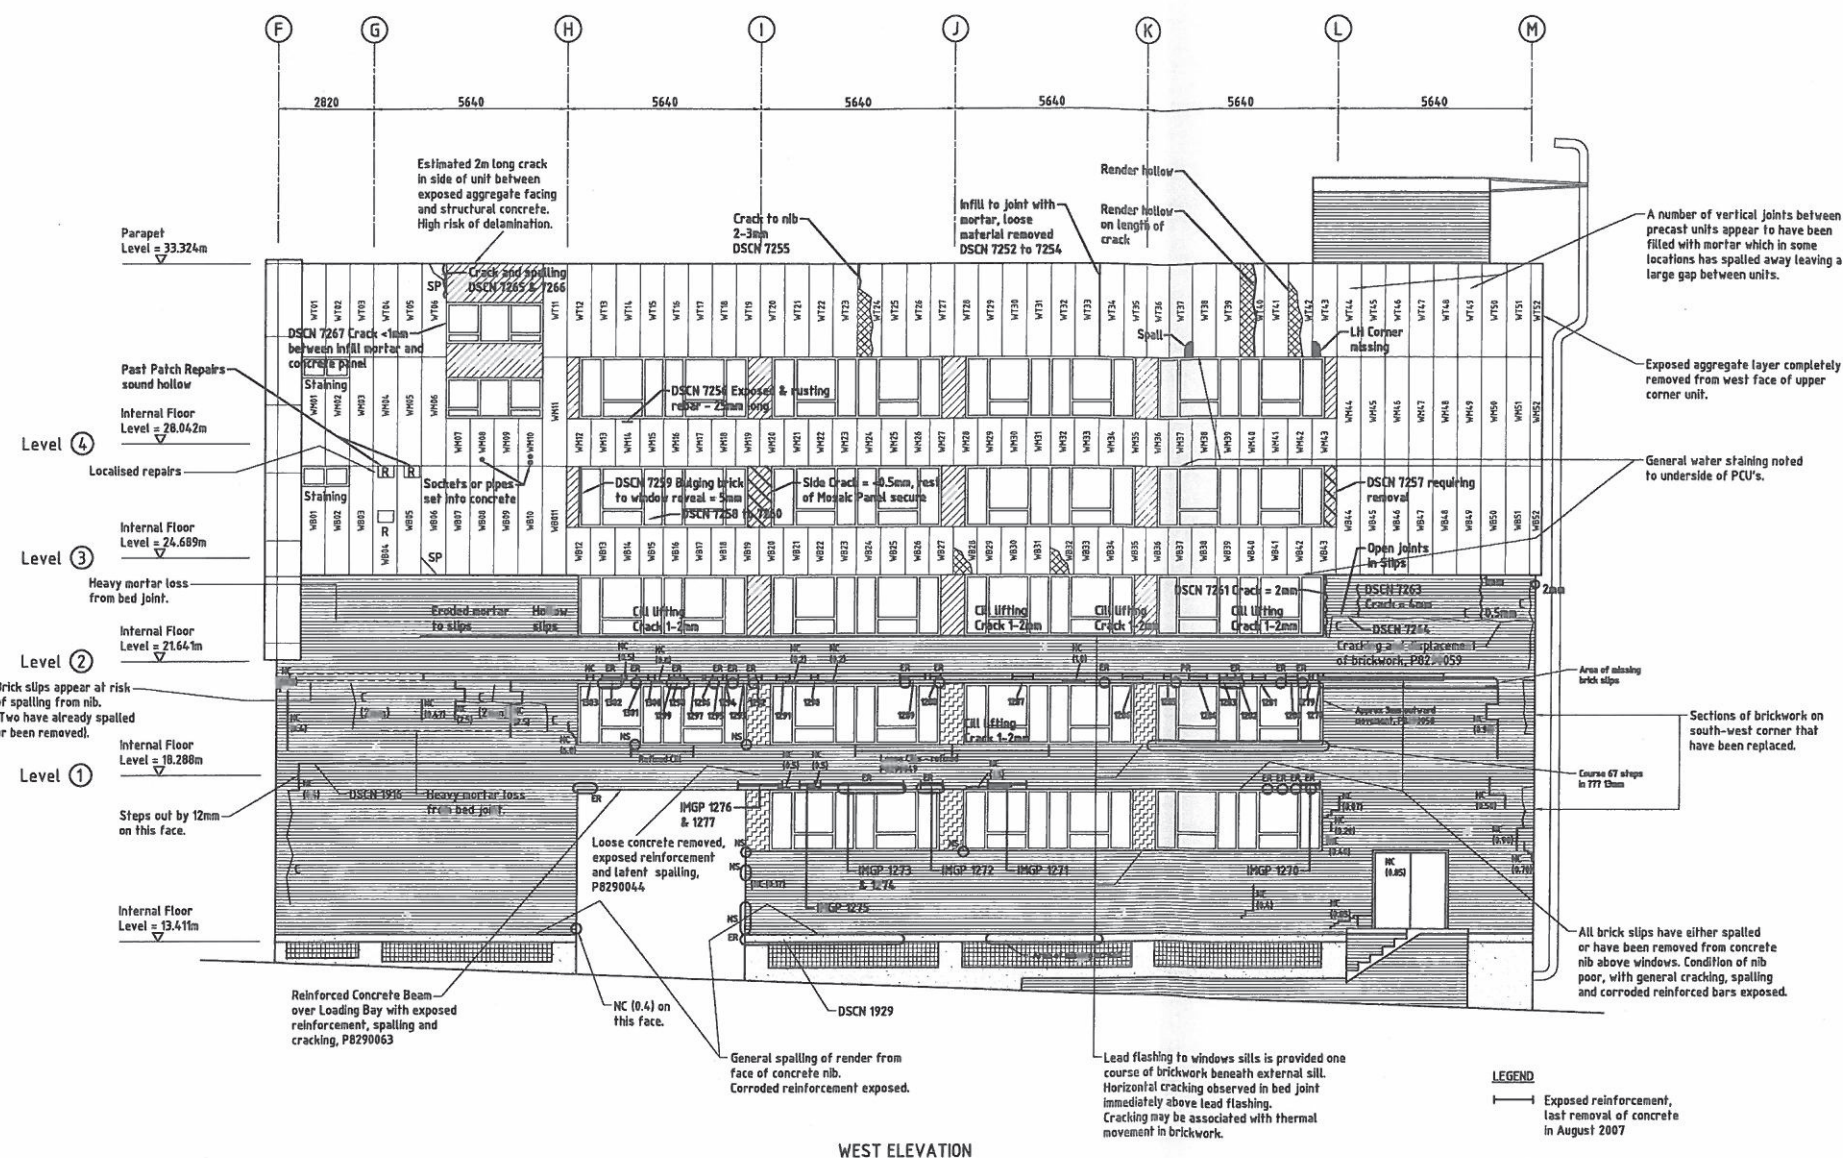
WEST ELEVATION

- 2.7 In general, Shear Design's reporting's on the condition of the external face of the west elevation would concur with the extensive damages reported by the previous engineering survey of the west elevation carried out by Stirling Maynard & Partners Consulting Engineers 2007, [Appendix v](#).
