# SIMON REAMES ARCHAEOLOGY

## Archaeological Watching Brief Report

Old St Peter's Church, Peterstone, Wentlooge, Cardiff, CF3 2TR

Prepared for  
Newport City Council

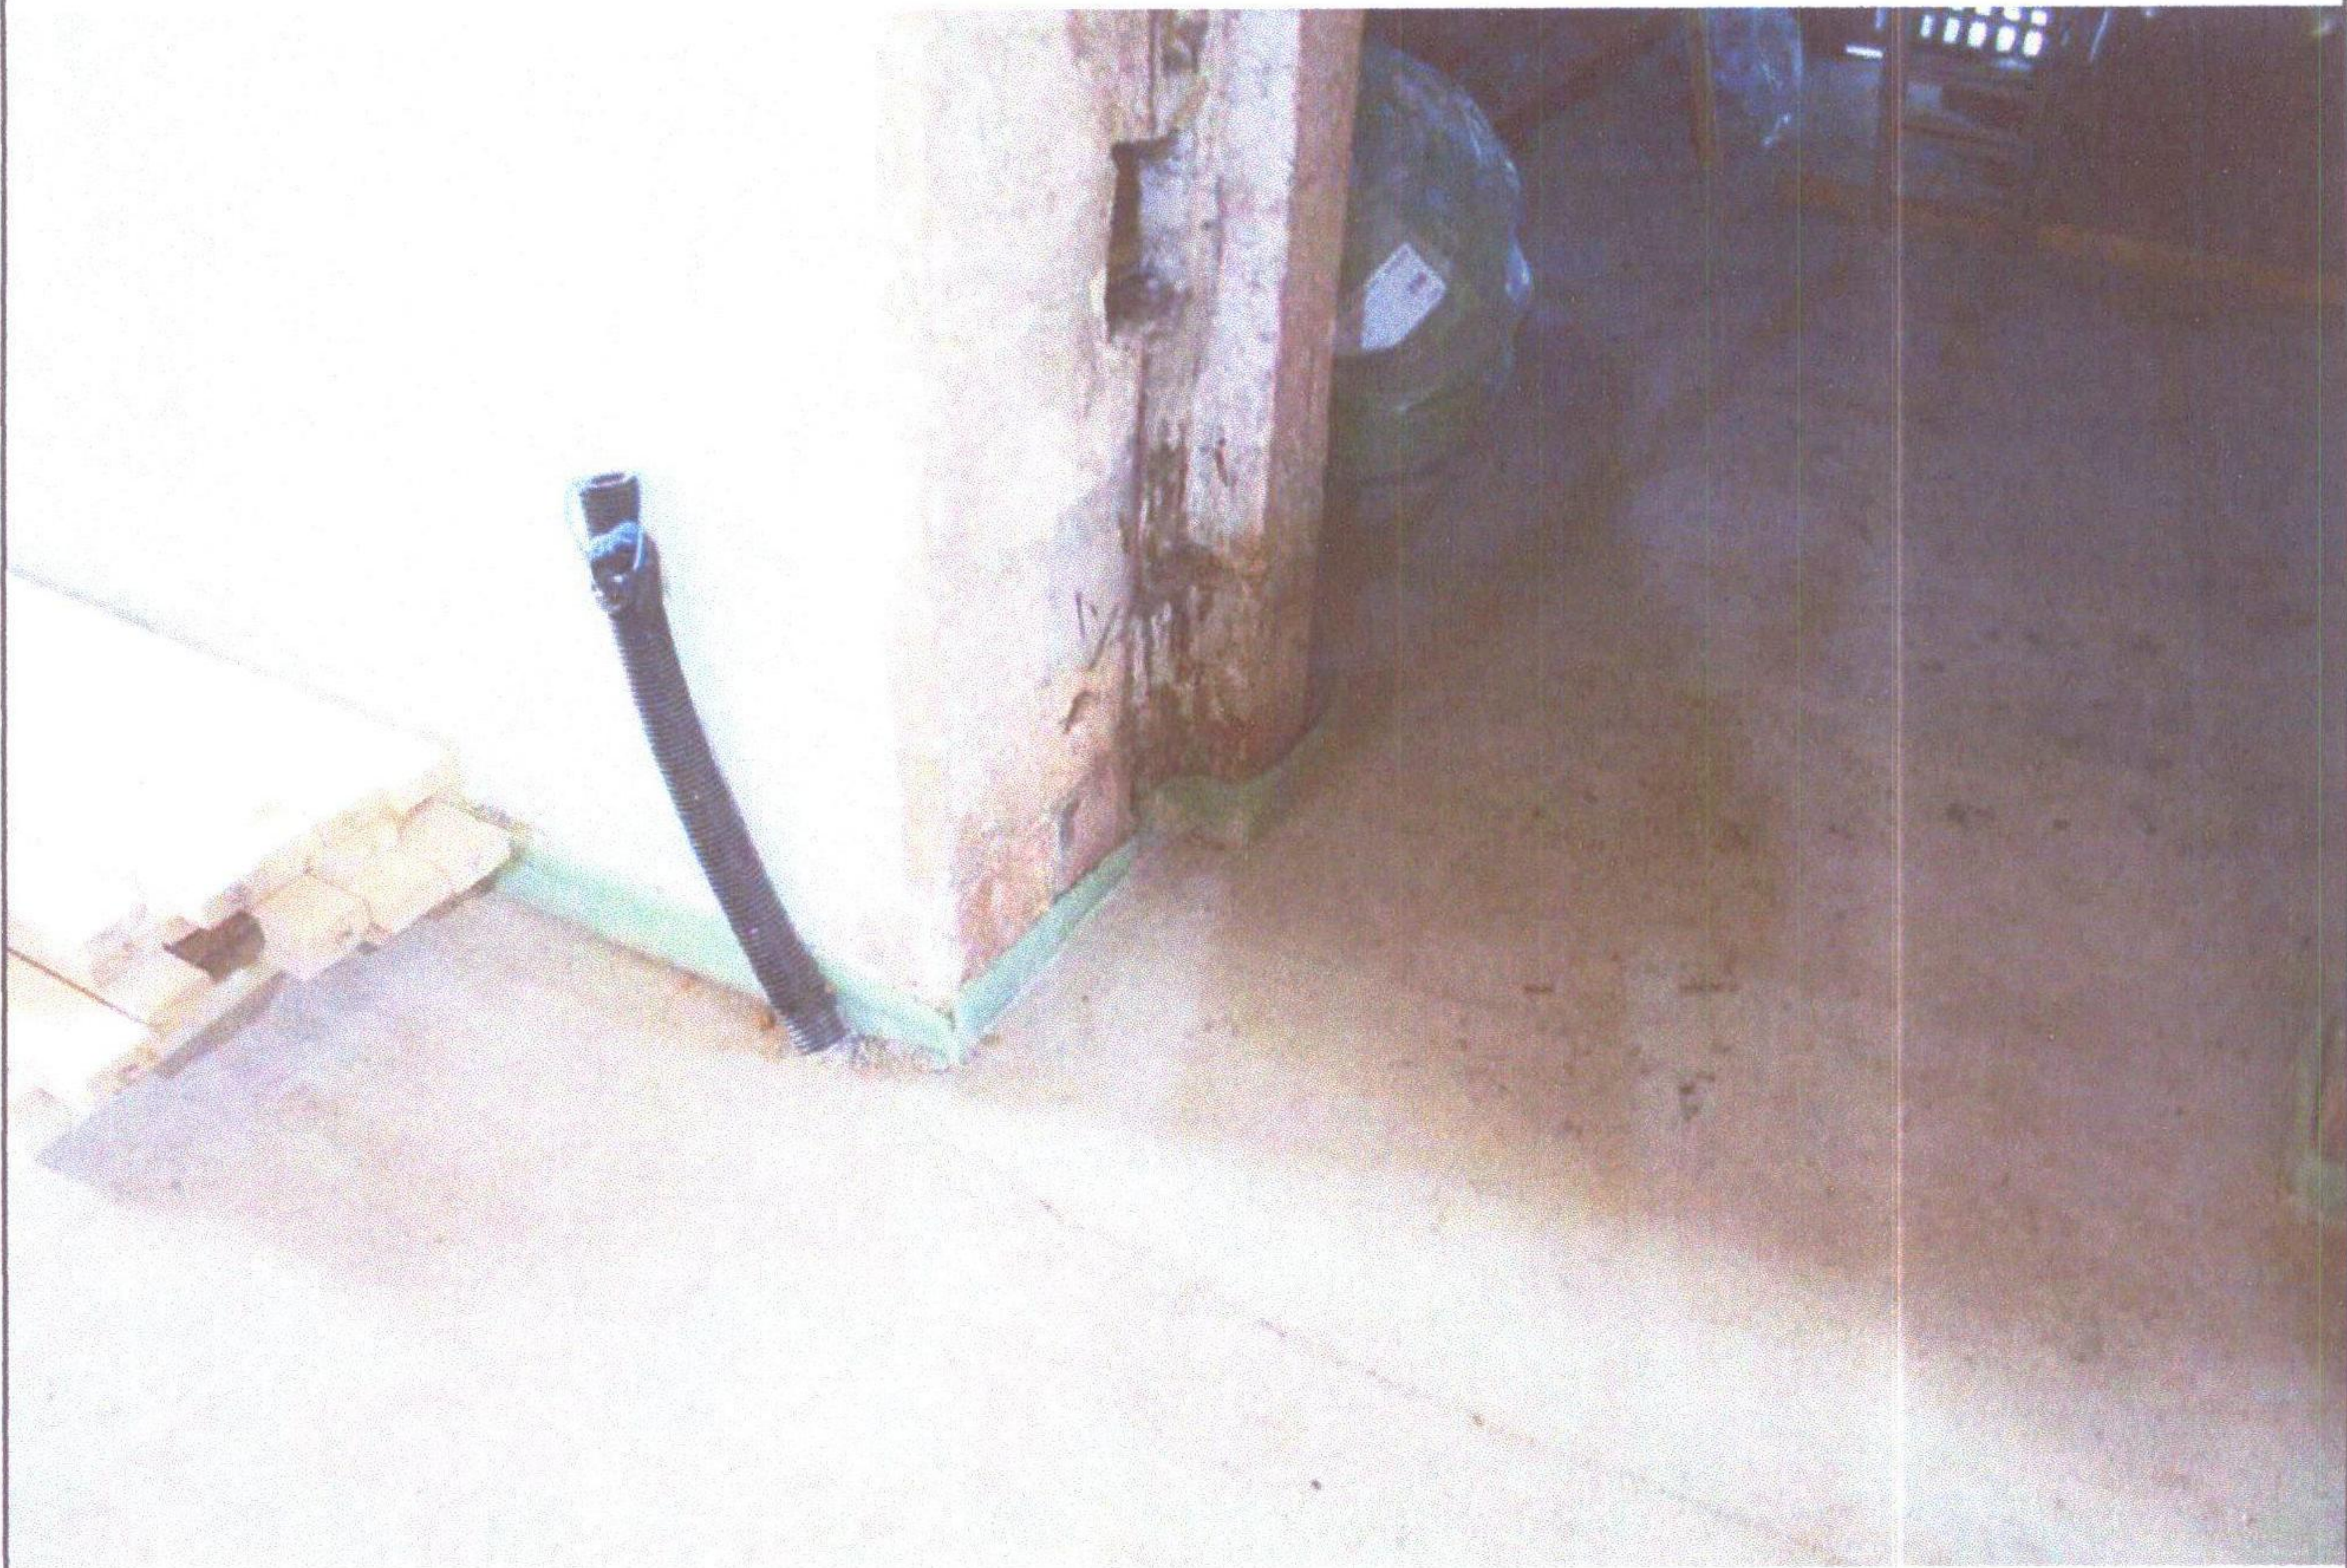
Plate 1

- 3.2.7. Where archaeological remains were encountered, such as the foundations and pillar bases, a recommended barrier layer was installed to separate the modern concrete from the historical fabric of the structure (**Plate 1**).

Internal Shot of Barrier Layer Between the Modern Concrete and Original Building Fabric

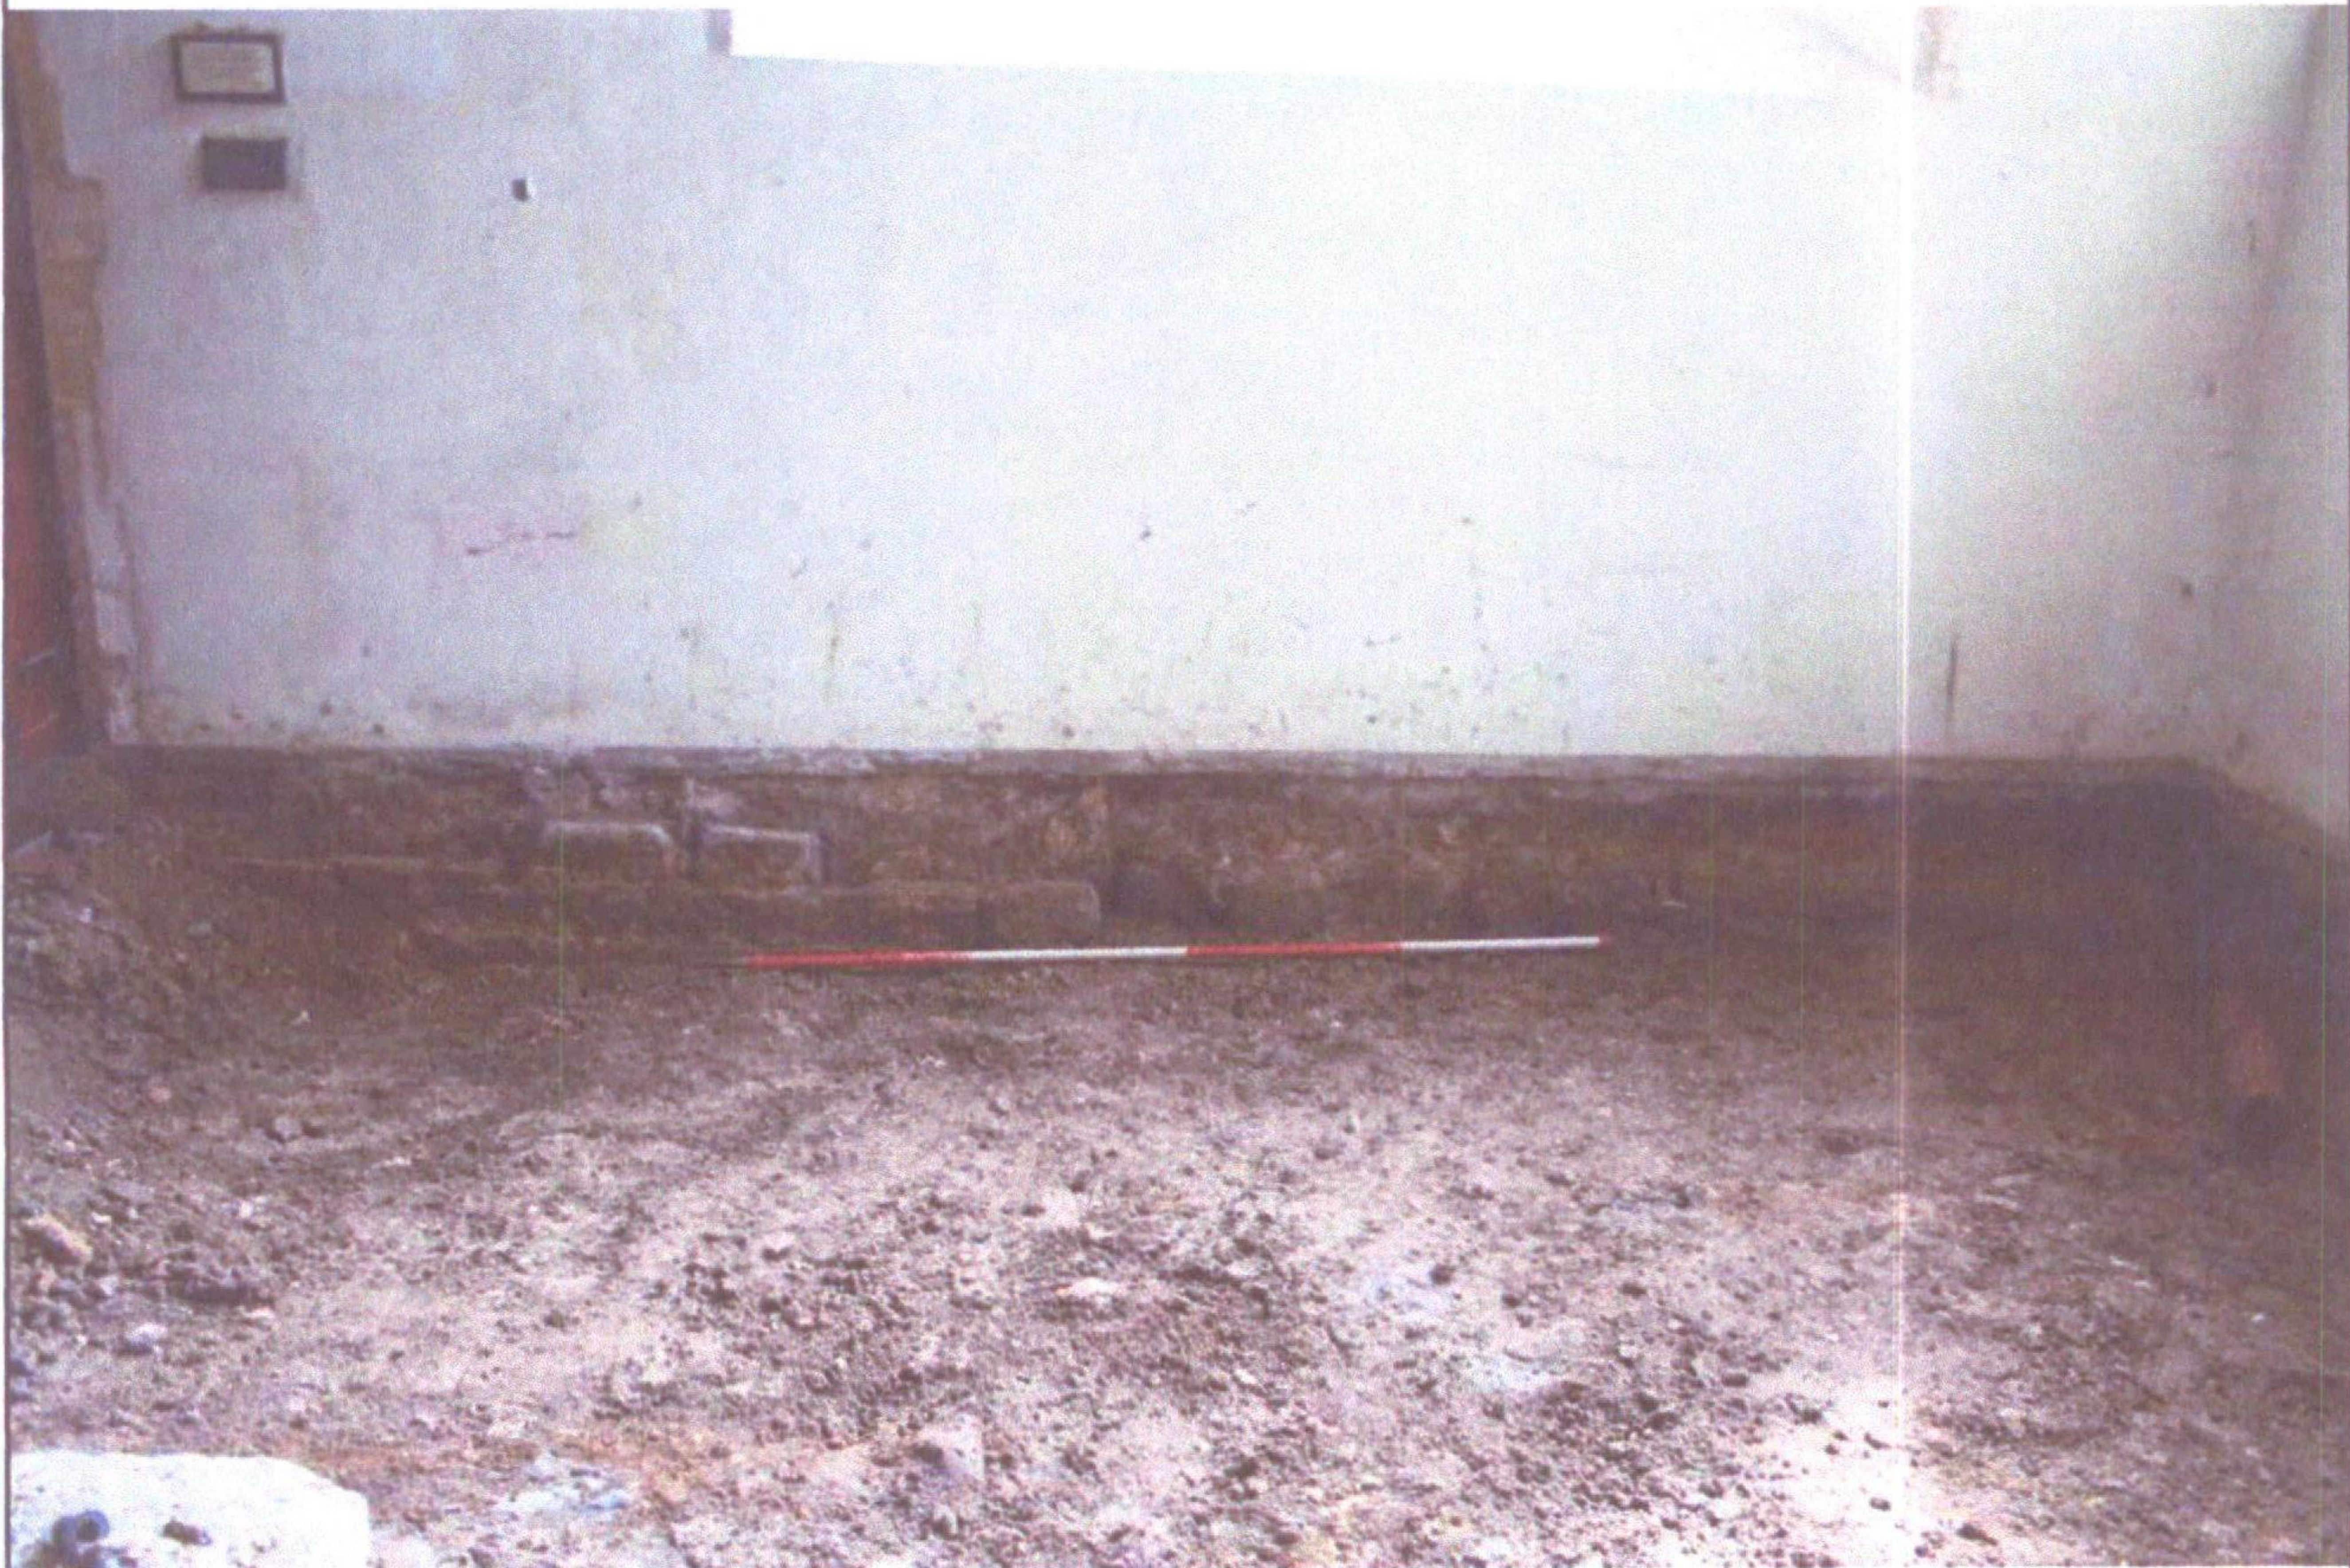
Plate 2

Internal Shot of Structure {122} below Structure {123}

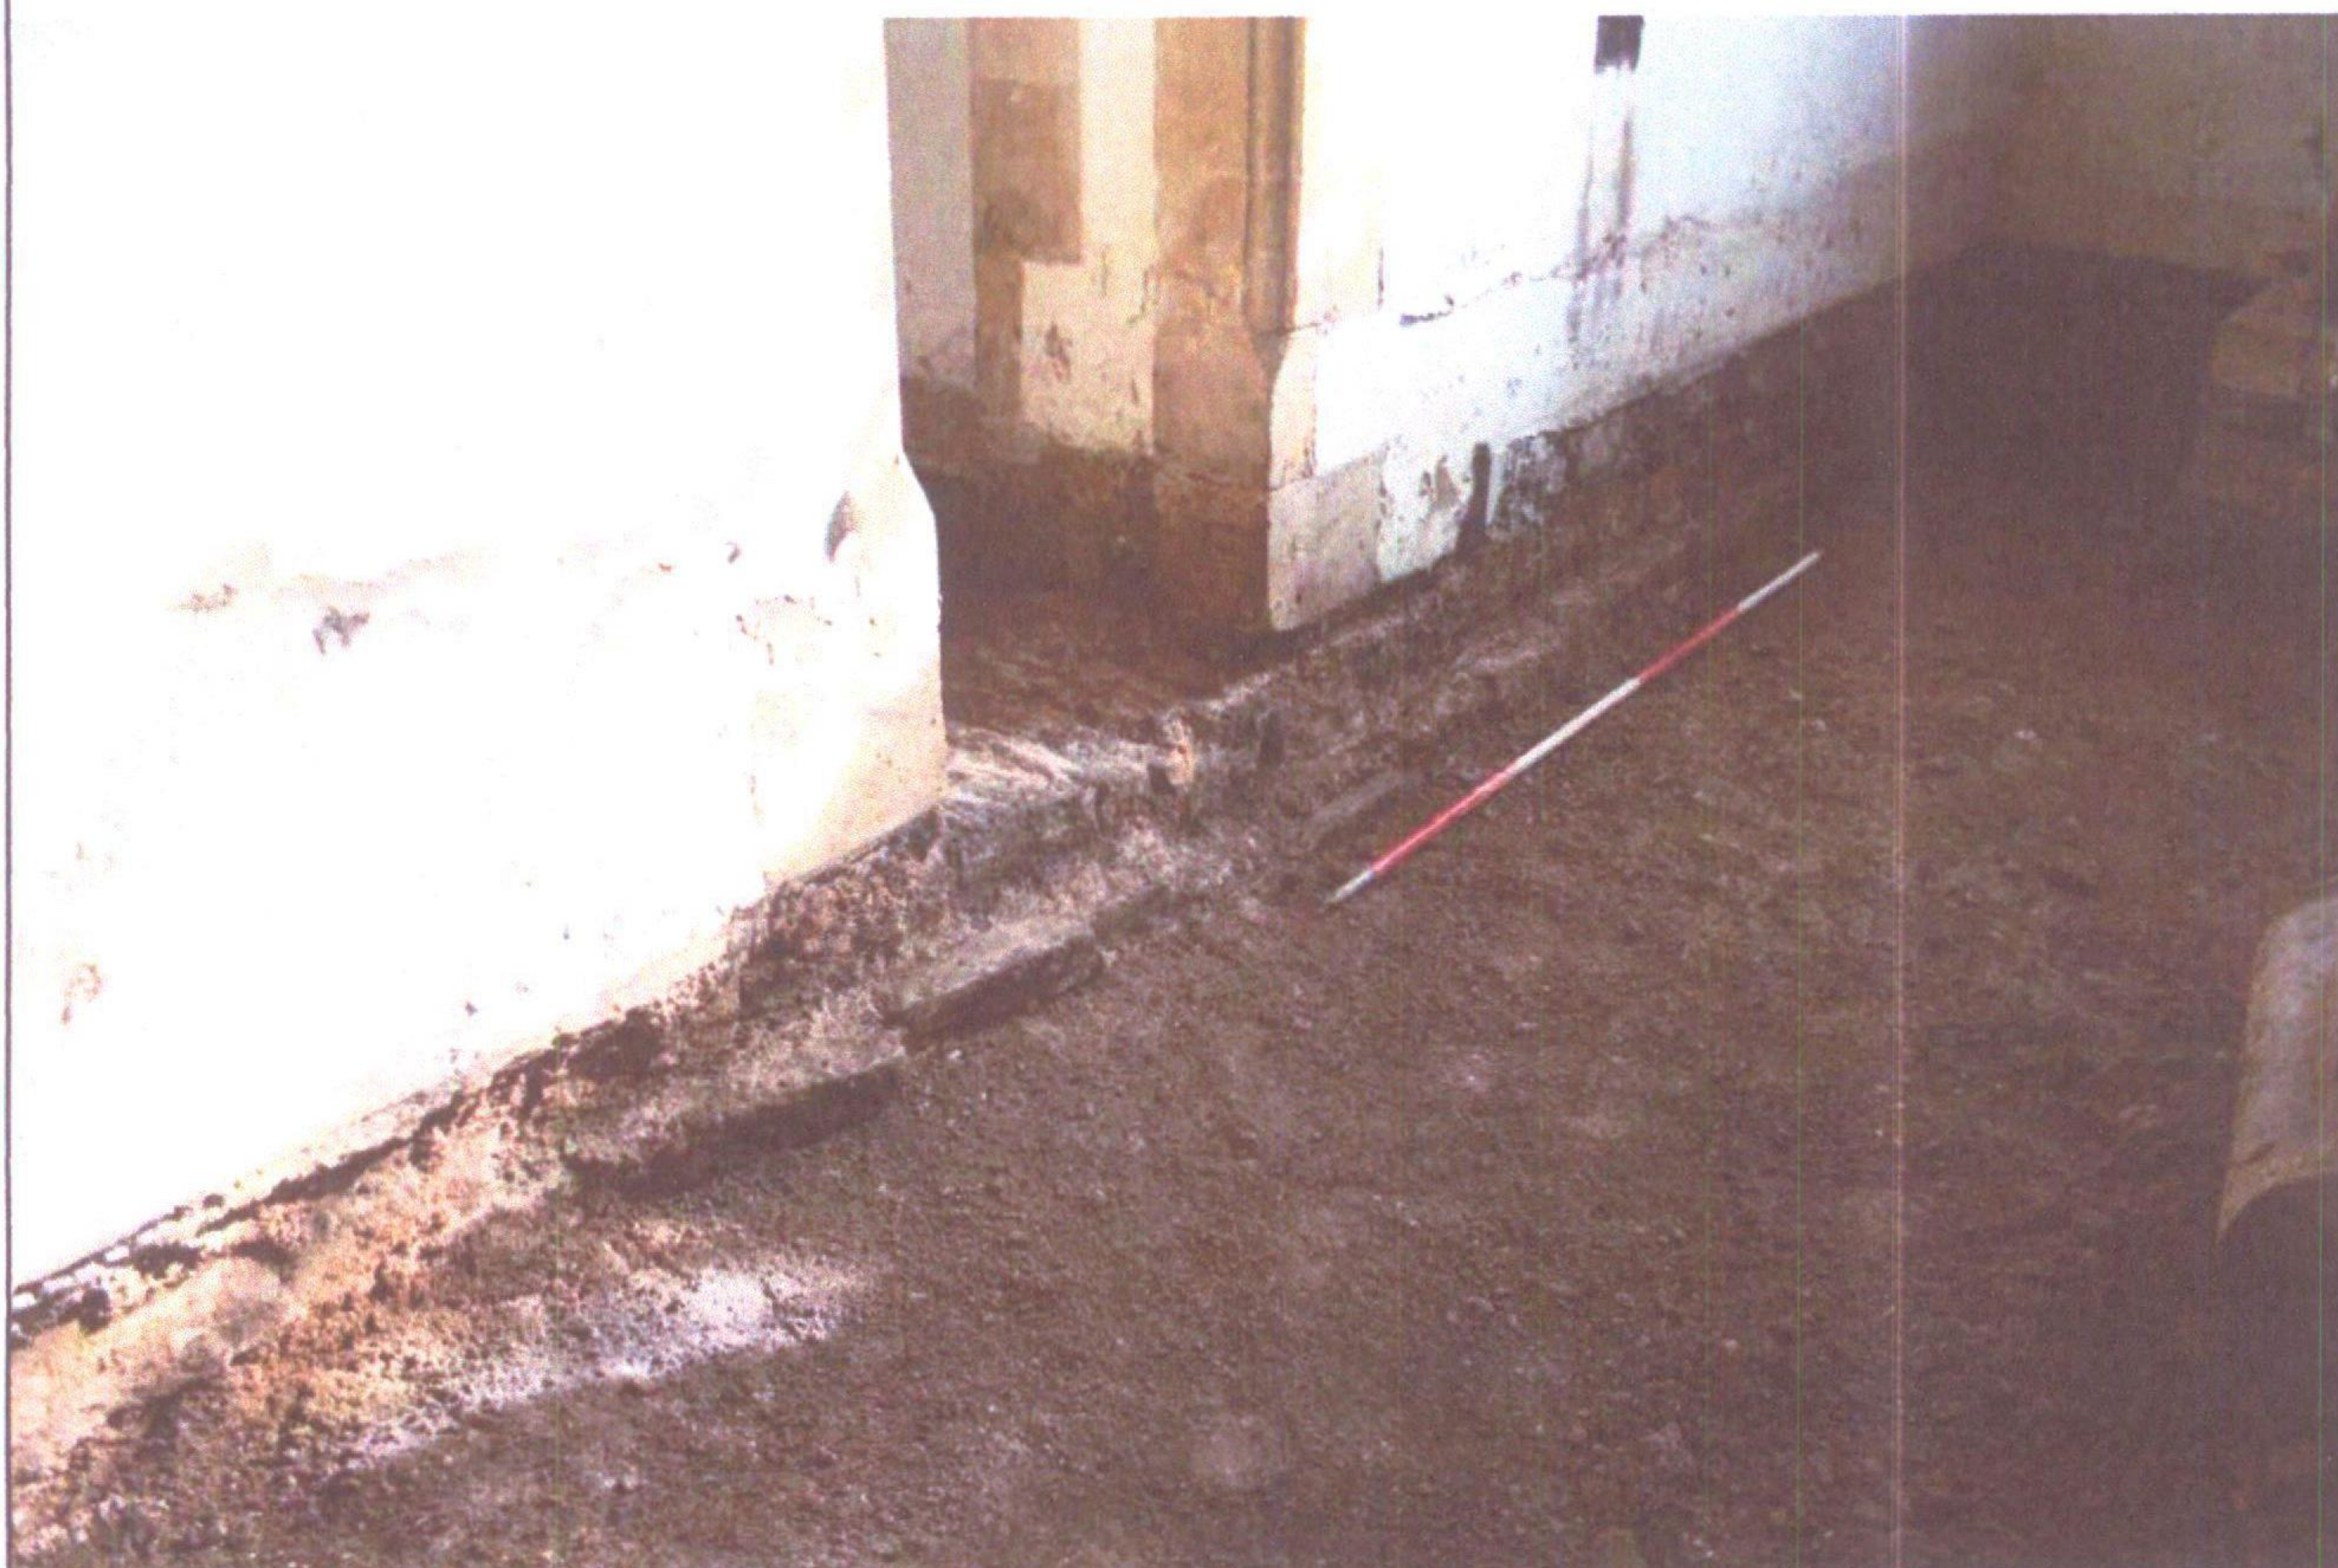
Plate 3

Internal Shot of Structure {122} below Structure {123}

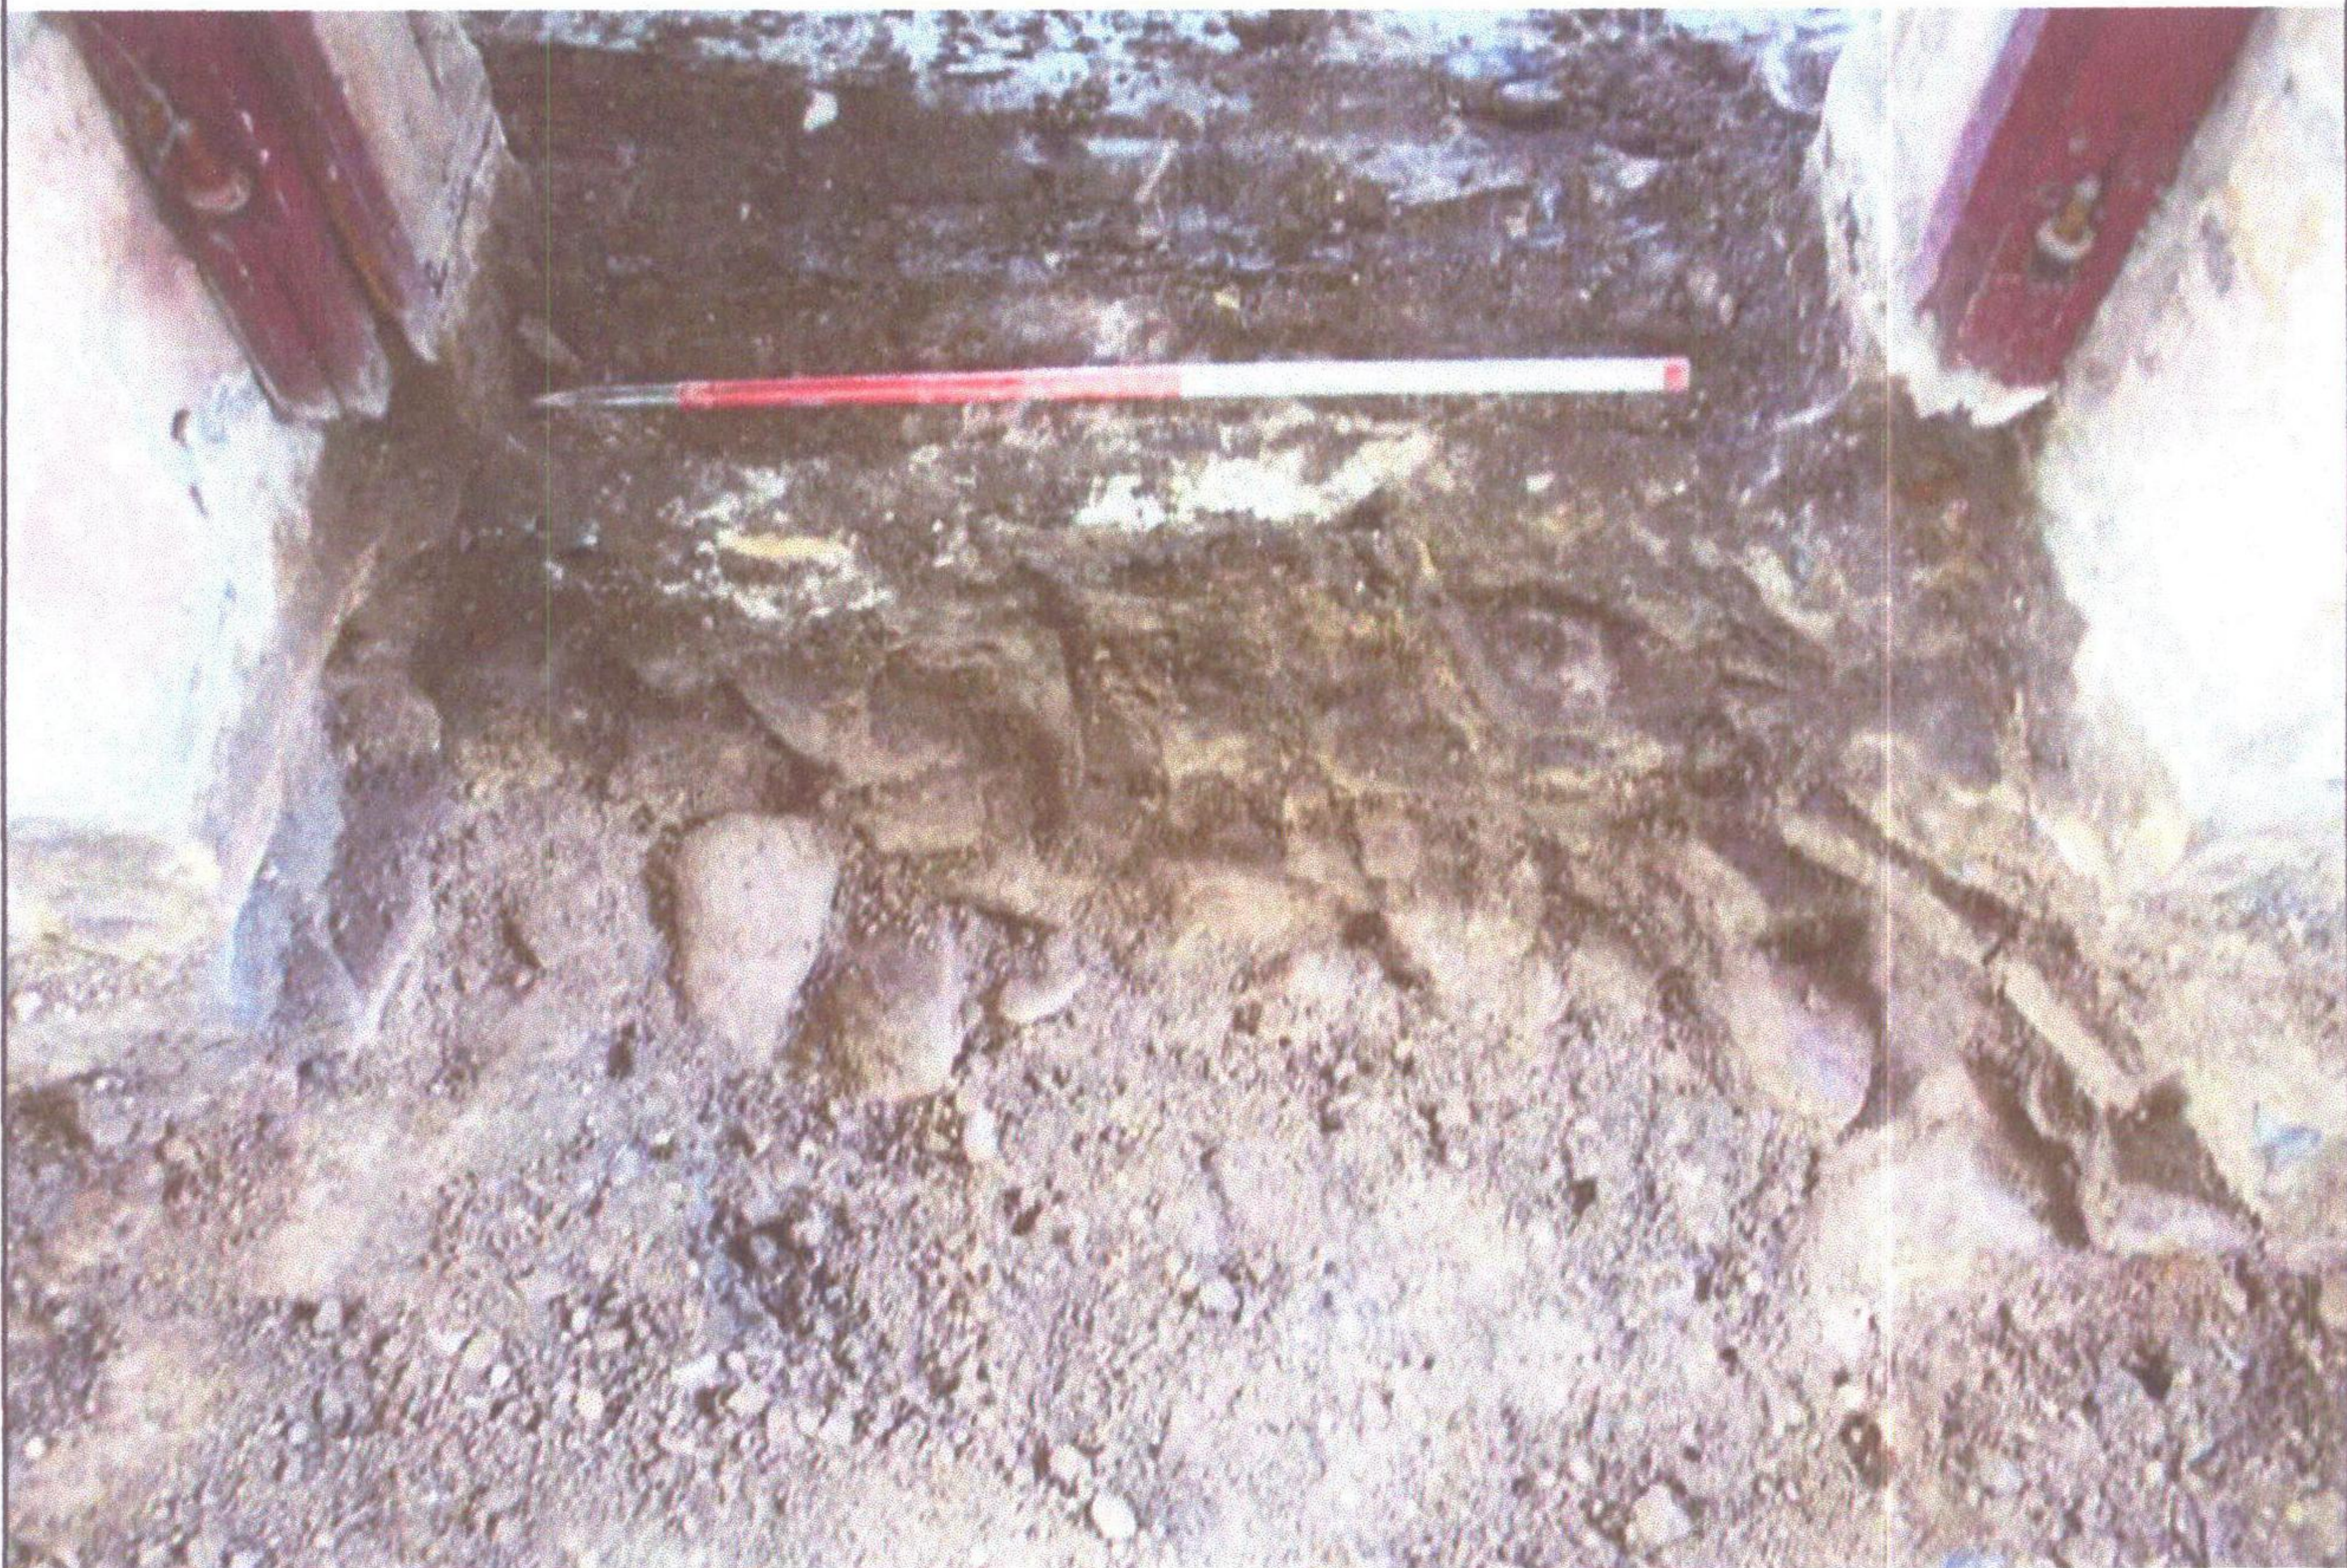
Plate 4

Internal Shot of Structure {122} below Structure {123} at the  
South Porch Threshold

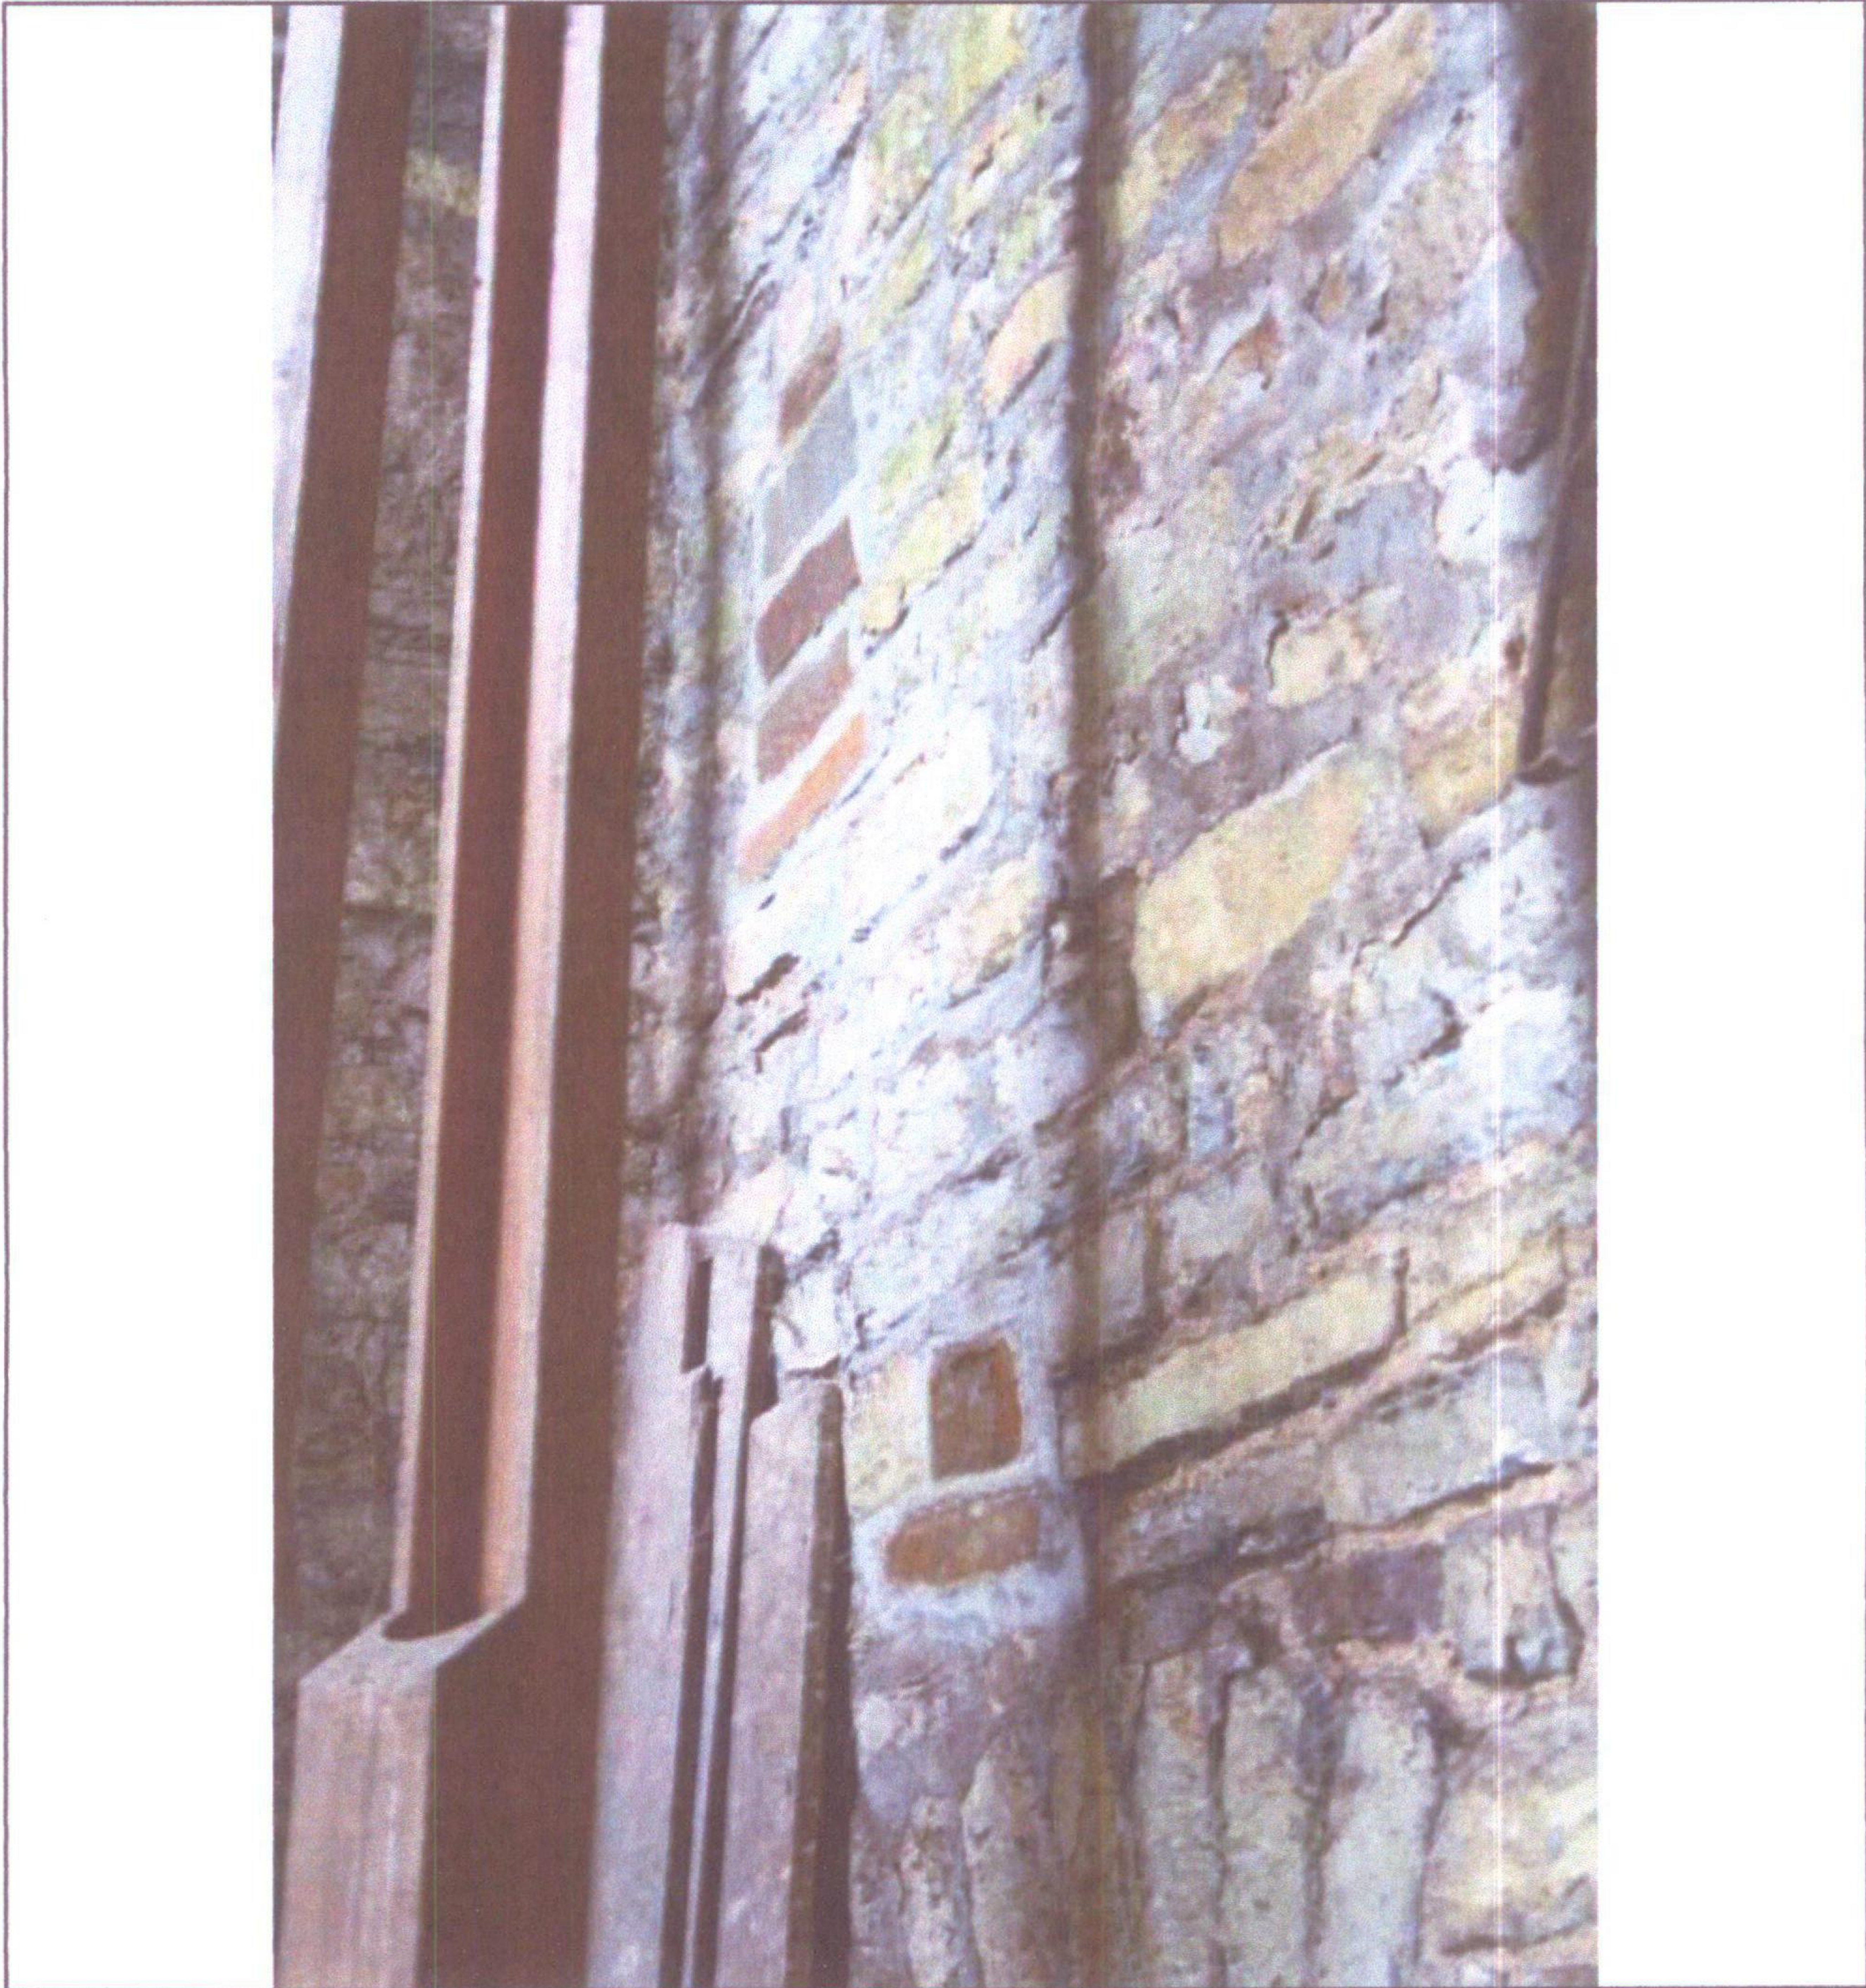
Plate 5

Internal Shot of the First Floor of the Tower Showing Modern  
Brick Repairs

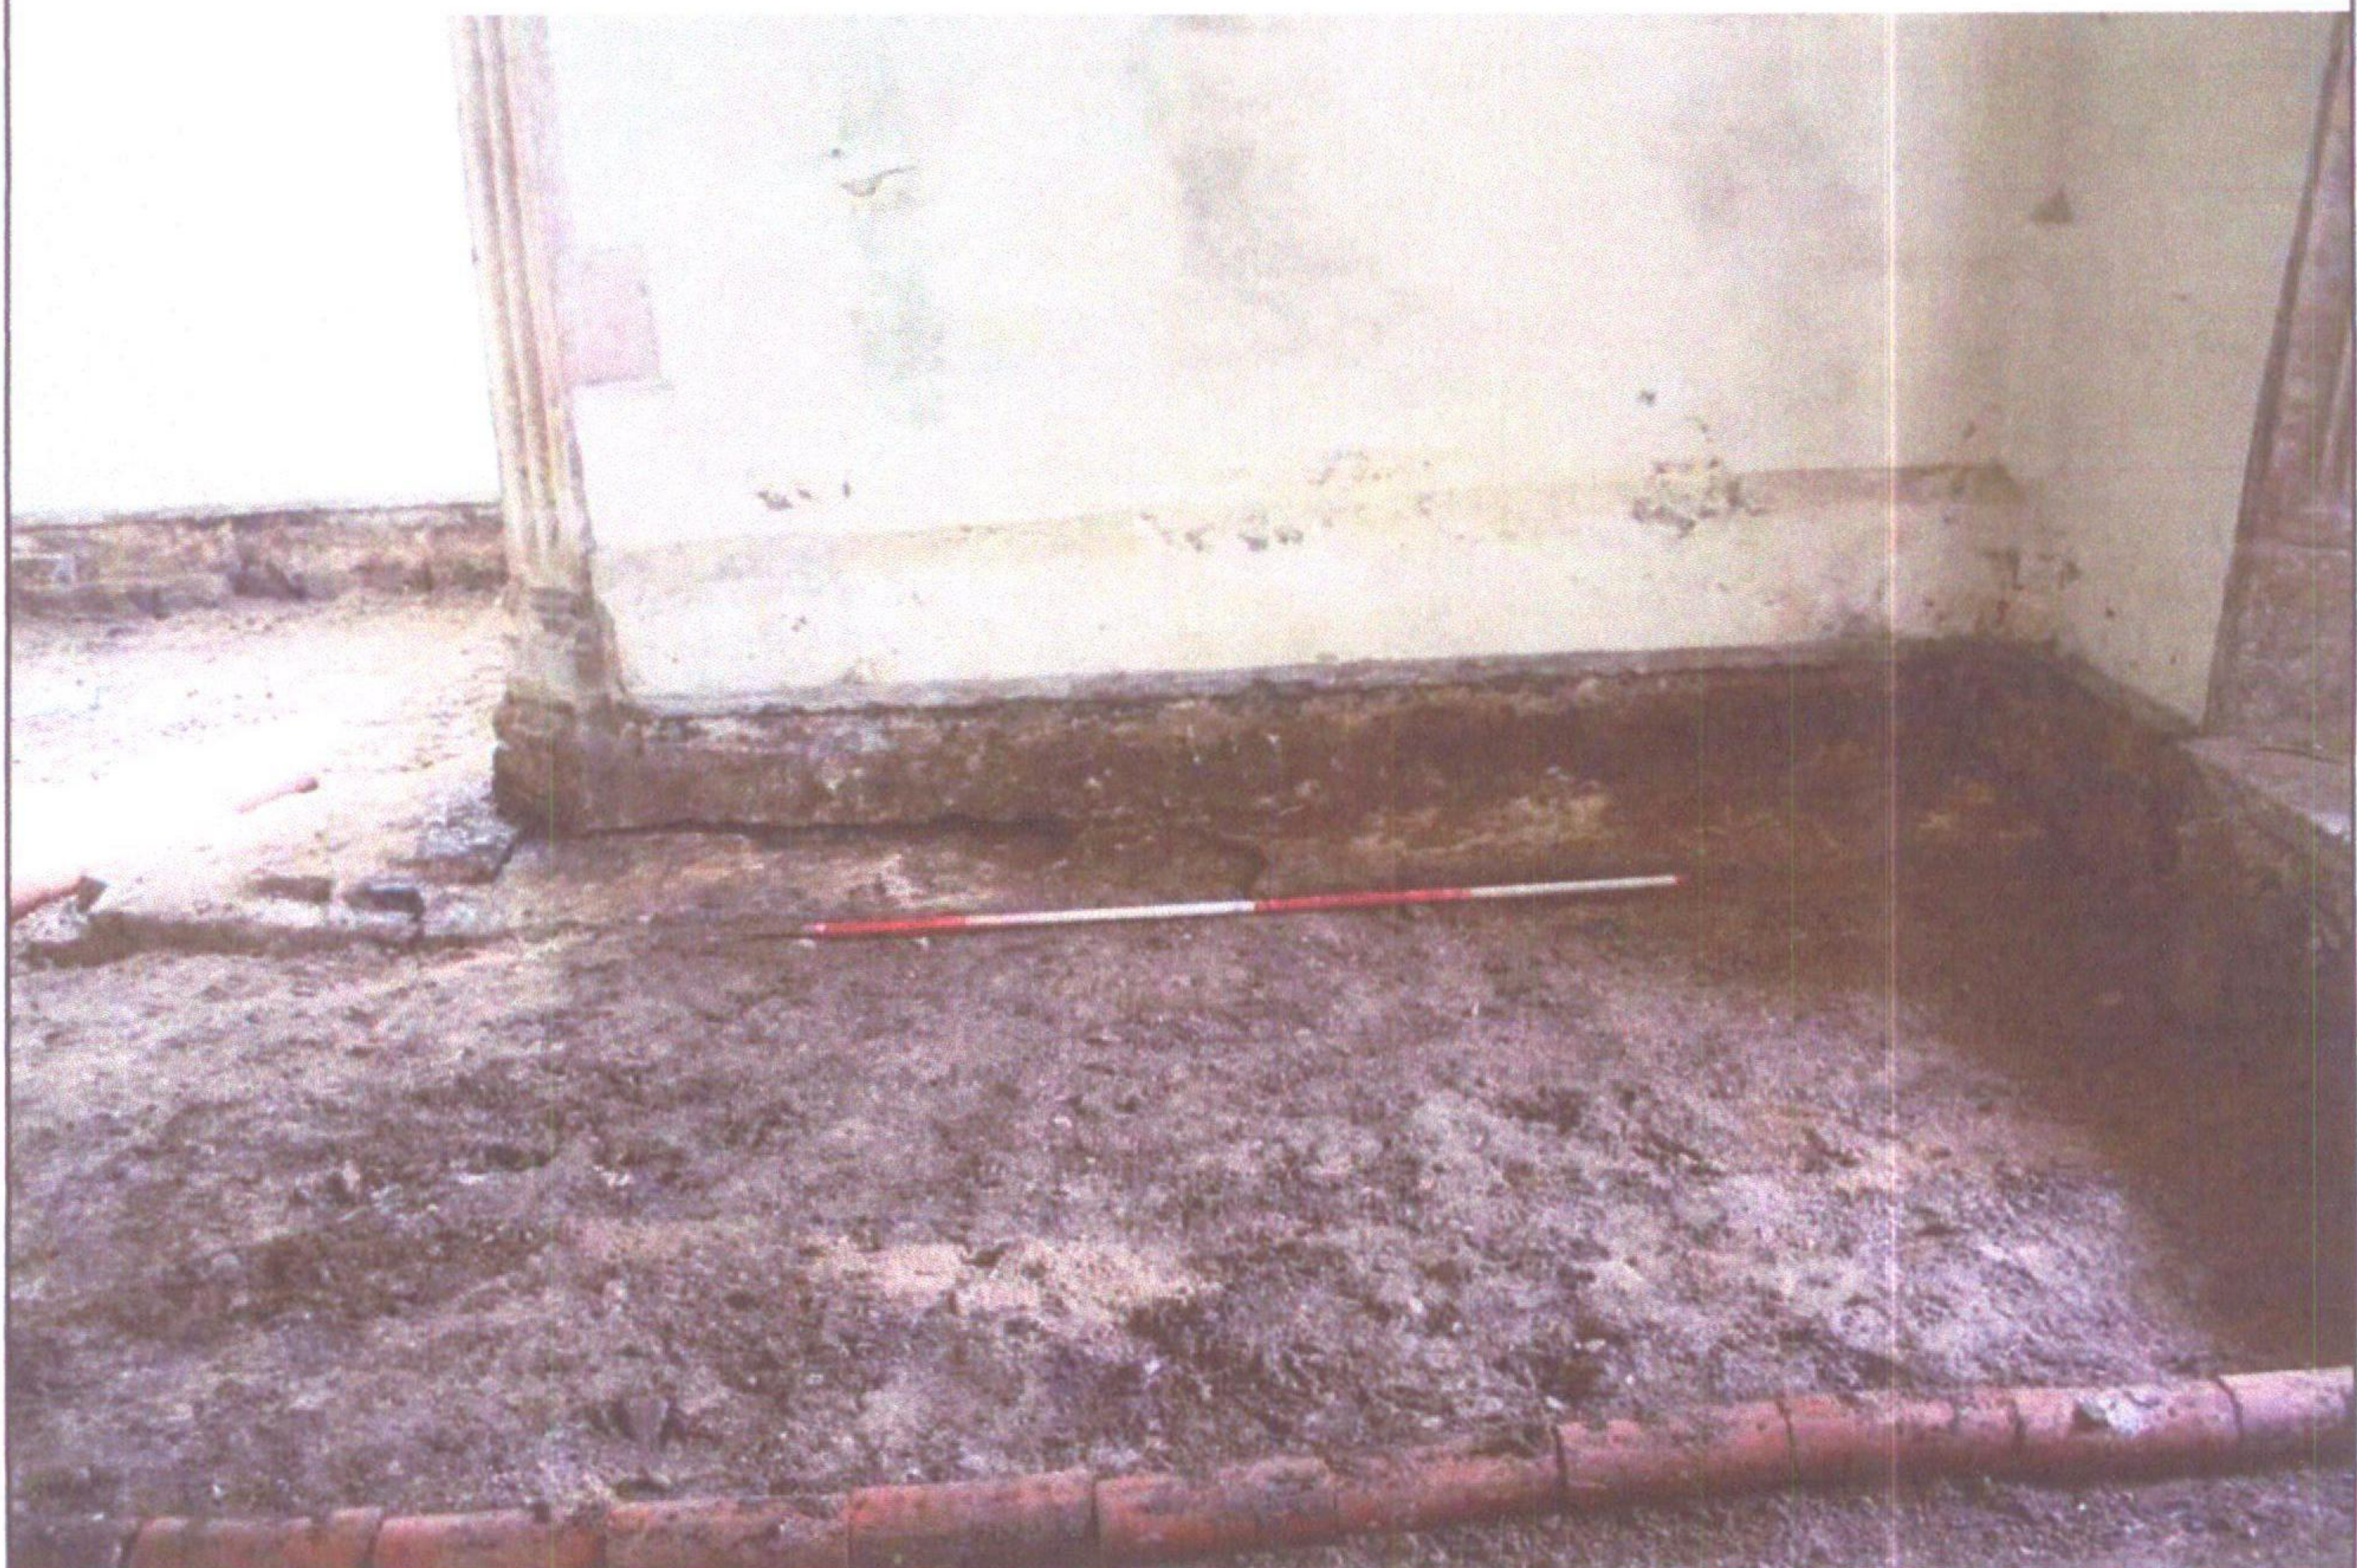
Plate 6

*Within the present-day church building, the foundations of an earlier structure were revealed as well as successive alterations throughout the church. Damage to the foundations were also uncovered potentially linked to the visible lean of the tower.*

Internal Shot of Broken Southwestern Foundation
