# SIMON REAMES ARCHAEOLOGY

## Archaeological Watching Brief Report

Old St Peter's Church, Peterstone, Wentlooge, Cardiff, CF3 2TR

Prepared for  
Newport City Council

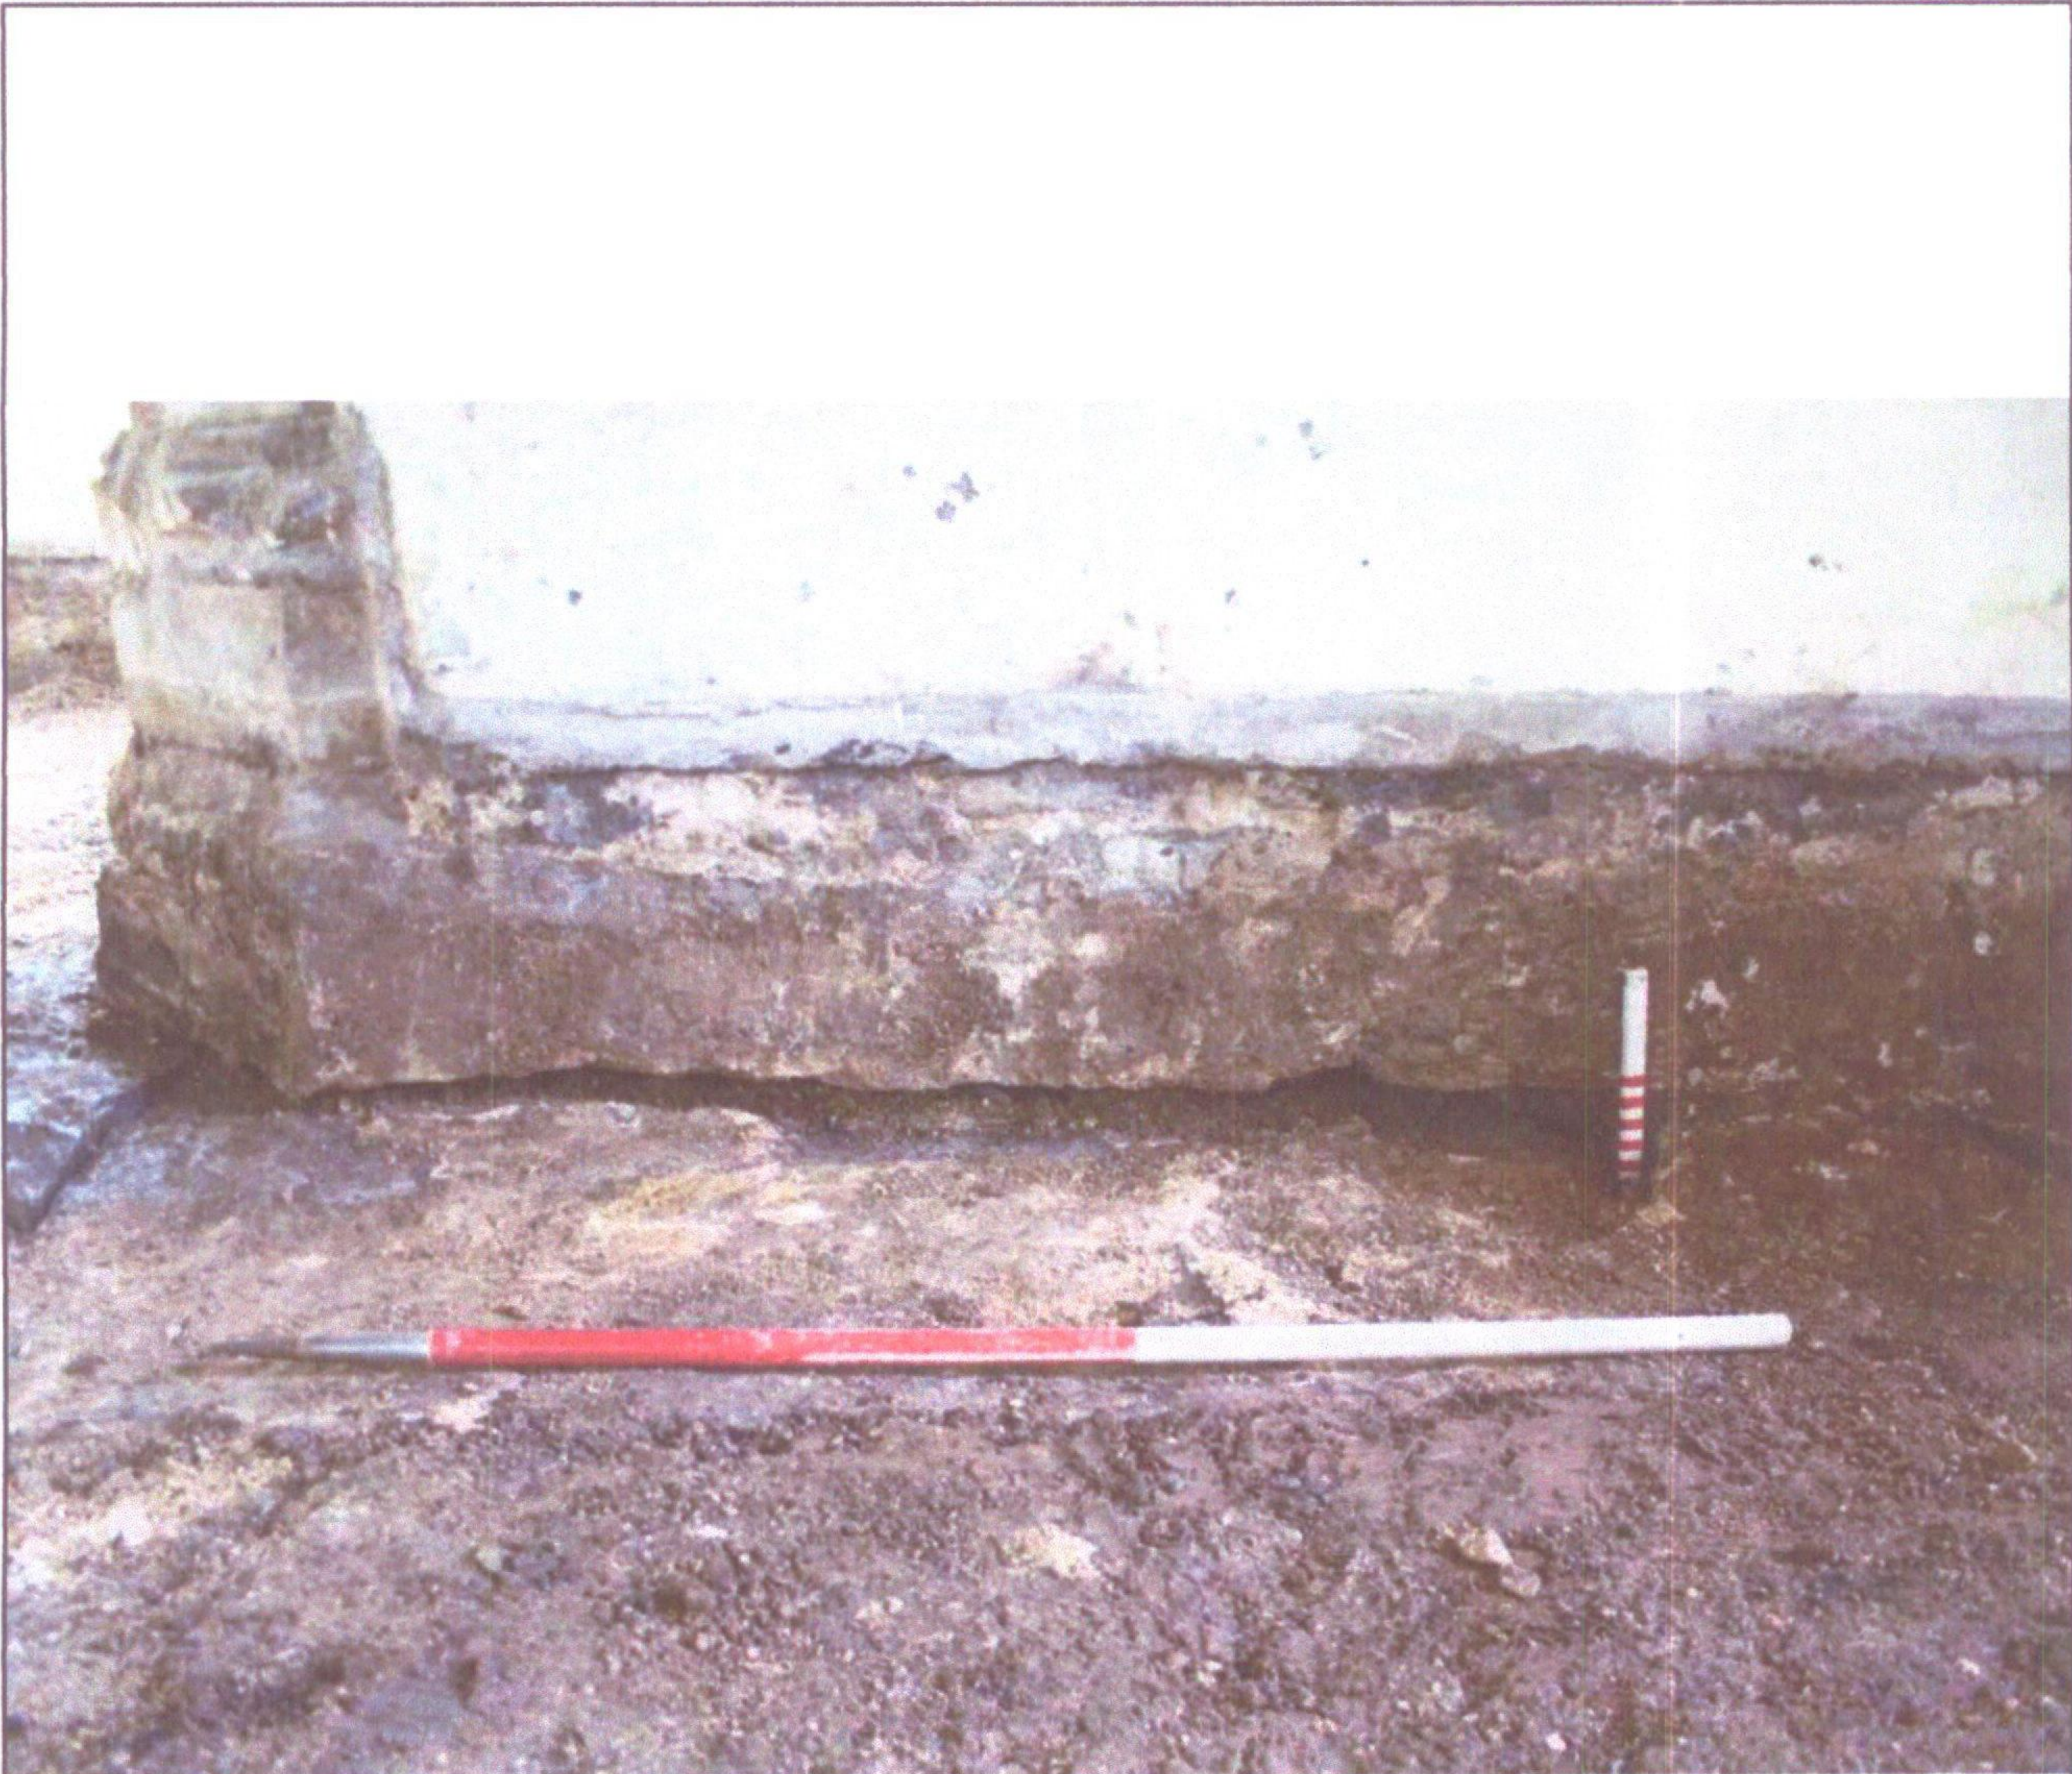
Plate 7

Internal Shot of Broken Southwestern Foundation - Close Up

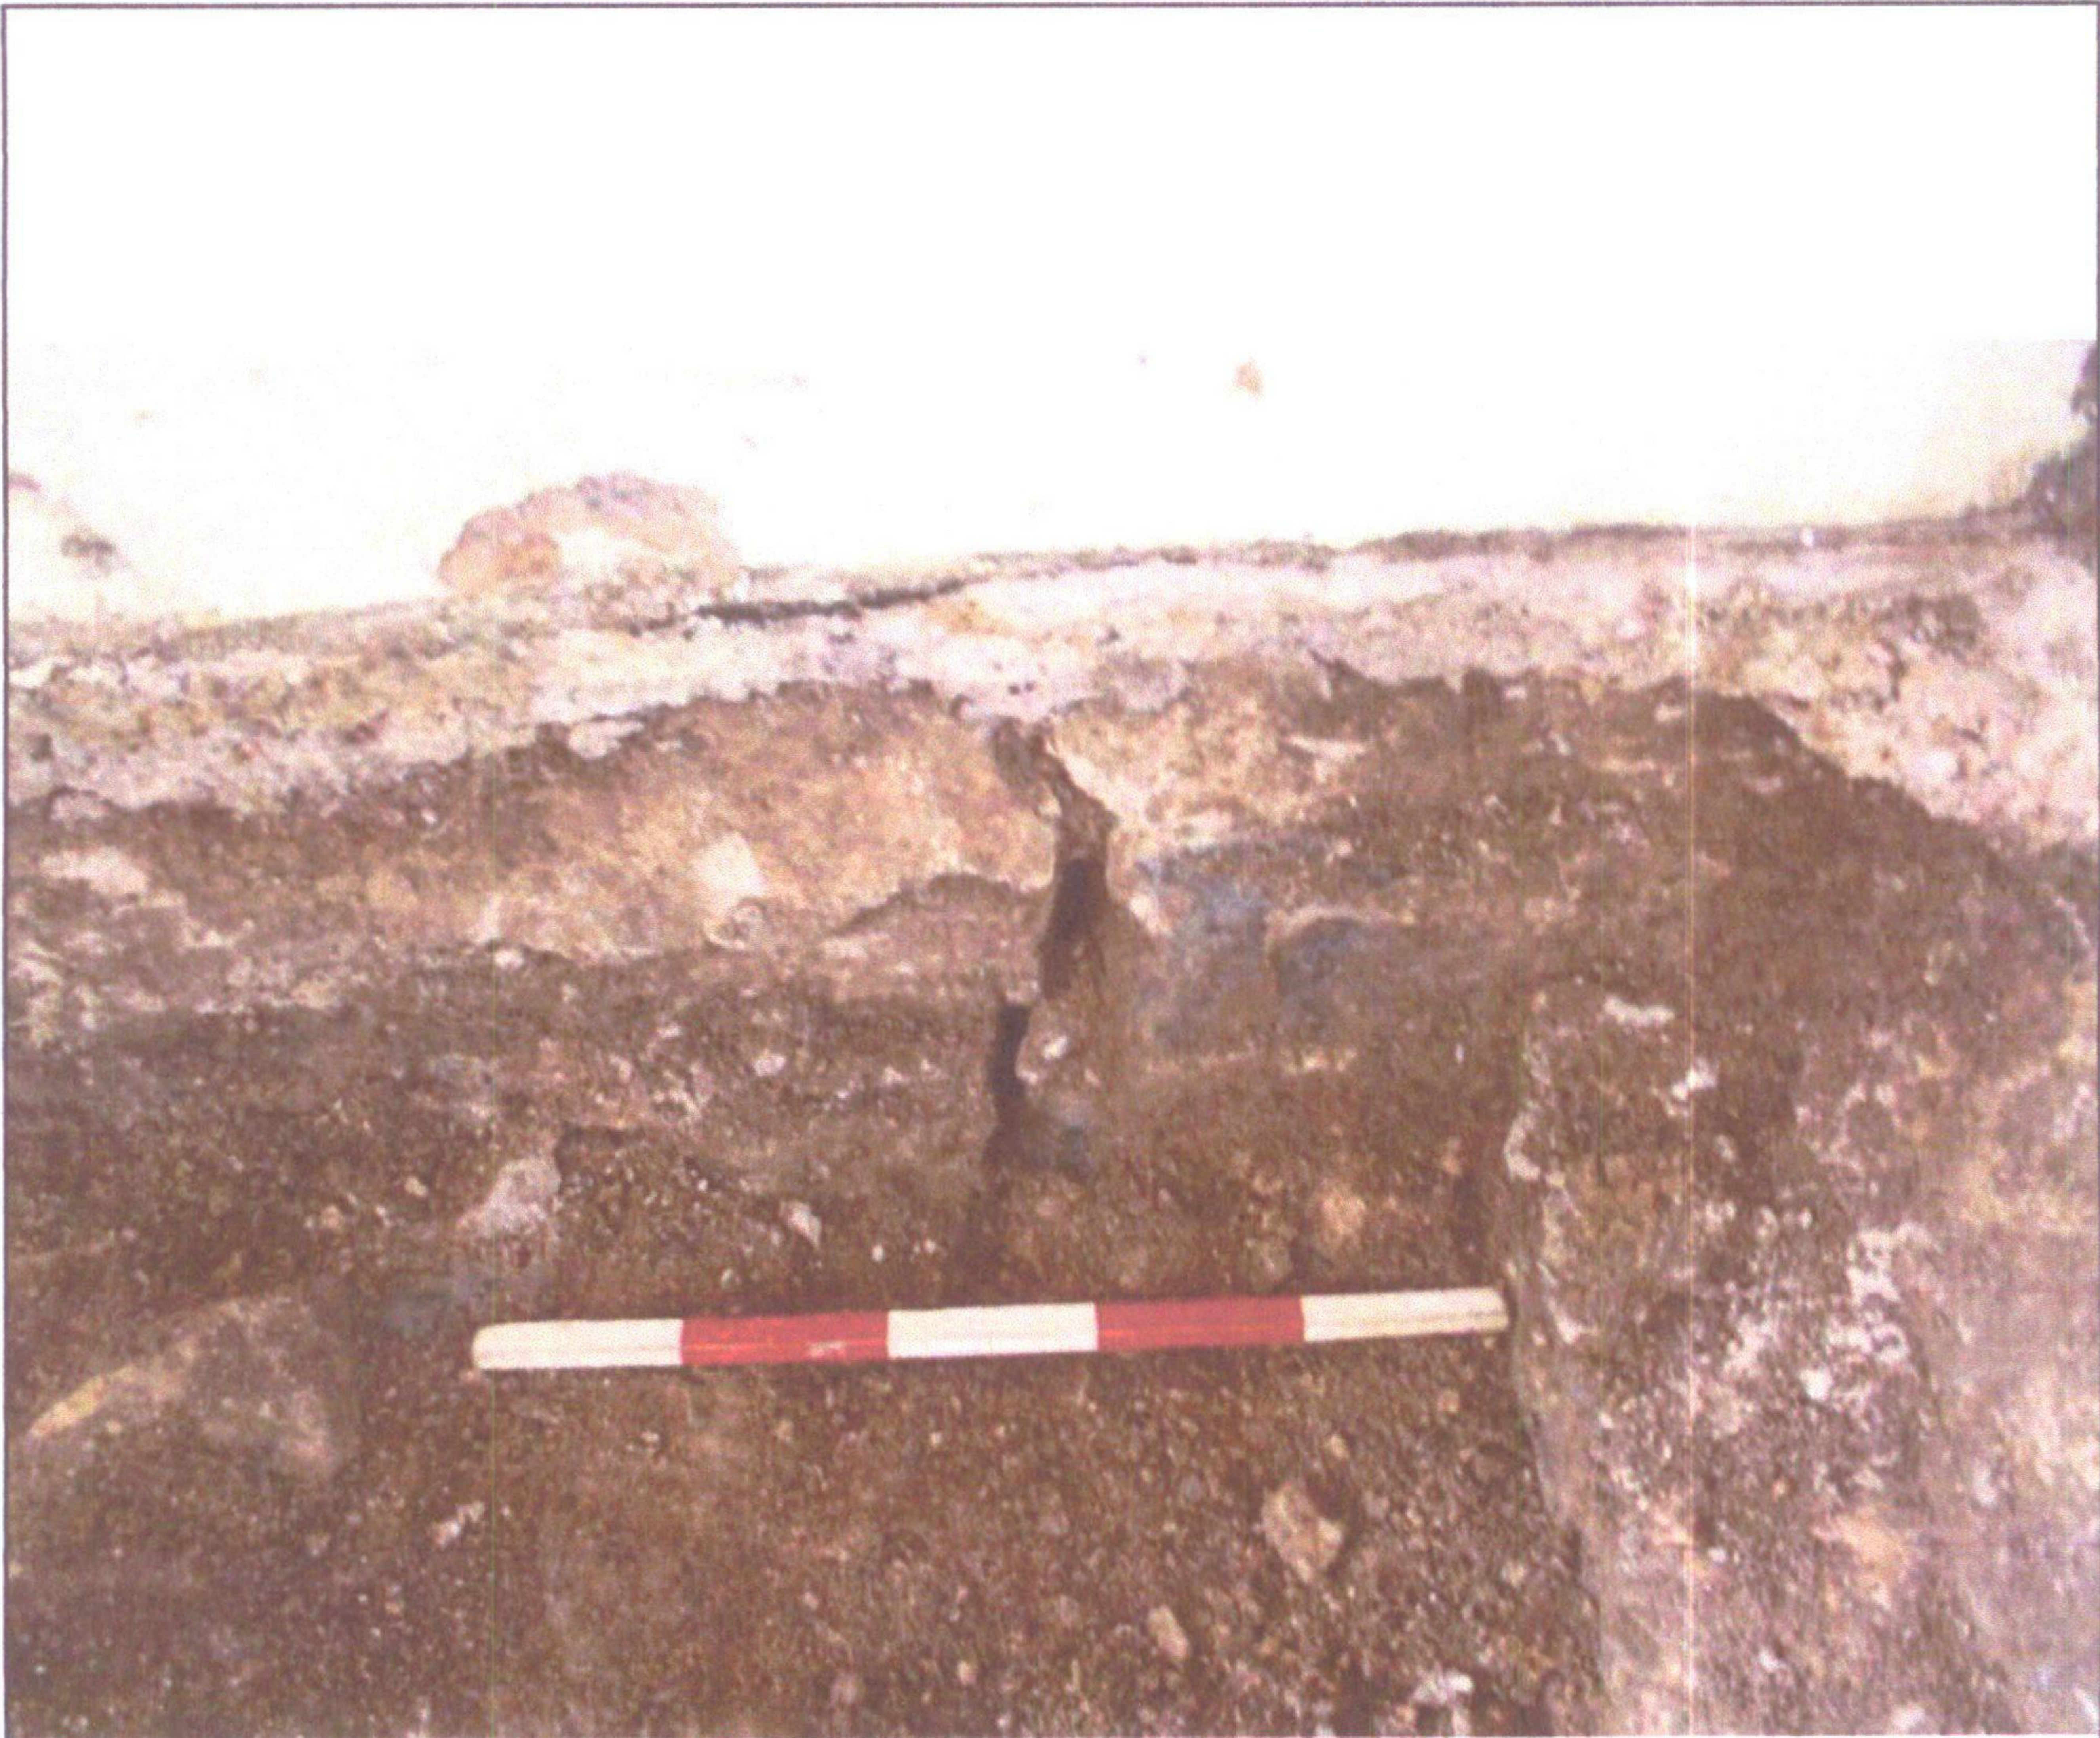
Plate 8

foundation layers on the southern wall of the chancel (**Plate 8**) and south-easternmost column (**Plate 9**).

Internal Shot of Broken South Chancel Foundation

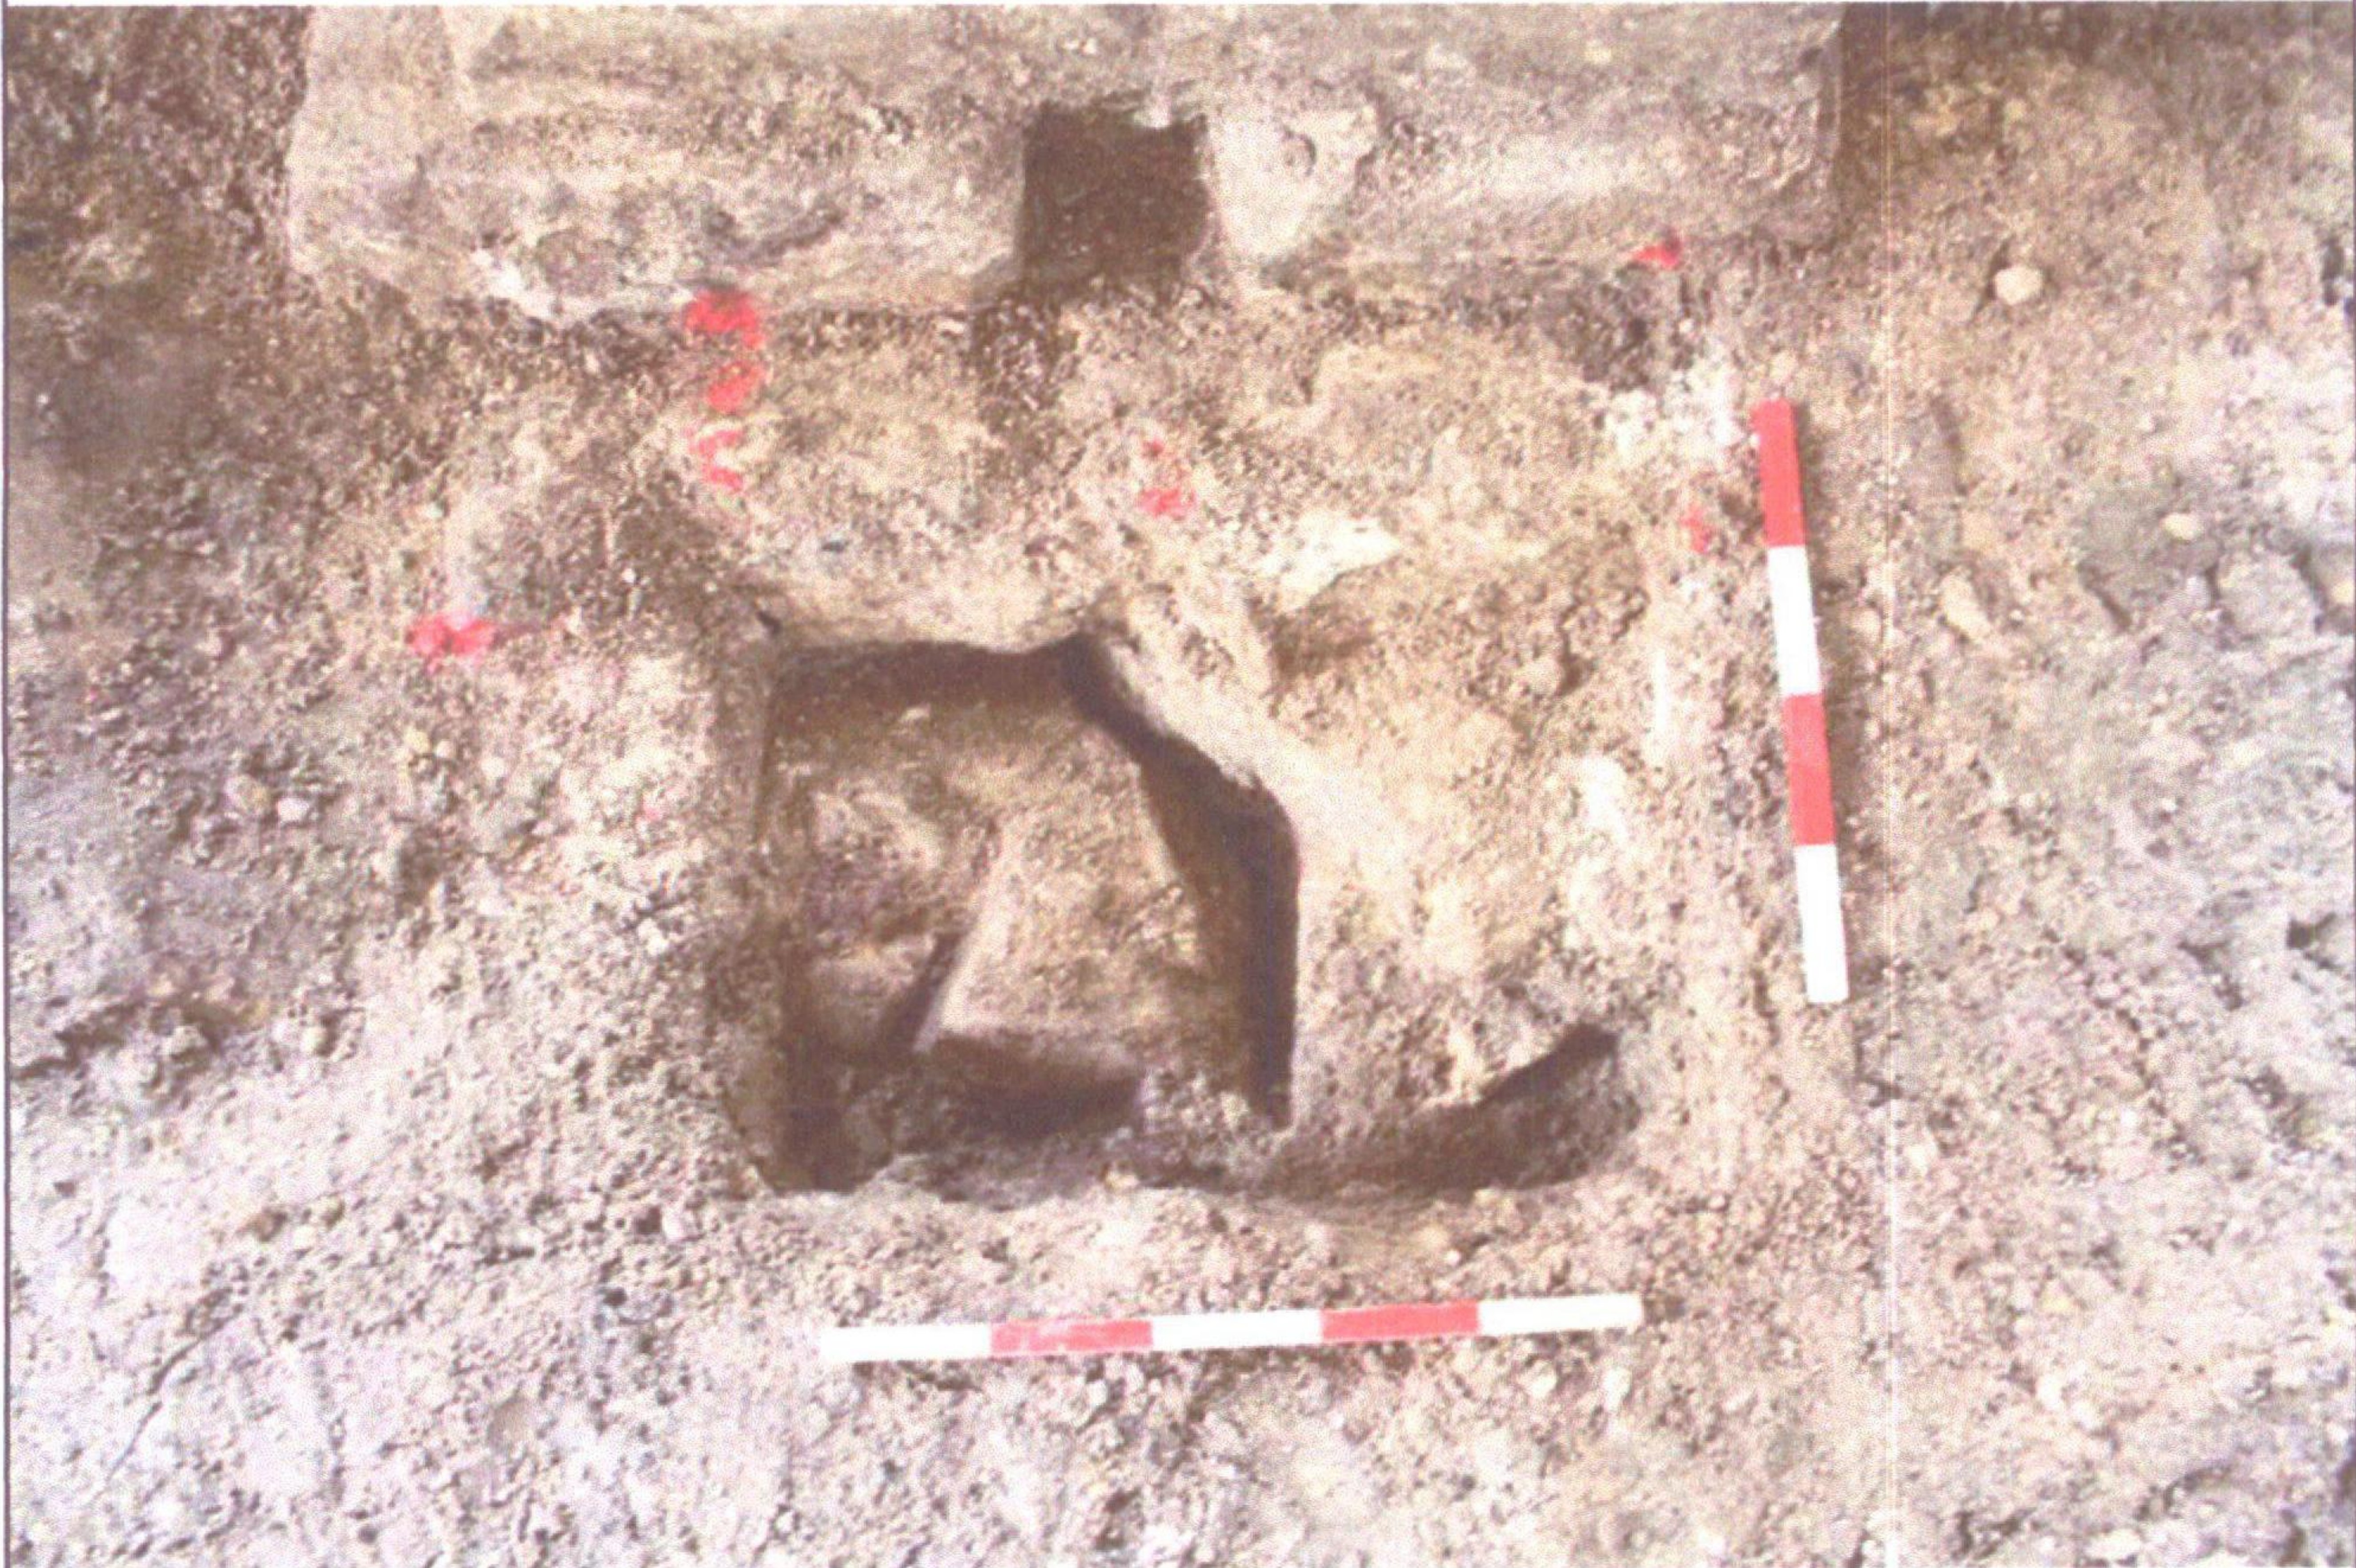
Plate 9

Internal Shot of Broken South Chancel Column Foundation

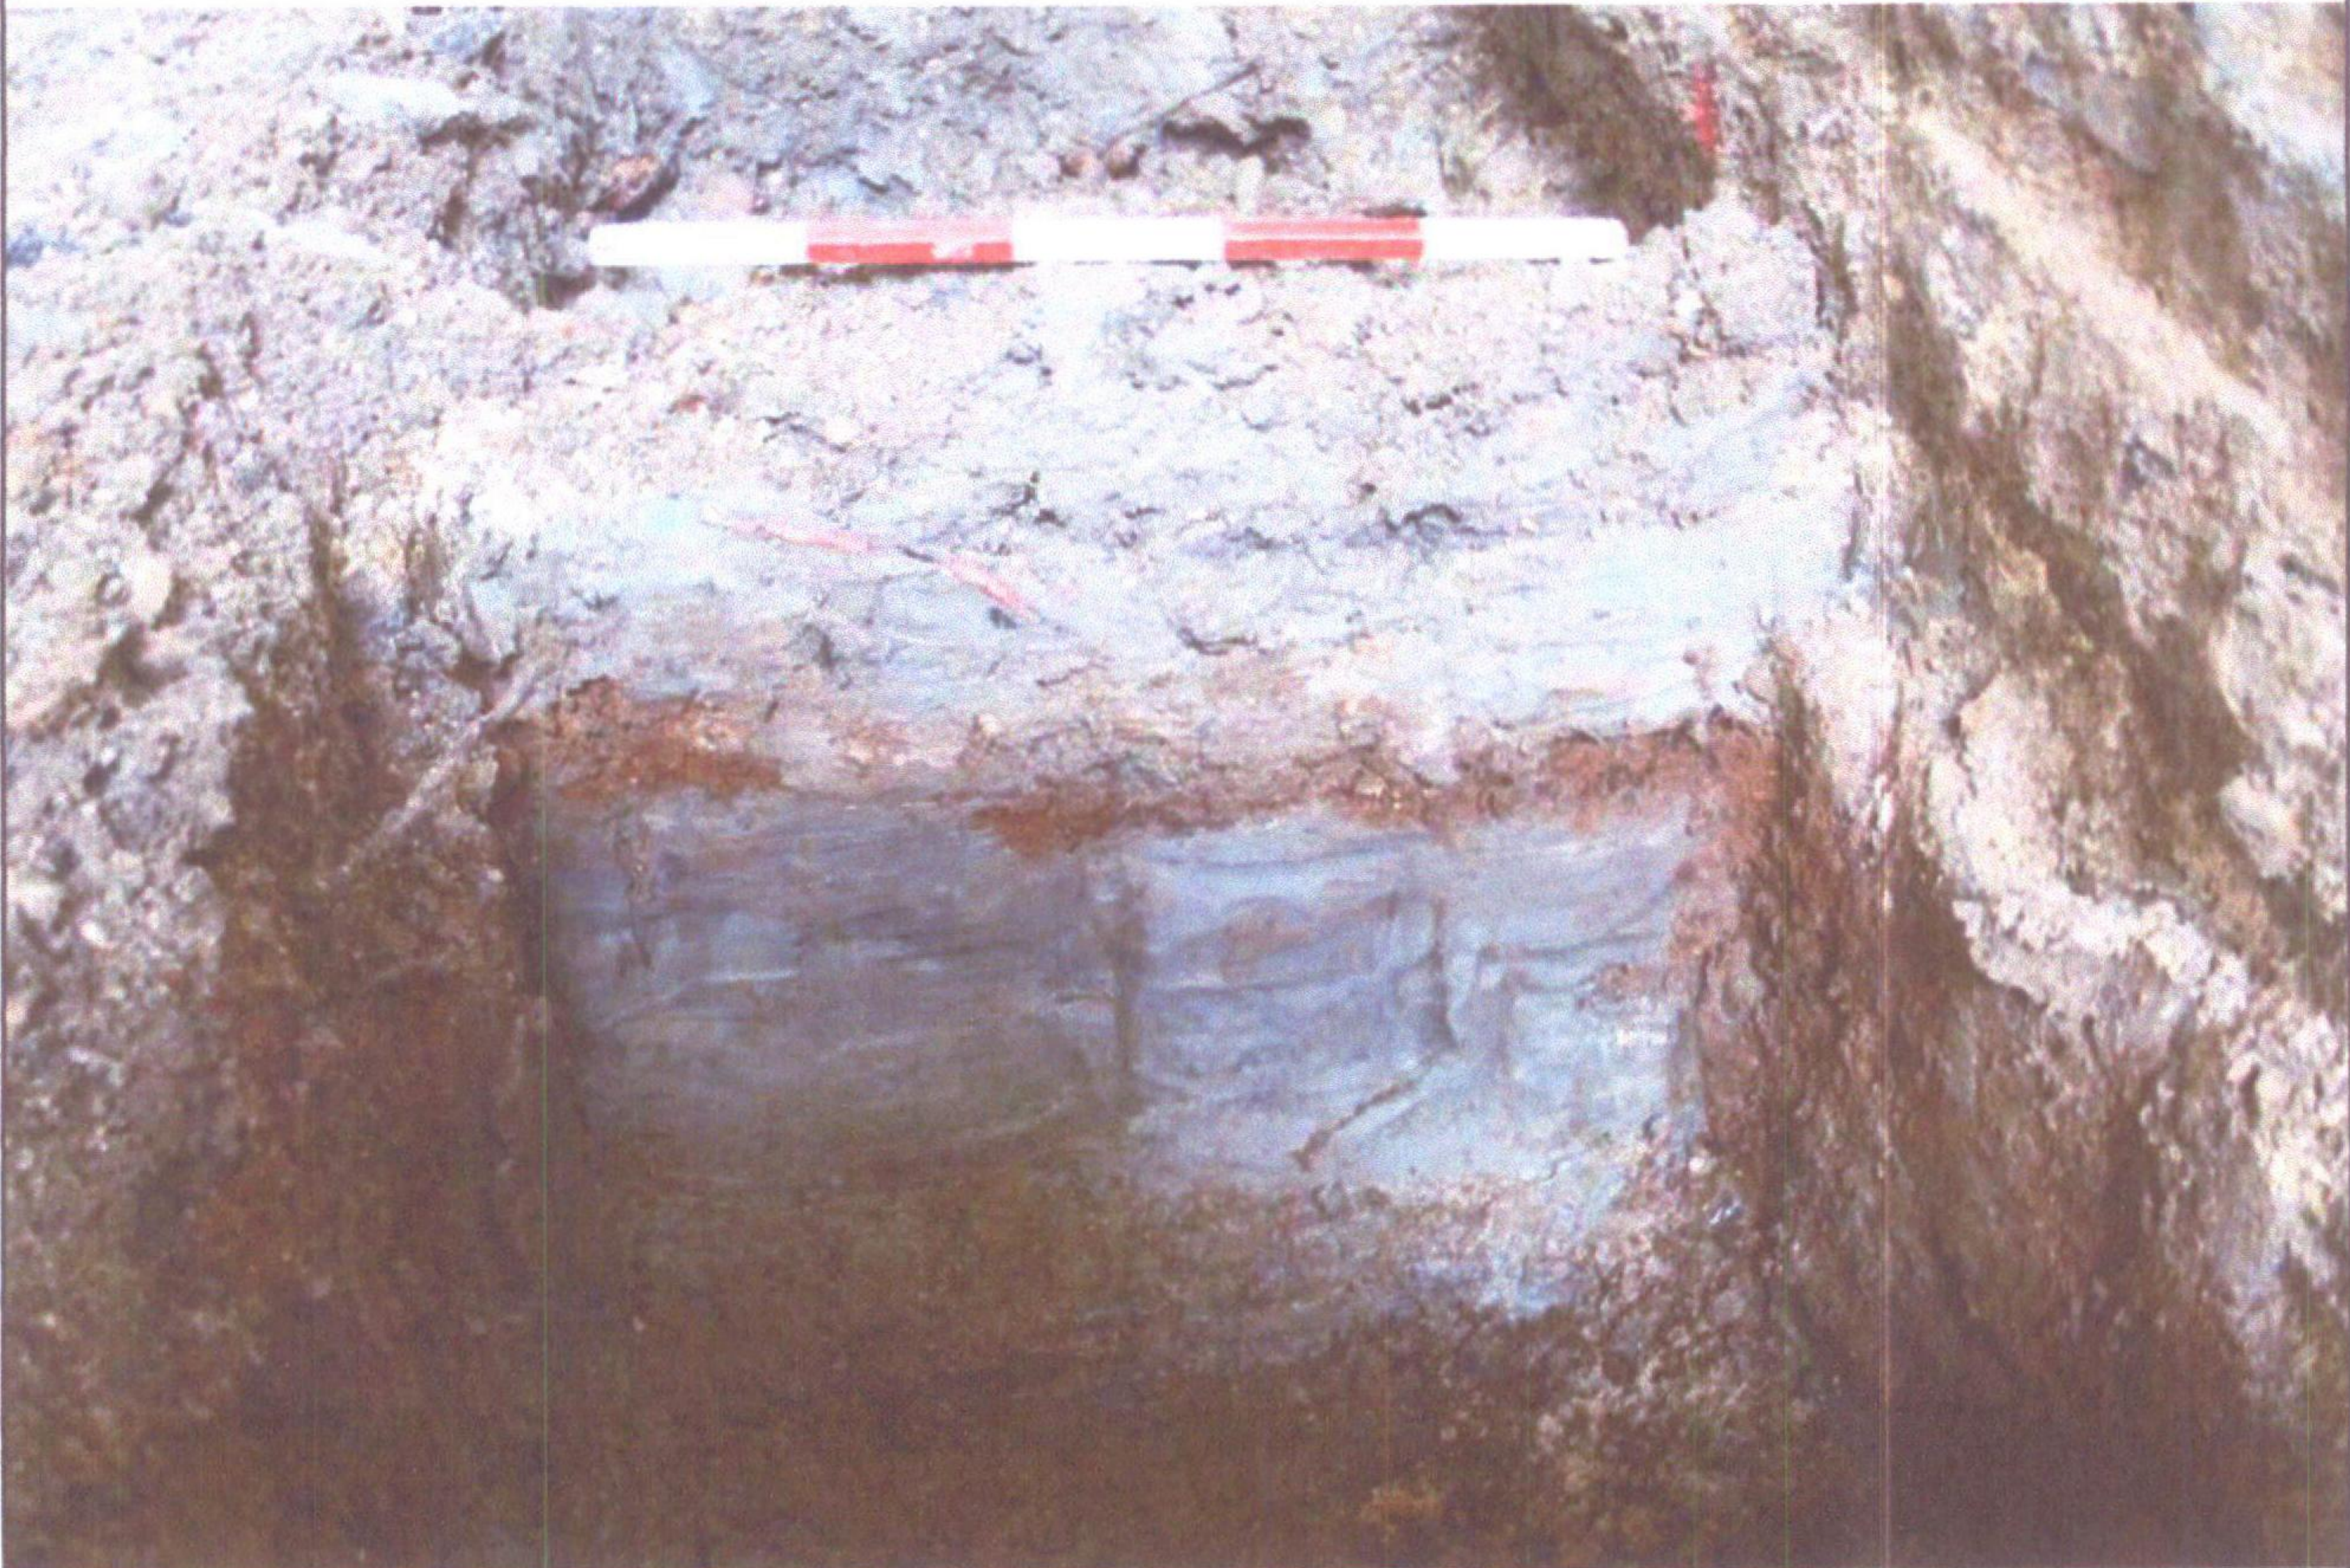
Plate 10

- 4.3.3. Physically overlying deposit (105), deposit (120) was a 0.05m thick, firm to compact reddish-brown clayey-silt gravel with sharp edges which was observed at a depth of 0.53m below the present-day ground level (4.8m aOD) (**Figure 4**). Deposit (120) is a deliberate backfill of unknown origin with well sorted gravels and pieces of lime mortar throughout and was observed sporadically throughout the chancel and nave of the church. The deposit was also observed extending approximately 0.5m around the base of the church columns and extending up 0.14m (4.94m aOD) up from the surrounding layer. Deposit (120) appears to be a foundational layer for the present-day church possibly incorporating a proto floor/binding/levelling layer and lime mortar foundational base for the columns (**Plate 10**).

Internal Shot of Waster Water Service Trench

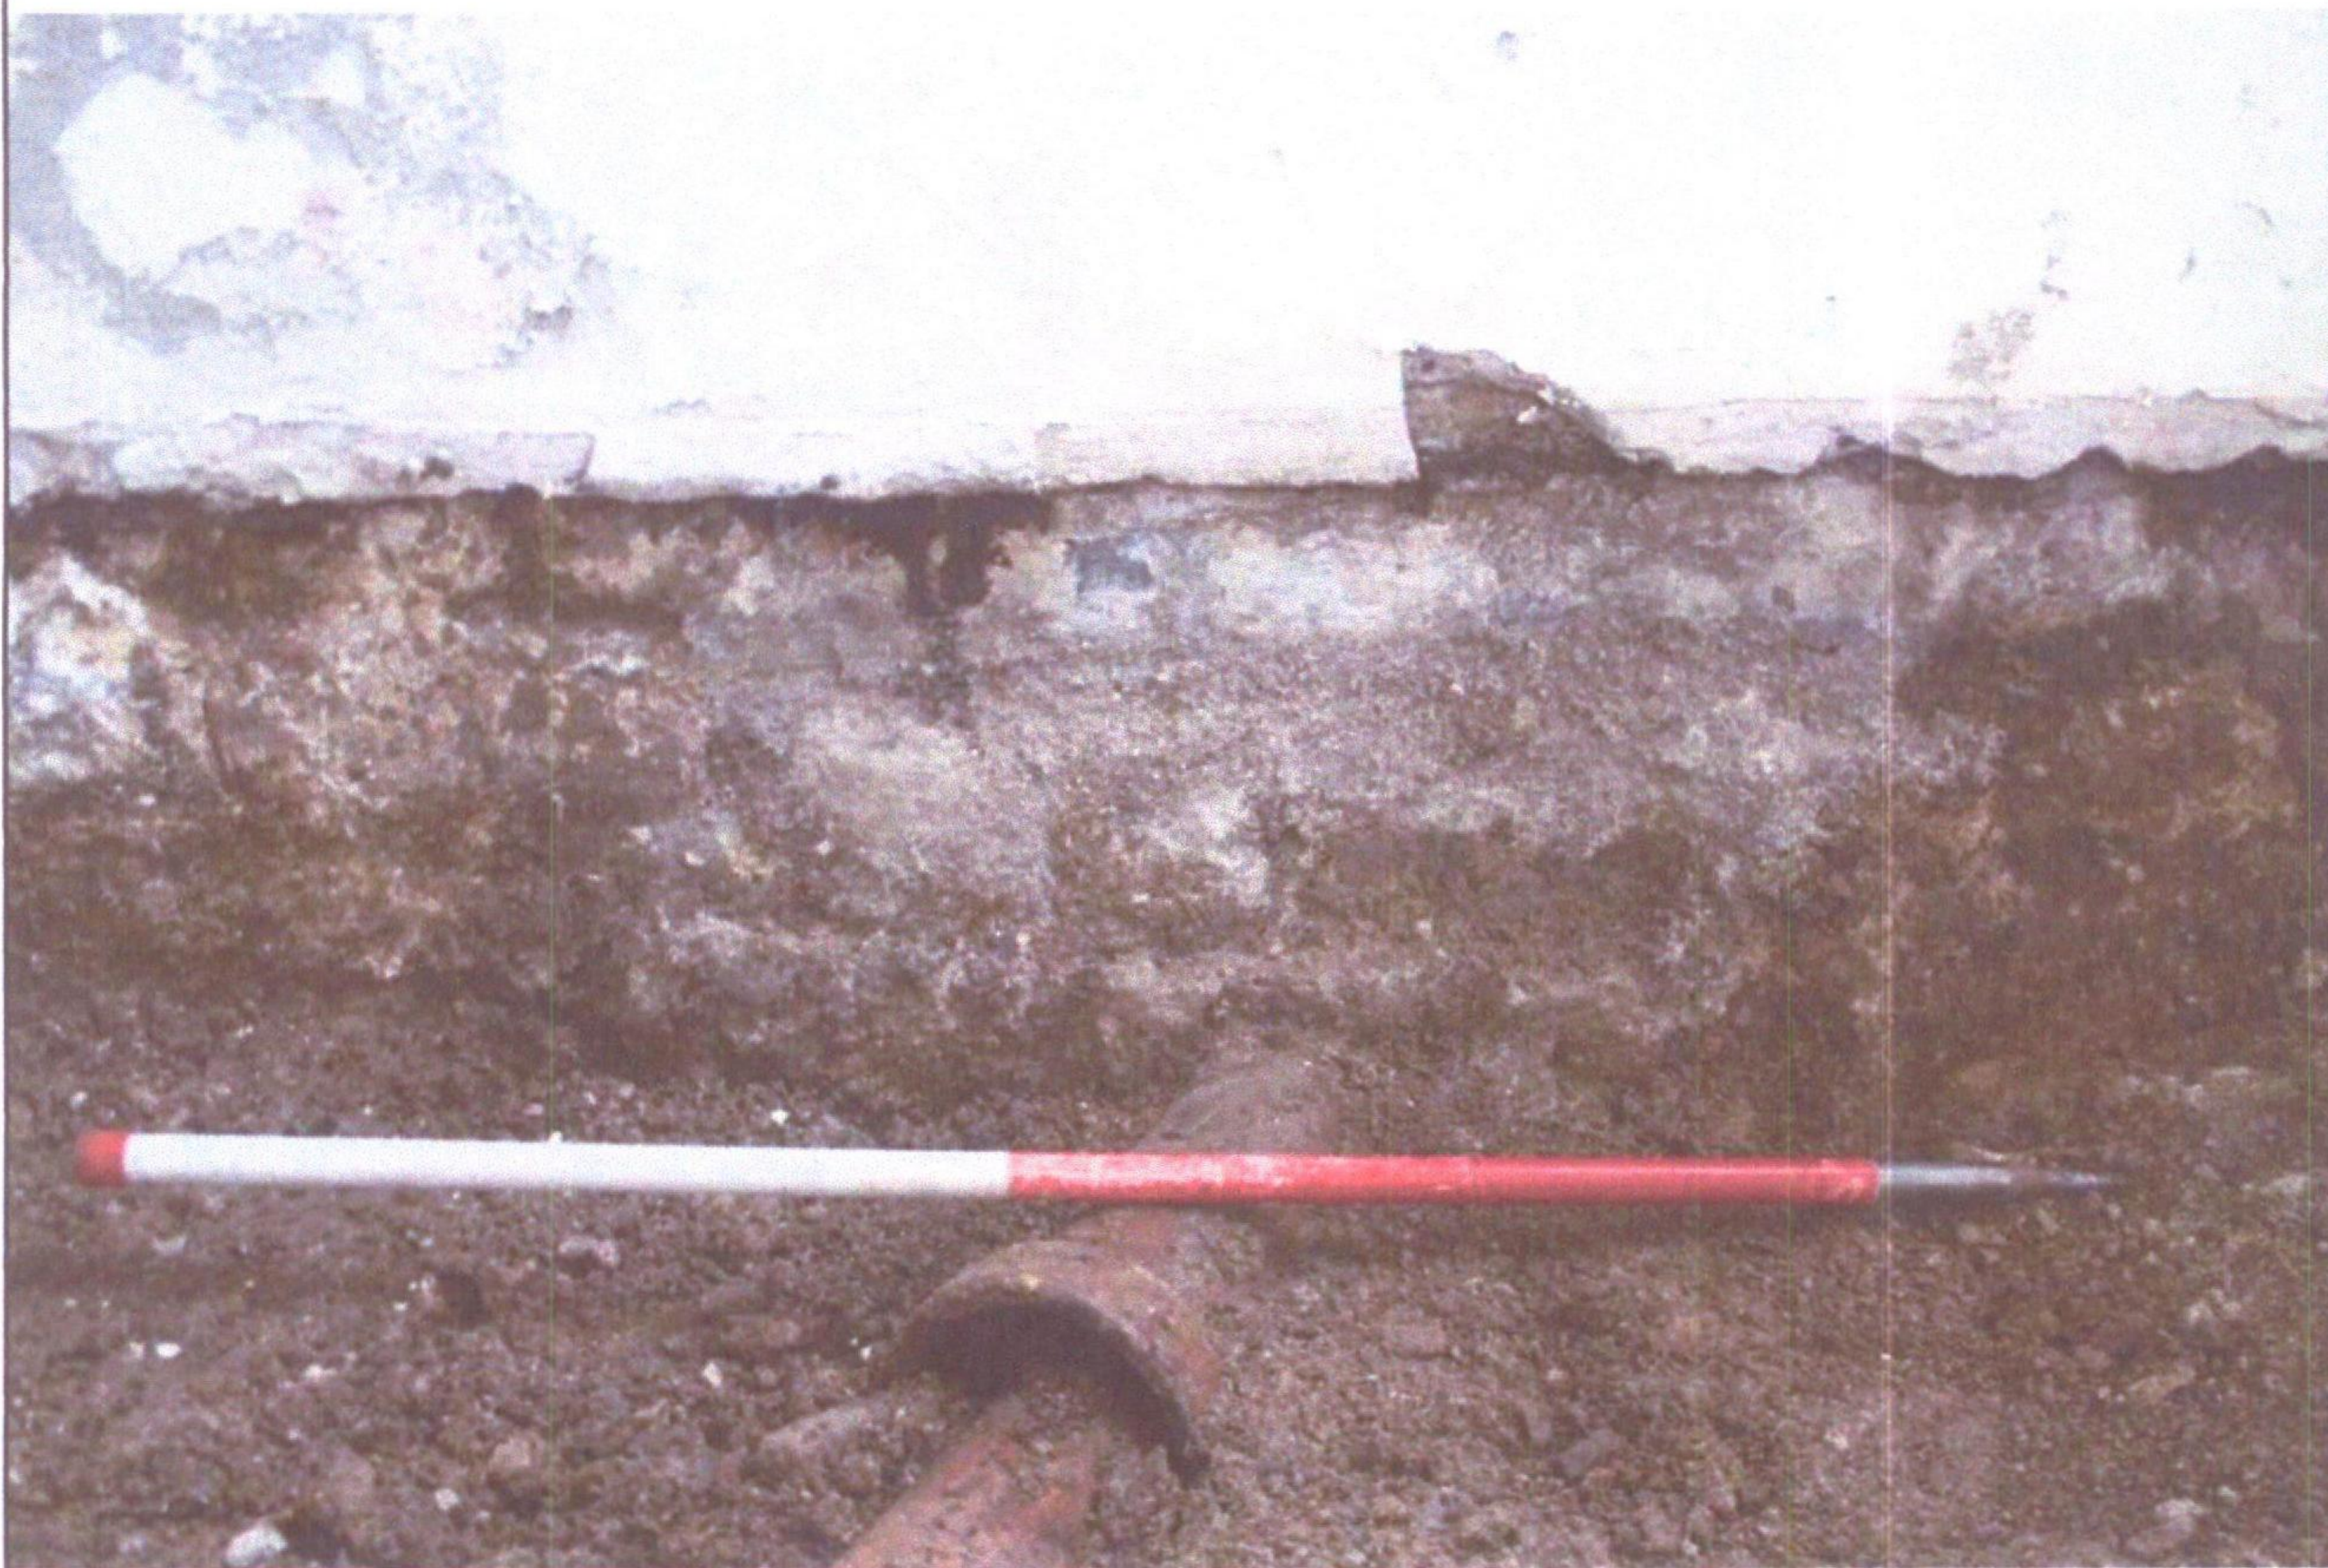
Plate 11

Internal Shot of Clay Pipe and Salt Glaze Drainage
