## **ARBORICULTURAL ASSESSMENT - NORFOLK HOUSE NURSERY**

| <b>Location:</b> | Norfolk House Nursery, 9 Caerau Crescent, Newport NP20 4HG | | |
| <b>Client:</b> | Norfolk House Nursery | <b>Reference:</b> | S251113.2 |
| <b>Author:</b> | John Mitchener | <b>Report Date:</b> | 21 February 2025 |

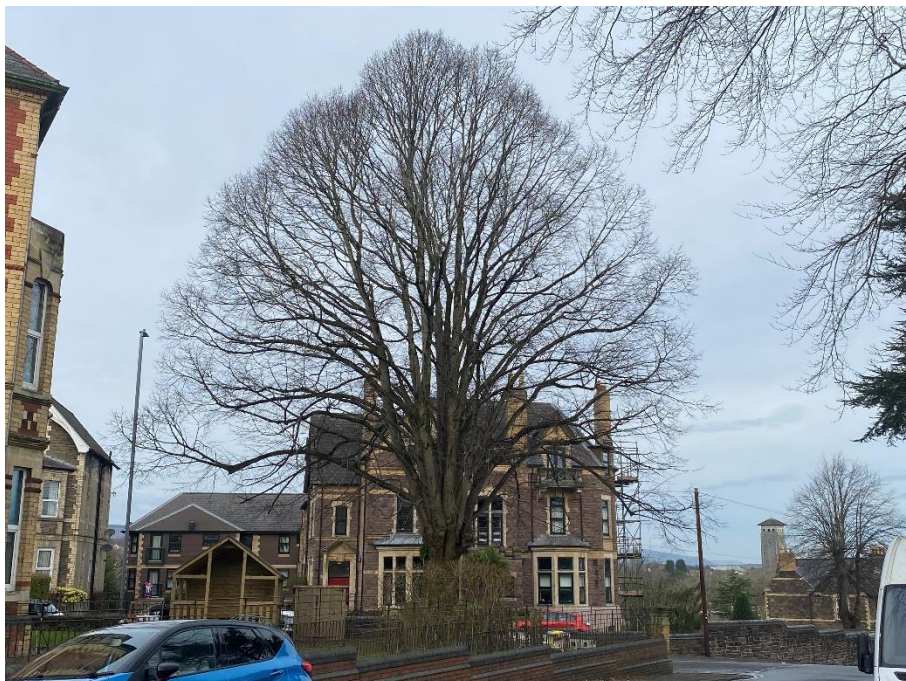
Tree T1 is positioned at the frontage of the Site and close to the junction between Caerau Crescent and Caerau Road. The tree was likely planted at around the same time as the adjacent building was constructed and is therefore of Victorian origin. It has a form which indicates that it was historically managed in a pollarded form but in more recent years has been allowed to grow and now supports a crown of substantial height and width.

Tree T1 does not exhibit any obvious defects which would raise concerns over tree safety. It does however have some branches which are below the recommended height over the highway and the crown contains several pieces of deadwood which could break and fall into either Caerau Crescent or Caerau Road. Also, some of the smaller stems positioned within the interior of the crown have become suppressed due to shading and now exhibit only limited leaf growth, poor physiological function and a sub-optimal height to diameter ratio. The long-term future of these suppressed stems is therefore questionable, and they are likely to either die or break if not removed via pruning.

***Photograph 1: Tree T1 viewed from Caerau Crescent and looking in an easterly direction***

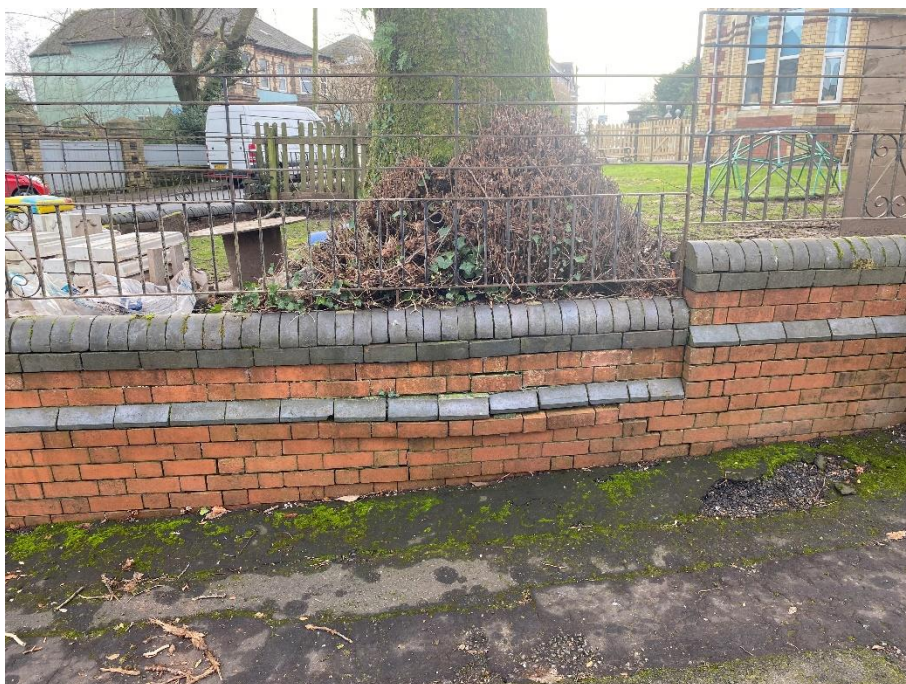
During the course of the assessment, it was noted that the brick-built retaining wall adjacent to tree T1 is damaged with an approximately six-metre-long section of wall either leaning outwards into the highway and/or showing laterally displaced bricks and cracked or missing pointing. In places brickwork is sufficiently loose that it can be removed from the wall by hand and there is an obvious risk that parts of the wall will fall onto the adjacent public footway.

Damage to the brick retaining wall has been caused by the growth of roots from tree T1. Damage has resulted from tree roots pushing against the wall thereby forcing it outwards. This damage will

continue to get worse as the tree ages and grows.

***Photograph 2: Retaining wall adjacent to tree T1***

Based upon our experience of such matters, it is likely that the damaged section of boundary will need to be dismantled and re-built. This will require the cutting back or removal of all tree roots which are otherwise pressing against the wall and causing damage. Other roots, which may foreseeably cause further damage in the future may also need to be removed.

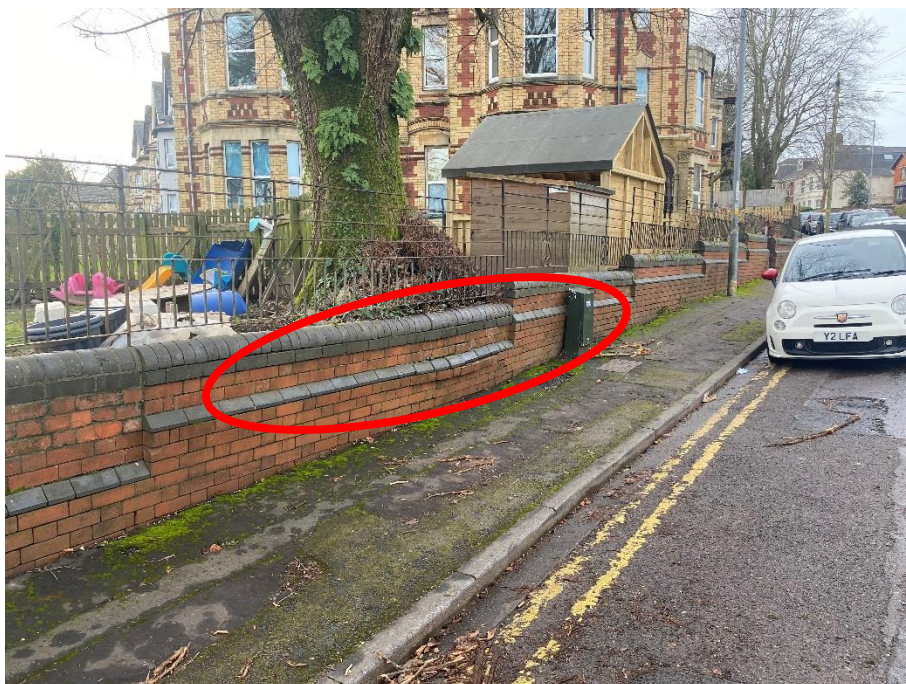
***Photograph 3: Assumed extend of damage to retaining wall (ringed in red)***

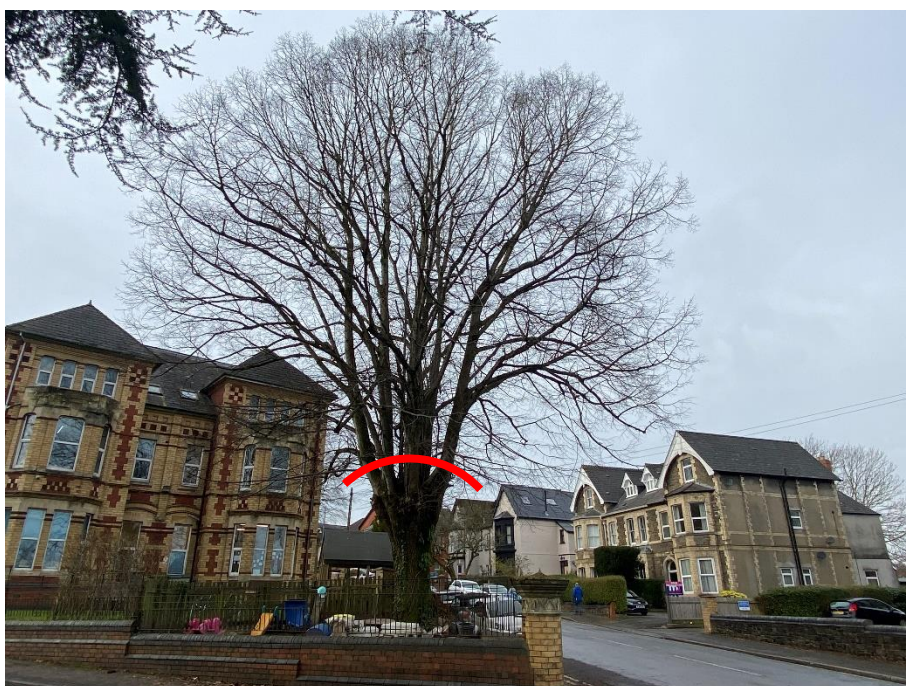
***Photograph 4: Tree T1, proposed point of pollarding indicated by red line***

In light of the above, it is recommended that the tree be pruned in order to reduce its height and spread before any repairs to the wall are undertaken, including the cutting or removal of tree roots. In order to guarantee the ongoing stability of the tree, and as a means of counteracting any decay which may arise following the cutting or removal of roots, it is advised that tree pruning extends to include the pollarding of the tree in its original form. The location of the proposed pollard points is illustrated in **Photograph 4**.
