**Coc Y North Barn, Coc Y North Lane, Rhiwderin**

**Structural Inspection Report**

## **Steve Morgan Associates**

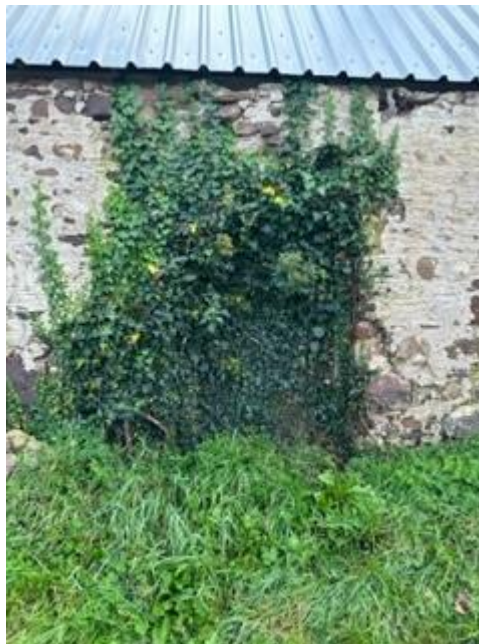
The front elevation contains a double door opening to the left of the elevation. To the right-hand side of the elevation there is evidence of historic repair to the door reveal with brickwork added. The lintel over the opening is timber and is likely to require replacement.

The elevation is partially concealed by vegetation. The vegetation should be treated and removed with any damage to the masonry made good.

There is a small return in the elevation to the left-hand side. It is possible that this may have been due to an historic addition to the original barn. The wall adjacent to the return and adjacent to the left-hand gable has a large crack running from eaves level down to the base of the wall. The crack will require stitching. It would also be prudent to inspect the foundations at the base of the wall at this location as the ground levels appear to have reduced, possible due to erosion/localised settlement of the external ground.

Figure 1  
Front (Coc Y North Road) elevation 1 of 5

Figure 2  
Front (Coc Y North Road) elevation 2 of 5

Figure 3  
Front (Coc Y North Road) elevation 3 of 5

Figure 4  
Front (Coc Y North Road) elevation 4 of 5

Figure 5  
Front (Coc Y North Road) elevation 5 of 5

- (xii) It is probable that some rebuilding/repair/resetting of masonry at eaves level will be required.
- (xiii) The crack to the front elevation should be repaired. This can be carried out once the cause of the movement to the front elevation/left hand gable corner has been established. The repair can comprise resetting of masonry across the crack or, potentially, a proprietary crack stitching system.

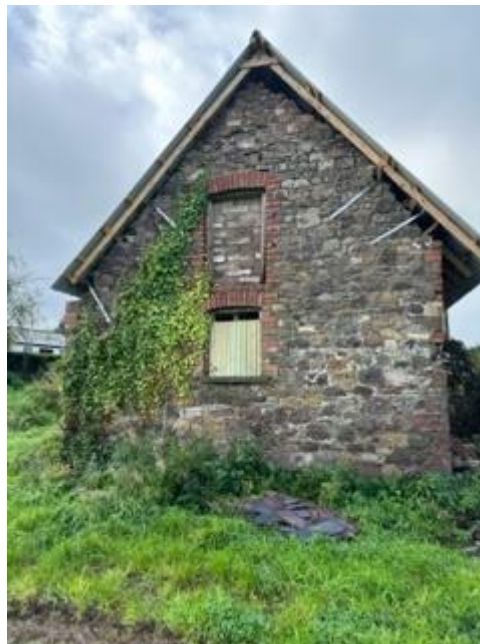
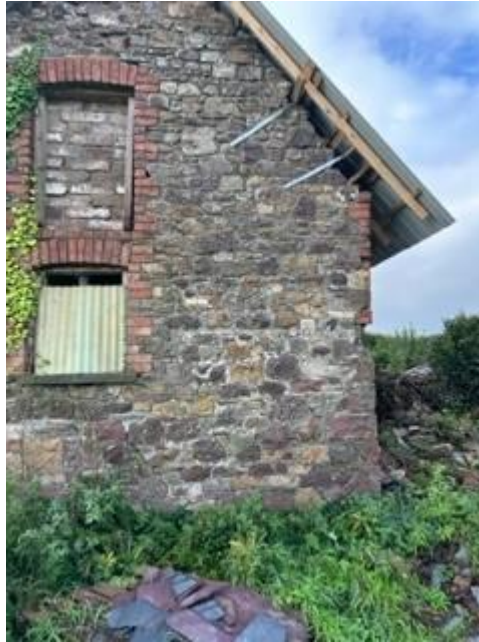
The left-hand gable is of random masonry as the front elevation. There are two window openings in the elevations, one at ground and one at first floor level. The first-floor opening has been blocked up. The windows have brickwork features to the perimeter. It is possible that the first-floor opening was a door opening.

The elevation contains the steel straps used to secure the roof structure. It is anticipated that these will be removed in the proposed scheme and an alternative solution proposed for the strapping.

This elevation again contains a large area of vegetation which should be treated and removed.

Figure 6  
Left hand gable end elevation.

Figure 7  
Close up of Figure 6

- (x) All vegetation should be treated and removed. Some repair to the bed joints can be anticipated once the vegetation is removed. The extent of the repointing can only be assessed when the vegetation has been removed.

- (xi) The current strapping detail is considered aesthetically unacceptable. The roof design should consider internal straps concealed on any inner skin to the conversion.

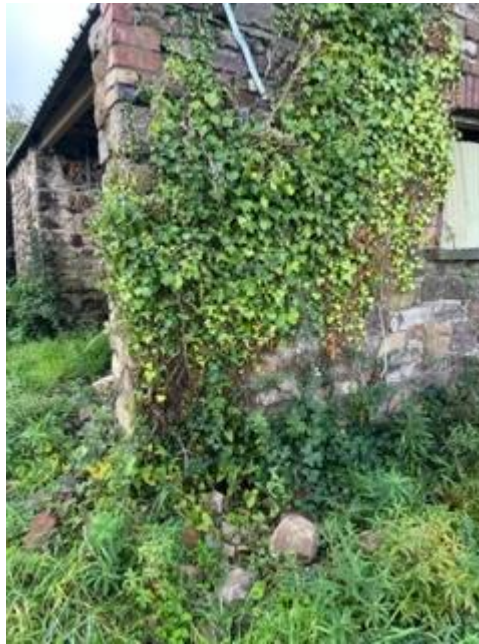
Figure 9  
Close up of low-level masonry deterioration

- (iii) It will be necessary to carefully expose the base of the wall to the left-hand gable before the extent of remedial measures can be fully assessed. The ground levels may also need to be built up locally to prevent further deterioration of the wall in this location.

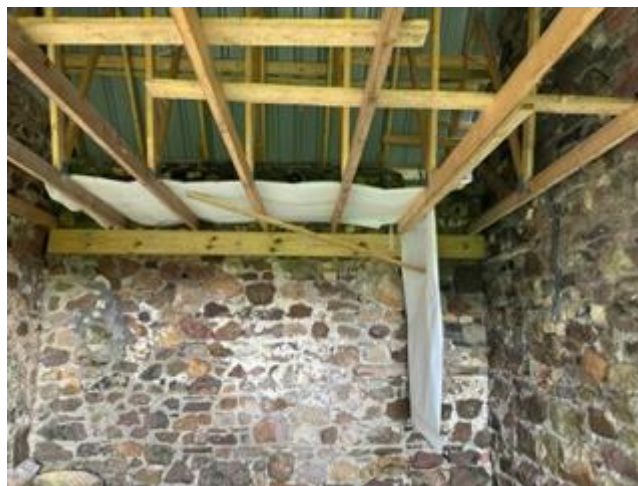
The area is open plan with the soffit of the roof trusses exposed. There is evidence of separation between the front elevation and gable walls, however this appears historic. It should be noted that the separation occurs at the location where the external ground levels appear to have eroded.

Figure 10  
Internal elevation left hand room (from Coc Y North Road)

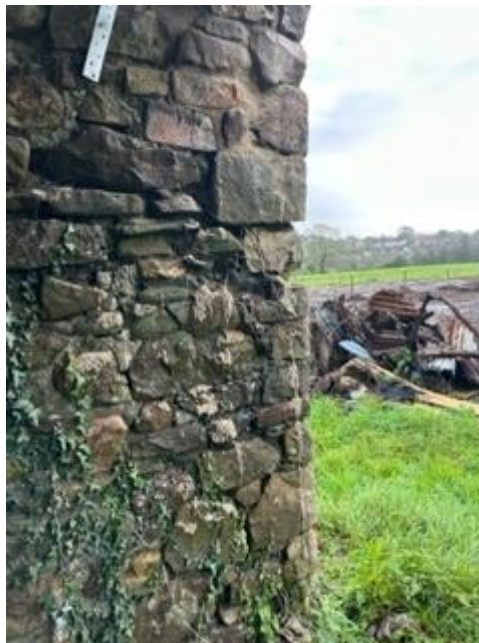
Figure 12  
Deterioration to gable end - internally

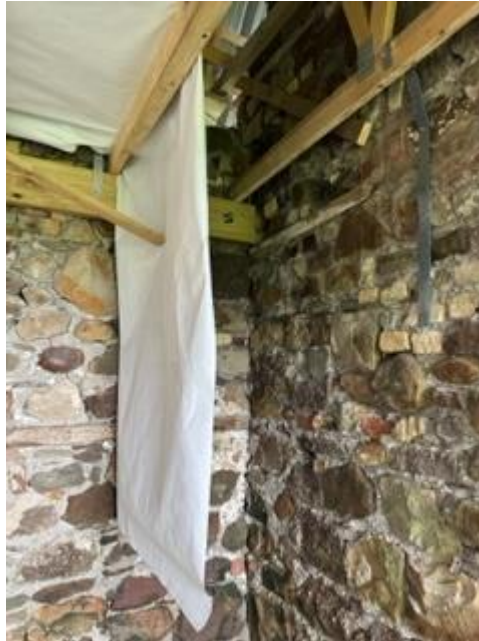
Figure 14  
Cracking at junction of gable end and LH gable end elevation

Figure 15  
As Figure 14

Figure 16  
As Figure 14

- (vii) The internal cracks at the junction of the front elevation wall and gable end wall should be trapped/tied in. The repair can comprise galvanised straps at close centres.

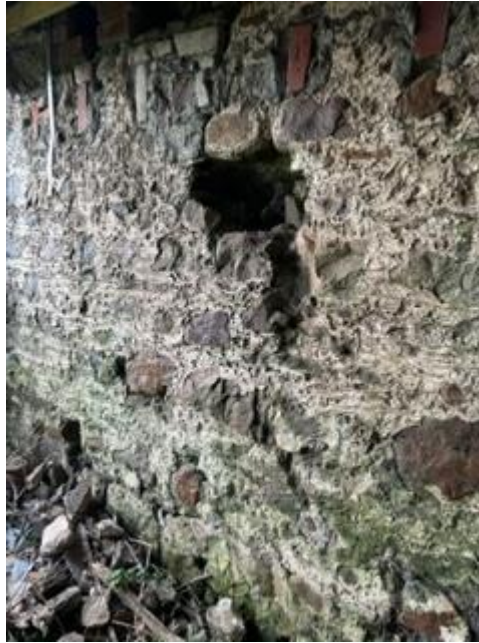
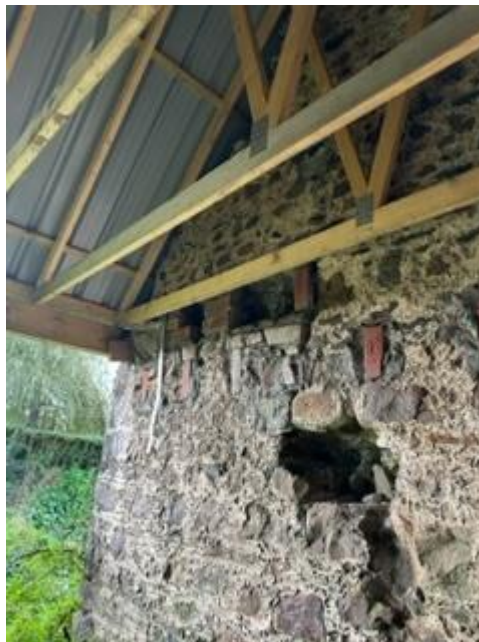
There is evidence of minor damage to the internal wall. Some repair/rebuilding will be required locally.

Figure 17  
Internal deterioration to internal wall

Figure 18  
As Figure 17

- (viii) Some minor masonry repairs will be required internally where voids were noted to the main wall.
- (ix) Minor rebuilding of the masonry will be required to the rear elevation double doors and to the gable end/rear elevation junction.

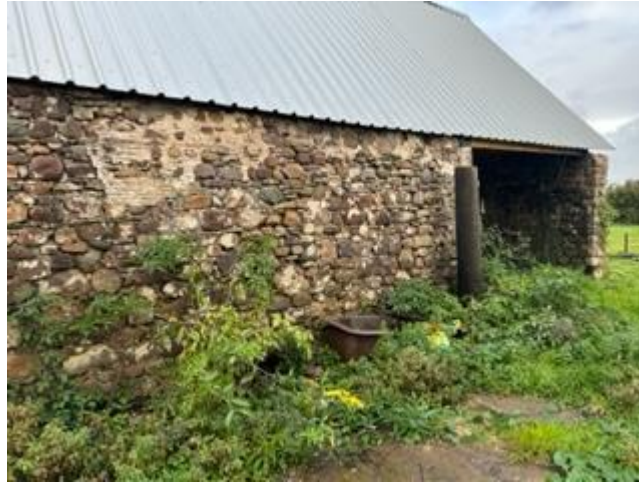
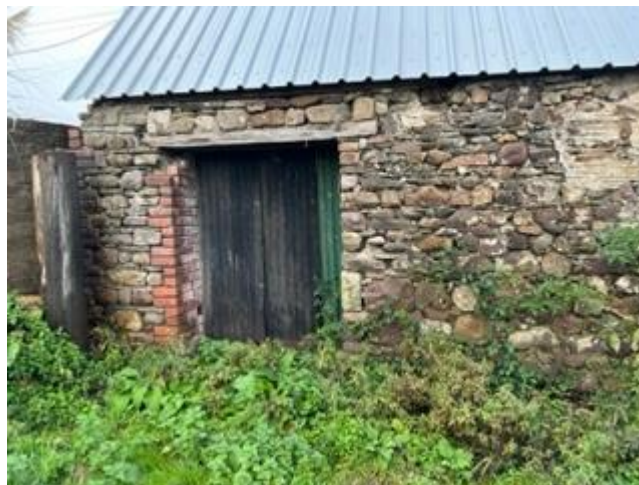
The rear elevation contains a large opening to the right of the elevation which extends up to the gable end. A further double door opening is located to the left of the elevation. The lintel over the left-hand opening has deflected significantly and will need to be replaced. There is also some deterioration of the masonry to the left of this opening and some minor repair/rebuilding can be anticipated.

The masonry to the rear elevation is painted with the finish having deteriorated.

Figure 19  
Rear elevation

Figure 20  
As Figure 19

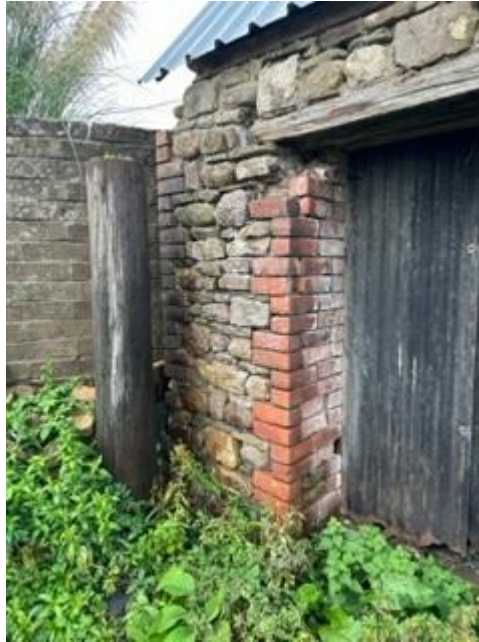
Figure 21  
Brickwork reveals to structural opening.

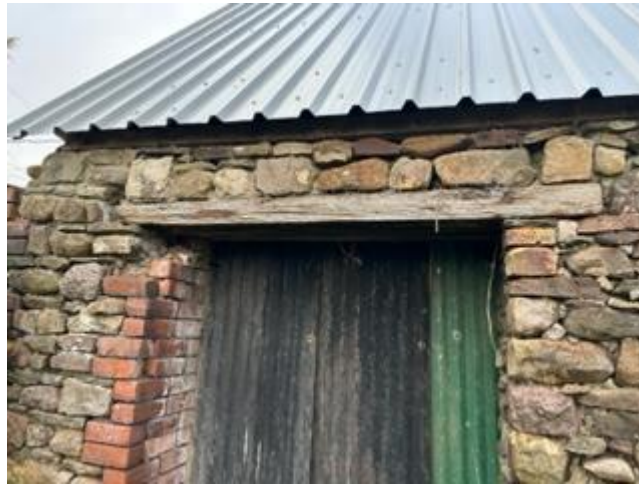
Figure 23  
Lintel to structural opening.

- (v) All lintels are likely to require replacement but, as a minimum, they will need to be checked when fully exposed.
- (vi) It would be prudent to carry out a more detailed inspection of the room to the right-hand side of the barn with no access available at the time of the inspection.

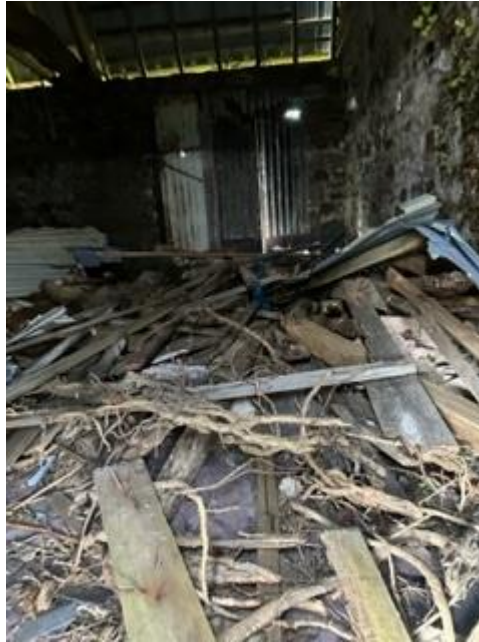
The roof finish is as the adjacent room. There is significant debris within the room which will need to be removed to enable a more detailed inspection. There was no obvious evidence of deterioration of the perimeter walls.

Figure 25  
Debris to right hand room.
