## Ground Gas Protection System Verification Report

**REPORT TITLE** : **Ground Gas Protection System Verification Report, Phase 2A, Herbert Road, Newport**

**REPORT REFERENCE** : **140521-12032-01**

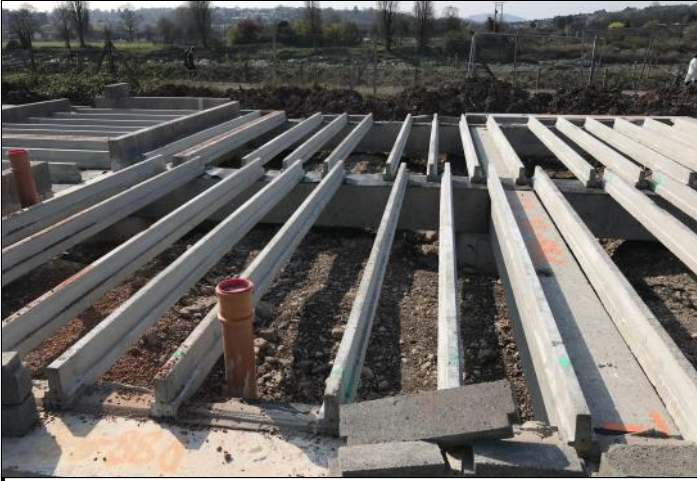
Photographs	
No.	Description
1	Sub-floor void
2, 3	Corner details
4, 5	Full plot
6, 7	Service entry sealing
8	Reinforcement placement

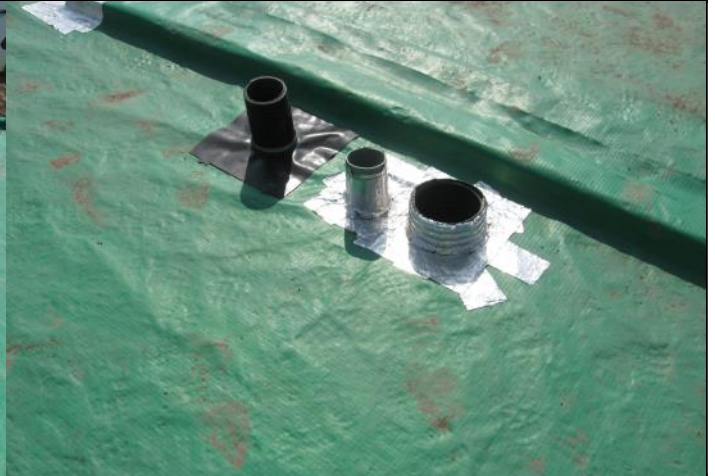
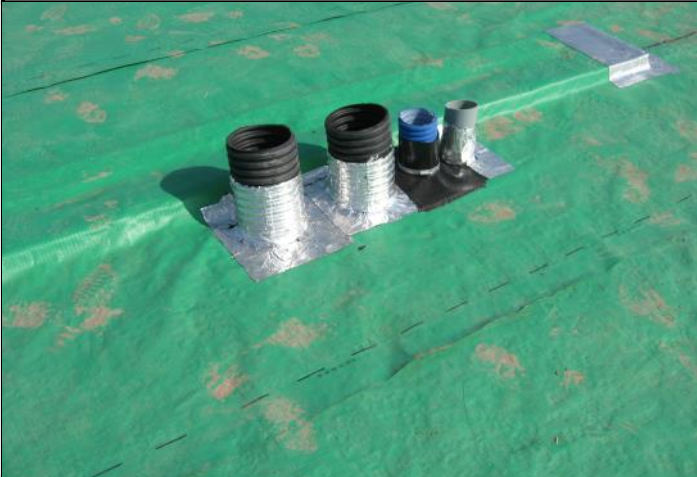
Conclusions
<p>The gas protection measures inspected: A - are acceptable and comply with the specification; B - Are Acceptable but attention is drawn to issues related to item no. XX; C - Are not acceptable due to the issues related to item no. XX. <b>B - service entry ducts to be sealed at later date, photos to be provided by PM</b></p>

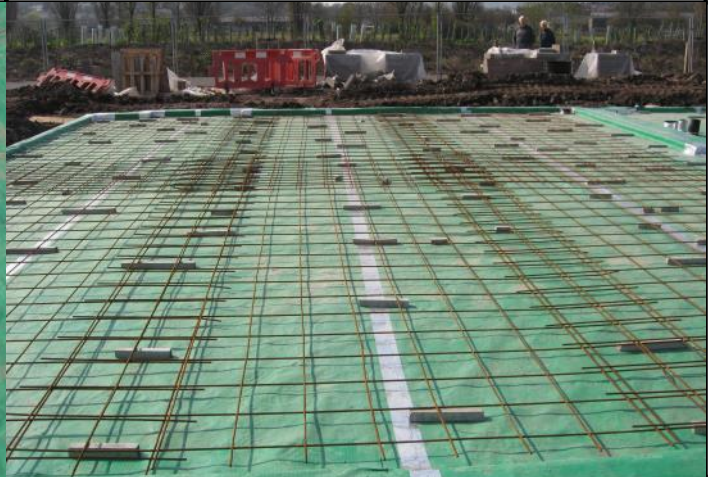
8

**Additional Information:** Steel reinforcements laid during inspection visit. Care was taken, no damage recorded.

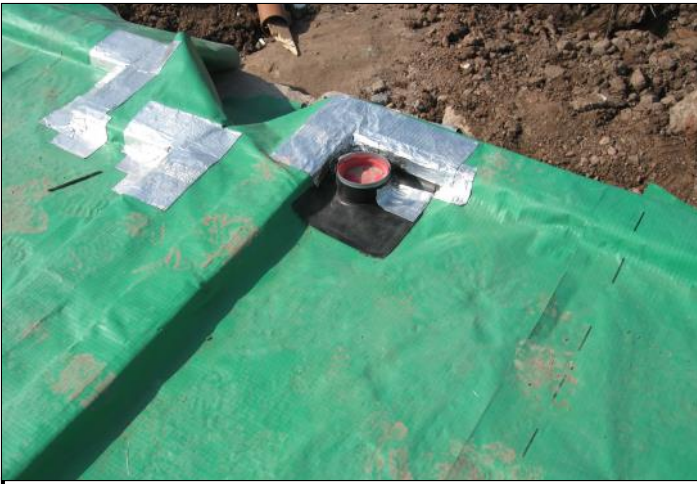
No.	Description
1	Top-hat and corner details
2	Full plot
3,	Corner details
4	Threshold corner details
5	Inappropriate use of lap tape

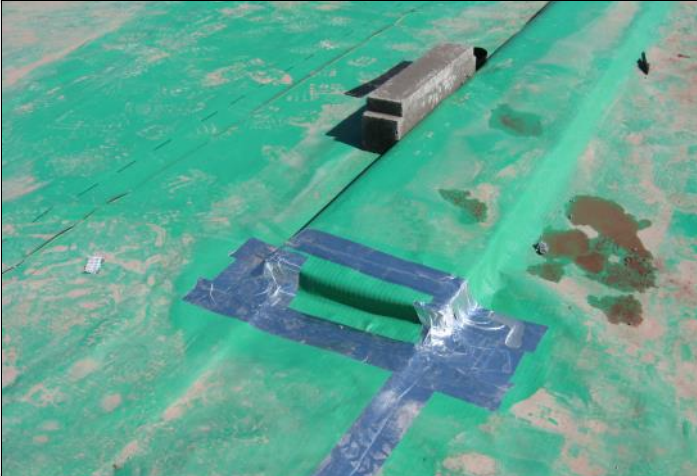
5

On one occasion the incorrect use of foil lap tape was observed. The installer had used the incorrect tape to detail an internal corner. The issue was rectified by removal of the tape and replacement with SOLCO XL Jointing tape.

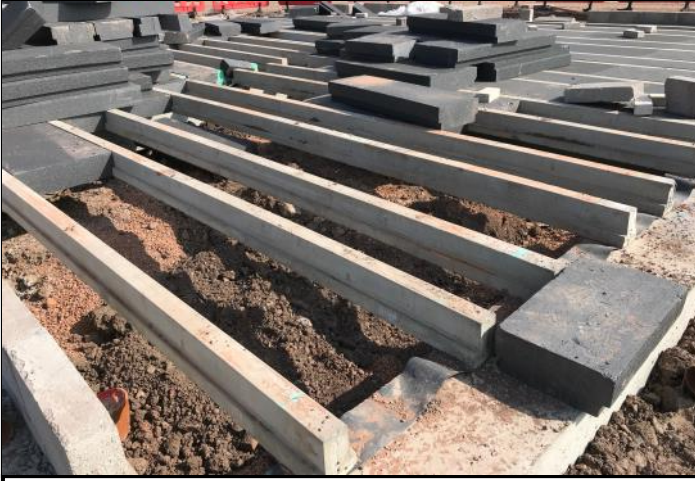
No.	Description
1	Sub-floor void
2,	Corner details
3,	Top-hats
4	Full plot
5	Threshold detailing and service entry sealing
6	Corner details
