## **Former Zanzibar nightclub**

### **Proposed Methodology of works**

**Revision 1 – 25.03.2025**

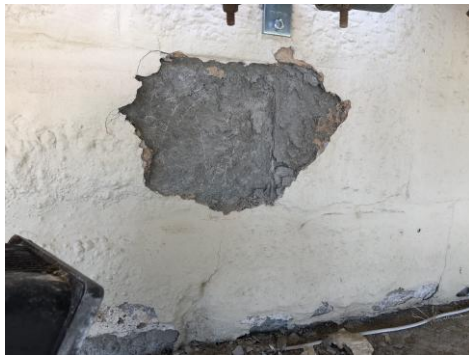
The face retained stone façades at 40 Stow Hill is constructed from dimensioned Pennant sandstone with a bush hammered feature face combined with dressed Bath stone features to openings, pilaster features and pediment. The façade is heavily painted and the true make up of the underlying stone work cannot be fully confirmed at this point.

The dimensioned Pennant sandstone has suffered badly from frost damage due to the painted coatings and the feature finish of the stonework where exposed has been lost to lamination. Whilst the obvious method of removing these coatings would be the DOFF and / or TORC systems, the initial removal could be carried out by hand to identify sound and defective areas. It is clear at this point that the original surface finish has been lost in the majority of areas.

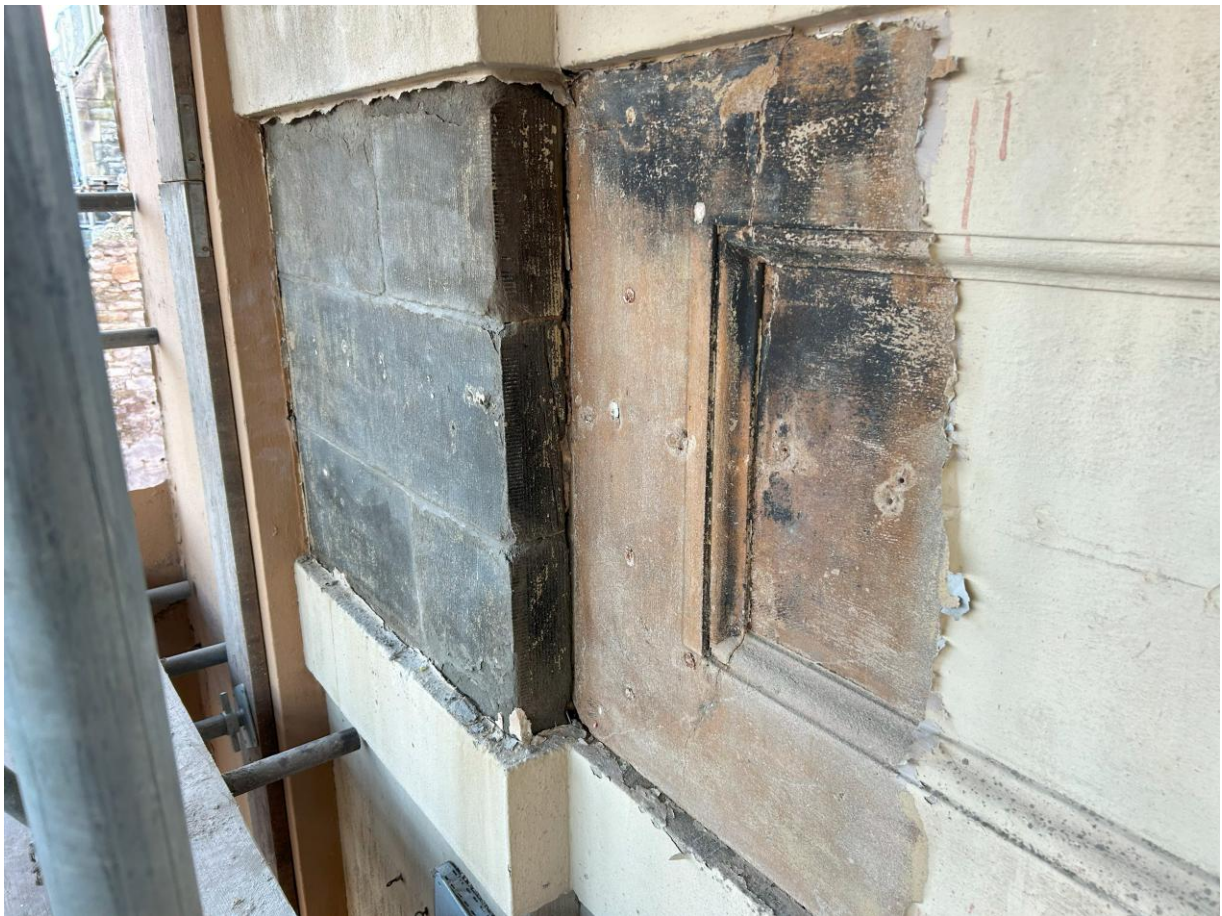
Samples of this systems have been carried out successfully and inspected on this façade. The following is a photo of the sample on both the Pennant and Bath stone features.

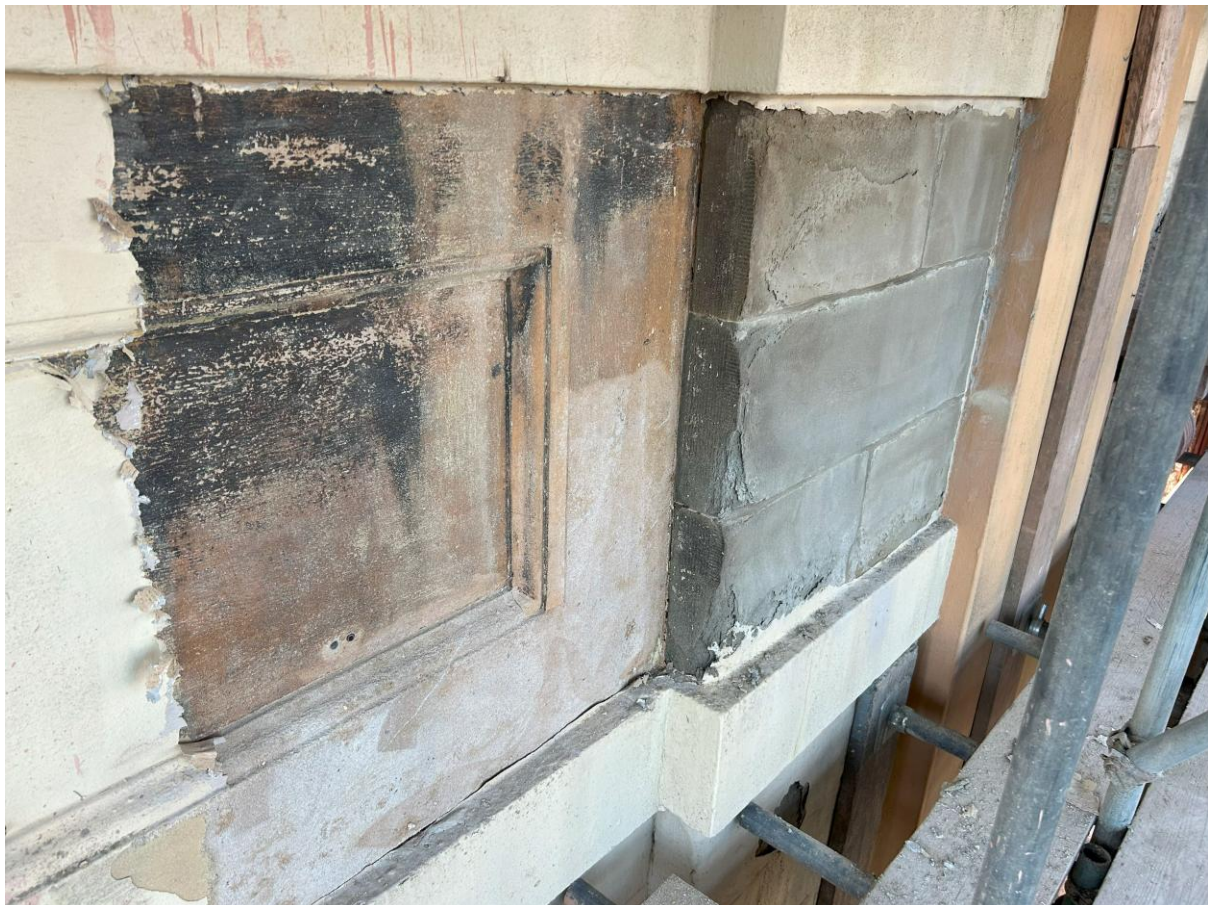
Samples of this systems have been carried out successfully and inspected on this façade. The following is a photo of the sample cleaning on both the Pennant and Bath stone features. Only the lower section of Bath has been TORC cleaned to remove carbon

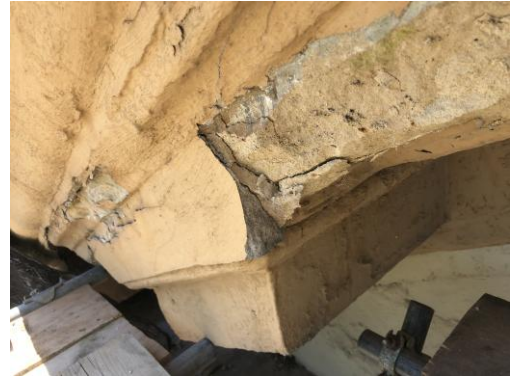
The main pediment has been covered with a felt or similar membrane which has broken down and will need to be removed or replaced dependant on the stone condition beneath. Various sections of the front moulding have failed or been replaced in a mortar repair and will need new stone indents or replacements.

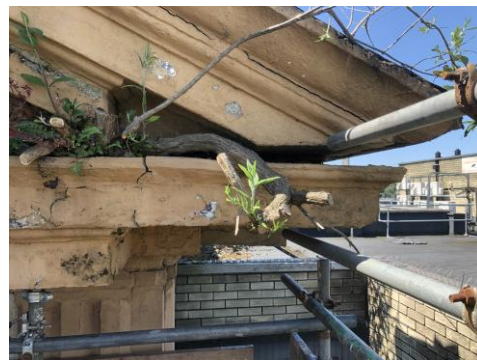
The buddleia root to the Right-hand side of the Tympanum has cause considerable damage both lifting the coping and forcing the area below out of line. To reset and or replace these sections will require suitable crantage.
