# Brynglas House

Structural Condition Survey Report

**Newport Norse**

Project Number: 11735

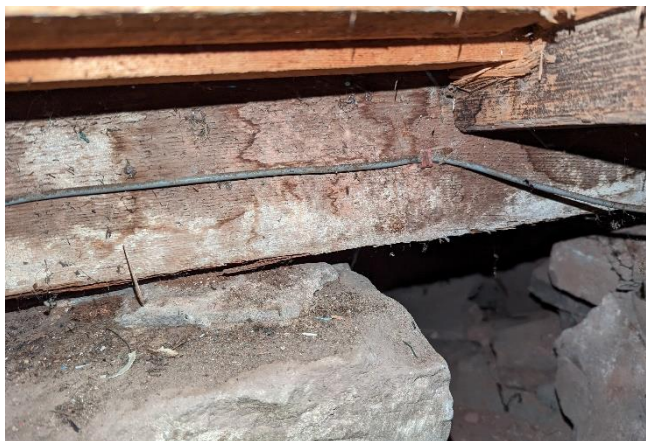
3.1.4 There is some evidence of discoloration on the faces of the joists beneath room No. 26 which appears to be due to historic water damage / rising damp from the ground below. Timbers however were inspected to be generally sound and robust.

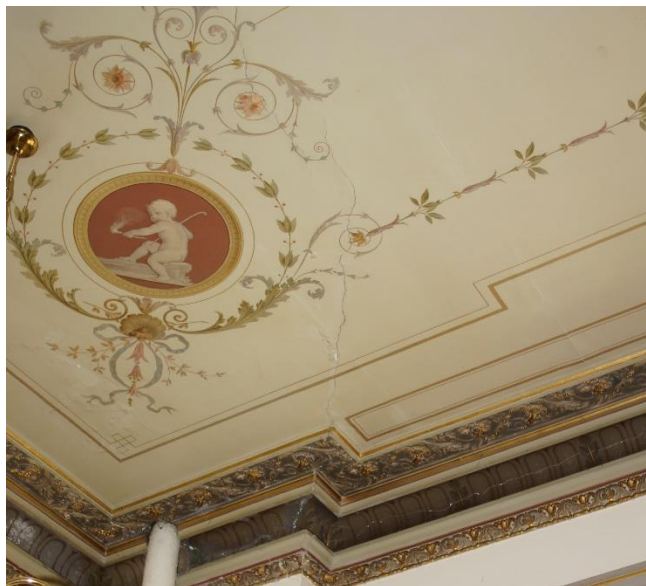
- 3.2.2 There are several long horizontal and diagonal cracks (1-3mm crack widths) to the historic decorative plaster ceiling and perimeter mouldings below room 37 (ceiling of room 26). Similar cracking is present in the ceiling over room 24.

- 5.1.2 It is suspected that the cracks in the historic plaster ceiling below room 37 is a result of historic deflection of the beams and underlying ceiling joists. The beams are numerically suitable for imposed UDLs of  $1.2\text{kN/m}^2$  when considering the beam as a fully restrained, simply supported beams.

- 7.4.2 To improve the deflection and moment capacity of the existing floor beams, we recommend strengthening works are undertaken. To strengthen the beams, we propose setting and fixing a steel T section into the top face of the beams which will improve the overall performance under live loads. Steelwork will be specifically designed to achieve the desired occupancy loading. Following strengthening of the beams, we recommend that the plaster ceilings are repaired. The decorated ceiling in particular should be repaired by a suitable plaster contractor. Repairing plaster prior to beam strengthening may risk the defects coming back.

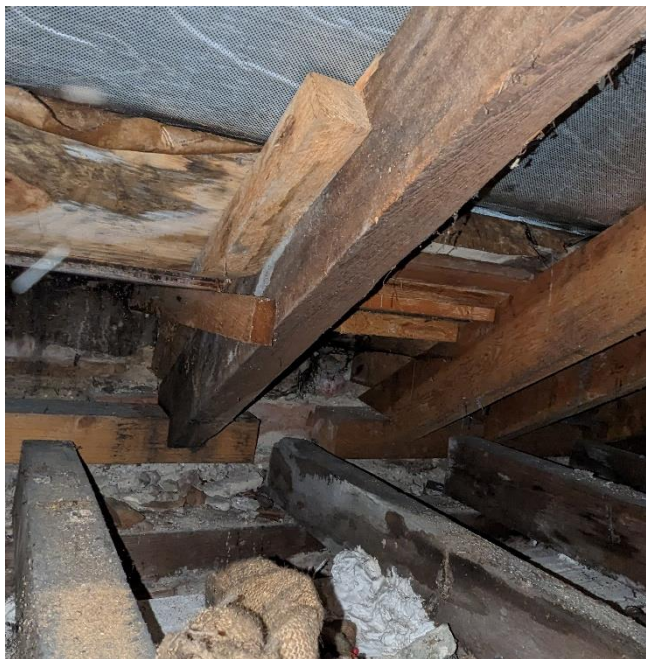
- 3.3.1 Where inspected the roof and ceiling structure was generally observed to be in reasonable condition however there are some localised areas of degraded / softened timbers. Water ingress is suspected to be an ongoing issue as suggested by the poorly performing roof finishes, missing lead flashings and localised defects in the parapets along the perimeter of the building. These items will be further described in sections below.
- 3.3.2 Discolouration of existing timbers is suggestive of previous and potentially ongoing water ingress issues which has/is likely degraded the robustness of the existing roof structure.

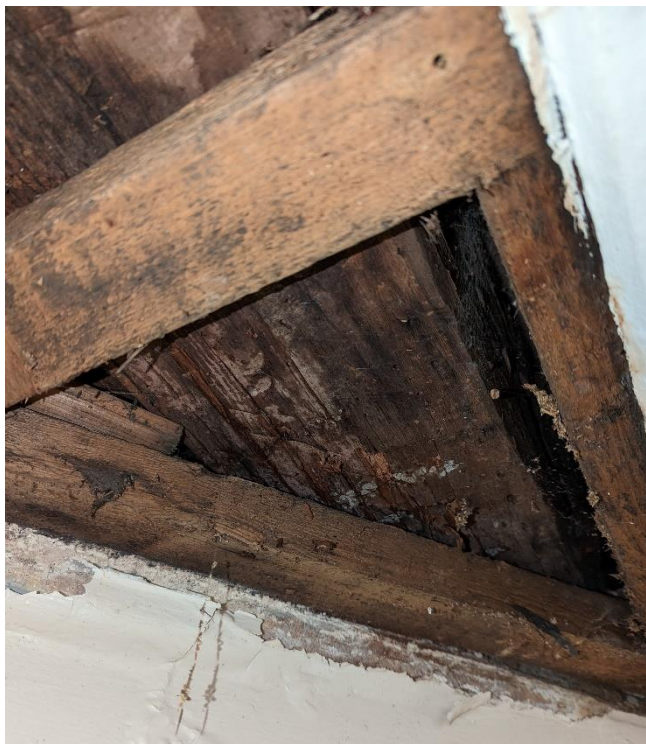
3.3.3 At the south bearing of the timber twin beams over the head of the southernmost curved bay window, the timber is significantly softened and deteriorated and is limiting the robustness of the roof support in this location. It took minimal effort to penetrate the beam with a screwdriver. The beams span the full width of the bay window and support the ends of the principal rafters supporting the roof construction and are therefore structurally significant.

3.3.4 The beams appear stable state however are of structural concern due to the risk of in the event of further deterioration as a result of water ingress.

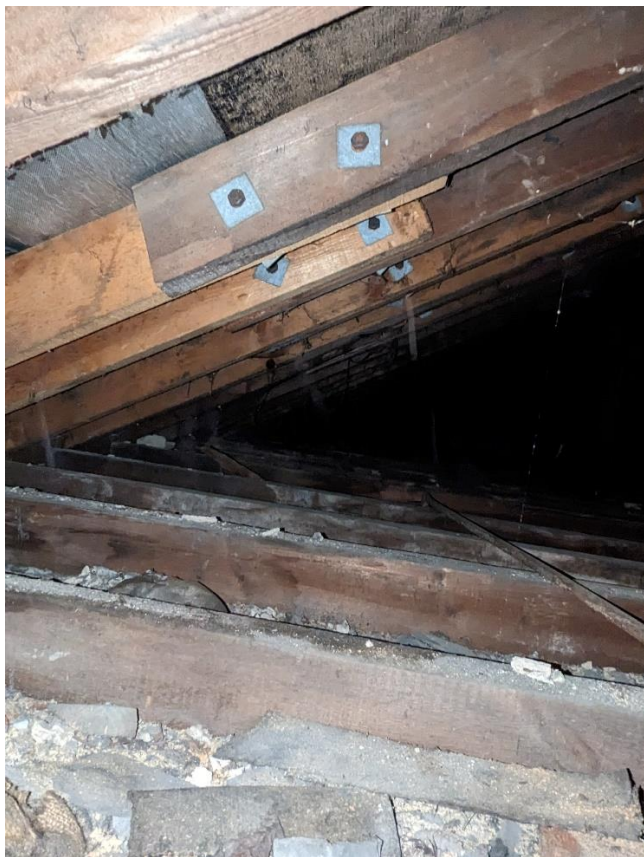
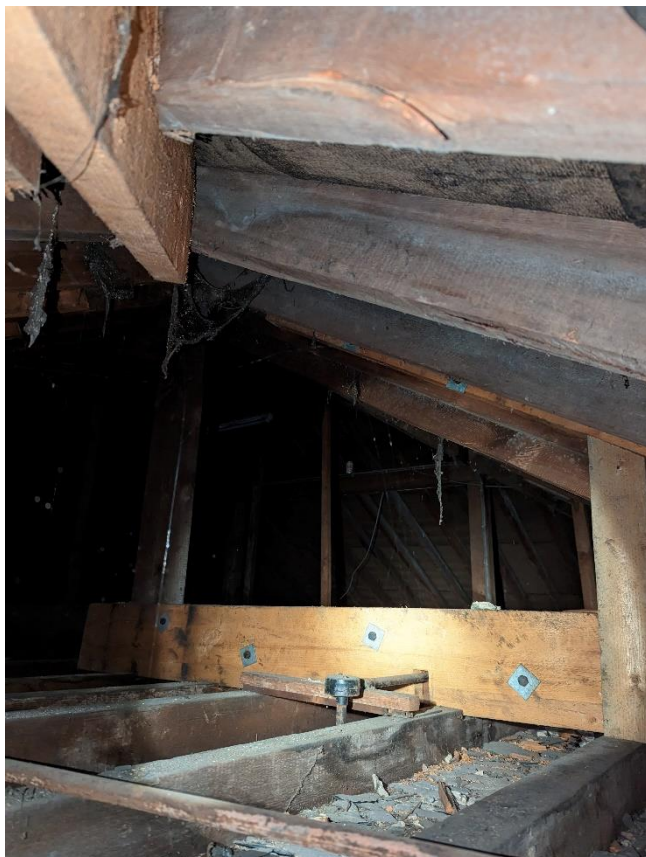
3.3.5 The photos below show where original rafters have been cut at approx. 1m from the wall plate and new sections of softwood have been spliced (bolted) to the original timbers. Similarly, the trusses have been retrofitted with additional softwood sections which have been bolted to the side of the tie beams. The reasons for these works are unknown however may be suggestive of previous repair works undertaken to the roof structure.

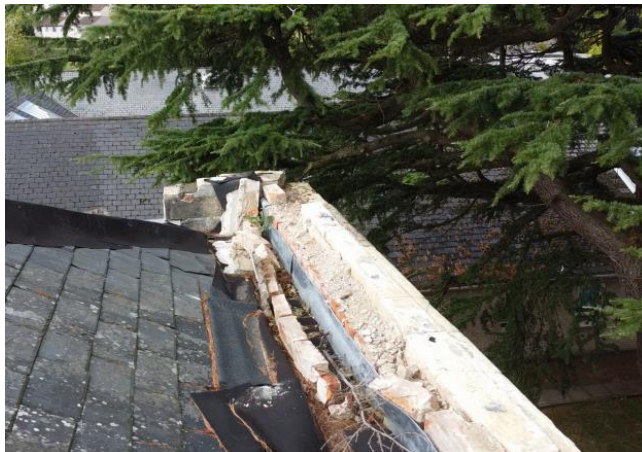
- 3.3.7 At the north west corner of the roof, the upper course of brickwork leaf has collapsed inwards leaving the corework and backing to façade stonework exposed and vulnerable to weather attack. The masonry in its current condition appears stable however continued deterioration is likely to cause issues such as degradation of bedjoints / stonework.

- 3.3.8 The roof coverings behind are in poor condition and likely not performing adequately with regards to draining the roof to the nearest outlets.

- 7.3 Roof
- 7.3.1 We recommend that the existing roof finishes are inspected by a conservation accredited architect / contractor and a schedule of required repairs is produced with consideration to reinstating water tightness and integrity of the roofs.

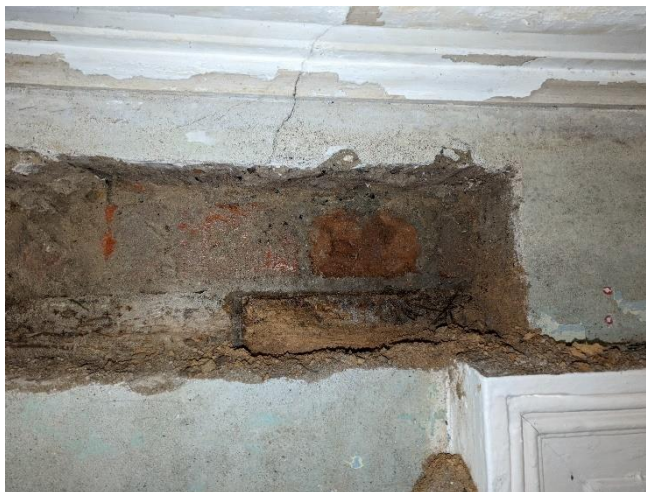
- 3.4.2 Internal timber lintels were exposed during the inspections and were confirmed to comprise of 100mm deep timber lintels. Where exposed the lintels were generally in sound condition with no significant signs of softening or degradation. Lintels beyond the internal face were not exposed and therefore not inspectable during the visit.

- 7.2.2 During the render repair works, we recommend that once render is removed from around window heads, an engineer is to be approached to inspect the form and condition of the external lintels (timber / steel) and exposed masonry. If lintels are found to be degraded, we may recommend that these are replaced with precast concrete at the time for improved performance and longevity.

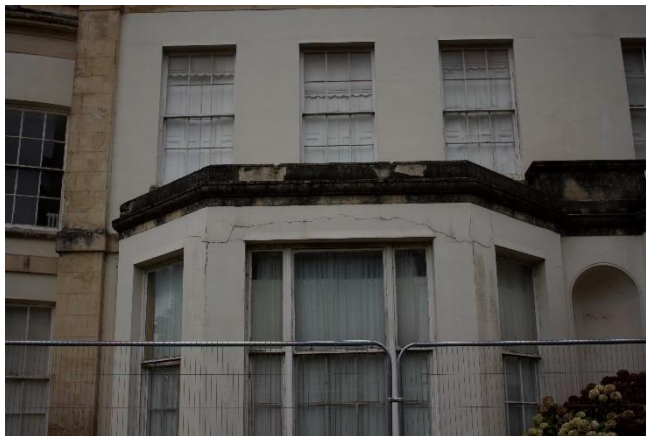
- 3.4.3 Masonry over the top of the southernmost bay window is showing signs of distress by means of a long crack in the render along the top of the windows. The causes for the cracking were not identified during the inspections however the issues appear stable in their current condition. However further weathering of the finishes is likely to permit water ingress through the walls with the potential to cause deterioration to the masonry fabric leading to further cracking / loss of historic fabric.

- 7.2 Walls
- 7.2.1 For the external walls, no specific causes of the cracks in the render have been identified therefore we recommend the cracks in the render are repaired as part of a full render repair to the building.

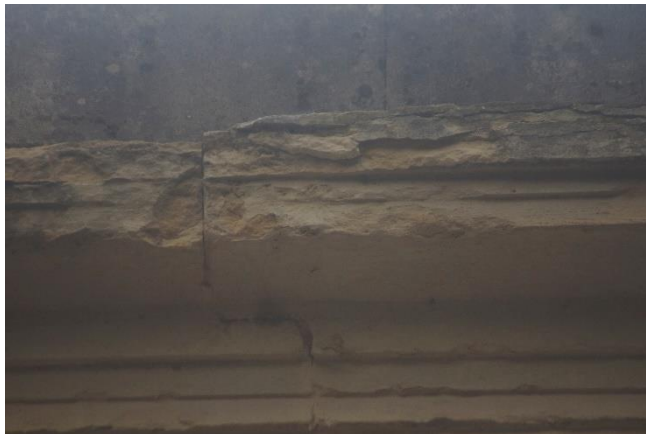
- 3.4.4 Along the border of the roof, the lead flashing has been historically removed by vandals. Where the lead flashing is missing, the projecting string course stones are degrading and delaminating at high level. Stones appear stable in their current condition however continued weathering is likely to degrade stones further resulting in further loss of historic fabric.

- 7.2.3 Consideration should be given to replacing the flashing along the projecting string course along the perimeter of the roof with specific considerations to waterproofing.

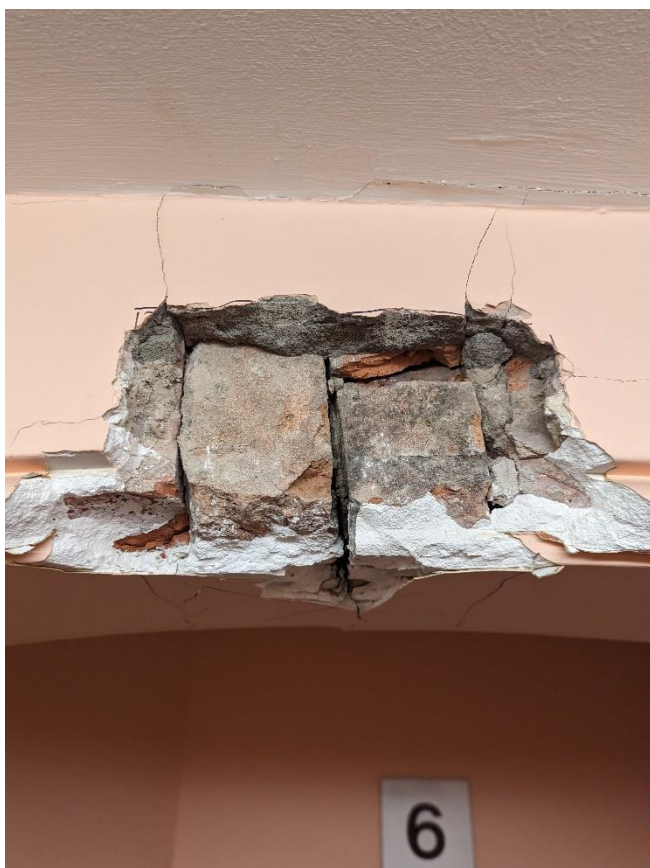
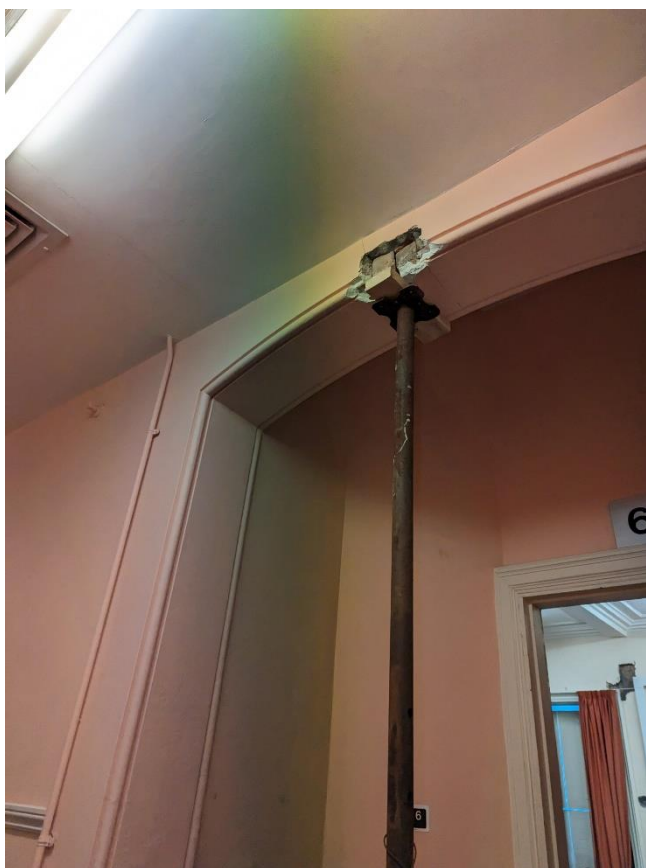
- 3.4.5 In 1No. location, at the entrance to room no. 36, cracking was observed in the plasterwork at the crown and up the internal elevation of the 1 brick thick masonry arch. On removing a localised patch of the plasterwork, the crack was confirmed to continue through the full thickness of the arch. Stones were locally loose and at risk of falling if left unsupported therefore a prop was installed to the underside of the arch to hold brickwork in place until remedial works can be undertaken.

- 7.2.4 For the internal arch, we recommend the arch is repaired and an allowance is made for installing 4No. 600mm long stainless steel pins, and repairing cracks on the front and rear elevations by installing 4No. 1m lengths of stainless steel bed joint reinforcement (Helibar or similar approved) and bedding in lime mortar. Once repair works have been completed the existing prop can be removed.
