# Brynglas House

## Visual Exterior Structural Inspection - Elevations

Client: Newport Norse  
Project Ref: C2723  
Report Revision: P01

| Document reference | C2723-CAM-ZZ-XX-RP-S-0001 |

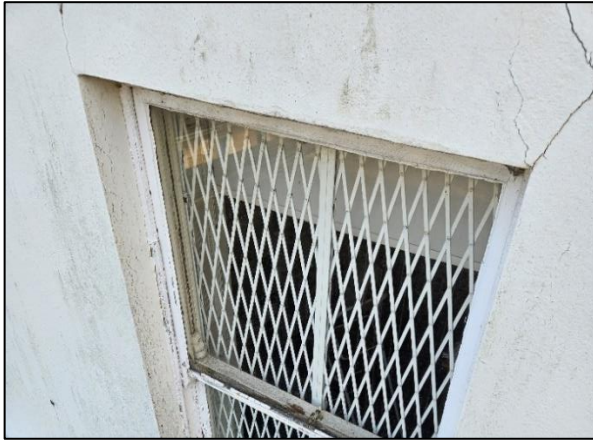
- 4.1.1 There are a few vertically propagating cracks located on all elevations see Appendix A. These are primarily propagating from the corner lines of windows and sills but can also be found around door frames. **See Photo 4.1.**

*Figure 4-1 – Window Cracking*

- 5.1.2 The cracking noted to the render finish has likely occurred due to the age and type of render installed. The elevations have been tapped and loose render removed. There is one (due to the bee's nest) which they missed. This is to be completed.

- 6.1.1 We would recommend that where cracking is present that the rendered areas are cleaned back and the presence of cracking through the masonry be determined by a suitably qualified contractor. If crack stitching is required follow guidance in Appendix B. From the current visual inspection cracking in the masonry has not been noted at this stage therefore if no cracking is present in the stonework/ brick masonry the render can be re-applied to the localised area with the addition of plasterer's lath mesh, to limit the likelihood of further cracking in the future.

- 6.1.2 The render repair specification should be agreed with the client, planning officer and Cadw. Should lime render be applied to the structure to suit its historic construction. However, the existing render is a concrete render which was reapplied circa 40-50 years ago. The patch replacement should ideally match the historic construction of lime render; however, it will not match and act the same as the existing concrete render. Client to confirm final render specification. Most likely concrete render to match, then painted white to suit building finish.

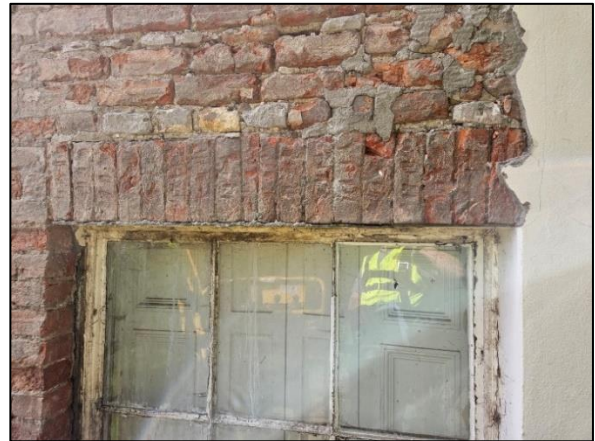
- 4.1.2 Steel lintels have visible corrosion above window frames in multiple locations. **See Photo 4.2.**
- 4.1.3 There are instances where no lintel is present and no arched brick soldier has been implemented above window frames, it is advised these areas to be investigated and monitored for loose stones. **See Photo 4.3.**

*Figure 4-2 – Corrosion on Steel Lintel*

- 5.1.3 Steel lintels have corroded possibly due to oxidation from historically poorly galvanised coatings and water ingress through cracked render. Therefore, due to inadequate prior corrosion protection, oxidation can occur resulting in corroding of the steelwork and subsequently spalling render in the surrounding areas.

- 6.1.3 On the corroded steel lintels, we would recommend that the area is stripped of finishes and the loss of section to the steel element determined, by cleaning back to bright metal, treating for rust and a paint coating applied to the metal such as Forsoc Galvafruid paint or similar, to prevent future corrosion.

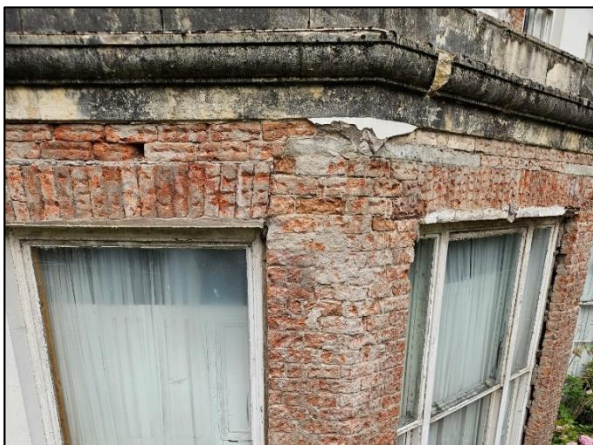
*Figure 4-3 - No Arched Brick Soldier or Lintel*

- 5.1.4 An agreement with the client and Cadw on any remediation measures will be required. Including specification for the render repairs.
- 5.1.5 Windows where there are no steel lintels supporting the masonry and no arched soldier is present will need closer inspection to assess their structural integrity.

- 6.1.4 In the window openings where no steel lintels or soldier/arches are present we would recommend a suitable contractor assess for loose stonework and if found these areas have a new steel lintel implemented to support the stonework above, loose stones removed reinstalled and repointed prior to rendering.

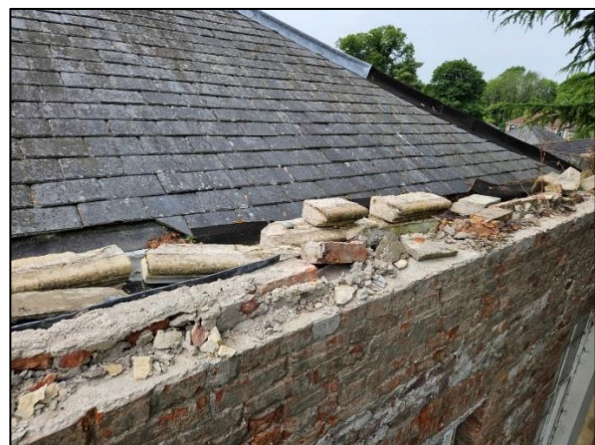
- 4.1.4 Sections of the coping stone around the top of the structure have either become dislodged or been removed and therefore are not adequately restrained. **See Photo 4.4.** In areas the coping/dressing stones also are exhibiting signs of weathered and the grouting between the stones has eroded completely in multiple sections. **See Photo 4.5.**

*Figure 4-4 - Dislodged Coping Stones*

- 6.1.5 In the section where the coping stone has become detached, we would recommend these be taken down and rebuilt using the original stone, we would recommend in all areas where the coping stones or upstands are weathered or loose these ideally be repaired or replaced "like for like" in the near future, primarily in areas where there is a concern of these breaking away.

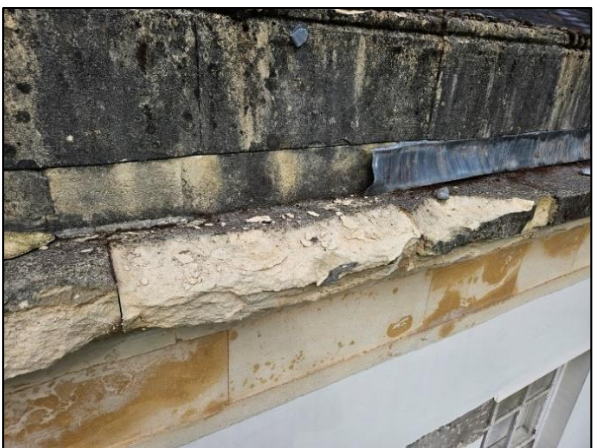
*Figure 4-5 - Weathered Coping Stones*

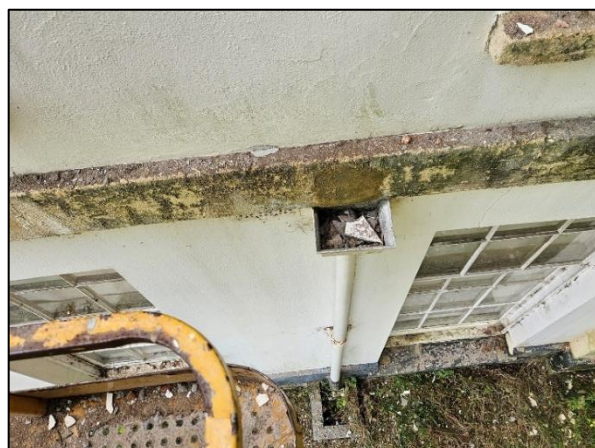
- 4.1.5 There are multiple instances around the elevation of the structure where gutters and drainpipes are blocked causing inadequate drainage, possibly due to the render tapping and removal in some areas and additionally due to vegetation growth. **See Photo 4.6.**

*Figure 4-6 - Blocked Gutters*

- 6.1.6 Where drainpipes are too corroded and cannot be repaired, we would recommend these be replaced like for like. All drainpipes and gulleys at ground level which rainwater pipes discharge into are blocked should be cleared to allow adequate drainage.

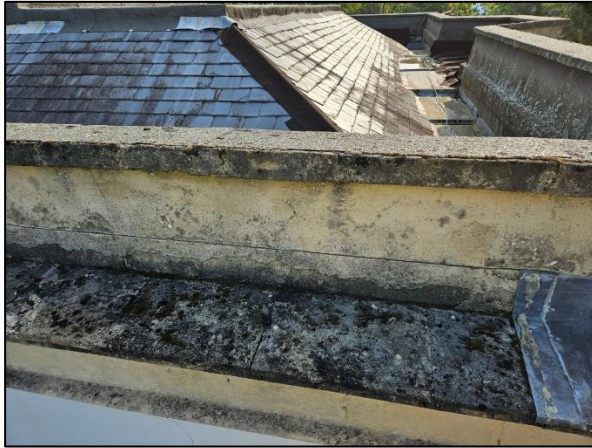
- 4.1.6 Lead lining at the roof base and around the coping has been removed in multiple sections of the roofing. **See Photo 4.7.**
- 4.1.7 On the South Elevation the chimney stone is in poor condition. **See photo 4.8.**

*Figure 4-7 - Lead Lining Missing*

- 6.1.7 Where roofing repairs are required for the hip or for lead lining, we recommend a suitably skilled roofing contractor be consulted as to the extent of the required repairs, the lining be replaced either for a suitable contractor specified lead or an alternate product with the aims of limiting water ingress to the structure, these should be confirmed with the local planning, the client Newport Norse and Cadw.

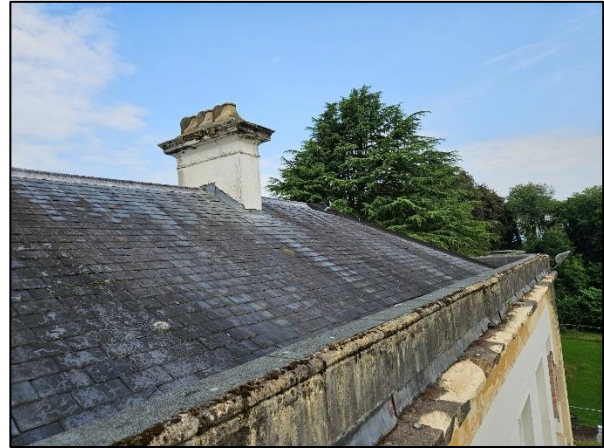
*Figure 4-8 - Chimney Poor Condition*

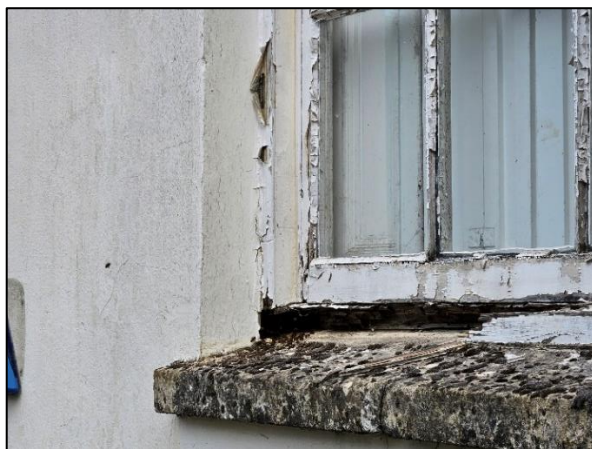
- 4.1.8 Due to the age of the structure and the windows being historically wooden constructed a majority of these have rotted, (in one instance due to a bee's nest located inside the structure). **See photo 4.9.**

*Figure 4-9 - Bees Nest Entrance in Rotten Window Frame*

- 6.1.8 Where window frames have rotted due to timber construction, we would recommend these be repaired where possible or replaced "like for like", or for a more modern yet historically tasteful alternative to be confirmed with the local planning authority due to the listed nature of the building.

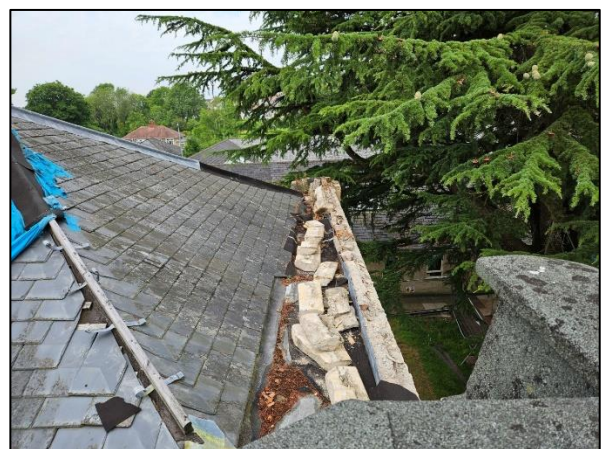
- 4.1.9 Coping stones and upstands are in poor condition on the East elevation and require replacing. **See Photo 4.10.**
- 4.1.10 On the North elevation a section of roof requires hip repair. **See Photo 4.11.**

*Figure 4-10 - Coping Stones in Poor Condition*

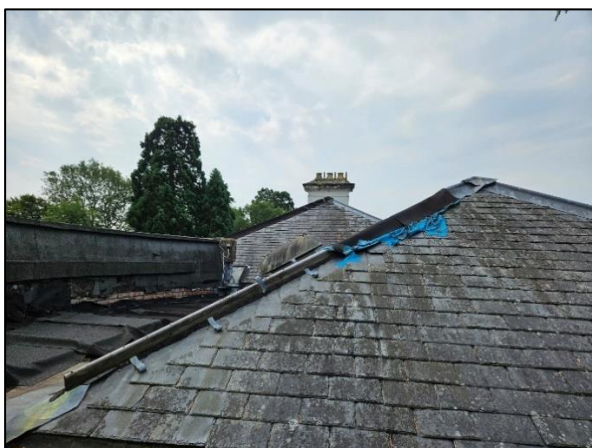
*Figure 4-11 - Roof Hip Repair*

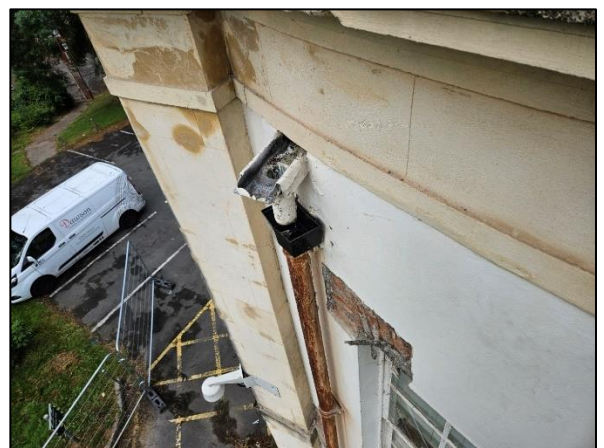
- 4.1.11 Corrosion in present to sections of the historic guttering and rainwater pipes. **See Photo 4.12.**
- 4.1.12 A secondary bees' nest is present on the West elevation.

*Figure 4-12 - Gutters and Downpipes Corroded*

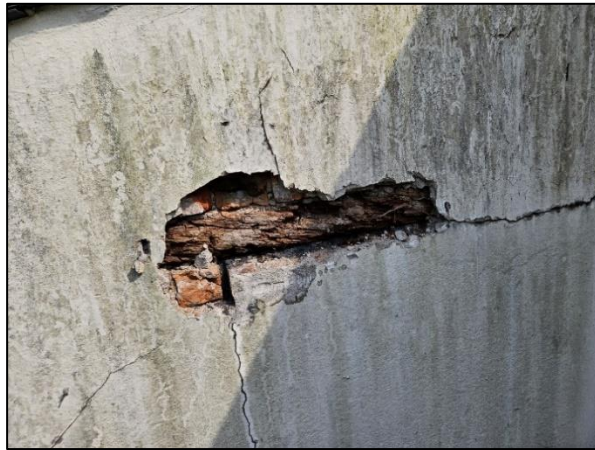
- 4.1.13 A singular rotten timber is located inside of the wall located of the West elevation, the purpose of which could not be identified during the exterior visual inspection. **See Photo 4.13.**

*Figure 4-13 - Rotten Timber in Wall*

- 5.1.6 The rotten timber located in the wall should be assessed as to the purpose and ideally removed if possible. From an exterior visual inspection this cannot be confirmed at this stage, ideally this would be inspected internally by an engineer or suitable contractor.

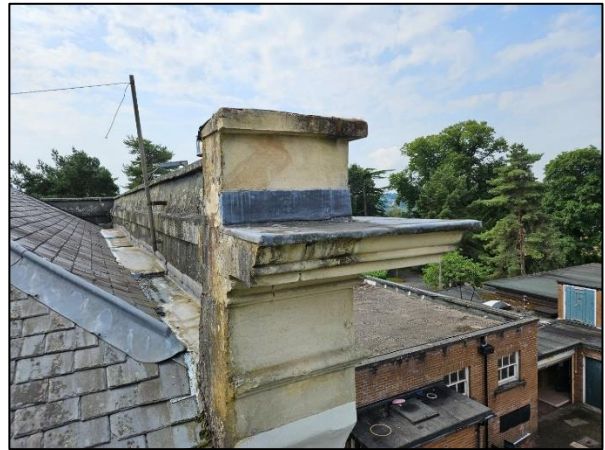
- 4.1.14 Paint slurry has been noted on the stonework of the west elevation.
- 4.1.15 The top coping stone on the west elevation has been historically cut back, which is cantilevering but appears ok presently, however would be advised to be monitored due to the risk of detachment in the future. **See Photo 4.14.**

*Figure 4-14 - Cantilever Top Stone*

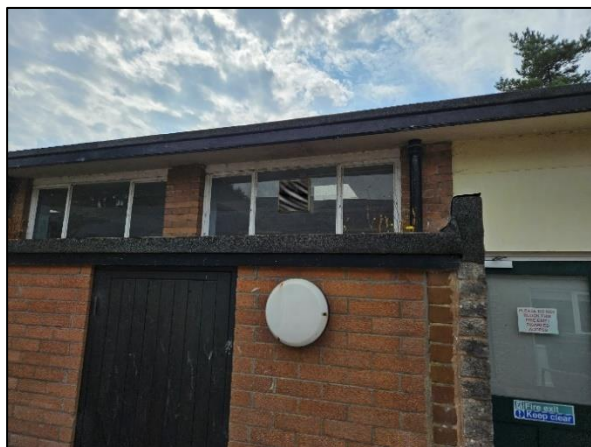
- 4.1.16 A smashed window has been noted on the north elevation of the rear extension. **See Photo 4.15.**
- 4.1.17 Vegetation is growing at the base of the downpipe on the north elevation of the extension due to inadequate drainage and an un-sloped flat roof allowing ponding at the base. **See Photo 4.16.**

*Figure 4-15 - Broken Window*

- 5.1.9 Due to the age and rotting of multiple windows frames we would recommend these be addressed to limit water ingress to the structure.
- 5.1.10 The smashed window should be repaired, as this is not part of the listed structure this can be altered without written consent from the planning authority for whichever the cheapest alternative is.

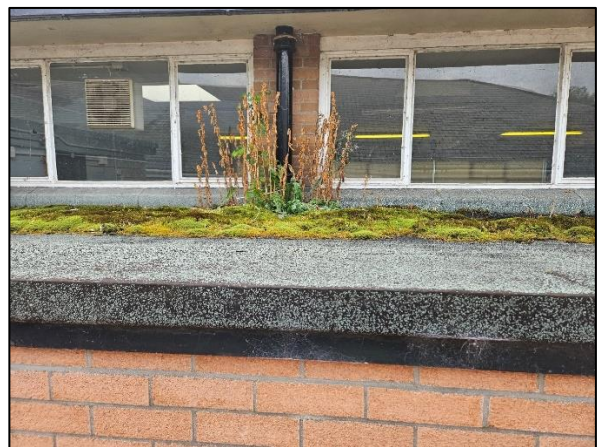
*Figure 4-16 - Growth and Ponding on Flat Roof*

- 6.1.9 The flat roof with ponding on the extension should be cleaned of all growth, a maintenance plan written and therefore cleaned periodically to stop future deterioration to the flat roof.

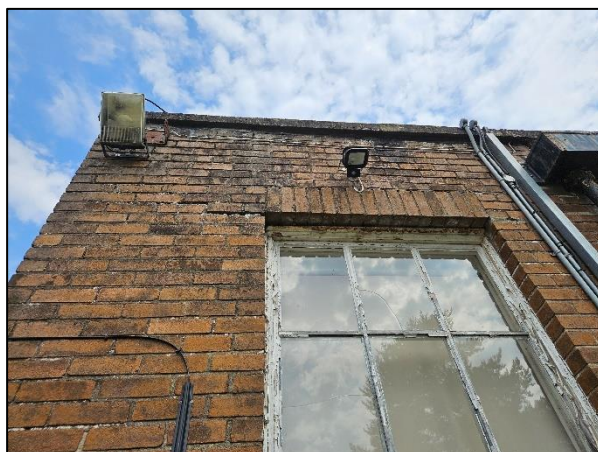
- 4.1.18 On the south elevation of the extension there are 5 windows where the soldier course overhangs the steel lintel substantially. This should be monitored by the site facilities team periodically for any movement. **See Photo 4.17.**
- 4.1.19 A section on the west extension elevation could not be inspected due to no access. Similarly, a section on the main structure south and east elevations could not be tapped due to the bee's nest being located at the first-floor level.
- 4.1.20 See photographs below of the external structure at the time of the inspection.

*Figure 4-17 - Soldier Overhangs Steel Lintels*
