# **BRYNGLAS HOUSE: REPLACEMENT OF STOLEN ROOF LEAD**

## HERITAGE IMPACT STATEMENT

Newport City Council

Issue 02

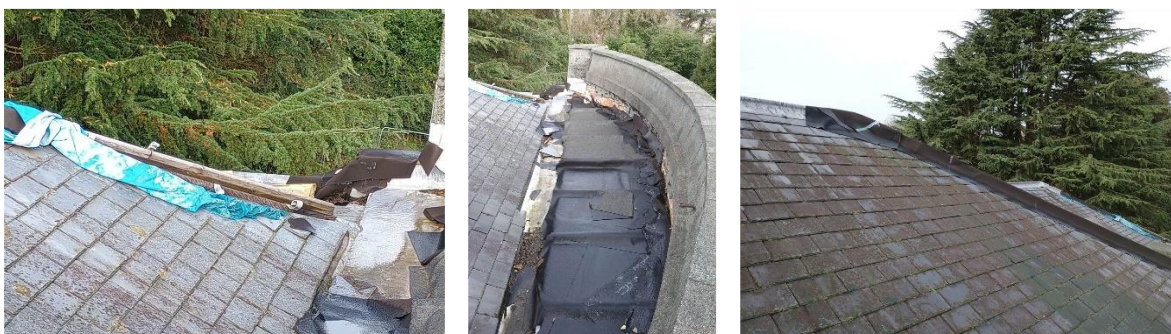
**Left:** Typical views of stolen lead and temporary repairs, which are now failing

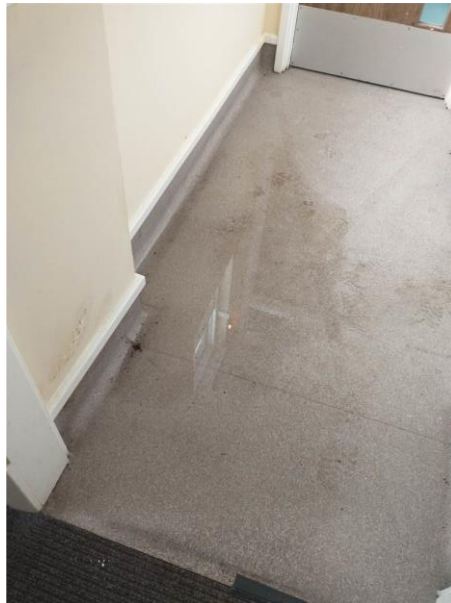
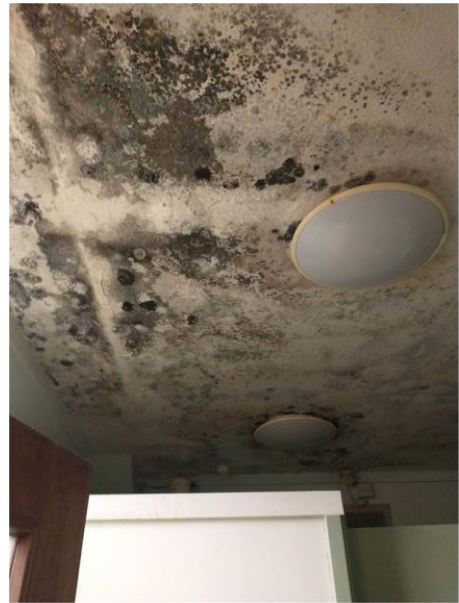
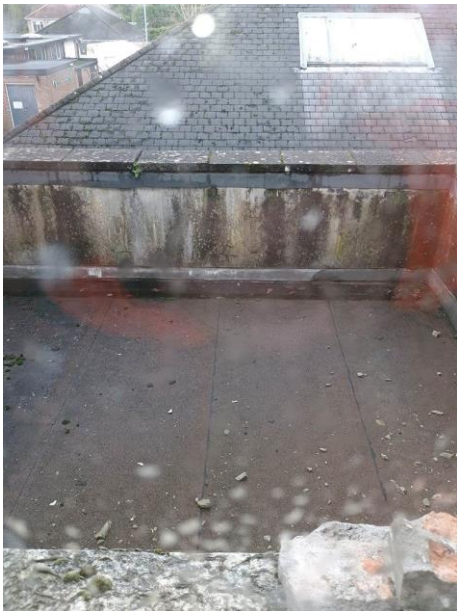
This work is necessary since these felt roof coverings are at the end of their serviceable lives. There are numerous blisters and widespread liquid repairs, indicating that there has been a longstanding issue with water-ingress in these locations. The toilet area beneath the north-west roof is frequently flooded and significant mould growth has become established on the ceilings.

**Right:** images showing water-related deterioration to the toilet area (below north-west roof)

3.1.1. The existing felt waterproofing is to be overlayed with a Derbigum Olivine cap sheet in conjunction with a Eurorroof self-adhesive underlay.

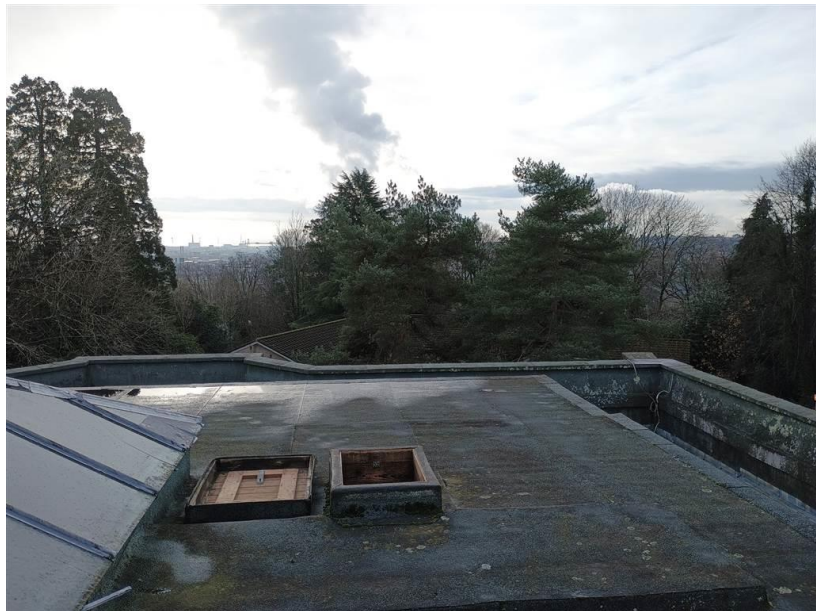
**Above:** main flat roof (felt)

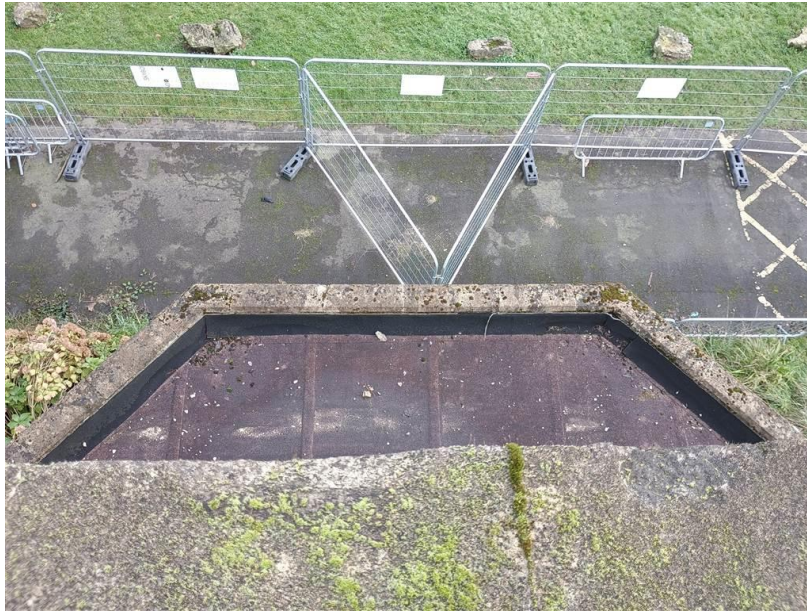
- **Previous usage** – the two middle bays on the eastern elevation are already covered in felt, although this is at the end of its serviceable lifespan.

**Left:** existing felt to one of the window bays

3.2.1. The parapet gutters and roofs above the bay windows are to be covered with the Eurorof Premium High Performance Roofing System. Remaining lead is to be stripped and the underlying timber deck will be inspected prior to application. The principal heritage officer will be informed if any further repairs are necessary first.

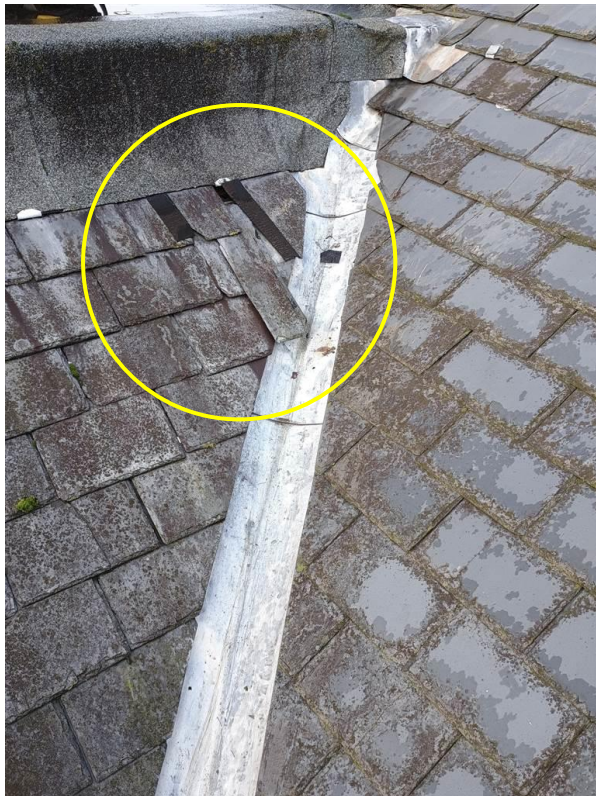
These repairs are necessary to arrest water-ingress and protect historic fabric beneath from saturation.

**Left:** typical view of slipped slates

3.3.1. Slipped slates are to be reaffixed. The condition of nails and battens/ sarking boards will be assessed prior to repairs. Rusted iron nails and fixings will be replaced with copper or stainless steel equivalents, or tingles.

3.3.2. Missing or broken slates are to be replaced with Canadian (Glendyne) natural slate.

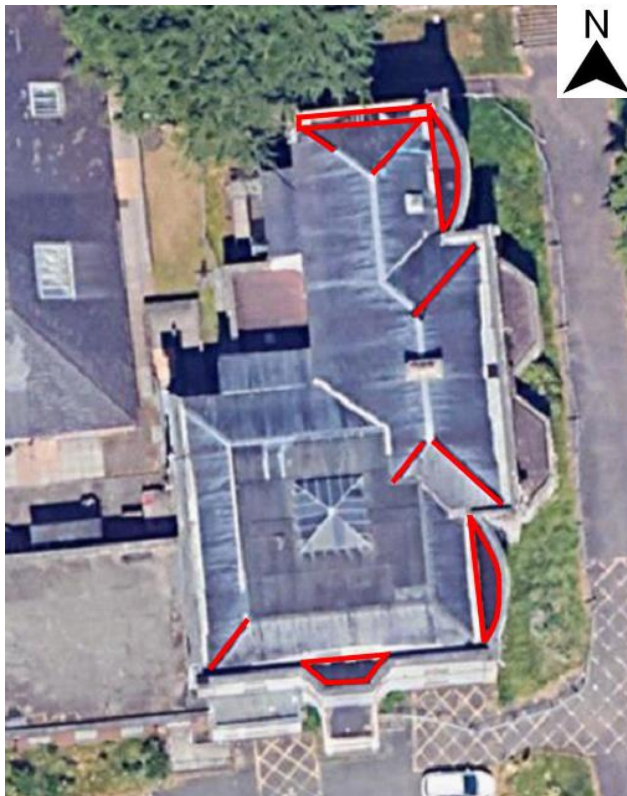
**Left:** roof plan showing extent of lead theft

Replacement of the lead rolls on the ridges and hips is necessary because, as indicated by the markup overleaf, the latter has been targeted disproportionately by thieves. Whilst only a relatively small section of lead is missing from the ridges (the closest ridge to the north face of the chimney), it is preferable to remove the remainder and replace with Klover Wakaflex lead flashing alternative for the following reasons:

- 3.4.1 Given repeated lead theft, it is proposed not to reinstate missing/stolen lead. Instead, the applicant wishes to substitute that taken for another material. The remaining lead on the ridges and hips is to be stripped and replaced with Klover Wakaflex lead flashing alternative.

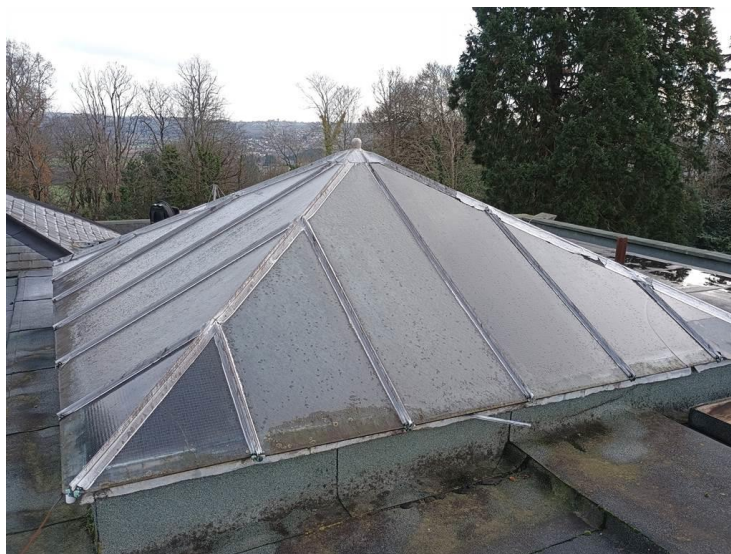
**Right:** existing poor condition of roof lantern

These repairs are necessary to address benign neglect/ lack of maintenance and to ensure that the roof lantern remains weathertight.

- 3.6.1. All cracked Georgian glass panes are to be replaced like-for-like and localised glazing bar repairs will be carried out.

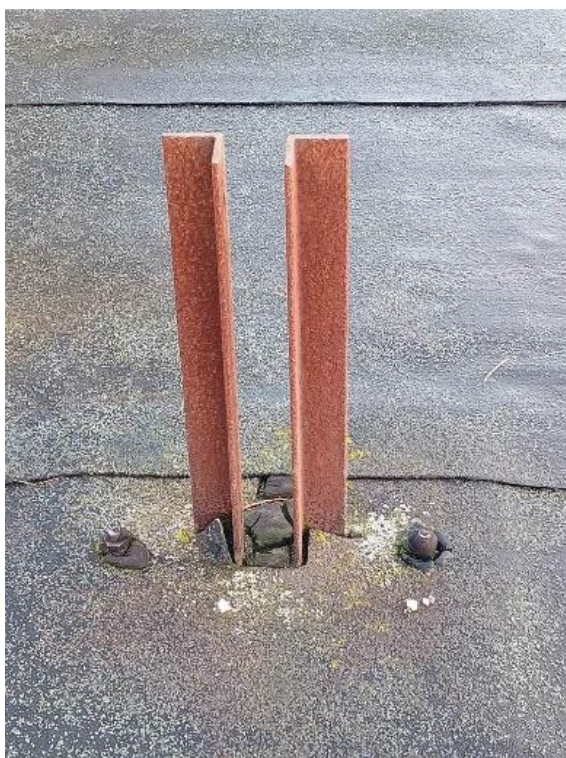
These additions are not in keeping with the building and their removal will make a positive visual contribution. The radio mast support bracket is projecting from the main flat roof area and its flashing detail is sub-standard. Its removal will design out a potentially vulnerable water-ingress point.

**Left:** redundant radio mast support bracket

- 3.7.1. All inappropriate and redundant modern fixings, including an old radio mast support bracket and cabling will be carefully removed from the roof.
