# ALUMASC ROOFING

## Roof Condition Report

Project:  
Brynglas House

Project ID: SP143935  
Date of issue: 14/01/2025

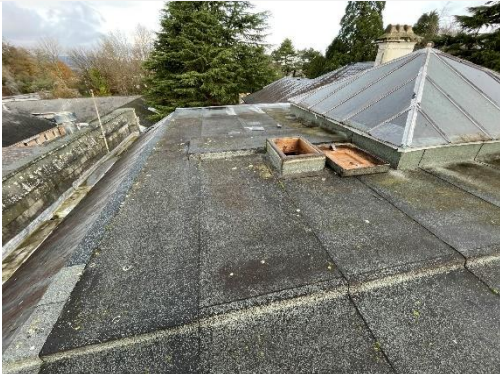
Overview of Roof A - The current system appears to be in a reasonable condition with minor repairs visible.

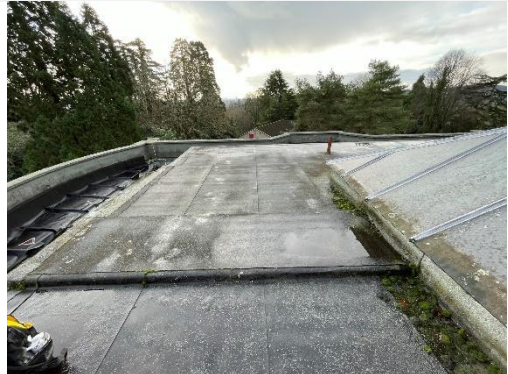
General overview of the existing roof area, opposite side.

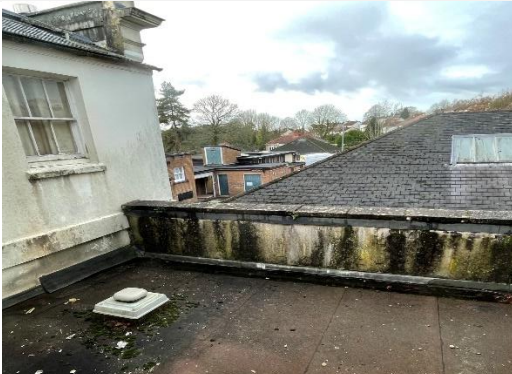
Overview of Roof B - The current system has reached the end of its serviceable life. The redundant mushroom vent should be removed from the roof prior to the commencement of works.

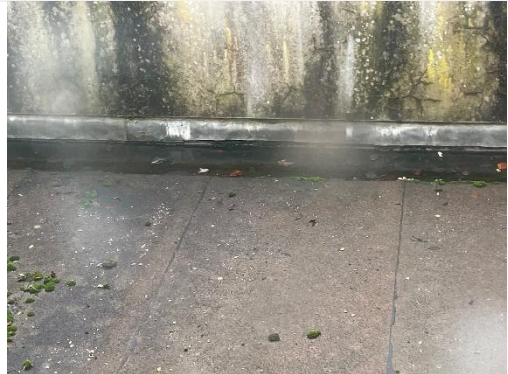
The internal gutter is holding a significant amount of ponding water. Regular maintenance should be implemented to prevent any future blockages.

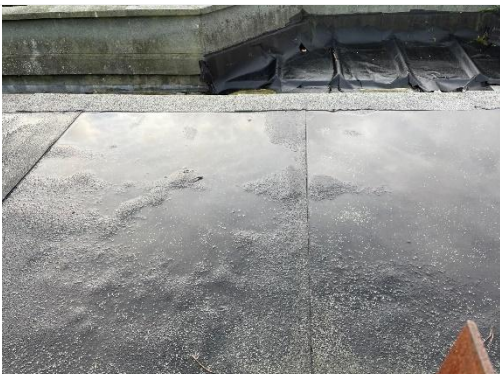
- Blisters are evident throughout which are a raised area where there is a loss of adhesion between layers caused by entrapped air and/or moisture within the existing system which expands as the temperature rises. If left undisturbed blisters do not necessarily indicate the failure of a system, however, they do present a greater risk of water ingress problems in the future and can also interfere with drainage.

Blistering is visible throughout the roof, indicating raised areas where adhesion between layers has been lost due to trapped air and/or moisture. These pockets expand as the temperature increases. Before refurbishment, all blisters will need to be cut out.

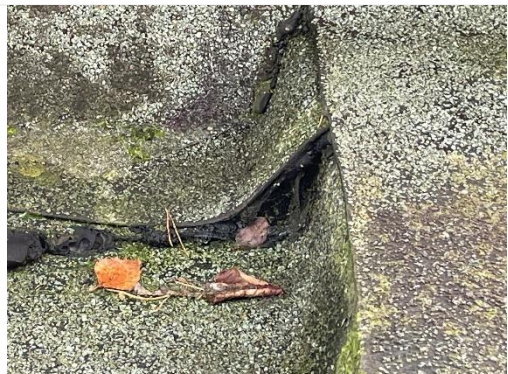
Certain sections of the detailing have started to debond. If not addressed, they will inevitably lead to water ingress.

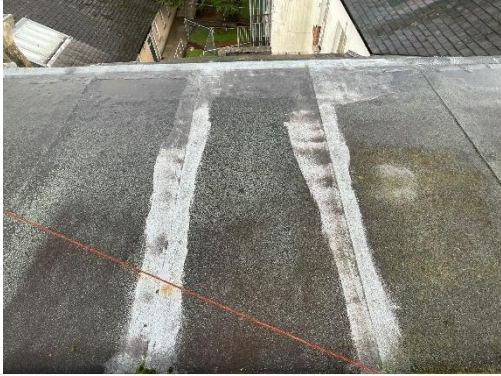
- Defects have been repaired using a liquid coating. In our experience, this type of remedial can only be considered a short-term solution.

Liquid repairs are evident across the roof area, these should only be considered as short-term solution.

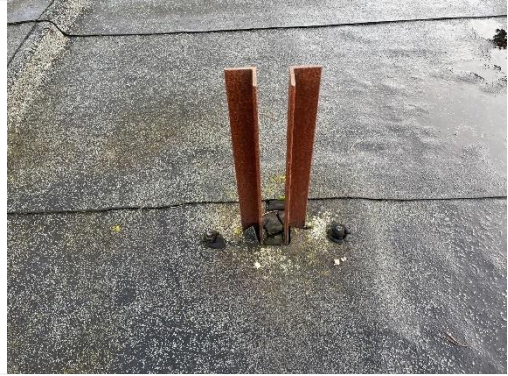
Redundant supports are being removed during the refurbishment works.

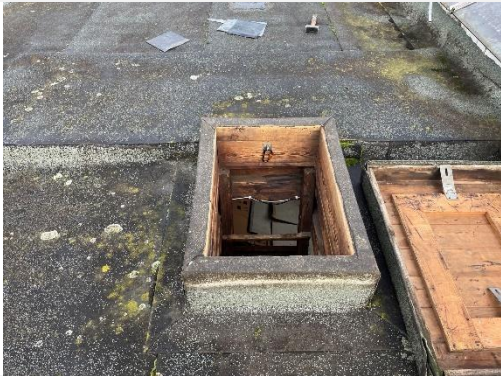
The access hatch will need to be re-detailed and cover reinstated, as part of the scope of works.

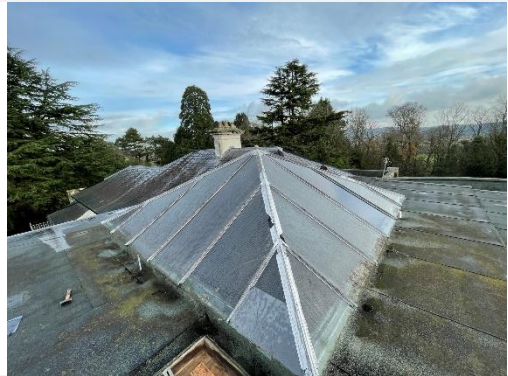
The rooflight is still in use and shall remain in situ. The client has stated that they will carry out the restoration work and bring it back to a suitable condition

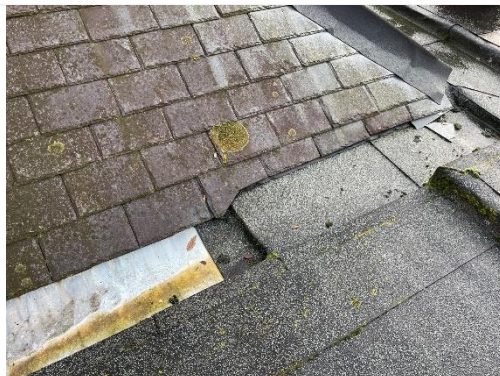
At the pitched roof abutment, the bottom two or three courses of tiles will need to be removed and safely set aside, to allow for the new system to be installed.

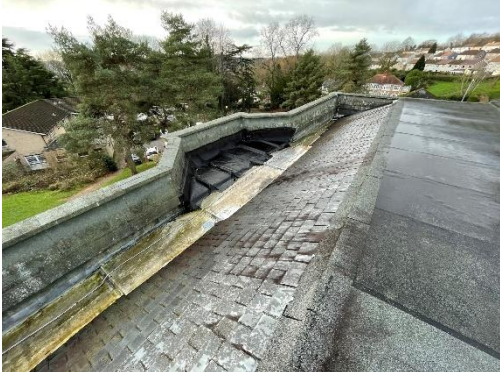
Overview of the existing roof area.

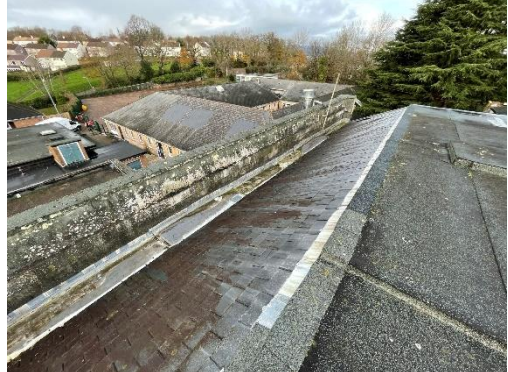
General overview of existing roof area, opposite side.

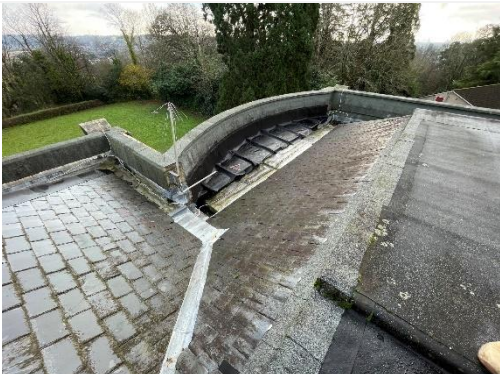
Further overview of the existing roof area.

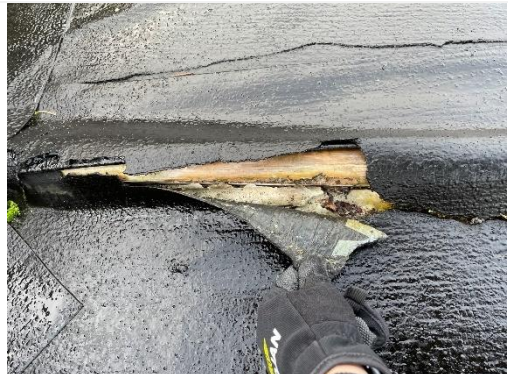
Large scale temporary repairs were installed, but these have now started to fail re-exposing the issue.

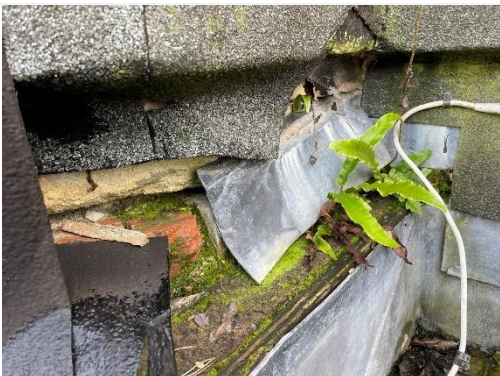
The existing detailing is poor.

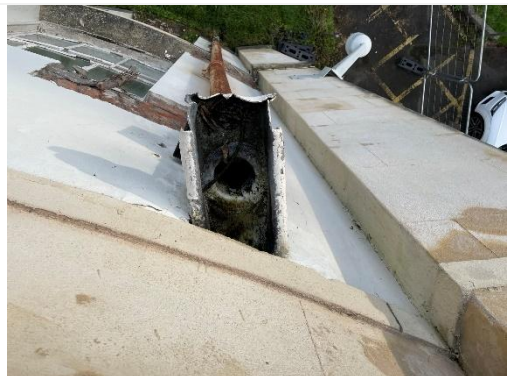
The existing rainwater goods are in poor condition and should be renewed during the refurbishment.

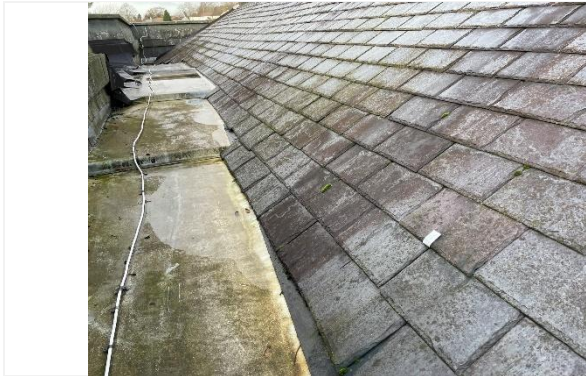
At the pitched roof abutment, the bottom two or three courses of tiles will need to be removed and safely set aside. This is to allow for the new system to be installed correctly.

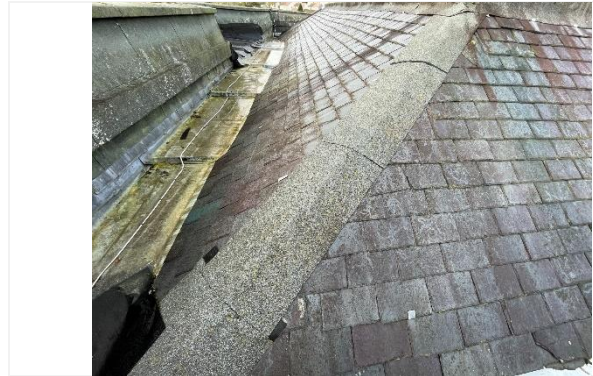
Damaged sections of the pitched roof area are to be included within the scope of works. Lead or appropriate replacement tiles is to be used.

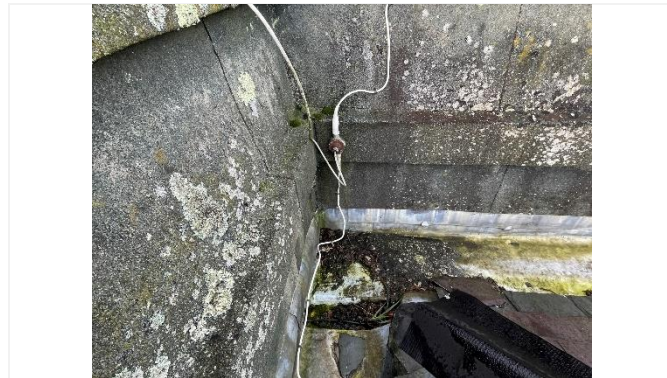
Redundant cables should be permanently removed from the roof area.

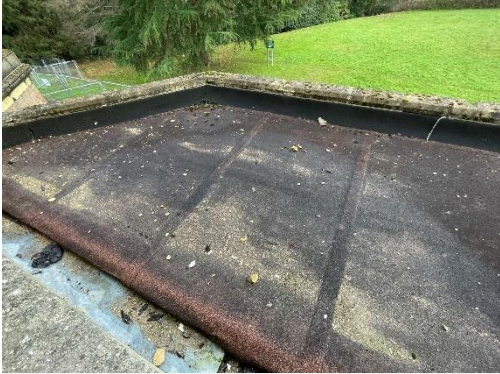
Overview of the existing roof area. The current system has reached the end of its serviceable life.

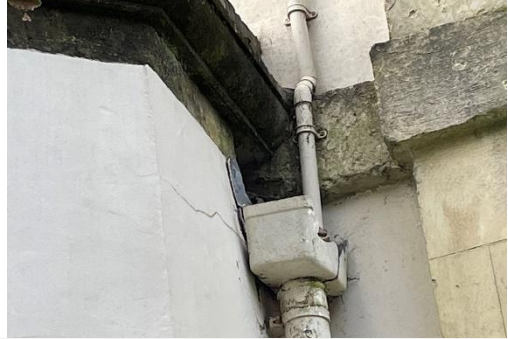
The existing rainwater goods are in poor condition and should be replaced during the refurbishment.

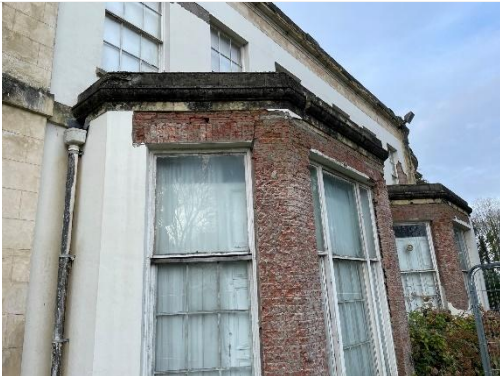
The existing brickwork is inadequate and should be repaired/repointed.

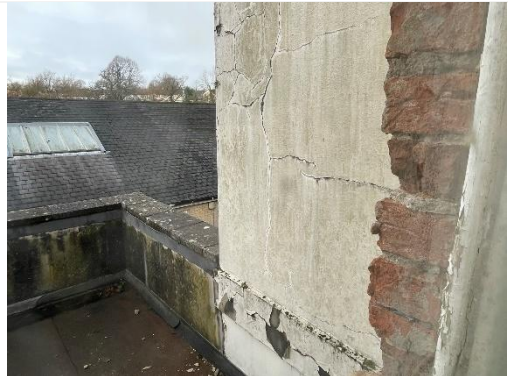
The damaged render is likely contributing to water ingress and should be replaced as part of the re-roofing works to ensure a watertight and durable finish.

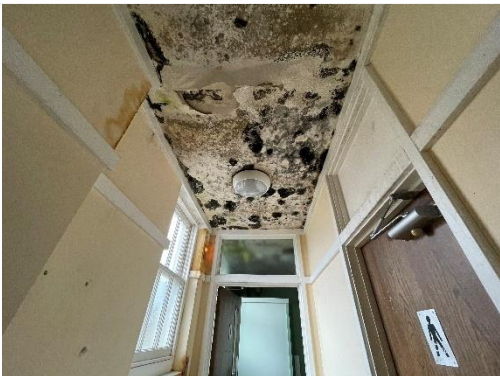
Significant water ingress has caused mould to occur. This indicates that water is penetrating the current waterproofing.

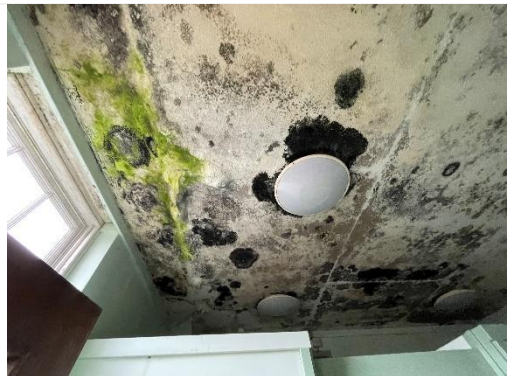
Further evidence of water ingress.

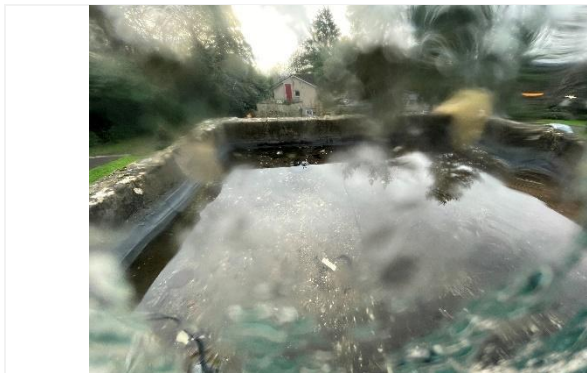
Overview of the existing roof area.

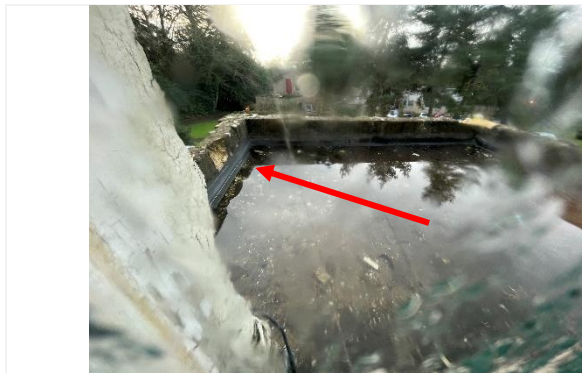
The existing parapet wall is significantly damaged. This should be encapsulated by the new waterproofing.

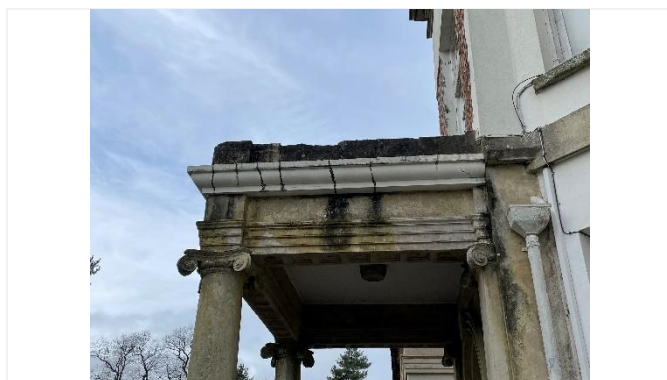
The external gutters are in poor condition and should be removed and replaced during the refurbishment works.
