# Management Survey Report Assessment and Register of Asbestos Containing Materials

9 Clyffard Crescent, Newport,  
Gwent, NP20 4GE

Centre Peace Homes

Job No J050628

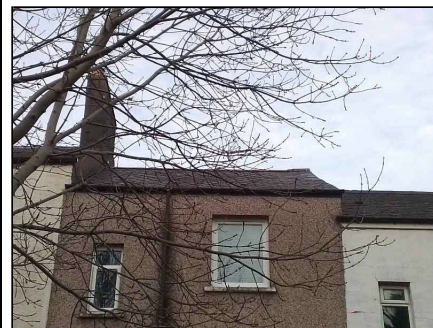
| Inspection Number | Location, position and description | Product | Extent, condition, surface treatment and other comments | Material Risk Rating | | Priority Risk Rating | | Advised Action | Photograph |
|---|---|---|---|---|---|---|---|---|---|
| Inspection 16<br>Presumed | 1st Floor, External, Cement tiles to roof | Cement | Approximately 45m²<br>Good Condition<br>Unsealed. Unable to sample due to height restrictions | 1 | 5<br>Low | 0 | 2<br>Very Low | Manage ACM in place | |
| | | | | Total Risk = 7 Low | | | | | |

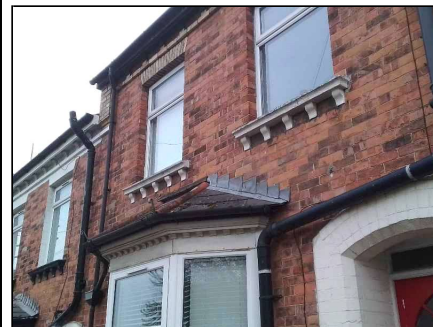
| Inspection Number | Location, position and description | Product | Extent, condition, surface treatment and other comments | Material Risk Rating | | Priority Risk Rating | | Advised Action | Photograph |
|---|---|---|---|---|---|---|---|---|---|
| Inspection 19<br>Presumed | Ground Floor, External, Cement tiles to bay window roof | Cement | Approximately 3m²<br>Good Condition<br>Unsealed. Unable to sample as no safe location to erect ladder | 1 | 5<br>Low | 0 | 2<br>Very Low | Manage ACM in place | |
| | | | | Total Risk = 7 Low | | | | | |

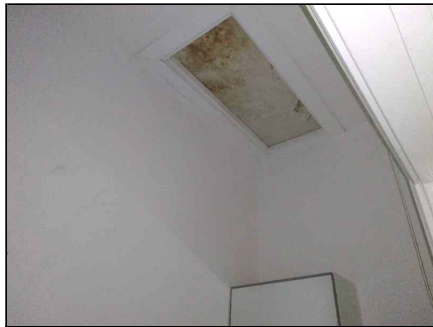
| Inspection Number | Location/Description | Comments | Advised Action | Photograph |
|---|---|---|---|---|
| Inspection 1<br>Presumed | 1st Floor,<br>Loft,<br>No access | Due to restricted space within room, unable to erect ladder safely | Survey prior to works | |

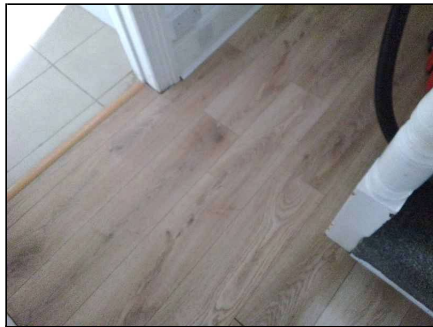
| Inspection Number | Location/Description | Comments | Advised Action | Photograph |
|---|---|---|---|---|
| Inspection 7<br>Presumed | Ground Floor,<br>Hall,<br>No access beneath laminate | Would cause excessive damage | Survey prior to works | |

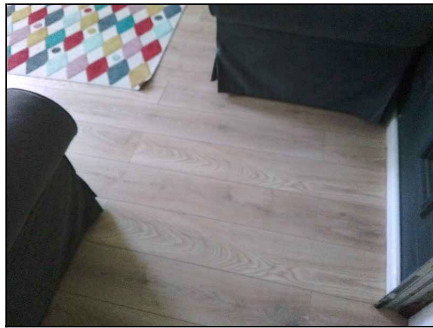
| Inspection Number | Location/Description | Comments | Advised Action | Photograph |
|---|---|---|---|---|
| Inspection 8<br>Presumed | Ground Floor,<br>Lounge,<br>No access beneath laminate | Would cause excessive damage | Survey prior to works | |

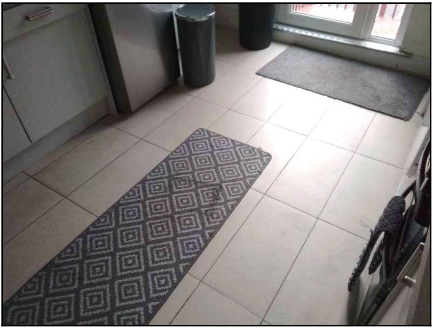
| Inspection Number | Location/Description | Comments | Advised Action | Photograph |
|---|---|---|---|---|
| Inspection 9 Presumed | Ground Floor,<br>Kitchen,<br>No access beneath ceramic tiled floor | Would cause excessive damage | Survey prior to works | |

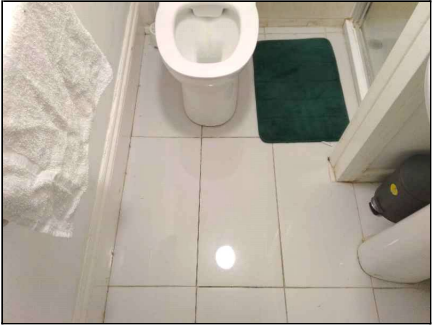
| Inspection Number | Location/Description | Comments | Advised Action | Photograph |
|---|---|---|---|---|
| Inspection 11 Presumed | Ground Floor,<br>Shower Room,<br>No access beneath ceramic tiled floor | Would cause excessive damage | Survey prior to works | |

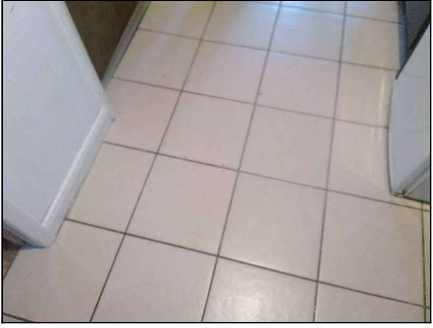
| Inspection Number | Location/Description | Comments | Advised Action | Photograph |
|---|---|---|---|---|
| Inspection 12 Presumed | Lower Ground Floor,<br>Kitchen,<br>No access beneath laminate | Would cause excessive damage | Survey prior to works | |

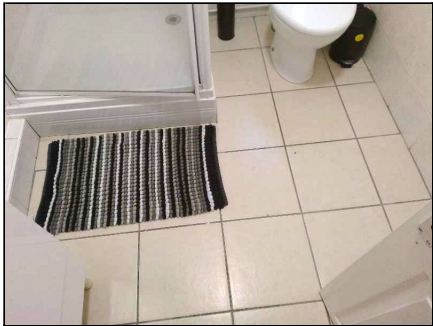
| Inspection Number | Location/Description | Comments | Advised Action | Photograph |
|---|---|---|---|---|
| Inspection 13 Presumed | Lower Ground Floor,<br>Shower Room,<br>No access beneath laminate | Would cause excessive damage | Survey prior to works | |

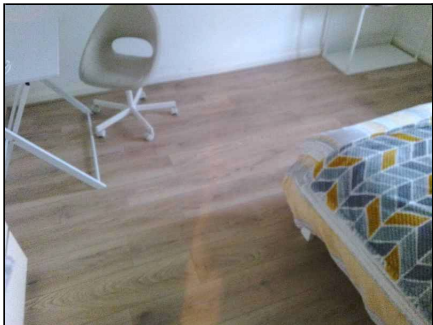
| Inspection Number | Location/Description | Comments | Advised Action | Photograph |
|---|---|---|---|---|
| Inspection 14 Presumed | Lower Ground Floor,<br>Bedroom 4,<br>No access beneath laminate | Would cause excessive damage | Survey prior to works | |

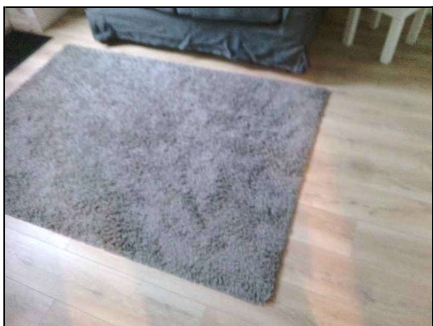
| Inspection Number | Location/Description | Comments | Advised Action | Photograph |
|---|---|---|---|---|
| Inspection 15 Presumed | Lower Ground Floor,<br>Lounge,<br>No access beneath laminate | Would cause excessive damage | Survey prior to works | |

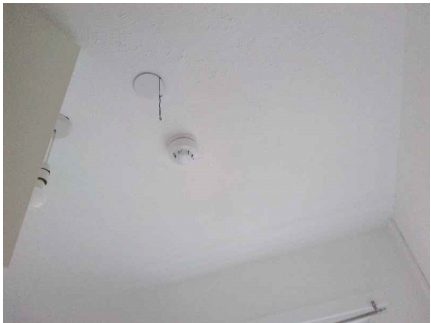
| Inspection Number | Location/Position/Description | Product | Comments | Photograph |
|---|---|---|---|---|
| Inspection 2<br>HP006024 | 1st Floor,<br>Bedroom 3,<br>Textured coating to lath and plaster<br>ceiling, stipple | Textured<br>Coating | Approximately 5m <sup>2</sup><br>Good Condition<br>Reinforced composite<br>material | |

| Laboratory or Site<br>Sample number | Origin of sample/<br>Location/Client reference/Description | *Type of product | Content |
|---|---|---|---|
| Inspection 2 HP006024 | 1st Floor, Bedroom 3, Textured coating to lath and plaster ceiling, stipple | Textured Coating | No Asbestos Detected |

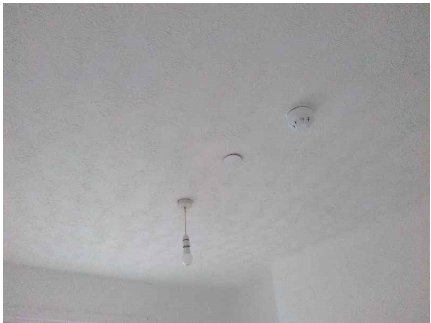
| Inspection Number | Location/Position/Description | Product | Comments | Photograph |
|---|---|---|---|---|
| Inspection 3<br>Strongly Presumed<br>Same As HP006024 | 1st Floor,<br>Bedroom 2,<br>Textured coating to lath and plaster<br>ceiling, stipple | Textured<br>Coating | Approximately 12m <sup>2</sup><br>Good Condition<br>Reinforced composite<br>material | |
