## Archaeological Watching Brief Report

Old St Peter's Church, Peterstone, Wentlooge, Cardiff, CF3 2TR

Prepared for  
Newport City Council

October 2024

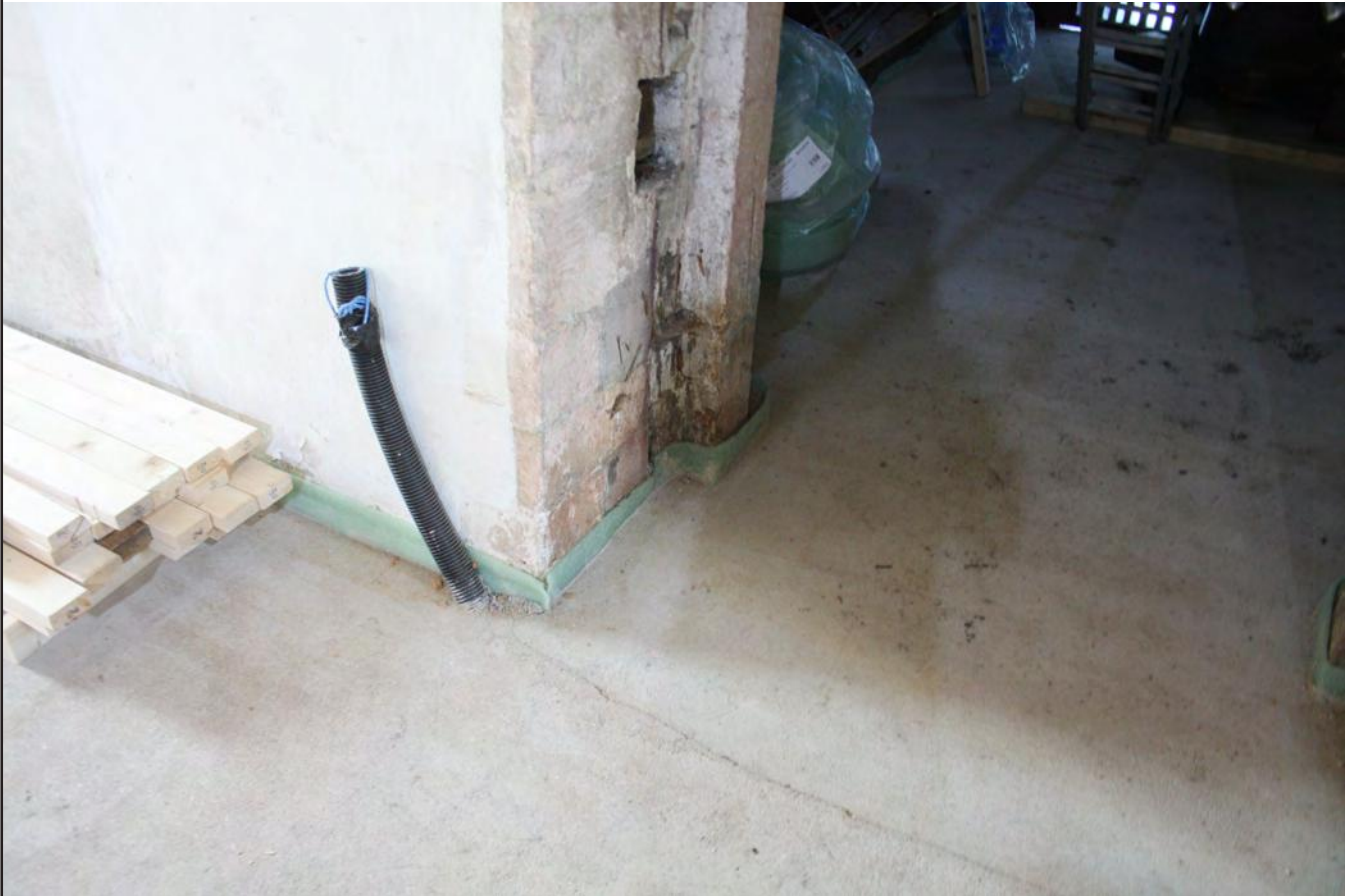
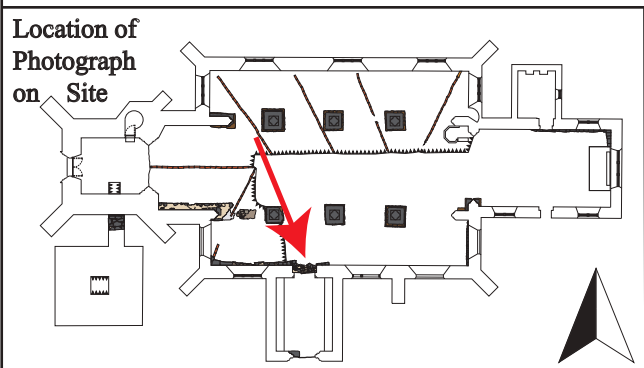
Plate 1

- 3.2.7. Where archaeological remains were encountered, such as the foundations and pillar bases, a recommended barrier layer was installed to separate the modern concrete from the historical fabric of the structure (**Plate 1**).

Internal Shot of Barrier Layer Between the Modern Concrete and Original Building Fabric

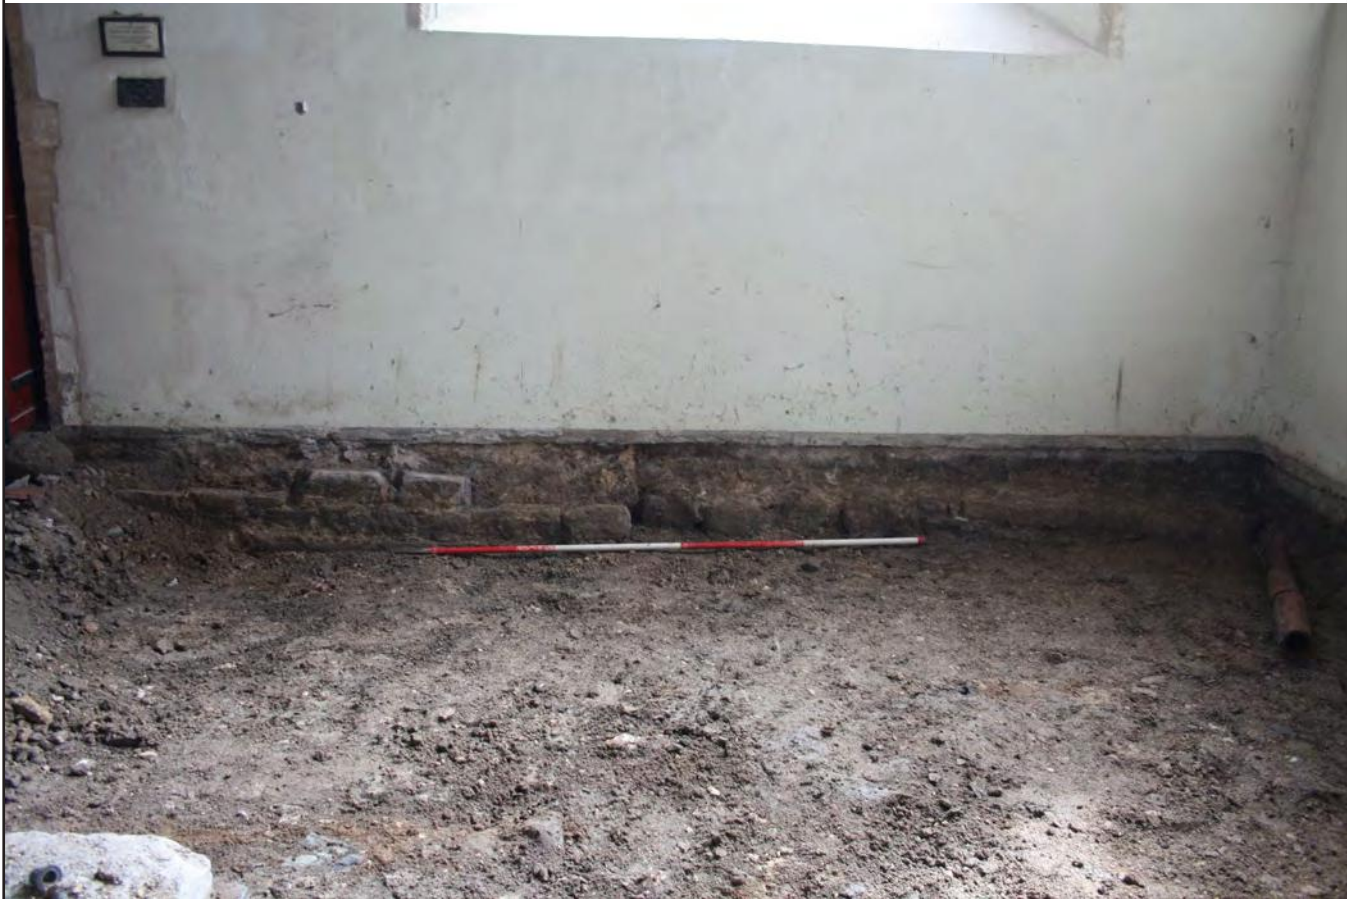
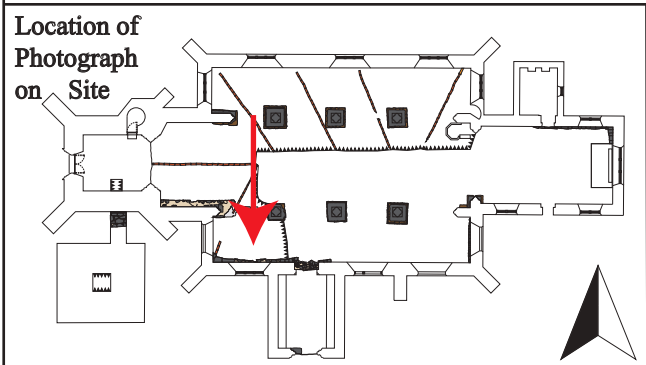
Plate 2

Internal Shot of Structure {122} below Structure {123}

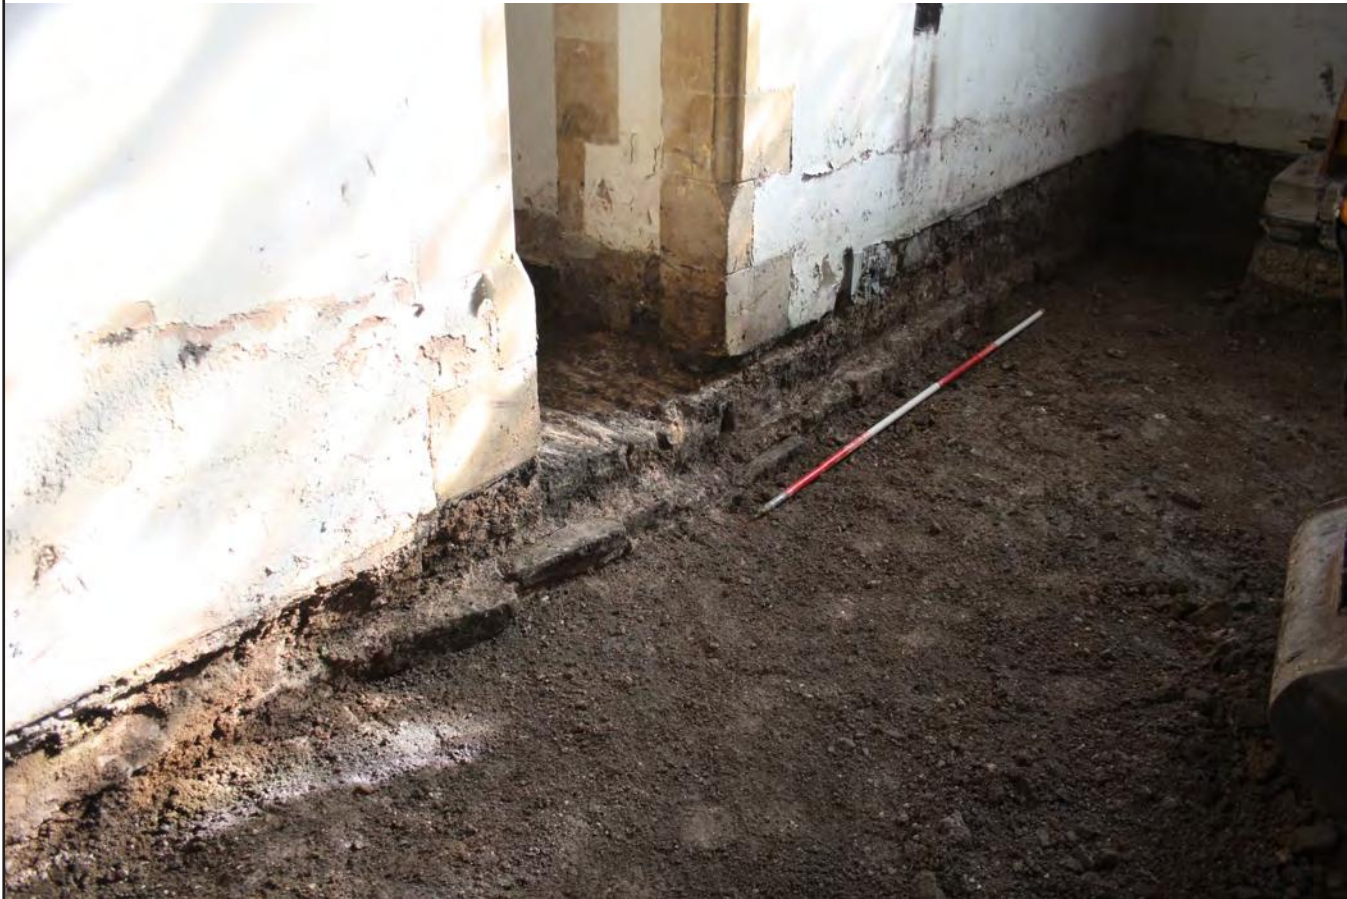
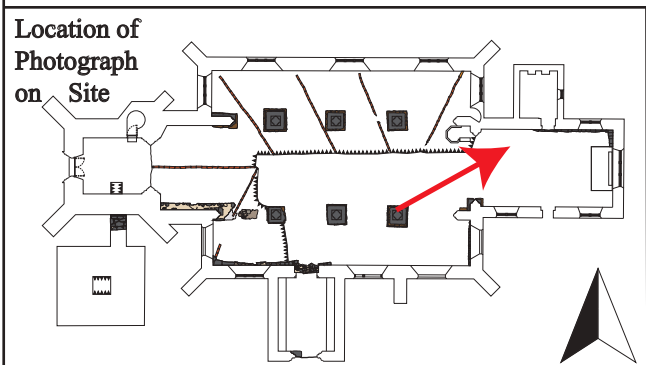
Plate 3

Internal Shot of Structure {122} below Structure {123}

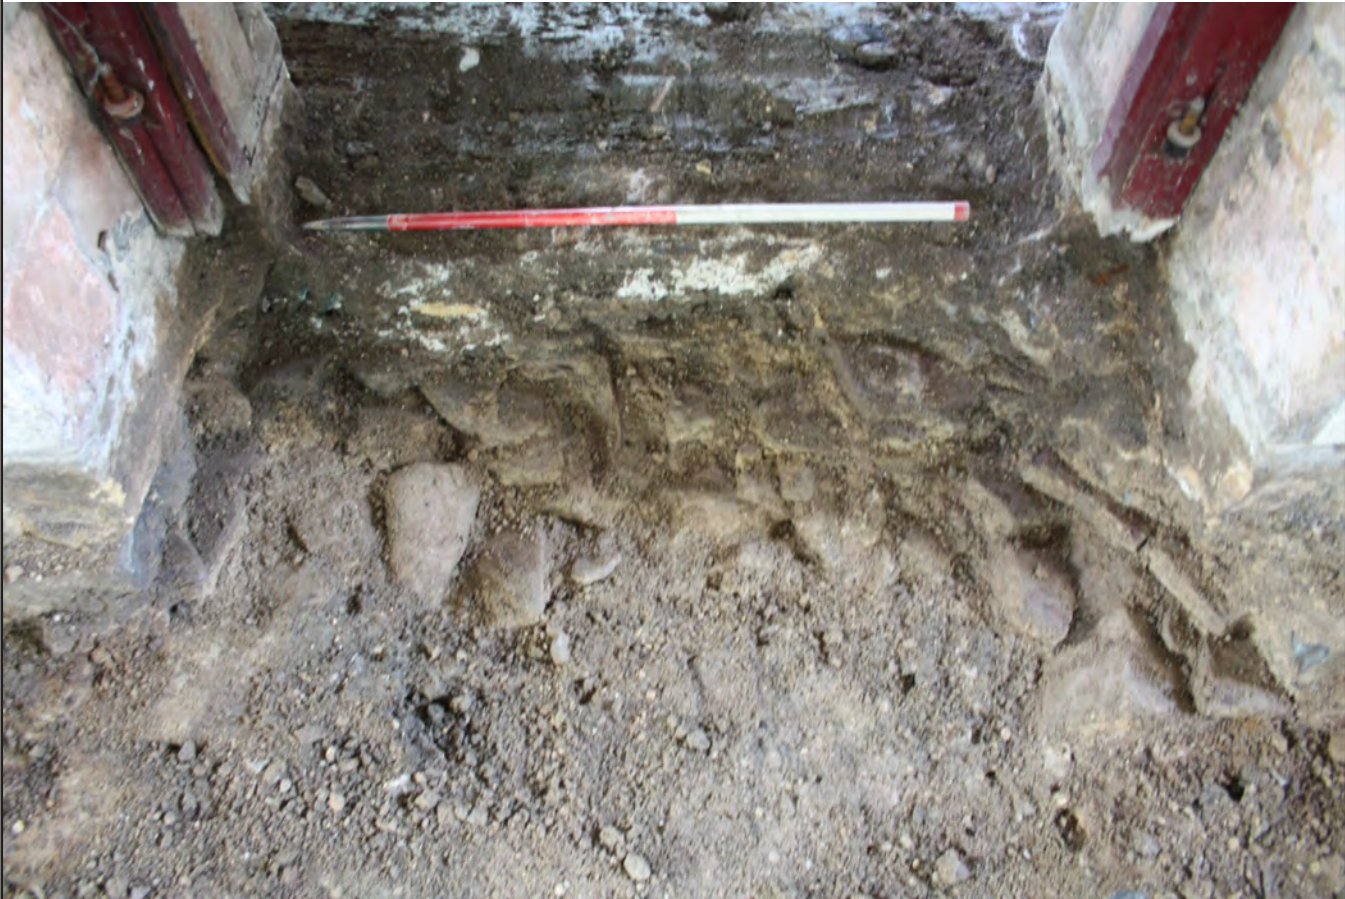
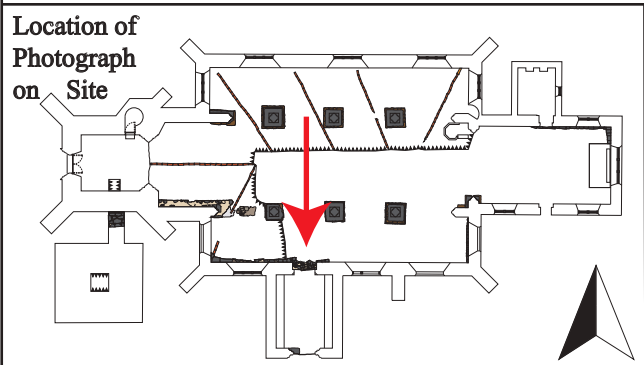
Plate 4

Internal Shot of Structure {122} below Structure {123} at the South Porch Threshold

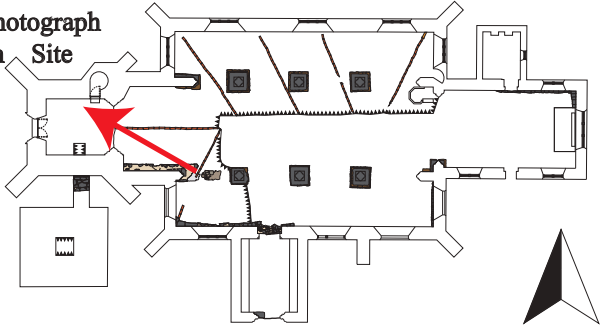
Plate 5

Internal Shot of the First Floor of the Tower Showing Modern  
Brick Repairs

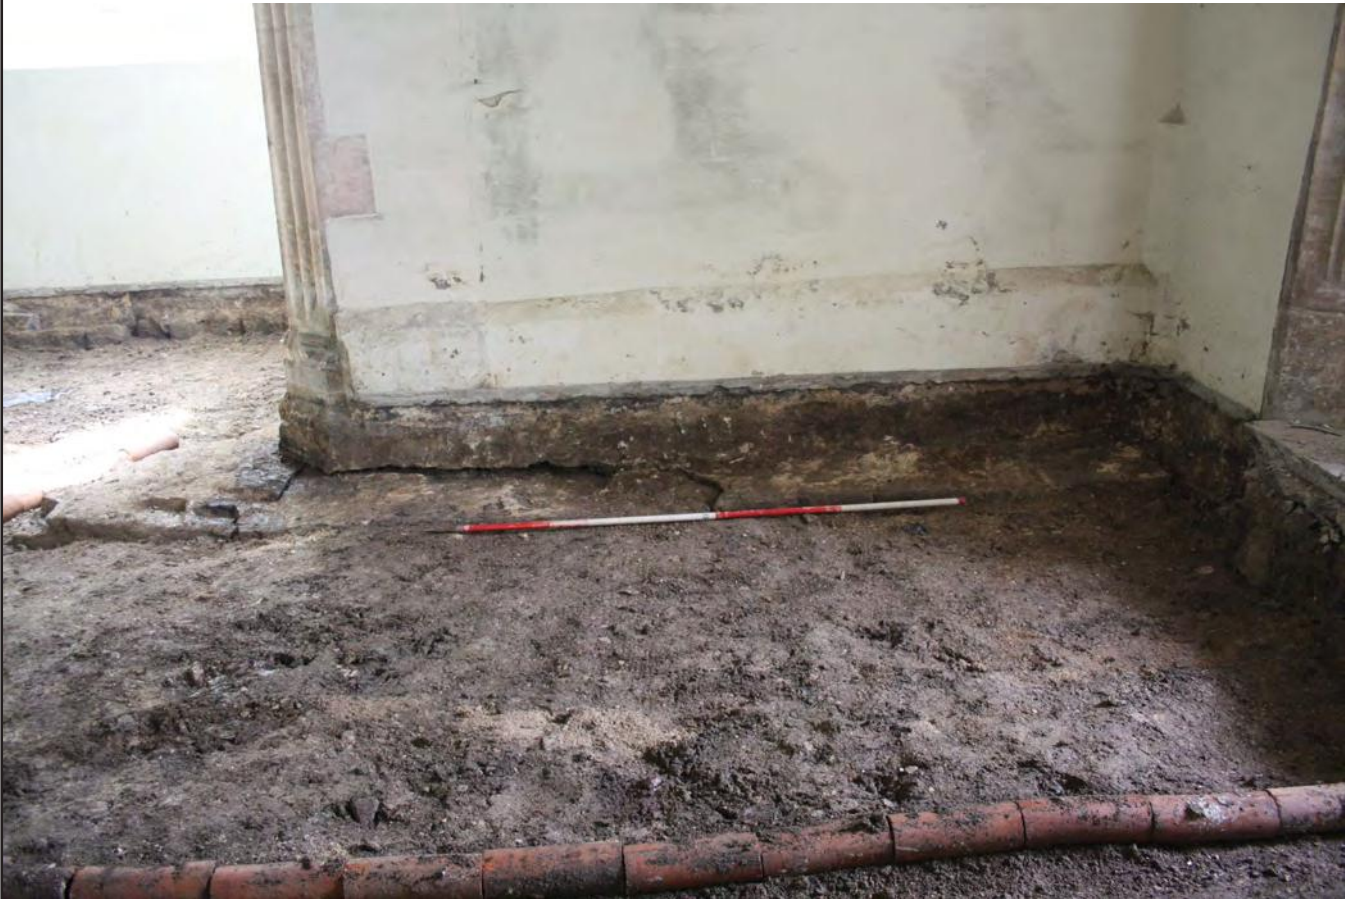
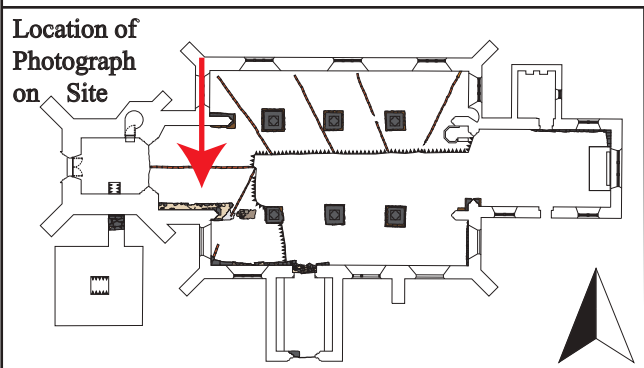
Plate 6

Internal Shot of Broken Southwestern Foundation

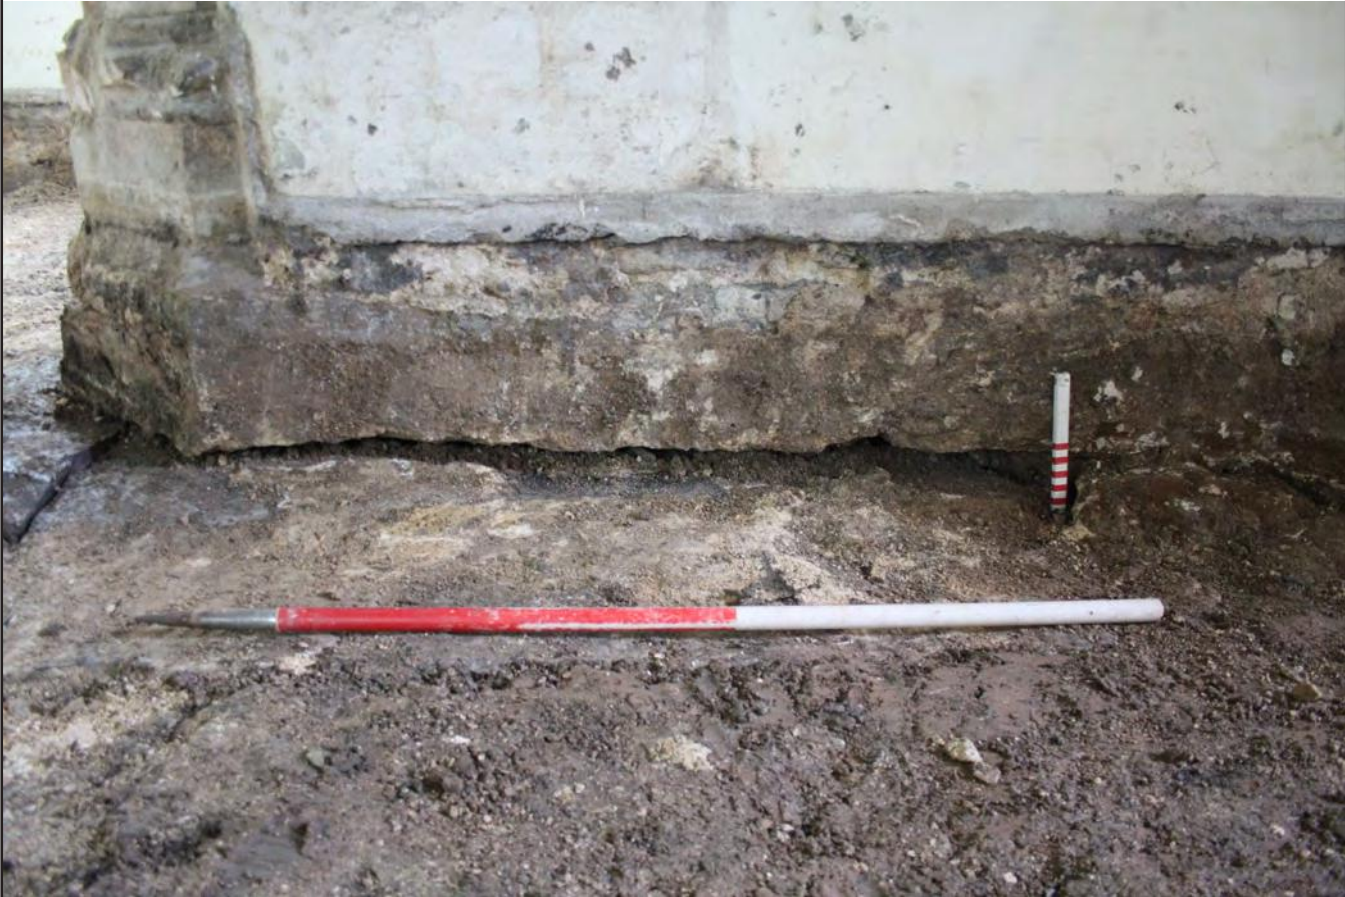
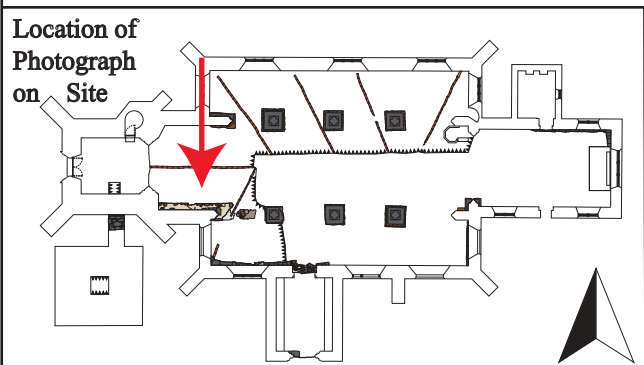
Plate 7

Internal Shot of Broken Southwestern Foundation - Close Up

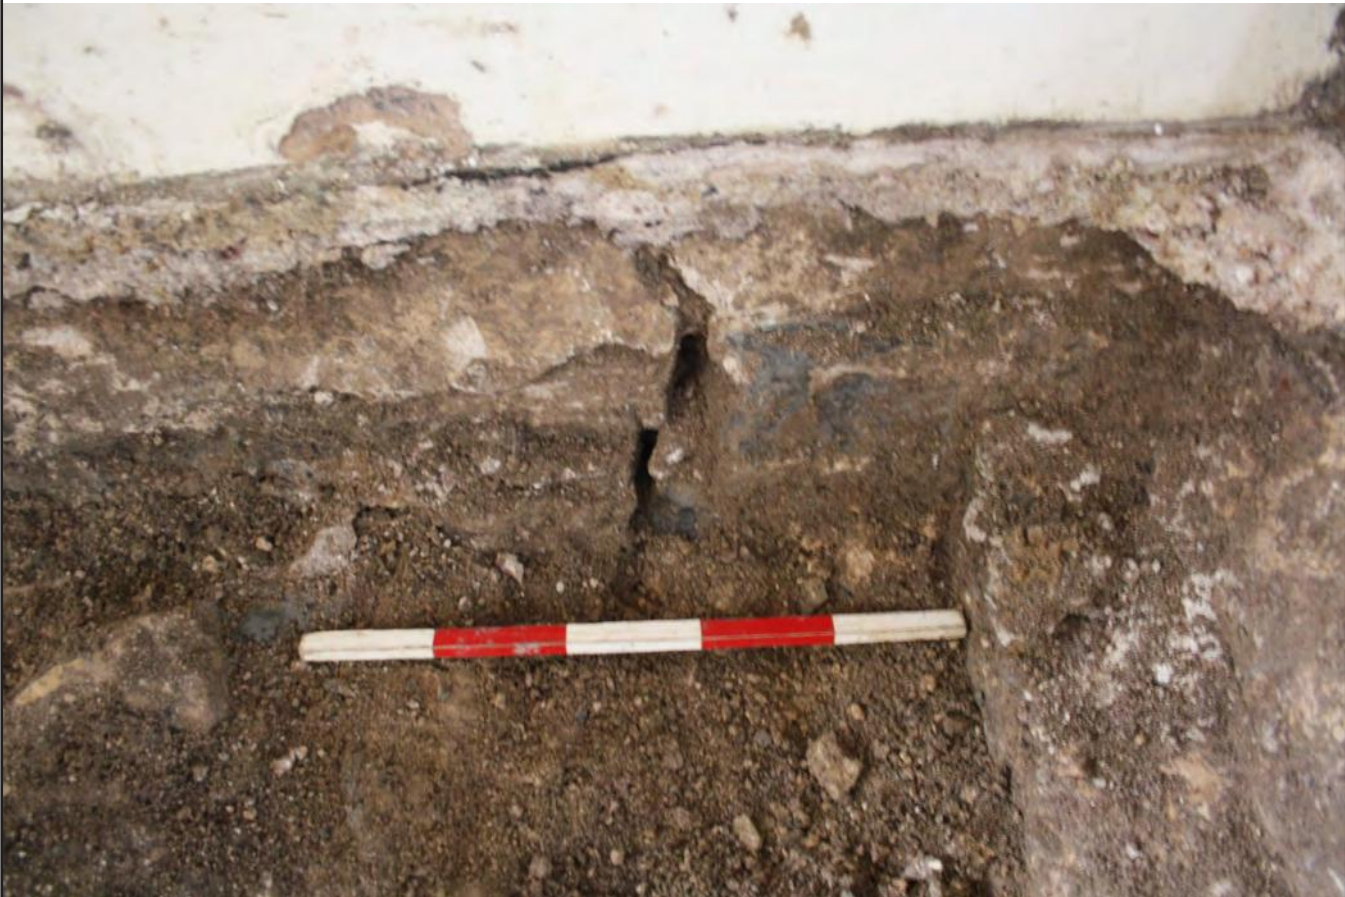
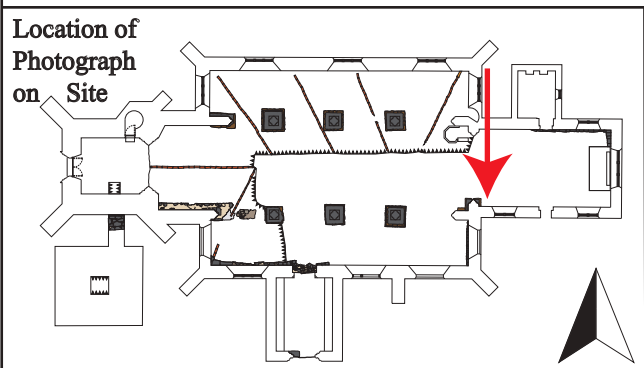
Plate 8

foundation layers on the southern wall of the chancel (**Plate 8**) and south-easternmost column (**Plate 9**).

Internal Shot of Broken South Chancel Foundation

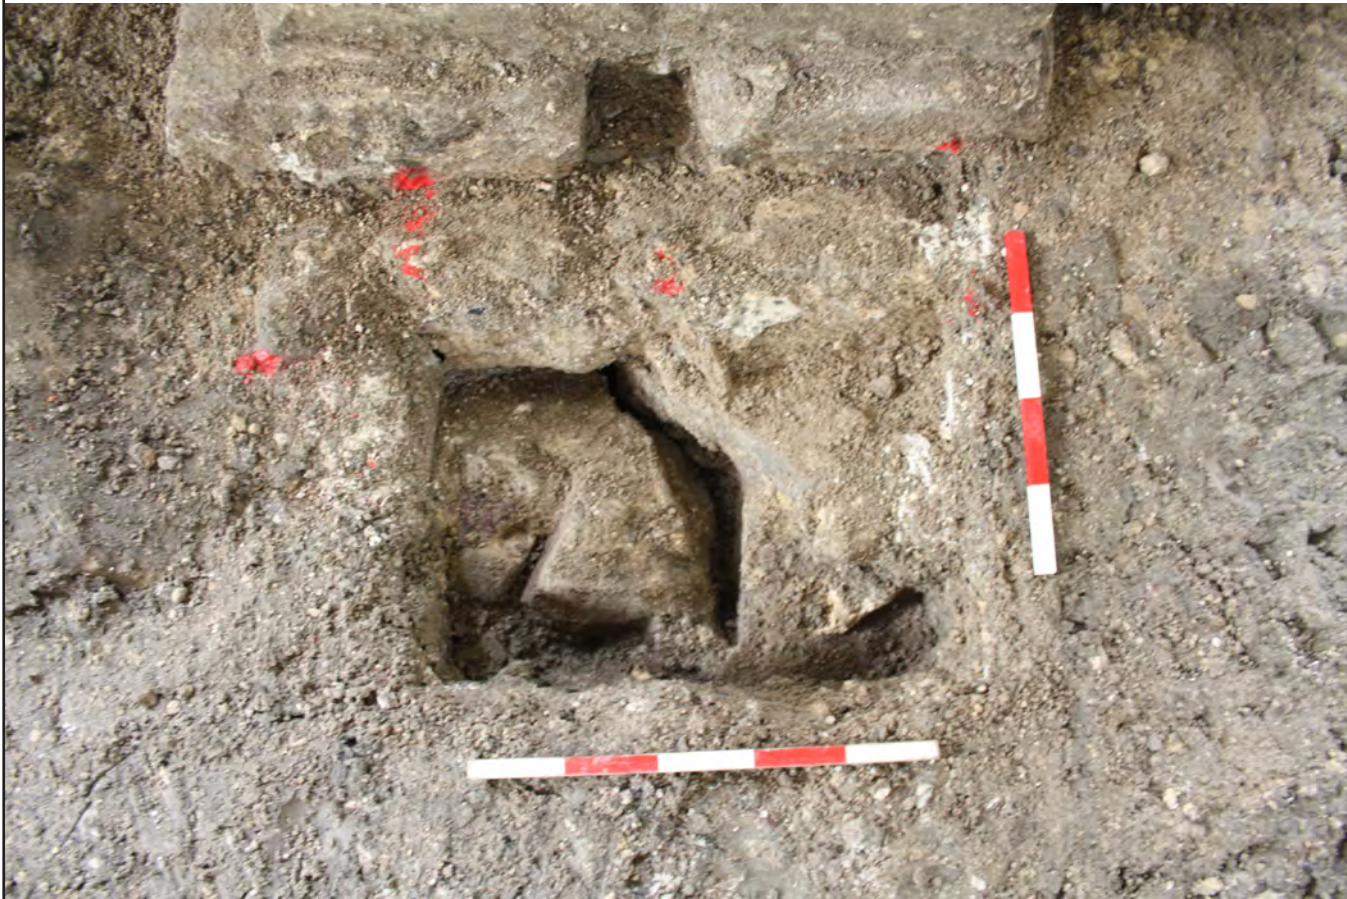
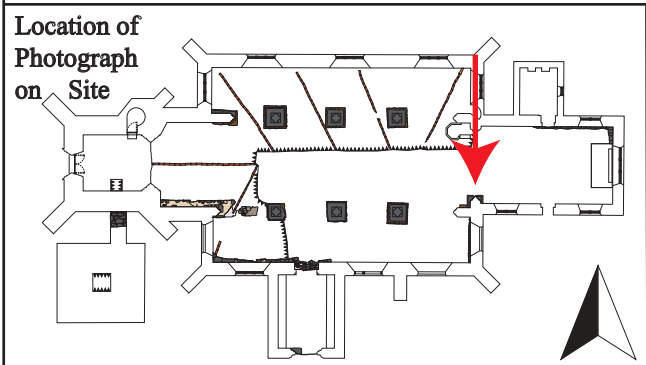
Plate 9

Internal Shot of Broken South Chancel Column Foundation

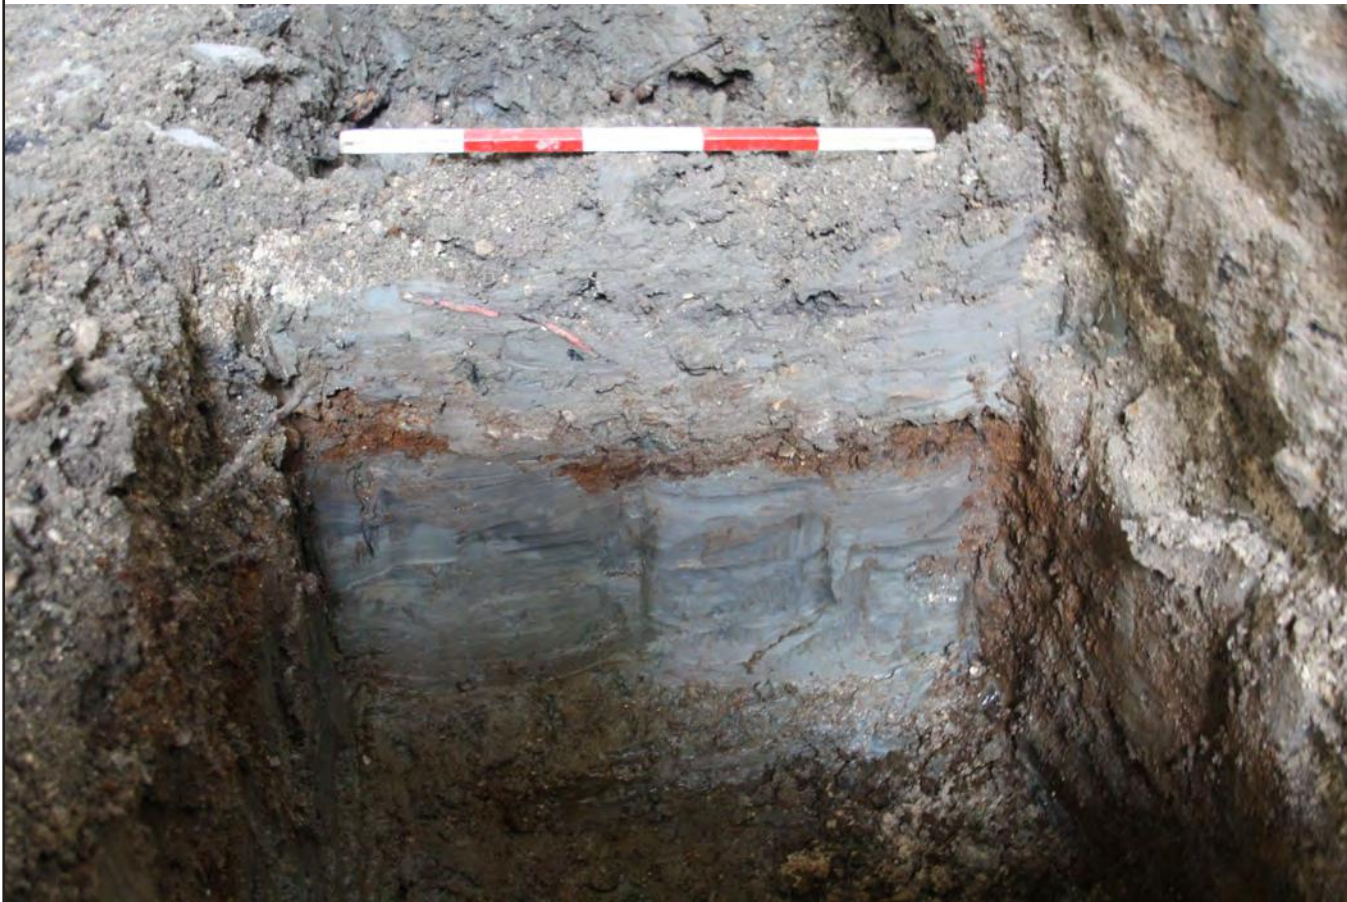
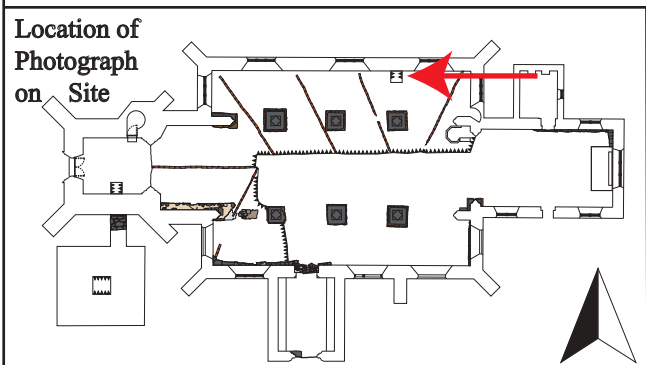
Plate 10

- 4.3.3. Physically overlying deposit (105), deposit (120) was a 0.05m thick, firm to compact reddish-brown clayey-silt gravel with sharp edges which was observed at a depth of 0.53m below the present-day ground level (4.8m aOD) (**Figure 4**). Deposit (120) is a deliberate backfill of unknown origin with well sorted gravels and pieces of lime mortar throughout and was observed sporadically throughout the chancel and nave of the church. The deposit was also observed extending approximately 0.5m around the base of the church columns and extending up 0.14m (4.94m aOD) up from the surrounding layer. Deposit (120) appears to be a foundational layer for the present-day church possibly incorporating a proto floor/binding/levelling layer and lime mortar foundational base for the columns (**Plate 10**).

Internal Shot of Waster Water Service Trench

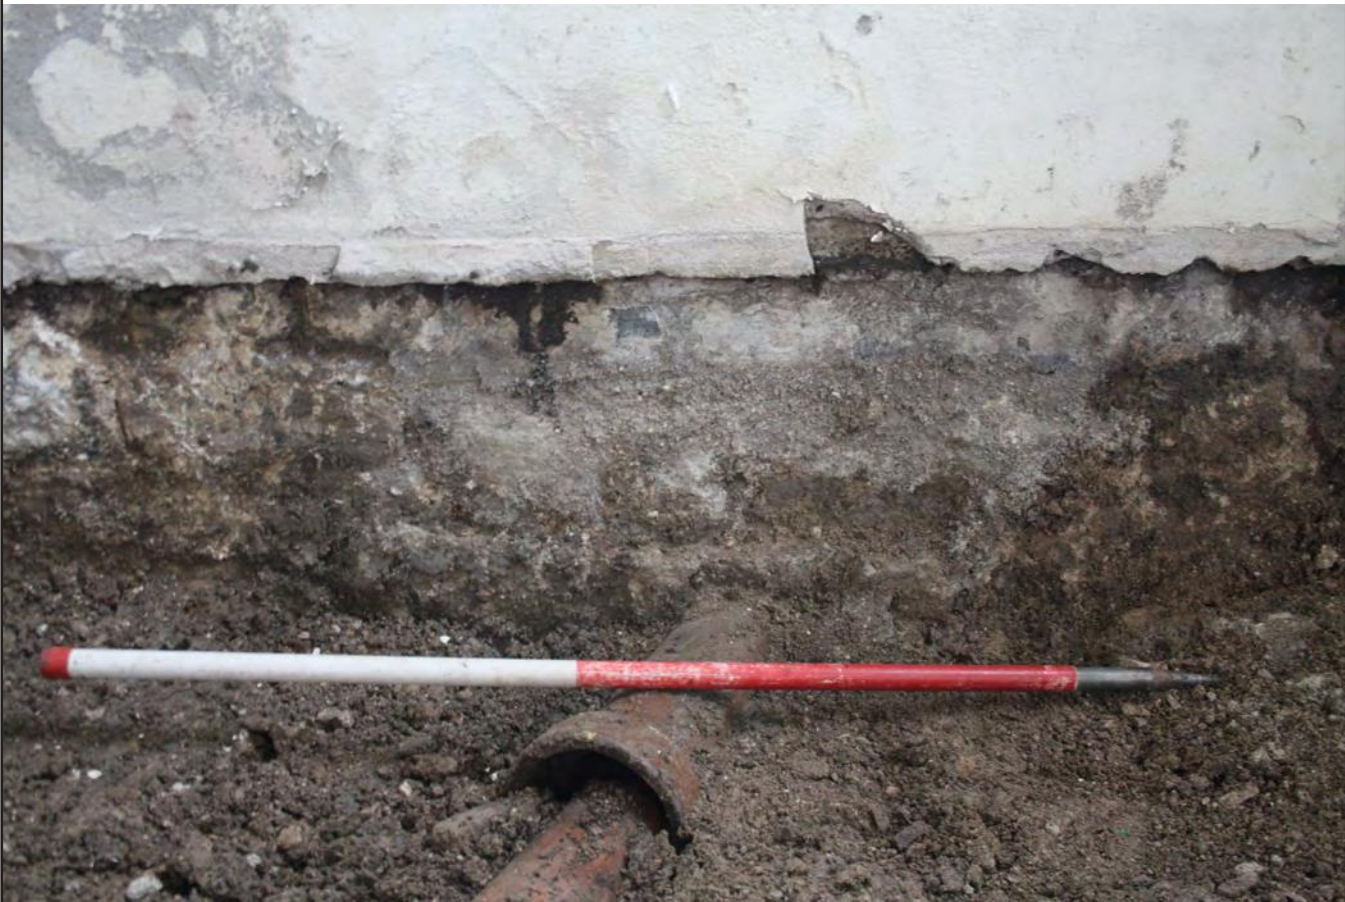
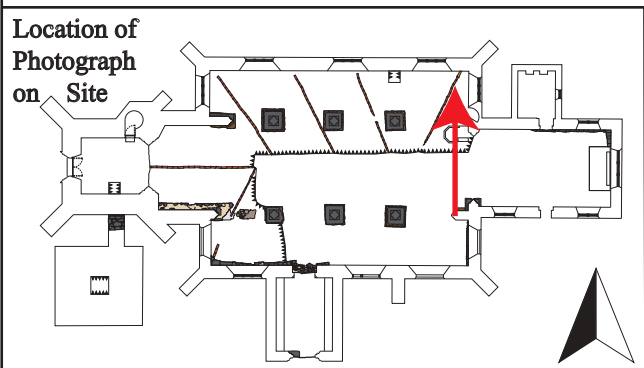
Plate 11

Internal Shot of Clay Pipe and Salt Glaze Drainage
