## Re survey date: 2029

Treecare Consulting  
james@treecareconsulting.co.uk  
07939 150 457  
01633 882 890

## **Document summary**

## **Sonic tomography result and drill test T1**

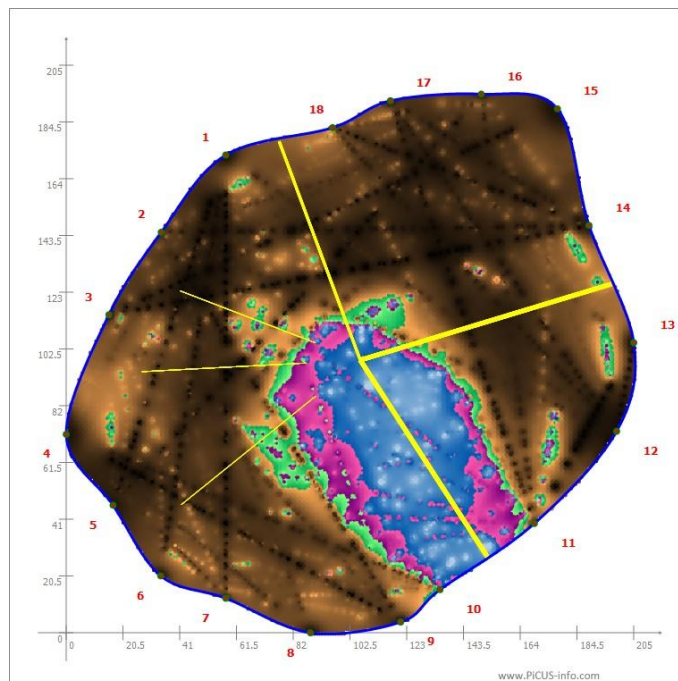
T1 Copper beech has been recorded previously as having decay in the low stem. During the 2026 tree survey, T1 was also scanned using Picus 3 Sonic Tomography to understand internal decay levels.

- Blue and white is poor sound transmission = advanced decay/cavity.
- Black/brown normal sound transmission = wood.
- Green/pink is wood being degraded/alterd.
- Yellow lines are radial barriers to sound (cracks or separated section due to tight buttressing where sound can't pass freely between two surfaces).

- Large open crown copper beech in a high target area.
- Previous assessment and recommendations carried out.
- Normal physiology.
- No significant increase in fruiting bodies.
- Normal resonance testing.
- Ivy cleared from basal region during assessment.
- Lower-level basal fluting rules out sonic tomography at ground level.
- Scan shows numerous radial barriers to sound. These are seen as buttress inclusions and bark seams on the tree.
- A decay line/fruiting body line does extend up the southern buttress to around 1.8m. This is adjacent to the southern eastern non tensile scaffold limb.
- Drill readings at scan measuring points support scan image result well. Compare to previous assessment.

**See T1 in tree schedules for recommendations.**

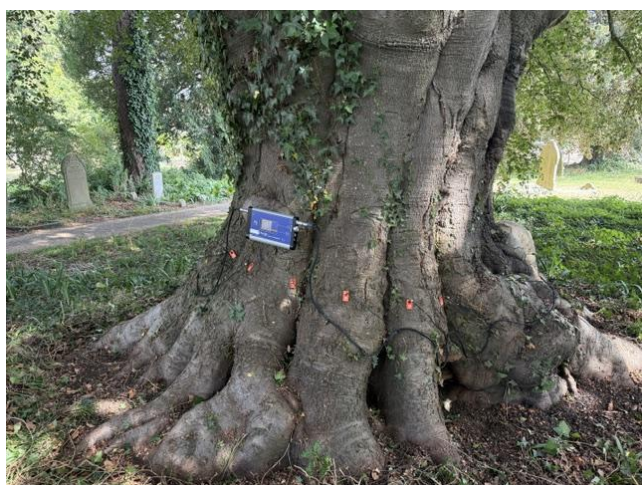
- Drill readings taken to cross check the scan result match the scans findings at 0.5m in the main stem. This section is below the south east non-tensile limb attachment point.
- Drill readings through the south east non tensile limb base towards the decay region in the tree records decay forming within, behind and below the non-tensile region of the tree. Previous bracing has been installed to compensate for loss of structural loading. Compare previous assessment.
- Drill and scan combined suggest there is an ongoing loss of structural support for the non-tensile south east limb.
- Crown weight reduction and bracing checks required. Discuss pruning options with pruning contractor and check bracing as required by installer.

Picus 3 set up on tree for scanning.

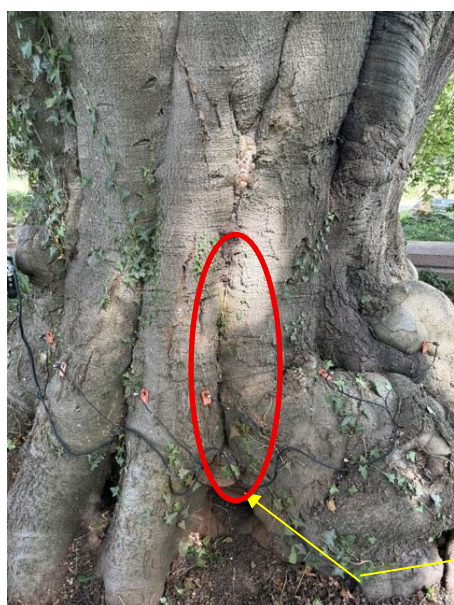
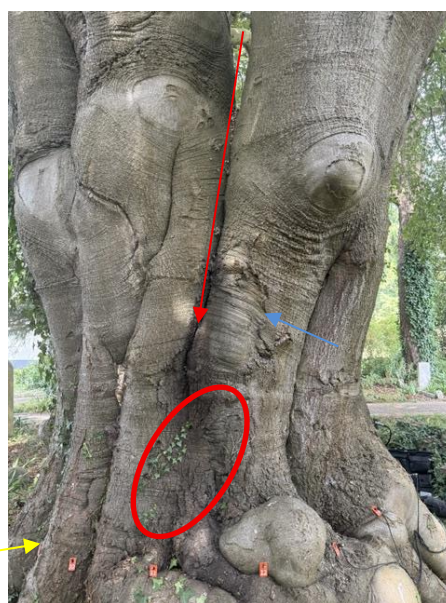
Ganoderma brackets arrowed in yellow. Decay region in red oval. Non-tensile fork arrow in red. Blue arrow upper drill test.

| Tree No | Date | Spread M - stem to drip line | Height (M) | Area usage | Tag No | Species | Age/Class | Physiological condition | Structural condition | Consideration | Defects | Work recommendation | Priority | Further Investigation | Further Investigation type |
|---|---|---|---|---|---|---|---|---|---|---|---|---|---|---|---|
| T1 | 20260722 | 12 | 28 | High use | None | Copper beech | Mature | Normal for species | Damaged | Nuisance - general; Public safety; Damage to structures/object from trees; Damage to tree health | Ganoderma australe decay fungi bracket's south side basal flare. Non-tensile main forks. Collar and steel cable brace system in crown. Large diameter dead wood. Foliage near light and low over Road. | Remove ivy and dead wood from tree. Check bracing for wear and correct dimensions/fitting. Check crown for damaged branches, prune out as required. Subtle weight reducing crown reduction of targeted limbs/regions of crown to reduce weight 2-3m ASLB using NTP. Prune back from light 2m, lift foliage over highway to 5.2m | 2= Low | Not required | None |
