## Archaeological Watching Brief Report

Old St Peter's Church, Peterstone, Wentlooge, Cardiff, CF3 2TR

Prepared for  
Newport City Council

October 2024

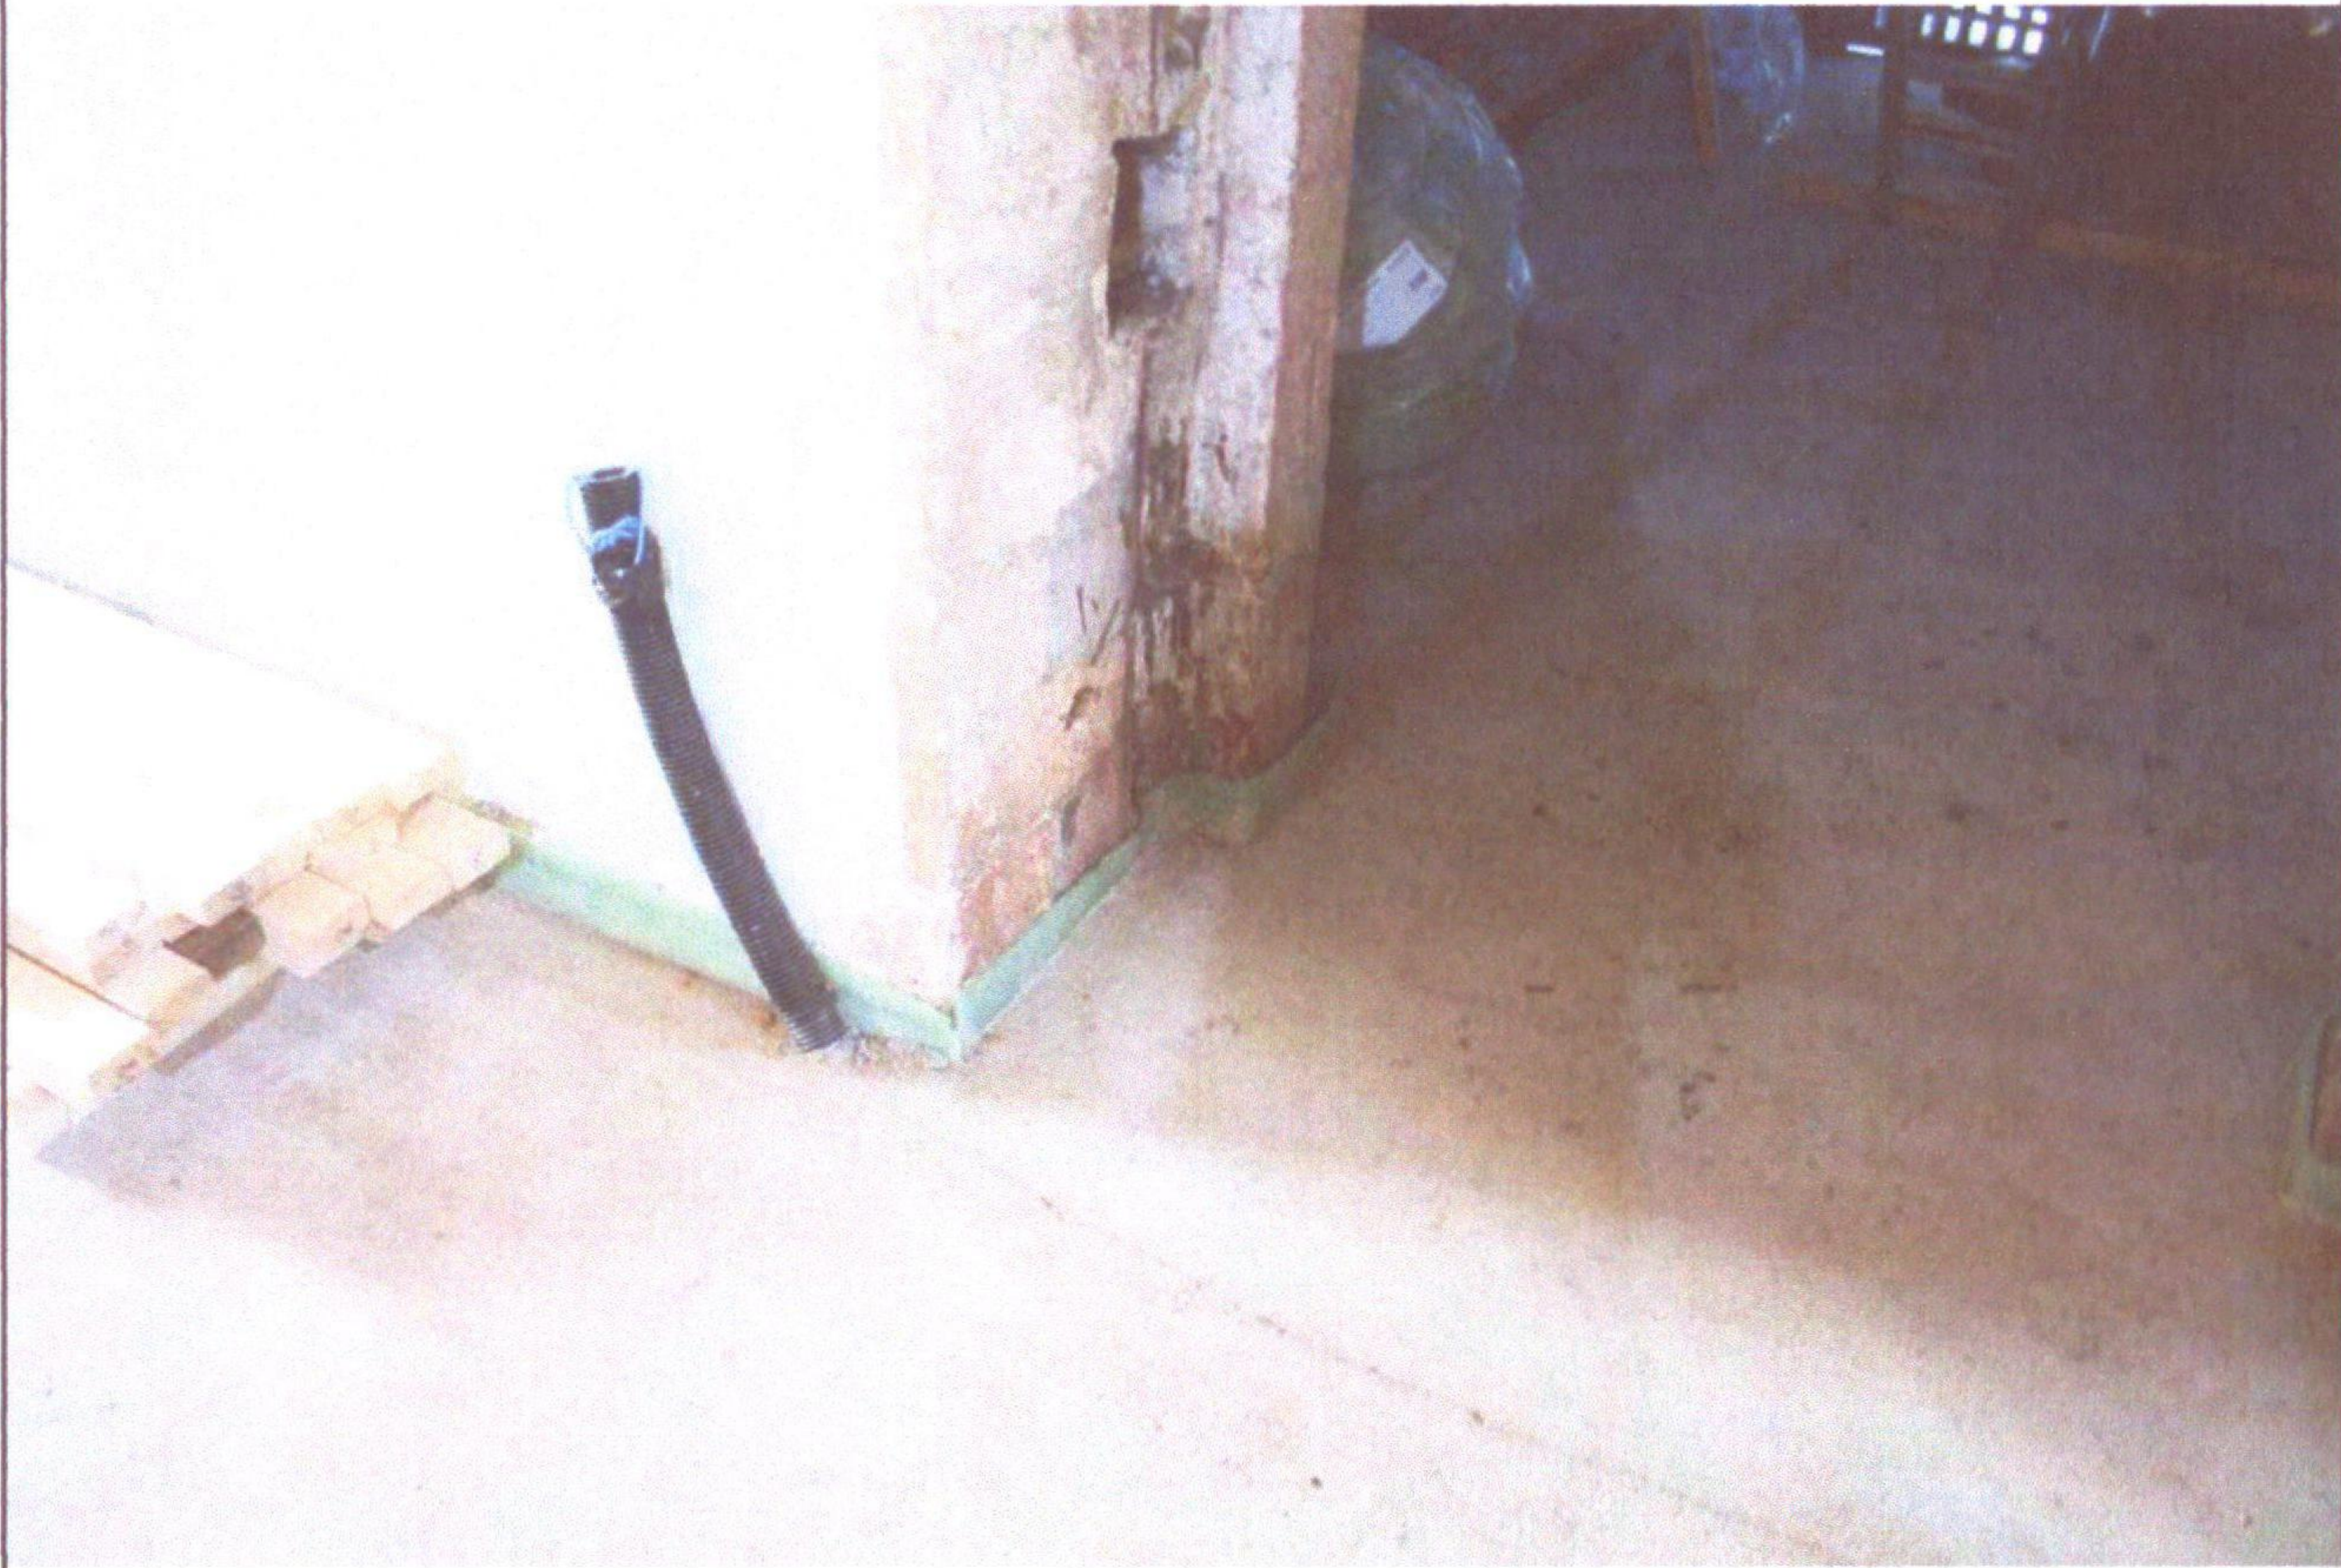
Plate 1

- 3.2.7. Where archaeological remains were encountered, such as the foundations and pillar bases, a recommended barrier layer was installed to separate the modern concrete from the historical fabric of the structure (**Plate 1**).

Internal Shot of Barrier Layer Between the Modern Concrete  
and Original Building Fabric

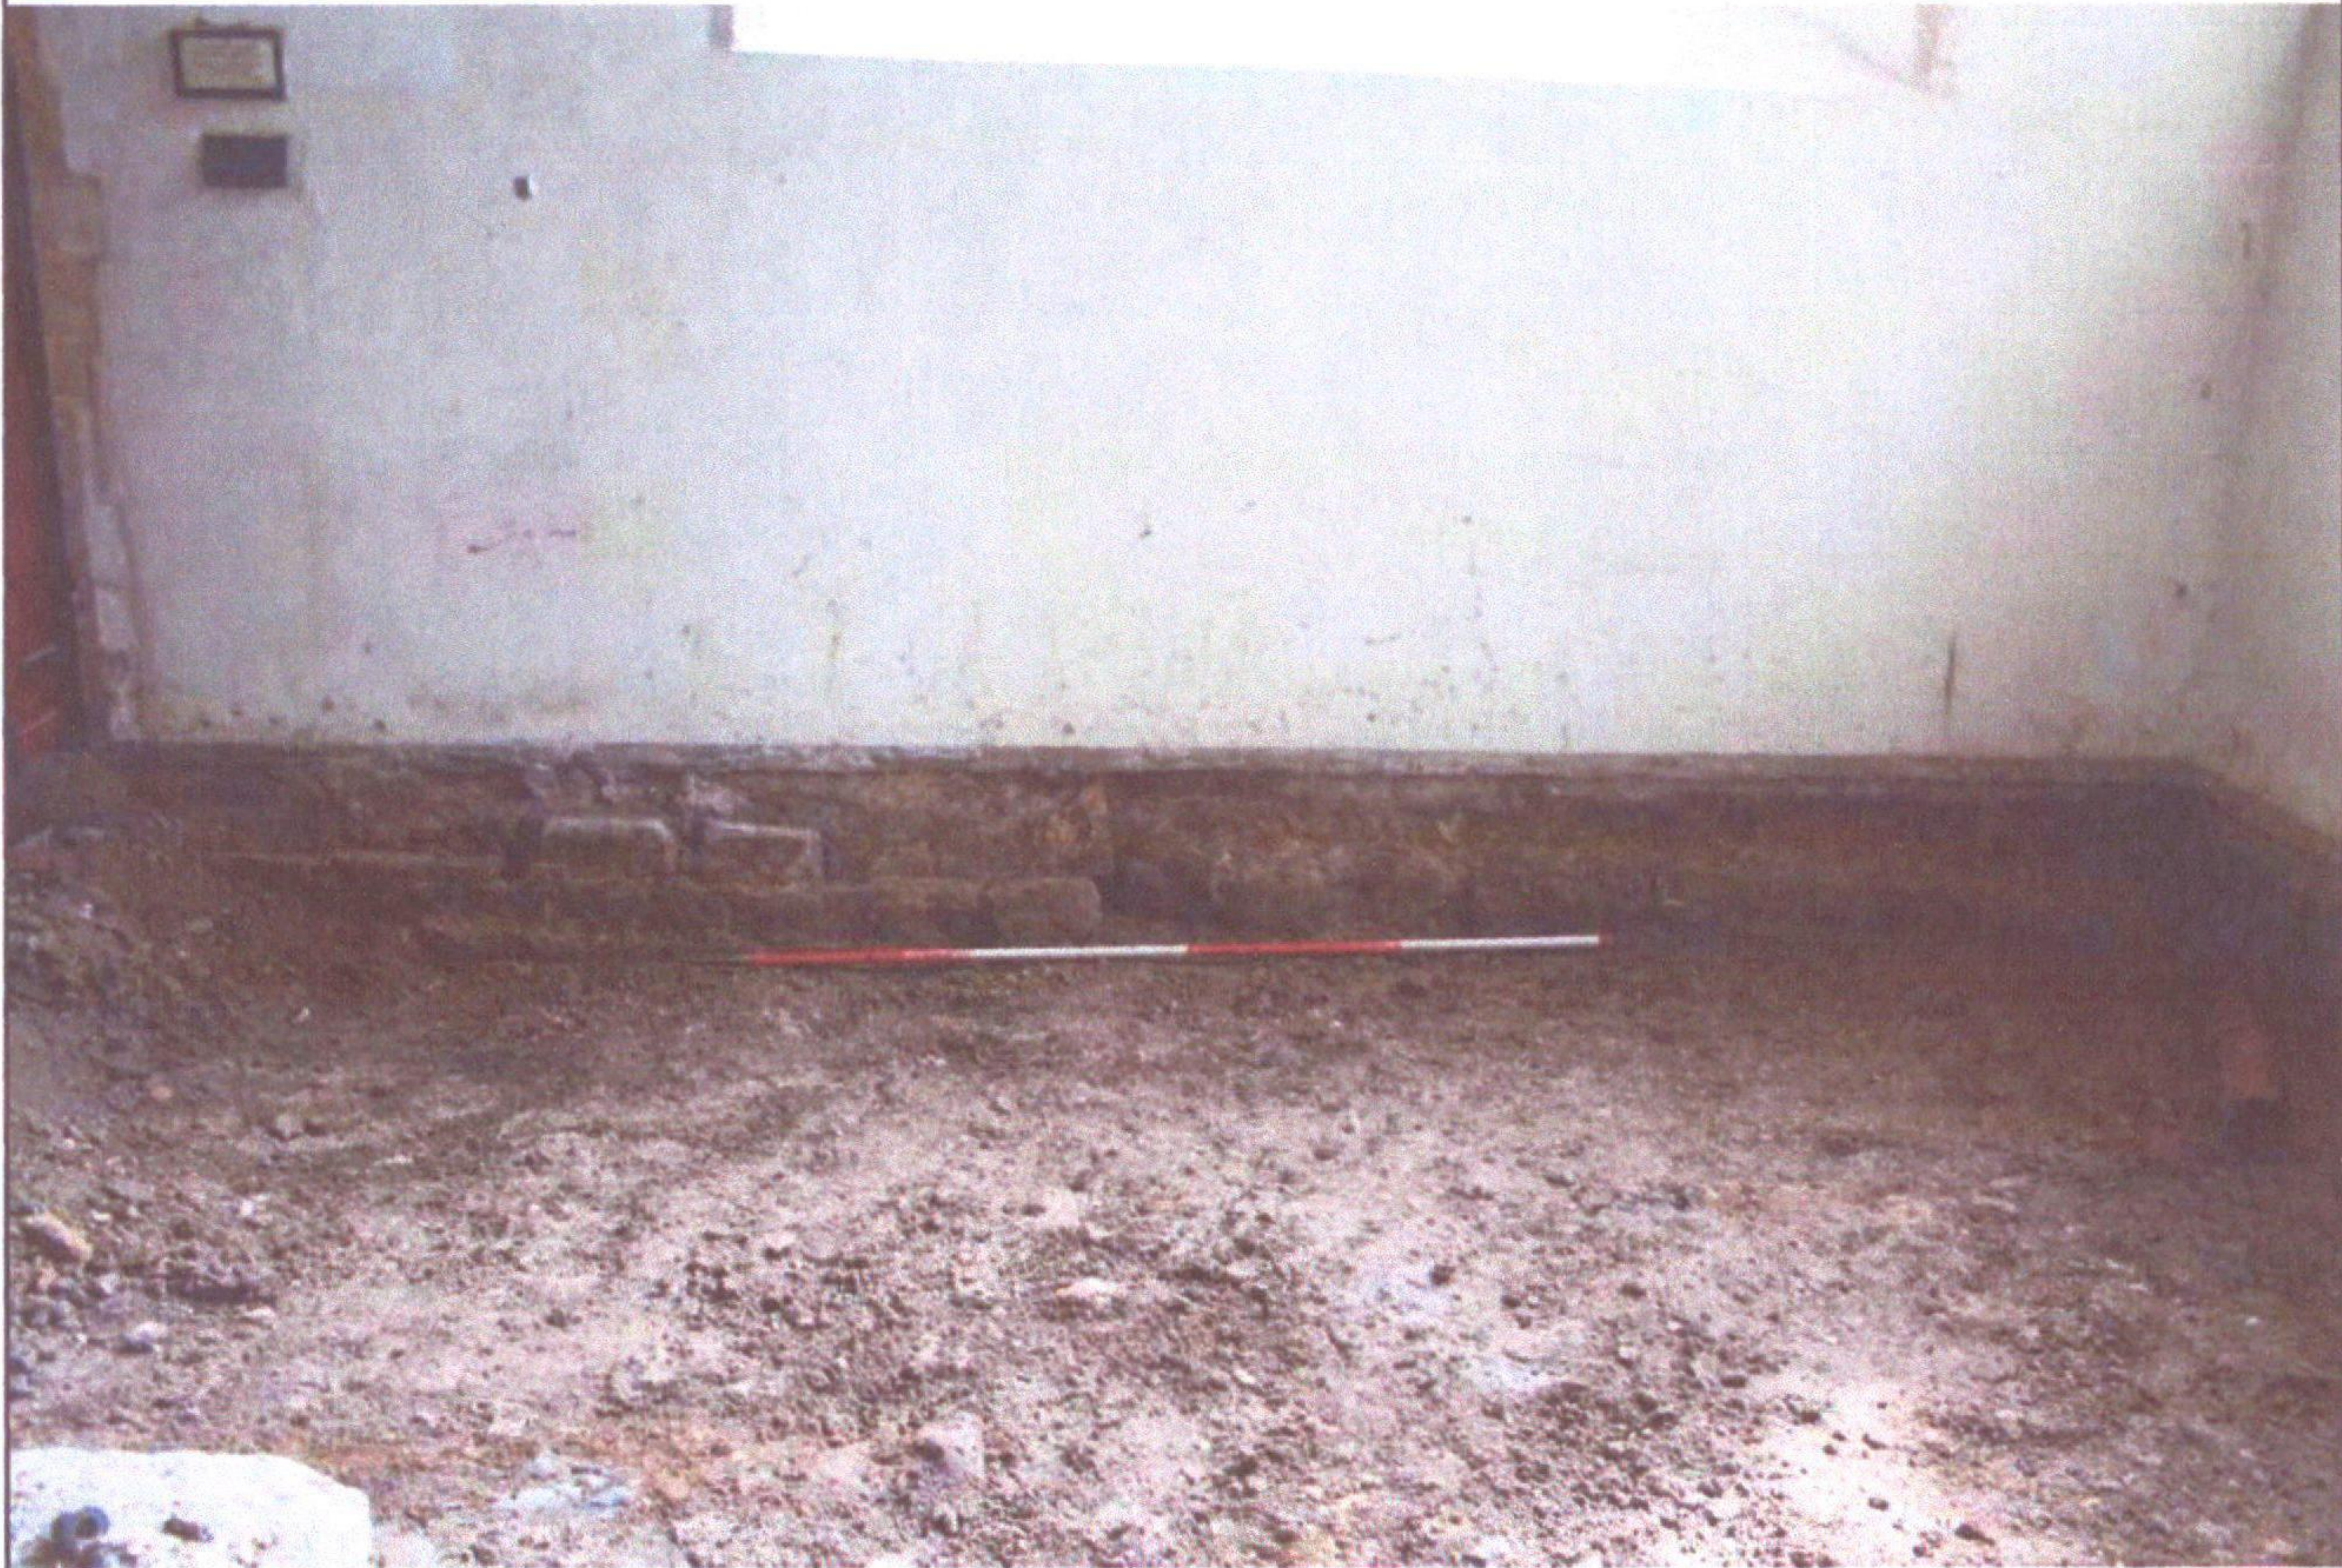
Plate 2

Internal Shot of Structure {122} below Structure {123}

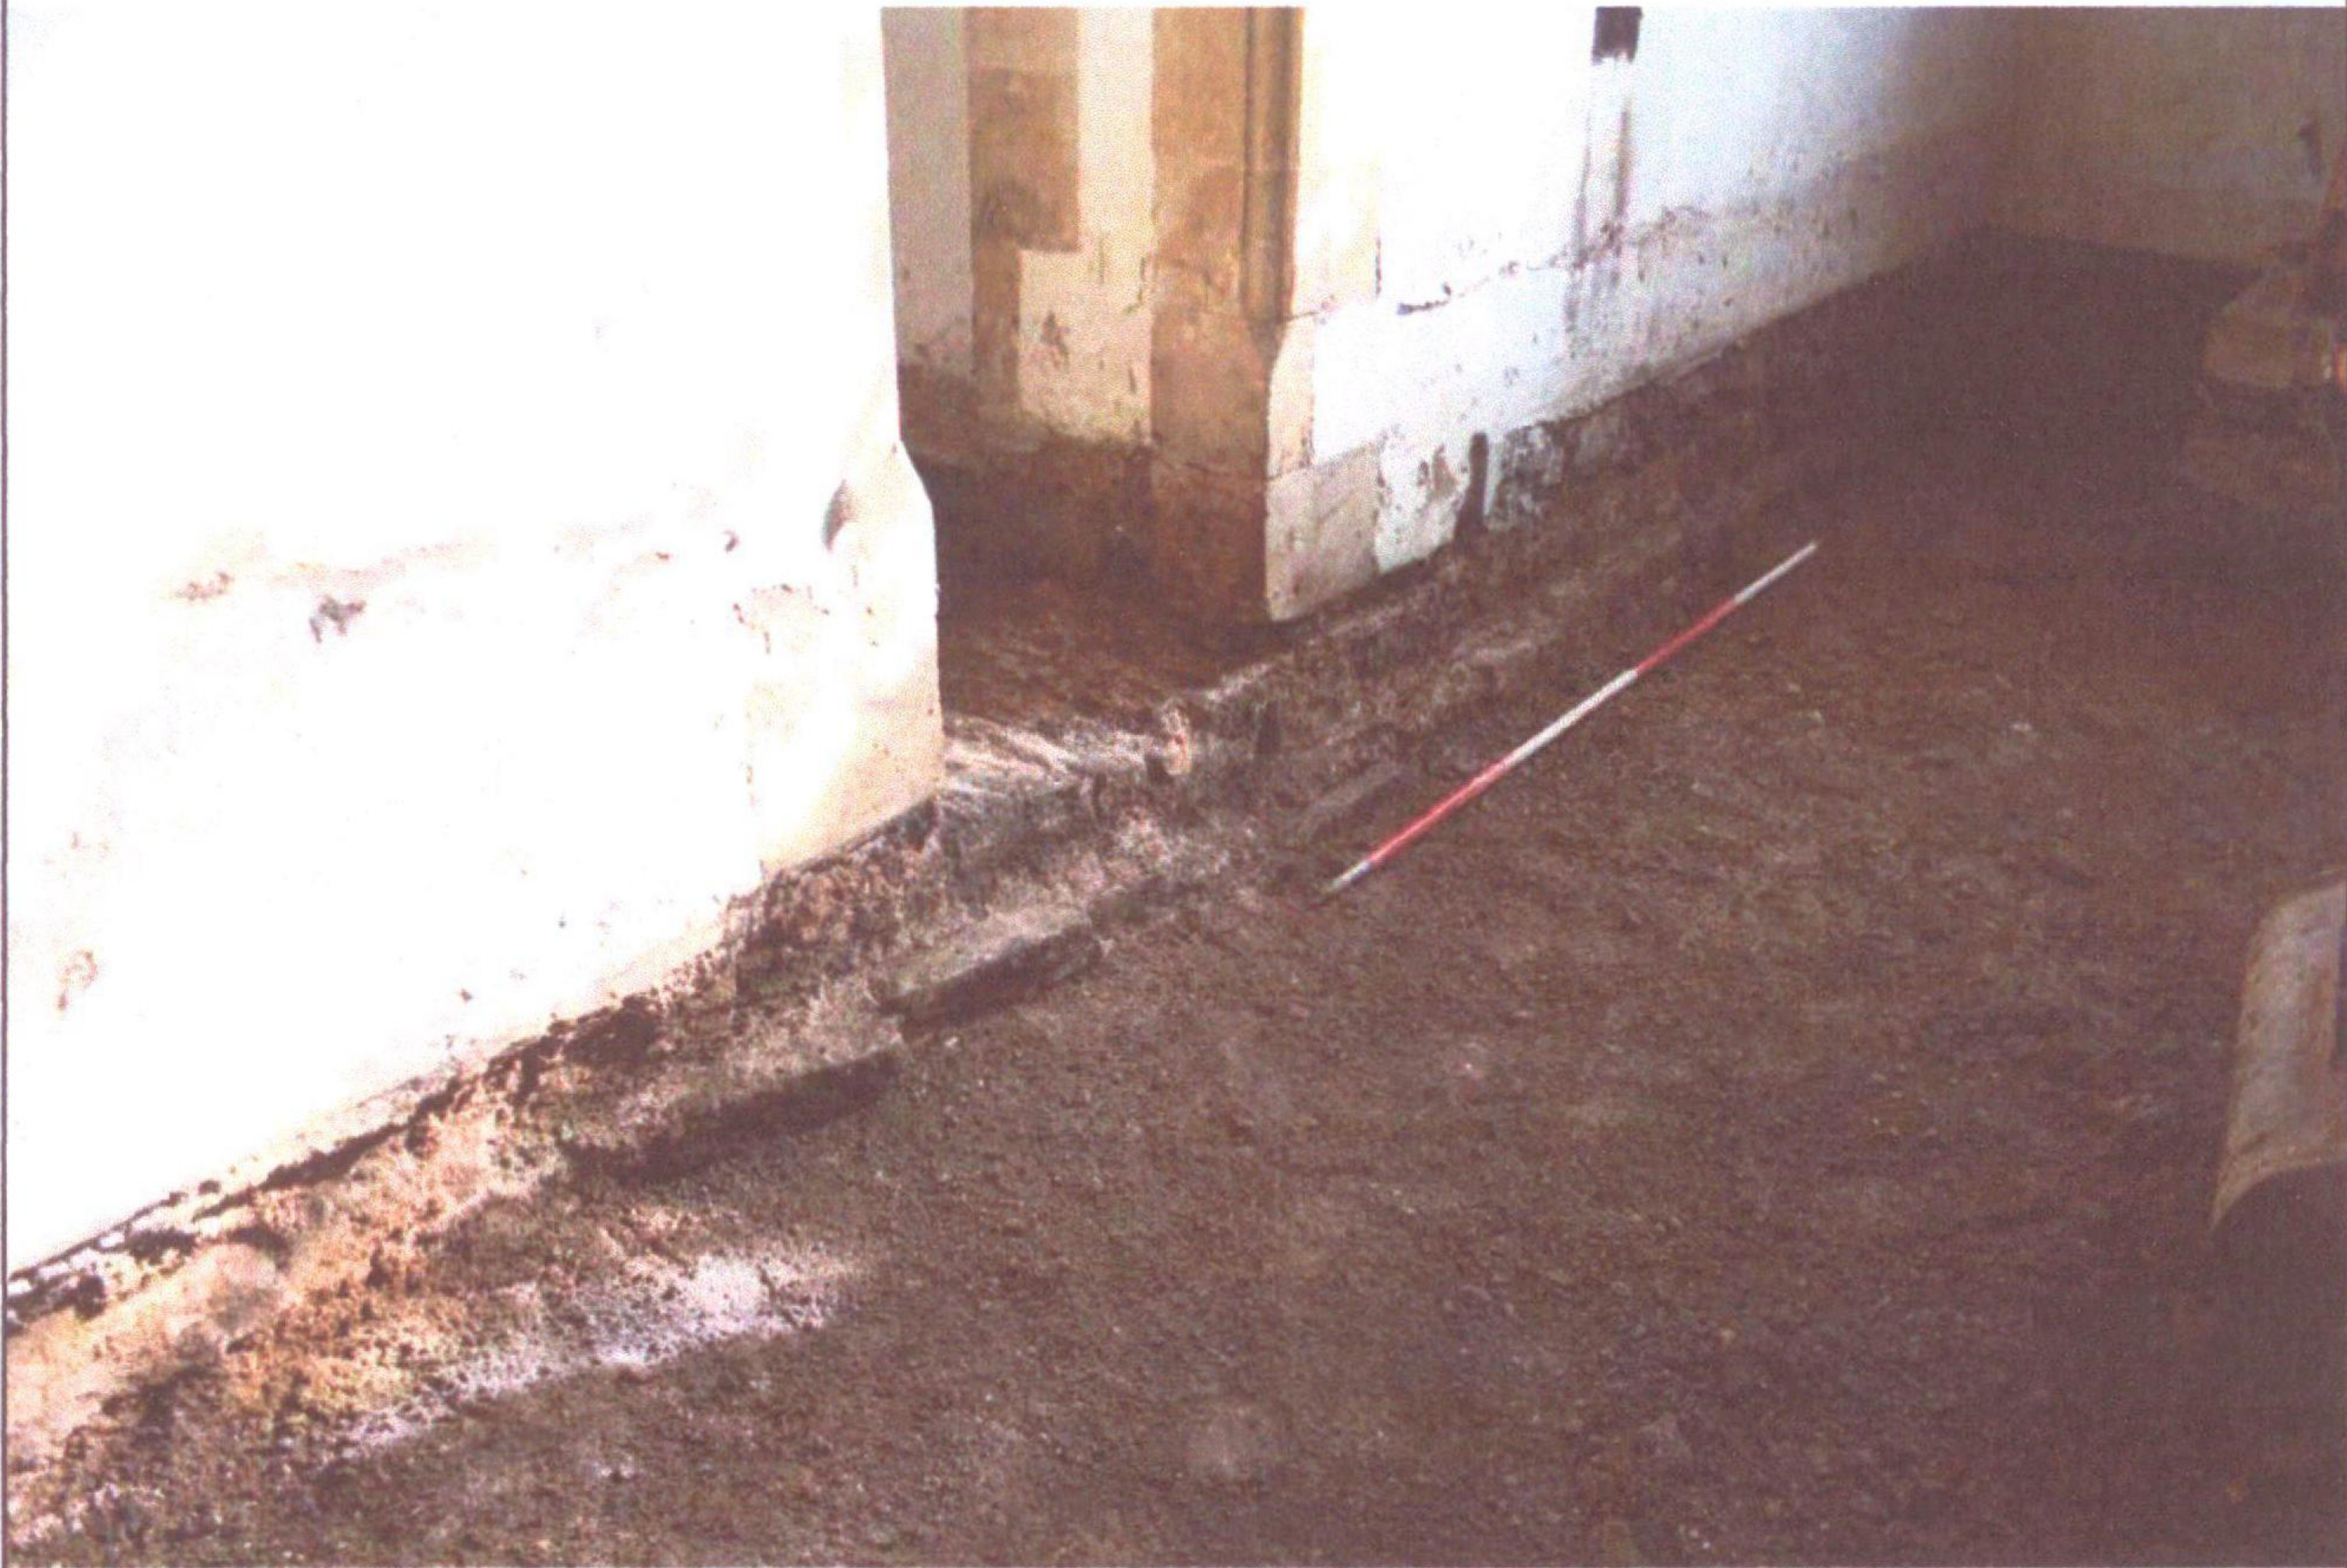
Plate 3

Internal Shot of Structure {122} below Structure {123}

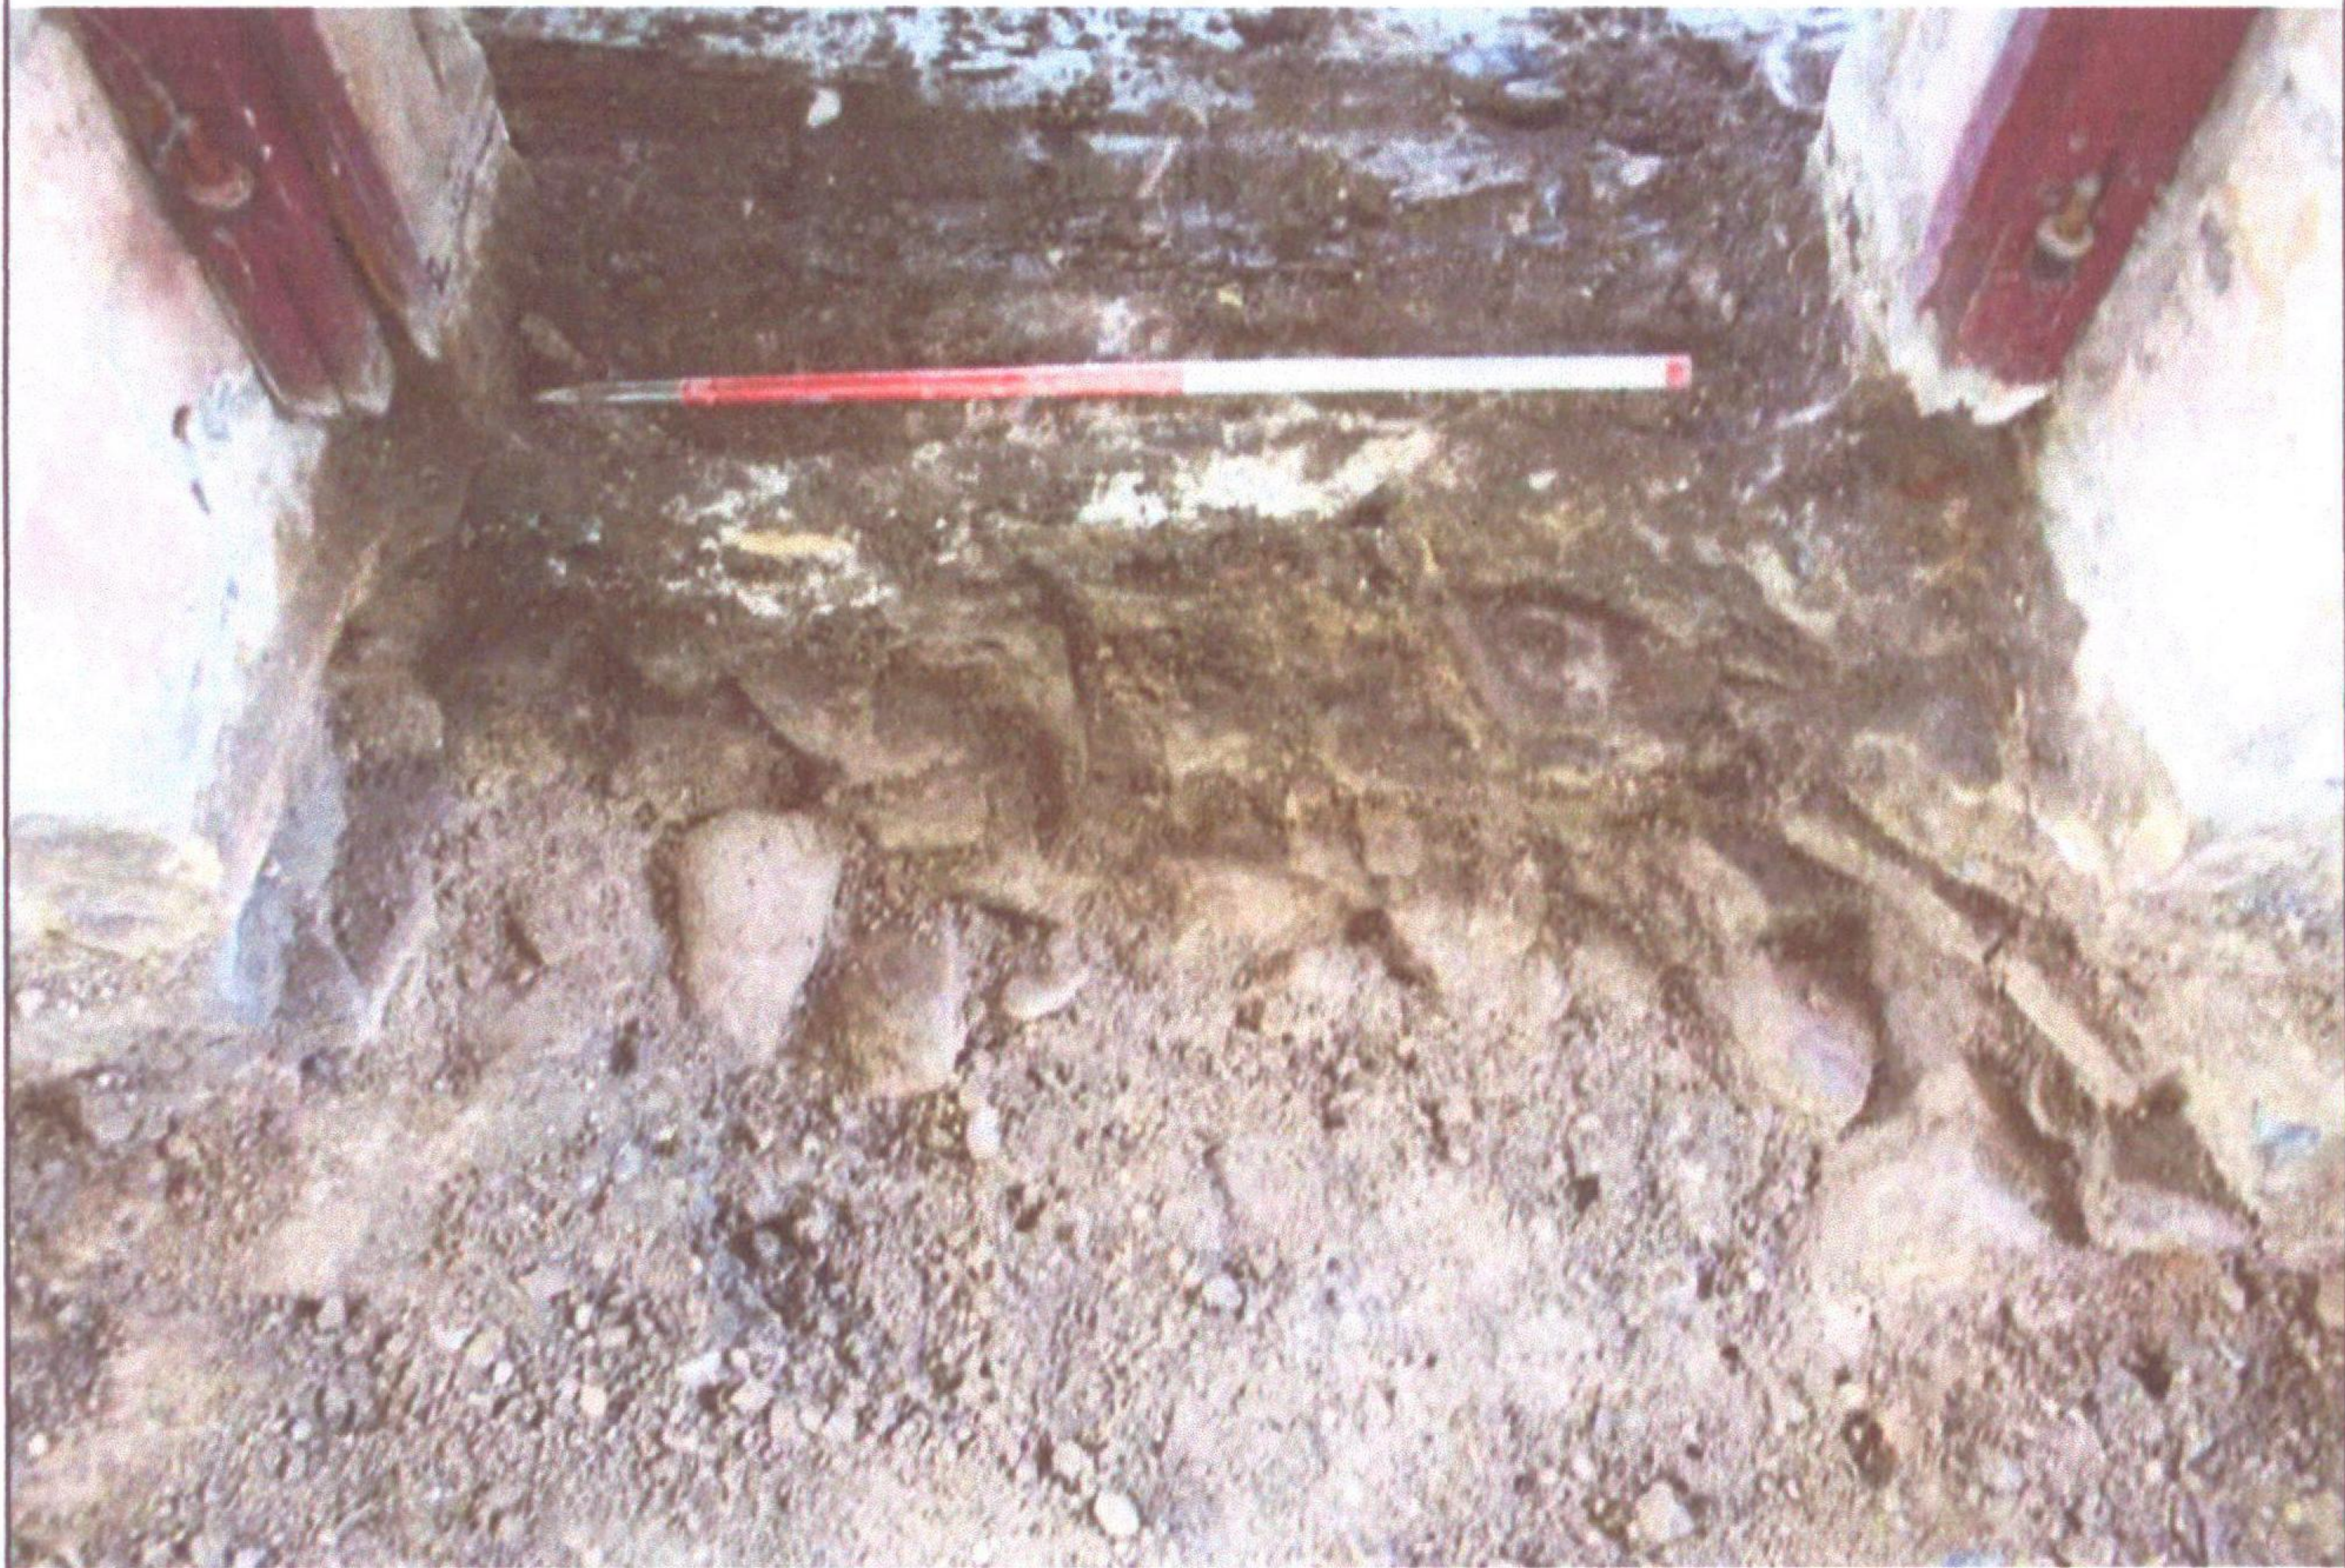
Plate 4

Internal Shot of Structure {122} below Structure {123} at the  
South Porch Threshold

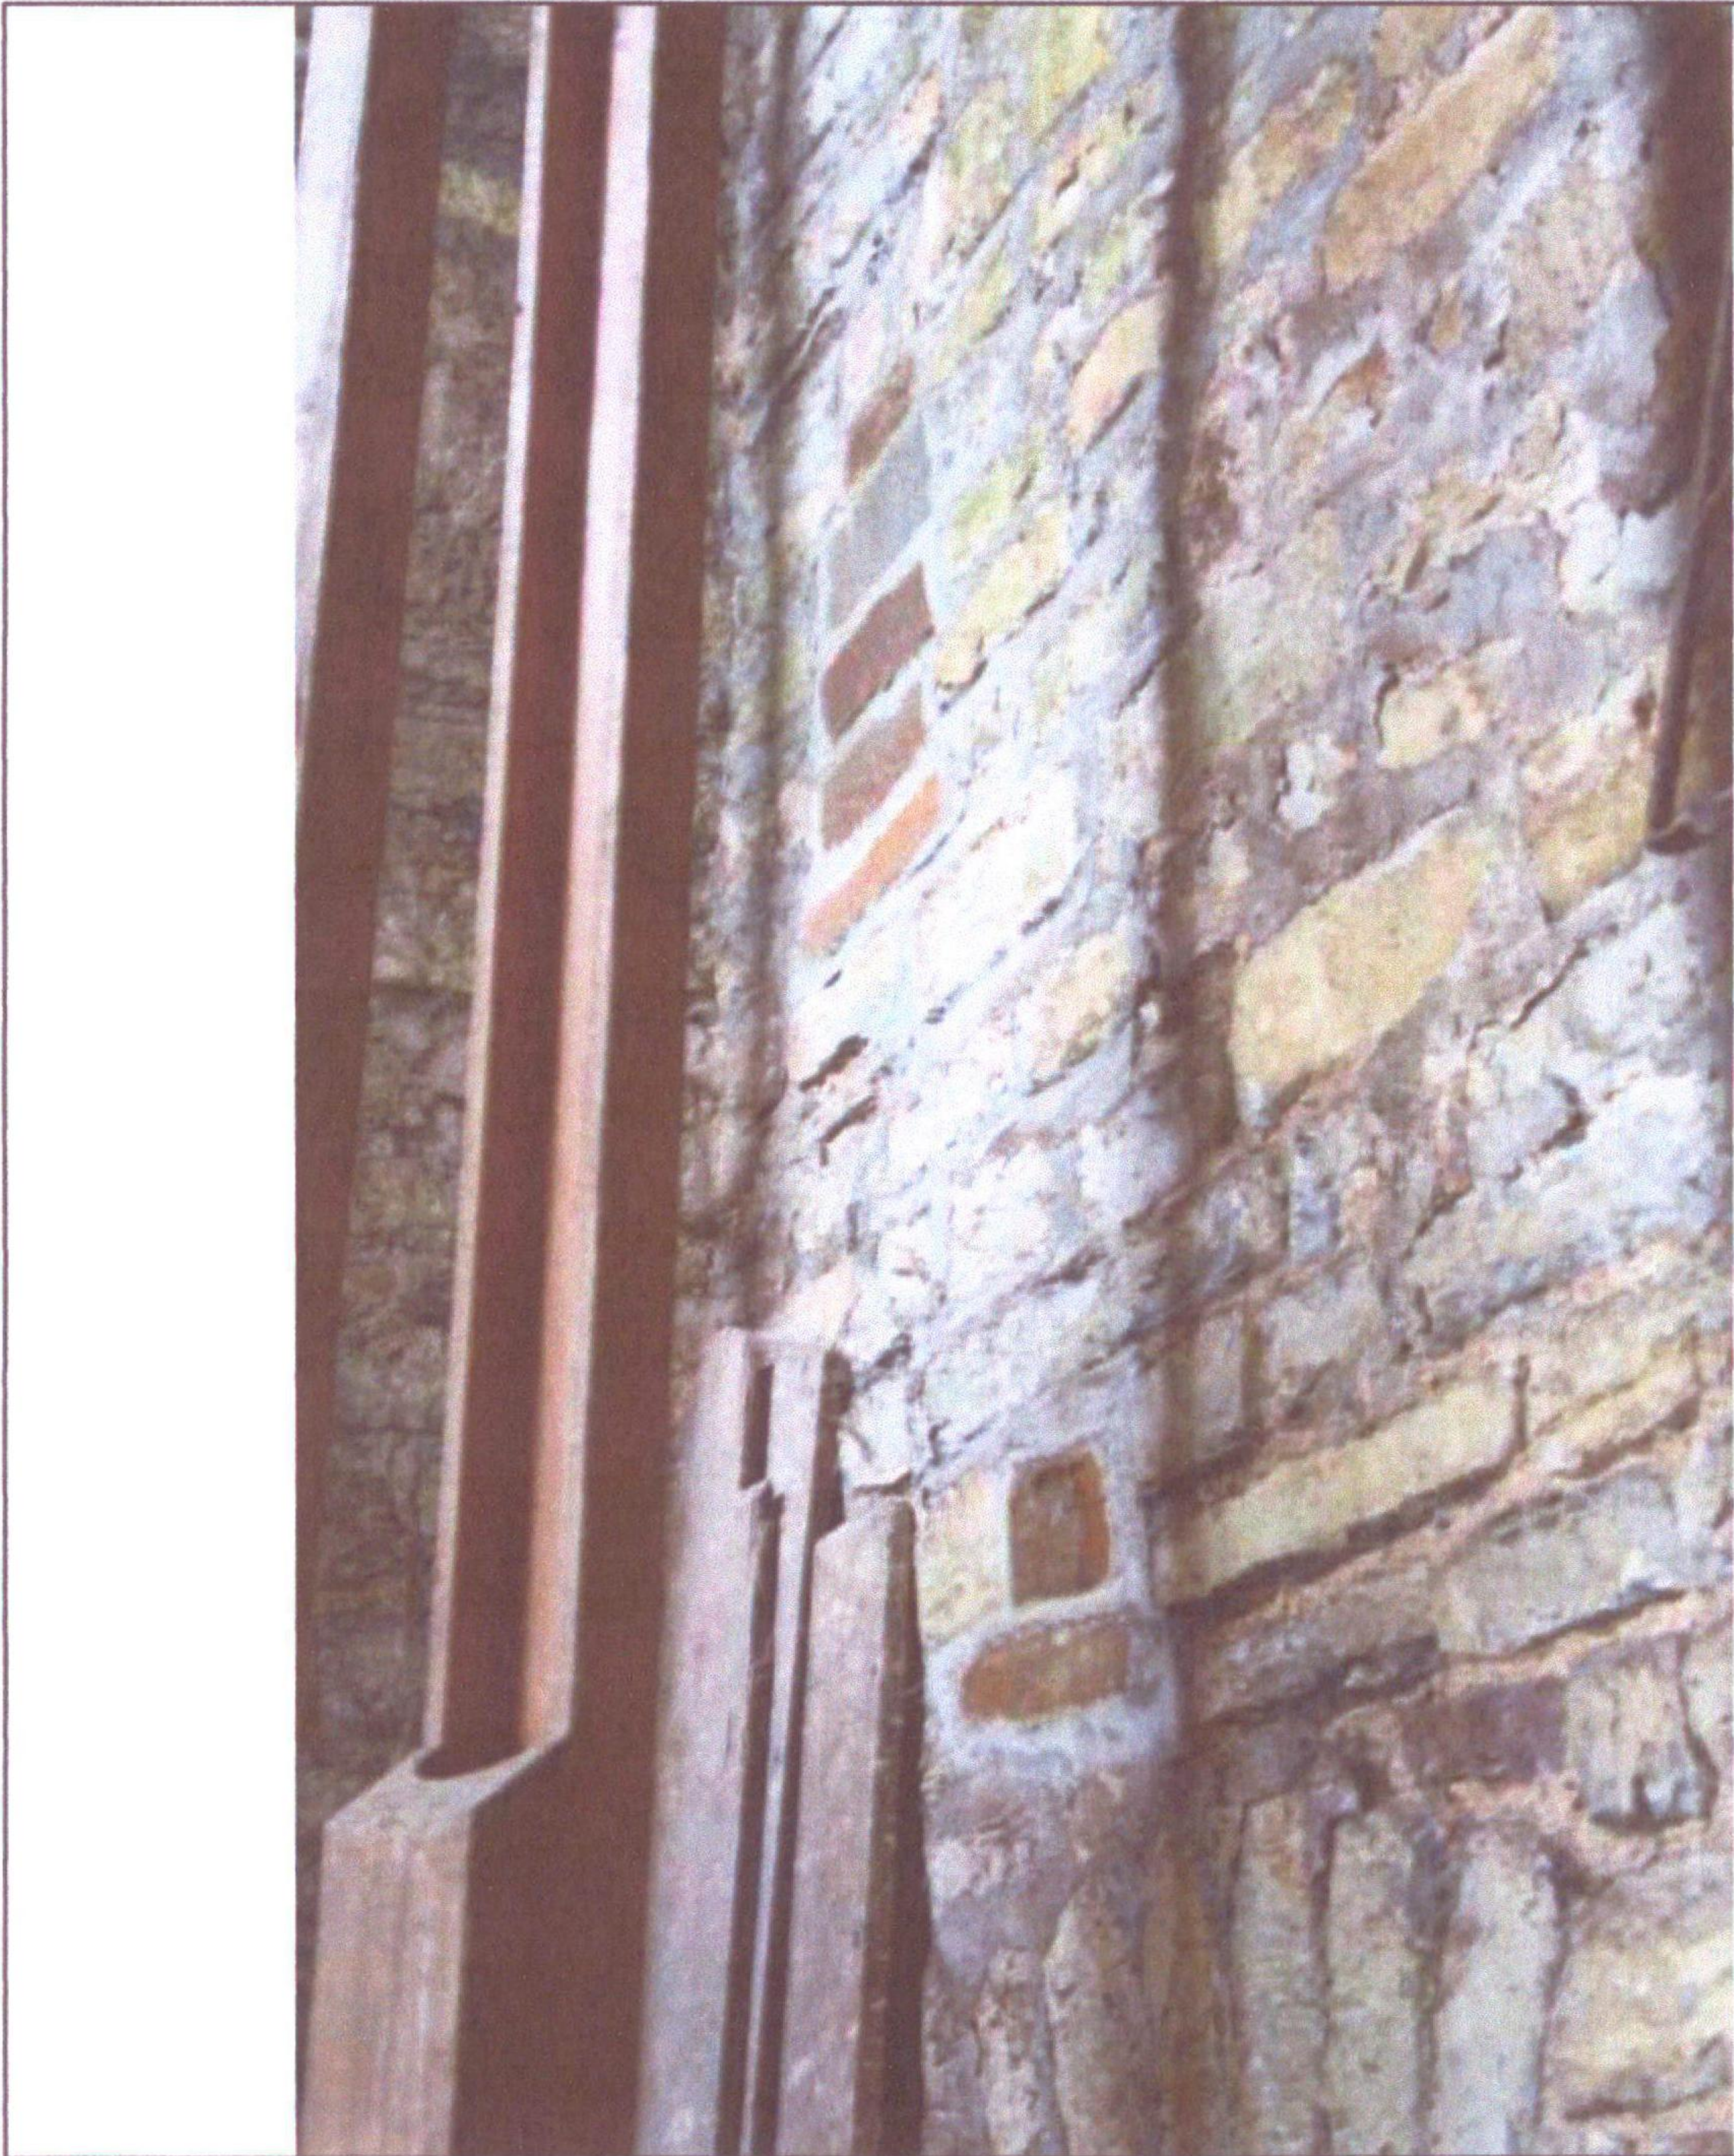
Plate 5

Internal Shot of the First Floor of the Tower Showing Modern Brick Repairs

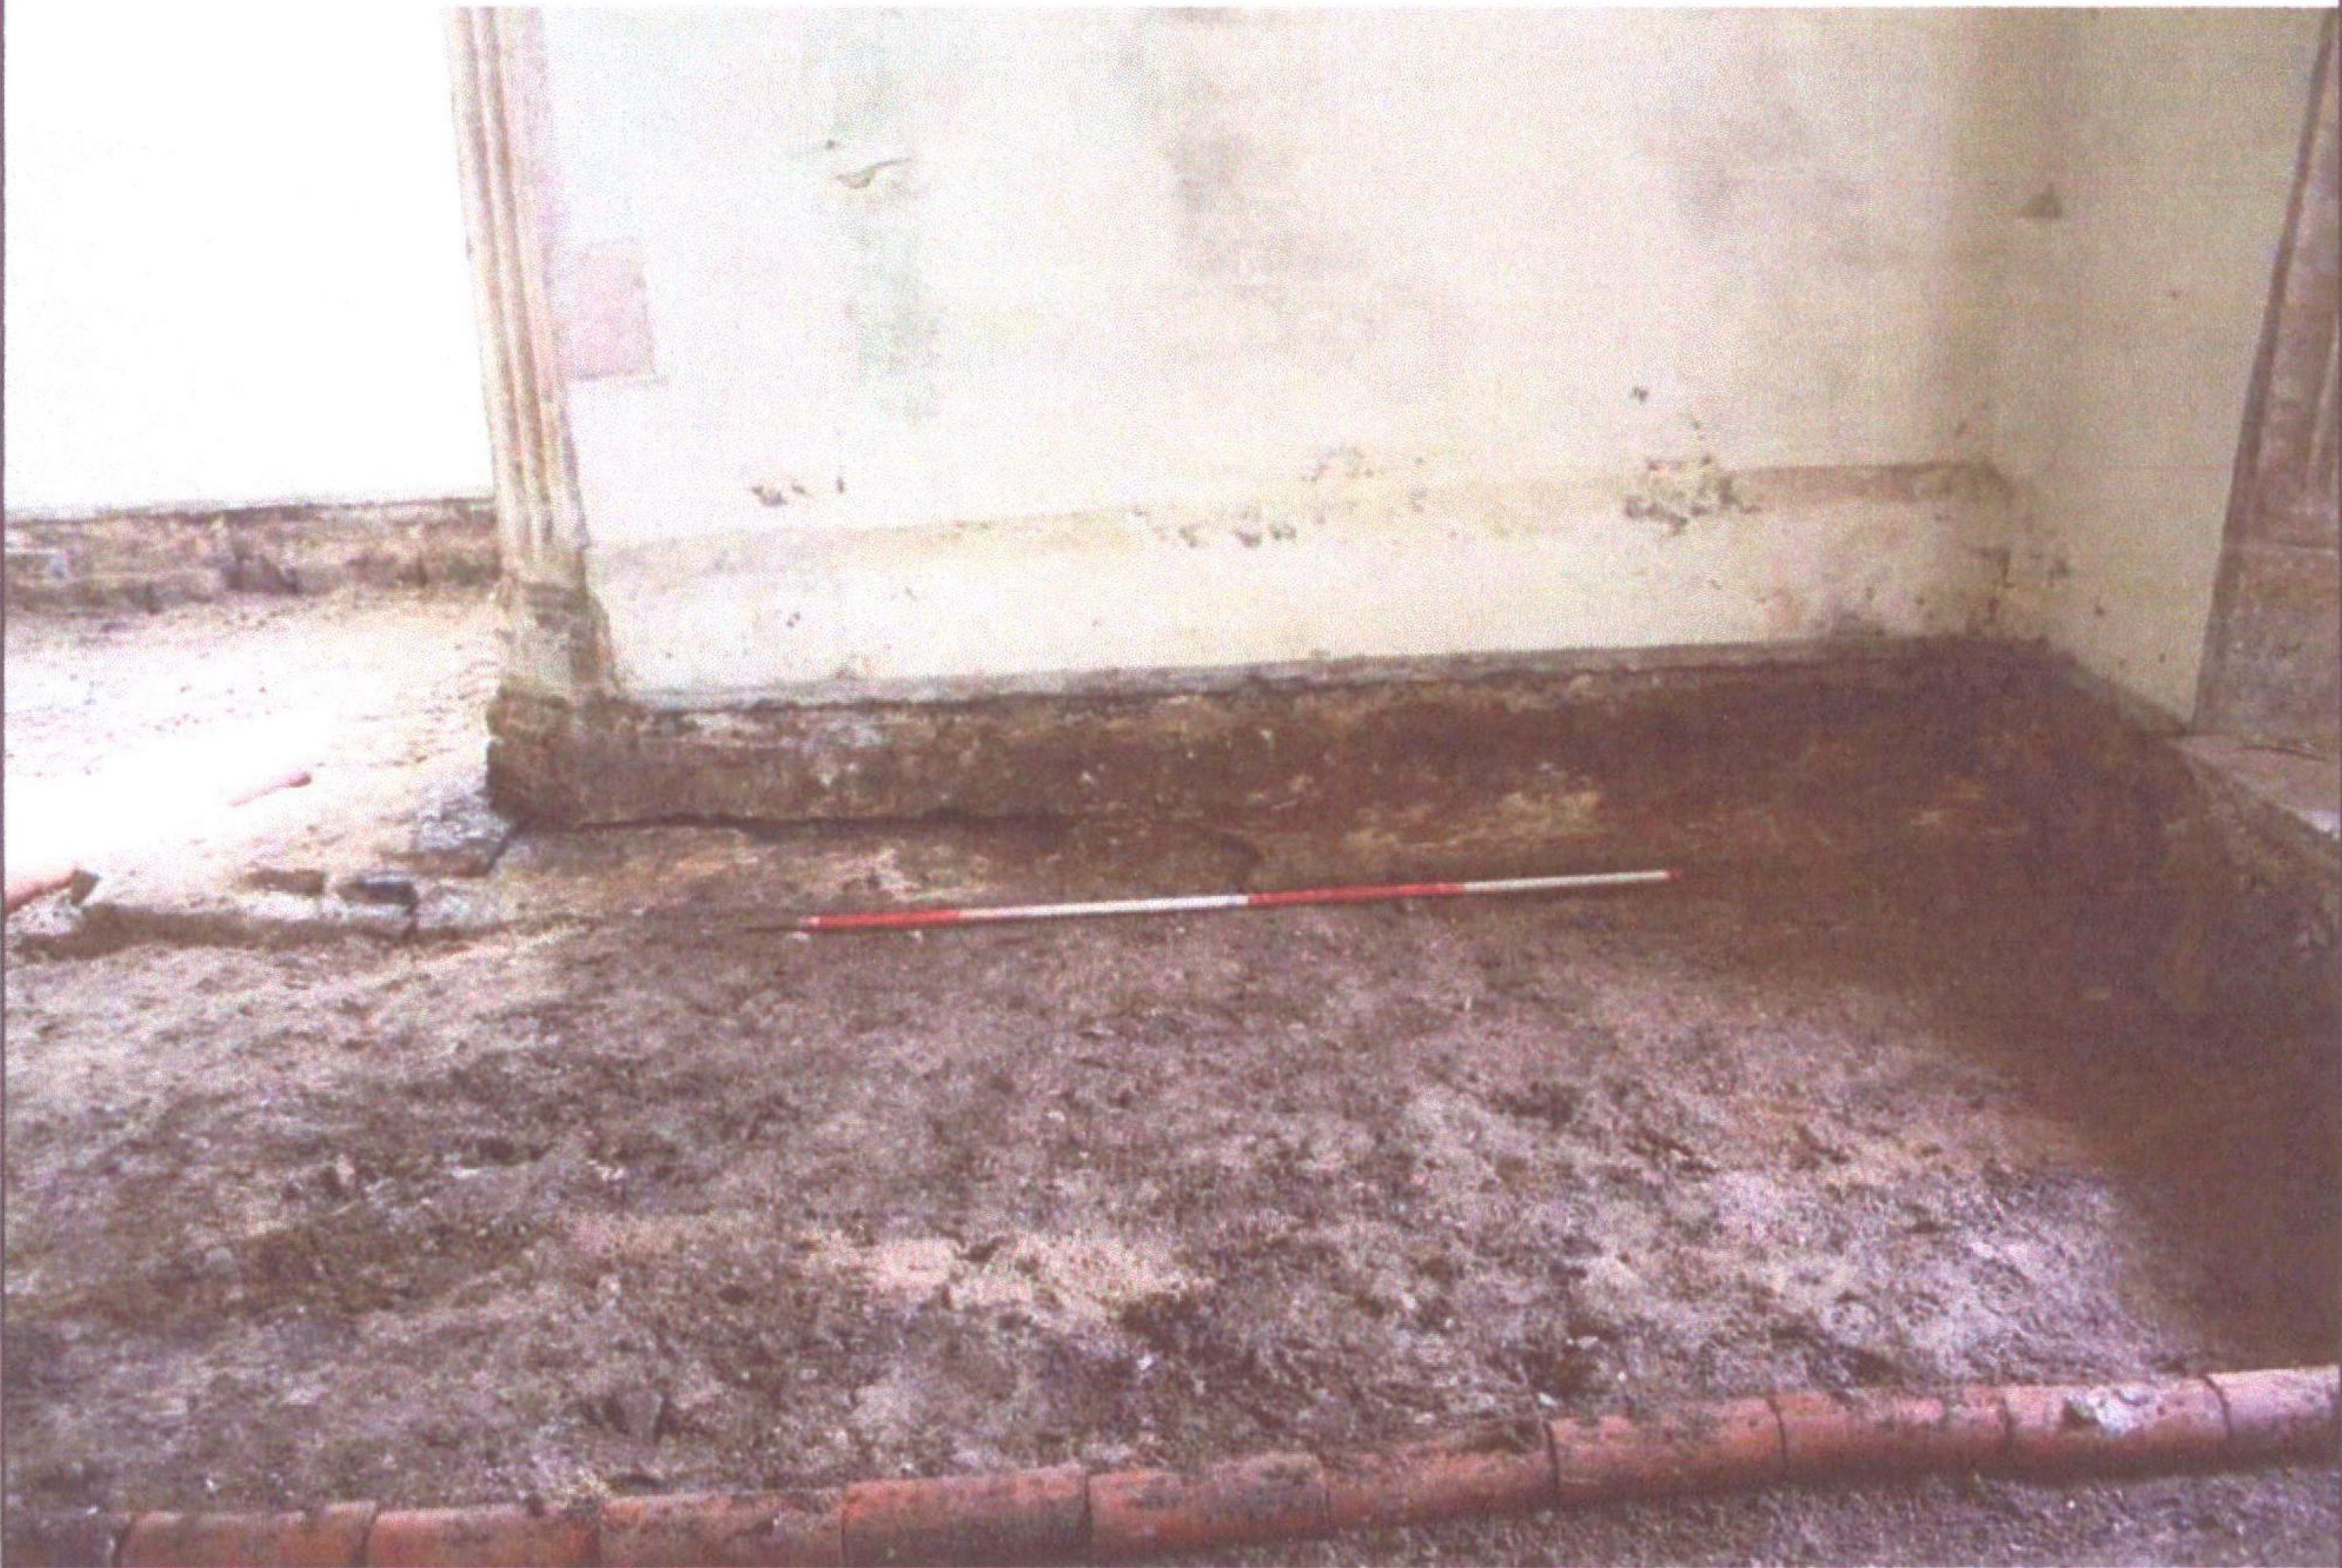
Plate 6

*Within the present-day church building, the foundations of an earlier structure were revealed as well as successive alterations throughout the church. Damage to the foundations were also uncovered potentially linked to the visible lean of the tower.*

Internal Shot of Broken Southwestern Foundation
