## Archaeological Watching Brief Report

Old St Peter's Church, Peterstone, Wentlooge, Cardiff, CF3 2TR

Prepared for  
Newport City Council

October 2024

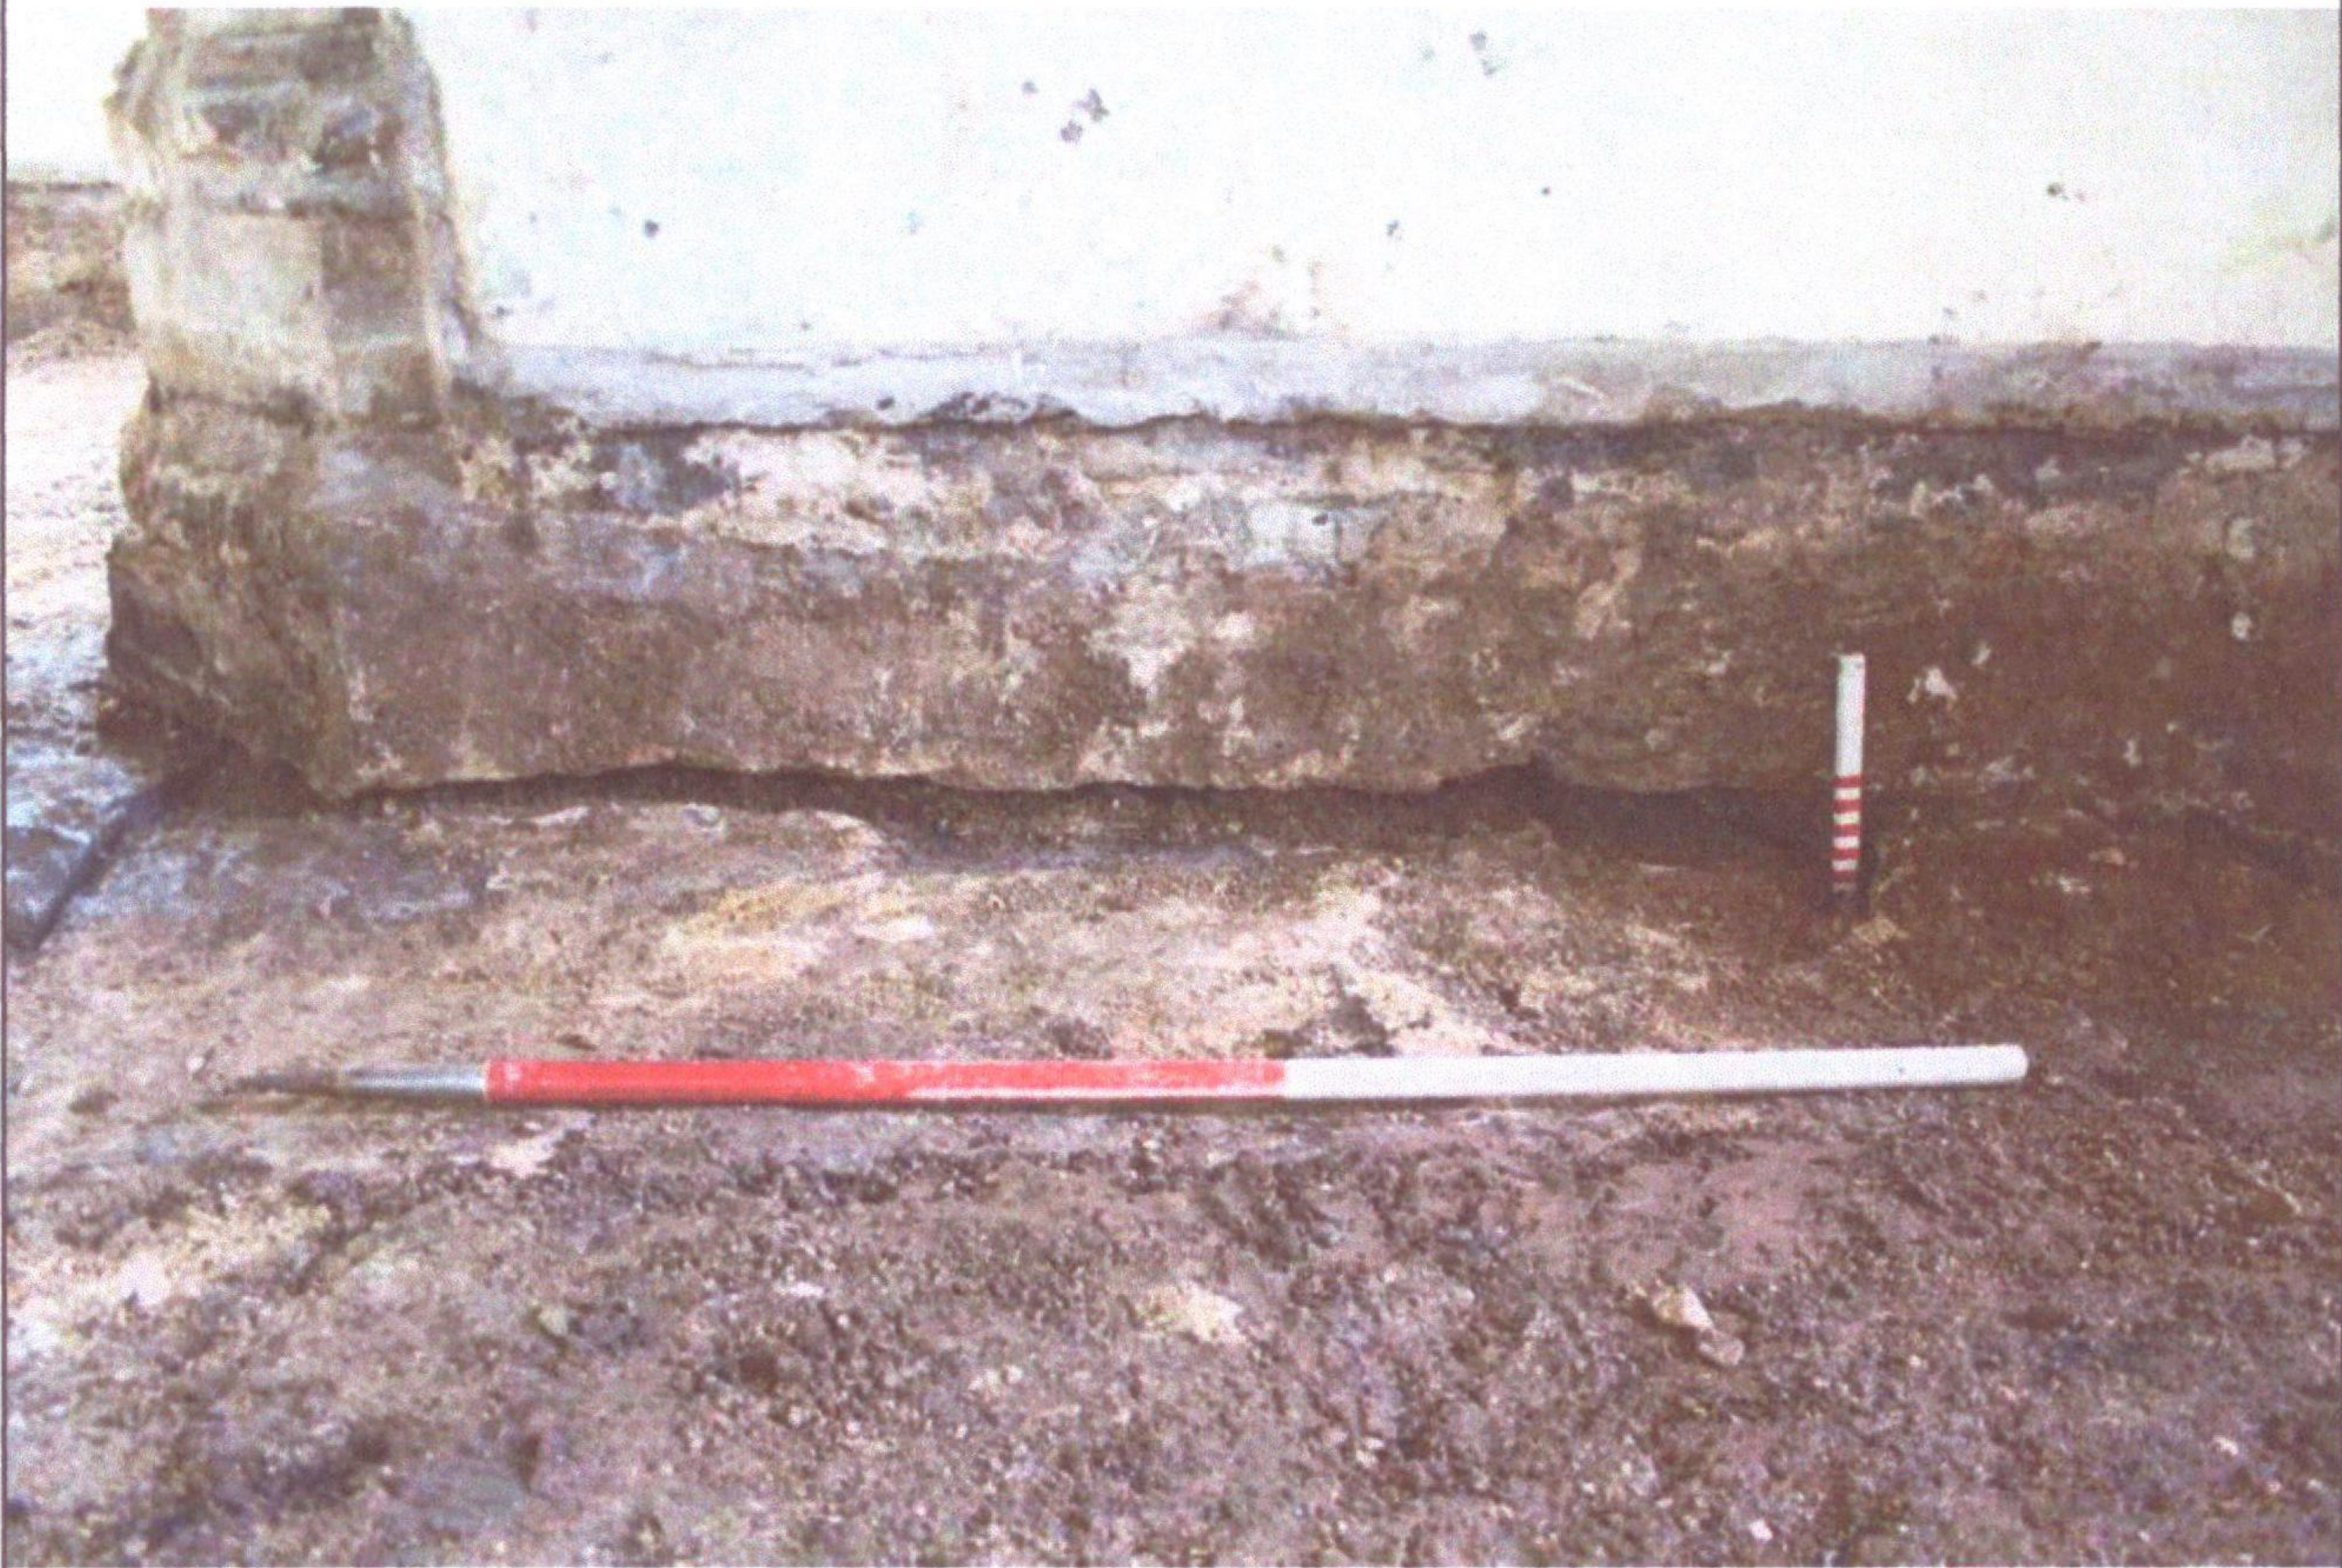
Plate 7

Internal Shot of Broken Southwestern Foundation - Close Up

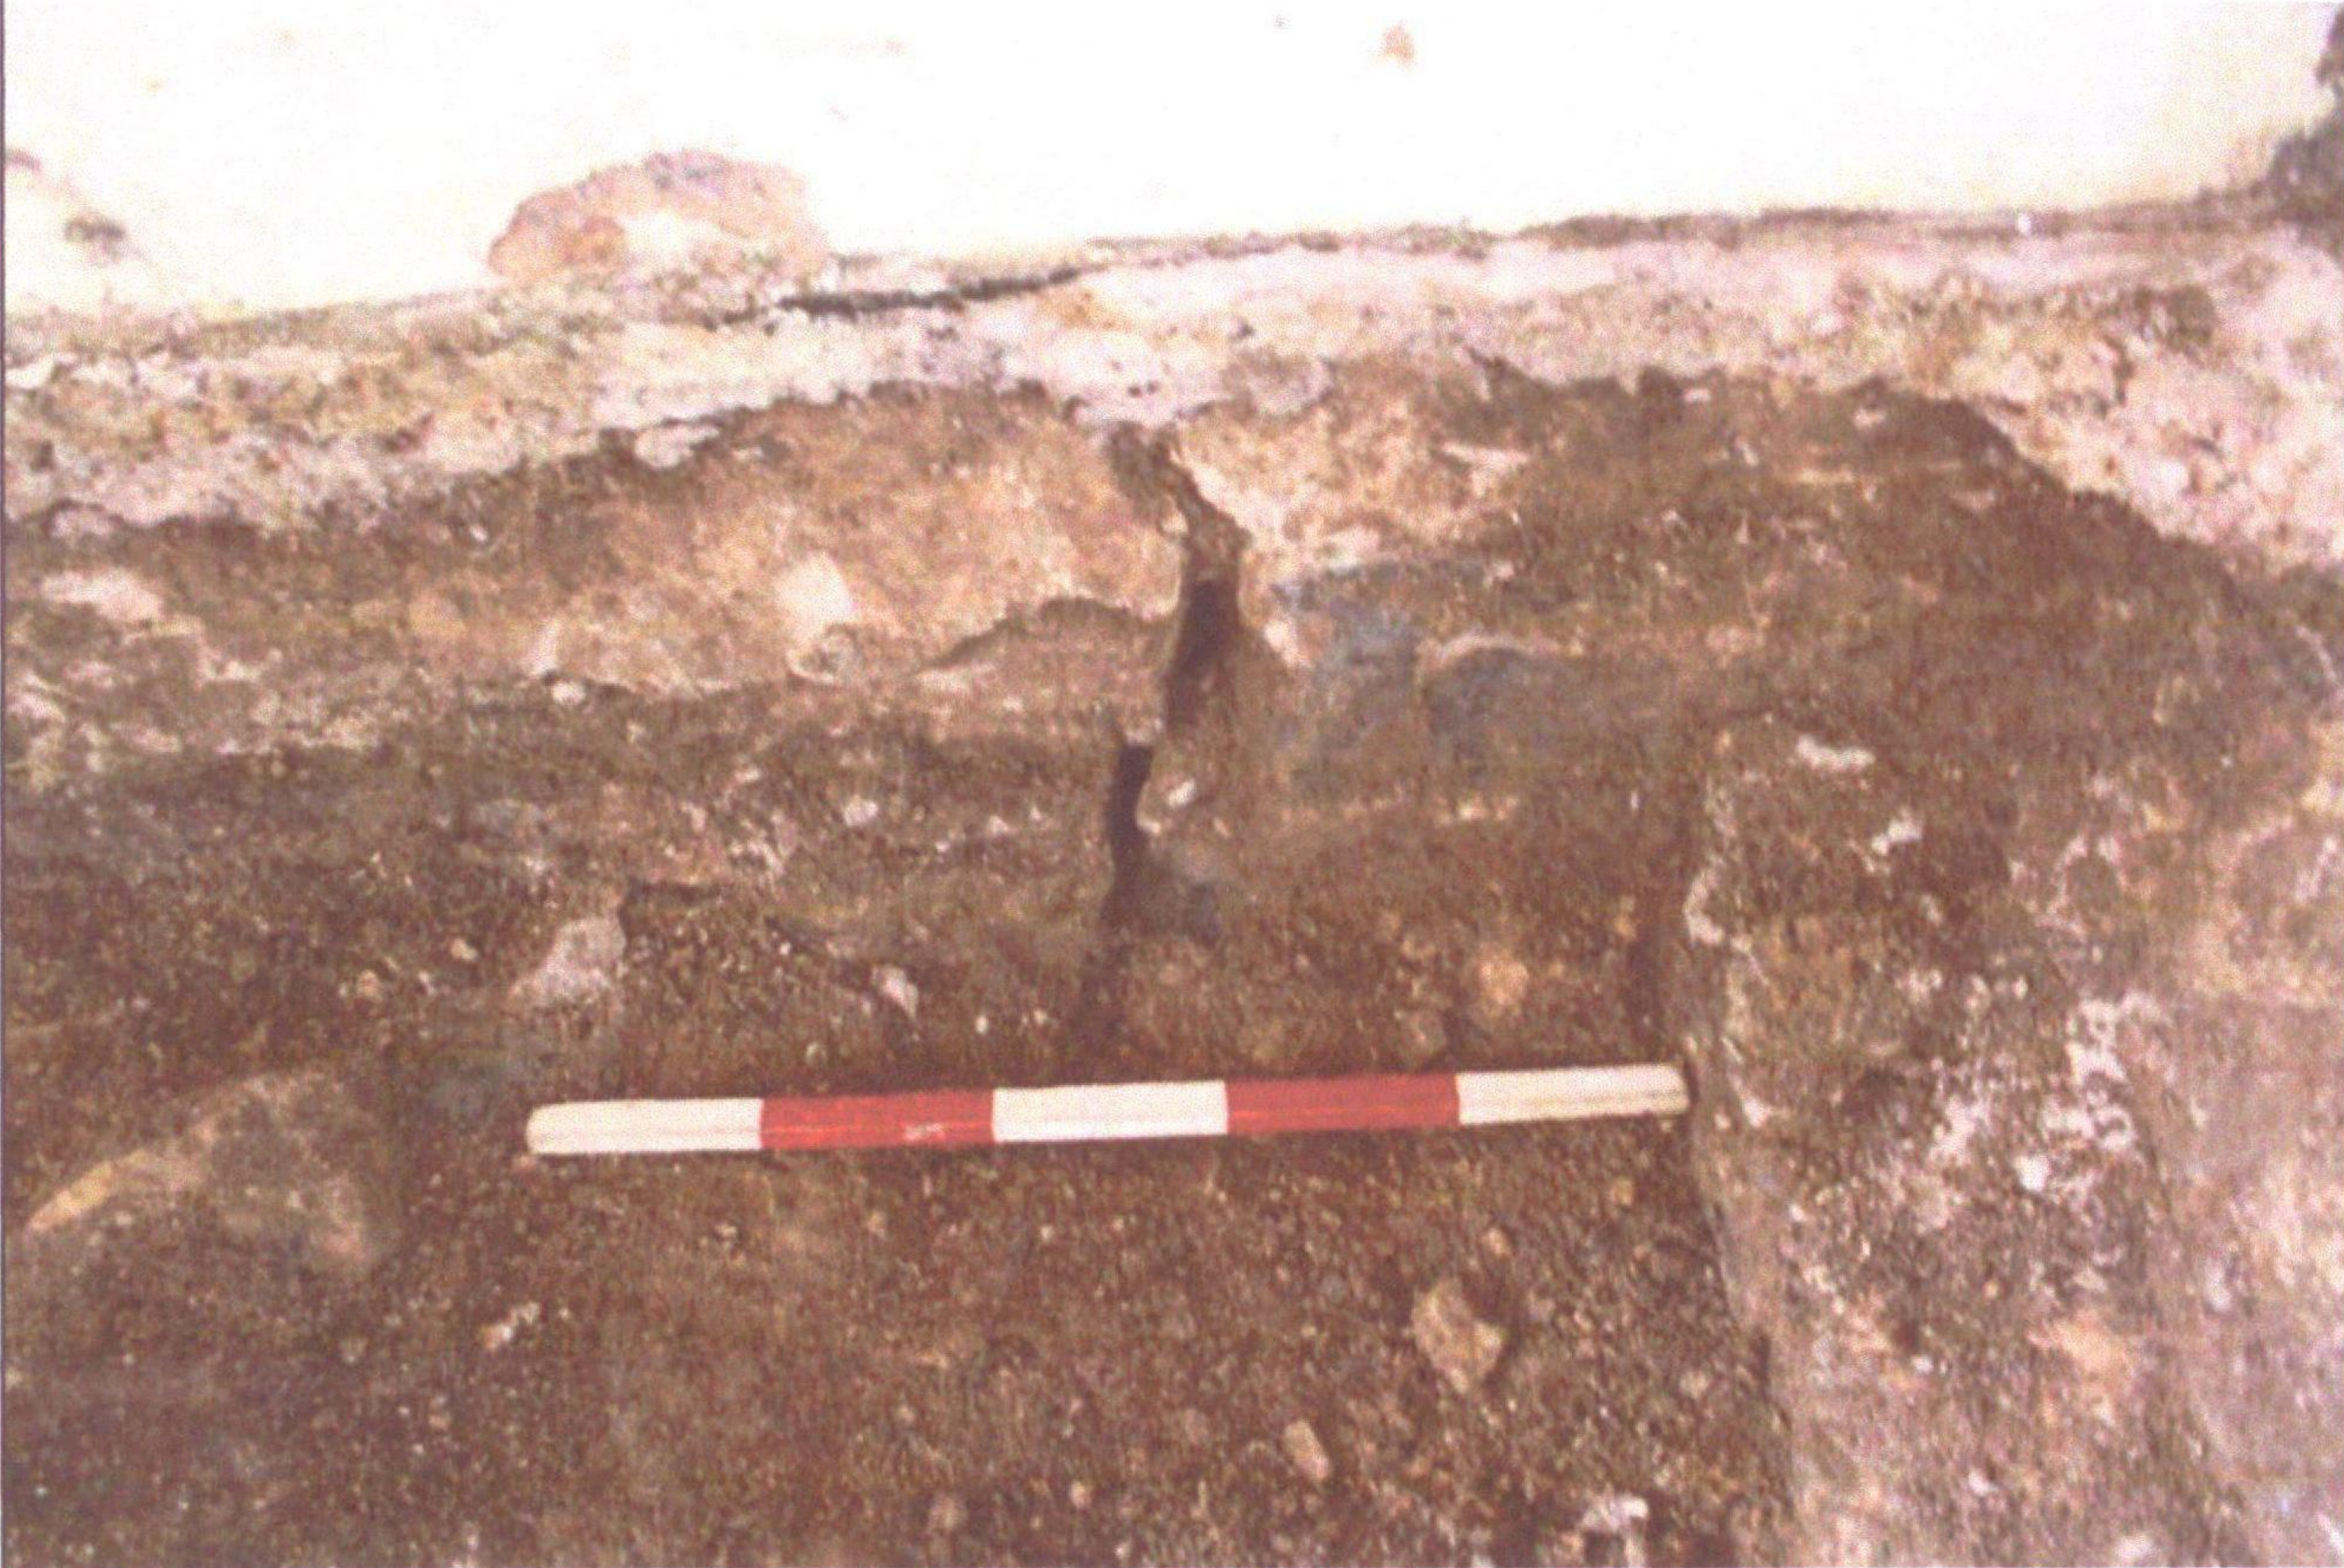
Plate 8

foundation layers on the southern wall of the chancel (**Plate 8**) and south-easternmost column (**Plate 9**).

Internal Shot of Broken South Chancel Foundation

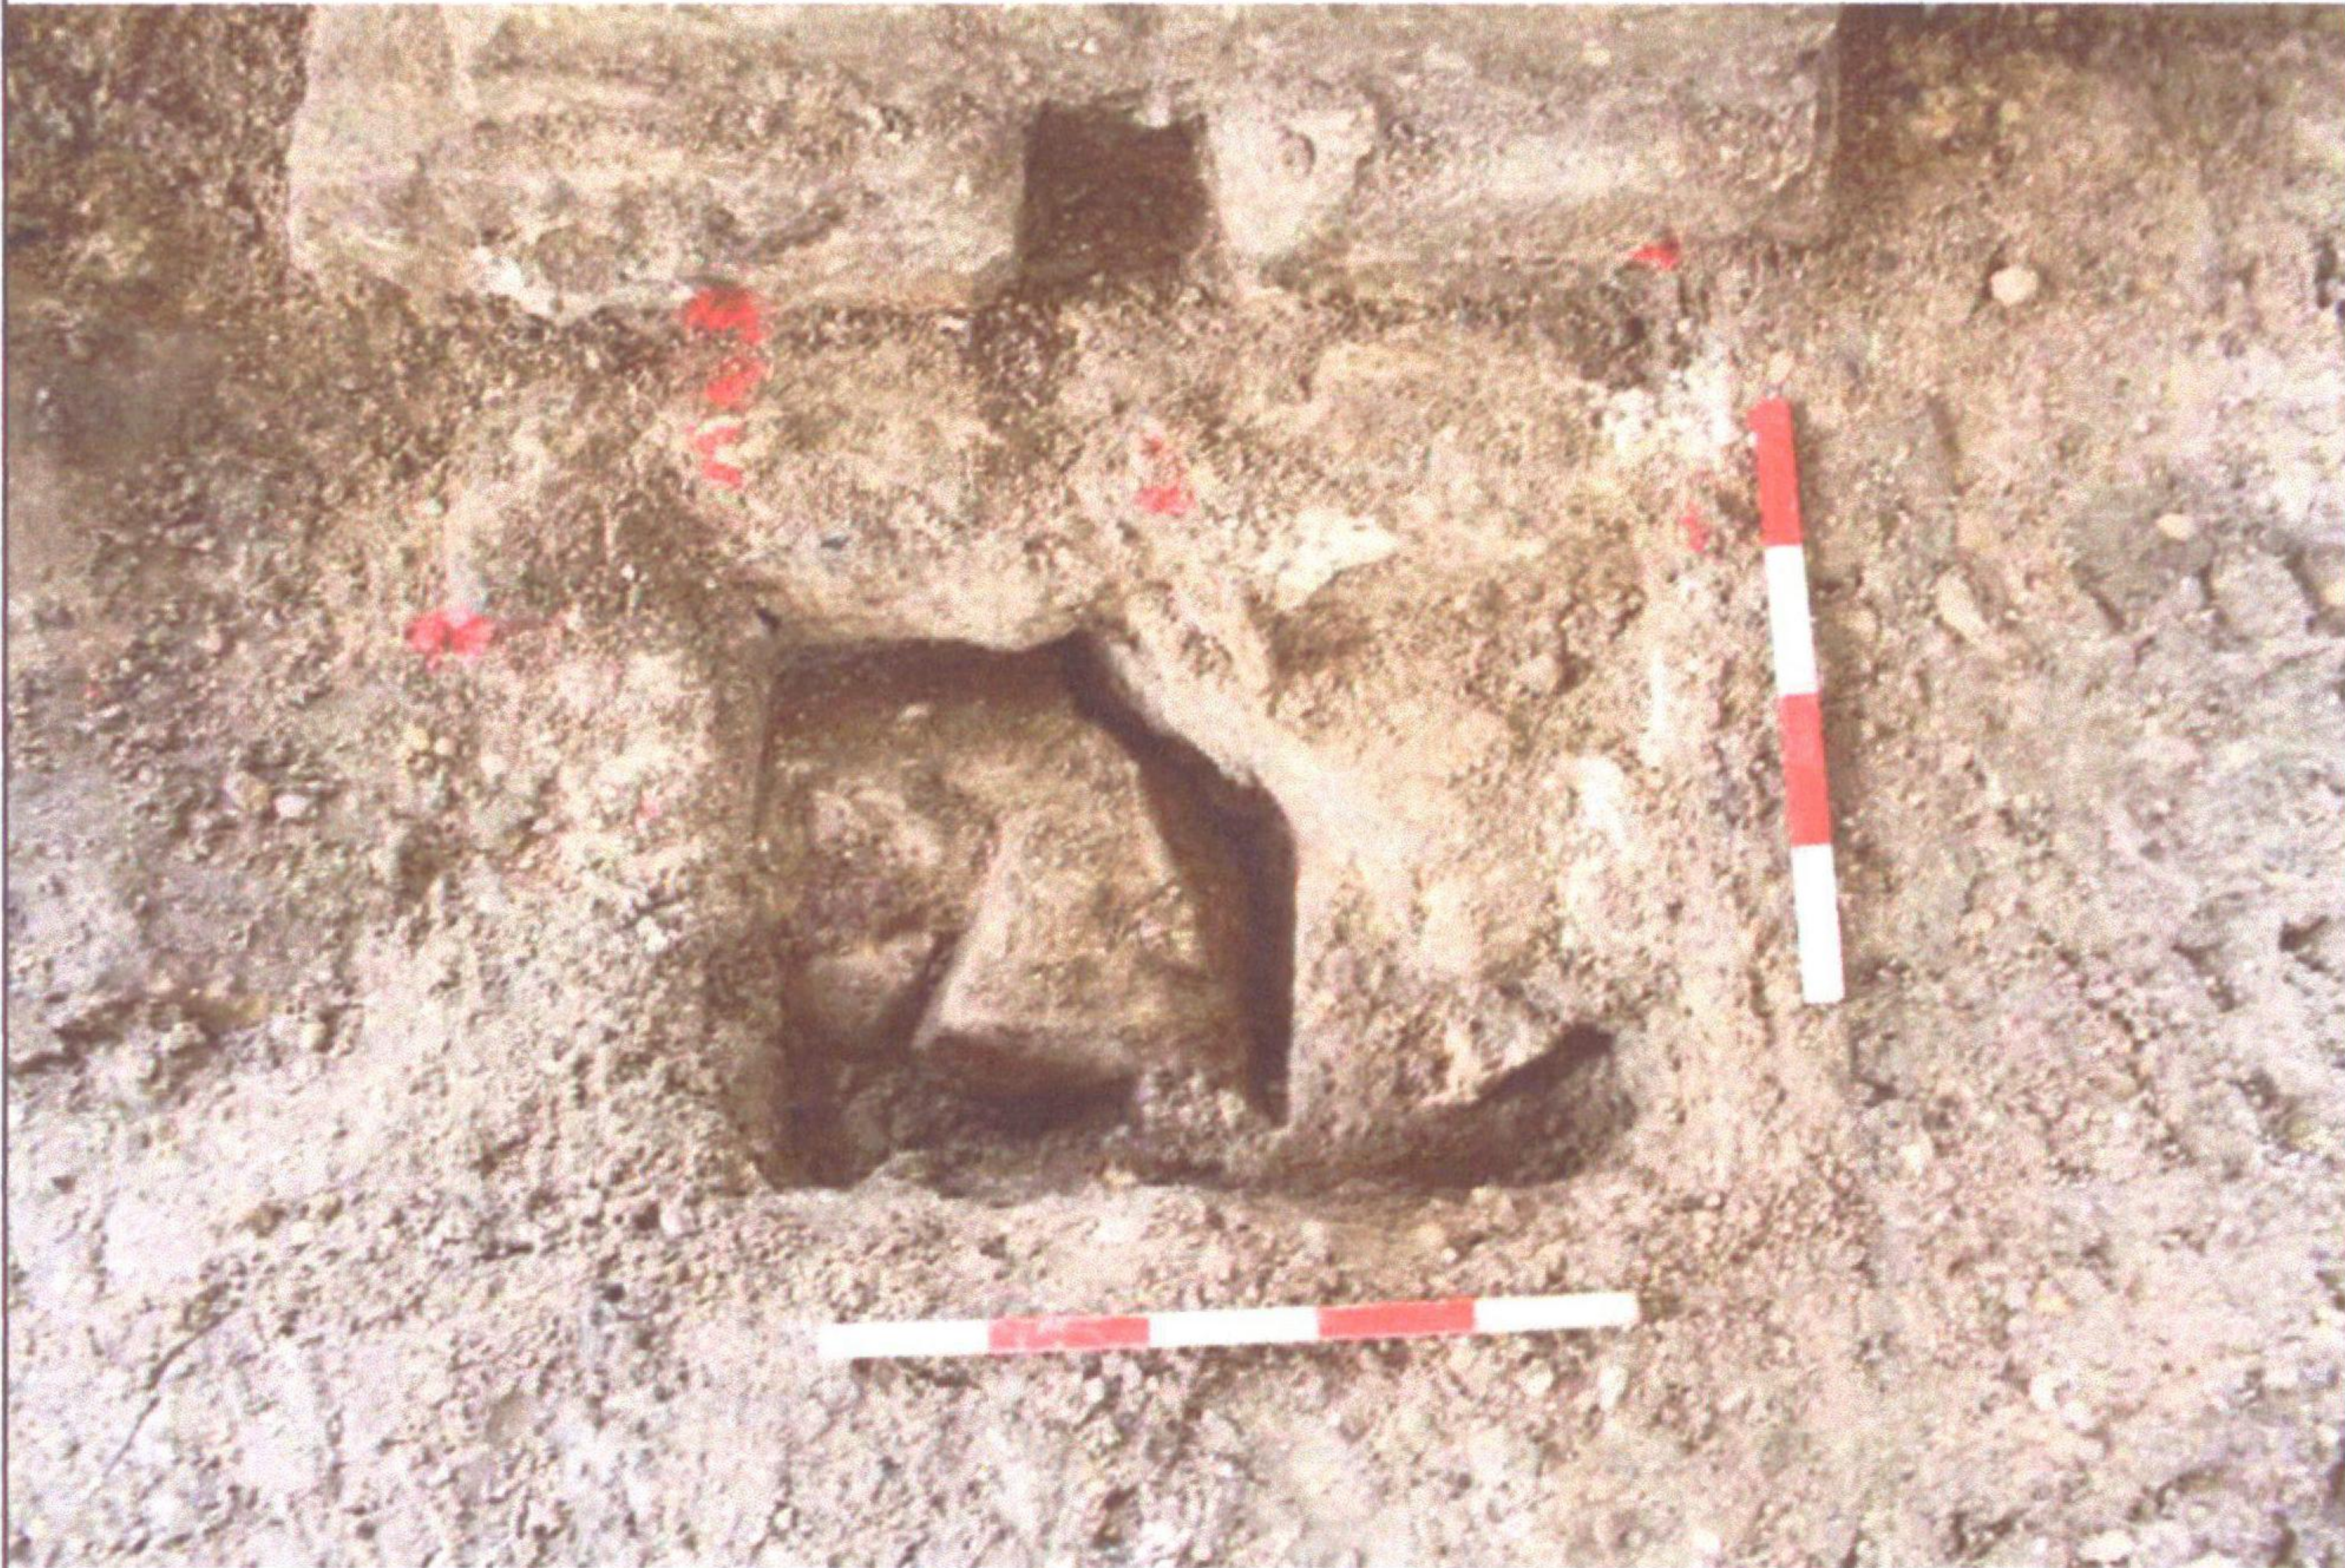
Plate 9

Internal Shot of Broken South Chancel Column Foundation

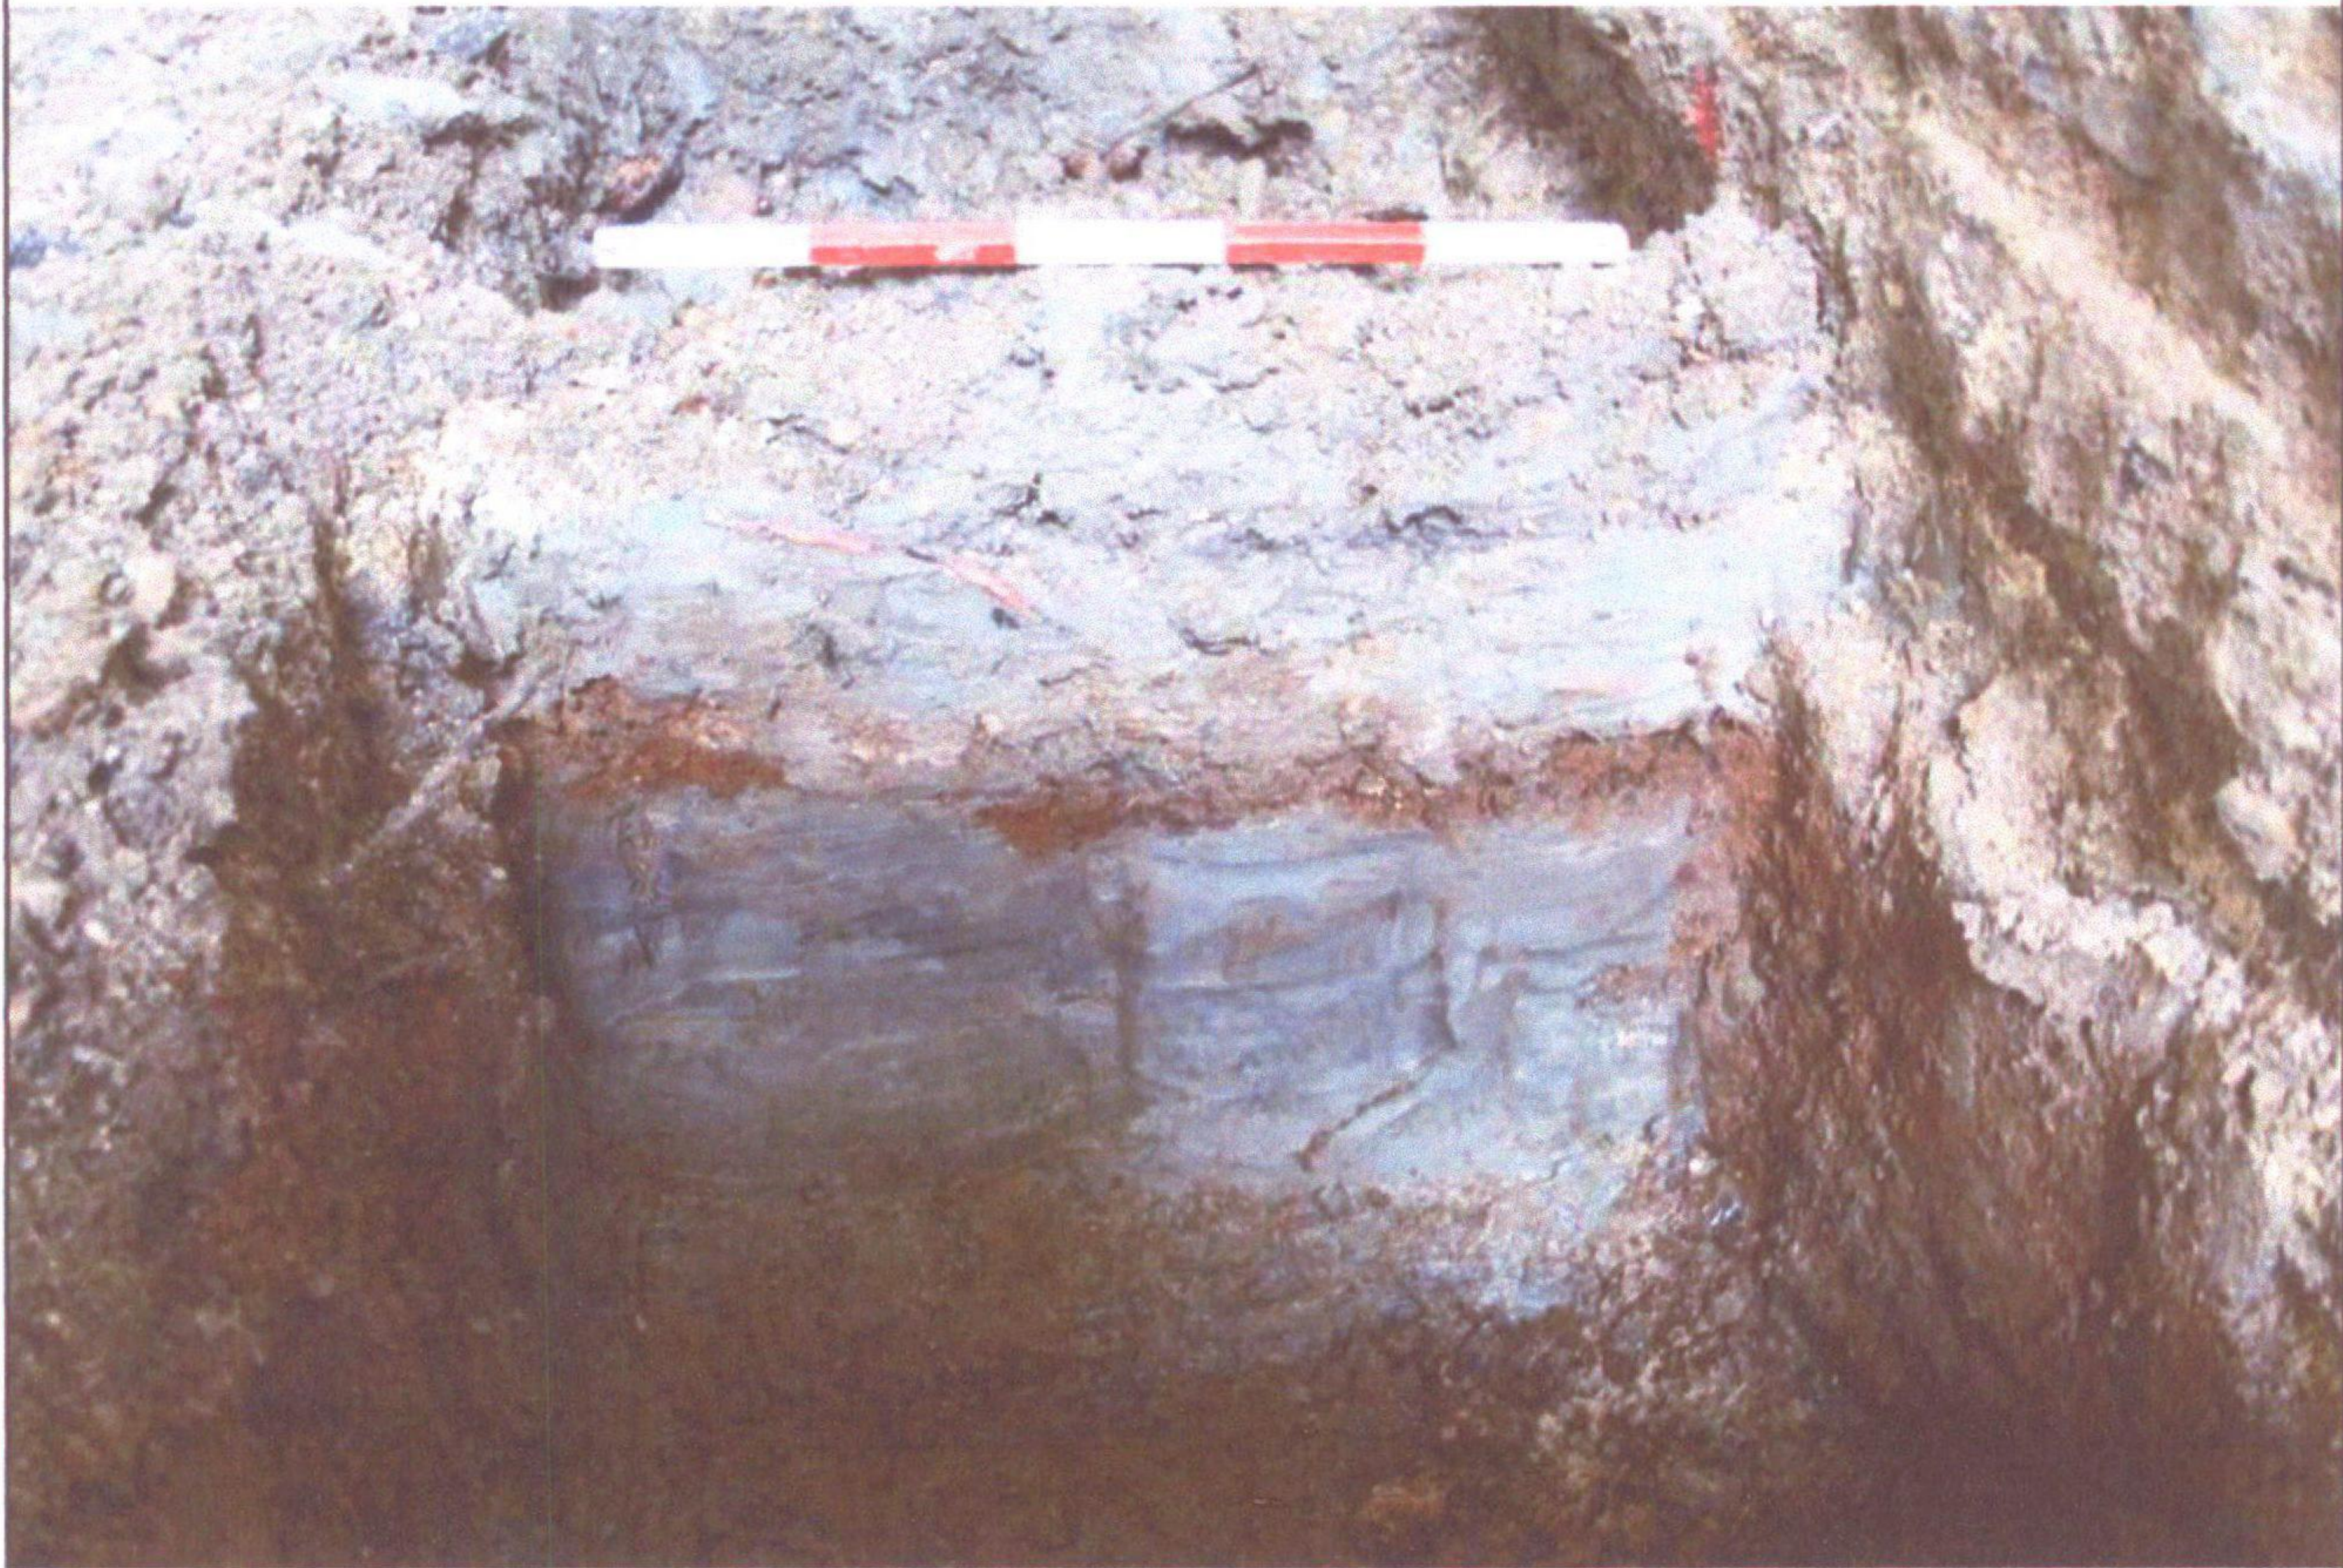
- 4.3.3. Physically overlying deposit (105), deposit (120) was a 0.05m thick, firm to compact reddish-brown clayey-silt gravel with sharp edges which was observed at a depth of 0.53m below the present-day ground level (4.8m aOD) (**Figure 4**). Deposit (120) is a deliberate backfill of unknown origin with well sorted gravels and pieces of lime mortar throughout and was observed sporadically throughout the chancel and nave of the church. The deposit was also observed extending approximately 0.5m around the base of the church columns and extending up 0.14m (4.94m aOD) up from the surrounding layer. Deposit (120) appears to be a foundational layer for the present-day church possibly incorporating a proto floor/binding/levelling layer and lime mortar foundational base for the columns (**Plate 10**).

Plate 10  
Internal Shot of Waster Water Service Trench

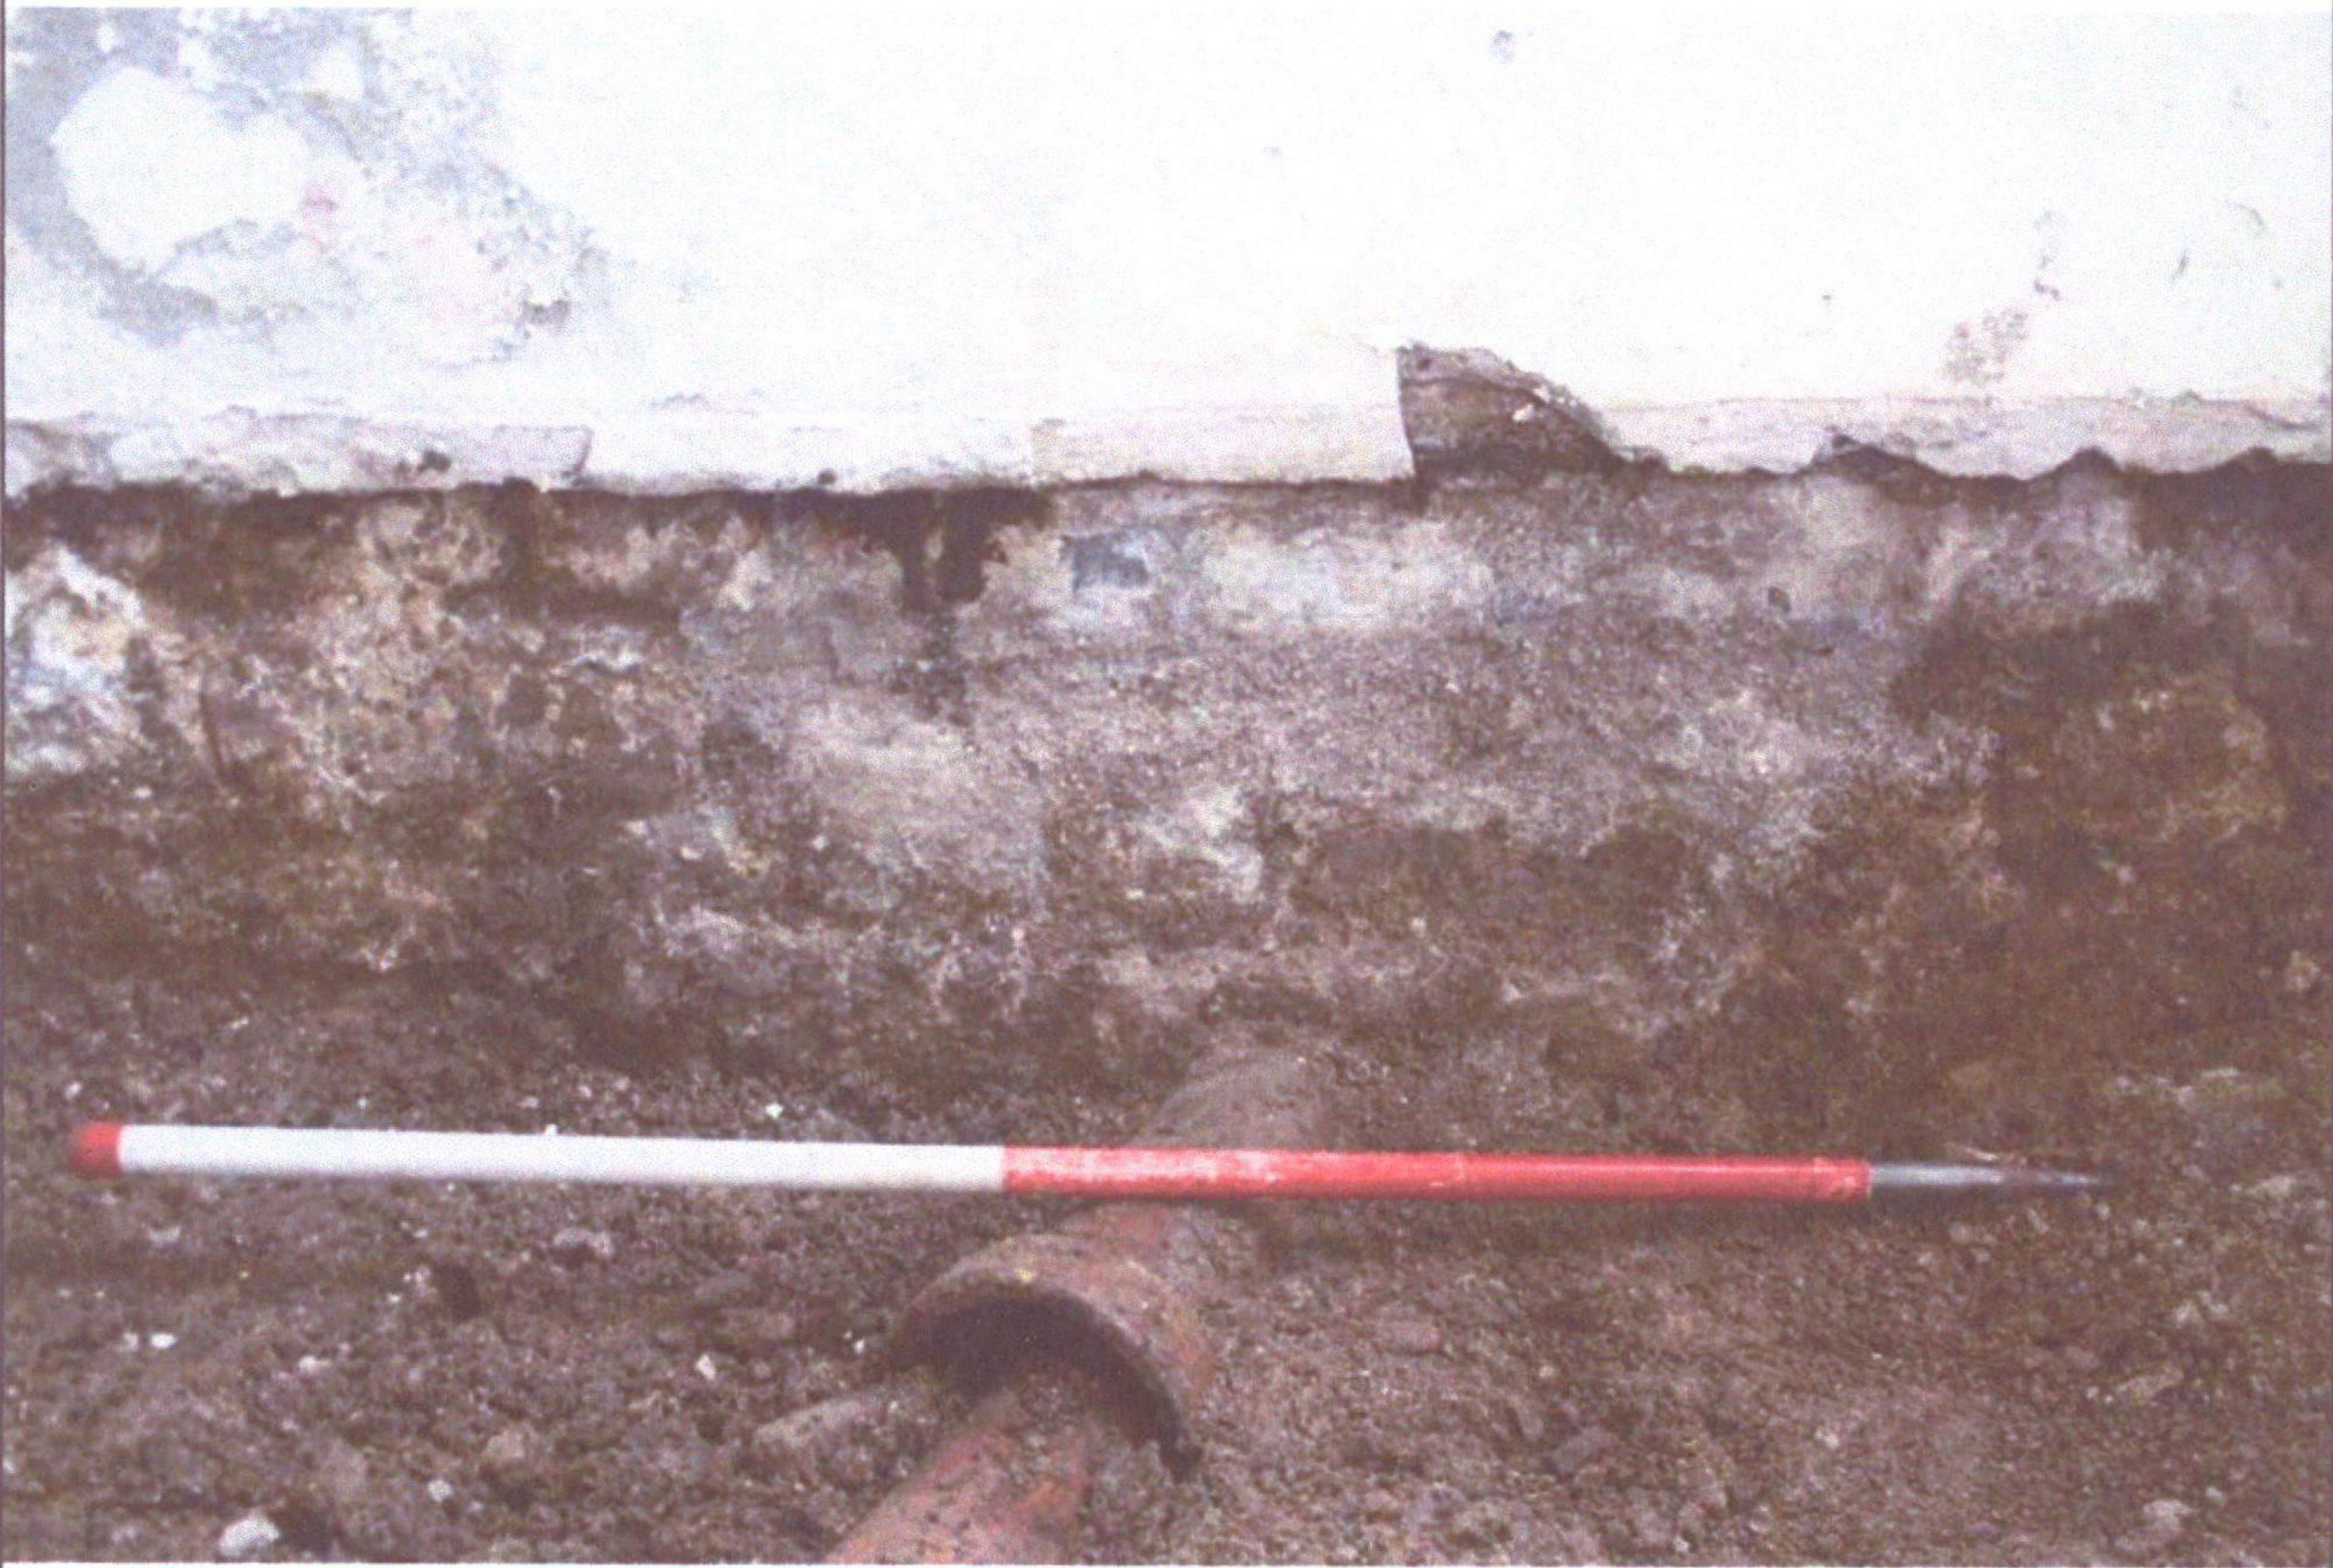
Plate 11

Internal Shot of Clay Pipe and Salt Glaze Drainage

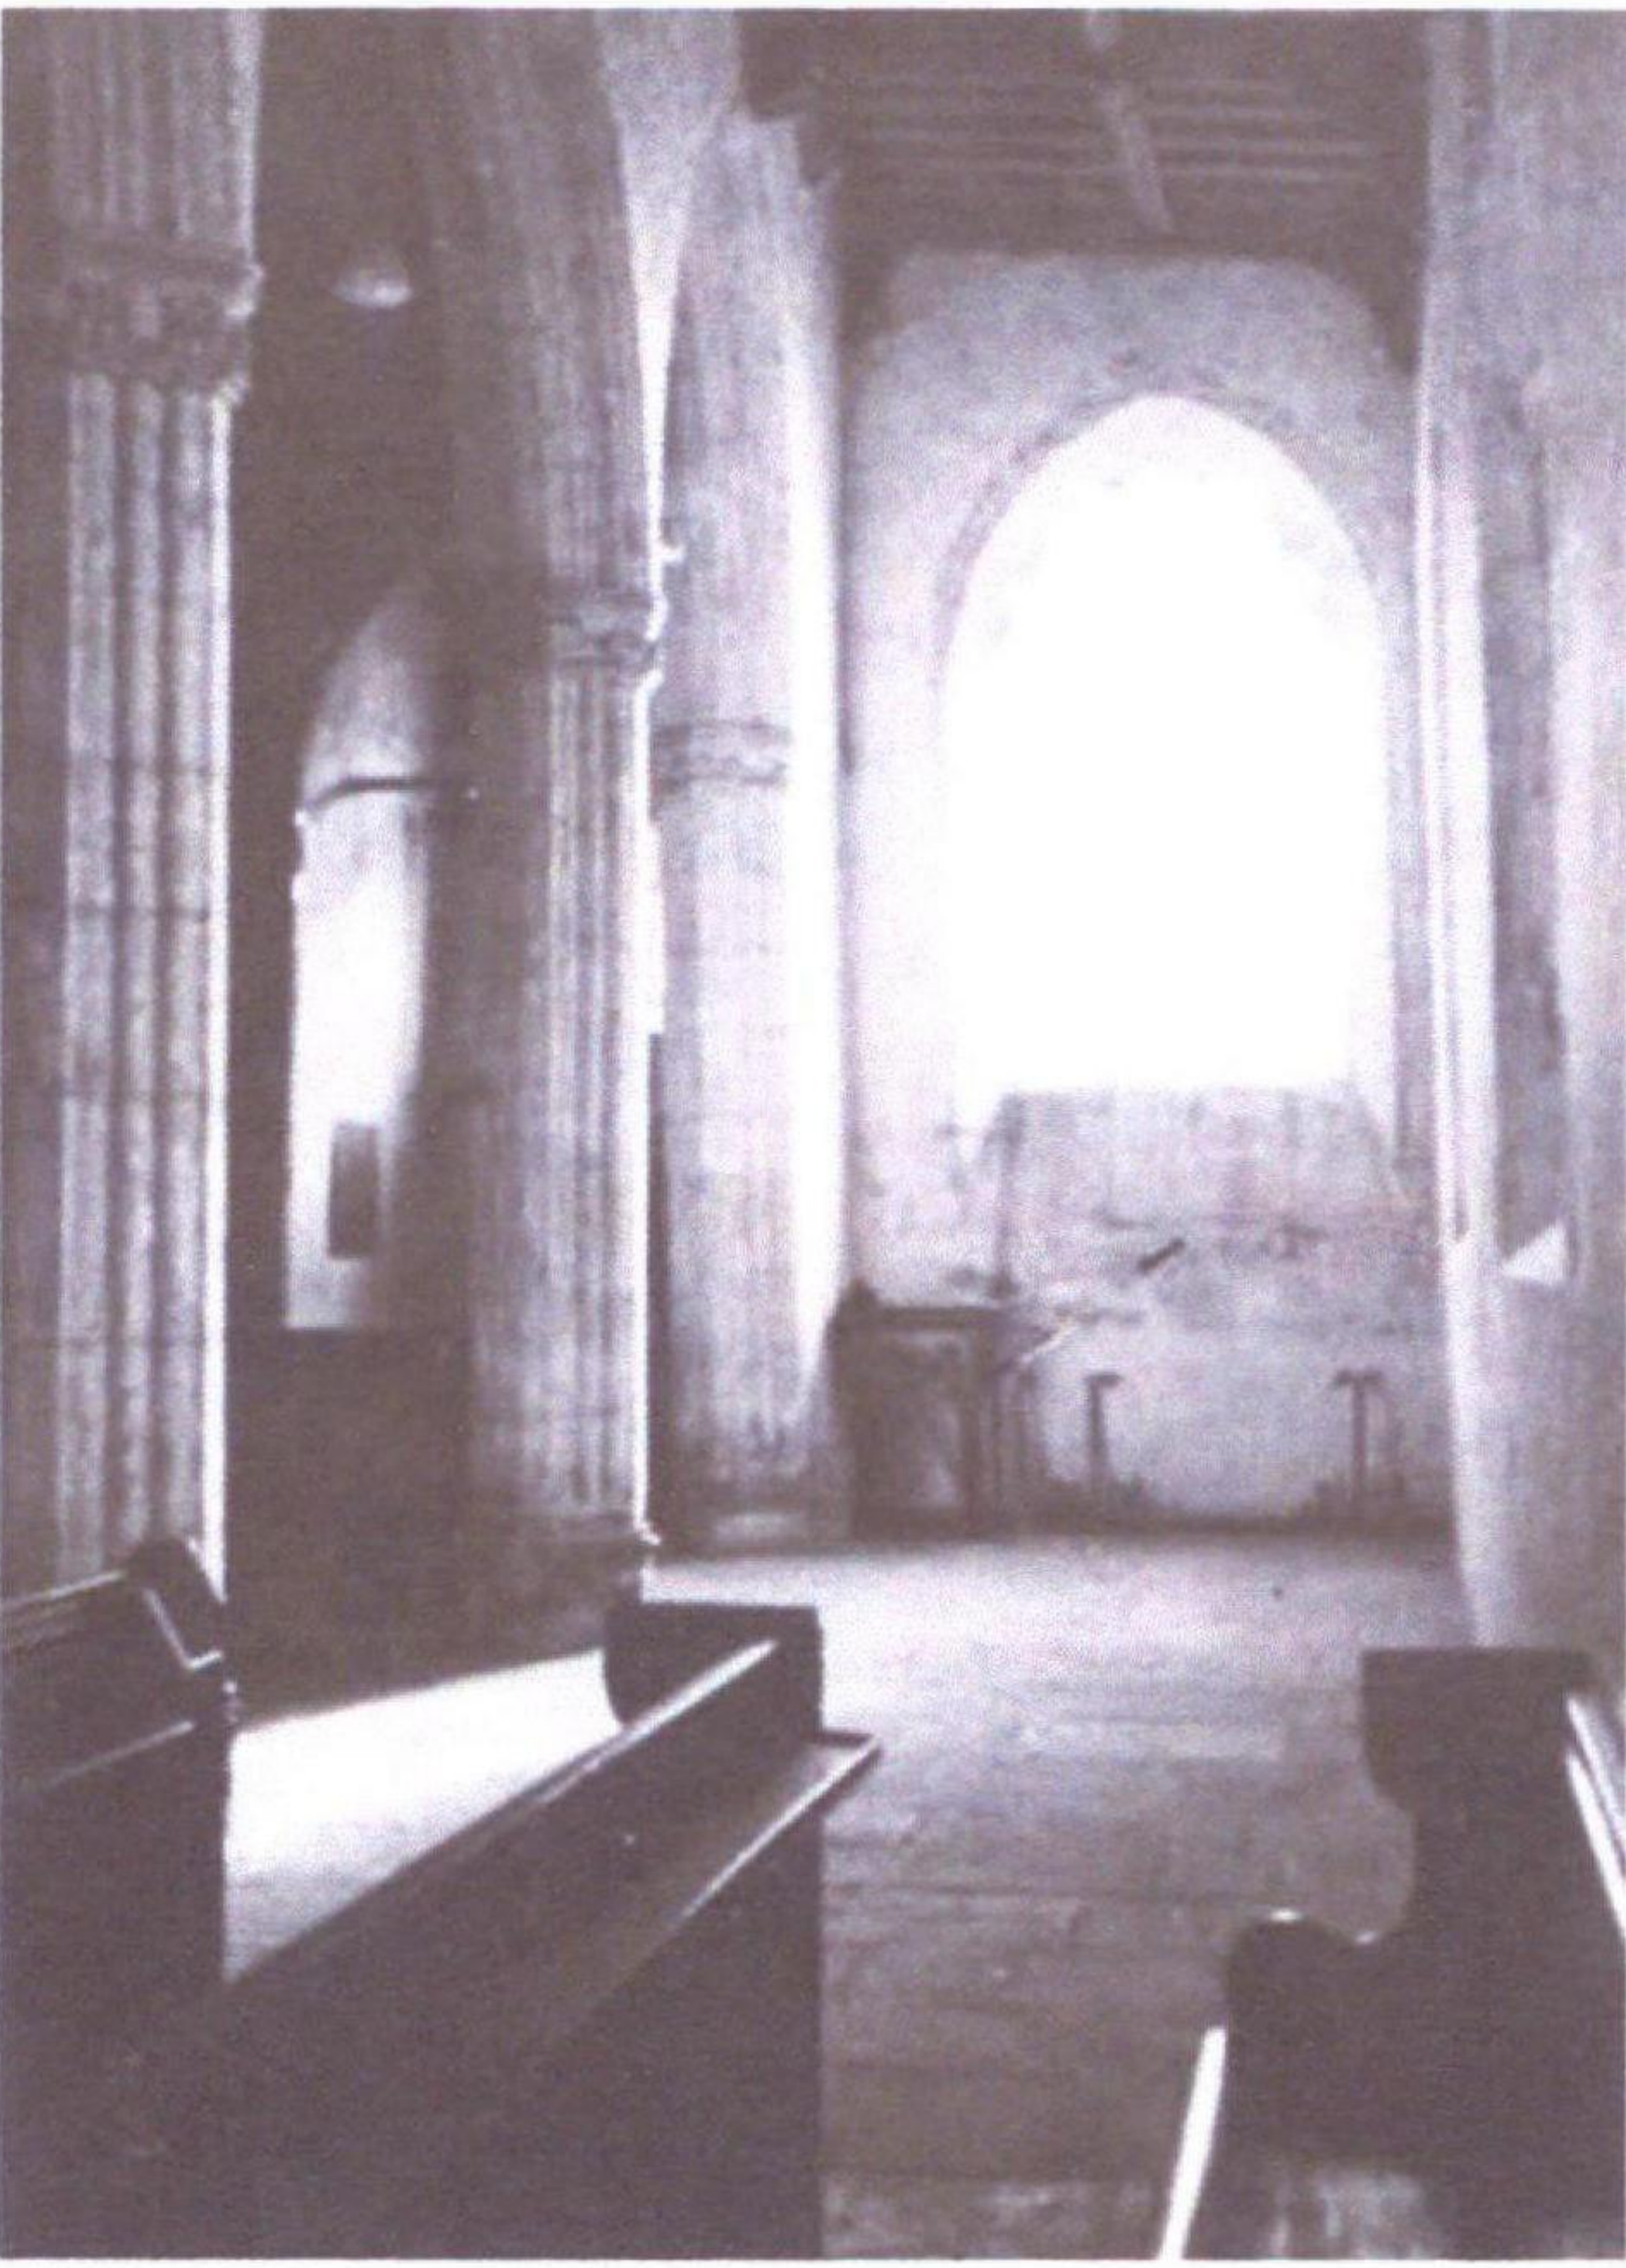
- 8.1.2. **Plate 16** reveals the interior of the north aisle looking west. The interior of the western end of the north aisle appears slightly more faded however this could well be due to inadequate lighting. The western end of the north aisle is bare with the exception of some furnishing at the extreme western extent. The present-day flagstone floor is clearly visible as is the slightly different alignment of the northwesternmost column.

Plate 16  
1949 Internal Shot of St Peter's Church Looking West  
Along the North Aisle  
© Copyright Frith Content Inc, Photo Ref.:P429303
