**RE: Visual Structural Inspection of Glass block Rooflight at Newport Civic Centre**

Cambria Consulting Ltd were appointed by Newport Norse, hereafter known as 'Client' to perform an assessment of the Glass Block Rooflight at Newport Civic Centre, Godfrey Rd, Newport, NP20 4UR, the purpose of the assessment was to inspect the structural condition of the glass block rooflight within the previous education office. We understand an incident where a section of render/concrete detached from the roof onto the suspended ceiling panels below started the investigation into the condition of the roof.

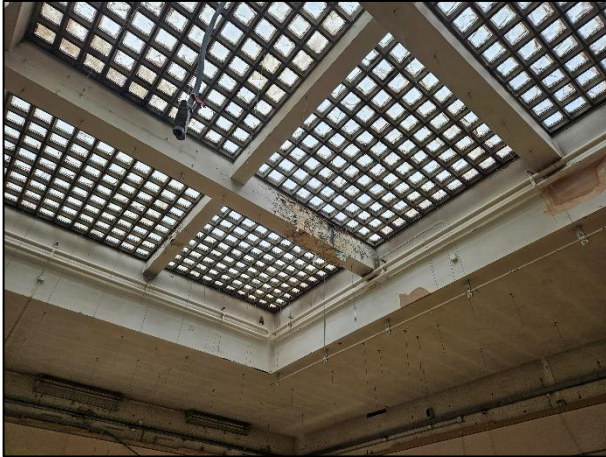
*Photograph 1 – View of Rooflight*

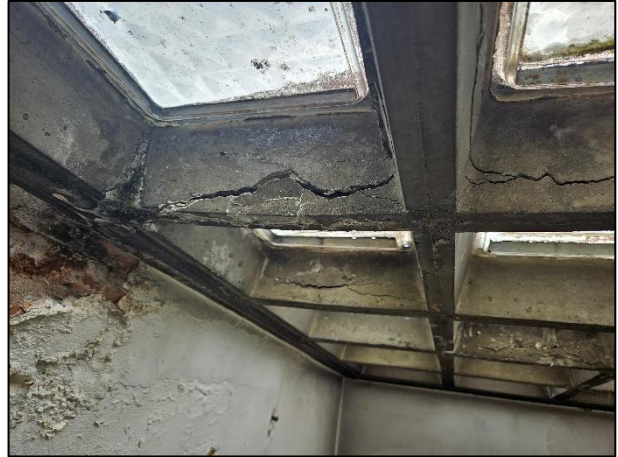
There is cracking and spalling noted to the concrete frame of the rooflight, this was noted as substantive to the size of the sections. The cracking was noted in areas to be circa 15mm. **See Photos 2,8-11.**

*Photograph 2 – Close up of cracking to concrete supporting frame*

Following future consultation with concrete specialist regarding the findings of their intrusive investigation we would recommend that the concrete frame for the Rooflight be replaced, unless the concrete specialist believe there is an alternate approach for remediation, this would need approval from Cadw historic environment authority.

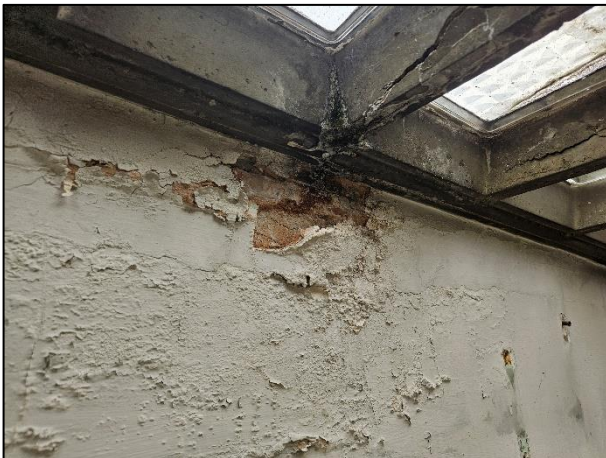
*Photograph 3 – Deterioration to main RC beams*

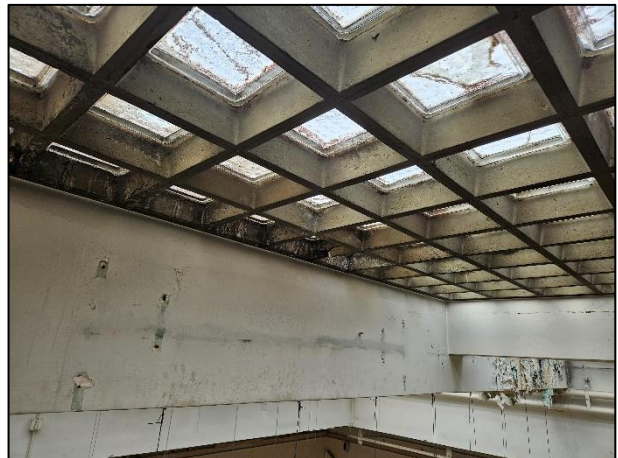
*Photograph 4 – Showing section of Glass Rooflight*

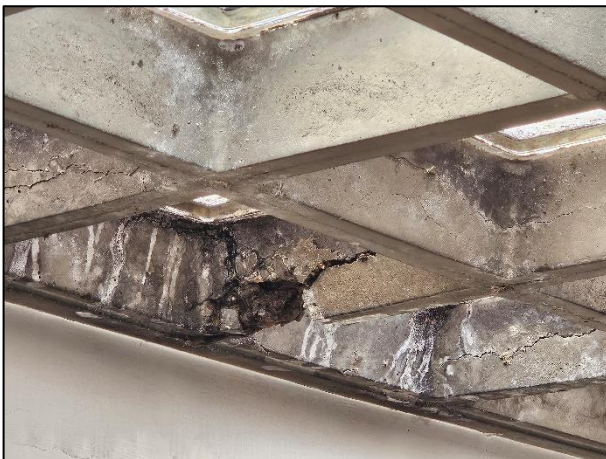
Spalling has also been noted to these members in area there is a loss of section of up to 50%. The rebar has also deteriorated, and a loss of section has additionally been noted to the reinforcement bars. **See Photos 5,15.**

*Photograph 5 – Large section of concrete missing from concrete rooflight frame*

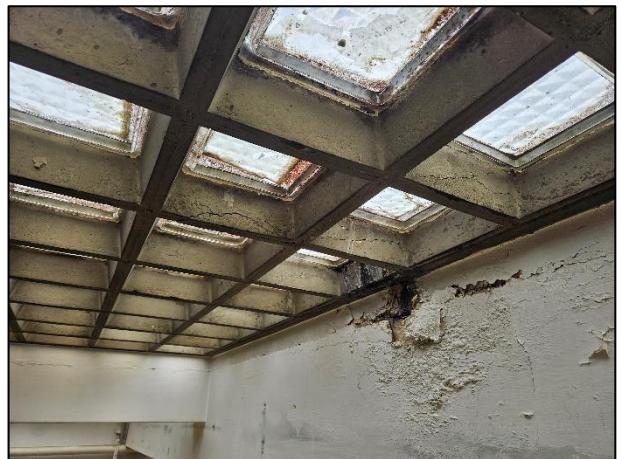
Water ingress has been identified to the structure which has caused areas of damp and likely the culprit to the cause for spalling is such a substantive extent. **See Photos 6,12-13.**

*Photograph 6 – Water ingress to main RC beam*

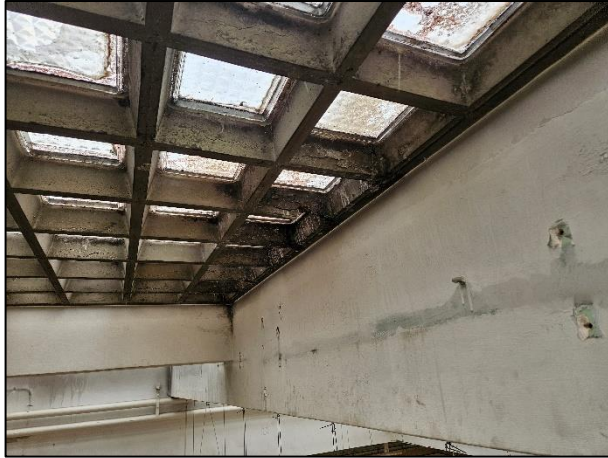
*Photograph 7 – Perforations to RC beam*

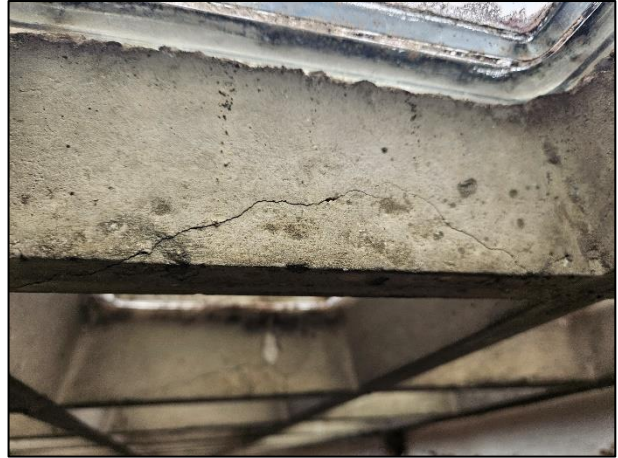
*Photograph 8 – Cracking to concrete rooflight frame*

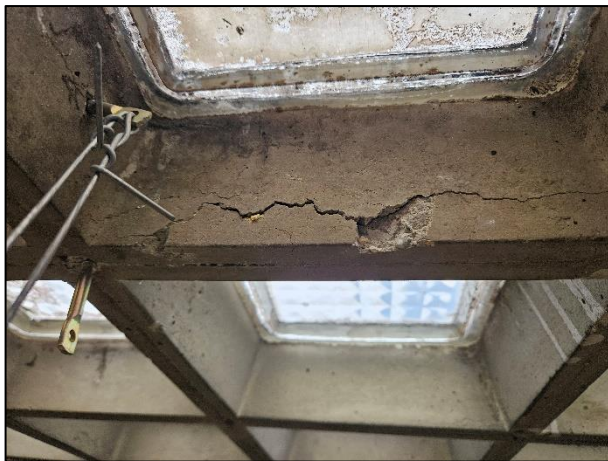
*Photograph 9 – Additional cracking to the frame*

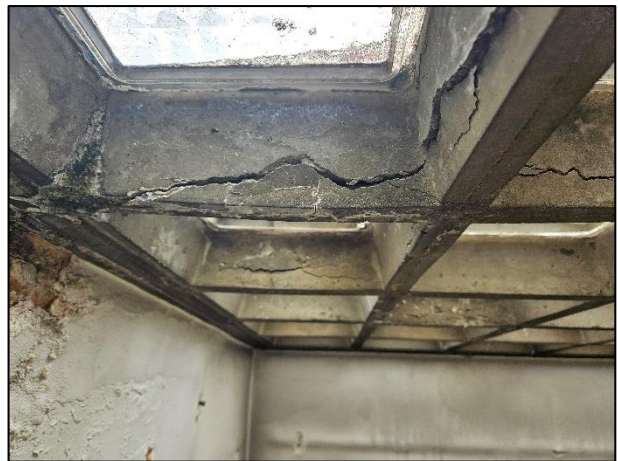
*Photograph 10 – Severe cracking to the frame in separate location*

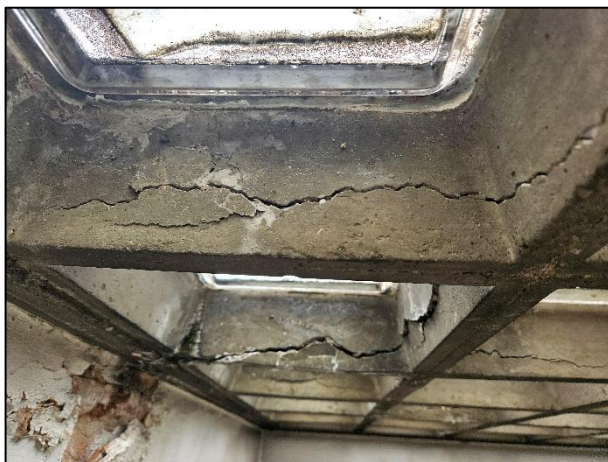
*Photograph 11 – Additional noted cracking*

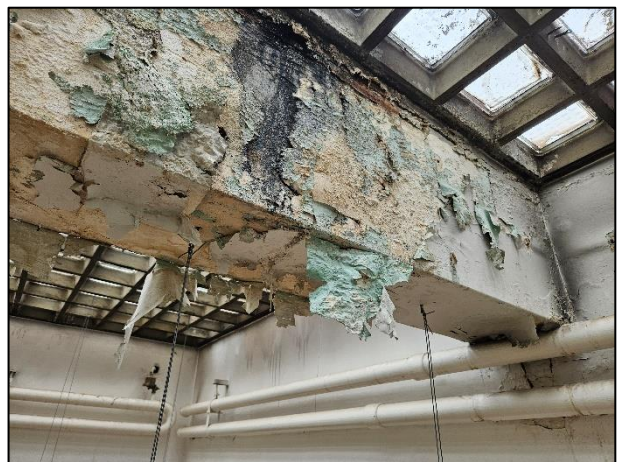
*Photograph 12 – Large deterioration to main RC beam exterior*

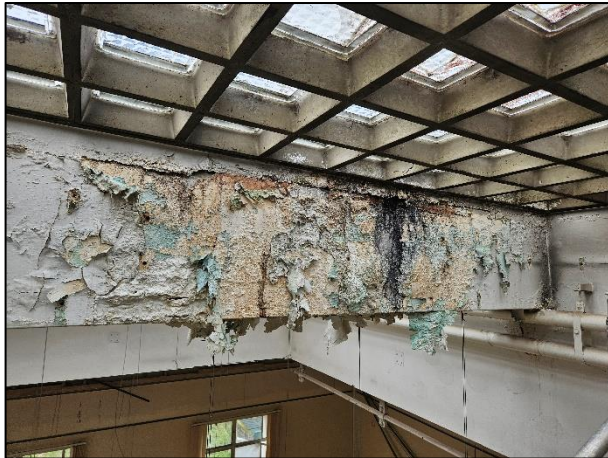
Photograph 13 – Further section on main RC beam damage

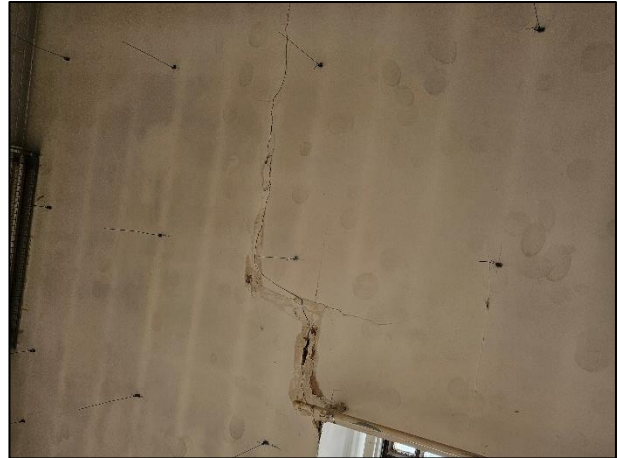
Diagonal cracking has been noted from the corner of the window to the roofline. It is unclear if this is just within the plaster finish to the wall or whether it extends into the structural wall behind. **See Photo 14.**

Photograph 14 – Diagonal cracking propagating window to roof

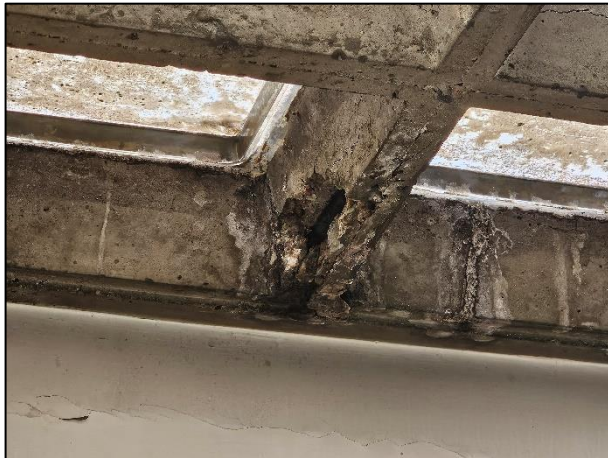
Photograph 15 – Close up of spalled area concrete from rooflight frame

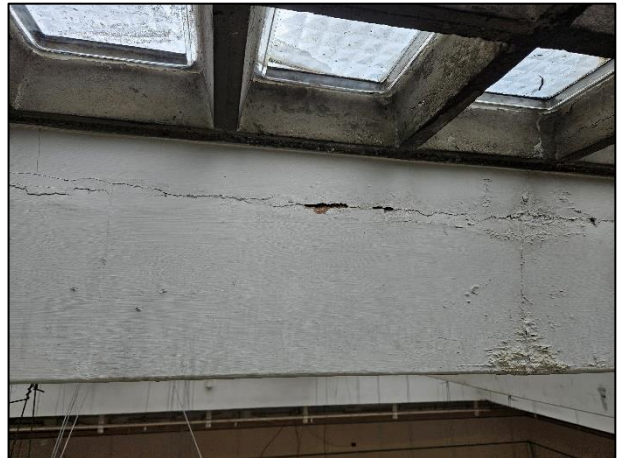
There is cracking noted to the primary RC beams additionally. **See Photos 16-17.**

Photograph 16 – Cracking to the RC beam horizontally

It would be advised that the removal of any external coatings (plaster) to the RC beams as to ascertain if there are any additional cracks to the underside of the beams. Any areas where there are cracks should be addressed and if there is any exposed rebar the methodology below should be followed.

Patchwork repairs are recommended to all cracked or spalled concrete. Many products are available within the UK such a manufacturer of a product is Sika (OSA) and are available for the proposed concrete repairs and protection of the beams from further deterioration.

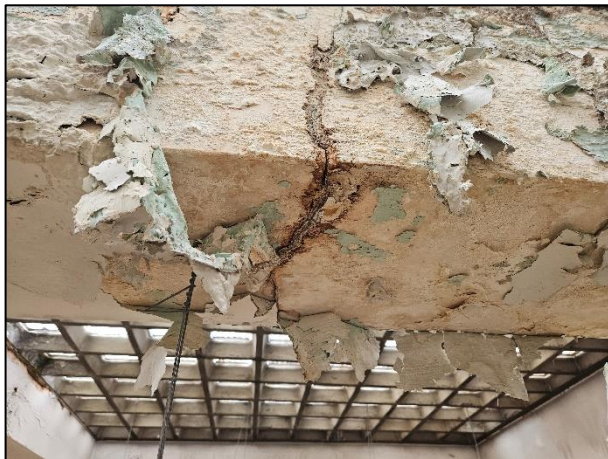
Photograph 17 – Large crack in RC beam up close

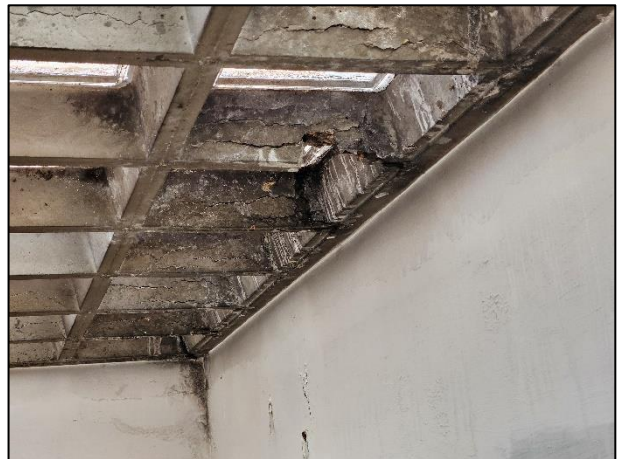
Photograph 18 – Spalling and cracking to Rooflight frame
