## Arboricultural survey report

Tree safety and condition survey of trees in indicated areas at:  
Priory Drive and Catsash Road, Langstone, Newport, Gwent. NP18 2LZ.

*27<sup>th</sup> October, 2025*

WTS reference: Catsash Road\_TSR\_RJW\_271025

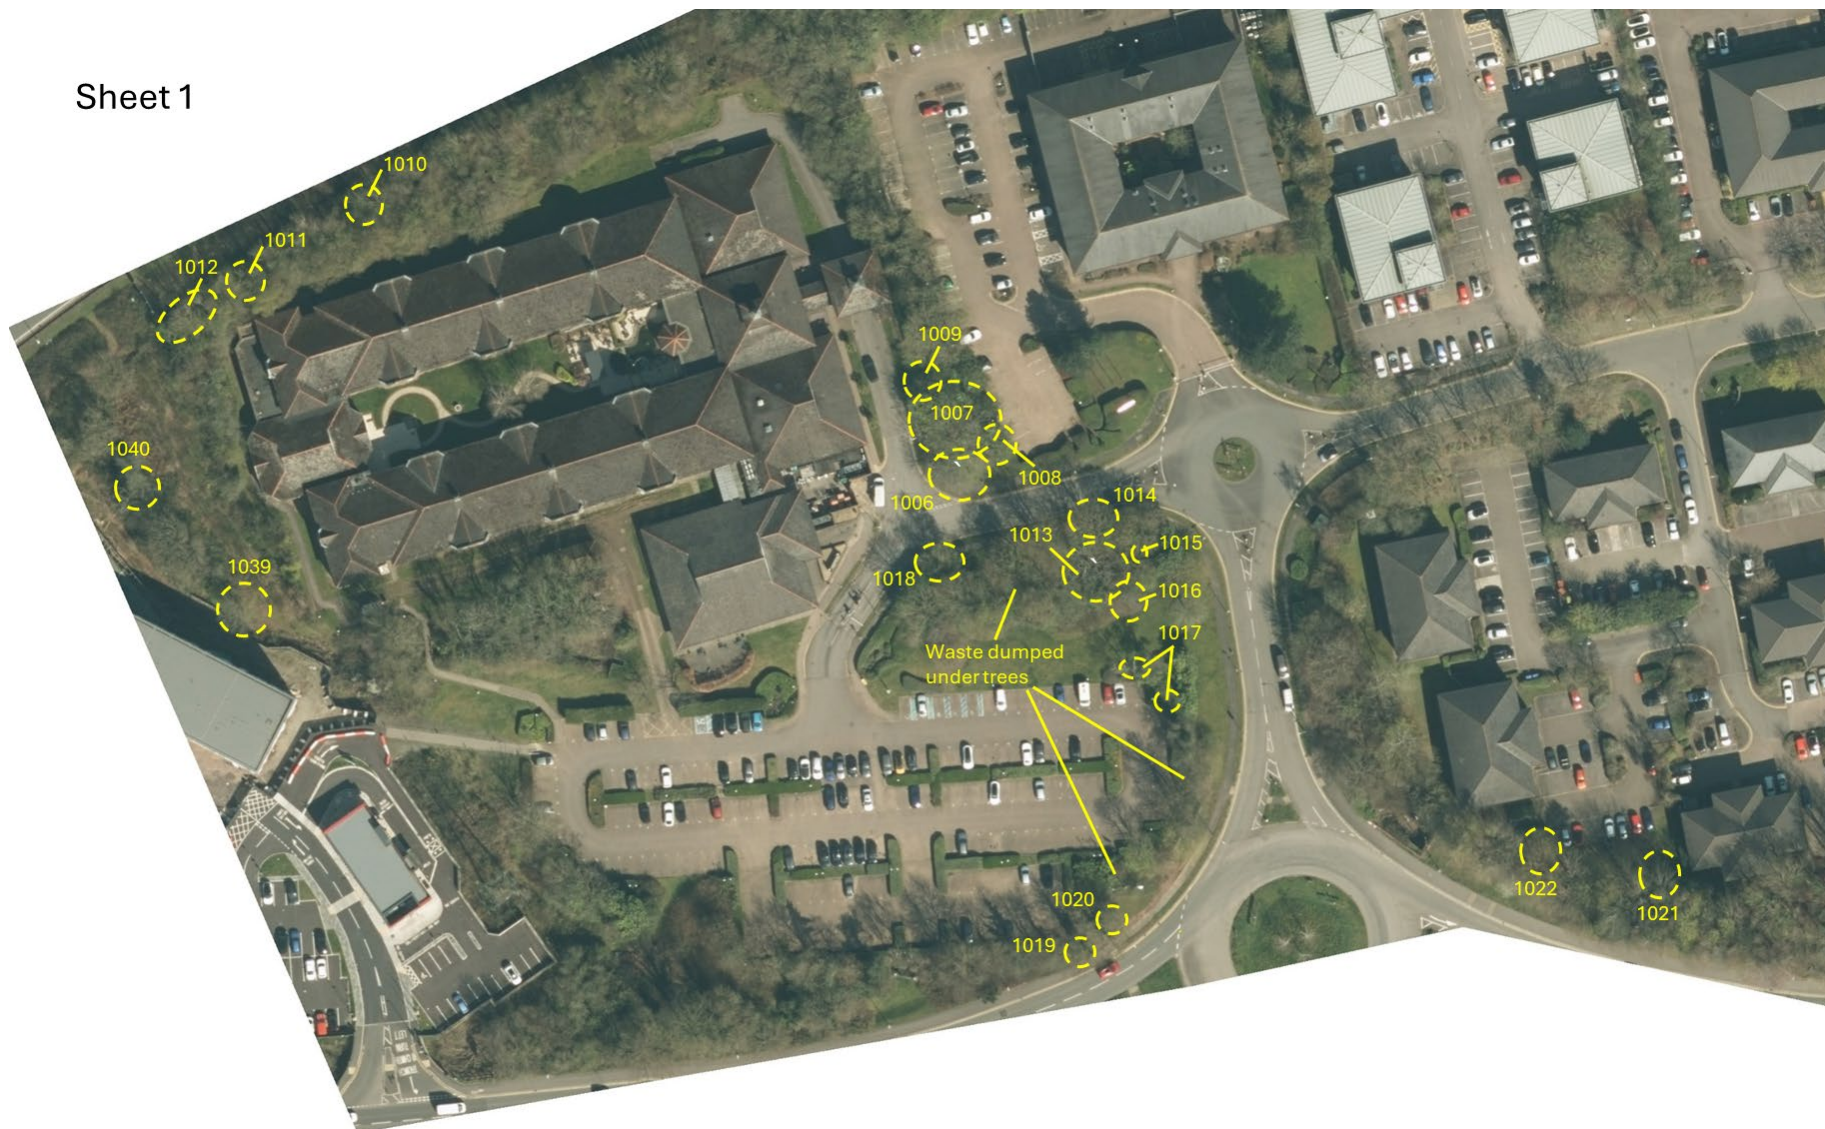
Sheet 1

Large quantities of green waste were found in the vicinity of trees 1013-1018 (map sheet 1). Small quantities of such material are of little significance and can generally be ignored. However, large quantities have negative impacts on trees and should not be allowed to accumulate. Through a complicated series of inter-related processes, decaying green waste acidifies soil and depletes nitrogen resulting in poor root function and a lack of nutrient availability for the whole tree. I advise that steps be taken to reduce the amount of waste deposited in this area and prevent the accumulation of further deposits in the future.

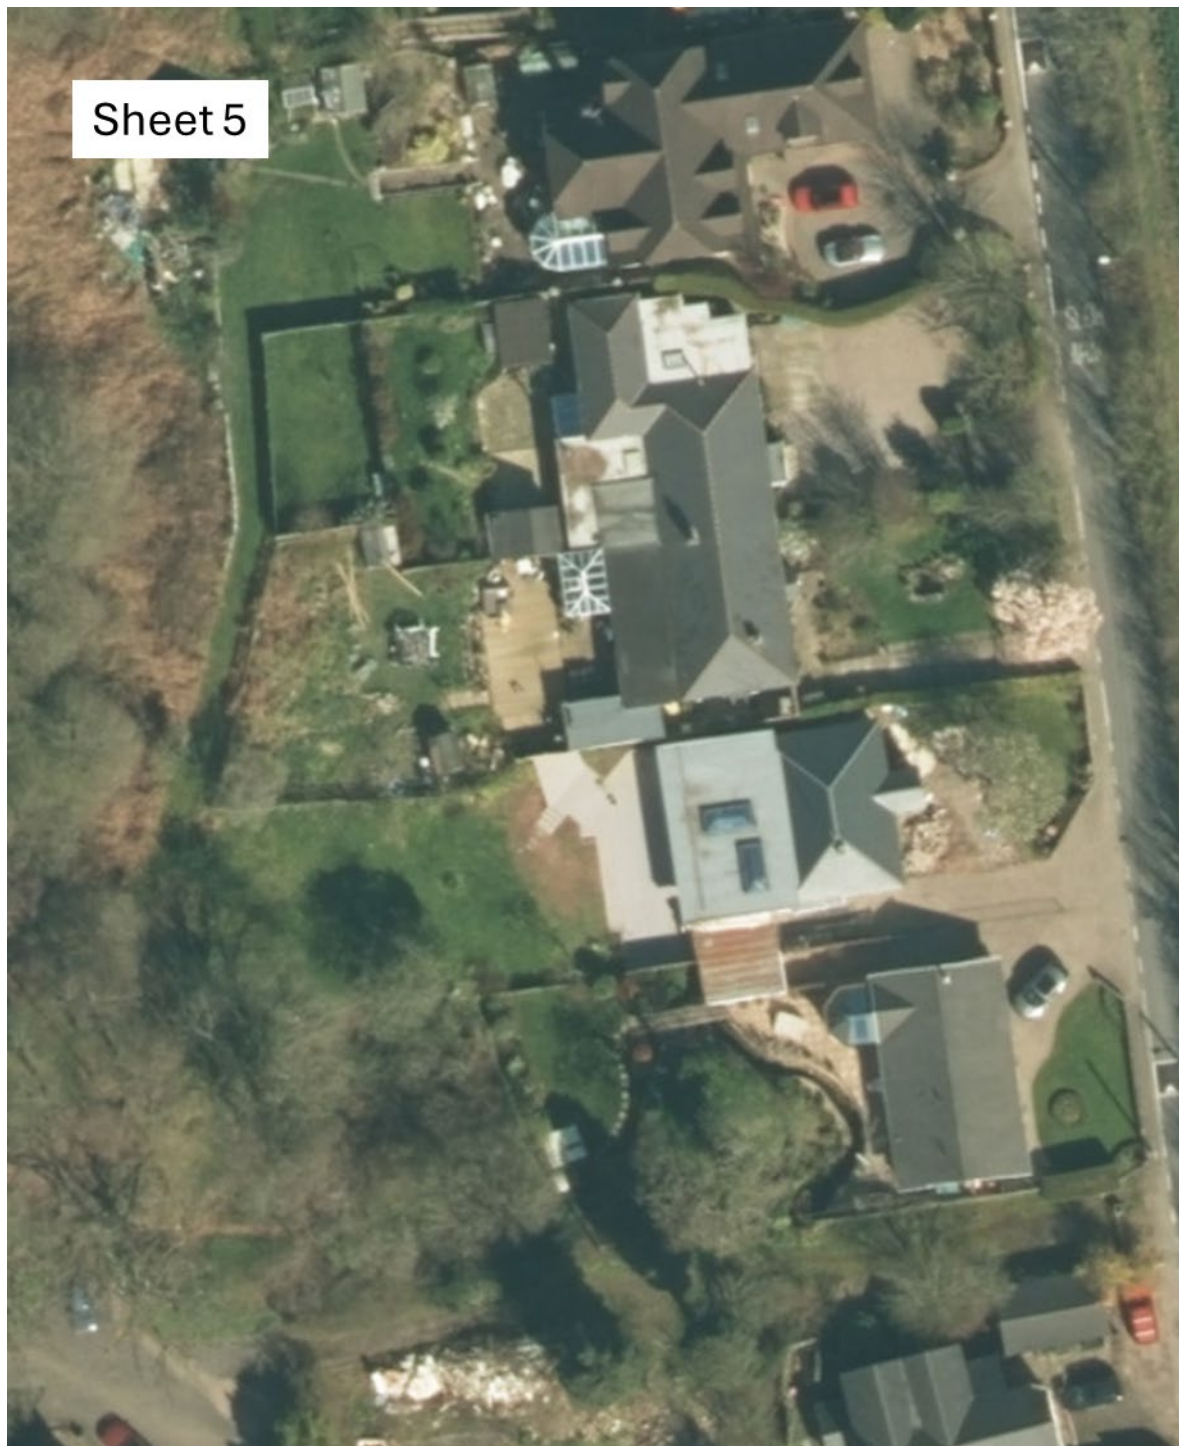
The area I was instructed to inspect has now been enclosed by private third party gardens is no longer accessible and was observed not to contain any trees.
