Photographic record – External condition schedule – Wall along high street  
Report undertaken 23<sup>rd</sup> October 2024

External wall along High street - WCs (Boys & Girls) & entrance lobby windows.

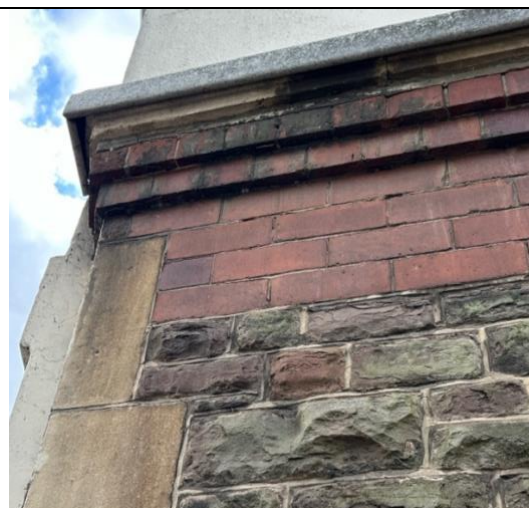
Corner junction with Broadway

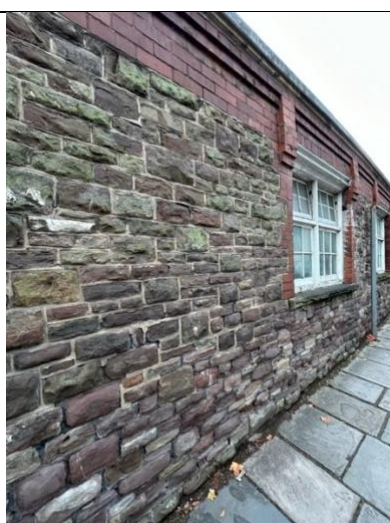
Brick upper courses, rockface stone below with bath stone at the corner junction – discoloured

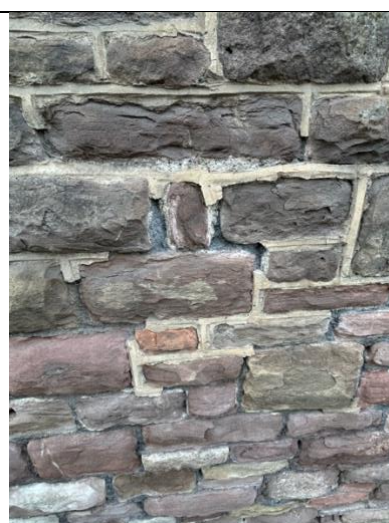
Weathered finish

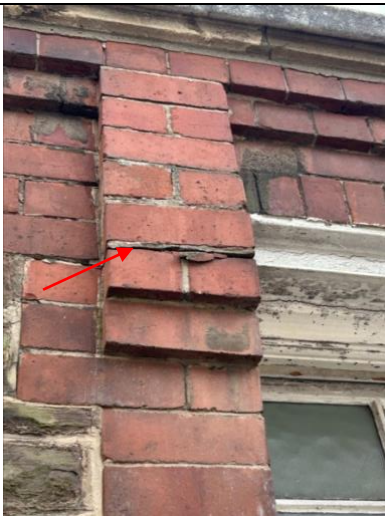
Brick detailing around window

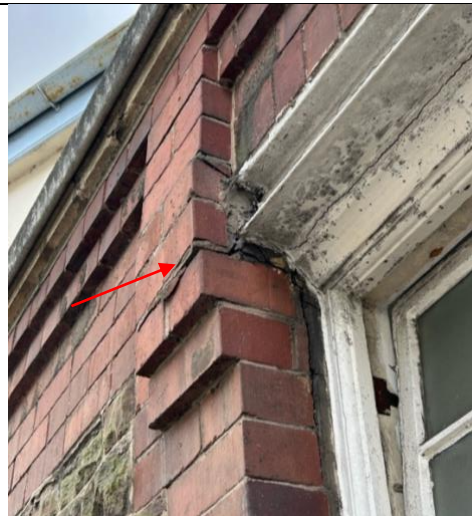
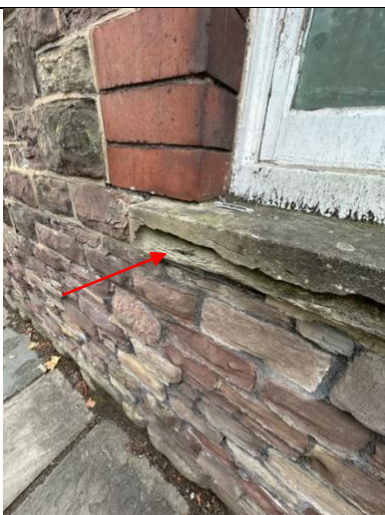
Left window stepped protrusion - brickwork has pushed away from the face of the wall, opening up the joint. Likely due to movement or corrosion of the steel lintel.

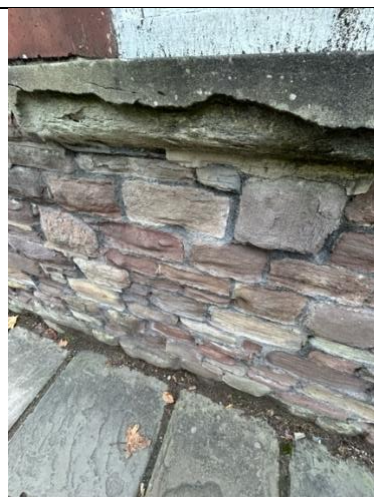
Boys WC (W2) – Delaminating stone cill.

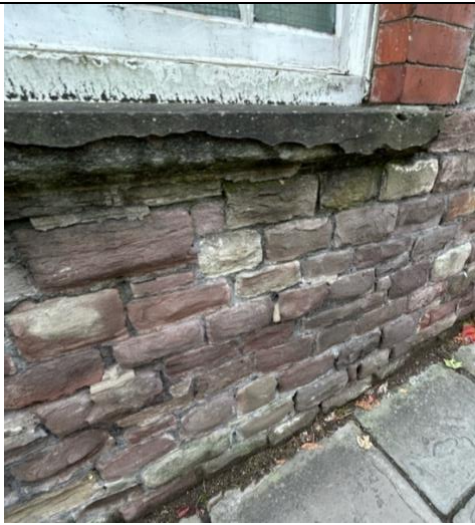
Boys WC (W2) – Delaminating stone cill.  
Weathered stonework

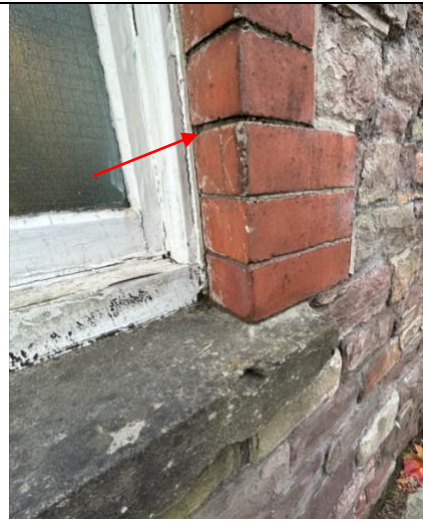
Boys WC (W2) – Delaminating stone cill.

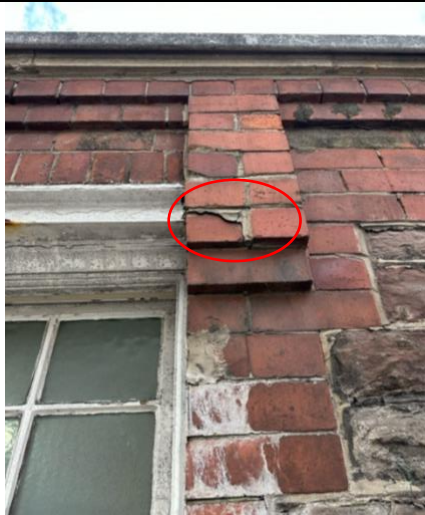
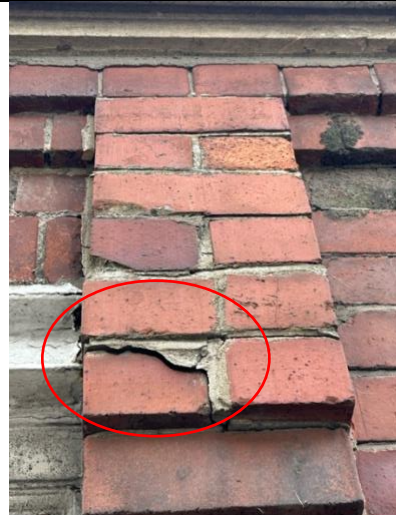
W2 right hand protrusion – slight movement around the beam

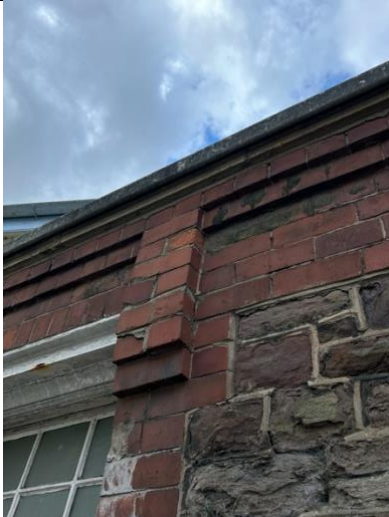
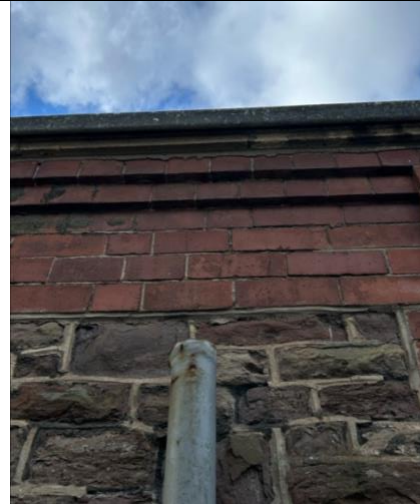
Crack to mortar joint

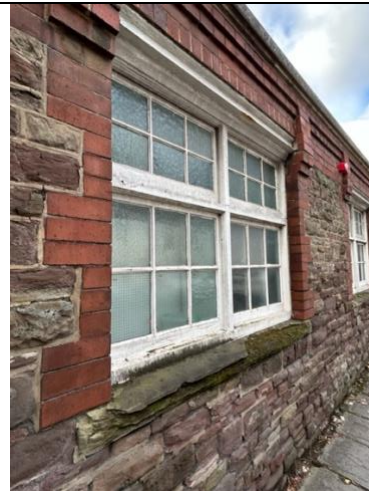
Weathered stone – various mortar type and condition – including cement mortar

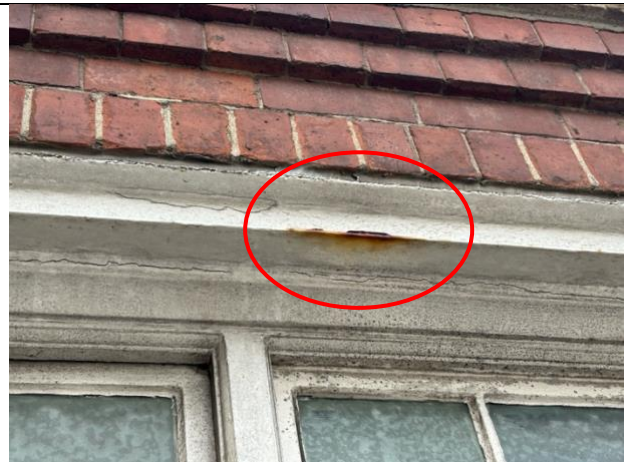
Evidence of spot corrosion to steel beam along edge.

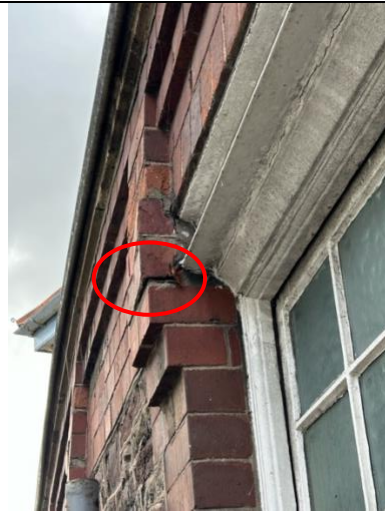
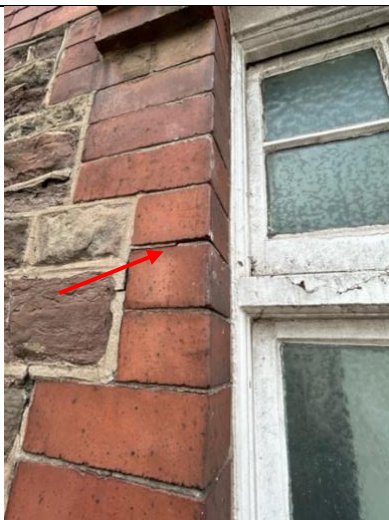
Left stepped protrusion - slight movement of third brick

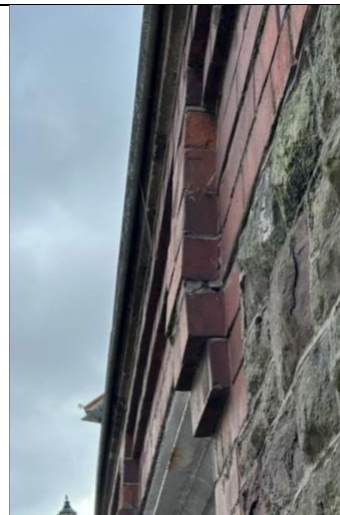
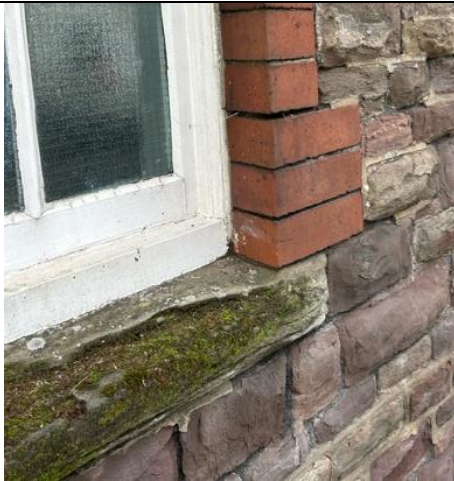
Right stepped protrusion - slight movement of third brick – previous repair to mortar noted.  
Gaps encouraging ingress at steel lintel junction

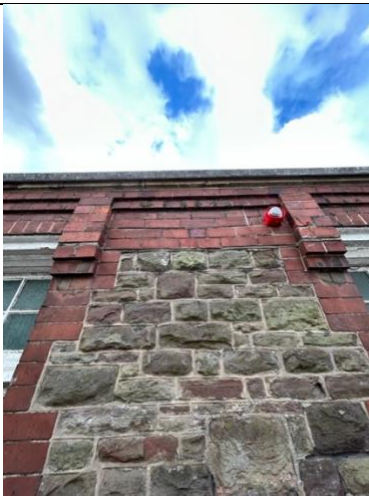
Deterioration of mortar joints – encouraging water ingress internally

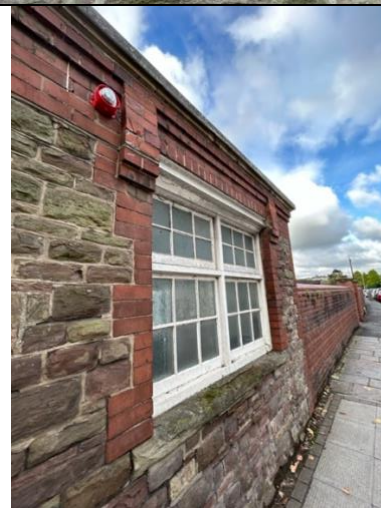
Weathered stonework and mortar joints

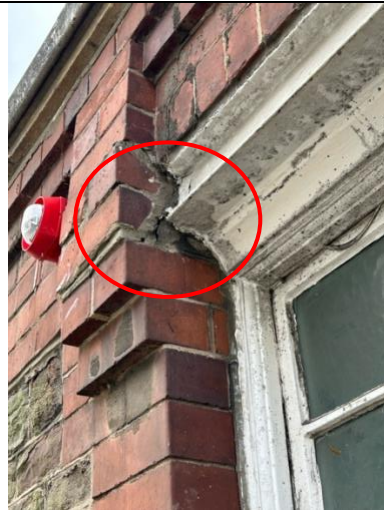
Left stepped protrusion - slight movement of third / forth brick

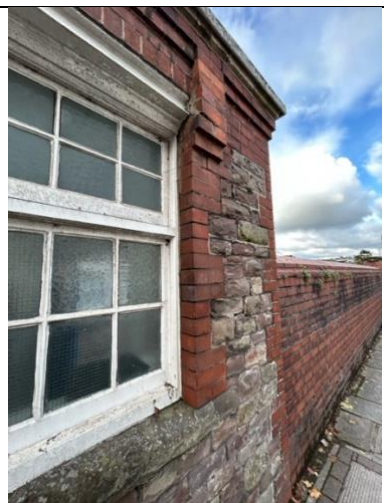
Cracked brickwork and mortar allowing water to track internally

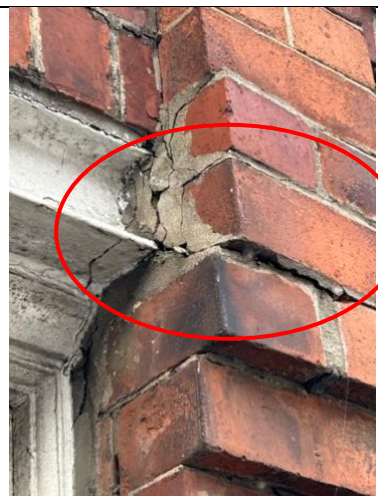
Right stepped protrusion - slight movement of second / third brick

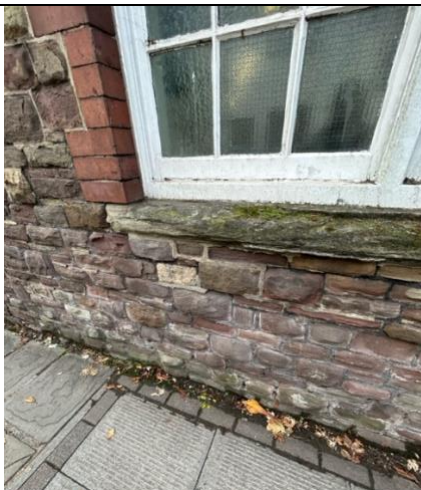
Water sits on the lower lip of the lintel causing water to track between the joints – resulting in further deterioration of lintel and mortar

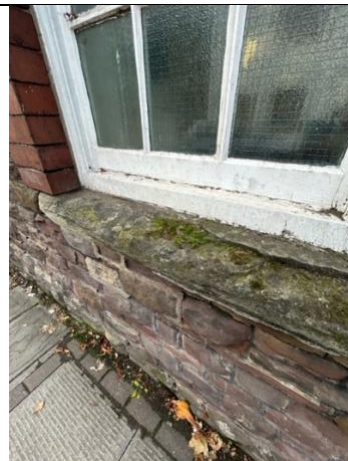
Weathered stonework below cill – colour deterioration from traffic pollution.

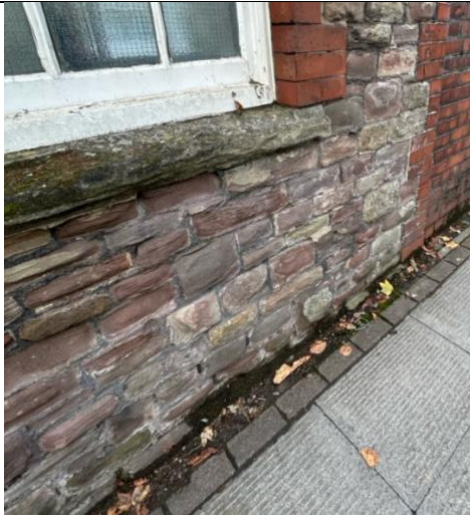
Weathered and deteriorated cill – worse condition out of the three cills. Moss growth to surface, areas becoming porous resulting in further deterioration.

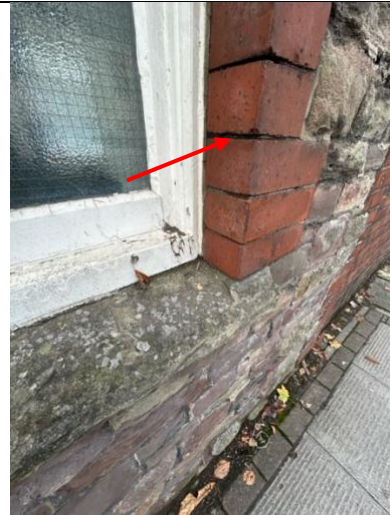
Deteriorated cill – weathered stonework below cill

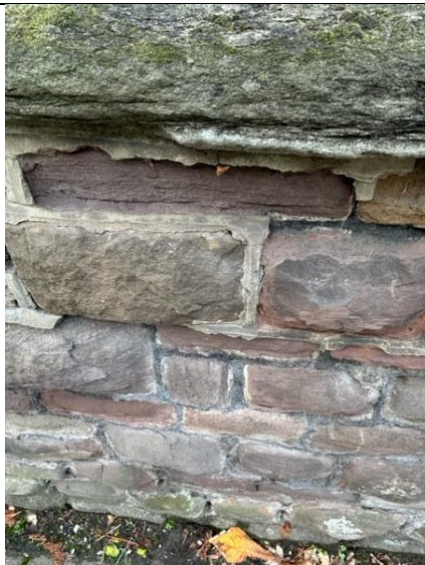
Deterioration of mortar joints – encouraging water ingress internally

Sand and cement mortar within joints impacting the surrounding stonework.
