Photographic record – Front porch lead roof review – Easter Holidays 2025

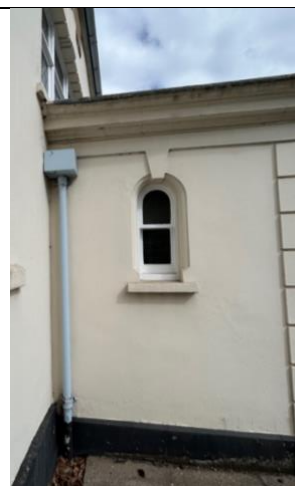
Left side elevation of porch – hopper and downpipe

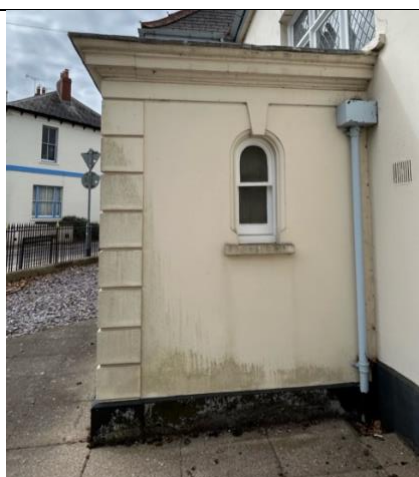
Right side elevation of porch – hopper and downpipe

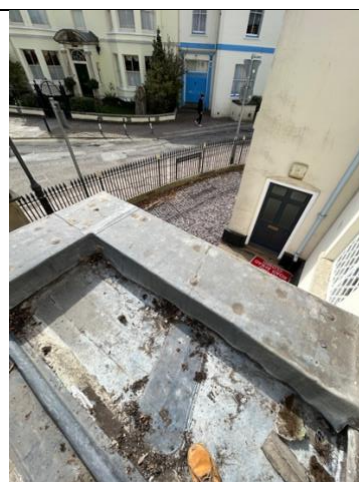
Lead capping – no allowance for expansion

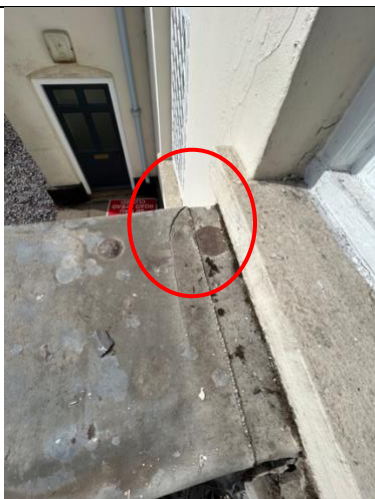
Split within the lead

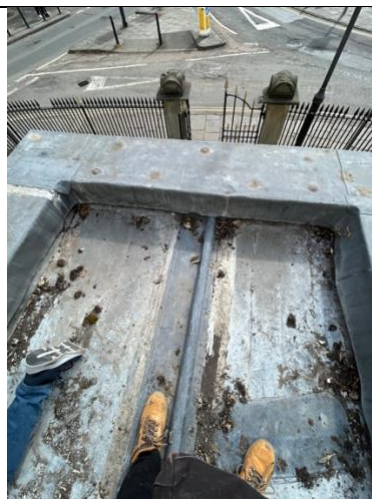
Aged lead roof – lead capped parapet wall. No allowance for expansion

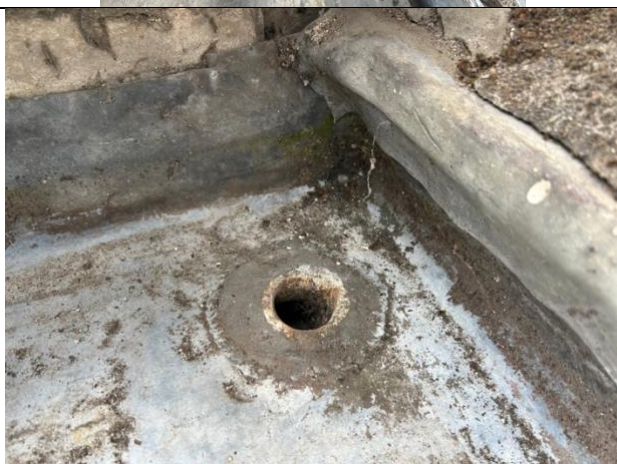
Small drainage outlet

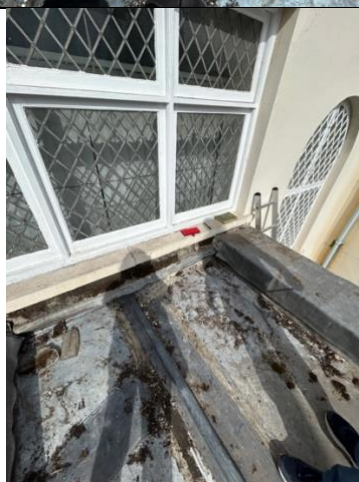
Roof to wall junction – poor detailing

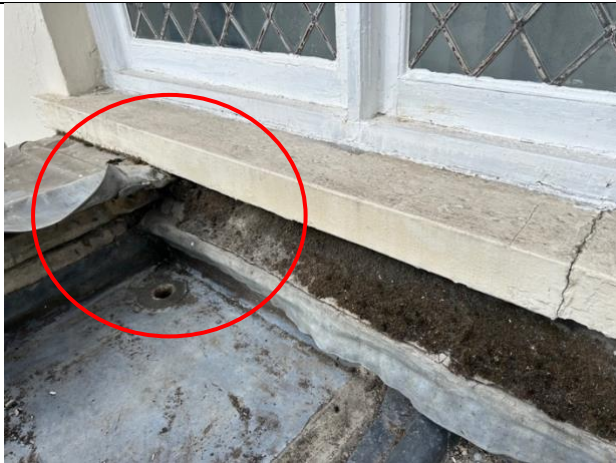
Poor detailing at the corner

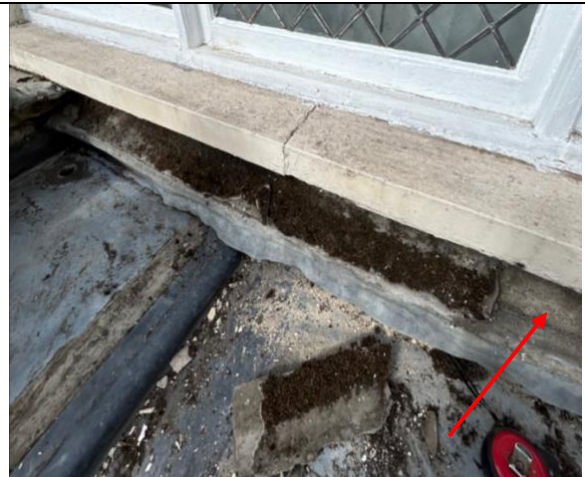
Lead cover flashing not chased into the wall – cement on top has failed

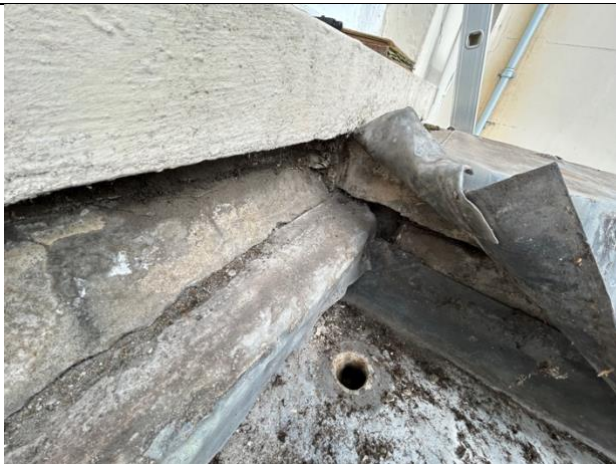
Small drainage outlet through the roof deck / wall. Discharges into a hopper. Potentially blocked / damaged within the structure

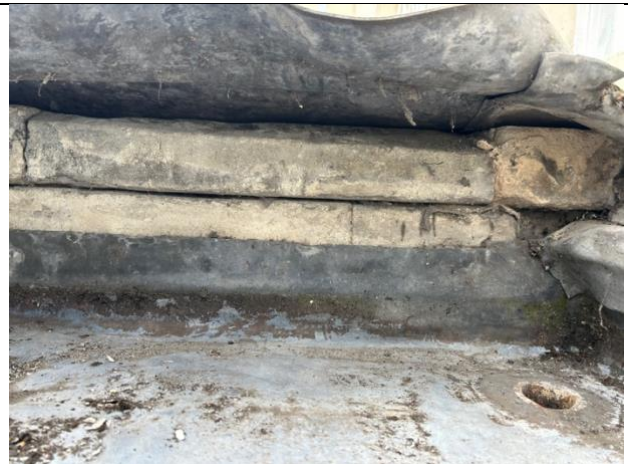
Lead pulled back – capping stones to parapet wall

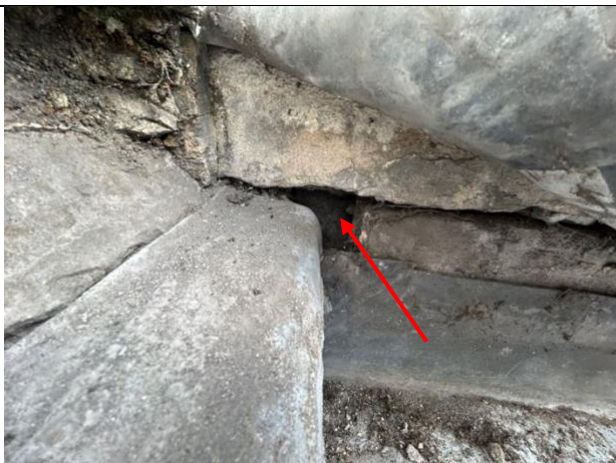
Gaps where lead meets the wall – potential route for water ingress

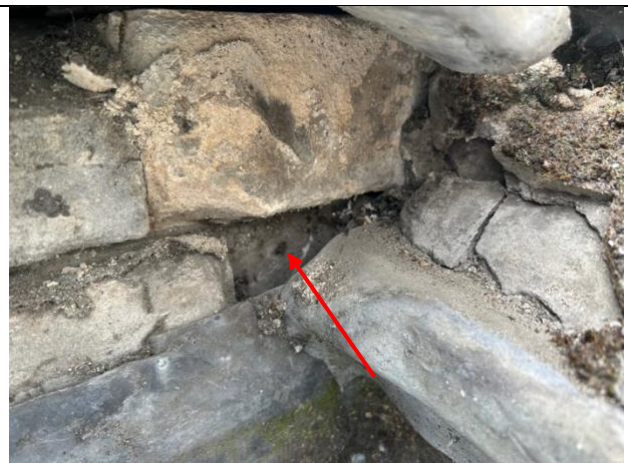
Gaps – potential route for water ingress.

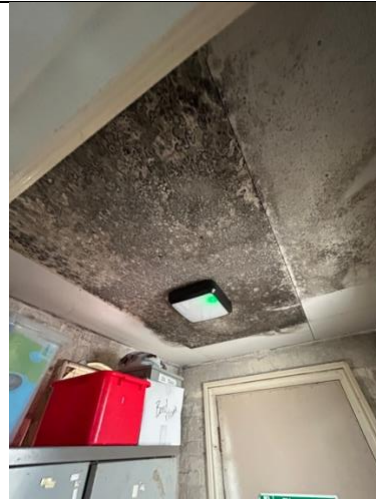
Porch ceiling – previously replaced

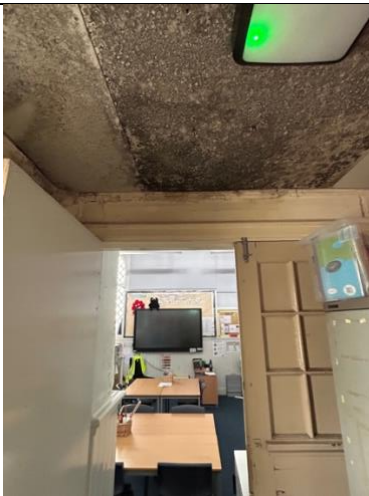
Porch ceiling – previously replaced

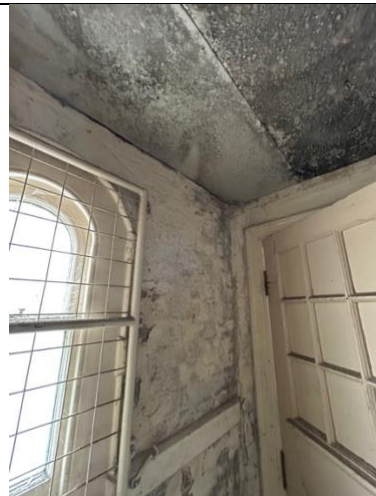
Porch ceiling – previously replaced
