Photographic record – slate roof areas to be replaced / upgraded – Summer 2025

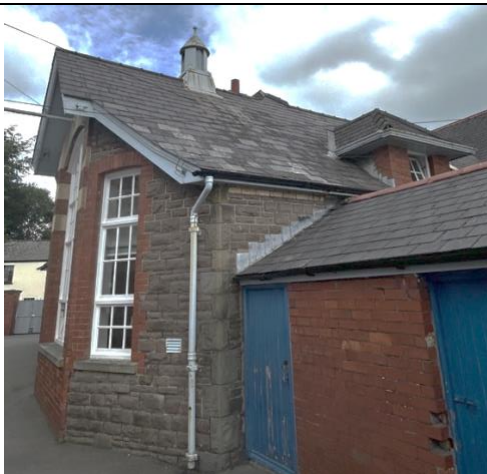
Slope over courtyard – slates have previously slipped – Partial slate roof and slates beyond and including dormer potentially asbestos TBC

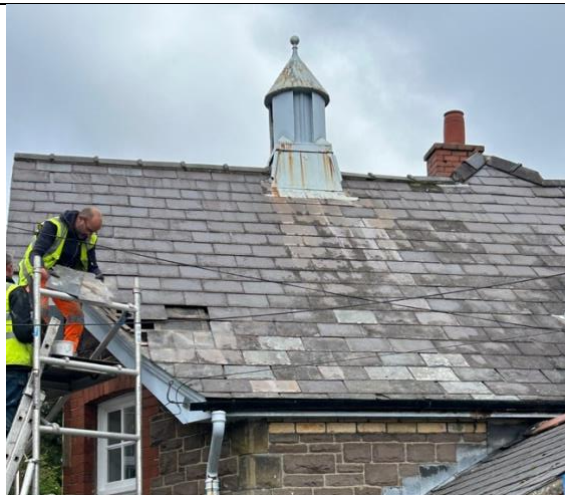
Emergency slate repairs over Easter 2025 – Salvaged Welsh slate provided

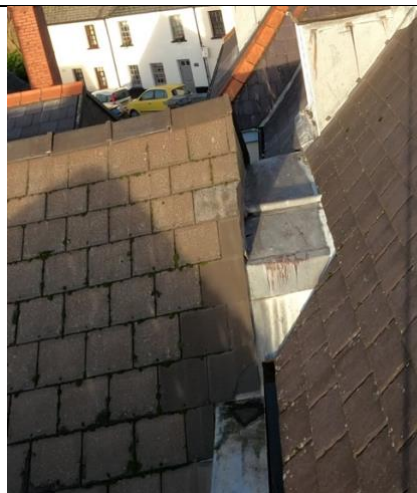
Roof area junctions including small lead roof – to be reviewed

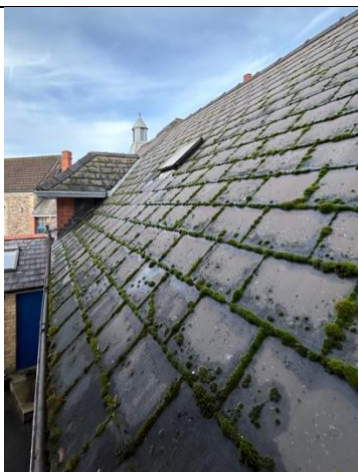
Possibly asbestos slates to part of the roof

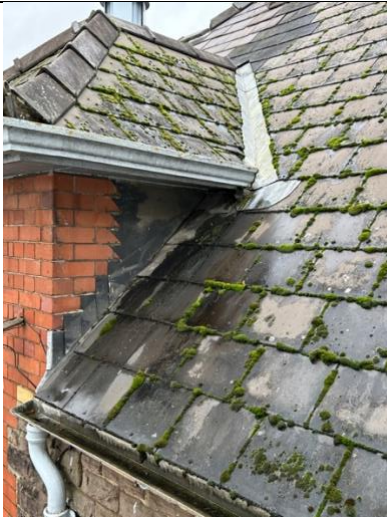
Valley front dormer – potential asbestos slates

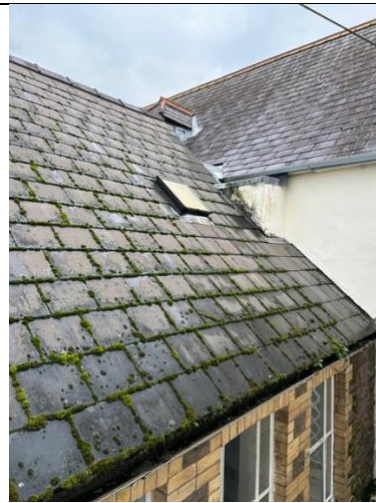
Some areas potentially asbestos slates

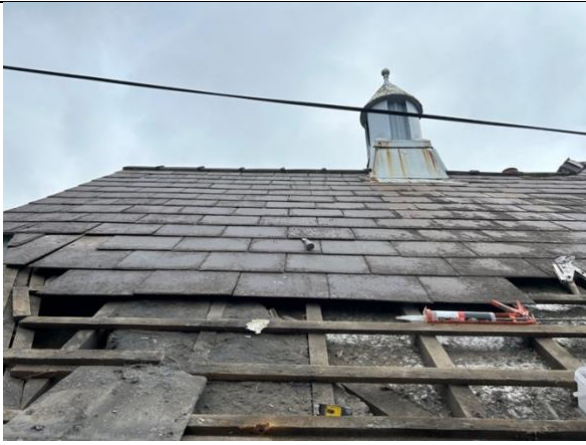
Emergency repairs undertaken over Easter –  
Deteriorated timber battens and nail fixings.

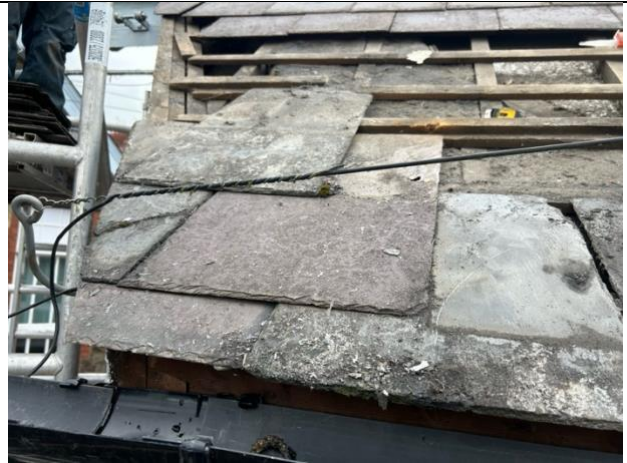
Emergency repairs undertaken over Easter –  
Deteriorated timber battens and nail fixings.

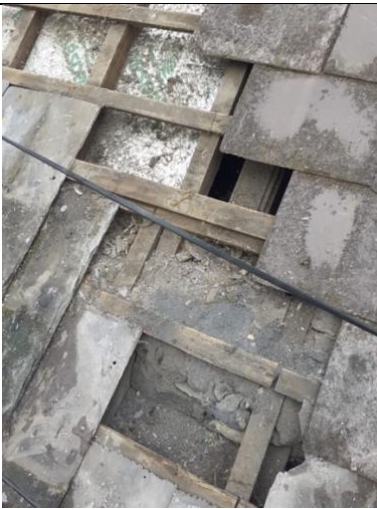
Emergency repairs undertaken over Easter –  
Deteriorated timber battens and nail fixings.

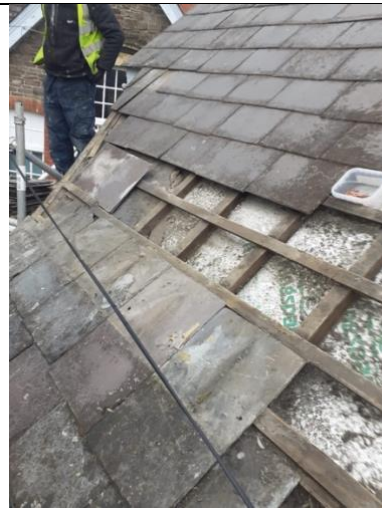
Emergency repairs undertaken over Easter – Some  
areas of Kingspan insulation previously provided

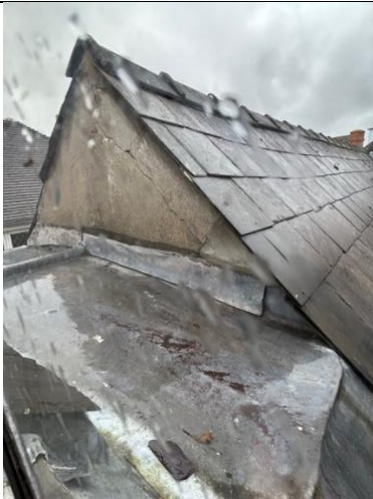
Lead roof to be reviewed – render replaced

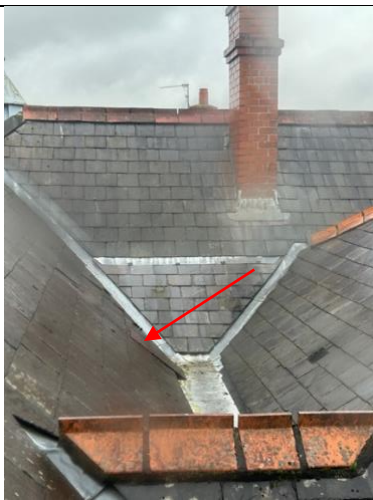
Rear slope to be replaced with New Glendine slate (TBC) – Slates slipped / damaged

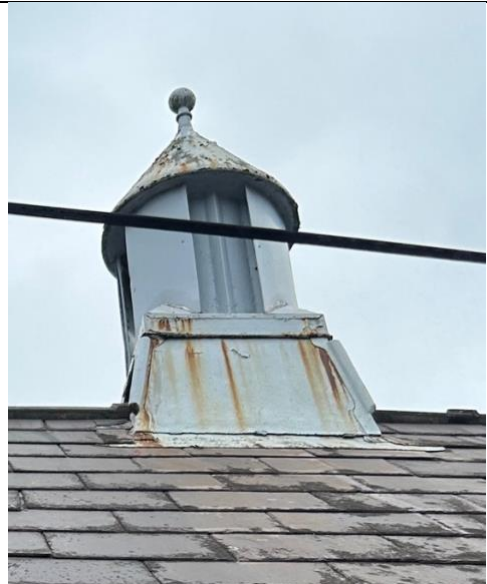
Right slope - currently allowing water ingress to occur into the classroom below.
