## **Felthorpe House, College Road, Caerleon**

Cofnodi Adeiladau Hanesyddol / Historic Building Recording

Planning App.No: 26/0342

**Rhif Adroddiad / Report Number 2026/1069**

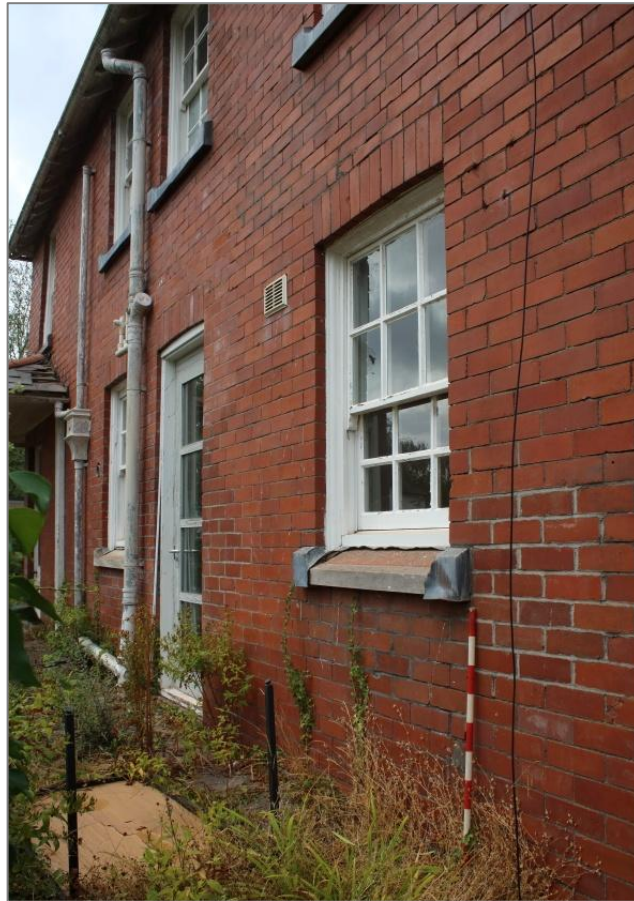
- 4.13. Midway along the face beyond the veranda roof is a second doorway in a similar brick surround but containing a modern glazed panel door. A change in mortar around the doorway suggest an area of repair or repointing that includes an adjacent window and extends up to the roofline (Photo 9).

*Photo 9: View west along the garden face of the house, showing the reduced height sash window. 1m scale.*

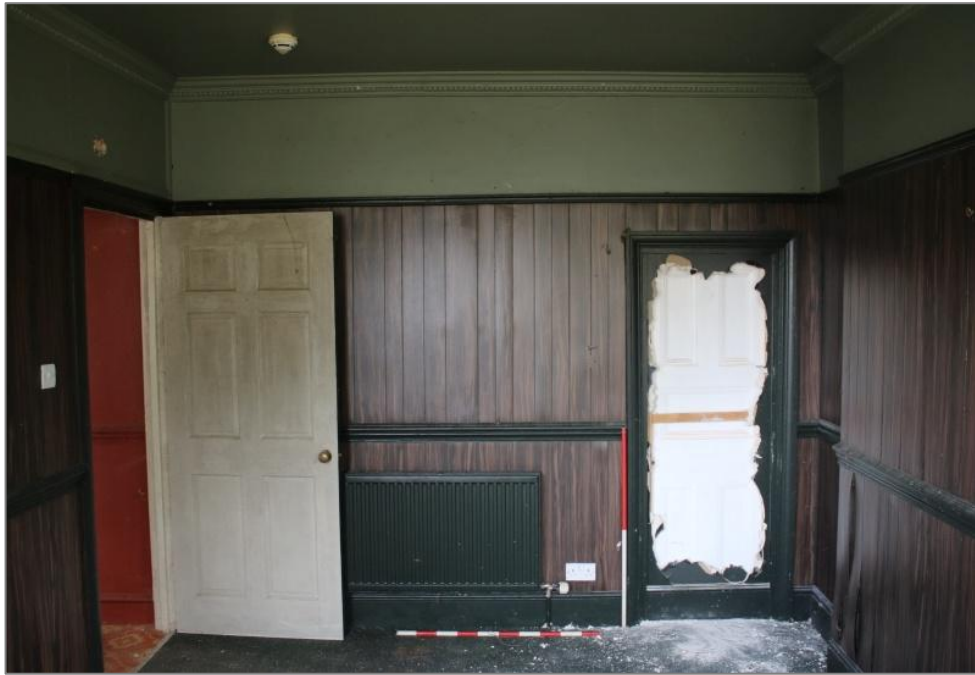
- 4.33. Beyond, a traditional timber panel door with rounded brass handle accesses a room occupying the front bay window area (Photo 31). The floor is carpeted, with high torus skirting, modern wood-panel effect walling and continuation of dado rail, picture rail and coving. The room is lit by three sash windows in the bay (Photo 32), all with opaque glass panels in the lower half, with an adjacent glazed doorway accessing the garden beyond. In the rear northeast wall lies a wood-panelled door, shorter than the typical doorways and since blocked with plasterboard (Photo 33).

*Photo 33: View northeast of the blocked doorway in the front bay window room. 1m scales.*

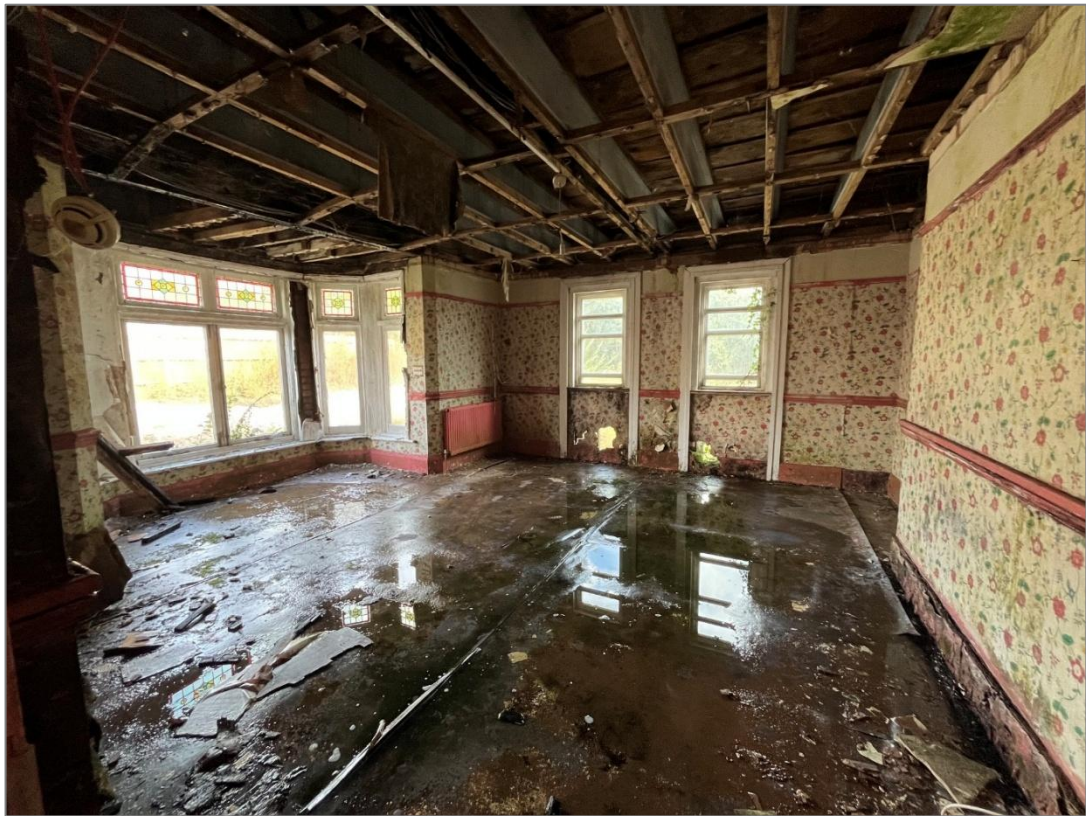
- 4.39. The room occupying the single storey extension was not closely examined due to water ingress through the flat roof. The room is accessed from the end of the entrance hallway beyond the stairs, through a modern timber fire door. The floor appears to be vinyl-covered, high chamfered skirting, with a continuation of the dado and picture rails (Photo 42). The walls are covered in floral-design wallpaper up to the picture rail. The ceiling has come down through water damage. The room is lit by casement windows in the bay to the northwest, with painted leaded glass panels in an Edwardian style above (Photo 43). A pair of doors lie in the northeast wall (as described externally), but these have been part boarded internally to turn them into windows with additional internal glazing. The large window into the adjoining room to the southwest is similarly boarded. A boarded fireplace lies on the southeast wall (Photo 44).

*Photo 42: View northeast into the room occupying the single-storey extension.*

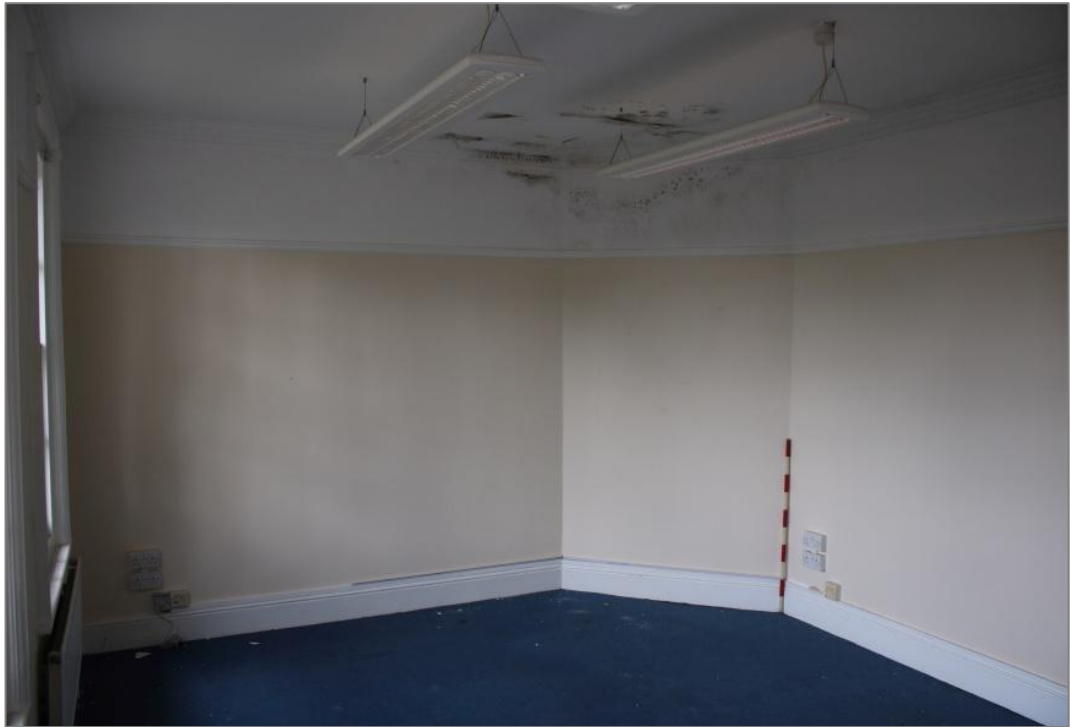
- 4.43. Bedroom 2 is carpeted with torus skirting, plain plastered walls, picture rail, decorative coving and plain plastered ceiling with modern strip lighting (Photo 49). The room is lit by three sash windows in the southwest wall, two standard size and one narrower window. An angled east corner suggests a blocked fireplace (Photo 50).

*Photo 50: View northwest of blocked corner fireplace in Bedroom 2. 1m scale.*

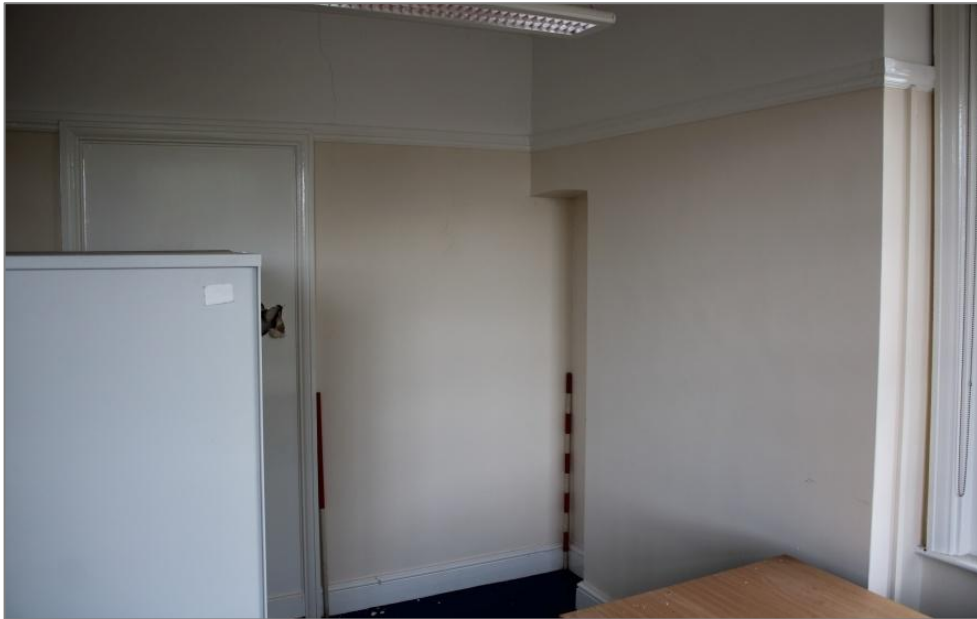
- 4.44. Bedroom 3 is carpeted with torus skirting, plain plastered walls, picture rail, decorative coving, plain plastered ceiling and modern strip lighting (Photo 51). It is lit by two standard sash windows and a narrower sash in the southwest wall and a third standard sash window in the southeast wall. The southeast walls steps in, with a small rounded-head alcove against the northeast wall, suggesting a blocked fireplace on the southeast wall (Photo 52). A blocked doorway lies adjacent on the northeast wall.

*Photo 52: View northeast in Bedroom 3, showing the block fireplace on the right, and blocked door on the left, all obscured by modern office furniture. 1m scales.*
