**Ground Gas Protection System
Validation Report:**
Residential Development
Phases 2B, 2C & 2D
Herbert Road
Newport

REPORT TITLE : **Ground Gas Protection System Validation Report: Residential Development, Phases 2B, 2C & 2D, Herbert Road, Newport**

REPORT REFERENCE : **TFW_0920_12032_GGVR_V01**

DATE : **September 2020**

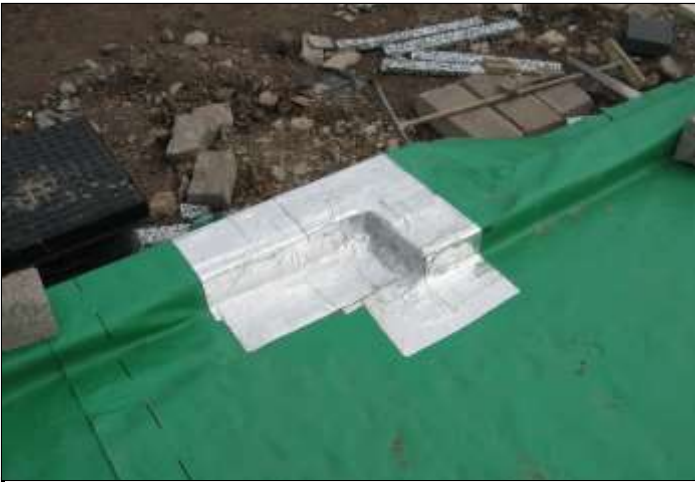
Photographs	
No.	Description
1	Corner detail
2	Service entries
3	Repaired puncture
4	Repaired puncture
5	Damage post screeding
6	Liquid seal repair
7	Liquid seal repair
8

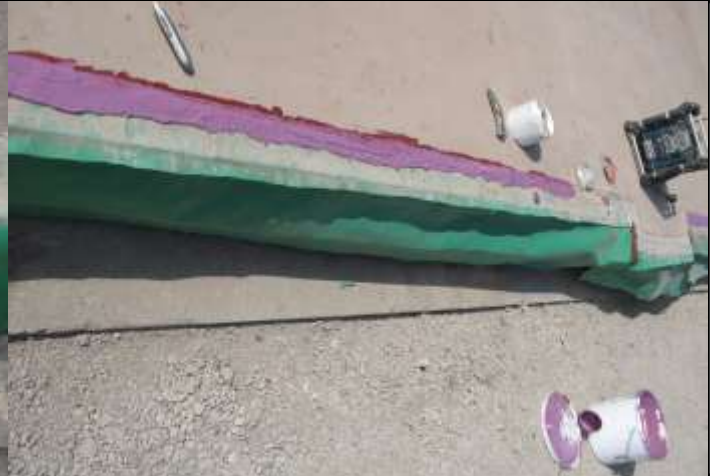
6

2.2	External wall airbricks	9 periscopes installed
2.3	Internal sleeper walls/Beams	Seen previously - Clear 150mm void minimum
2.4	External vents trenches/ducts	NA
<p>Additional Notes: 1/5/19 - damaged occurred to membrane perimeter from screeding process. Asked for membrane to be cleaned off to inspect damage fully. 25/5/19 - inspected repair to damaged perimeter membrane. Membrane either replaced or damage repaired with Solseal liquid gas barrier to manufacture recommendations.</p>

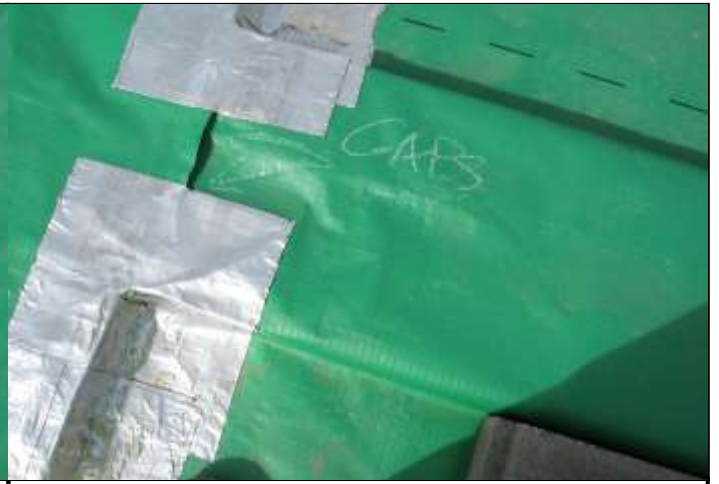
No.	Description
1	Installer repair
2	Gap in joint, later sealed
3	Service entries
4	Corner details
5	Perimeter repair
6	Party wall repair
7	Perimeter repair
8	Perimeter repair

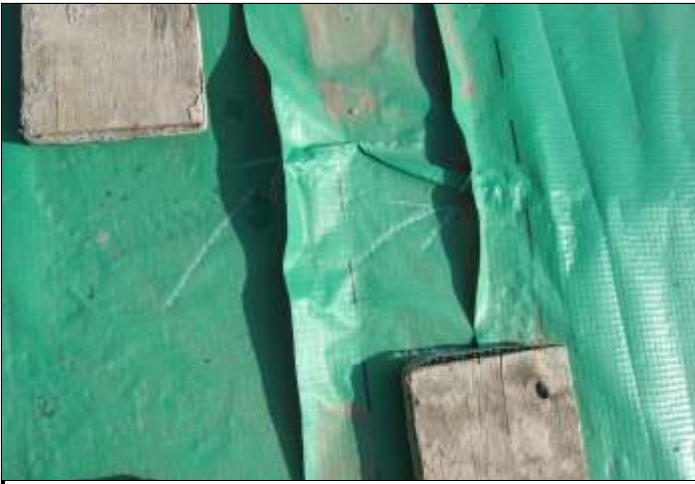
Photographs	
No.	Description
1	2No. fish mouths
2	Hole in membrane
3	Corner details
4	Service entries
5	Fish mouths repaired
6	Holes repaired
7	Perimeter repair
8	Perimeter repair

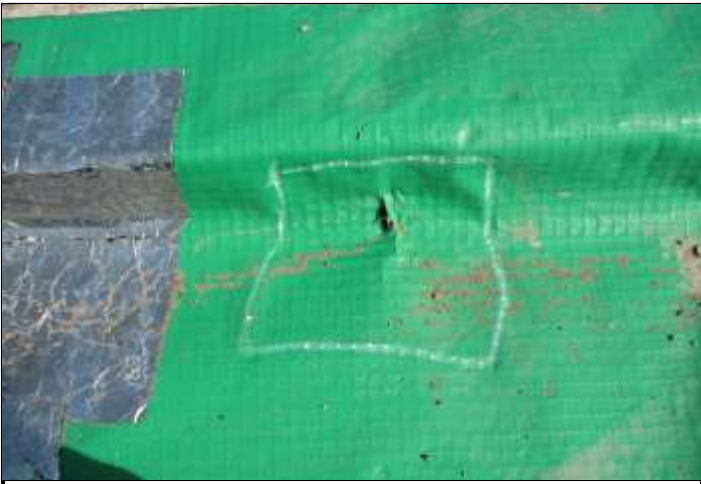
Photographs	
No.	Description
1	Hole in membrane
2	Holes repaired
3	Corner details
4	Service entries
5	Joints repaired
6	Perimeter repair
7	Perimeter repair
8	Perimeter repair
