**Imported Fill  
Validation Report**  
Proposed Residential  
Development  
Herbert Road  
Newport

Keepmoat

**October 2016**

**Report No. 12032/VR1**

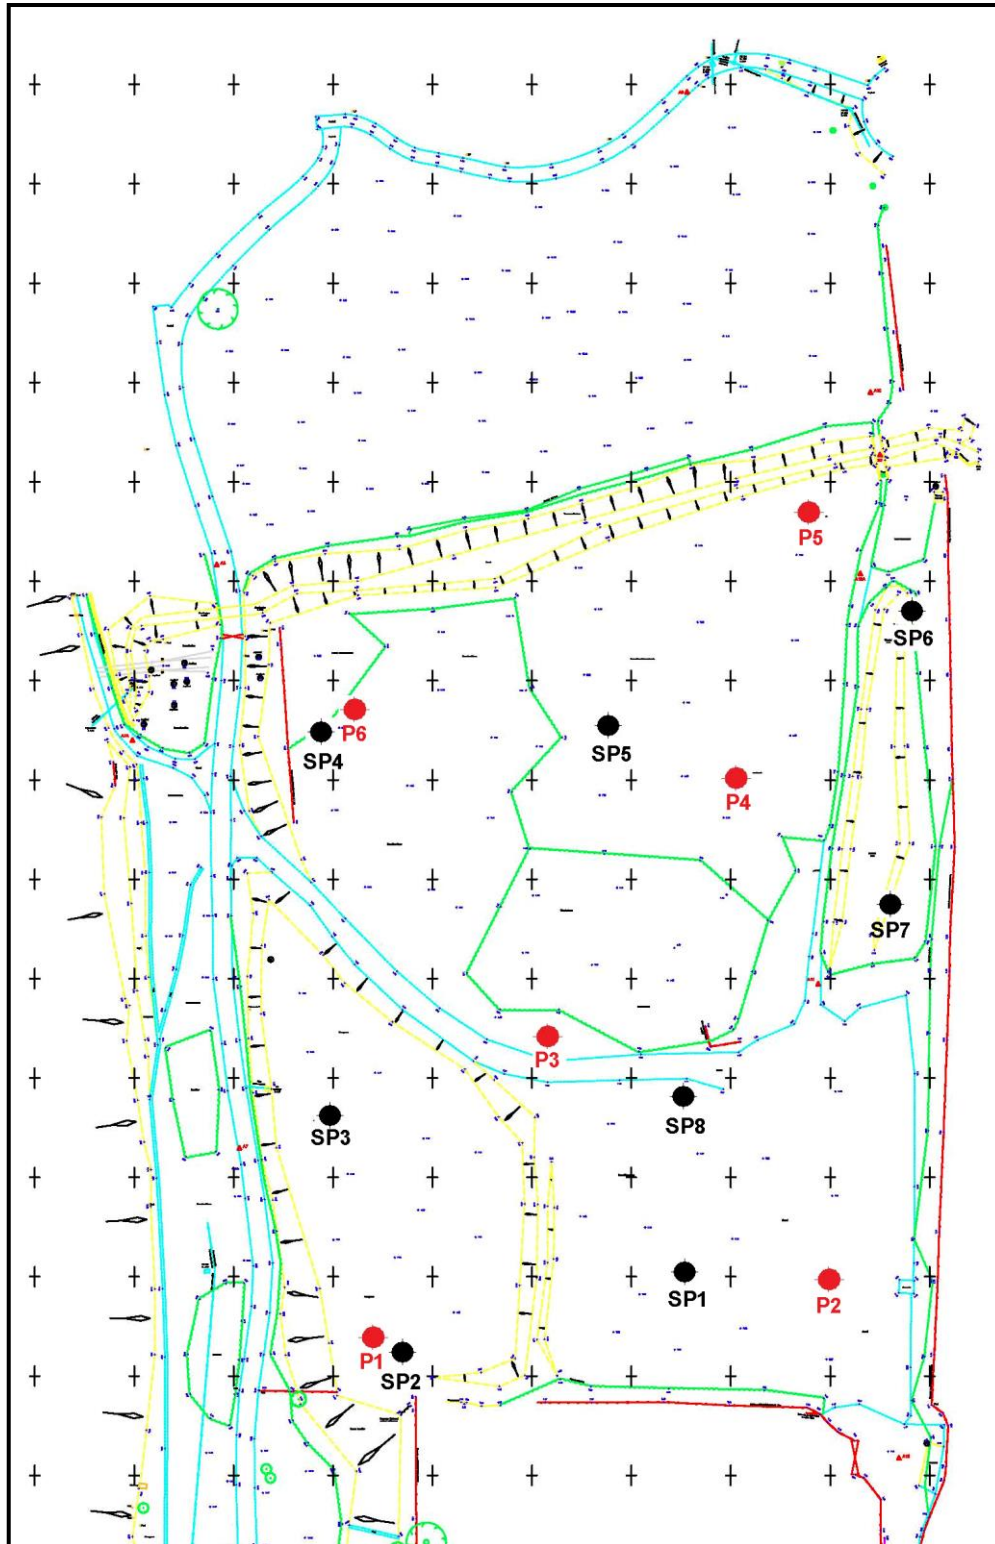
**Figure 6.1: Piezometer (P1 – P6) and Settlement Pin (SP1 – SP8) Locations**

During July 2015 six vibrating wire piezometers and eight settlement monitoring pins were installed across the site.

During earthworks half of the monitoring points were lost or damaged resulting in the loss of data comparable to baseline conditions. Monitoring Pins 2, 3, 4 and 6 were lost. Monitoring Pins 1, 5, 7 and 8 remain intact.

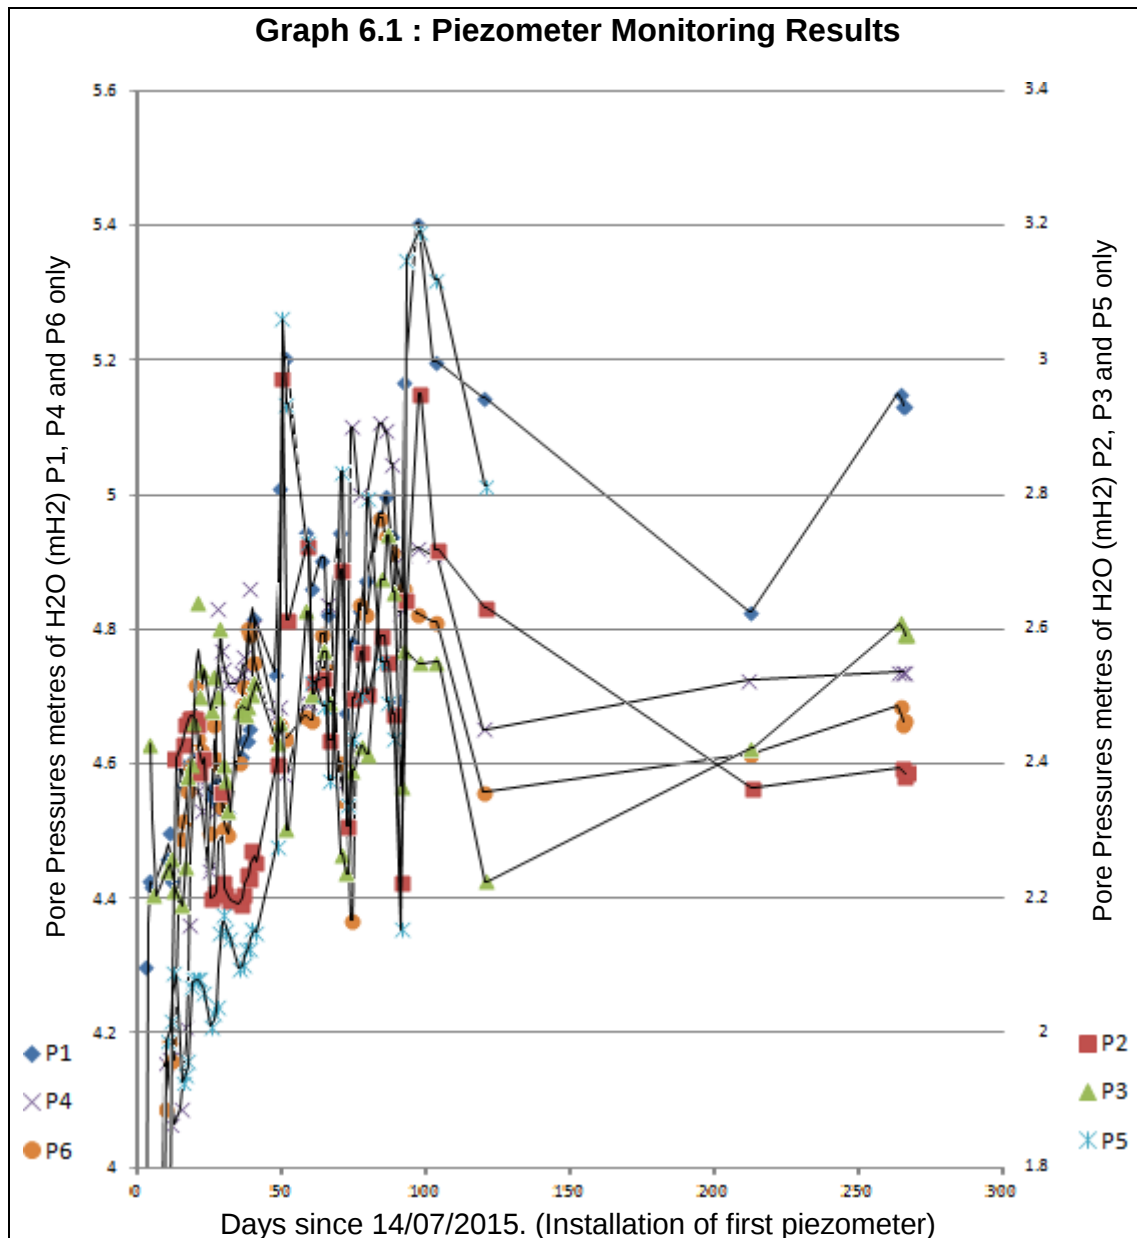
During full time supervision the increasing pore water pressures observed from the piezometers appeared to correlate with the placement of fill. As evidenced by jumps in pore water pressure over the day. Peak pore water pressure dissipated initially quickly but the rate of dissipation reduced resulting in jumps of pore water pressure.

| <b>Table 6.3 Summary of Piezometer Monitoring to Date 14/7/15 to 27/5/16</b> | | |
|---|---|---|
| <p>Piezometer P4 dissipated initially falling to 55% of peak pore water pressure after 3 months. Pore water pressure at Piezometer P4 has failed to dissipate in the last 4 months and currently in excess of 60% of peak pore water pressure.</p> <p>After a period of dispersion of water pressure there was a slight increase in pore water pressure at Piezometer P4 located near a recently placed plateaued stockpile.</p> | | |

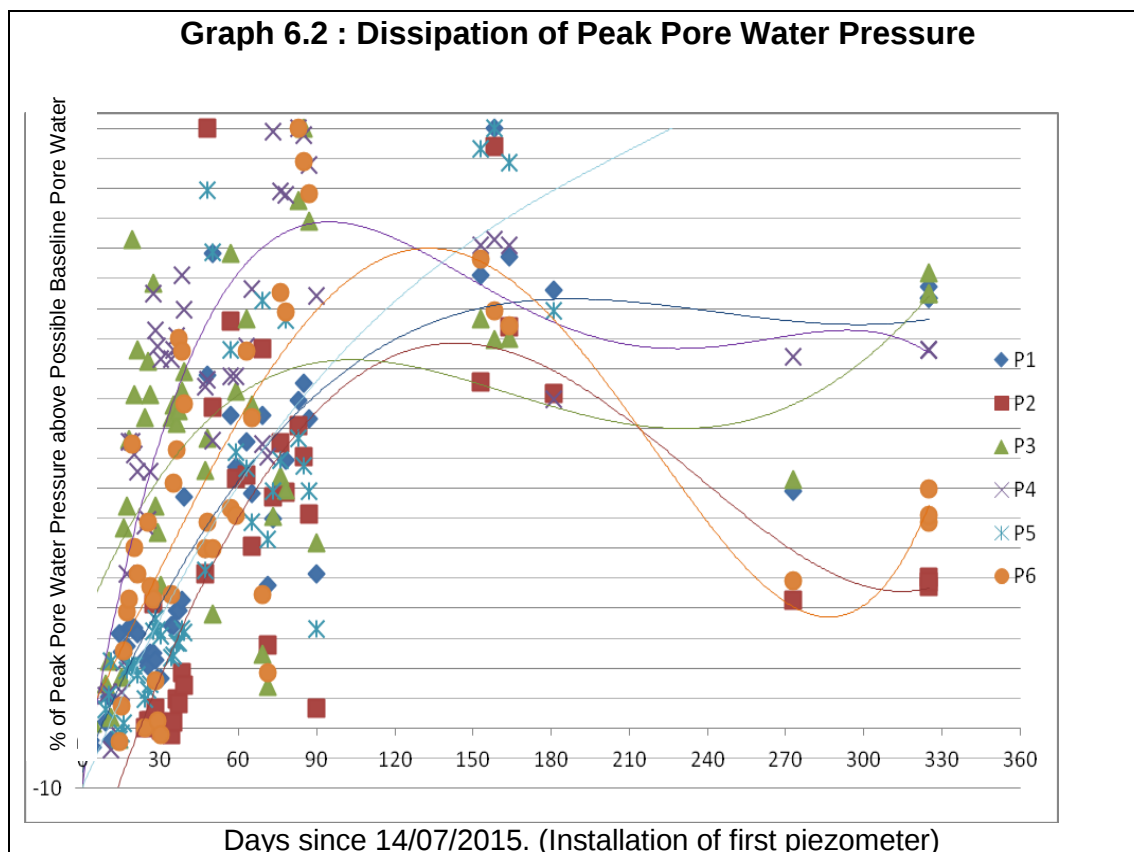
During settlement pore water pressure dissipates as water is squeezed out of consolidating material. The graph below shows the generation of peak pore water pressure generated by the placement of fill typically between 3 and 5 months after the commencement of the earthworks.

Pore water pressure has been observed to be dissipating, evidence of consolidation and settlement. However the monitoring of pore water pressure dissipation has been disrupted by unsupervised filling events subsequent to the termination of full time supervision.

Pore water pressure dissipation of a single filling event should produce a single curve. Unsupervised filling events are likely to explain for the polymodal lines of best fit of pore water dissipation suggesting that following the initial placement of the assessed stockpile further material has been placed on site. Gaps in monitoring at 4 months and 8 months after the commencement of the earthworks have lead to some uncertainty over likely pore water pressures beneath the site at those times.

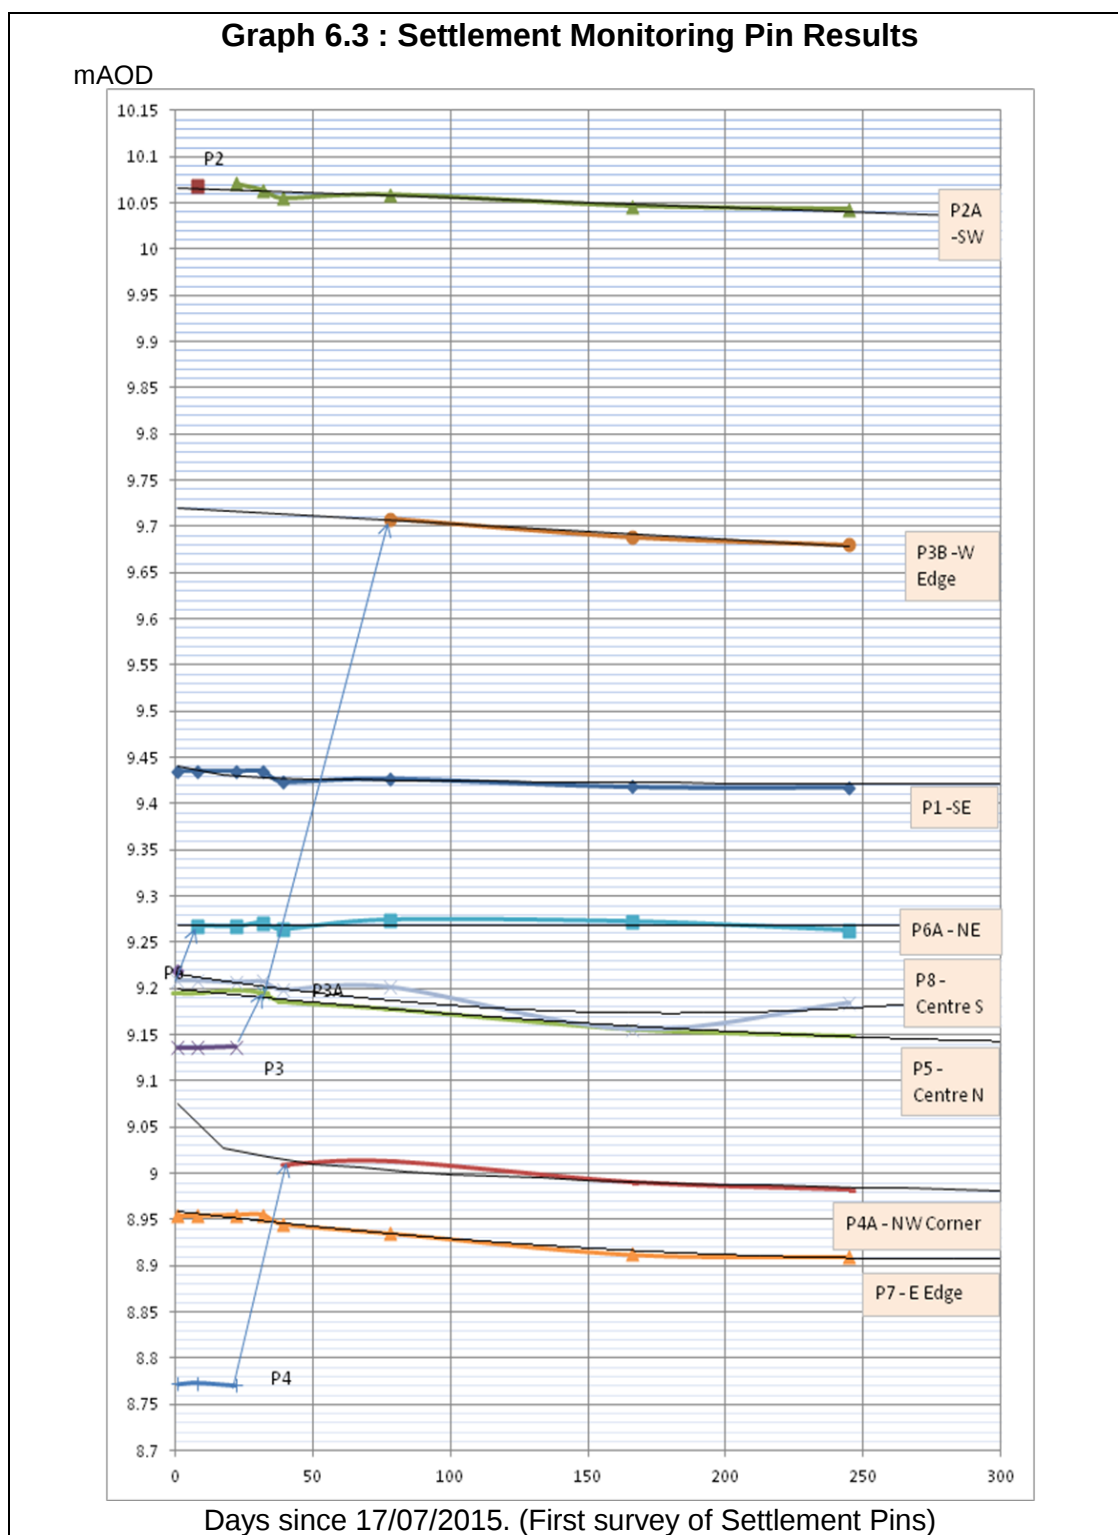
The graph below shows all of the surveyed monitoring pins on an arithmetic time scale. When a monitoring pin was damaged or destroyed an effort was made to replace the pin. When a monitoring pin was damaged / destroyed it was given a sequential alphabetical designation.

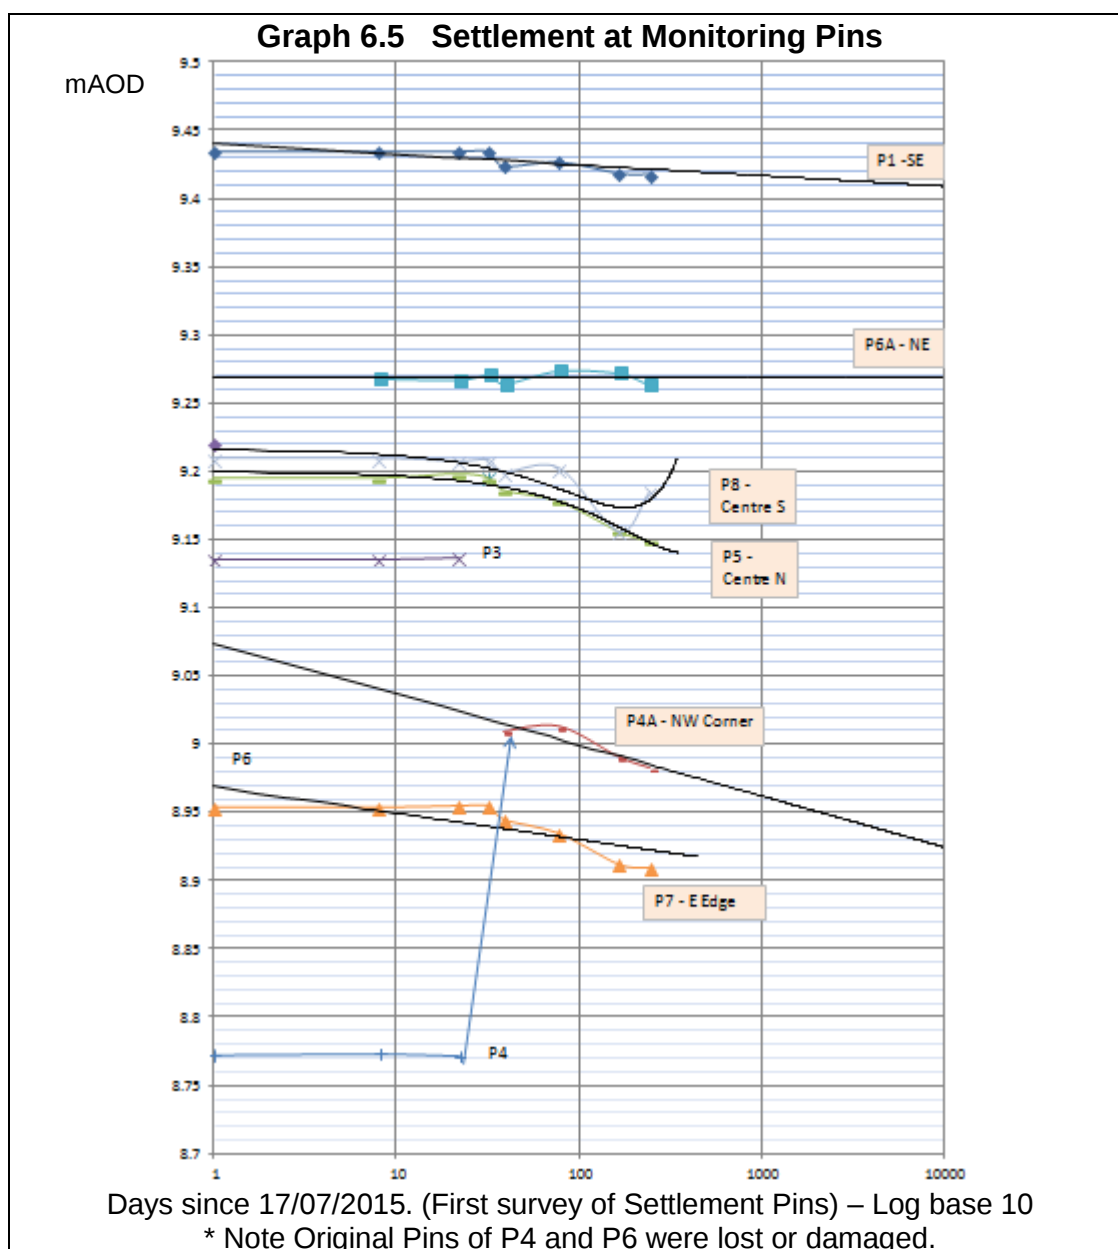
Unfortunately baseline conditions for Monitoring Pin 2 (located within the south-western corner of the site) were lost as the pin was destroyed following the placement of fill. Monitoring Pin 2A however recorded ~28mm of settlement over 7 months. Whilst the initial readings may be lost it may be possible to conjecture future settlement from the data obtained.

Unfortunately baseline conditions for Monitoring Pin 3 (located on the western edge of the site) were lost as the pin was destroyed following the placement of fill. Monitoring Pin 3A was similarly lost. It is considered that any attempt to assess future settlement from Monitoring Pin 3B would be open to too much error and inaccuracy to predict. It is however noted that having measured ~30mm settlement in 5 months that future settlement at this location may be greater than at Monitoring Pin 2A.

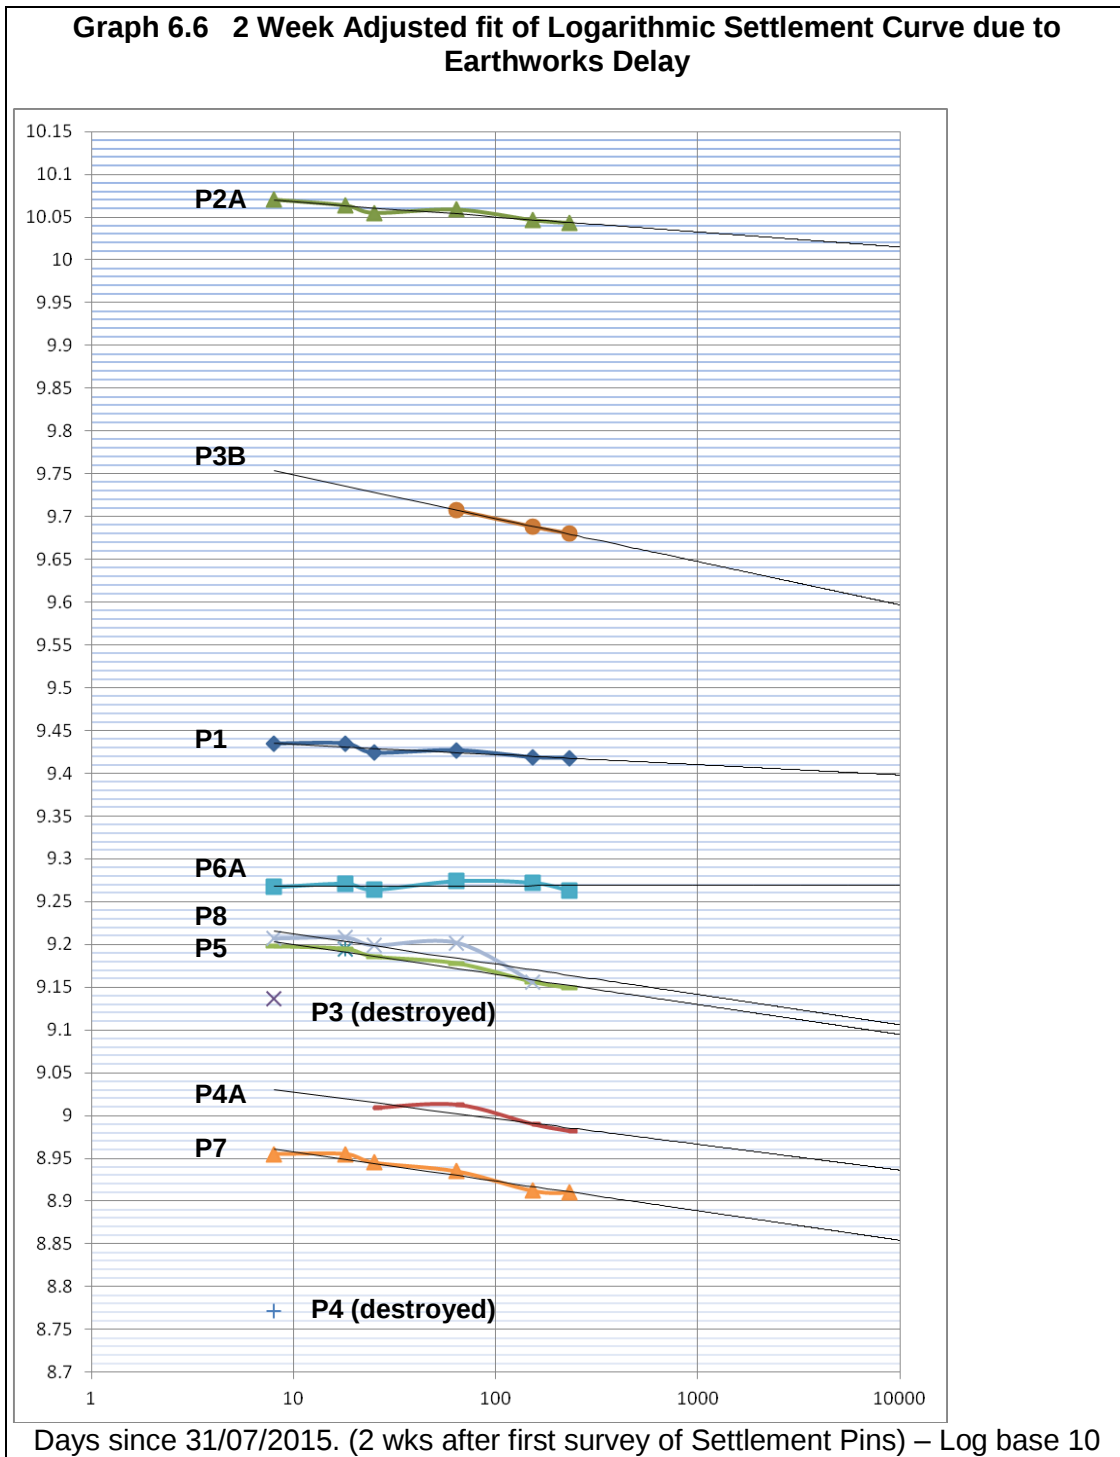
Data for Monitoring Pins 5, 7 and 8 do not appear to fit a logarithmic settlement curve as no settlement was observed within the first two weeks. This suggests that the start date may be out. Therefore Graph 3.6 shows settlement on a logarithmic scale starting on 31/7/2015, two weeks after the commencement of the earthworks. Settlement at Monitoring Pins 5 and 7 appear to be a closer fit as a result.

Monitoring Pin 8 from the southern centre of the site continues to deviate from a logarithmic settlement curve. It may be that the pin was damaged or that multiple phases of earthworks over an extended period mean that settlement cannot be traced from a single event. The most recent survey result indicates an increase in level, which suggests that the pin may be damaged and has been discounted from the estimate below.

In an effort to predict settlement the existing trend, which may be inaccurate, indicate a possible settlement to ~9.1mAOD, a further ~50mm settlement from recent level. It is noted however that the settlement prediction is comparable to Monitoring Pin 5 which is expected to be similar.

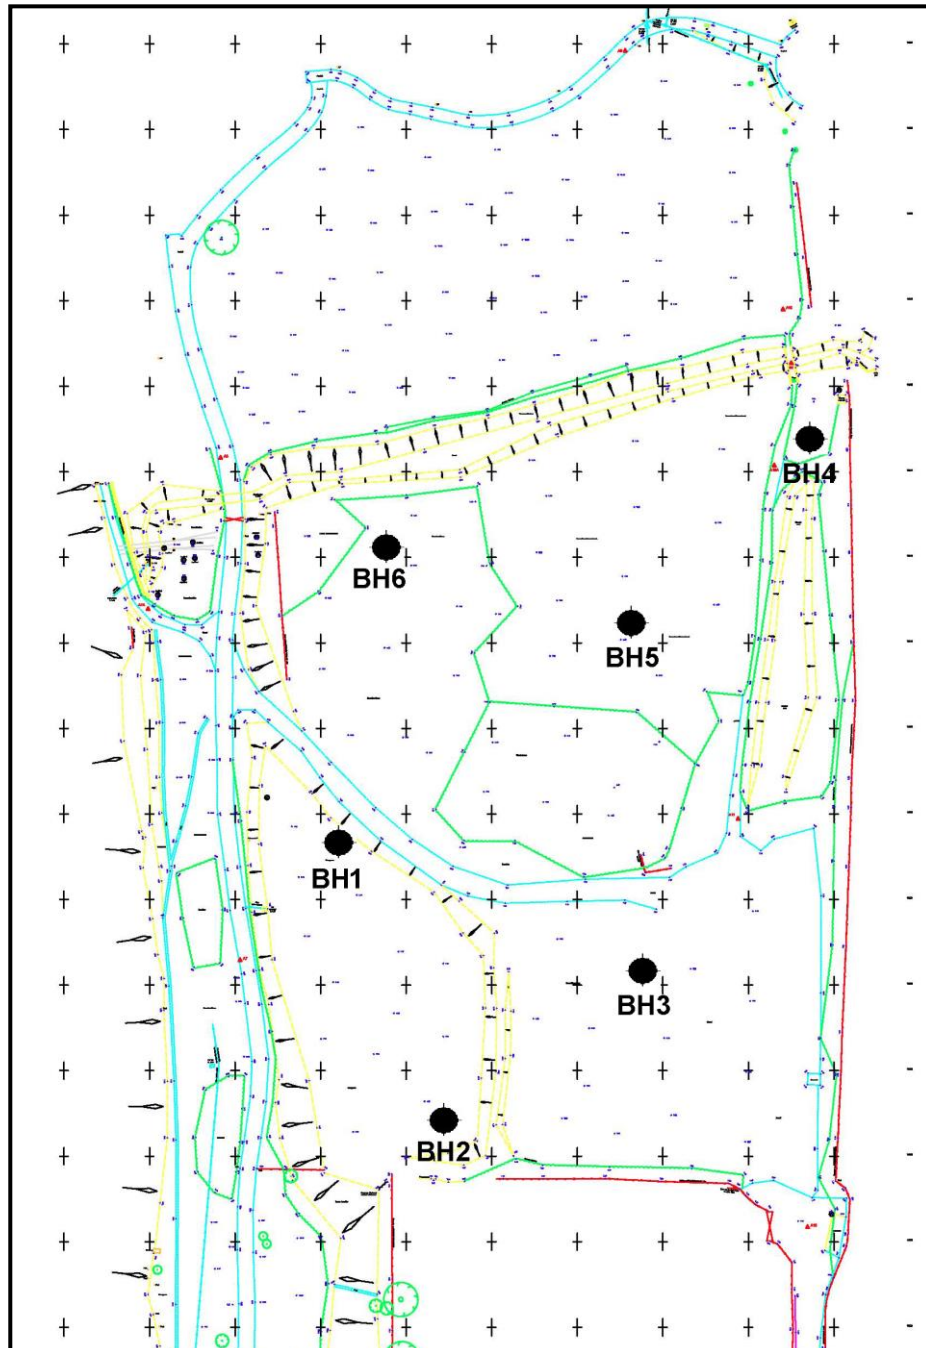
**Figure 7.1: Water Monitoring Well Locations**

Six water monitoring wells were installed, BH1 to BH6, as illustrated in **Figure 7.1** below.
