**IMPORTED FILL  
VALIDATION REPORT**

Proposed Residential Development  
Herbert Road  
Newport

**Report No. 12032/VR1**

**REPORT TITLE** : **Imported Fill Validation Report :**  
**Herbert Road, Newport**

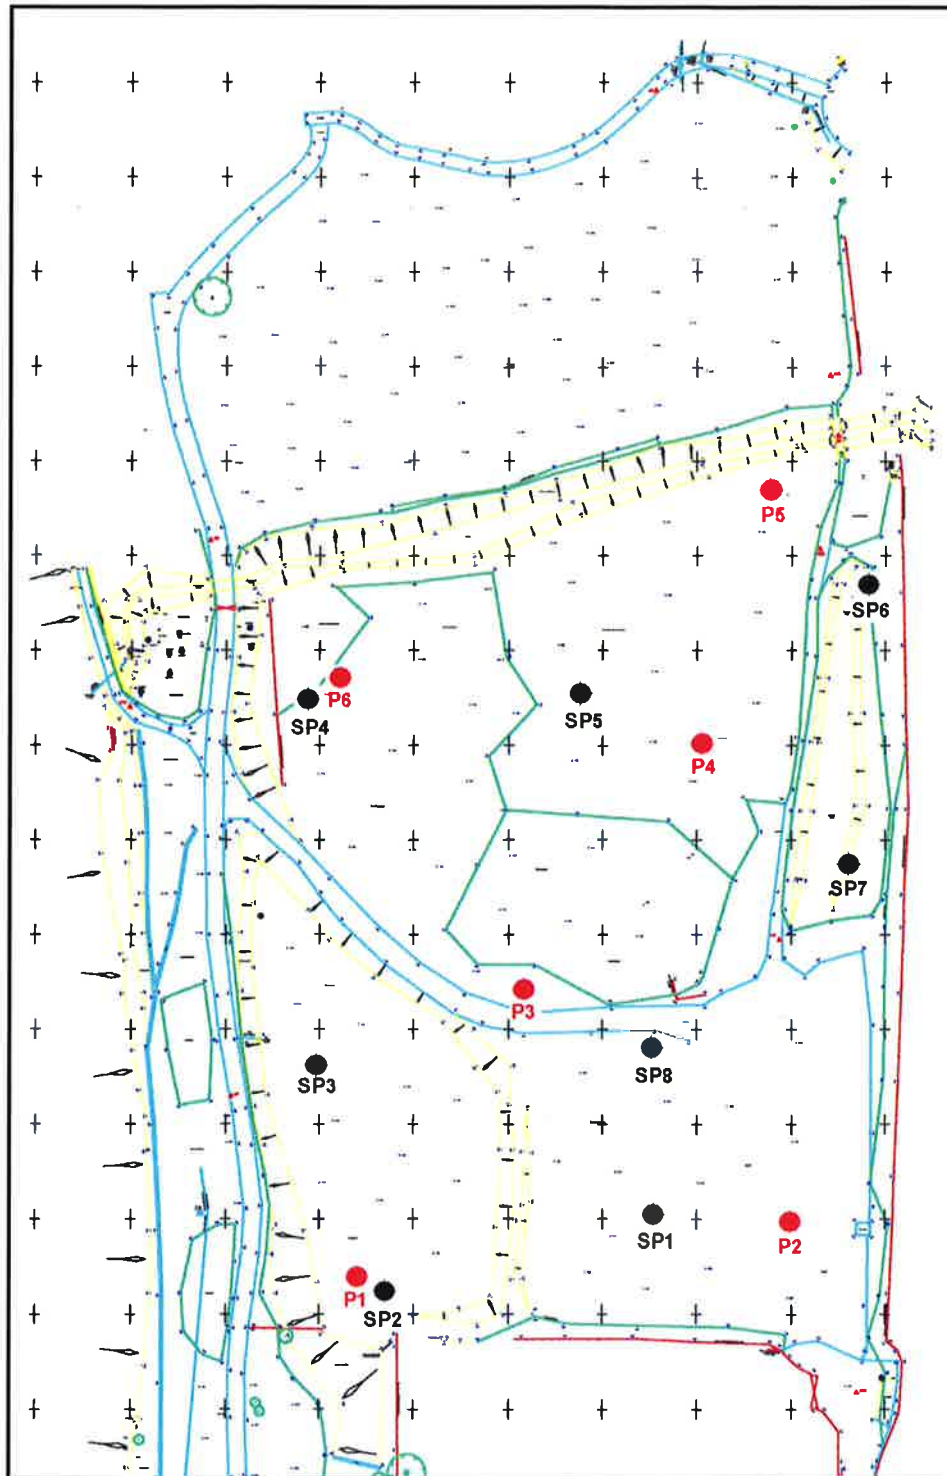
**Figure 5.1: Piezometer (P1 – P6) and Settlement Pin (SP1 – SP8) Locations**

During July 2015 six vibrating wire piezometers and eight settlement monitoring pins were installed across the site.

During earthworks half of the monitoring points were lost or damaged resulting in the loss of data comparable to baseline conditions. Monitoring Pins 2, 3, 4 and 6 were lost. Monitoring Pins 1, 5, 7 and 8 remain intact.

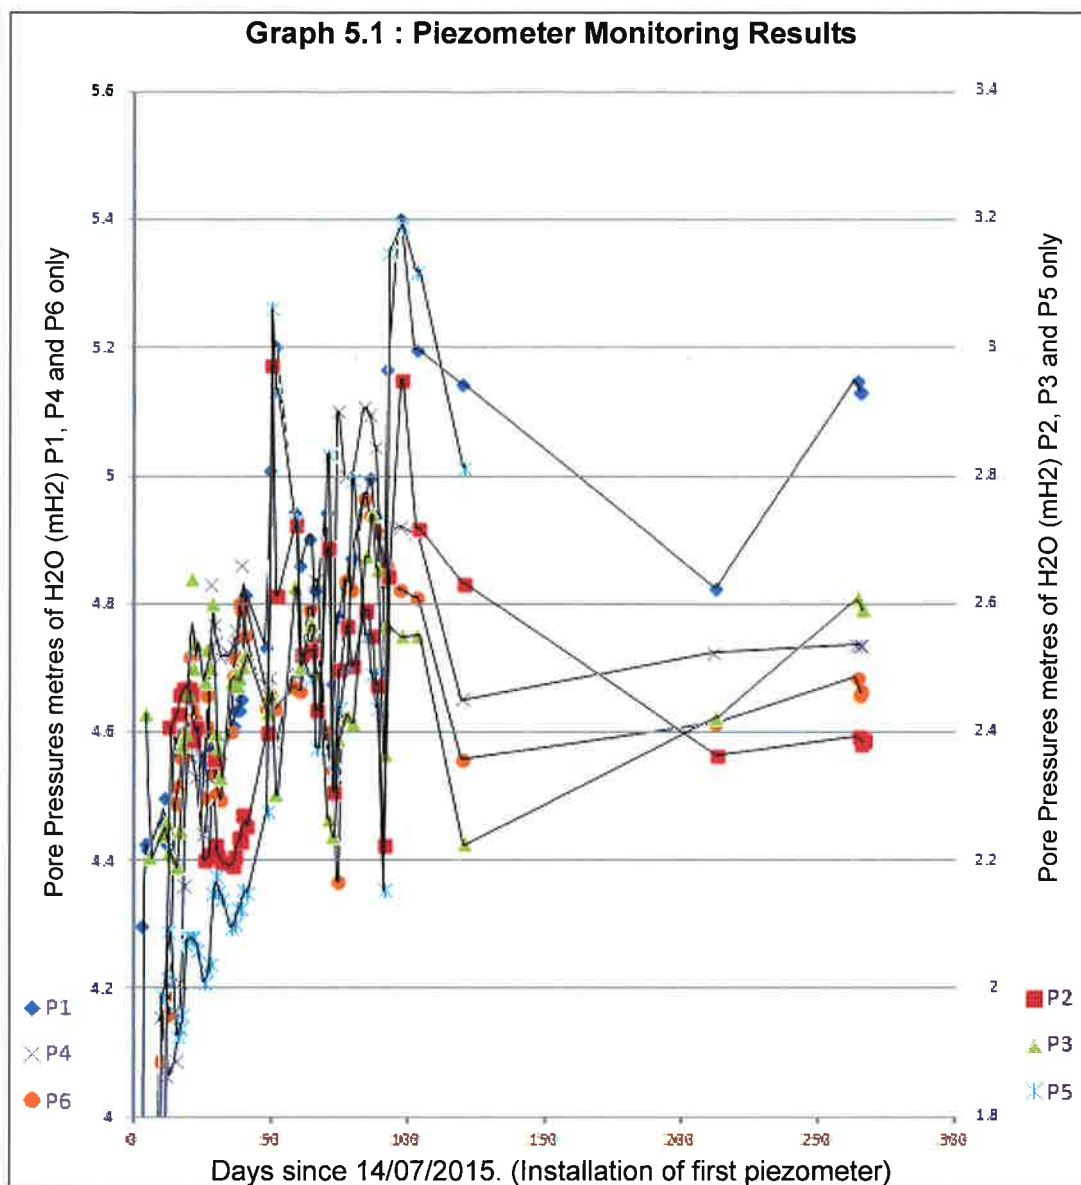
During full time supervision the increasing pore water pressures observed from the piezometers appeared to correlate with the placement of fill. As evidenced by jumps in pore water pressure over the day. Peak pore water pressure dissipated initially quickly but the rate of dissipation reduced resulting in jumps of pore water pressure.

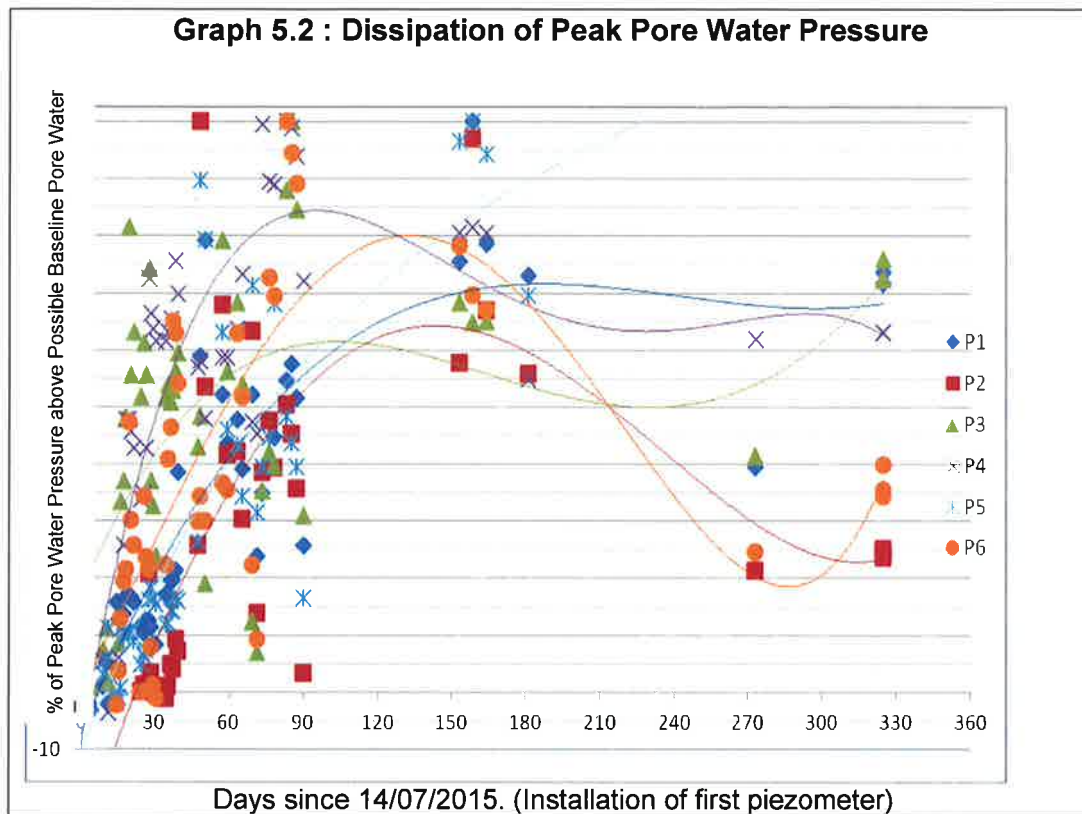
During settlement pore water pressure dissipates as water is squeezed out of consolidating material. The graph below shows the generation of peak pore water pressure generated by the placement of fill typically between 3 and 5 months after the commencement of the earthworks.

Pore water pressure has been observed to be dissipating, evidence of consolidation and settlement. However the monitoring of pore water pressure dissipation has been disrupted by unsupervised filling events subsequent to the termination of full time supervision.

Pore water pressure dissipation of a single filling event should produce a single curve. Unsupervised filling events are likely to explain for the polymodal lines of best fit of pore water dissipation suggesting that following the initial placement of the assessed stockpile further material has been placed on site. Gaps in monitoring at 4 months and 8 months after the commencement of the earthworks have lead to some uncertainty over likely pore water pressures beneath the site at those times.

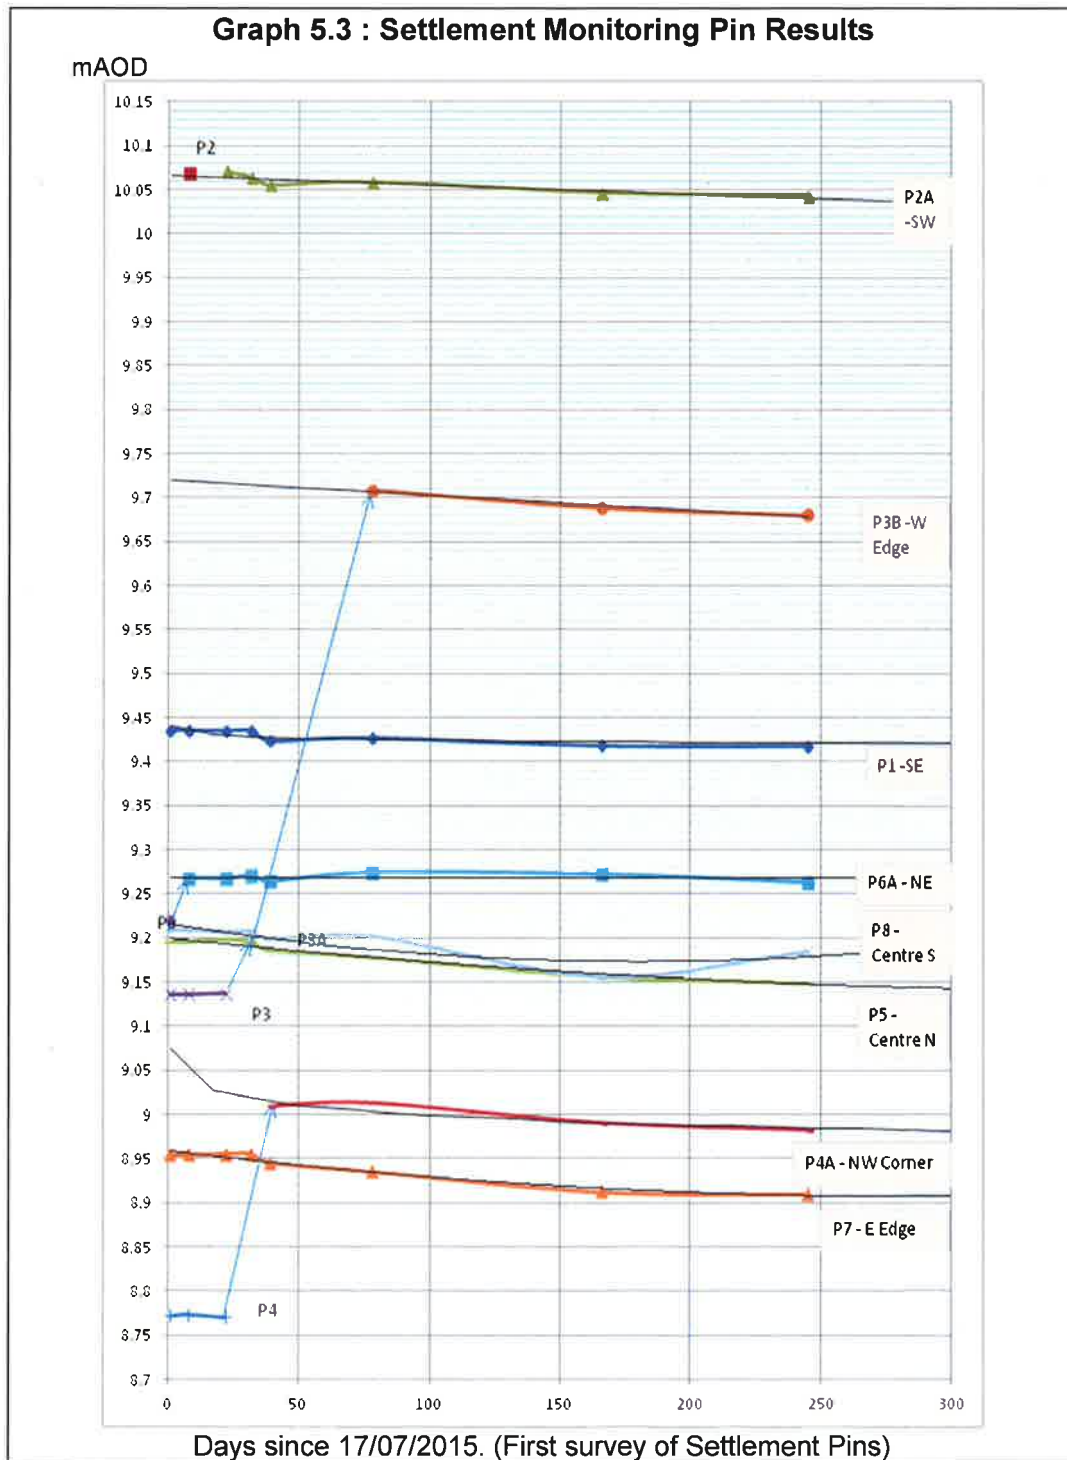
The graph below shows all of the surveyed monitoring pins on an arithmetic time scale. When a monitoring pin was damaged or destroyed an effort was made to replace the pin. When a monitoring pin was damaged / destroyed it was given a sequential alphabetical designation.

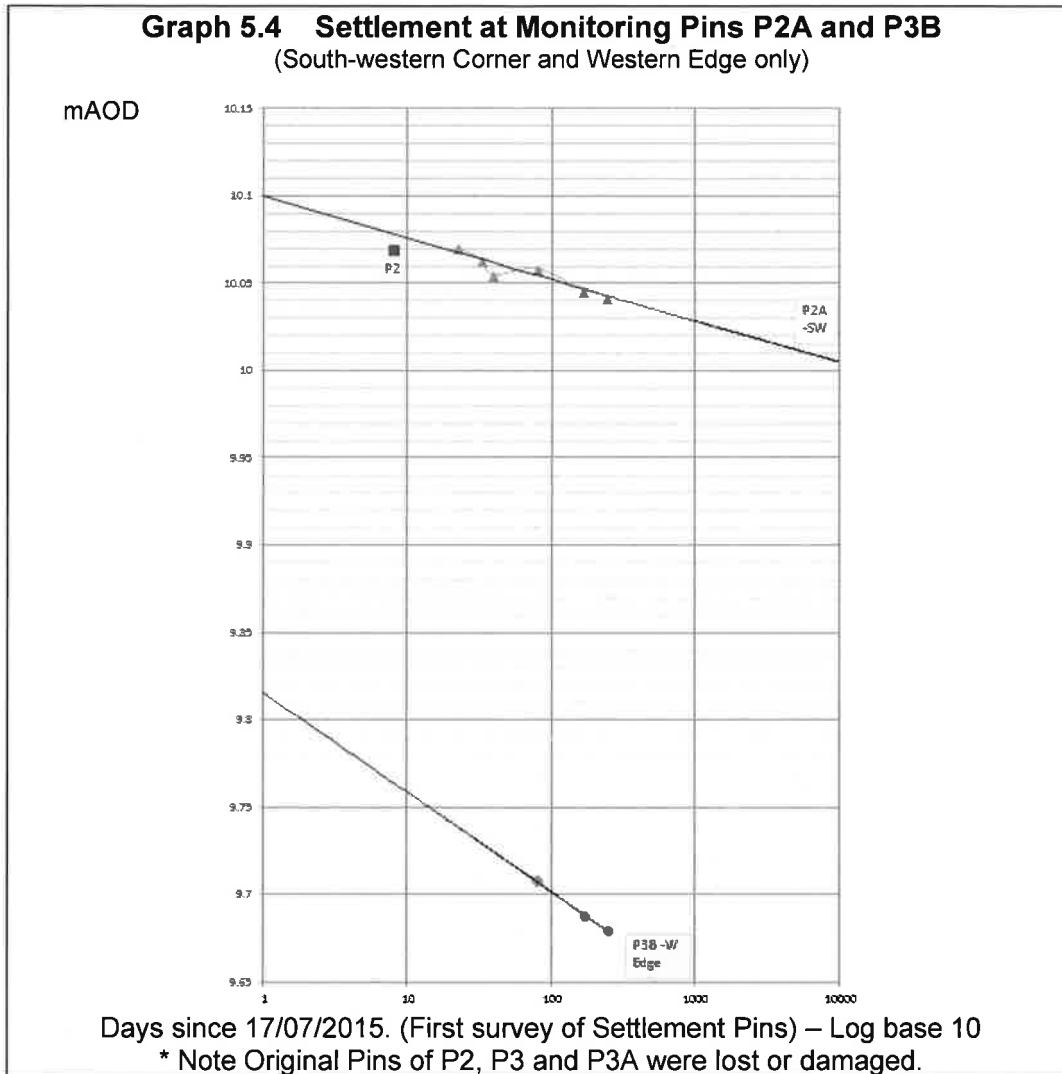
In principle secondary settlement is infinite with settlement rates dropping on a logarithmic scale. However in practice the increase in settlement after  $10^4$  days (~30years) appears to be generally "complete".

Unfortunately baseline conditions for Monitoring Pin 2 (located within the south-western corner of the site) were lost as the pin was destroyed following the placement of fill. Monitoring Pin 2A however recorded ~28mm of settlement over 7 months. Whilst the initial readings may be lost it may be possible to conjecture future settlement from the data obtained.

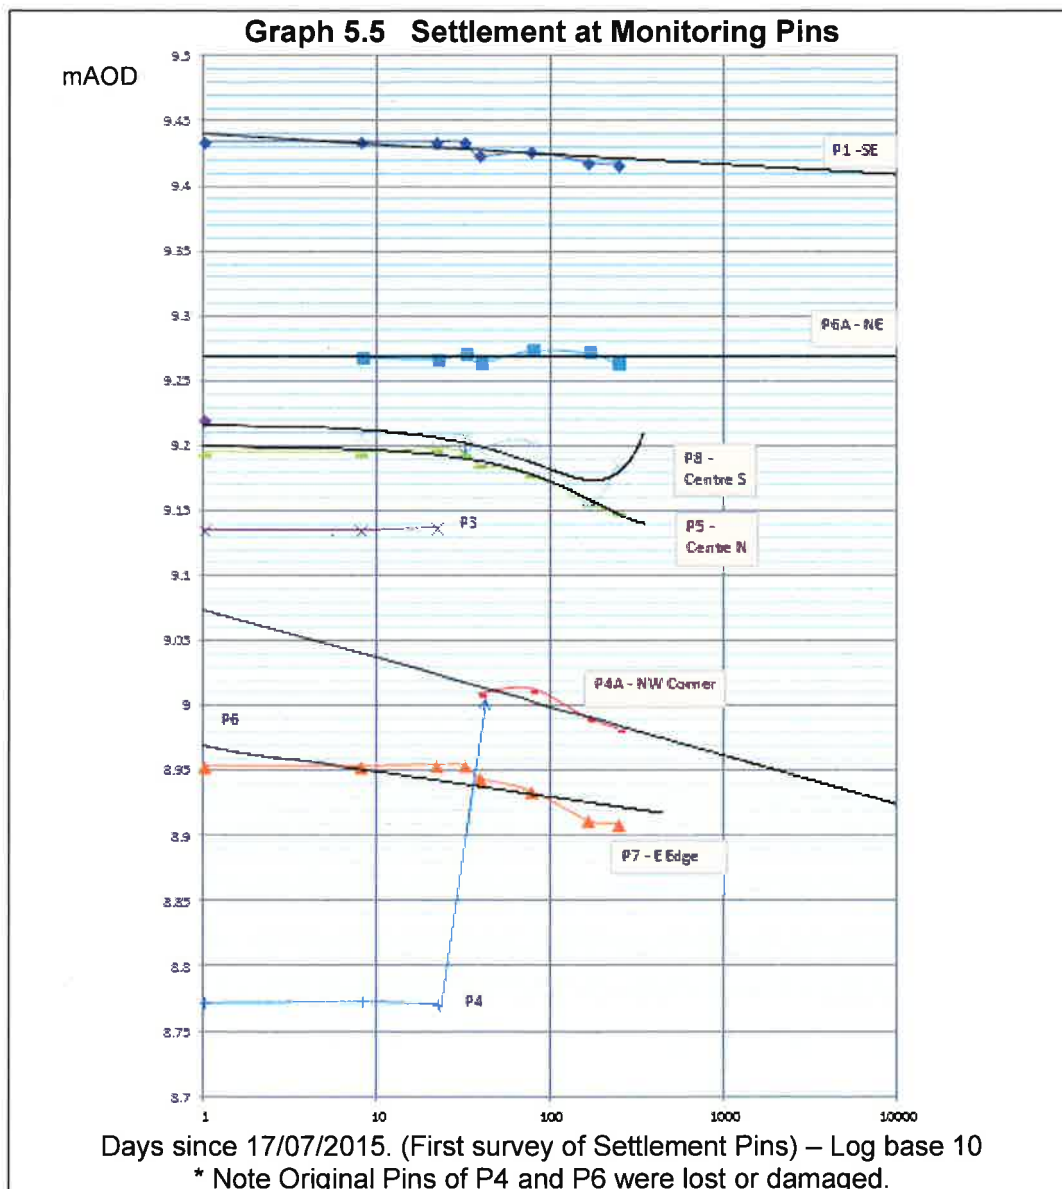
Unfortunately baseline conditions for Monitoring Pin 3 (located on the western edge of the site) were lost as the pin was destroyed following the placement of fill. Monitoring Pin 3A was similarly lost. It is considered that any attempt to assess future settlement from Monitoring Pin 3B would be open to too much error and inaccuracy to predict. It is however noted that having measured ~30mm settlement in 5 months that future settlement at this location may be greater than at Monitoring Pin 2A.

Data for Monitoring Pin 1 (located near the South-eastern Corner of the site) is complete and to date indicates settlement of ~10mm over 8 months. Conjecturing future settlement from the data obtained indicates that levels may settle to 9.41mAOD after  $10^4$  days (~30years or 2045). With the last survey indicating levels of 9.42m a further 0.010m (10mm) should be anticipated under the current surcharge by 2045.

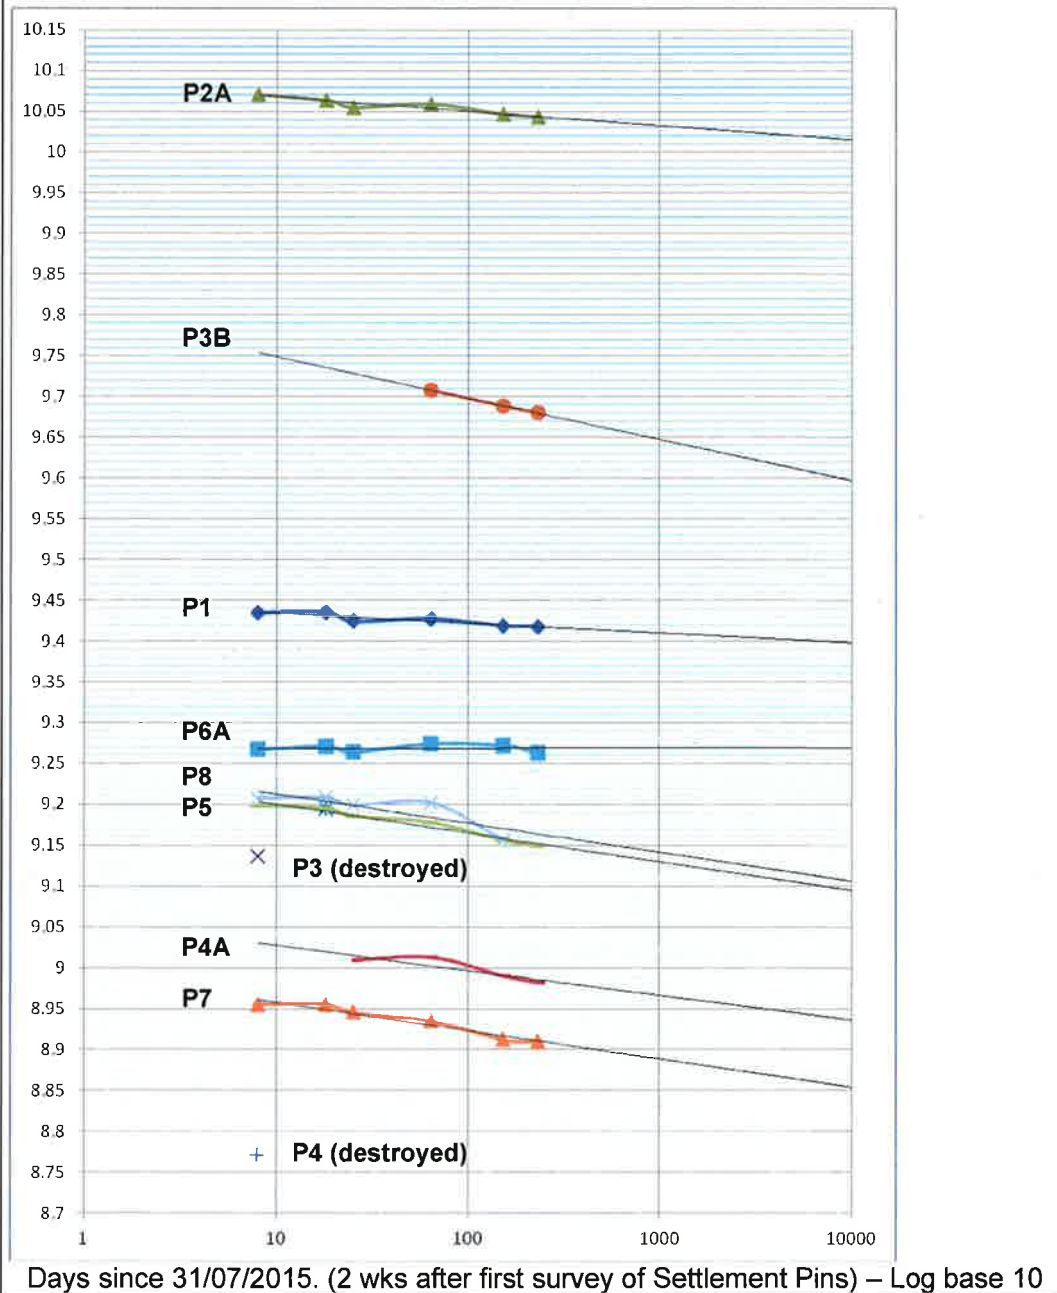
**Graph 5.6 2 Week Adjusted fit of Logarithmic Settlement Curve due to Earthworks Delay**

Data for Monitoring Pins 5, 7 and 8 do not appear to fit a logarithmic settlement curve as no settlement was observed within the first two weeks. This suggests that the start date may be out. Therefore Graph 3.6 shows settlement on a logarithmic scale starting on 31/7/2015, two weeks after the commencement of the earthworks. Settlement at Monitoring Pins 5 and 7 appear to be a closer fit as a result.

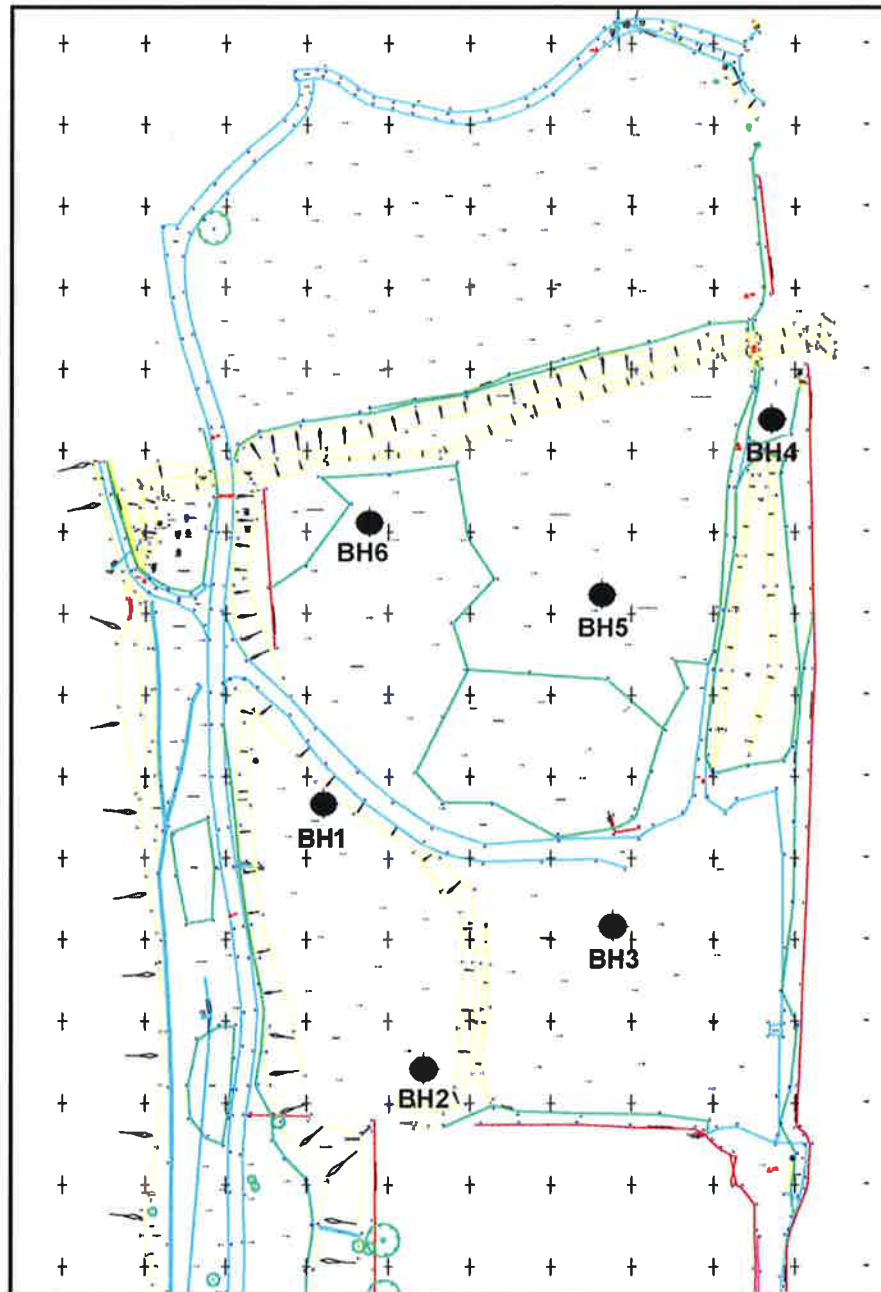
**Figure 6.1: Water Monitoring Well Locations**

Six water monitoring wells were installed, BH1 to BH6, as illustrated in **Figure 6.1** below.
