**Earthworks
Validation Report**
Proposed Residential Development
Herbert Road
Newport

Phases 2 - 4

REPORT TITLE : **Earthworks Validation Report:
Herbert Road, Newport, Phases 2 - 4**

JOB NUMBER : **12032/VR1-V3**

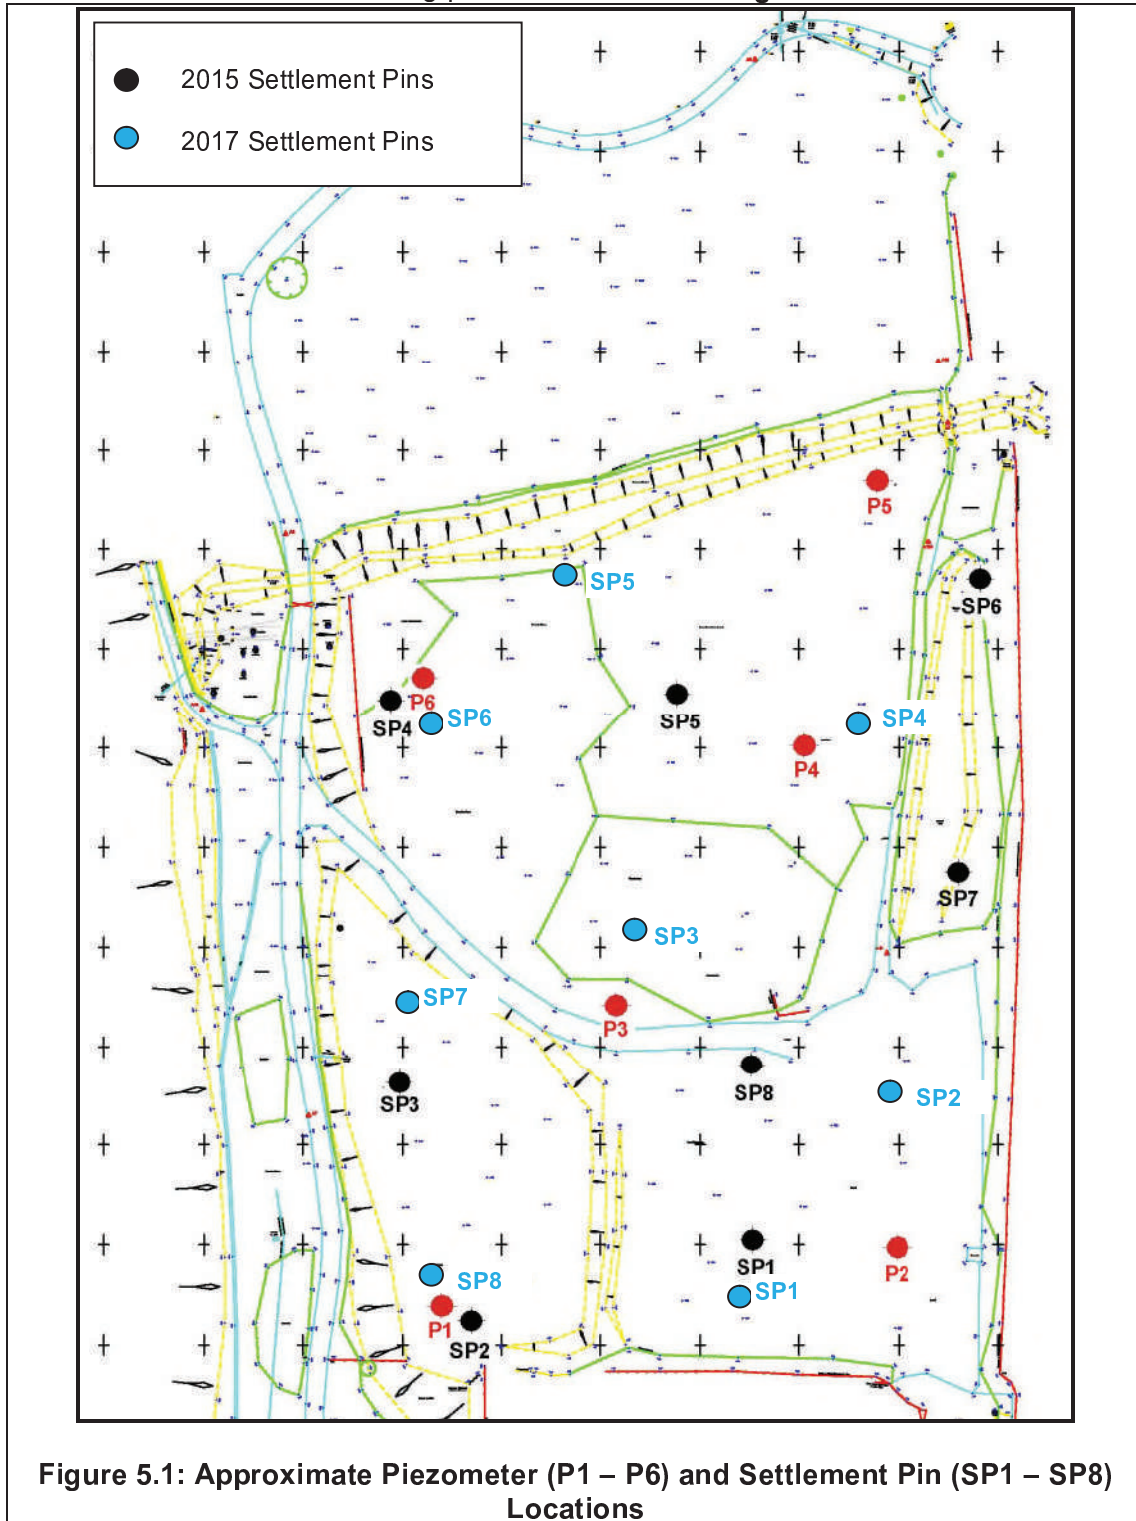
During July 2015 six vibrating wire piezometers and eight settlement monitoring pins were installed across the site. In June 2017 eight new settlement pins were installed to replace the original pins that, with the exception of one, had been damaged through site activity.

The location of these monitoring points is illustrated in **Figure 5.1** below.

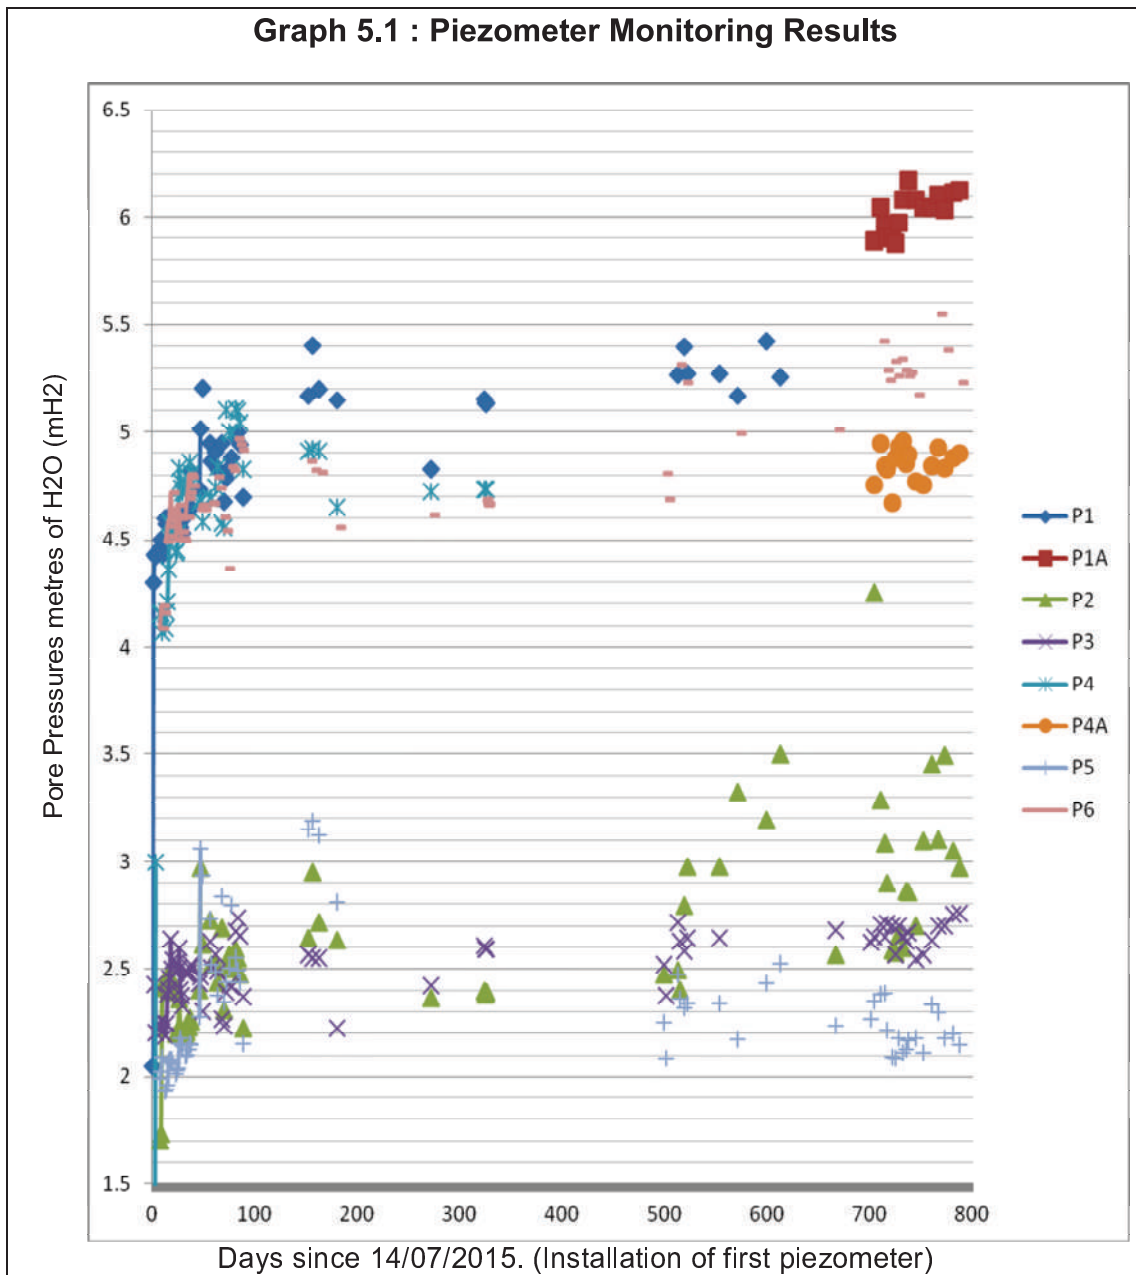
During full time supervision the increasing pore water pressures observed from the piezometers appeared to correlate with the placement of fill. As evidenced by jumps in pore water pressure over the day. Peak pore water pressure dissipated initially quickly but the rate of dissipation reduced resulting in jumps of pore water pressure.

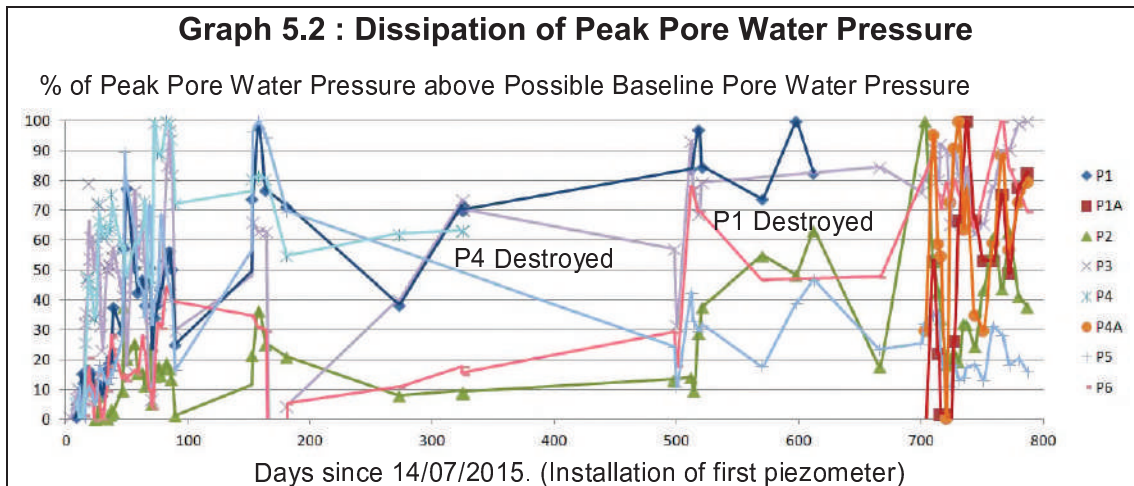
During settlement pore water pressure dissipates as water is squeezed out of consolidating material. The graph below shows the generation of peak pore water pressure generated by the placement of fill typically between 3 and 5 months after the commencement of the earthworks.

Pore water pressure has been observed to be dissipating, evidence of consolidation and settlement. However the monitoring of pore water pressure dissipation has been disrupted by filling events.

Pore water pressure dissipation of a single filling event should produce a single curve. However multiple filling events are likely to explain for the peaks and troughs of pore water dissipation suggesting that following the initial placement of the assessed stockpile further material has been placed on site.

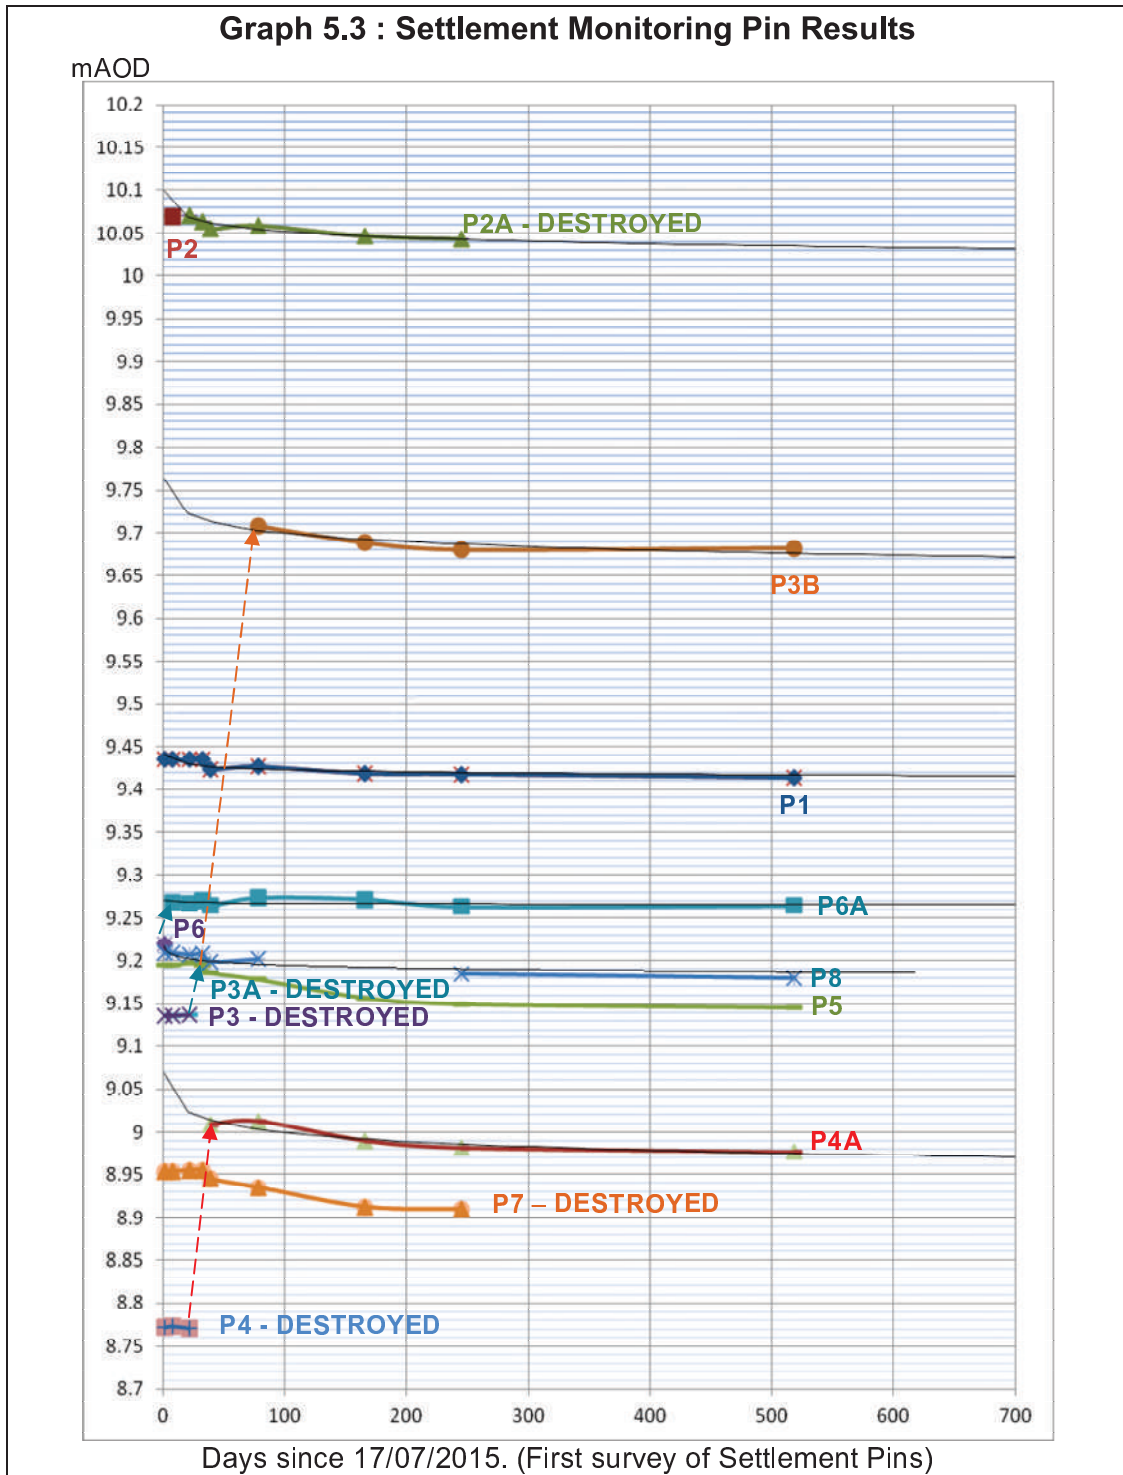
The graph below shows all of the surveyed original monitoring pins on an arithmetic time scale. When a monitoring pin was damaged or destroyed an effort was made to replace the pin. When a monitoring pin was damaged / destroyed it was given a sequential alphabetical designation.

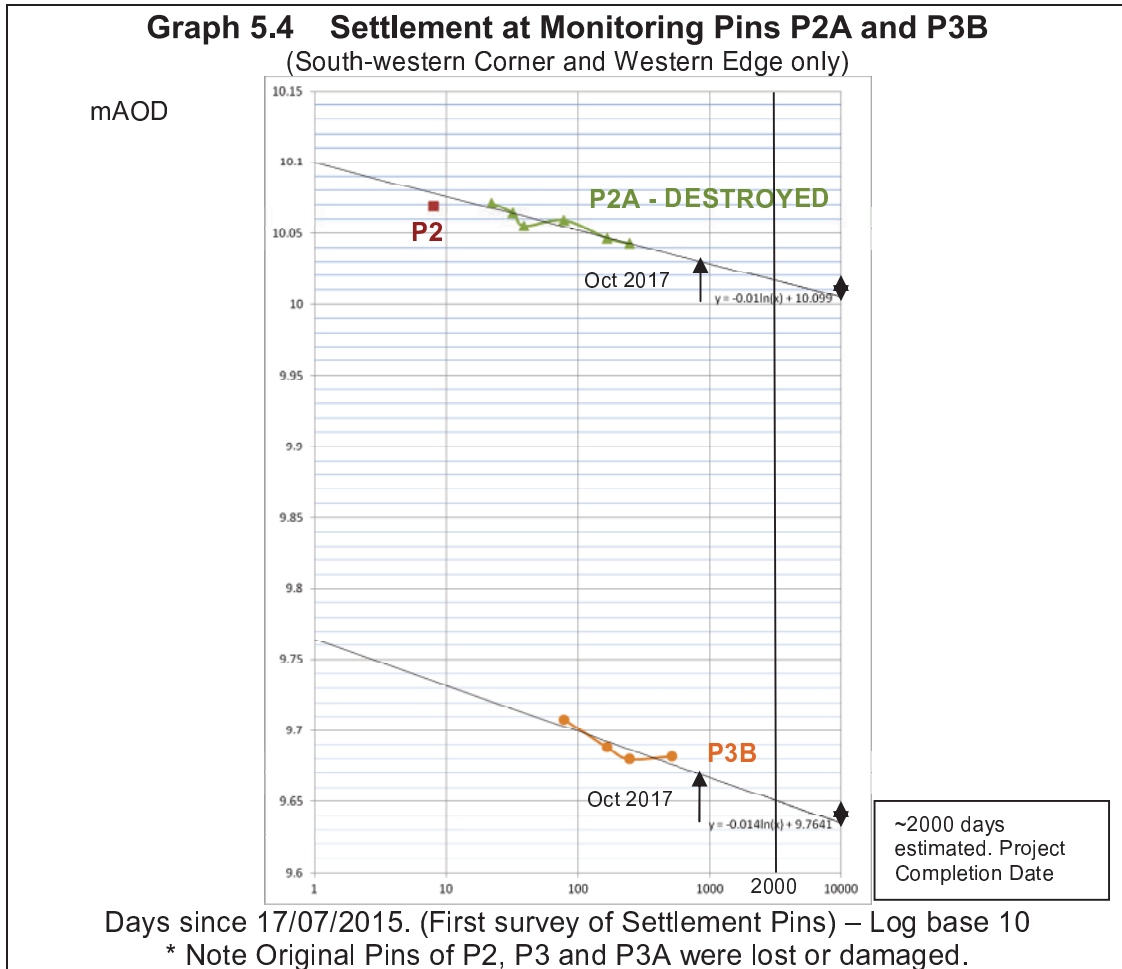
In principle secondary settlement is infinite with settlement rates dropping on a logarithmic scale. However in practice the increase in settlement after 10^4 days (~30years) appears to be generally “complete”.

Unfortunately baseline conditions for Monitoring Pin 2 (located within the south-western corner of the site) were lost as the pin was destroyed following the placement of fill. Monitoring Pin 2A however recorded ~28mm of settlement over 223 days. Whilst the initial readings may be lost and the monitoring point has been destroyed it may be possible to conjecture future settlement from the data obtained.

Unfortunately baseline conditions for Monitoring Pin 3 (located on the western edge of the site) were following the placement of fill. Monitoring Pin 3A was similarly lost. It is considered that any attempt to assess future settlement from Monitoring Pin 3B would be open to too much error and inaccuracy to predict. 28mm settlement was measured over 440days. Future settlement at this location may be slightly greater than at Monitoring Pin 2A but still less than 50mm or ~20mm after project completion.

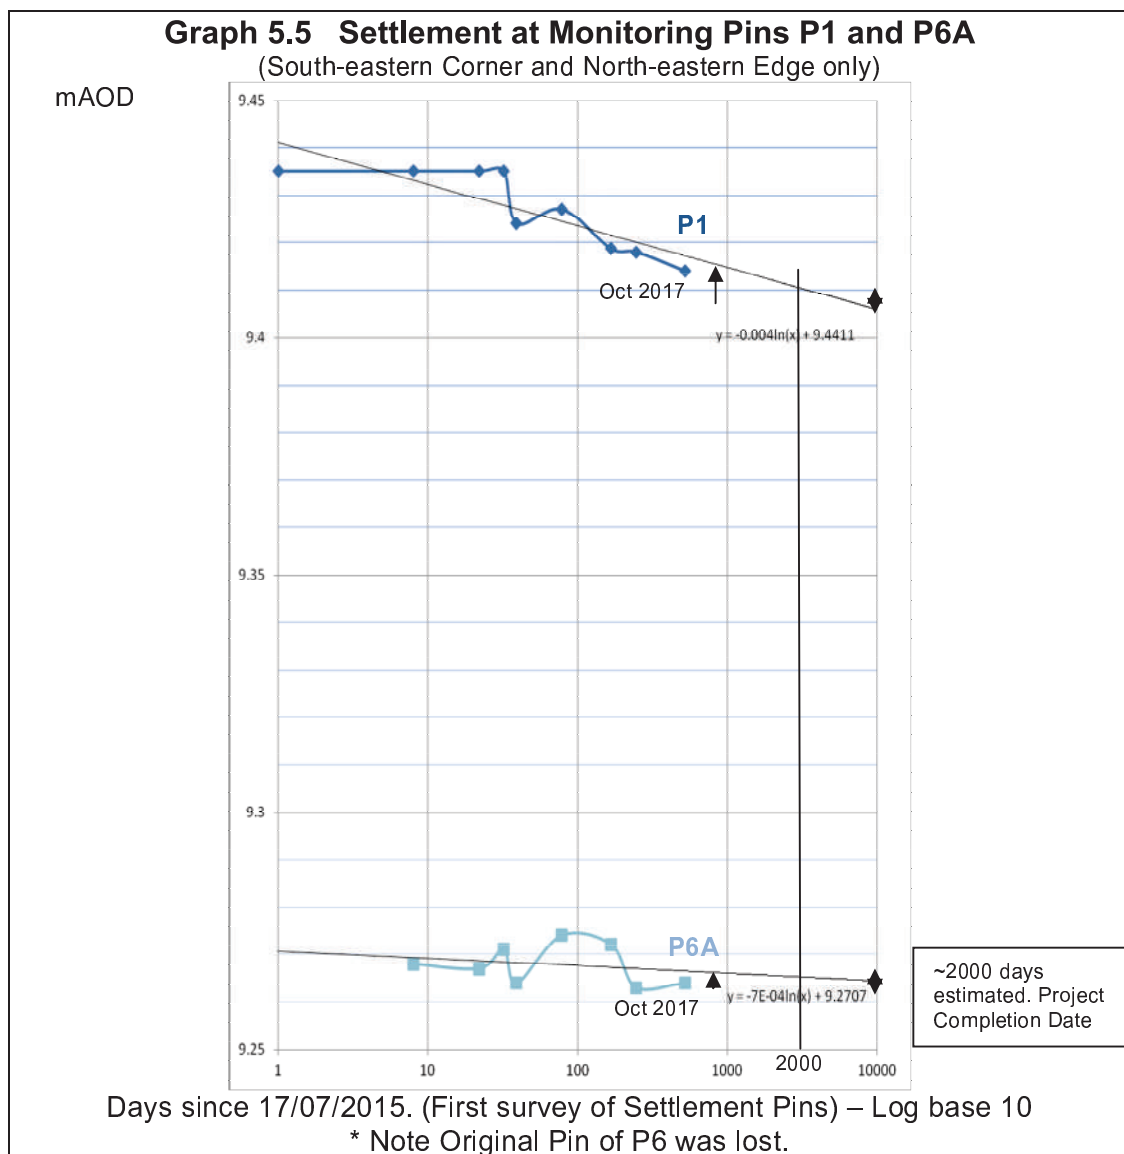
Data for Monitoring Pin 1 (located near the South-eastern Corner of the site) is complete and to date indicates settlement of ~21mm over 517 days. Conjecturing future settlement from the data obtained indicates that levels may settle to 9.405mAOD after 10^4 days (~30years or 2045). With the last survey indicating levels of 9.414m a further 0.010m (10mm) should be anticipated under the current surcharge by 2045 or ~5mm after project completion.

Unfortunately baseline conditions for Monitoring Pin 6 (located within the North-eastern corner of the site) were lost as the pin was destroyed. Monitoring Pin 6A has however recorded ~5mm of settlement over 510 days. Whilst the initial readings may be lost it may be possible to conjecture future settlement from the data obtained.

Following the current trend of settlement the above graph indicates at that levels may have settled at 9.27mAOD after 10^4 days (~30years or 2045). With the survey indicating fluctuating levels of 9.263m no further settlement is anticipated under the current surcharge by 2045.

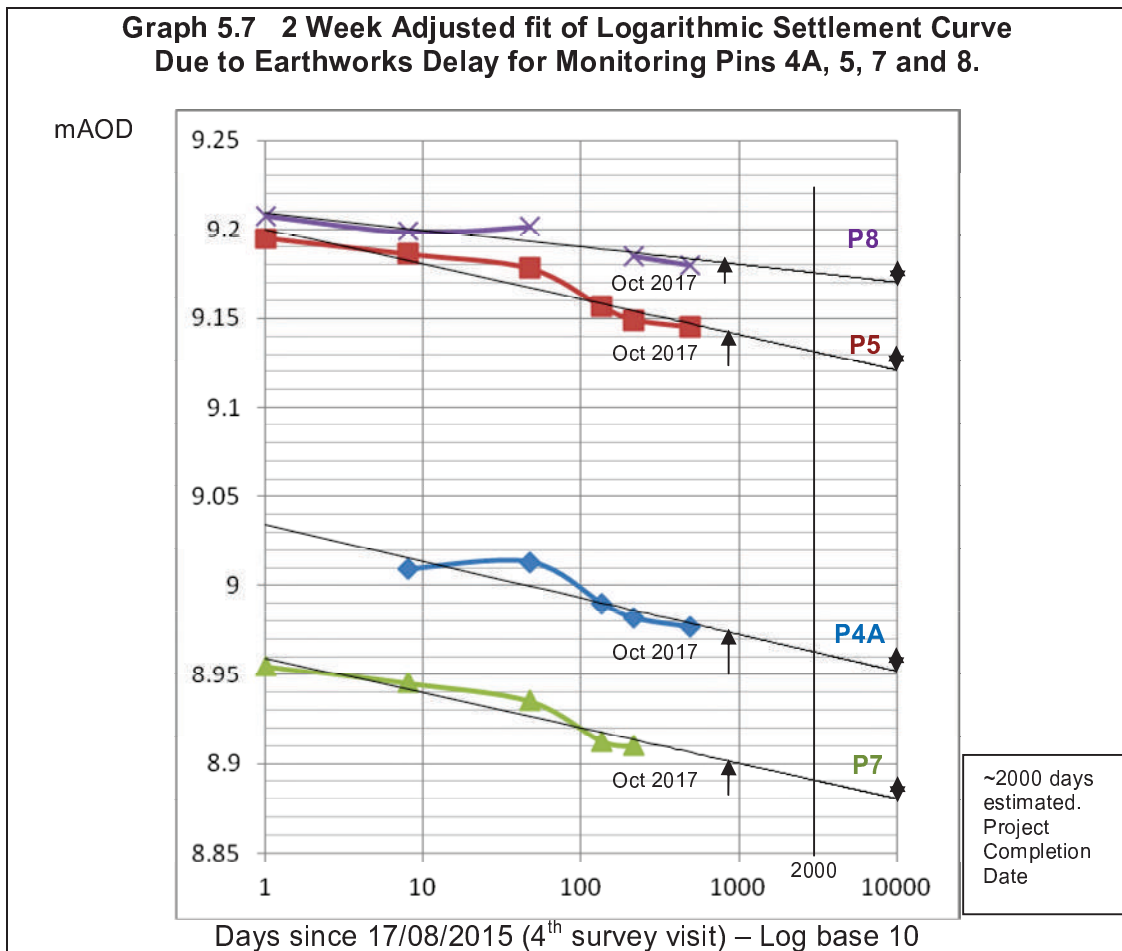
Unfortunately baseline conditions for Monitoring Pin 4 (located within the North-western corner of the site) were lost as the pin was destroyed. Monitoring Pin 4 recorded 1mm of settlement within ~20 days. It is considered that any attempt to assess future settlement at Monitoring Pin 4A would be open to too much error and inaccuracy to predict.

It is noted that following the current trend of settlement the graph indicates at that levels may settle to 8.950mAOD after 10^4 days (~30years or 2045). With the most recent survey indicating levels of 8.978mAOD a further ~30mm settlement is anticipated under the current surcharge by 2045 or ~20mm after project completion.

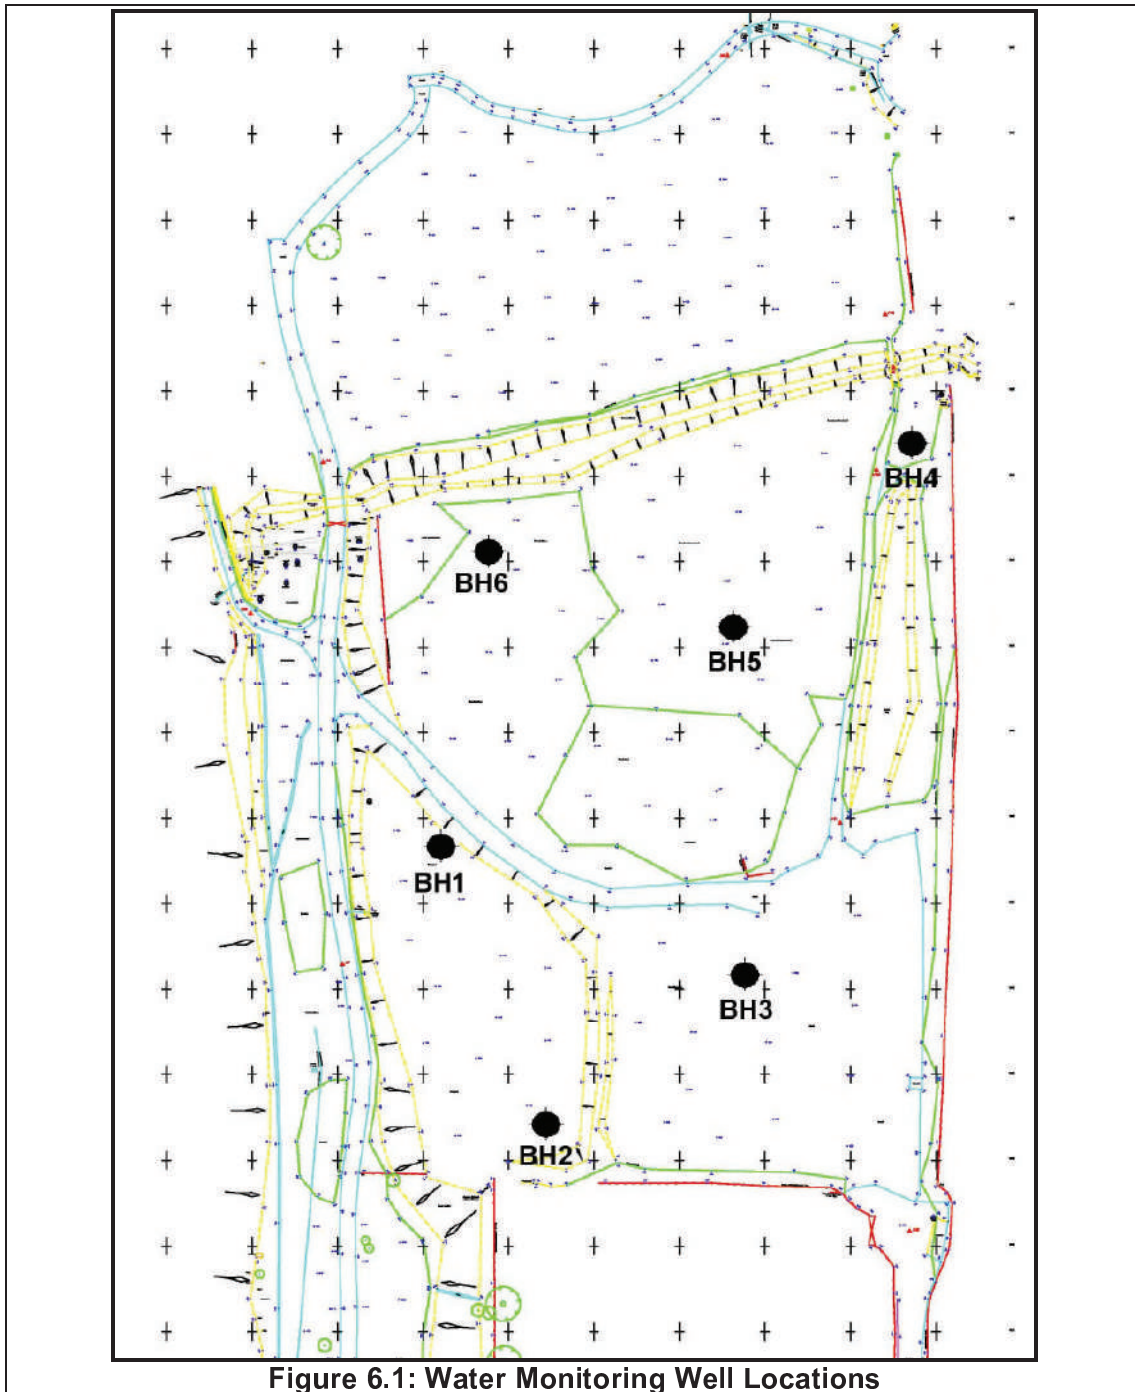
Six water monitoring wells were installed, BH1 to BH6, as illustrated in **Figure 6.1** below.
